Experimental Investigation of Material Transfer on Bearings for Total Hip Arthroplasty—A Retrieval Study on Ceramic and Metallic Femoral Heads

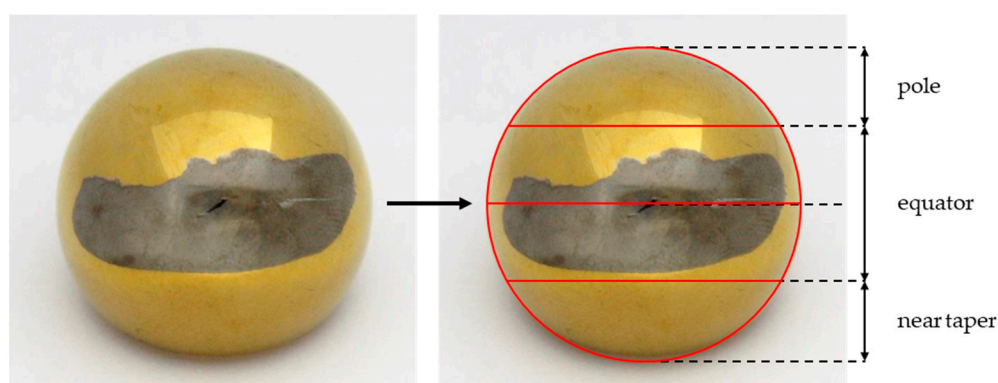
Figure 2. TiN-coated femoral head with metallic deposition in the equatorial area.

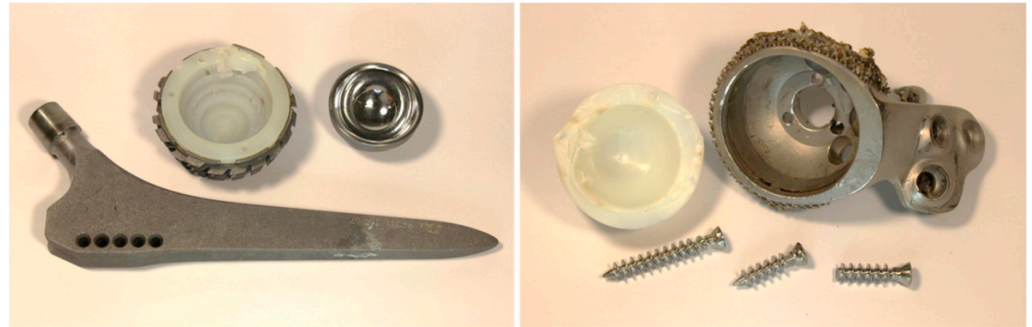
Figure 4. Examples of revised total hip implant systems.

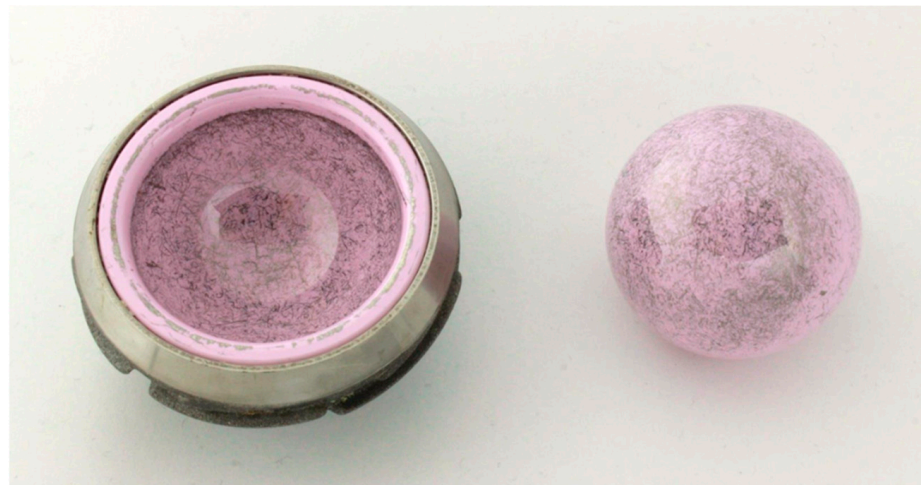
The metallic deposition can also be found in part in the associated metallic or ceramic bearing surfaces (see Figure 5). However, the more noticeable contamination is found on the femoral heads.

Figure 5. Ceramic-on-ceramic bearing couple with globally distributed metallic deposition on femoral head and insert.

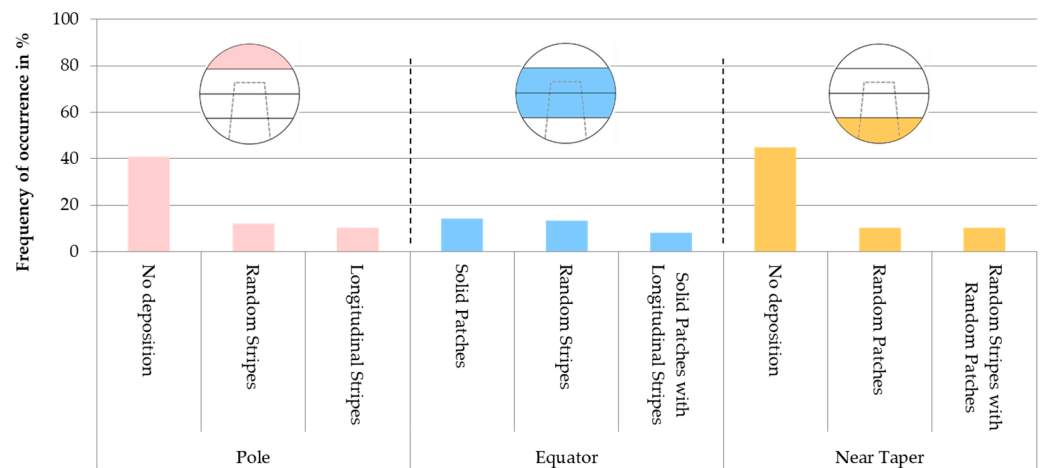
The metallic deposition occurred most frequently in the area of the equator. In 53.1% of the heads, metallic deposits were found in the equator and pole regions without contamination of the taper-near area. However, there was no case in this study in which metallic contamination occurred exclusively in the pole area. A total of 40.8% of the heads had no metallic depositions in the pole area at all. The most prevalent deposition patterns on the pole area were random stripes (12.2%) and longitudinal stripes (10.2%). In the equatorial area, the three most recurrent deposition patterns were solid patches (14.3%), random stripes (13.3%) and a combination of solid patches and longitudinal stripes (8.2%). In the near taper area, the majority of heads also showed no deposition (44.9%). The most prevalent patterns of deposition were random patches and a combination of random stripes and random patches (10.2% each, see Figure 6).

Figure 6. Most frequent deposition patterns on the femoral heads in the areas pole, equator and near taper.

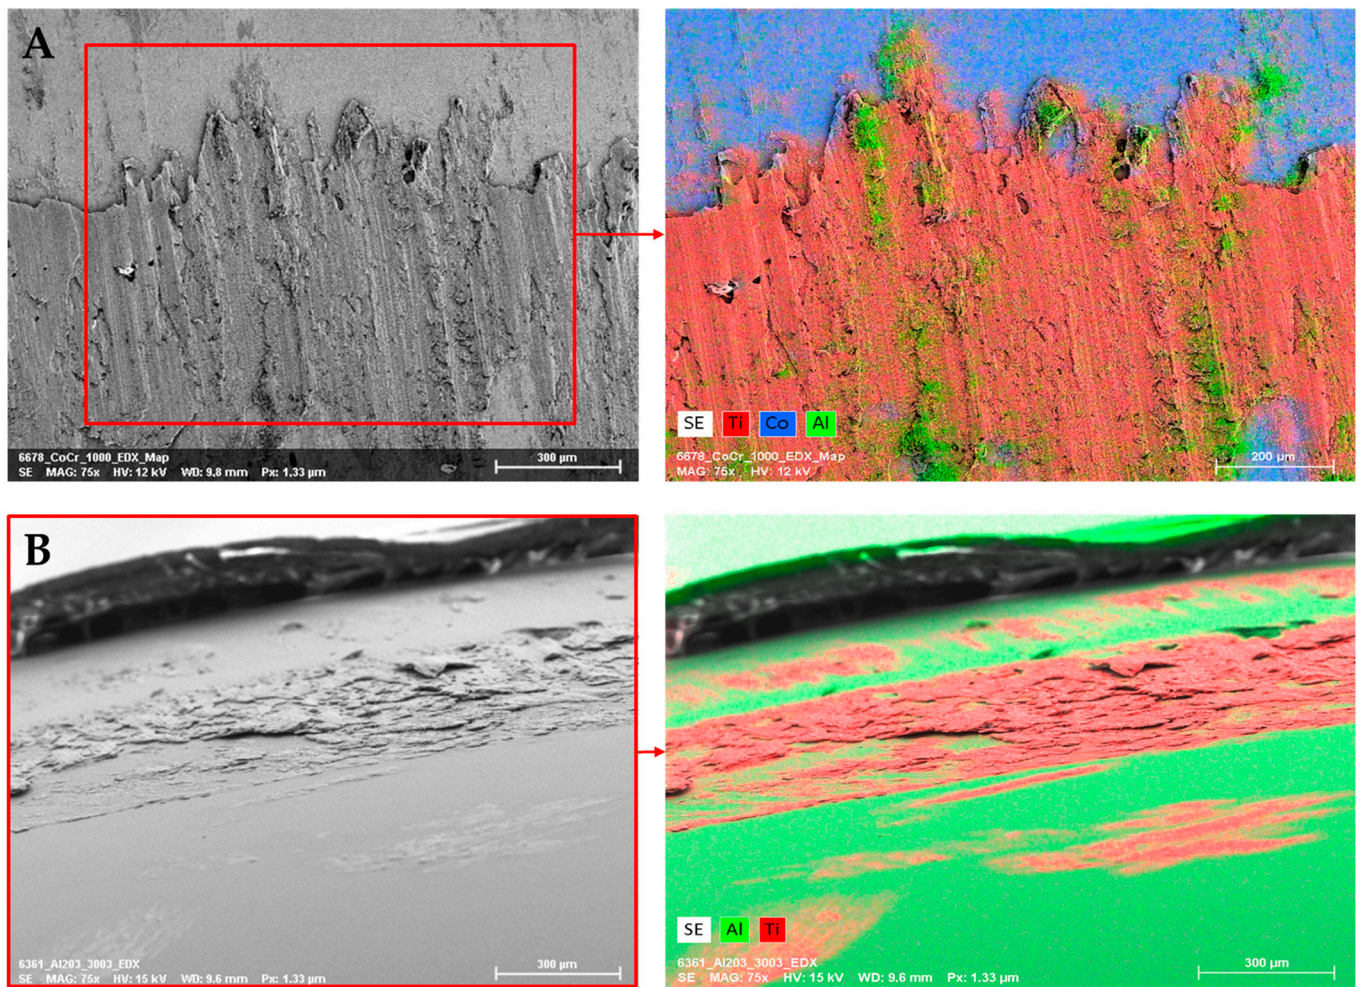
By means of EDX analysis and mapping, individual elements could be assigned to the metallic deposition. Metallic deposit, which consisted of the same material as the original surface of the head, was only included in the analysis if it could be clearly defined as a deposition. Figure 7 shows an example of the composition of the metallic deposit based on a mapping on a CoCr and an alumina head.

Figure 7. EDX mapping on retrieved femoral heads; (A) metallic deposit containing Ti and Al on CoCr femoral head and (B) metallic deposit containing Ti on alumina ceramic head.
