# A Computational Approach to the Prediction of the Floating Condition of ROPAX Vessel after Firewater Accumulation in Firefighting Operation

**Abstract:** A reliable estimation of the floating condition of a roll on/roll off cargo (ROPAX) vessel after the accumulation of firewater on the vehicle deck is extremely important for making correct decisions on evacuation and abandonment. Thus, for the seafarer working on a ROPAX vessel, there is a demand for a time-dependent prediction of the floating condition of the vessel after the firewater accumulation. For this purpose, a new iterative computational approach, based on quasi-static theory, is presented. The approach is examined through the records observed in an accident of the M/V Dashun. The results show that the approach has good accuracy and feasibility provided that the actual heeling angle and cargo shift during the accident are carefully monitored.

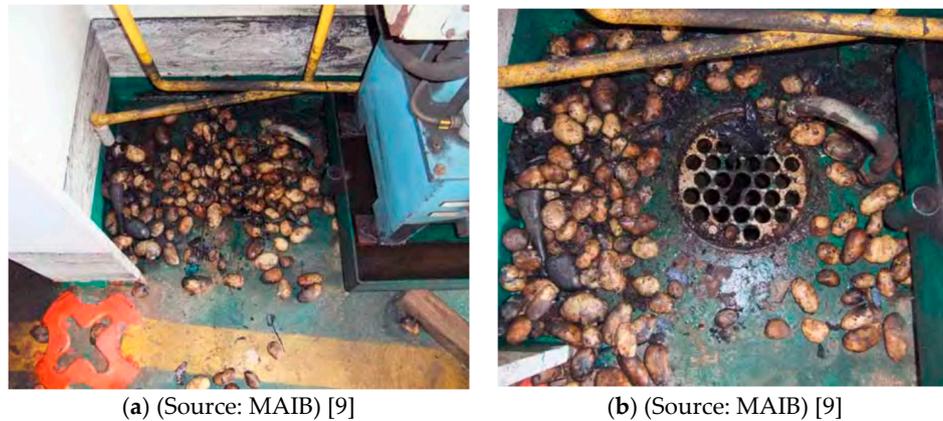
blocked (as shown in Figure 1). Subsequently, water will build up in the deck if sufficient scuppers are blocked and the access to the openings for manually cleaning the debris becomes impracticable because of large amounts of heat and smoke.

Figure 1. A deck scupper blocked by potatoes. (a) Blocked. (b) Removed.

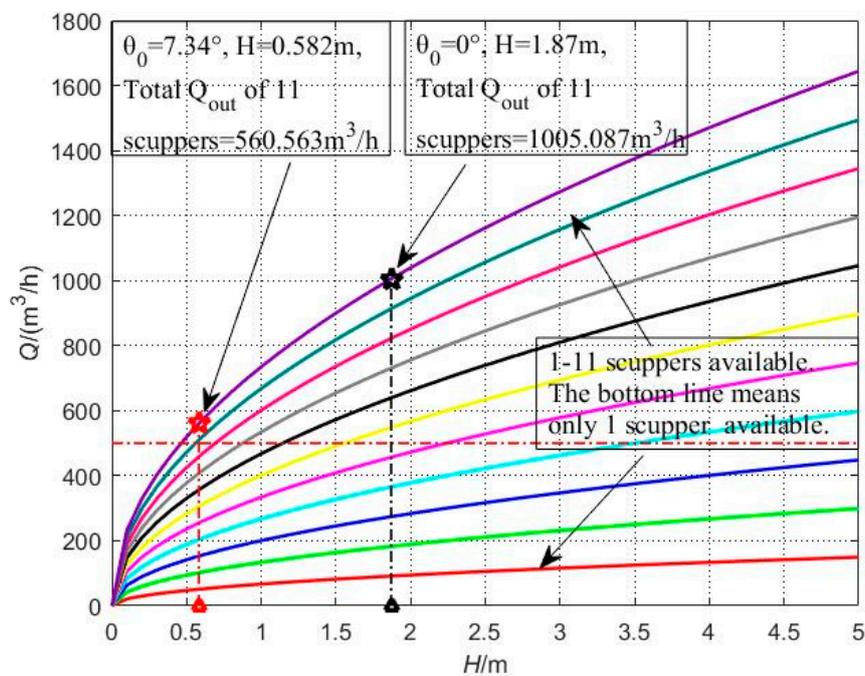
Before the accumulation of firewater, the total elevation head difference  $H$  is, if there is no a persistent heeling, determined by the initial freeboard of the vehicle deck D,  $F_0$ . According to the actual loading condition of the M/V Dashun, as shown in Table 3, it can be revealed that the average velocity of flow out  $v = 2.06927836$  m/s, and the coefficient of frictional head loss  $f = 0.05233750$  when the firewater initially accumulated on the vehicle deck D. Then, the volumetric flow rate of the flow out for a single scupper  $Q_{out} = 91.37157275$  m<sup>3</sup>/h at the beginning. The total discharge capacity of vehicle deck D at different  $H$  can then be computed as shown in Figure 6. In the case of the accident of the M/V Dashun, the total volumetric flow rate of the flow into vehicle deck D, including that sprayed from the water-drencher system and the flow from the upper vehicle deck through the vehicle passage ramp,  $Q_{in}$ , is calculated as 500 m<sup>3</sup>/h at least [30]. As shown in Figure 6, if all 11 scuppers are available, the firewater will not accumulate. However, the firewater will surely accumulate if only 5 or less scuppers are available.

**Figure 6.** Scupper discharge capacity of vehicle deck D.

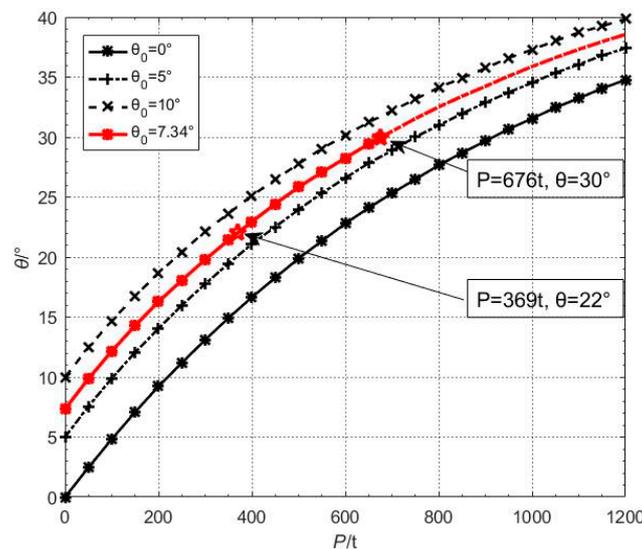
As shown in Figure 7, the red line indicates the computation results of the change in the heeling angle with the increase of accumulated firewater. The red line in Figure 8 shows the change of the heeling angle with the passing of time. According to the results of the computation, 2 of 11 scuppers

are definitely blocked on the port side of the M/V Dashun, which means that the blocking condition in vehicle deck D is not as serious as what was concluded in [5,6] and that the accumulation of firewater is mainly caused by the influence of the persistent heeling due to cargo shift. According to computation results, it was 1936 h local time when the vessel was heeled to 30°. In the records observed in the accident, it was 1930 h local time the vessel was heeled to approximately 30° on the port side. The error for this record is approximately 6 min within a total time consumption of 189 min. According to [31], a salvage boat, “Yanjiu13”, arrived at the scene of the accident at about 1910, and tried to throw a heaving line to M/V Dashun at about 1921 local time after communication with it. During this period, the heeling angle of the M/V Dashun was about 21° to 22° on the port side. Therefore, the maximum error of the computation result of the heeling angle of 22°, as shown in Figure 8, is 22 min within total time consumption 180 min, and the minimum error is about 11 min. For making a correct decision on a further operation after the firewater accumulation, this computational approach is feasible and practicable. What should be mentioned here is that the calculation of the persist heeling angle caused by cargo shift, the total volumetric flow into vehicle deck D, and the heeling angle observed in severe weather may give a contribution to the error of the approach. However, these errors will be minimized in a modern ROPAX vessel equipped with precision instruments.

Figure 7. The firewater accumulation of the M/V Dashun accident.

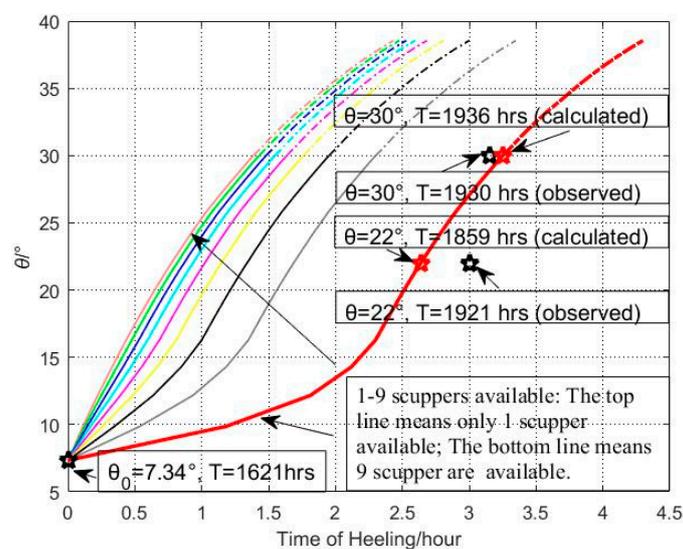
Figure 8. The heeling time of the M/V Dashun accident after the blockage of 2 of 11 scuppers.

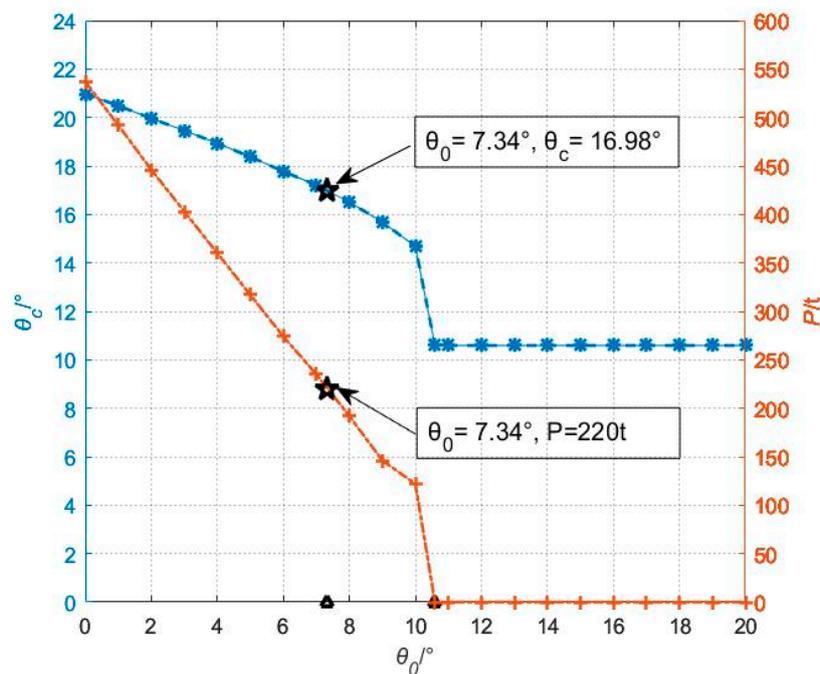
According to the loading condition of the M/V Dashun, 220 t of accumulated firewater would have made the heeling angle of the vessel reach the critical value,  $\theta_c = 16.98^\circ$ , after the cargo shift had caused a persistent heeling angle  $\theta_0 = 7.34^\circ$  on the port side (as shown in Figure 11).

Figure 11. Critical heeling angle,  $\theta_c$ , and the corresponding firewater weight,  $P$ .

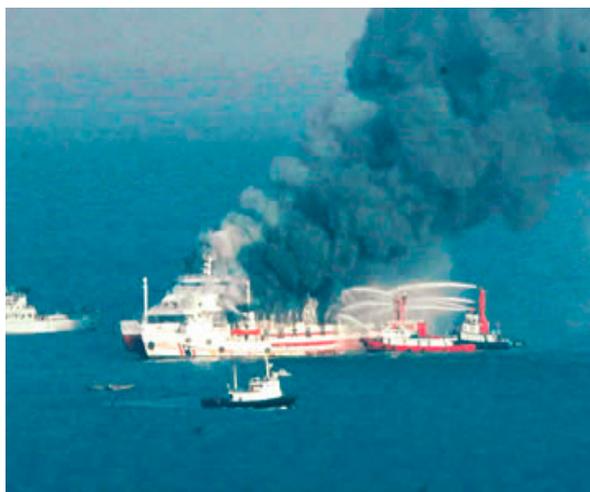
Since its implementation, the Guidelines have played a good role in preventing firewater accumulation on Ro-Ro decks. But the risk of firewater accumulation still exist, especially when the vessel is in port. It should be noted that the fire extinguishing system (usually low-pressure CO<sub>2</sub>) is ineffective when the ship is in port, as external and internal ramps are open and can in many cases not be closed quickly in the case of a fire [36]. To avoid a major fire accident, many ports throughout the world have been equipped with fireboats with a large spraying capacity. For example, the M/V Daxiao 01, one of the firefighting boats with the maximum water spraying capacity in China at present, has been equipped with a main water firefighting gun with spraying capacity 3600 m<sup>3</sup>/h. If firefighting boats with such a large water spraying capacity are fully engaged in the firefighting of ROPAX vessels, the situation may become deteriorated even though the drainage system has been designed as per the requirements of SOLAS regulations (Figure 12).

**Figure 12.** Two fire boats engaged in the firefighting of the M/V Liaohai.
