Failure Analysis of Chromium Plating Layer on the Surface of the Piston Rod of the Hydraulic Jack

Qiankun Zhang ¹, Jiangan Wang ^{1,2,*}, Wenjing Shen ¹, Fengshan Huang ^{3,*} and Yongjie Zhao ⁴

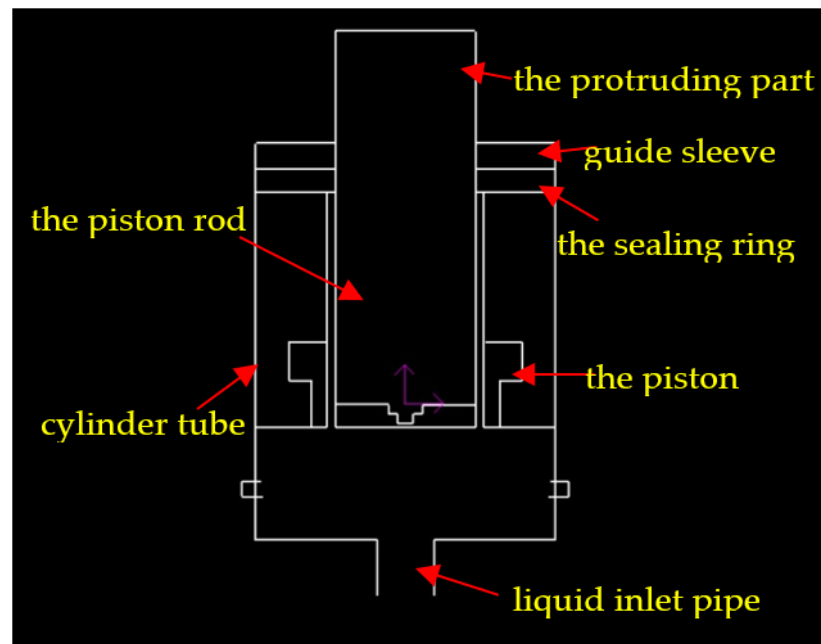
The hydraulic jack used liquid as the working medium, transmitting power through the change of the sealing volume. The liquid used was the No. 4 resident solution, which was developed and manufactured by the Armory factory and was composed of ethylene glycol, distilled water, corrosion inhibitor, and other additives. The liquid was mainly used for artillery recoil devices, pressure balancing machines, and hydraulic jacks, which possessed excellent low-temperature and hydraulic transmission properties. The piston rod made a reciprocating linear motion in the hydraulic cylinder to lift heavy objects. The speed of the piston rod that contacted the sealing ring and guide sleeve was not fast during movement, as shown in Figure 1.

Figure 1. A schematic diagram of the motion of the piston rod.

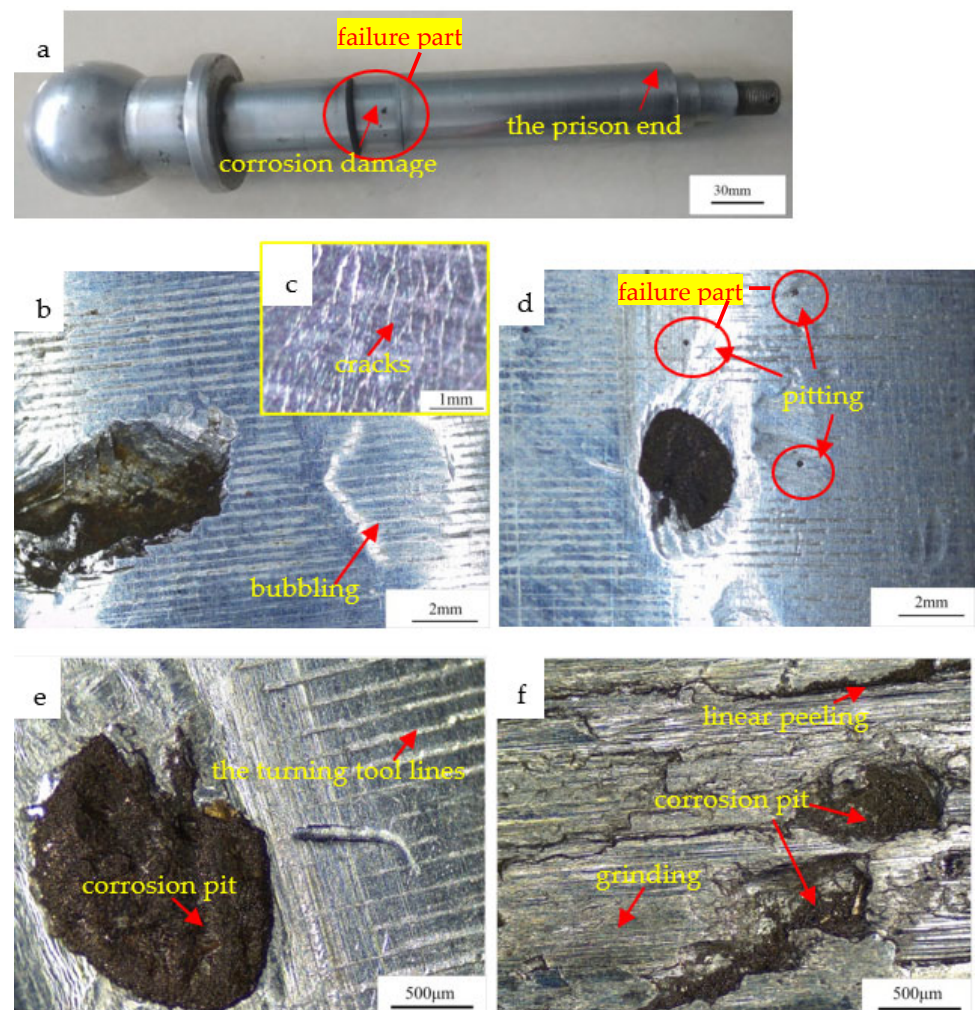
In this case, as shown in Figure 2a, the substrate material of the piston rod was 40Cr, which was a kind of artillery alloy structural steel, and its technical standard was YB476-64. Its length was 400 mm, and the diameter of its main part was 45 mm. The surface of the piston rod was a milky white chromium plating layer. The piston rod had different requirements for various parts during the chromium plating [10], and the thickness range of the chromium layer was 0.04–0.06 mm. The thickness of the chromium layer of its main part was 0.04 mm, and the thickness of the chromium layer in the head of the piston rod was increased to 0.06 mm. The surface finish of the central part of the piston rod was $\nabla 7$, and the surface roughness was calculated as Ra6.3–Ra12.5 μm .

Figure 2. Macroscopic morphology observation: (a) piston rod; (b) bubbling of the chromium plating layer; (c) magnified surface of bubbling; (d) pitting; (e) corrosion pit; (f) grinding and peeling.

The hydraulic jack was used in the military factory and was an accessory piece for the artillery. After the piston rod worked for a while, the corrosion pit and peeling occurred on the chromium plating layer in the middle area of the piston rod. No corrosion damage was found on the chromium plating layer close to the piston end, as shown in Figure 2a. Figure 2b shows the bubbling of the chromium plating layer in which a number of cracks were distributed on its surface in Figure 2c. Some pitting was distributed in the middle area of the piston rod in Figure 2d. In addition, there were also two defects in the middle area: corrosion pit and linear peeling, as shown in Figure 2e,f. Through measurement and observation, the areas of the corrosion pits were different, and the pit was black. The chromium plating layer completely fell off and the substrate was exposed. It could also be seen that the chromium plating layer on the edge of the corrosion pit was rough and uneven, and the clear turning tool lines were left by a profiling deposition. After grinding, the thickness of the chromium plating layer was reduced. In addition, the shape and density of the cracks in the chromium plating layer were changed, and linear peeling along the cracks occurred. The linear peeling was about 3 mm in length and 0.1 mm in width, distributed along the circumferential direction in which black substances were also distributed.

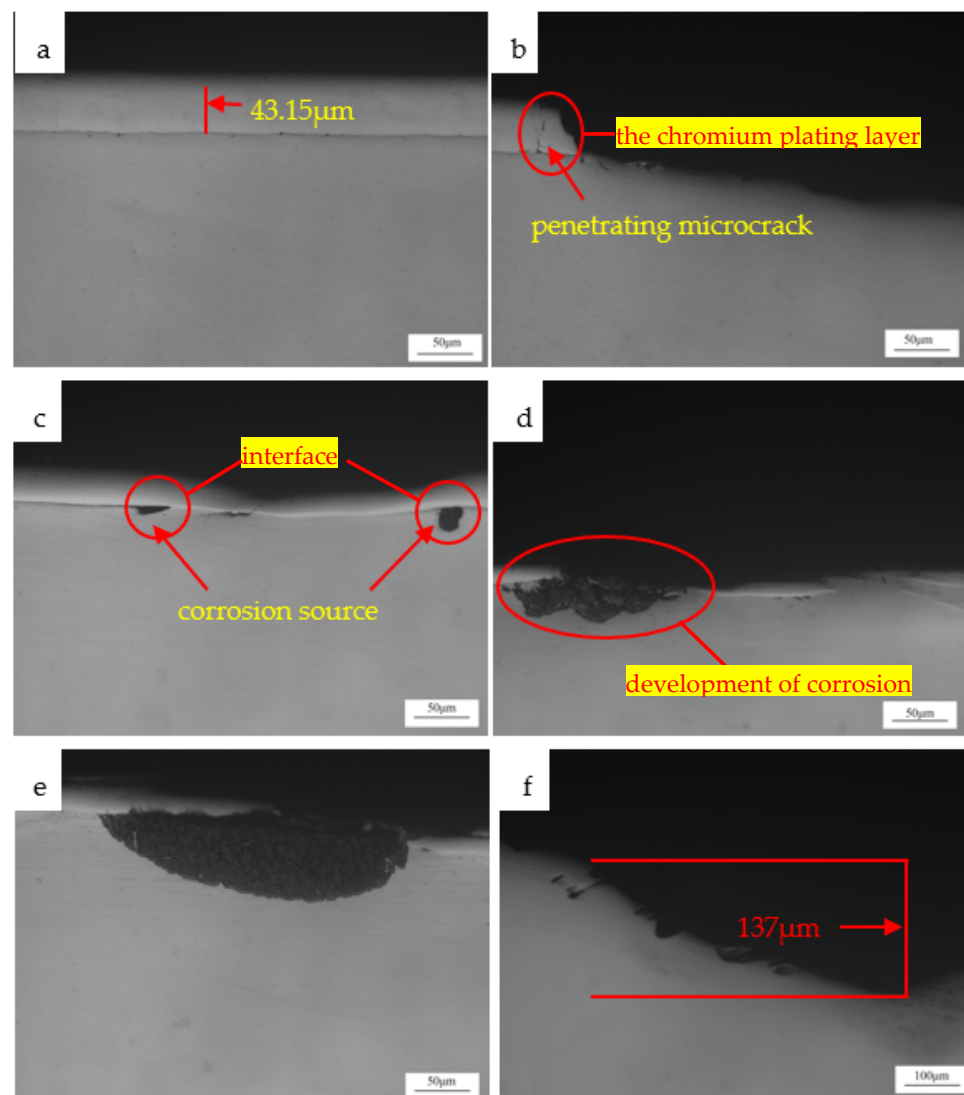
As shown in Figure 3, the bonding state between the chromium plating layer and the substrate was observed through a metallographic microscope. According to Figure 3a, the thickness of the chromium plating layer in the middle of the piston rod was 43.15 μm , which was physically combined with the substrate material. In Figure 3b, cracks penetrating the chromium plating layer were found, which could provide a channel for the corrosive medium. In Figure 3c, the substrate had been corroded, and corrosion sources existed at the interface between the chromium plating layer and the substrate. At this time, the chromium plating layer was not peeled off. The corrosion in Figure 3d extended further and the chromium plating layer cracked and peeled off, making the corrosion medium easier to penetrate, and the corrosion intensified. In Figure 3e, part of the chromium plating layer had separated from the substrate, resulting in the steel substrate being completely exposed. The chromium plating layer belonged to the cathodic coating. The combination of a large cathode and a small anode aggravated the corrosion, resulting in the corrosion area of the substrate being larger. In Figure 3f, the steel substrate was further corroded, resulting in the fracture and peeling of the chromium plating layer at the edge of the corrosion pit.

The corrosion of the steel substrate proceeded along the width and depth direction of the corrosion pit. It could be seen that the pit depth was $137\ \mu\text{m}$ in Figure 3f.

Figure 3. OM observation on the bonding state of the chromium plating layer and substrate: (a) intact part; (b) penetrating microcrack; (c) corrosion source; (d) development of corrosion; (e) aggravation of corrosion; (f) the cross-section of corrosion pit.

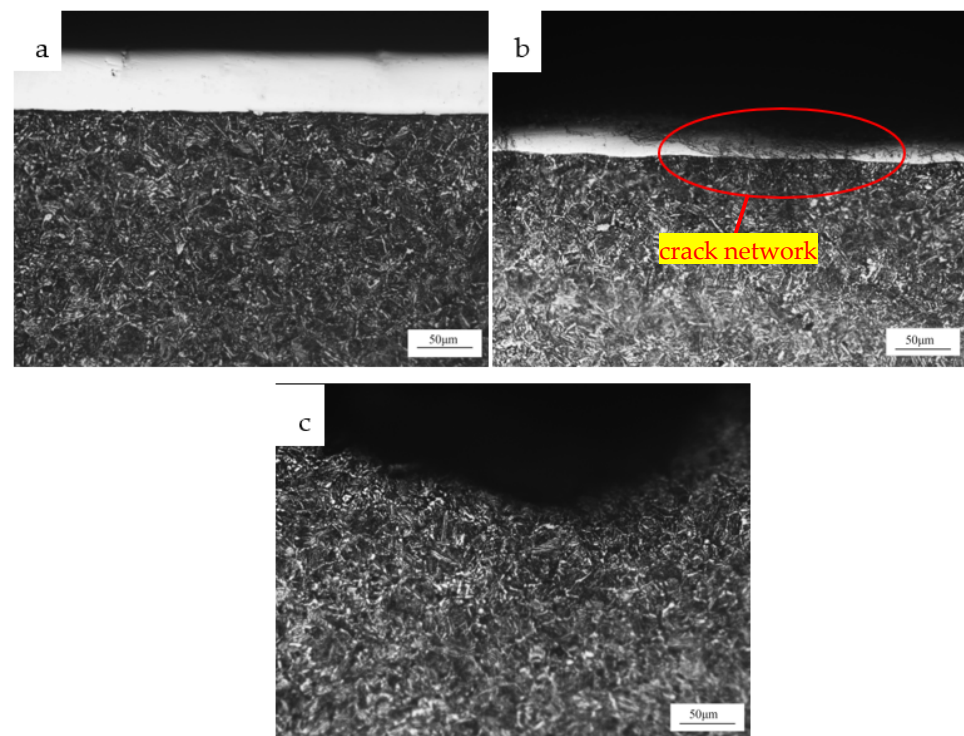
The cross-section of the test piece was ground and polished so that the structure could be observed after the corrosion. It could be seen from Figure 4a that the substrate structure was tempered sorbite and that fine, uniform, and white cementite were distributed in the ferrite substrate. Here, the carbides were spherical and stable. The hardness of the substrate was $240\text{HV}0.2$, and the chromium plating layer was $600\text{HV}0.2$ by using a Vickers hardness tester, which met the standard requirements. In Figure 4b, a crack network existed in the chromium plating layer, and some cracks penetrated the chromium plating layer. Figure 4c shows the cross-sectional structure morphology of the corrosion pit where no cracks occurred near the pit, and the structure was typical.

Figure 4. OM observation of structure: (a) substrate; (b) crack part; (c) the cross-section of corrosion pit.

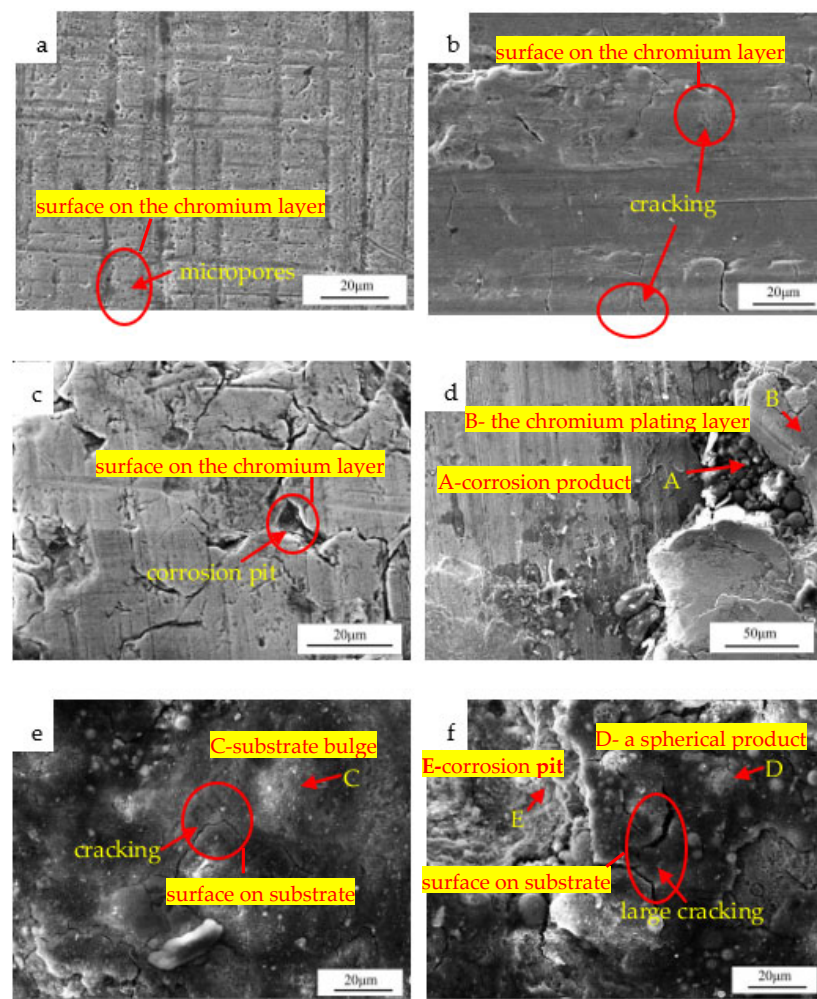
Figure 5 is an SEM observation of the surface morphology. The turning tool lines and micropores were distributed on the surface of the chromium plating layer in Figure 5a. It could be seen from Figure 5b that cracking was distributed on the surface of the chromium plating layer. The chromium plating layer in Figure 5c was seriously cracked and partially peeled, and corrosion pits also occurred. The chromium plating layer was broken and peeled in a large area, and corrosion products could be seen in Figure 5d. Point A was a spherical corrosion product and the composition of point A was detected. In Table 2, it could be seen that Fe was the main element, and the content of the O and S was, respectively, 11.49 and 0.52%, indicating iron oxides and sulfides were formed here. The composition analysis of point B in Figure 5d showed that Cr was the main element, and the content was 85.73%, suggesting the chromium plating layer. In addition, Point B also contained the elements C and O. Element C was caused by the residual dry lubricating oil on the surface of the piston rod, and element O should be the result of the oxidation of the chromium plating layer in the air. Figure 5e shows the morphology of a corrosion pit where the surface was rough and uneven, with bulges and cracks. Point C was a bulge and the composition analysis of point C showed that Fe was the main element, and the content of O and S was, respectively, 11.18 and 0.6%, indicating that the substrate was seriously corroded here. Figure 5f showed a corrosion extension where large cracks, substrate peeling, and pits were distributed. Point D was a spherical bulge that was distributed more on the substrate. The composition analysis showed more O and S elements and was parallel to point C, indicating the substrate was seriously corroded. Point E was a pit, and EDS showed that the content of the O element was 26.20%, indicating that the corrosion here was the most serious.

Figure 5. SEM micromorphology observation: (a) chromium plating layer; (b) cracking; (c) corrosion pit; (d) peeling of the chromium plating layer; (e) exposed substrate; (f) corrosion extension.

For the network cracks and penetrating cracks in the chromium plating layer, it should be that there was a considerable internal stress in the chromium plating layer. In addition, the chromium plating layer had high hardness and brittleness, which made it easy to produce microcracks [12]. Generally, after chromium plating, there was a specific residual tensile stress in the chromium plating layer. The reason for this was that the layer's equilibrium spacing between atoms was smaller than the substrate, resulting in additional tensile stress on the chromium plating layer [5]. In addition, chromium was deposited in the electroplating process, accompanying the generation of a large amount of hydrogen, which would penetrate the chromium layer and react with the chromium to form CrH, which was unstable and brittle. Some studies have shown that the internal stress on the surface of the chromium layer and the stress caused by hydrogen diffusion to the chromium layer are surface residual tensile stresses. Cracks would appear when the stress exceeded the fracture strength of the chromium layer material [13]. At the same time, to achieve the required contour accuracy, the chromium plating layer also needed to be machined after electroplating, which was usually cylindrical-forming grinding. The superposition of the grinding force and internal stress in the chromium layer would change the density and shape of the cracks, aggravating the development of cracks in depth and width and leading to penetrating cracks in the chromium plating layer, as shown in Figures 2b and 5a. The turning tool lines on the surface of the piston rod were seen in Figure 1e, and the residual stress of the turning tool lines would also affect the cracking of the chromium plating layer [8]. In addition, loose pores on the surface of the chromium plating layer could also cause corrosion, as shown in Figure 2d. Pores would be created in the chromium plating process, which were generally small in size and high in distribution density [14], as shown in Figure 5a.

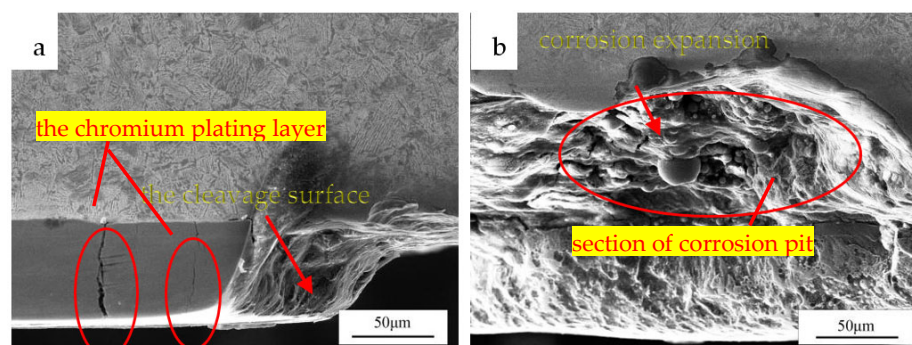
Figure 6 shows an observation of the SEM morphology of the cross-section. Penetrating cracks were found in Figure 6a, which would provide channels for the corrosive medium. A fractured chromium layer was also found and the cleavage surface was about 45° from the axis of the rod. It could be seen that the corrosion products were distributed in the pit, and corrosion expansion extending to the width and depth direction of the corrosion pit was identified in Figure 6b.

Figure 6. SEM morphology observation: (a) a fractured chromium layer; (b) section of corrosion pit.

the substrate corrode rapidly. The substrate would be further corroded, resulting in the fracture and peeling of the chromium plating layer at the edge of the corrosion pit. The fracture mode of the chromium layer was a 45° angle destruction, as shown in Figure 6a, and was equivalent to solid support bending destruction. One end of the rod was fixed, and the displacement was completely constrained in each direction. The cleavage part of the chromium plating layer was equivalent to the solid support end of the rod, the corrosion product under the cracked chromium layer expanded due to the volume, and the bending load was applied to the cracked chromium layer. Finally, the corrosion continued to expand to the depth and width direction of the corrosion pit, as shown in Figures 3f and 6b.
