Failure Analysis of the Crack and Leakage of a Crude Oil Pipeline under CO₂-Steam Flooding

¹ State Key Laboratory for Performance and Structure Safety of Petroleum Tubular Goods and Equipment Materials & CNPC Tubular Goods Research Institute, Xi'an 710077, China

Citation: Song, C.; Li, Y.; Wu, F.; Luo, J.; Li, L.; Li, G. Failure Analysis of the Crack and Leakage of a Crude Oil Pipeline under CO₂-Steam Flooding. *Processes* **2023**, *11*, 1567. <https://doi.org/10.3390/pr11051567>

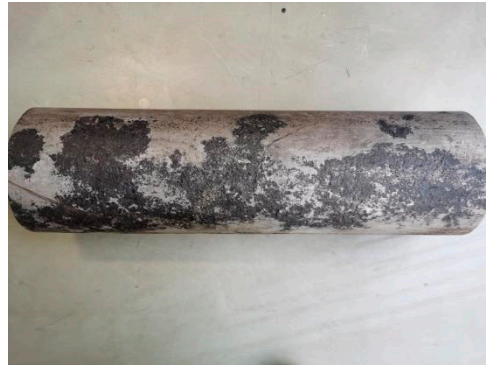
Nevertheless, the 316L stainless steel pipeline suddenly leaked out after nine months of service. Figure 1 shows the failed pipeline sample after cleaning with water + paraffin. The material of the pipeline is manufactured according to ASTM-A312 [12]. This pipeline sample is $\Phi 168 \text{ mm} \times 5 \text{ mm}$ and 600 mm long. Table 1 presents the design and operating conditions of the pipeline which operating pressure, temperature and flow rate are within allowable limits. In this work, the pipeline's material properties and cracking characteristics will be analyzed by several tests to clarify the causes of leakage failure. And the study results will provide a scientific basis for the selection of materials and corrosion protection of the pipeline under the new conditions of CO₂-steam flooding.

Figure 1. Macroscopic morphology of the pipeline sample.

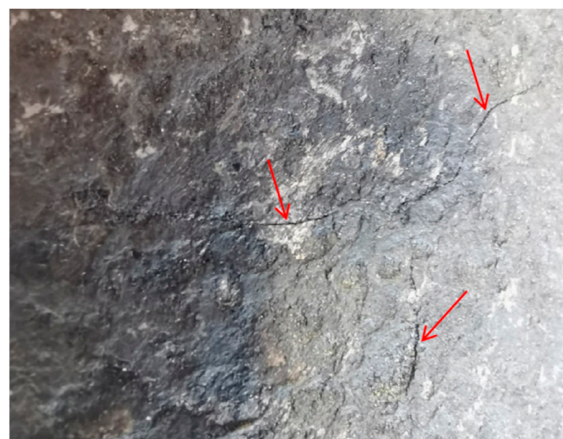
Figure 2 shows the external wall of the pipeline, which had a large contiguous blackened area. It results from dense corrosion pits in which some oil has been deposited. The depth of these corrosion pits is generally in the range of 1~2mm. Furthermore, corrosion pits and cracks are in the same area. The multiple crack crosses are observed at the bottom of the pits 30~150 mm in length. The main cracks are distributed along the pipeline transversely and longitudinally, as indicated by the arrows in Figure 2. The uncorroded area had a bright metallic luster, and no cracks were found. This suggests that uneven corrosion of the pipeline has occurred.

Figure 2. Macroscopic appearance of cracks and corrosion pits on the external surface (The arrows point to the cracks).

Macroscopic inspection reveals the existence of dense corrosion pits on the external wall of the pipeline, and XRD analysis further verifies the presence of Fe₂O₃, which is mainly a product of oxygen corrosion [17,18]. This is mainly because groundwater often contains dissolved oxygen from the air. Furthermore, it indicates that the insulation layer had broken down. Hence, localised pipeline corrosion is caused by underground water penetration into the insulation. Moreover, the higher the temperature, the more serious the corrosion will be, eventually resulting in large areas of pitting pits on the external wall of the pipeline.

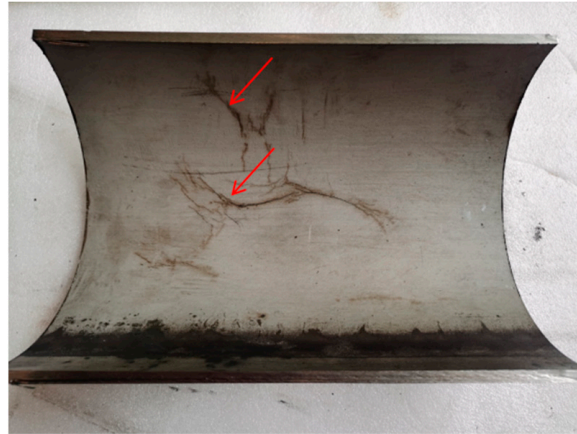
Figure 3 shows that the internal wall of the pipeline possessed multiple cracks at the same location as those on the external wall. Hence, penetration was suspected, but no corrosion pits were observed in the internal wall. Therefore, it should be indicated that the inner wall corrosion of the pipeline is not apparent under the fluid medium and working condition.

Figure 3. Macroscopic appearance of cracks on the internal surface (The arrows point to the cracks).

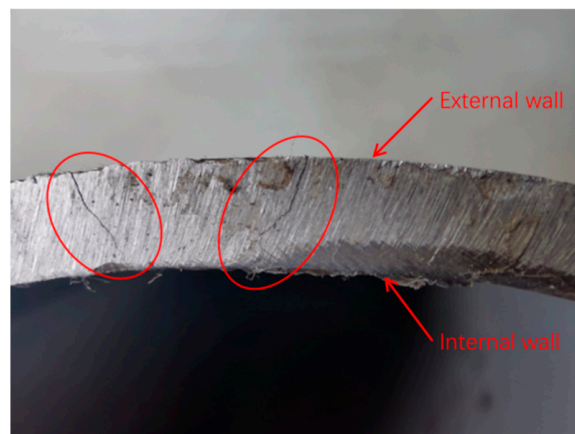
Figure 4 shows that the cracks originated from the external wall and expanded continuously to the internal wall according to the cross-sectional observation. It is more visualized and proved that the external soil environment of pipeline operation is the main influencing factor of cracking.

Figure 4. Macroscopic appearance of cracks extension along the section.

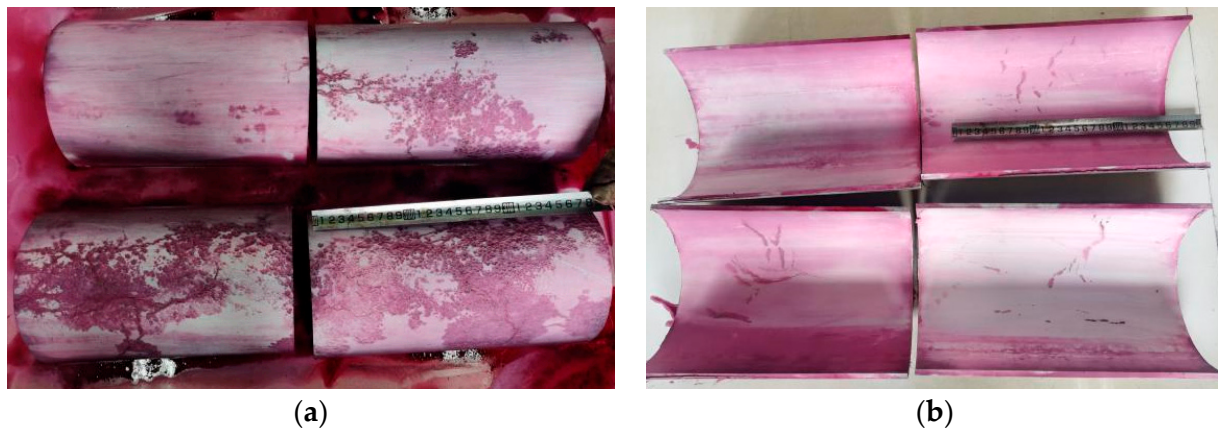
Figure 5 shows the macroscopic morphology of the pipeline after the penetration test. Large defects are observed on the external surface of the pipeline sample, including corrosion pits and cracks. In addition, many obvious branching cracks are observed on the internal surface of the pipeline sample. The cracks on the external wall are concentrated in the corrosion pit area, where the majority are longitudinal, and the cracks are determined as penetrated.

Figure 5. Macroscopic appearance of the pipeline sample after penetration testing: (a) external wall; (b) internal wall.

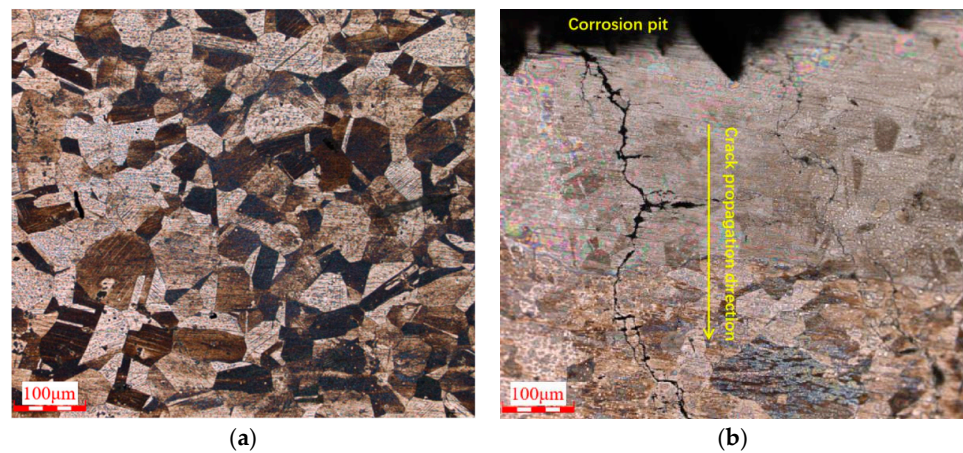
Figure 6 shows that the metallographic structure of the pipe body is austenite. No other abnormalities in the metallographic structure of nonmetallic inclusions and grain size. In addition, all cracks in the pipeline sample had similar characteristics, in which they all started from the external wall and extended to the internal wall. The cracks appear to be bifurcated, and no tissue distortion is seen. The main cracks are through crystal cracks, and part of the bifurcation is observed along the crystal fine cracks.

Figure 6. Metallographic structure of the pipeline: (a) pipeline body; (b) crack.

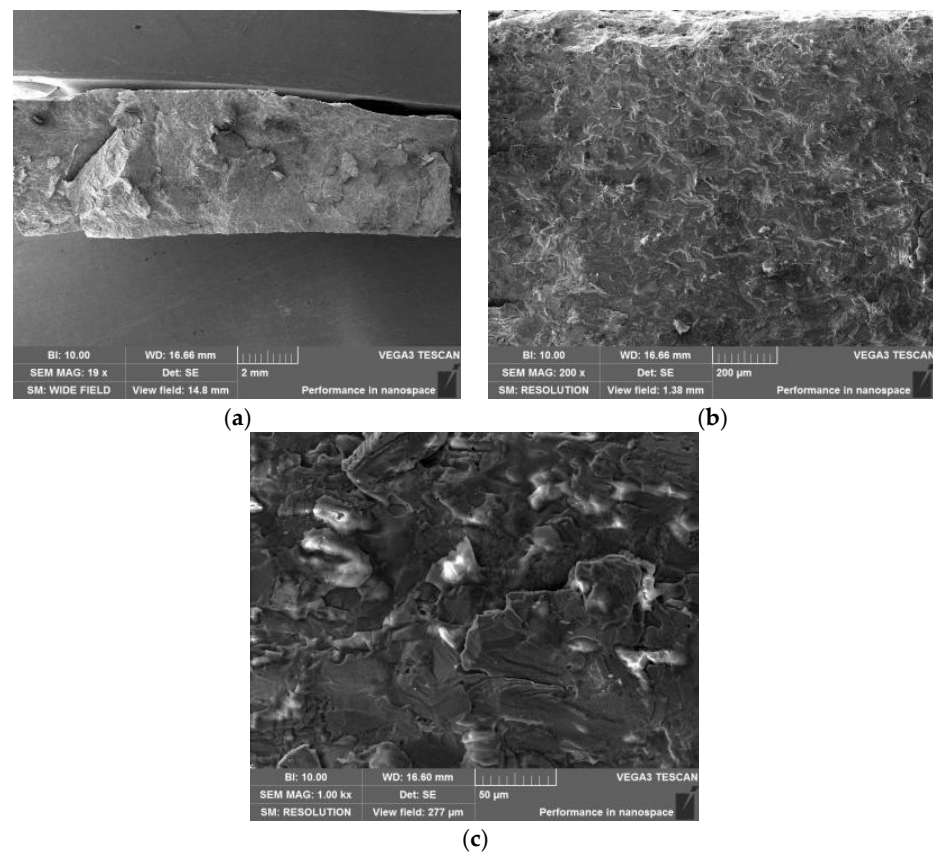
Figure 7 shows an SEM photo of the fracture at different magnifications. The fracture is flat, without necking, obvious deformation and thinning of wall thickness. As a result, this fracture indicates a clear, brittle fracture. Figure 8 and Table 4 show that the production elements within the cracks have O and Cl from external sources in addition to the metal matrix itself. The physical analysis of the product showed that it is mainly Fe_2O_3 which stems from oxygen corrosion, as shown in Figure 9.

Figure 7. Micromorphology of the fracture: (a) 19 \times ; (b) 200 \times ; (c) 1000 \times .

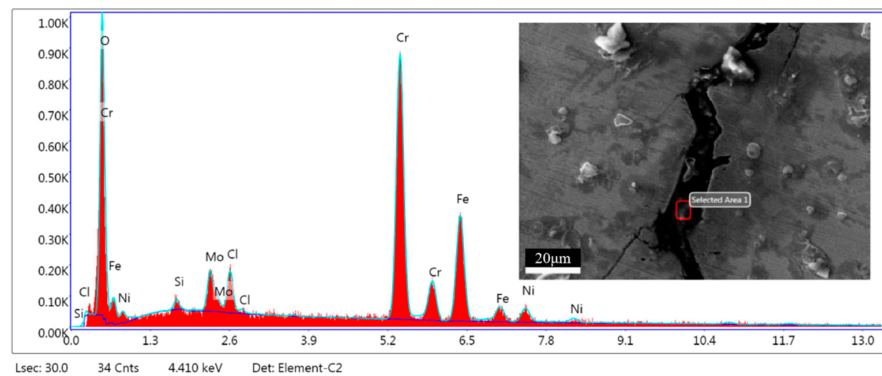
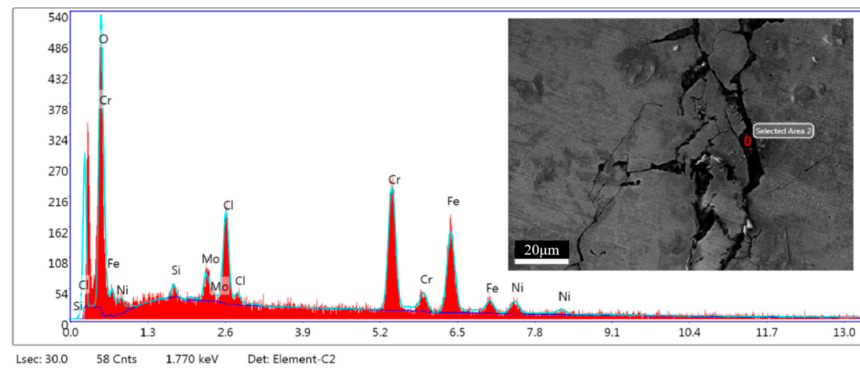
Figure 8. Micromorphology and EDS analysis result of the cracks: (a) Area 1; (b) Area 2.**Table 4.** Elemental content based on EDS analysis.

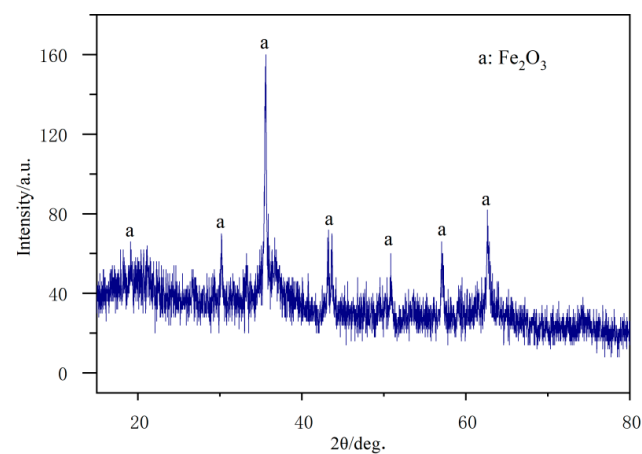
**Figure 9.** XRD patterns of the corrosion products.

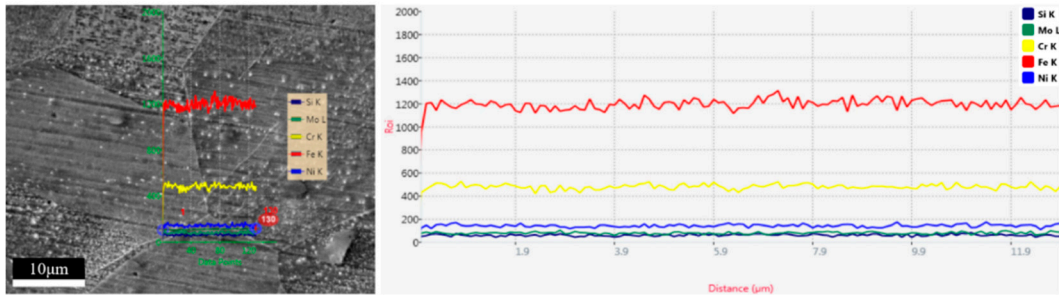
Besides, Figure 10 shows the content of each element has no significant change along grain boundaries. Therefore, it shows no carbide precipitation at the grain boundary, excluding the possibility of intergranular corrosion.

Figure 10. Linear EDS analysis along grain boundaries.

the sensitive range of chloride SCC. At the same time, an EDS line scan of the pipeline grain structure revealed no significant change in alloying element content, ruling out intergranular corrosion cracking due to intergranular Cr depletion.

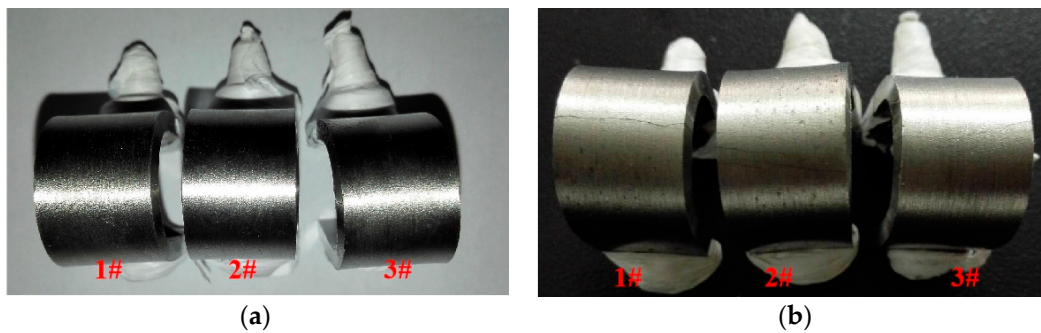
After 20 h of the chloride SCC test, cracks appear on the surface of specimens (1#, 2# and 3#), as shown in Figure 11. And the cracks are mainly concentrated in the bending section of the specimen, with fewer cracks in the straight edge section, as shown in Figure 12.

Figure 11. Chloride SCC test results: (a) before the test; (b) after the test.

The accelerated test for chloride SCC confirmed that the pipeline cracked after 20 h of testing, and it can be concluded that the pipeline does have a high susceptibility to chloride SCC.

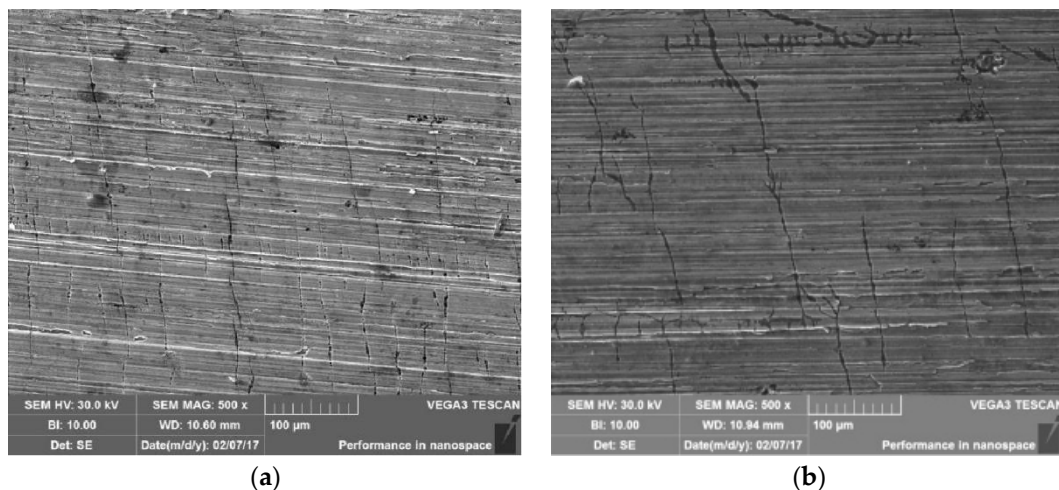
Figure 12. Crack morphology: (a) bending section; (b) straight edge.

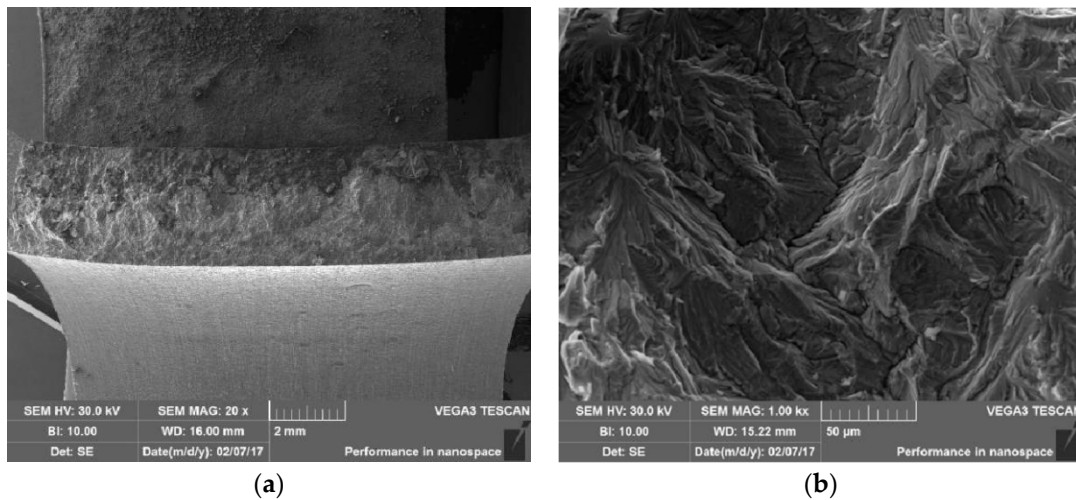
To further analyze the crack morphology, specimen 1# is separated along the longest crack in the center. Figure 13a presents the upper part of the fracture is corroded, indicating that the cracking starts from the outer wall and gradually extends to the interior. Figure 13b shows a tearing ling-like quasi-dissociative fracture, which was typical fracture morphology of crystal penetration.

Figure 13. Fracture morphology of specimen 1#: (a) 20 \times ; (b)1000 \times .
