Fatal Consequences of Safety Non-Compliance in Non-Commercial Ultralight Aviation: A Case Study

Keywords: airplane crash; accident cause analysis; ultralight aircraft

A fatal accident involving an unregistered ultralight aircraft lacking proper inspection and licensing is examined in this study. Pilot error during takeoff resulted in a stall and fatal crash, highlighting the critical importance of safety compliance in ultralight aviation. The consequences of non-compliance, including immediate death due to torn shoulder and lap belts upon impact, emphasize the necessity of adhering to safety standards. Another aspect involves the violation of aircraft use regulations. The use of faulty equipment that has not been certified can jeopardize the life of the user. The purpose of this paper is to analyze the accident and identify the sequence of events and conditions that contributed to or caused it. Through this analysis, we aim to enhance the understanding of safety vulnerabilities in ultralight aviation and advocate for stricter compliance with safety regulations to prevent future tragedies.

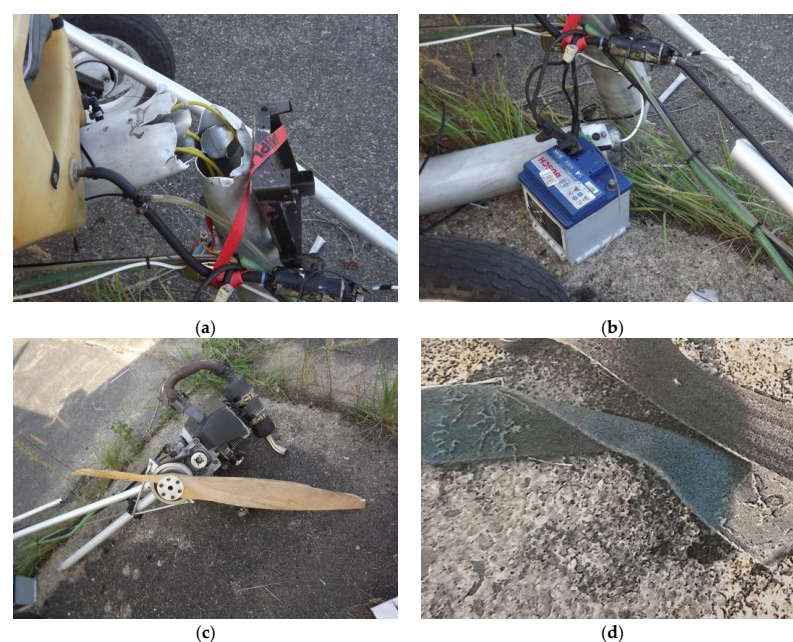
Figure 1. Damage to the front of the keel tube (a,b), propeller damage (c), broken shoulder straps (d).

The visual inspection conducted revealed that the engine was operational until the impact with the ground, as evidenced by the nature of the propeller damage (see Figure 1c). Furthermore, there was fuel in the carburetor, the fuel system was unobstructed, and there was sufficient fuel in the tank for the intended flight.

One altitude rudder drive cable, responsible for implementing downward rudder deflection, and the aileron drive cables were found to be broken. The nature of the cable breakage suggests the occurrence of a high tensile force (stranding). Notably, the pilot's seat, which also served as a fuel tank, remained undamaged.

During the flight, the pilot was wearing lap and shoulder belts and a helmet. However, the shoulder and lap belts were torn at the seams as a result of the crash (see Figure 1d).

Another critical factor contributing to the accident was the aircraft's components that had deteriorated over time, particularly the seat belts, which had lost their strength properties. It is plausible that the victim might have survived the crash if the seat belts had remained intact. However, it appears that the seat belts were not replaced during the aircraft's 28 years of operation and subsequently failed during the accident. Had new belts been installed, the likelihood of serious injury could have been diminished, as the pilot would not have been ejected from the seat, preventing the fatal impact of the head with the runway. Although compensatory spinal fractures might still have occurred, the chances of surviving the crash would have been significantly higher.

- **Regular Maintenance and Inspections:** Implement mandatory, frequent inspections of ultralight aircraft to ensure all components meet safety standards and to identify potential mechanical issues before they lead to accidents.

- **Technological Innovations:** Invest in the development and integration of advanced safety technologies, such as improved restraint systems, real-time monitoring of aircraft health, and enhanced flight control systems tailored for ultralight aircraft.
