A Brief Report of Hotel Collapse Causing Casualties in Suzhou, China

This paper presents the preliminary investigation into the cause of a recent hotel collapse in Wujiang, Suzhou, which resulted in 17 deaths and serious injuries to 5 people. The objective of this study is to contribute to the understanding of old building collapses accidents and supply effective recommendations. The background of this accidental event is first introduced, and then rescue operations are presented. Subsequently, a discussion on direct causes of collapse, management problems, as well as some measures to avoid similar accidents are proposed.

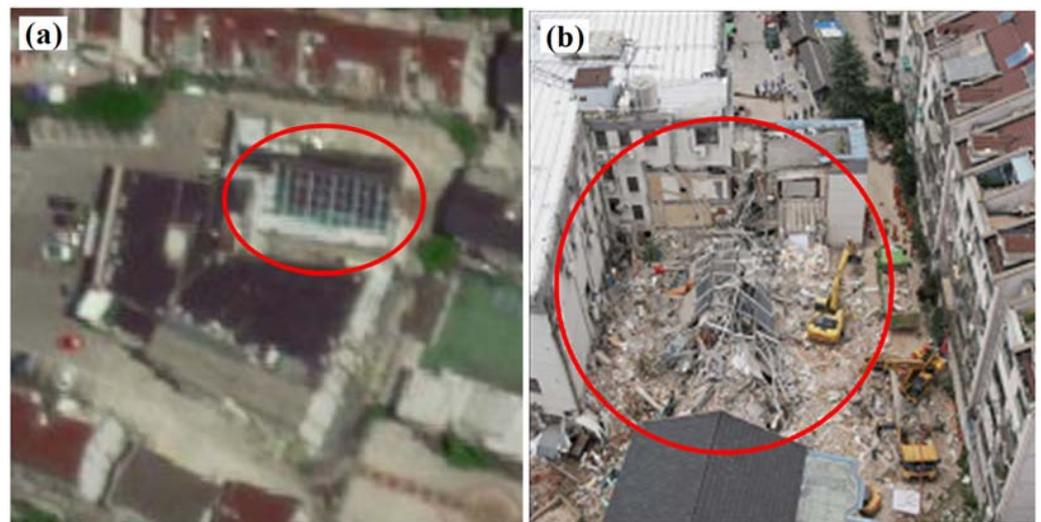
At about 15:33 on 12 July 2021, the auxiliary building of the Four Seasons Kaiquan Hotel collapsed in Wujiang District, Suzhou. Nearby witnesses reported that the collapse happened in a “split second”, causing a loud noise and a cloud of dust. Figure 2 shows an aerial view of the buildings before and after the accident. As can be seen from the picture, the structure of the main building remained basically intact, while the collapsed auxiliary building was completely destroyed. Moreover, according to the neighboring residents and customers who stayed at the hotel few days before the accident, the hotel underwent renovation works, during which the shaking of the floor could be clearly felt.

Figure 2. Aerial view of the auxiliary hotel building, (a) before and (b) after the breakdown (Source: <https://baijiahao.baidu.com/s?id=1705141641655563947&wfr=spider&for=pc>, accessed on 13 July 2021).

Preliminary investigations revealed that the main cause of the collapse was the illegal renovation of the building. The collapsed building built in the 1980s had gone through many illegal renovations throughout its life span. Particularly, the one that was carried out at the time of the collapse had not received any approval. However, the Chinese regulations stipulate that every building must undergo a thorough inspection and receive the approval of relevant authorities before rehabilitation or renovation operations. The reason is that, due to the change in ownership, building structures are generally transformed over the years, resulting in a slow accumulation of risks [22]. For example, on the surface, a single building decoration may seem harmless, while internally, it may deteriorate the bricks and concrete composing its structure. This is particularly true for the 30-year-old building investigated herein. After many instances of decoration and expansion, a fourth floor was added to the building, leading to a greatly increased load. Additionally, the internal load-bearing wall was seriously damaged in the decoration. This old auxiliary hotel building could not withstand the massive vibrations from the renovation works that were carried out. There have been numerous building collapses in recent years in China that were also caused by illegal alterations or expansions. Regardless, in case of such accidents, it is crucial to provide prompt and efficient rescue responses.

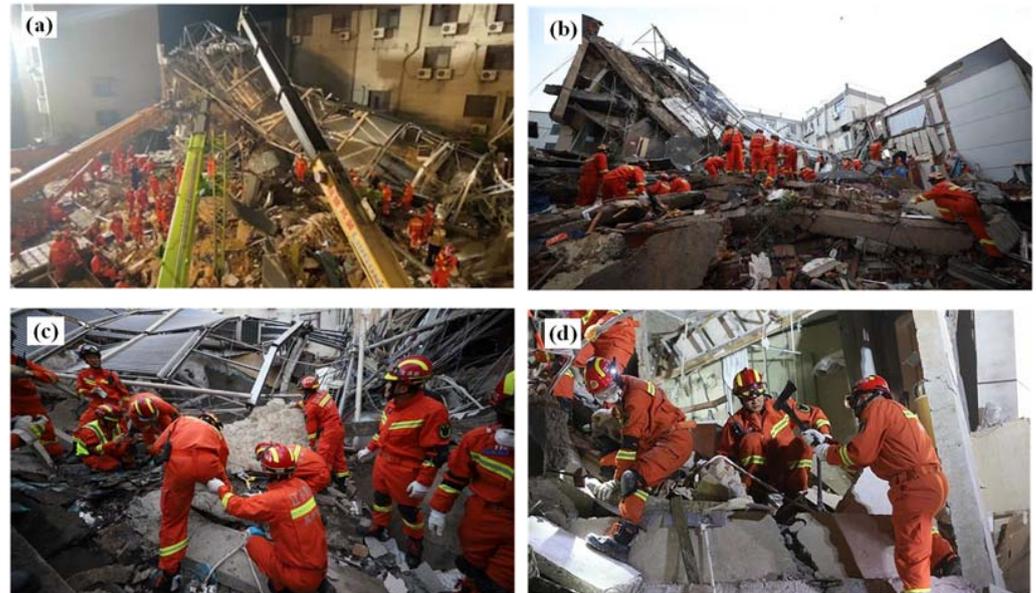
Figure 3. Rescue teams in action soon after the hotel collapse on 12 July 2021: (a) Removing collapsed building roof; (b) Searching lives; (c) Removing collapsed building materials; (d) Breaking large blocks of materials (Source: <https://www.163.com/dy/article/GEP44IPC05503FCU.html>, accessed on 13 July 2021).

From the photos shown in Figures 3 and 4, the building is in complete collapse, and the specific failure element that led to the collapse cannot be determined. According to a

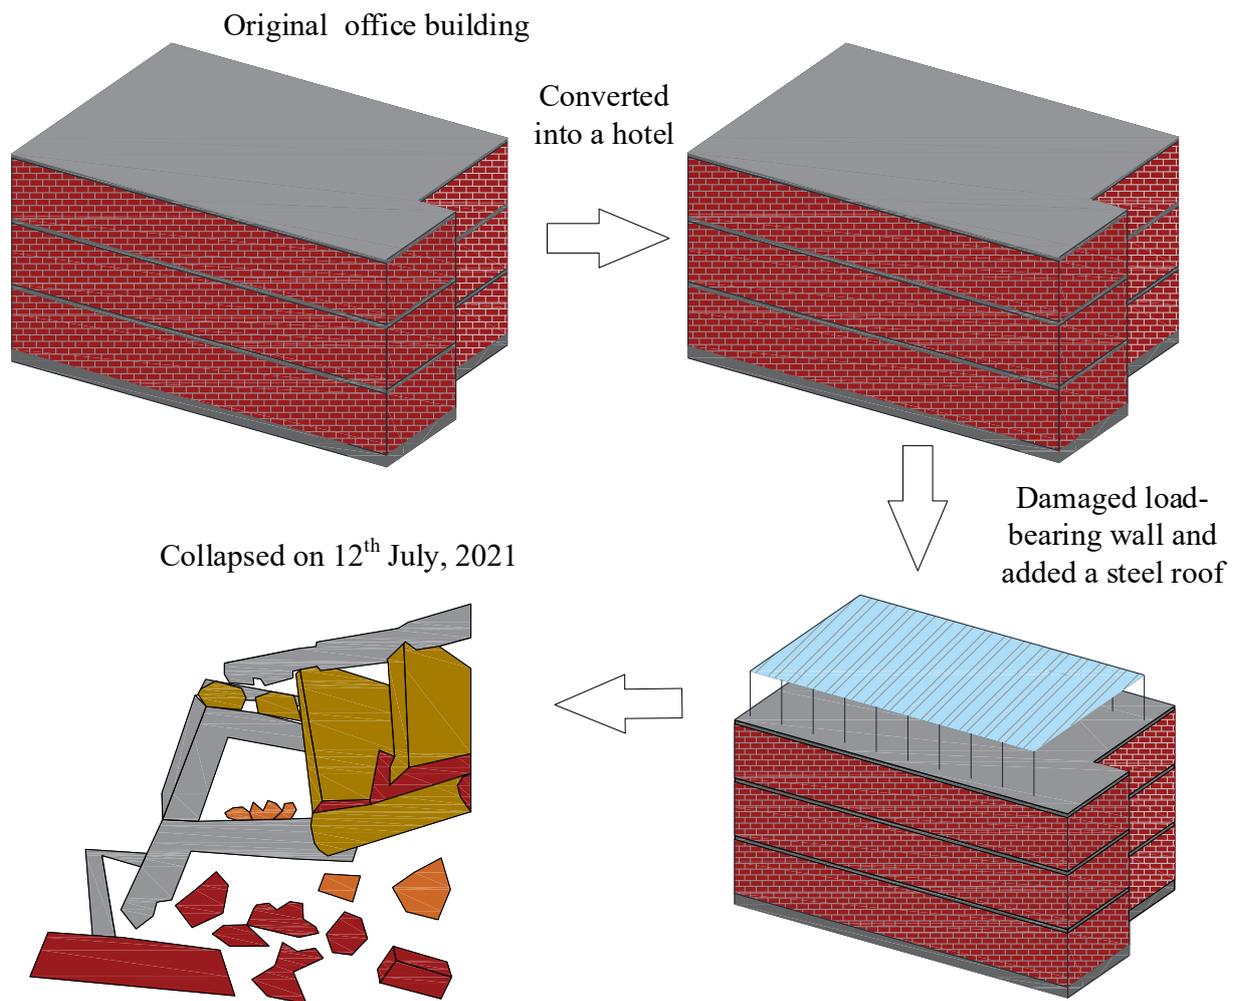
This section expands the understanding of the Suzhou’s collapse accident by discussing the causes of the accident. These three aspects include the illegal renovations and extensions of the building that collapsed, the quality problem of old buildings, as well as the laxism of relevant authorities. Figure 4 shows the changes of the collapsed building to better understand the cause of collapsing accident.

Figure 4. Remodeling of collapsed buildings over the last 30 years.

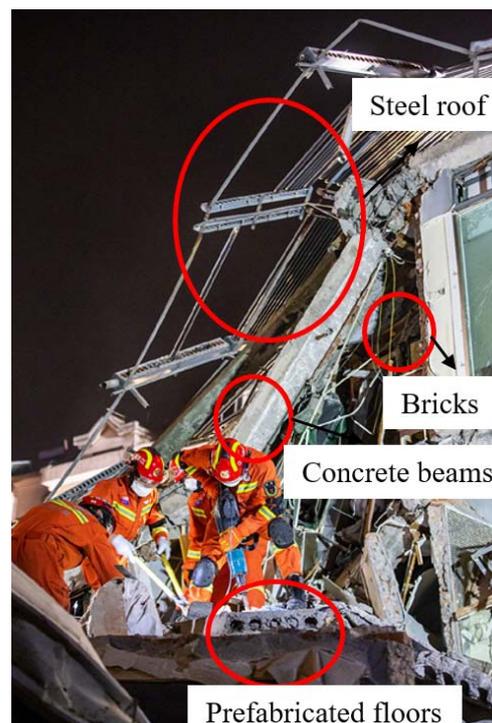
Structural mechanics analysis requires accurate building structures information. Although the construction time of the collapsed building is too early to find its building structure and inner structure, the building structure can be inferred from other information. Firstly, it can be indicated from the bricks and pre-fabricated floors in the rescue scene photo shown in Figure 5 that it is a masonry-concrete structure. Secondly, the building time of the collapsed building was 1980s, and masonry-concrete structure was the most commonly used structure in 1980s.

Figure 5. Photo of collapse site. (Picture Source: <https://weibo.com/u/2803301701?topnav=1&wvr=6&topsug=1>, accessed on 13 July 2021).

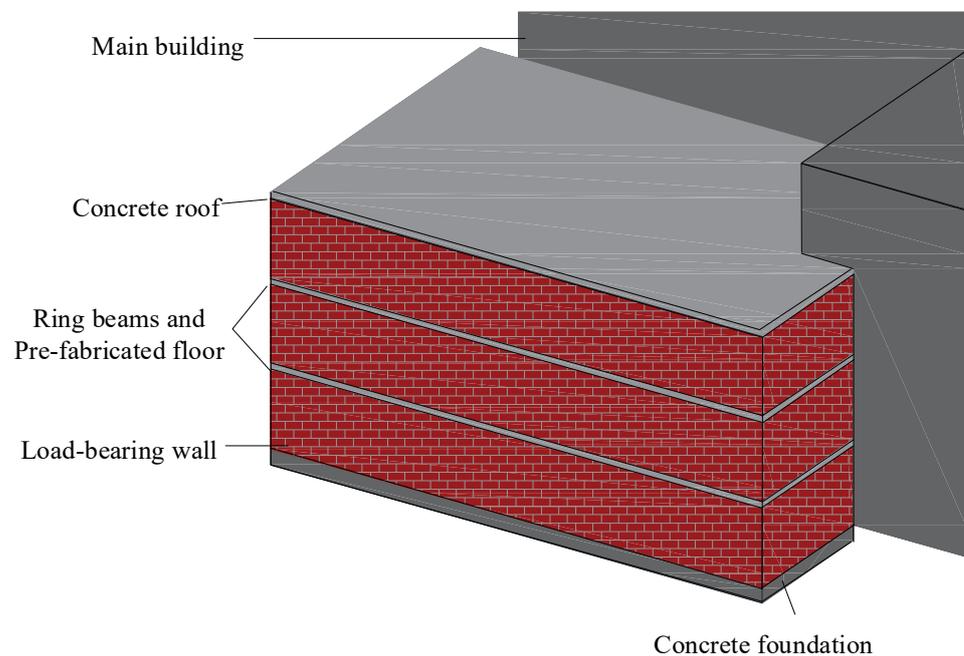
As shown in Figure 6, the load-bearing wall is the main loading-bearing unit in masonry-concrete structure. Different from the frame structure and shear wall structure commonly used in recent decades, the walls in masonry-concrete structure cannot be moved. Preliminary investigation show that the collapsed building was originally constructed as an office building and changed into a hotel. Over the next three decades, it had undergone numerous illegal renovations and extensions, and its interior walls that had been used for load bearing had been damaged. So, its structure has been changed, and other units bore more load for a long time. The ongoing renovation before the collapse accident also disturbed the structure, and it is the most possible cause that led to structure failure.

Figure 6. Sketch of masonry-concrete structure.
