Water Inrush Hazard in Shijingshan Tunnel during Construction, Zhuhai, Guangdong, China

Abstract: This short communication reports a water inrush hazard during the construction of the Shijingshan Tunnel in Zhuhai, Guangdong, China. On 15 July 2021, a water inrush accident occurred at the construction site 1.16 km away from the tunnel entrance, resulting in 14 casualties. The purpose of this study is to investigate and discuss the water inrush process in this atypical case. The principal causes of this tunneling accident include the special geological conditions at the construction site, high hydraulic conductivity at the part that connects the underground water system and the overlying water body (the Jida Reservoir), and the impact of heavy rainfall. Moreover, four significant suggestions are proposed to prevent the possible occurrence of water inrush disaster: (1) assessing the risk level in areas prone to water inrush; (2) getting a comprehensive geological prediction based on borehole data and artificial intelligent methods; (3) establishing a monitoring system during the tunneling process; (4) strengthening the self-protection skills of construction workers.

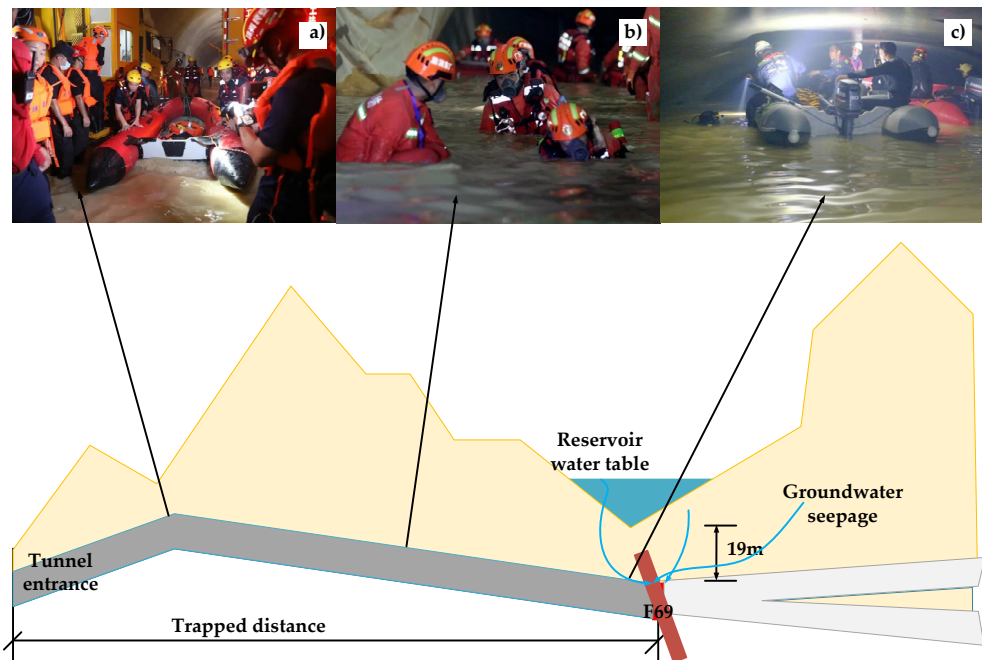
- There is a strong hydraulic connection between the tunnel and Jida reservoir. The water level of the reservoir decreased by 1.9 m within 1.5 h since the occurrence of water inrush accident. An estimate of $2.2 \times 10^5 \text{ m}^3$ water flowed from the reservoir into the tunnels. Due to the enhanced hydraulic connection in the early stage, abundant water supply in the tunnel increased the difficulty of drainage in the tunnel. At the same time, influenced by tunnel construction and the flooding accident, the hydraulic connection between the Jida reservoir and the tunnel increased, and abundant water supply in the tunnel further increased the difficulty of drainage in the tunnel.

Figure 2. Zone water level in the tunnel after water inrush accident: (a) The transport port is at the lowest water level (https://www.guancha.cn/politics/2021_07_17_598831_s.shtml, accessed on 18 January 2022); (b) The water in the middle reached rescuers' waists (https://www.xianjichina.com/news/details_275025.html, accessed on 18 January 2022); (c) The highest water level for rescue, where oxygen is scarce (https://www.thepaper.cn/newsDetail_forward_13726501, accessed on 18 January 2022).

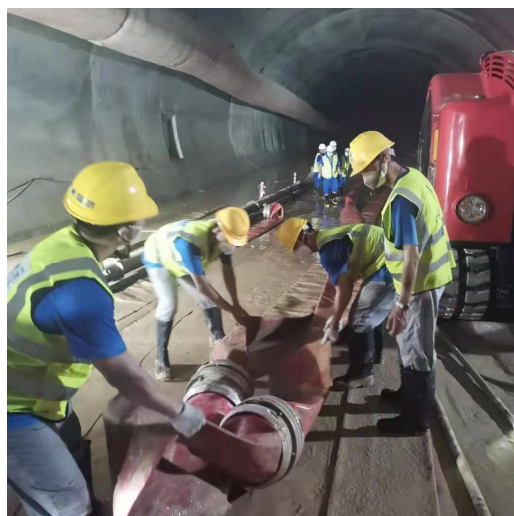
- In the upstream of the reservoir, a water barrier cofferdam was set to divide the reservoir into two parts, blocking the connection between the subsidence area and the water source of the reservoir, so that the external inflow of water into the tunnel was reduced from the original whole reservoir to a small pond. Then, the existing body of water above the tunnel collapse was drained. Through performing the above measures, the Jida reservoir surface water supply to the cave was prevented. Drainage equipment had been continuously increased, including 10 mud pumps, 7500 kW generators, 175 kW mixed-flow pump, 275 kW water pumps, 330 kW submersible pumps, 390 kW sewage pumps and 10 tank trucks. Pumping was also carried out inside the tunnel (see Figure 3). To solve the problem of excessive carbon monoxide

Figure 3. Rescue workers are laying out pumping equipment (Picture from: https://www.guancha.cn/politics/2021_07_17_598831_s.shtml, accessed on 18 January 2022).

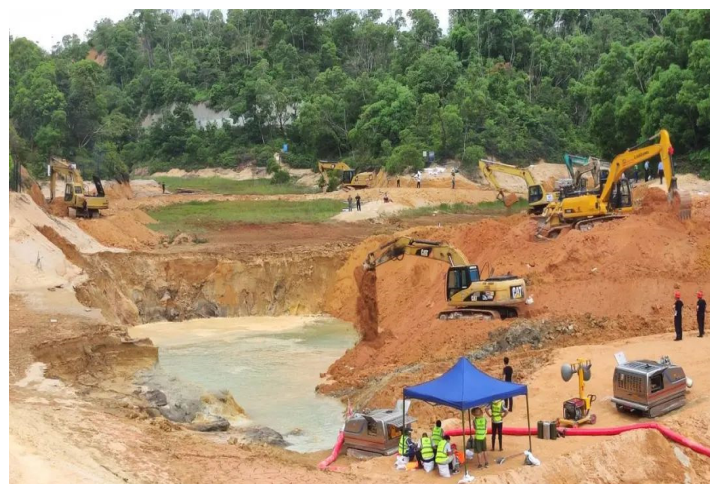
- The rock was already broken, so strong grouting was needed during the rescue to ensure the safety of people at the rescue operation surface. After the water was drained, the soil was backfilled in the surface pit, and the mechanical equipment working face was created by leveling and compaction. Figure 4 depicts the rescue site of reservoir above tunnel. Then, the all-in-one machine drilled and fully spread, and the double-liquid grouting technology was adopted to reinforce the backfilled soil and the face of the tunnel. The double slurry can be solidified within 30 to 50 s, so that the backfill soil can be solidified and compacted quickly, subsequently, the original loose soil can be condensed into a compact and integrated structure, so it can effectively block the reservoir water and underground fissure water flowing into the tunnel. Twenty sets of equipment and more than 110 workers had been invested, and the backfilling of the vault was completed by 3 p.m. on 16 July, with around 11,000 square meters of soil. As of 9 a.m. on 17 July, 90 tons of cement and 20 tons of sodium silicate had been put into the site, 12 integrated drilling and injection machines had been put into operation, and 50 square meters of grouting had been completed.

Figure 4. Rescue site cofferdam construction (Picture from: https://www.guancha.cn/politics/2021_07_17_598831_s.shtml, accessed on 18 January 2022).

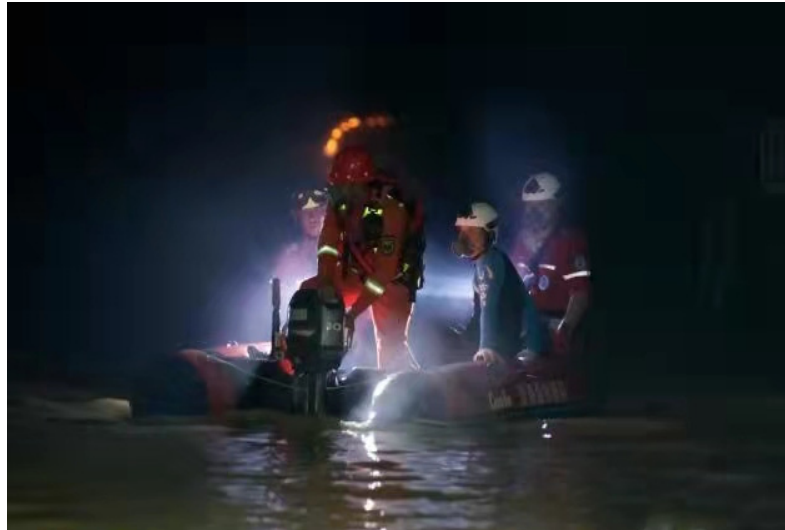
- Guangzhou Salvage Bureau of the Ministry of Transport had the primary goal of sparing no effort to save people, eight south China Sea salvage bureau divers, six Guangzhou salvage bureau divers and three rescue experts rushed to the scene to participate in the emergency rescue. As of 9 a.m. on the 19th, the bureau had sent four batches of divers for a total of 16 h of search and rescue in more than 900 m of tunnel waters. Figure 5 shows the divers launched search and rescue.

Figure 5. Rescuers are sending frogmen into the water. (Picture from: https://www.xianjichina.com/news/details_275025.html, accessed on 18 January 2022).

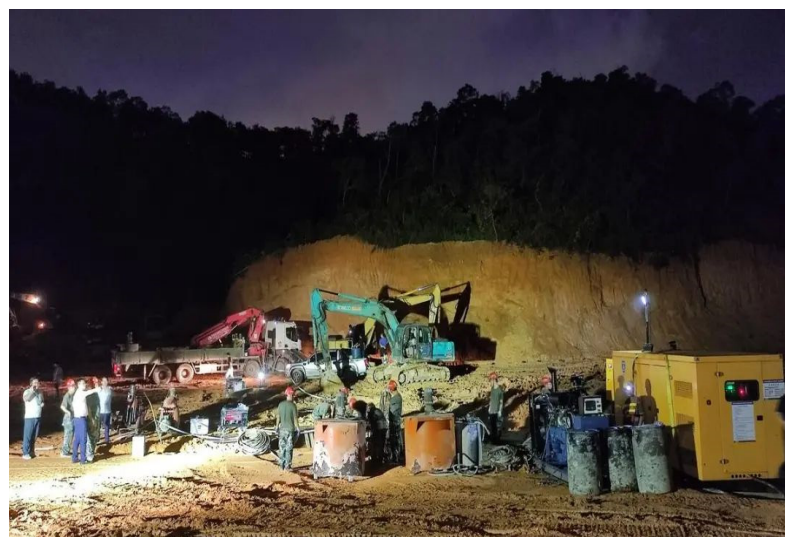
- Monitoring the tunnel structure safety and harmful gases in the cave. In order to prevent the occurrence of secondary disasters, the real-time monitoring of surface hydrology was constantly strengthened, especially the monitoring of mountain, reservoir, water body and surface backfill (see Figure 6). They monitored for tunnel leakage, ground subsidence and toxic and harmful gases in the cave and establishing a regular warning mechanism for the inside and outside of the cave every 30 min, to ensure the safety of rescue workers.

Figure 6. Emergency rescue and surveillance system on the right. (from: https://www.guancha.cn/politics/2021_07_17_598831_s.shtml, accessed on 18 January 2022).

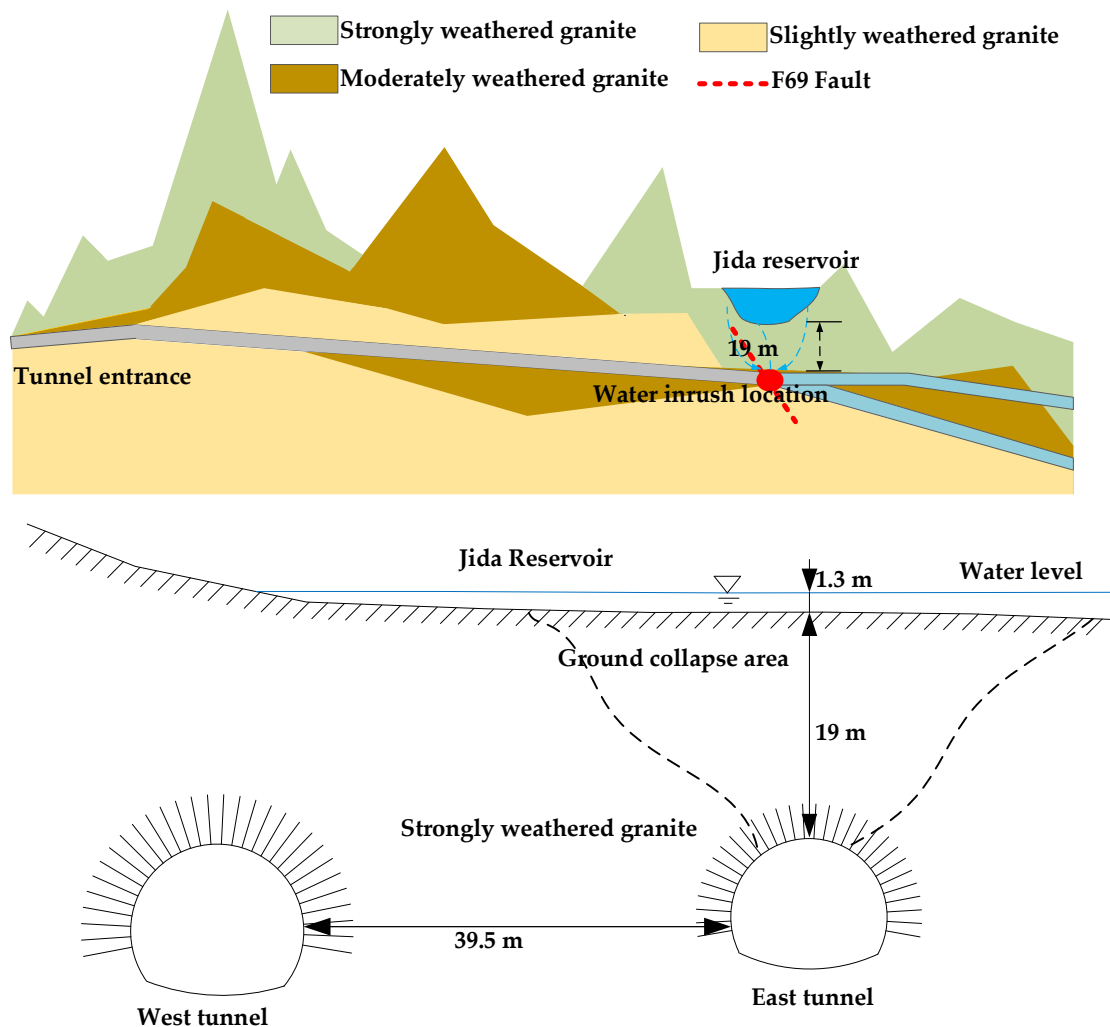
Figure 7. Geological profile in the site.

The tunnel begins near Bailian Village and crosses the entire Banzhang Mountain Forest Park from the south to the north side. The Shijingshan Tunnel was excavated by using NATM, which is adopted when the geology is typically through very hard rock with MPa levels greater than 100. Hard rock tunneling commonly involves blasting, and hard rock is broken before excavation. Figure 7 shows the geological profile in the site. During the construction process of the Shijingshan Tunnel, weathered granite was the primary component of Banzhang Mountain (see Figure 7), the distance between the crown of the tunnel and the bottom of the reservoir is approximately 19 m, which constitutes a major risk source for the Shijingshan tunnel. Before the accident, because of a lack of bore holes, the ground was roughly estimated as moderately weathered granite, which had sufficient strength to support the upper ground load in the bench cut method. However, during the detailed geological investigation after the accident, the actual geological conditions around the water inrush area were discovered to be strongly weathered granite with developed fractures. The strength of rocks decayed significantly under groundwater. The bench cut method of NATM would have a potential risk of collapse in this case. The inaccurate estimation of geology is another reason of this accident.

As shown in Figure 7, the strata are composed of fill soil, gravel sand, fully weathered granite, strongly weathered granite, moderately weathered granite and slightly weathered granite. Among them, the filling soil is located at the top and is about 2–6 m in thickness. The recommended values of geotechnical parameters of the soil layer are listed in Table 1.

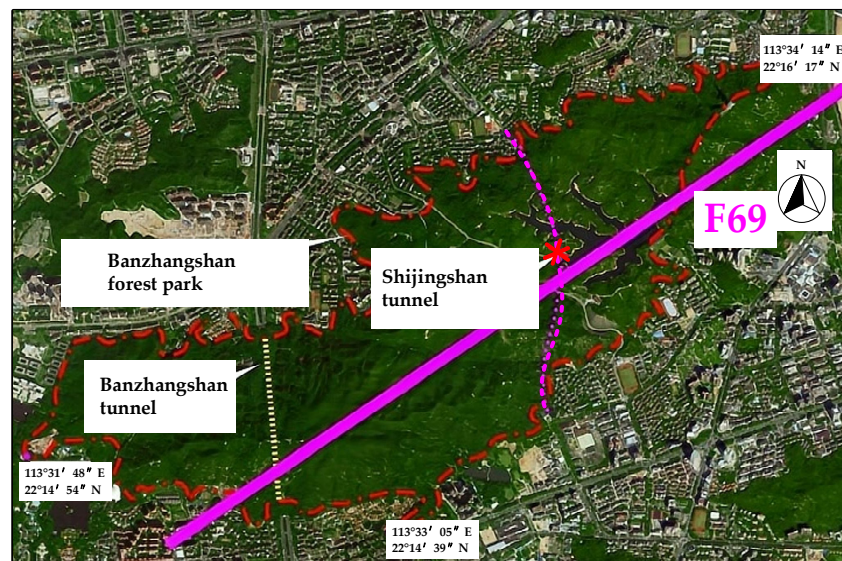
stratum contains fissures or faults. Figure 8 shows the intersection of Shijingshan tunnel and F69 is near Jida reservoir. The geological investigation before the construction of the Banzhangshan Tunnel revealed the existence of a fault crossing the Banzhang Mountains, which was referred to as the F69 fault based on the geological map of Zhuhai City (see Figure 8). This fault develops in the southwest-northeast direction. Considering the trend of this fault and the designed route of the Shijingshan Tunnel, there was a high probability that they may overlap around the site just underlying the Jida Reservoir. If this estimation was true, it would be the most dangerous area of the tunnel. Moreover, the reducing strength at the fault can intensify the instability of the excavation face of the tunnel. Consequently, if blasting excavation was undertaken without proper advanced support, the tunnel may collapse at any time owing to rock breakage.

Figure 8. The intersection of Shijingshan tunnel and F69 is near Jida reservoir. (<https://zhuanlan.zhihu.com/p/390890982>, accessed on 18 January 2022).

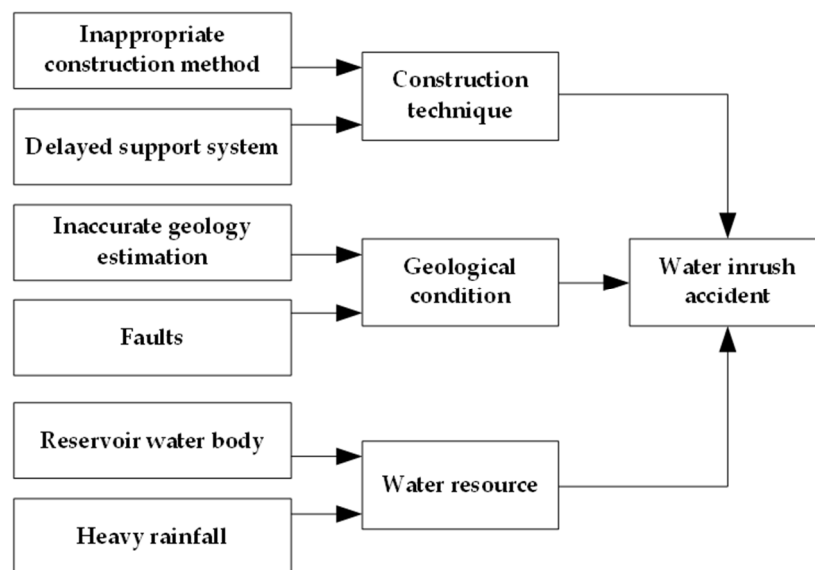
Figure 9. Triggering factors of water inrush accident.

2. The disaster was triggered by the coupling effects of: (i) high hydraulic conductivity of the surrounding soils at the construction site, (ii) faults formed around the construction site (F69), (iii) heavy rainfall prior to the accident and (iv) water source from the overlying reservoir.
