# Lessons Learned from the Module Production for the First CMS Silicon Tracker

Alan Honma

**Abstract:** A personal view of some of the more important lessons learned from the module production for the CMS silicon tracker. This work took place from about 2002–2005. The focus is on areas where I had strong personal involvement; therefore, the tasks of hybrid production, hybrid assembly, and the wire bonding of modules and hybrids are emphasized. This article will first give a general description of the silicon tracker project and how the module production was organized. Then, there will be description of several of the key issues or problems during the production and how they were resolved. Some recommendations for future similar large-scale productions will be given.

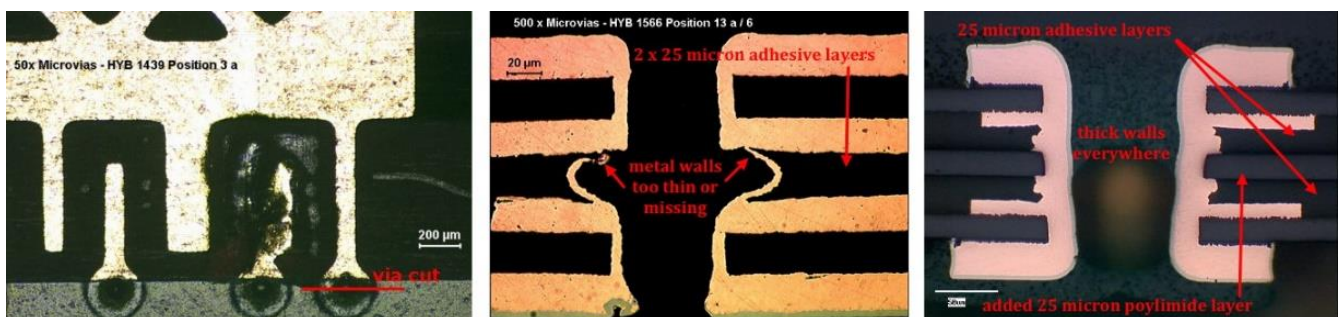
From the evidence of how the failure was seen in the electrical tests, the problem was found to be an open circuit that occurred in one key line in the hybrid. A simple electrical continuity test found this open circuit. The only likely reason for the open circuit was a failure in a via on that line, which had to connect one metal layer to another. Only a few lines on the hybrid that passed through vias were as critical as this one, without which one of the APV25 chips would not function correctly. Several of the hybrids with this problem were then sacrificed by being cross-sectioned to reveal the via's structure. What was found was quite surprising, there was very little metal in parts of the via. The metallization of the via hole should produce a cylinder of copper on the circuit's surface where the hole was made. This cylinder should be around 5  $\mu\text{m}$  thick (or more) at all points on the cylinder surface. Cross-sections were made through the vias in the PCBs in many locations such as the one indicated in the right photo of Figure 8. As can be seen in the middle photo in Figure 8, the cross-section showed that the metal skin was not at all uniform and in many places the thickness was much less than 5  $\mu\text{m}$  and in some places there was no copper at all. It was clear that such vias were not correct and could easily fail with time and especially with thermal cycling, which would stress the metal cylinder and cause already thin zones to crack and fail. Since in most of these poorly metallized vias there was still a thin amount of metal such that it would still conduct properly between the layers, the bare PCB would pass the open/short electrical tests. After assembly (which meant some mechanical stress and a large thermal one from the solder reflow process), a small number of electrical failures occurred on completed hybrids but up until then these were thought to be due to more random faults such as ASIC chip failures, line breaks, and poor soldering. A more careful examination revealed that many of the electrical failures were due to these vias going open circuit.

**Figure 8.** Left: Location of via cross-sectional cut. Middle: Original poorly plated via walls. Right: Improved solution giving correctly plated walls.

meanwhile, the PCB manufacturer tried a number of modifications in order to try to solve the problem even though they did not understand the actual cause. As it turned out, the studies to understand how the problem occurred concluded that the drilling of the vias caused an uneven hole wall to be made such that the adhesive layers in the stack-up were more abraded than the polyimide layers, giving the concave-like metal shape along the adhesive layers seen in the cross-sections. The solution that was chosen was to add a polyimide layer between the two adjacent adhesive layers in the center of the stack, thus reducing the adhesive thickness from 50 to 25  $\mu\text{m}$  (all other adhesive layers were only 25  $\mu\text{m}$ ). It was observed that the very poor metal thickness in the cross-sections occurred only at this thicker adhesive layer. In addition, the metallization process was modified to deposit more copper into the vias. The combination of these changes resulted in vias with much better metal thickness and uniformity, as can be seen in the right photo in Figure 8.

The above modification addressed only points 1 and 2 above. To address points 3 and 4, it was decided to add a “test coupon” to each PCB panel, which contained via “daisy chains”. The via daisy chain consisted of a very large number (several hundred) of all the types of vias used in the real circuit where a signal line passed in series through all of these vias such that one could see clearly if any of the several hundred vias went open-circuit using a single continuity test. Several of these via daisy chain structures were placed in different locations on the PCB panel. The test coupons could be removed from the panel and thus were subjected to several passes through a solder reflow cycle, giving them even more stress than the circuit would see during the soldering of the SMD components. In addition, we required that these test coupons see cold thermal cycles as well since the operational temperature of the CMS tracker was expected to be about  $-20\text{ }^{\circ}\text{C}$  at the later part of the detector lifetime (needed to minimize the radiation damage to the silicon sensors). Then, each coupon would have the via daisy chain tested for continuity and also a resistance measurement performed since this could reveal a weakening or reduction in the amount of metal in the vias even though it was still conductive. Finally, we required that all assembled circuits be subjected to five passive thermal cycles of  $-20\text{ }^{\circ}\text{C}$  to  $+30\text{ }^{\circ}\text{C}$  and an electrical test be performed after those thermal cycles.

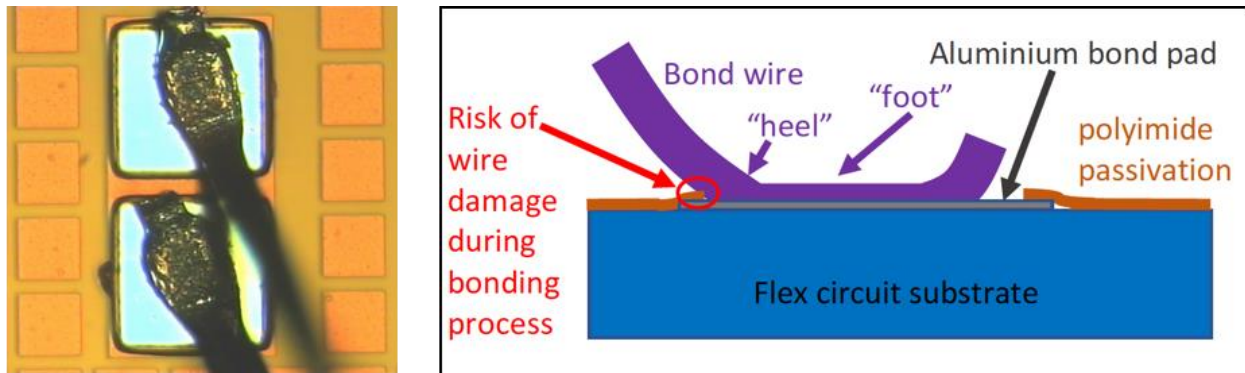
After several heated discussions about whether the company or CMS was conducting the test correctly, it was found that the result depended very strongly on precisely where the wire hook was placed when conducting the test. The company had chosen to pull very near the apex of the wire loop whereas CMS was pulling closer to the central point mid-way between the ends of the wire (a difference in distance of perhaps 0.3 mm out of the typical 3 mm length of a wire). However, this very small difference in pull location could lead to very large differences in the result. There were good reasons for choosing either position; the company's choice would result in the least change in position of the wire during the pull test (moving the wire will generally weaken it) whereas the CMS choice would result in the force applied to the two ends of the wire to be nearly equal, thus testing both ends fairly.

There were more heated discussions as to which was the correct method to use in order to apply the pull test criteria and decide if the wire bonding passed or failed those criteria. As CMS was the client and because we wanted the wires to be able to survive the handling and thermal changes over the long lifetime of the detector, we insisted that if a wire is slightly moved during this test, it should not lose 90% of its strength. In fact, a more careful analysis of why this weakness occurred after such a small flexing of the wire showed that because of the design of the ASIC, the wire was developing a crack at the point where the wire rose upward from the ASIC bond pad. This crack developed because there was a "passivation" (protection) layer of polyimide, which was about 7  $\mu\text{m}$  thick and surrounded the ASICs' wire bond pads. Because the bond pads were very small (95  $\mu\text{m}$   $\times$  95  $\mu\text{m}$ ), the bond weld foot (which was about 75  $\mu\text{m}$  long) often would run into the edge of the polyimide, which could create a dent in the soft aluminium wire and the local stresses and further movements of the wire during the bonding process caused a crack to form near this point (see Figure 11). If the wire was not much stressed further (as for the company's method of pull testing), the strength of the wire was close to normal. If the wire was moved physically (as was the case for the CMS method of pull testing), the crack would quickly propagate through much of the rest of the intact wire material and cause a failure with very little (or even no) pull force.

**Figure 11.** Left: Photo of wire bonds on an APV25 chip made by the hybrid assembler. Right: Drawing of a side view of one wire bond on an APV25 chip indicating the location of the probable cause of weakening of the wire.

The solution was to use a wire bonding tip that reduced the length of the bond weld foot and to position the placement of the foot to avoid hitting the edge of the polyimide. These solutions did work but prior to that one large batch of about 500 hybrids was rejected because of weakened bond wires. The problem could have been easily avoided if the bond pads had been made a bit larger and the polyimide passivation window had also been made larger. Unfortunately, the chip design was created years before the production and could not be changed. In prototype testing of wire bonding to the chip, this was performed by CMS and the problem of hitting the edge of the polyimide had not occurred, so the potential danger was not identified. It is true that the bond pad size was marginal and could have been made slightly larger without a major re-design of the chip. We note that future chip designs should allow for more space for the bond foot or a thinner passivation layer should be used (which is now the case, 1–2  $\mu\text{m}$  is more typical of recent ASICs). It was also important to realize that if there is a chance of wires being moved, a pull test that minimizes wire movement may not reveal crack damage that could lead to severe weakening and potential failure in the future.

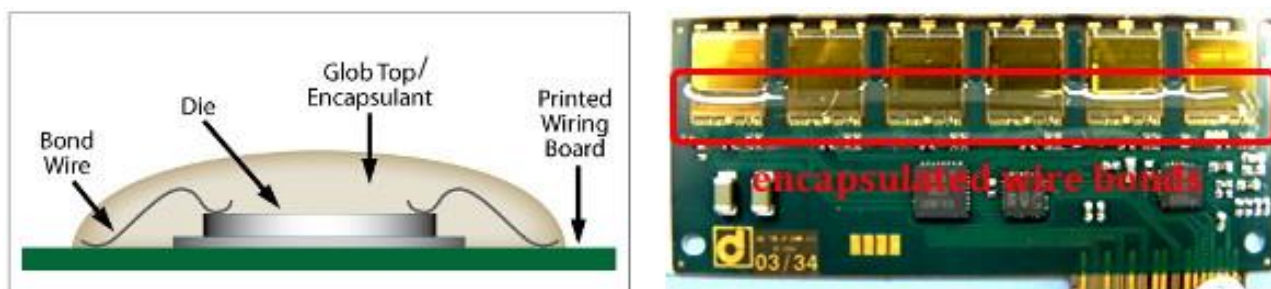
**Figure 12.** Left: Principle of encapsulation of wire bonds. Right: Photo of encapsulant on hybrid.

Since the modules would be bonded in 14 different sites in both the US and Europe, they would be seeing quite a lot of transport before being finally installed in the CMS pit in the LHC. Therefore, a solution was needed to avoid any such transport damage. One solution to this sort of damage has been used in industry for nearly as long as wire bonding has been used for chip attachment to its package. This solution is called potting or encapsulation and consists of encasing the chip and its wire bonds in a material that is applied as a fluid and then polymerizes or cools to become a solid (see Figure 12). Quite often the material used is a type of epoxy adhesive which hardens to something very tough and robust. However, this was not a good solution for the CMS modules as there was evidence that large surface coverage of epoxy adhesives on the active face of silicon sensors could damage or change the behavior of the charge collection of the sensor, thus degrading its use as a particle detector. It would not have been such a problem had the detector been intended for room temperature use only. However, the CMS silicon modules would need to operate at  $-20\text{ }^{\circ}\text{C}$  and, because of the large coefficient of thermal expansion (CTE) of these adhesives (typically 100 ppm/K compared to 3 ppm/K for silicon), there would be a very large stress on the silicon surface caused by the adhesive shrinkage when cold. Thus, it was decided to use a flexible silicone-based adhesive instead. This still had a large CTE but, because it remained flexible even at low temperatures, it would not create a large stress on the silicon surface. Many tests were performed to check that this material did protect the wires from vibration damage and yet did not overly stress the sensor at ambient or when cold. It also had to be tested for radiation hardness since it would receive a significant amount of radiation during the lifetime of the silicon tracker in LHC. In addition to this encapsulation, the sensor-to-sensor and sensor-to-pitch adapter edges were glued to a bridging piece of ceramic (which had a low CTE) in order to prevent these parts from moving with respect to each other. It was decided to apply the flexible encapsulant only for the modules made in the US, since those were the ones to experience air transport. The modules made in Europe had the extra support but not the encapsulation. There was no known transport damage to bond wires in any of the modules made during the production phase, so these solutions did work well.

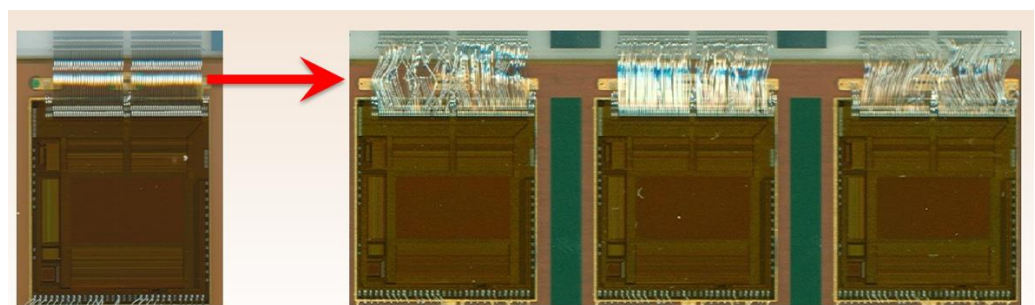
During the endcap module mounting work at CERN, a very large number of modules (about 400 in total) had their bond wires either damaged or broken. Several modules had the sensor broken and were thus non-repairable. However, those with only the bond wires damaged were usually repairable and could be re-installed in the endcap structures. The bond wire damage (an unreparable example is shown in Figure 13) was mostly to the wires going to the ASIC chips, either the signals coming from the sensors (via the pitch adapters) or those coming from the PCB (control, power, monitoring). In all but a small percentage of modules, the damaged bond wires were able to be repaired, thanks to the CERN wire bonding lab, which had excellent technical experience with very difficult bonding situations. It was clear from the way the wires were damaged that the operators had difficulty avoiding touching the area during the mounting of the module. The location of the mounting screws was very close to the wire bonds in many cases. Given that the mounting of the modules in other facilities resulted in much less damage, it was made clear that either a lack of training, a less safe method of mounting, or the need for performing the job very quickly led to this massive damage. If the CERN wire bond lab had not been nearby (it was downstairs in the same building as the module mounting) and available for these often-difficult repairs, there would not have been enough spare modules to complete the endcap installation on time. However, another lesson learned from this was that the encapsulation of those wires that could be safely encapsulated could have prevented much (but not all) of the installation damage described above.

**Figure 13.** Left: Normal row of bond wires. Right: Damaged wires on three chips during installation.
