Combined ND Techniques for Structural Assessment: The Case of Historic Nepali Constructions after the 2015 Gorkha Earthquake [†]

Abstract: Combined non-destructive in situ techniques—namely sonic tests and ambient vibration measurements—are applied on two Nepali Pagoda temples damaged by the 2015 Gorkha earthquake, providing the dynamic elastic modulus of masonry and the buildings’ frequencies.

This study presents an experimental investigation on two Nepali Pagoda temples damaged by the 2015 Gorkha Earthquake, namely Jagannath Temple in Kathmandu Durbar Square and Krishna Temple in Bhaktapur Durbar Square.

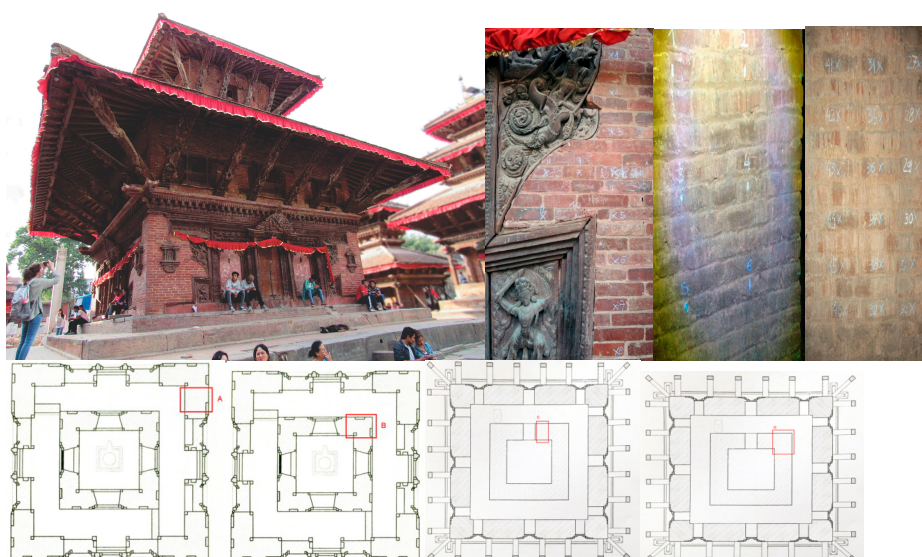
Figure 1. Jagannath Temple, Kathmandu.

The first historic construction investigated with both STs and AVMs is Jagannath Temple (Figure 1). STs have been applied in four zones, as indicated again in Figure 1. Some results are reported in Table 1 for zone A. Masonry density has been assumed according to [14].

In detail, the analysis of the results confirms the effects of damage and its distribution. In particular, it is evident from Table 1 that the zone in correspondence of the first floor appears less damaged than that at the ground floor.

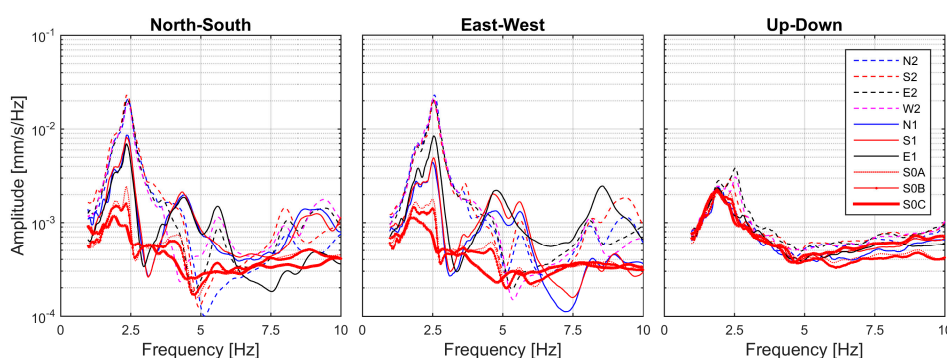
Figure 3. Fourier amplitude spectra of velocity, Jagannath Temple.

The first two frequencies correspond to the fundamental modes along the NS ($f_1 = 2.3$ Hz) and EW ($f_2 = 2.5$ Hz) directions, respectively. Similarly, the third and fourth frequencies correspond to the second modes along the NS ($f_3 = 4.3$ Hz) and EW ($f_4 = 4.7$ Hz) directions, respectively. The fifth frequency ($f_5 = 5.6$ Hz) corresponds to the first torsional mode around the vertical axis, as the N and S walls move along the EW direction, and the E and W wall along the NS direction. Two frequencies follow ($f_6 = 8.1$ Hz, $f_7 = 8.6$ Hz) without clear indications about their modal shape. The eighth frequency ($f_8 = 9.1$ Hz) correspond to the third mode along the NS direction. Finally, the ninth frequency ($f_9 = 9.4$ Hz) corresponds to the second torsional mode around the vertical axis. The measures at the second floor show the typical coupling between the horizontal and the vertical components due to the global bending response of the building. No significant peak was detected at the basement, south side, outside the temple, showing the absence of local amplification effects.

The frequency values reported in Section 2.1 with reference to Jagannath Temple evidenced a well-known and recognizable structural behaviour consisting of modes along the principal directions of the building and torsional modes. Horizontal and vertical components are coupled according to global flexural behaviour. The frequency values are in agreement with the level of wave velocity across the thickness of masonry, ranging between 850 and 1700 m/s, with reasonable level of homogeneity and low scatter. However, if we consider that the tests have been carried out on a damaged structure, both STs and AVMs seem to indicate that the dissipation capacity of the monument under seismic actions has been efficient and performing.

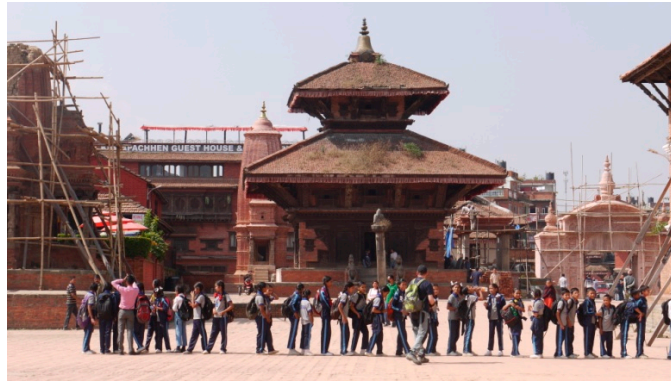
Figure 4. Krishna Temple, Bhaktapur.

In the case of Krishna Temple (Figure 4), STs, of direct and indirect type, have been applied at the base of the masonry bearing parts, as indicated in Tables 2 and 3.

According to well established relations between sonic wave velocity and masonry compactness, Table 2 confirms that the latter is low along both the horizontal and the vertical directions. This is probably due to internal damage and low level of maintenance. Moreover, the very low values of the sonic waves along the vertical direction over short distance (450 mm) highlight the poor mechanical performance of mud mortar joints.

Regarding Krishna Temple, both STs and AVMs show a less effective structural performance, which is consistent with higher level of observed damage. More specifically, a potential field of research is the integration of information from dynamic identification by means of AVMs—i.e., natural frequencies and modal shapes for each direction—and those from sonic wave velocity distribution in the walls along the same direction.

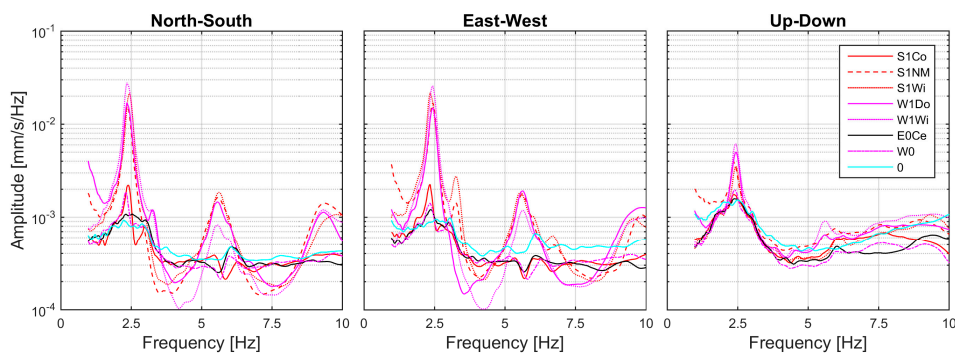
Figure 6. Fourier amplitude spectra of velocity, Krishna Temple.

The first two frequencies ($f_1 = 2.3$ Hz, $f_2 = 2.4$ Hz) have mixed components, along the NS and EW directions, possibly with torsion. The third frequency ($f_3 = 3.3$ Hz) corresponds to the first torsional mode around the vertical axis (the S wall moves along the EW direction and the W wall along the NS direction). The fourth frequency ($f_4 = 5.6$ Hz) has mixed components along the NS and EW directions. The fifth frequency ($f_5 = 6.1$ Hz) corresponds to the free-field and the basement, showing local amplification effects. Finally, the last three frequencies ($f_6 = 6.5$ Hz, $f_7 = 9.4$ Hz, $f_8 = 9.8$ Hz) have again mixed components along the NS and EW directions. Coupling between the horizontal and the vertical components can be found at the first floor.
