New Frontiers of Composites Applications in Heritage Buildings: Repair of Exposed Masonry of St. Nicola Church in Pisa

Pietro Croce

Citation: Croce, P. New Frontiers of Composites Applications in Heritage Buildings: Repair of Exposed Masonry of St. Nicola Church in Pisa. *J. Compos. Sci.* **2021**, *5*, 218. <https://doi.org/10.3390/jcs5080218>

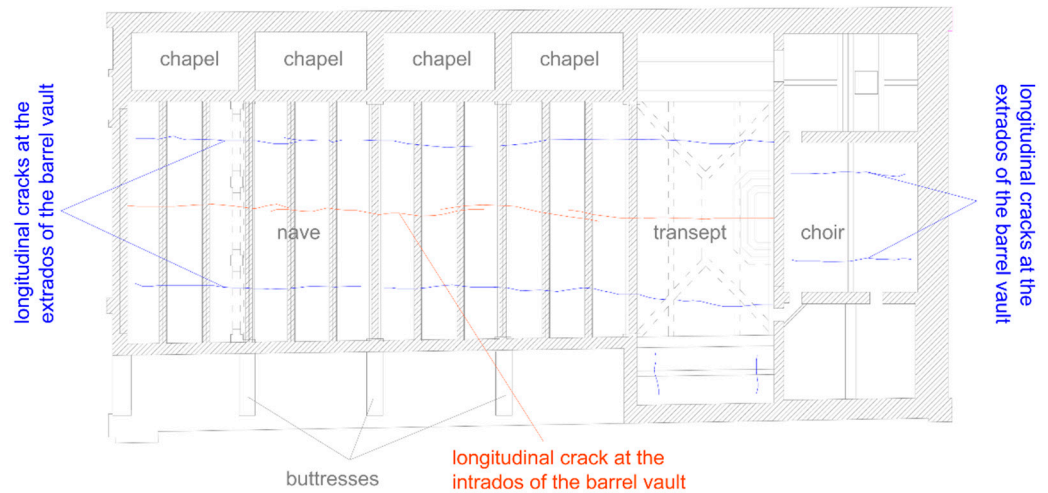
A first crack pattern, summarized in Figure 14, affected the longitudinal barrel vault of the nave and its stiffening arches. This crack pattern denoted the exemplary and classical vault mechanism, characterized by three longitudinal Pol Abraham’s hinged cracks [79,80]: A central one at the intrados of the crown (Figure 15a) and two lateral ones, nearly symmetric, at the extrados of the vault haunches (Figure 15b).

Figure 14. Crack pattern of the longitudinal barrel vault of the nave.

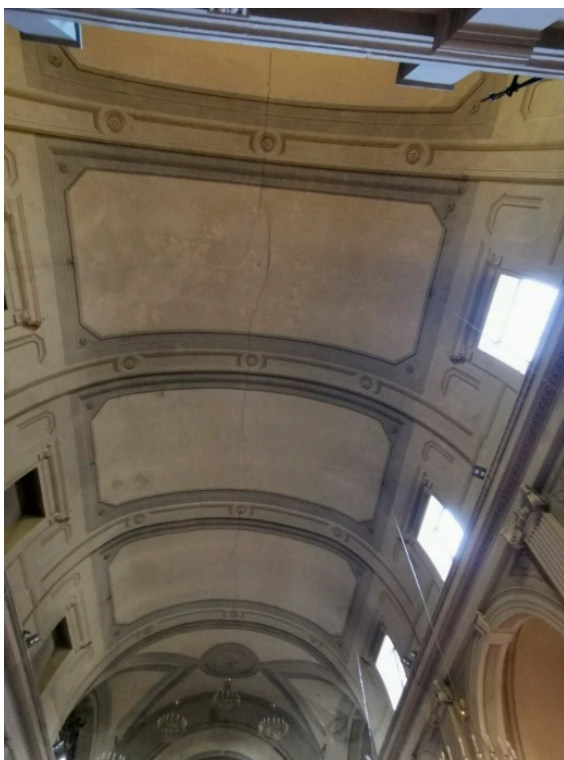
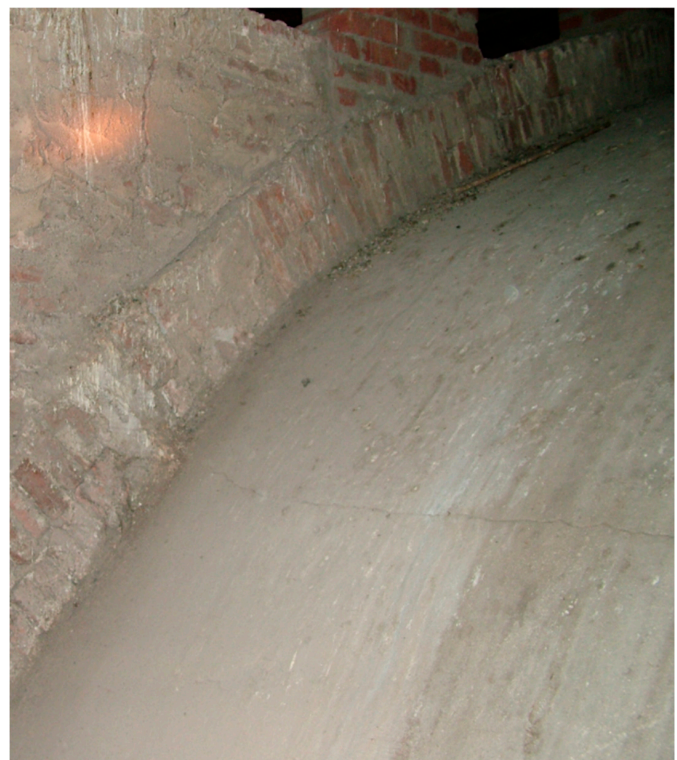
Figure 15. Longitudinal hinged cracks of the barrel vault of the nave: (a) longitudinal crack at the intrados; (b) longitudinal crack at the extrados of the barrel vault haunches.

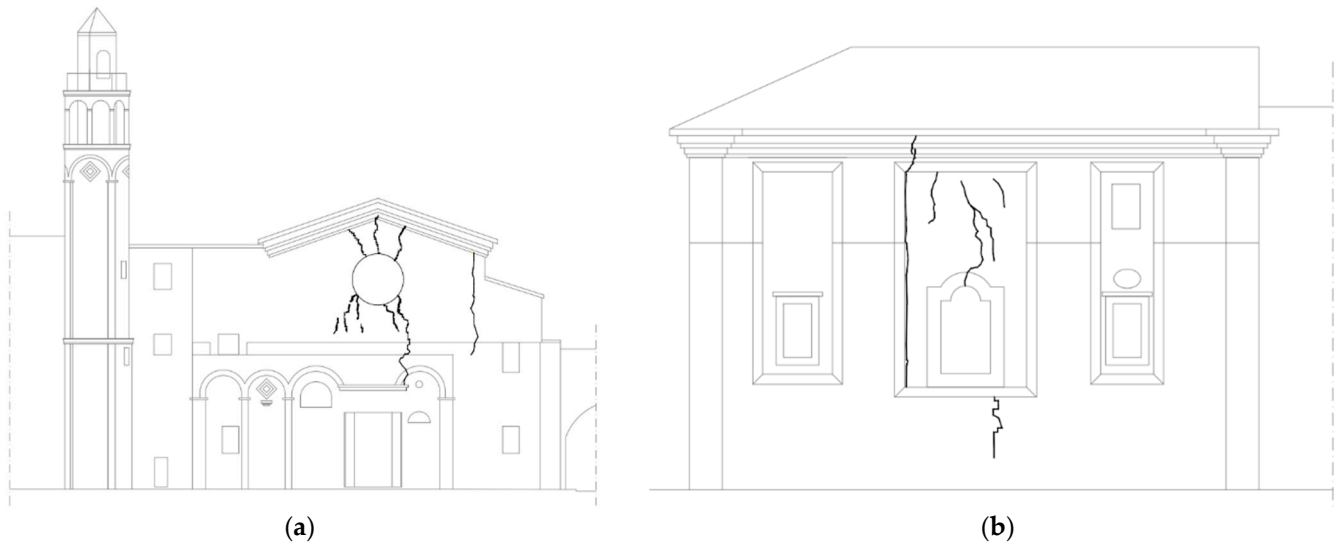
A second, clearly visible, family of vertical cracks, summarized in the diagrams of Figure 16a,b, was detected on the main façade (Figure 17) and on the rear façade (Figure 18). A common feature of these cracks, mainly concentrated near the rose windows on the main façade, and in the neighborhood of the second window on the rear façade, was the width increasing with the height.

Figure 16. Graphic representation of the crack pattern on the façades: (a) main façade; (b) rear façade.

The crack patterns just described are both coherent with a unique failure mechanism: the relative horizontal displacement of the vault abutments, caused by the horizontal thrust, and by the resulting out-of-plane rotation of the longitudinal walls, barely restrained by the main façade, and by the rear façade. The origins of this failure mechanism seem quite remote; in fact, several stone stripes have been detected on the main façade straddling the cracks (see Figure 17b). The presumable rationale of the insertions of these narrow stones was stitching the cracks, but, the stone stripes also having cracked, the results were clearly unsatisfactory.

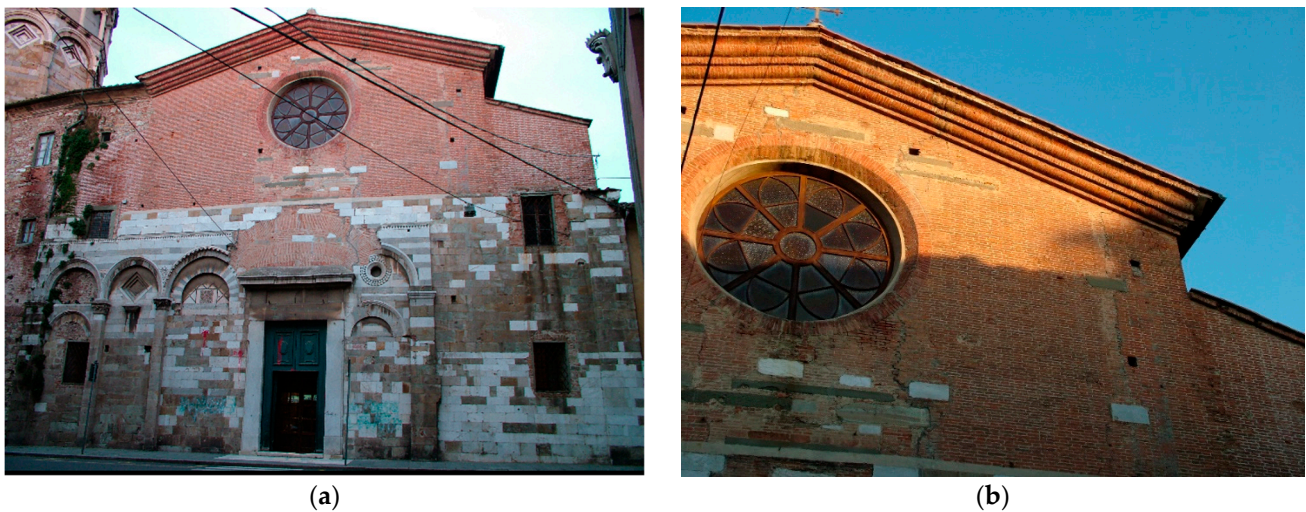
Figure 17. The crack pattern on the main façade: (a) general view; (b) detail.

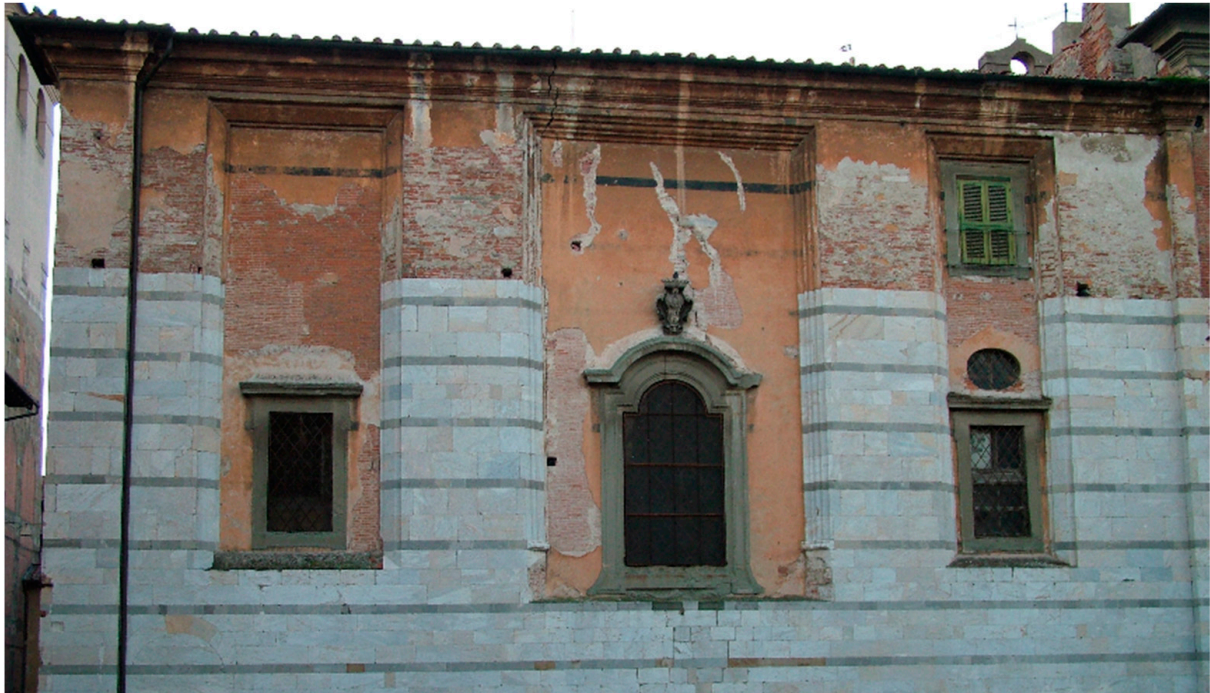
Figure 18. General view of the crack pattern on the rear façade.

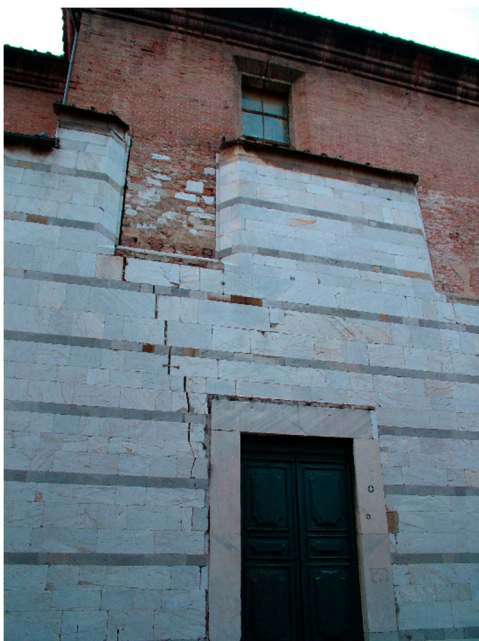
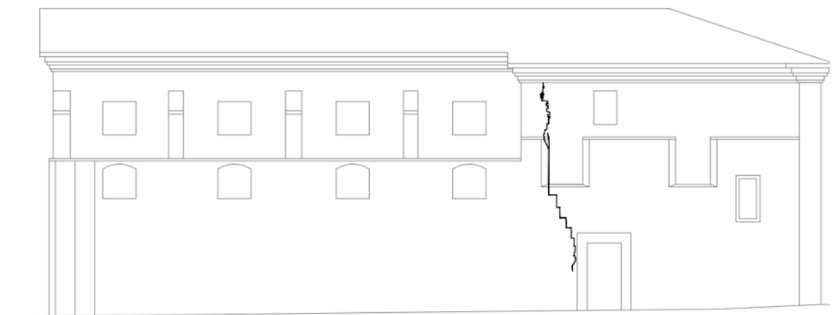
The third detected crack pattern was a significant vertical crack on the south façade, located at the connection between the nave and the transept, whose opening increased with the height (Figure 19). This crack was originated by a second failure mechanism, initiated

in fairly remote times: a settlement of the foundation of the corner between the main façade and the south façade, further emphasized by the construction, in the 19th century of the arched passage connecting the Church with the Royal Palace. Nevertheless, after a suitable analysis of the evolution of the crack over time, it was concluded that the settlement was no longer active, and that specific strengthening interventions of the foundation were unnecessary. For these reasons, the interventions were mainly concentrated on the façades.

Figure 19. The crack pattern on the south façade: (a) detail; (b) graphical representation.

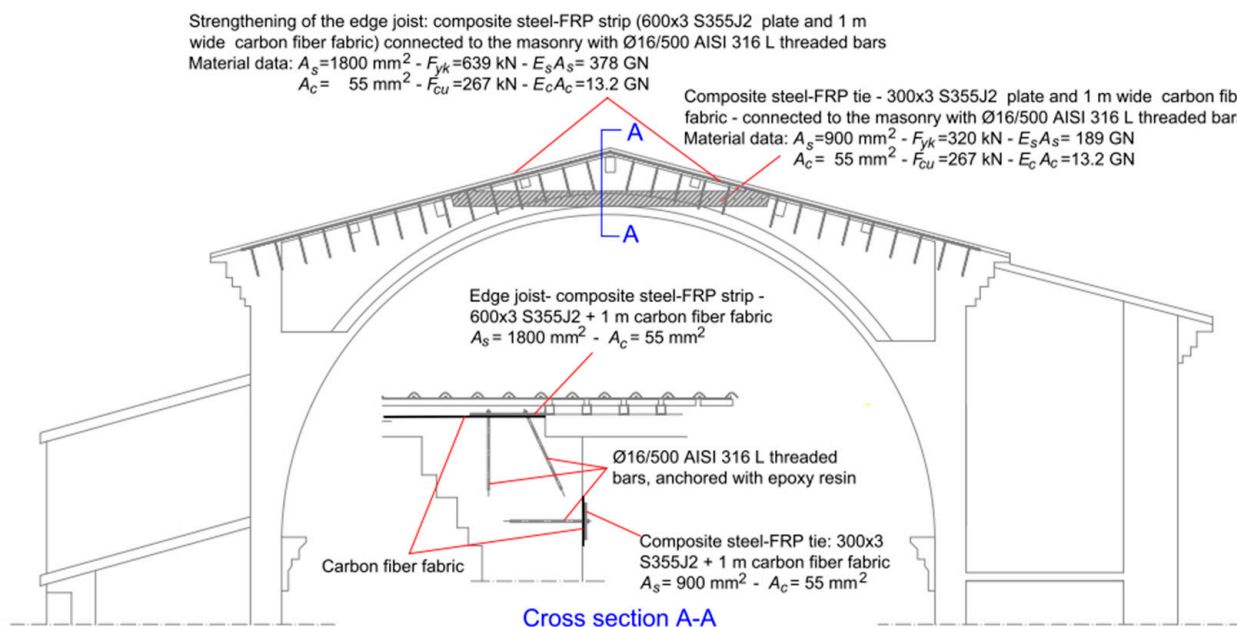
Figure 20. Main façade: strengthening of the edge joist at the top of the gable: type A intervention.

Type A intervention is summarized in Figure 20. It combines a composite steel-FRP strip, strengthening the edge joist at the top of the gable of the main façade (Figure 21a), with a composite steel-FRP horizontal tie, placed on the inner side of the gable, above the extrados of the barrel vault, covering the nave.

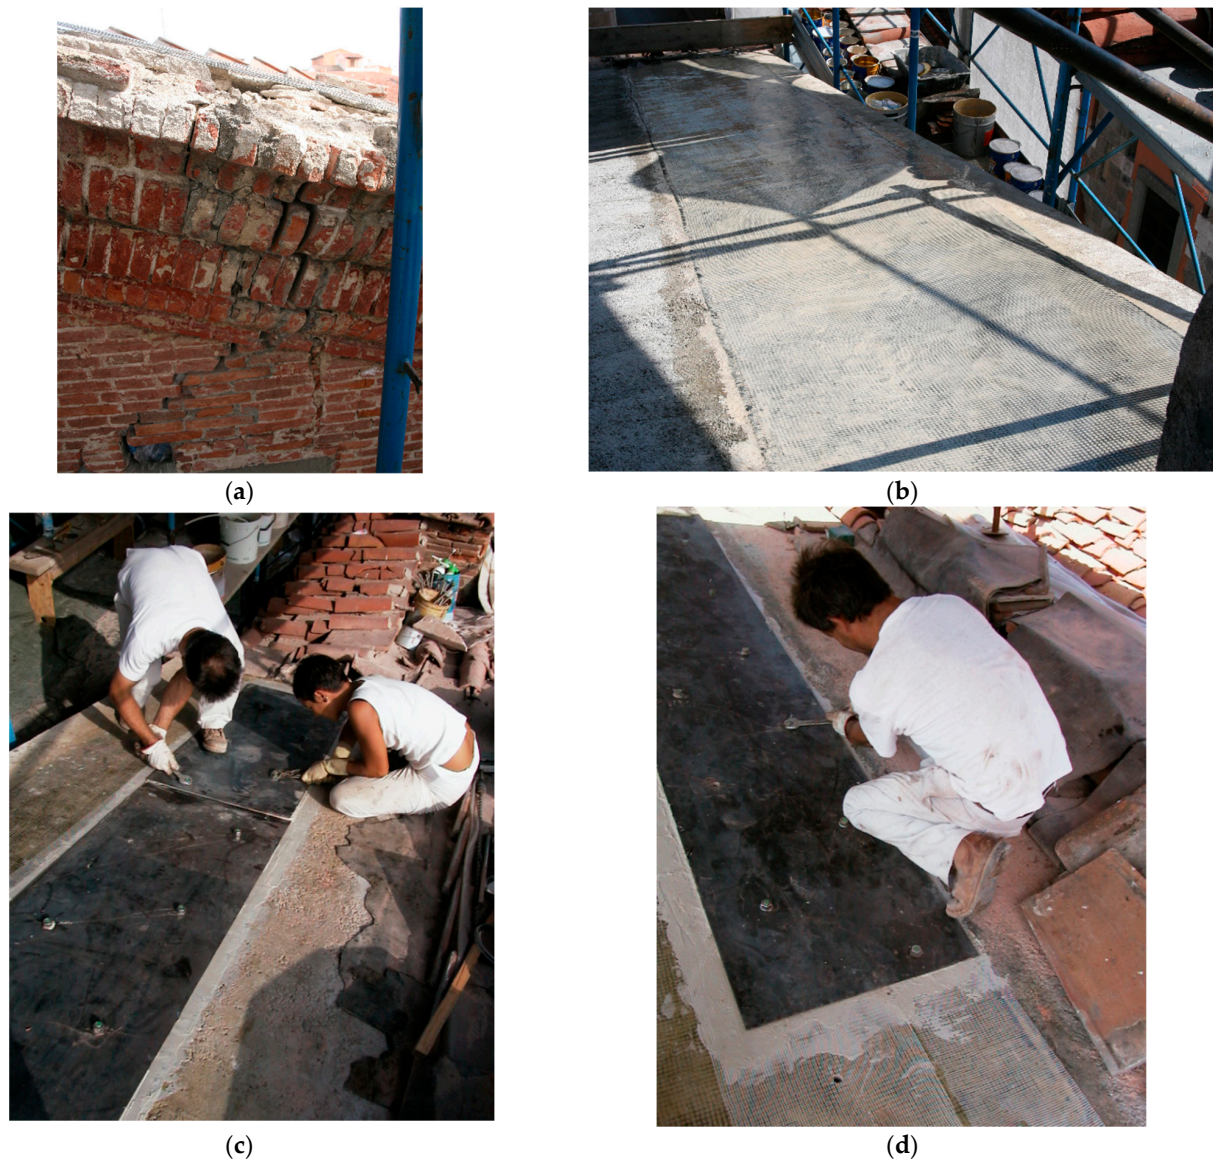
Figure 21. Phases of type A intervention: (a) edge joist before the intervention; (b) fixing of the carbon-fiber fabric; (c) upper steel plate; (d) glass-fiber net interposition for electrical insulation.

- cleaning of the masonry surface, removing all weak and loose parts, as well as any cause that would potentially reduce the adhesion of the reinforcement,
- preparation of the top surface and its dressing by means of fine mortar,

- insertion of the connecting bars,
- application of low viscosity resin,
- addition of a bidirectional carbon-fiber fabric, and its impregnation with the low viscosity resin,
- addition of the insulating glass-fiber net,
- application of the steel plate,
- zinc coating of the steel plate.

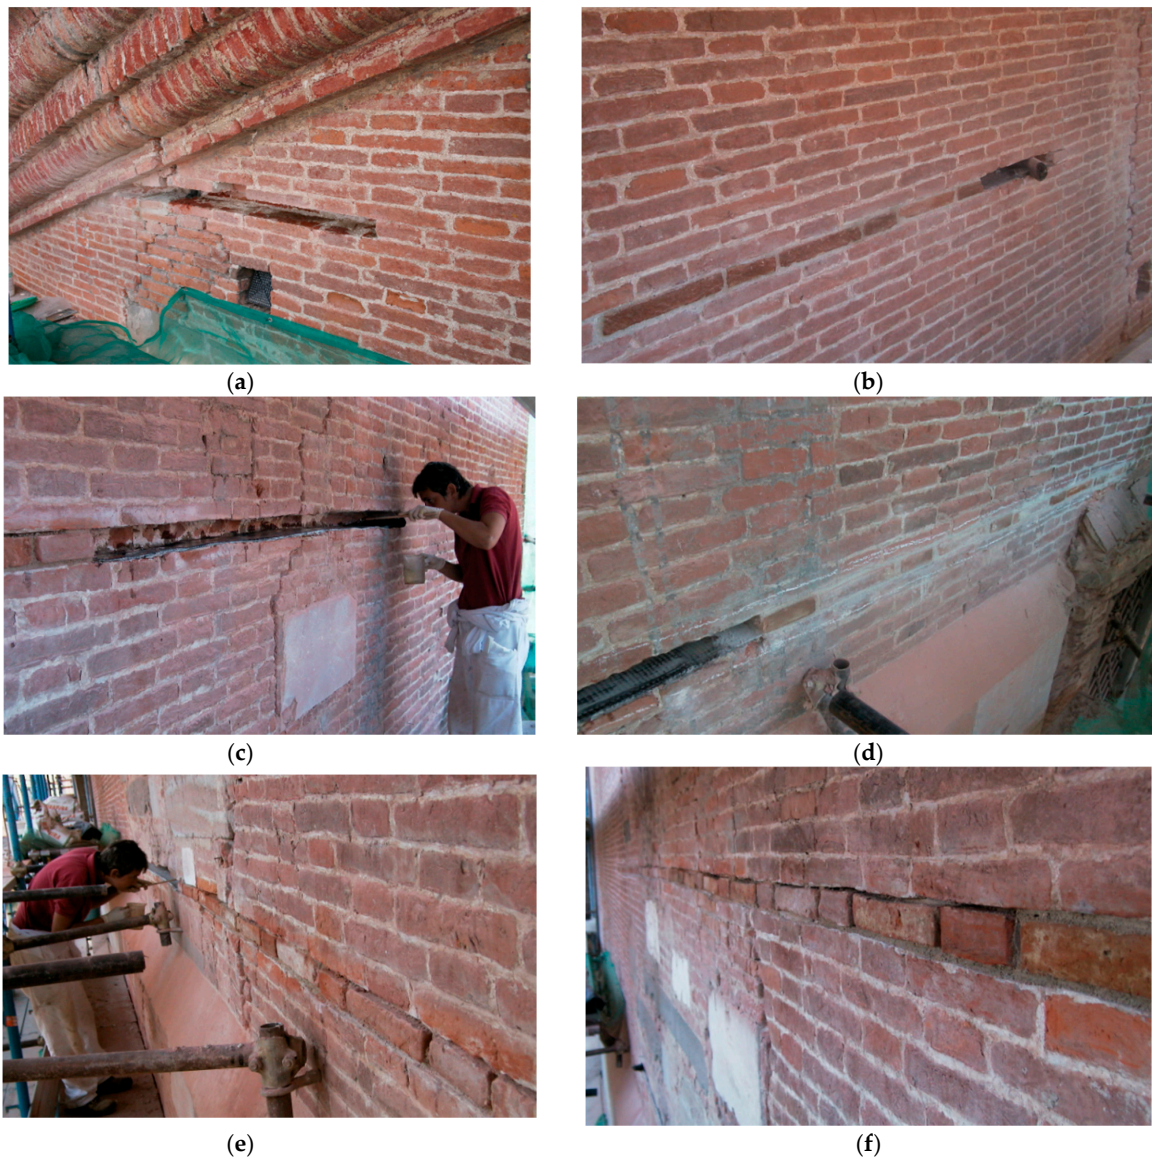
Figure 23. Relevant operational phases of the intervention: (a) removal of the first stretch of the brick course; (b) reconstruction of a stretch of the brick course, before unrolling the fiber roll; (c) unrolling and impregnation of fiber roll; (d) stretch of the brick course ready for reconstruction; (e) intervention in advanced stage; (f) intervention almost completed.

Because the operational phases, illustrated in Figure 23, perfectly matched those described in Section 2, additional information is unnecessary.

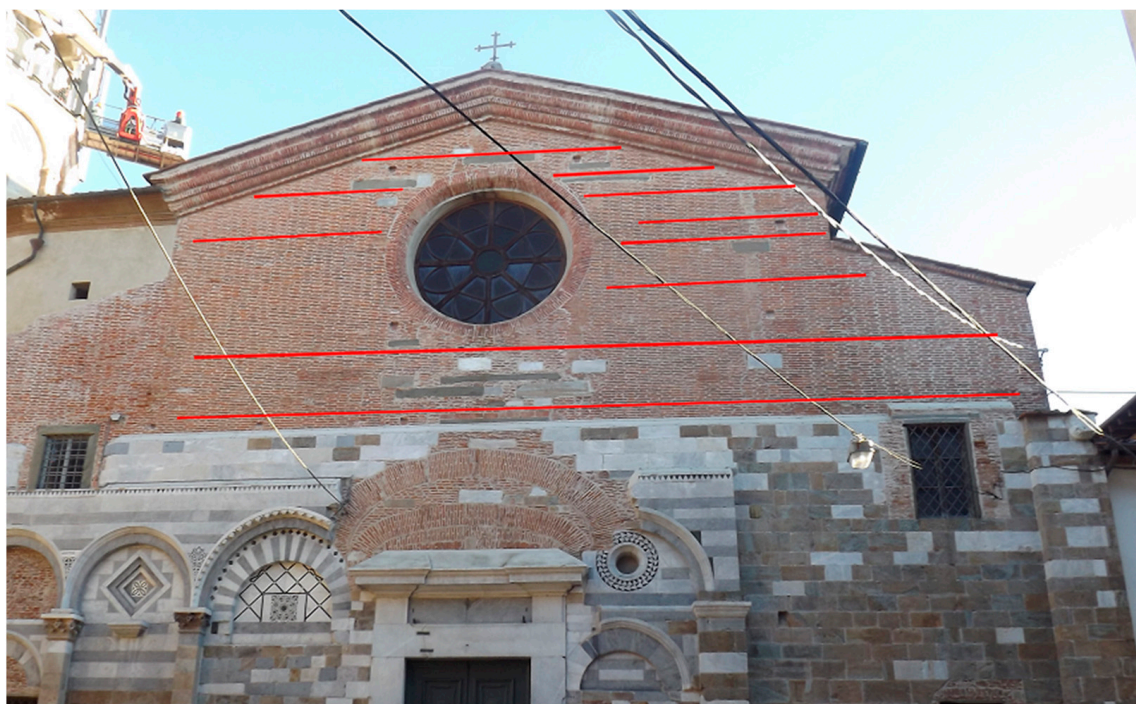
Figure 24. Strengthened brick courses of the main façade.

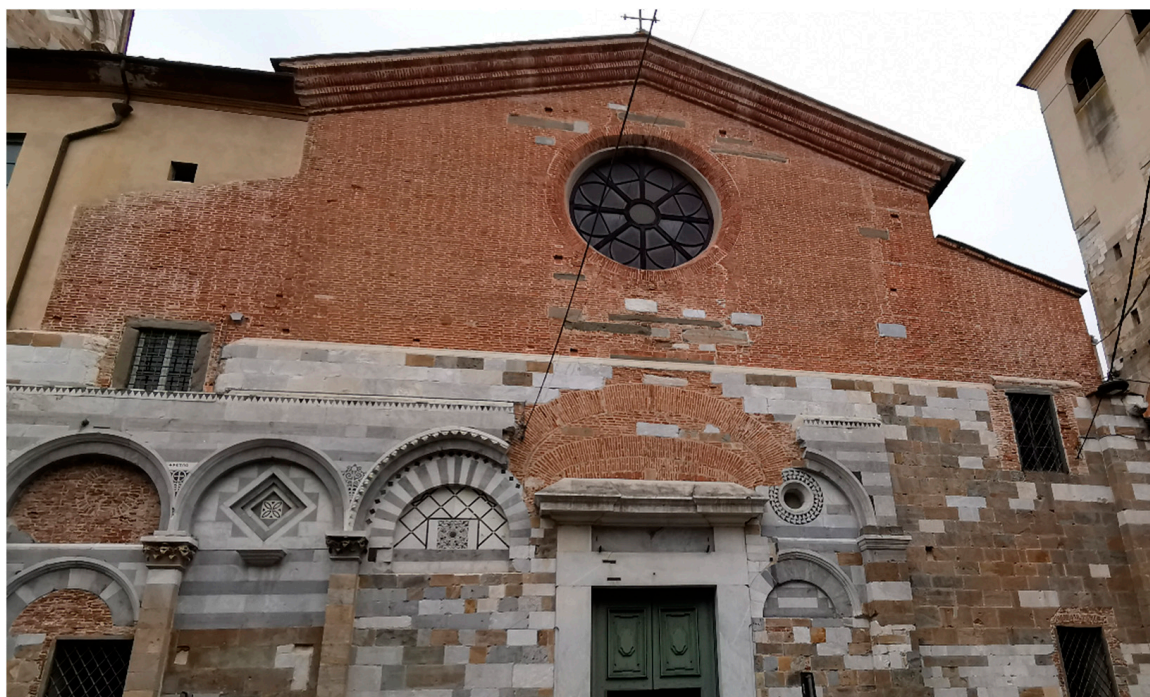
Figure 25. The actual aspect of the main façade—global view (June 2021).

Looking at the photos, it can be remarked that all the crack patterns have stabilized. In addition, till now,

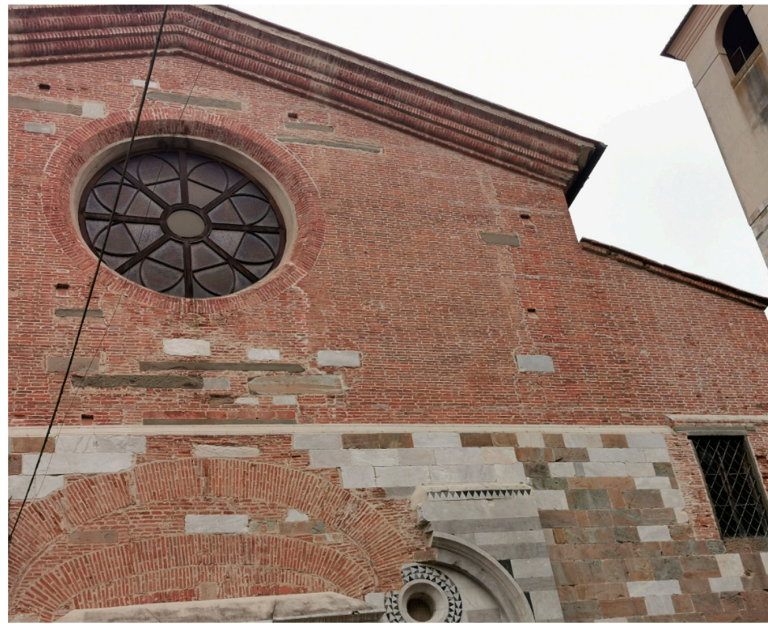
Figure 26. The actual aspect of the main façade—detail (June 2021).

- there is no evidence of the reopening of existing cracks, or of the formation of new cracks, on the exposed masonry of the main façade, as demonstrated in detail by the photo in Figure 26,
- the marble facing of the rear façade, reconstructed during the restoration works of 2005, is undamaged, while the crack pattern, previously evident in the neighborhood of the central window is no longer active (Figure 27b), and, finally,
- the vertical crack of the south façade is still closed, so confirming that the differential settlement, which originated it, is nearly inactive.

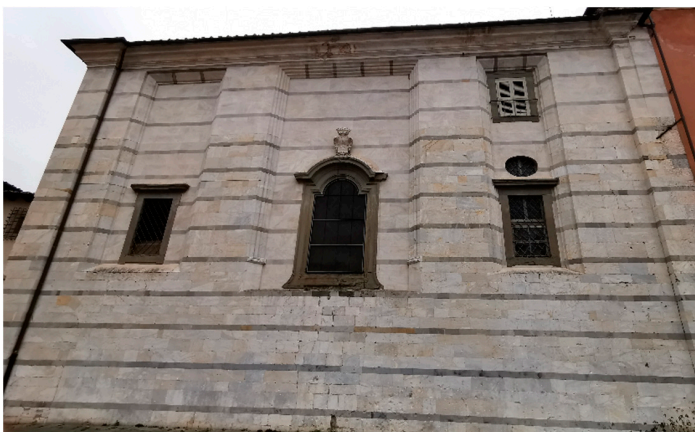
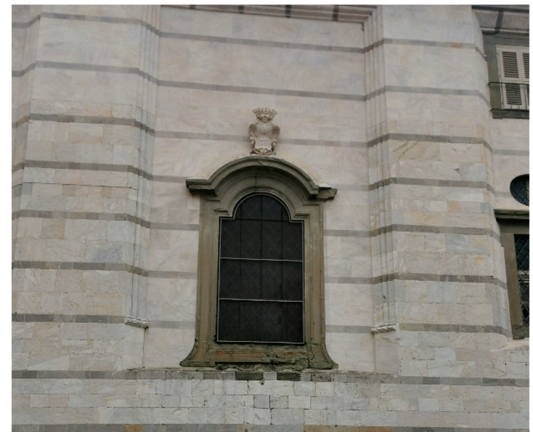
Figure 27. The actual aspect of the rear façade (June 2021): (a) global view; (b) detail.

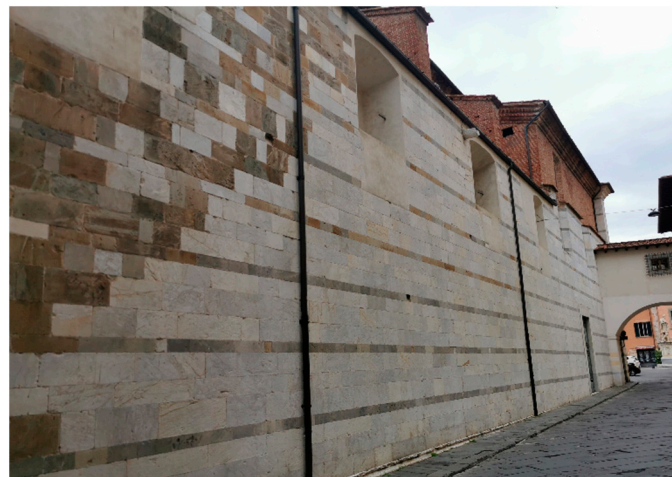
Figure 28. The actual aspect of the south façade (June 2021).
