Surface Mechanical Effects of Wildfires on Rocks in Climbing Areas

Pablo Yeste-Lizán ^{1,*}

Abstract: Wildfires are widely recognized as a cause of mechanical damage to rocks. Nevertheless, previous research has neglected how wildfires might impact sport climbing areas. In Spain, two large wildfires affected two climbing areas between 2020 and 2021. This paper addresses the rock mechanical effects of wildfires that could lead to safety issues, such as rock falls, climbing hold deterioration, and climbing anchor damage. In this study, the Non-Destructive Techniques (NDTs) of Ultrasonic Pulse Velocity (UPV) and Schmidt Hammer (SH) were used, and two types of measurements were carried out: randomized grid measurements and measurements along the climbing routes. Two phenomena were recognized: (a) thermal breakdown and (b) mineralogical changes. The results of using the SH show a relationship between the decrease in the rebound value and the observed mechanical damage. Field observations showed mechanical weathering, such as cracking, spalling, granular disaggregation, and thermochemical weathering with different temperature thresholds. Observed thermochemical reactions included redde

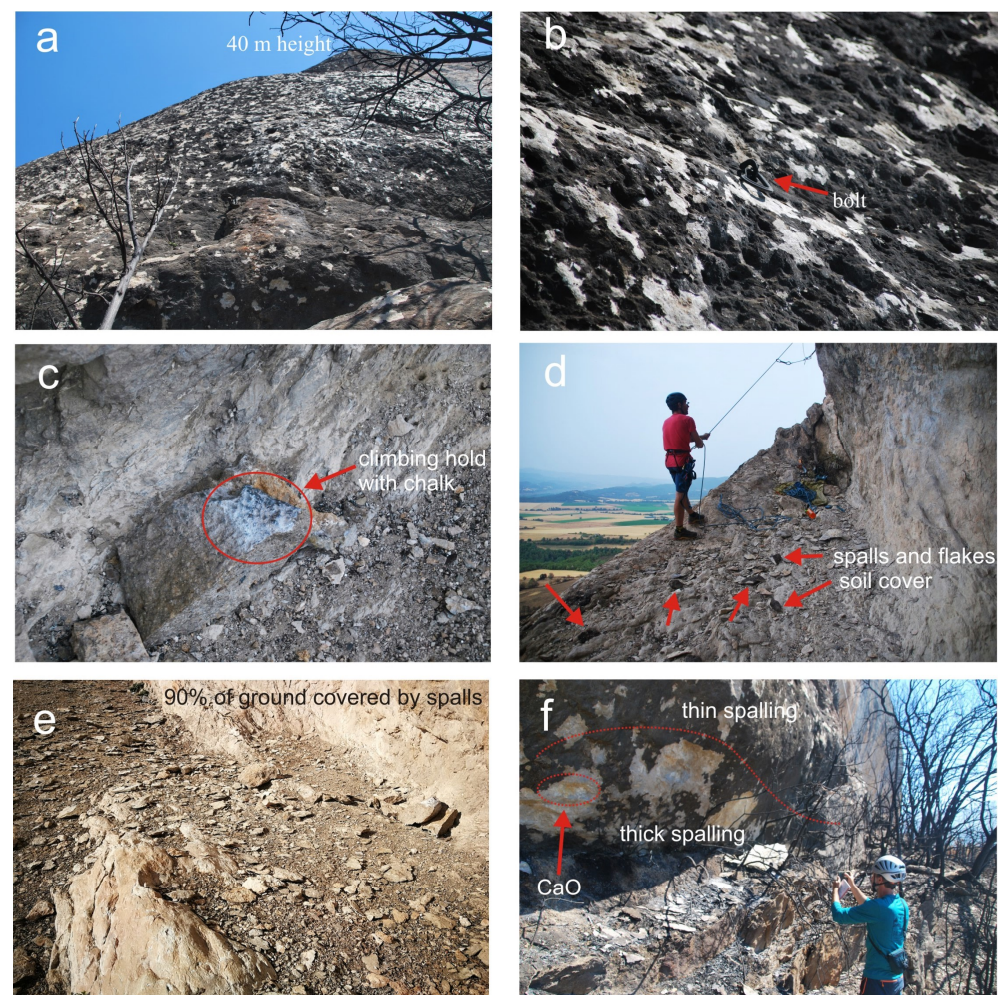
The wildfire effect observed on the climbing wall is the fall-out of thin slabs, arranged as great patches of metric size in some sectors of the wall. Spall scars show clean and fresh areas, easily observable and different from the dark burned areas without detached slabs. The thickness of the spalling oscillates between 2 and 20 mm, with 5 mm on average (Table 3). The spall size ranges from 5×10^{-3} to more than 0.5 m^2 . The lower part of the climbing wall has been affected by the wildfire, where it is impossible to identify the spall sizes. The effect of the wildfire is lower in the upper part of the climbing routes (Table 4).

Figure 7. Visible rock surface decay features in Oliana as a result of the fire: (a) flaking and spalling on the left side of the climbing crag; (b) extensive flaking affecting an anchor; (c) large rockfall from a climbing route (notice that the rock still preserves the climbing chalk); (d) climbing area covered by spalled flakes; (e) ground of climbing area is 90% covered by spalls (photograph: Toni Mas); (f) limit of thick and thin spalling due to prolonged heat in the lower part provided by adjacent burned bushes.

Regarding the size of the detached spalls by wildfire in the Oliana climbing wall, we measured blocks of 1.8 m long, 0.15 m thick, and about 2 m² in area. These fractured blocks are more abundant close to the ground, although they can be observed up to 3 m high in the wall. Moreover, previous fractures and weakness planes could favor the breaking of these blocks. In the most affected areas, spalls covering 90% of the soil were observed (Figure 7e).

The iconic climbing area of Oliana was affected in a different way. The left side of the wall has experienced dramatic changes by spalling, rockfalls, and shattering (Figure 7). All routes on the left side have been destroyed by fire, even up to the highest part (~40 m). The vertical hot currents caused a sudden thermal shock. Conversely, the central part of the wall—the place where the most iconic routes are located—was protected from the fire. The right side of the wall was also damaged (Figure 14a). Spalling not only affects the wall, but also several anchors lost a few centimeters of rock cover (Figure 14b–d). Surprisingly, the anchor test (Figure 14f) showed a good condition of all protections.

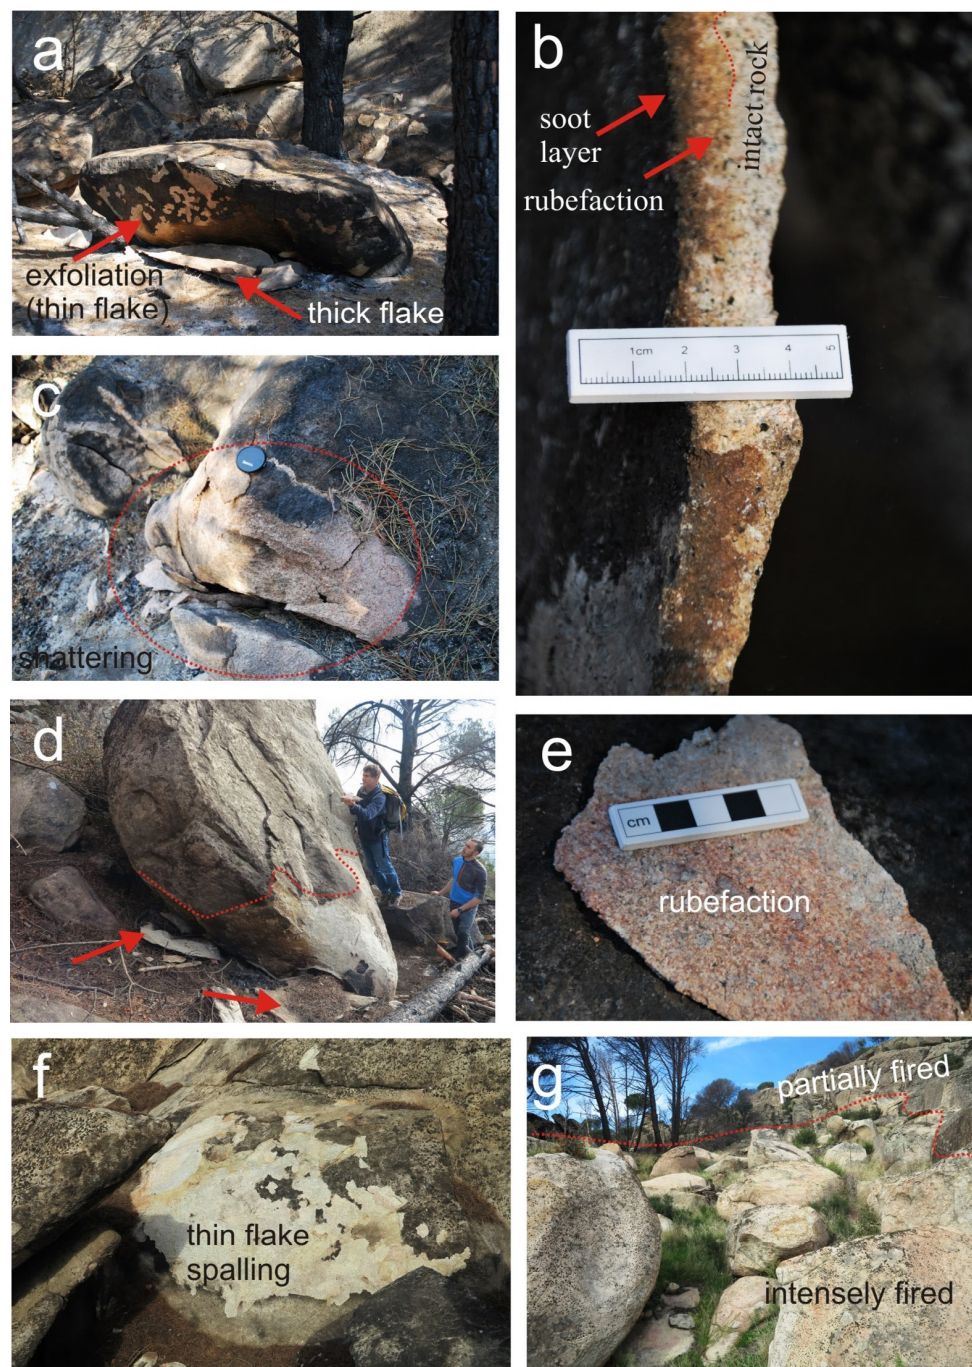
In Cadalso de los Vidrios, the effects of the wildfire affecting the granite rock surface depend on the persistence and temperature of the wildfire. In general, the effects of the wildfire were limited (Table 4), and the bottom 2–3 m of the walls were the most affected parts of the climbing routes. The main effect observed was detached rock spalling, with the spall thickness ranging from a few millimeters to a few centimeters (Table 3). The spalled areas range between 20 cm² and 0.5 m². The spalled areas are easily visible due to the sharp color change between the discoloration (either reddened or blackened) of the non-spalled rock surface and the lighter fresh-rock color of the spalled areas. Regarding the total affected climbing area in Cadalso, the east part is the most affected area, showing up to 30% of the surface of detached spalling at the bottom part of the climbing wall (Table 4). The top parts of the wall show a much smaller surface of detached spalling.

Another important effect of the wildfire is the formation of cracks in granite blocks (Figure 8), constituting a risk for climbing. These cracks can reach 1.5 m long and 1 m deep from the bottom of the granite rock. Subsets of subparallel fractures appear in areas where the wildfire reached the maximum temperature. Reddening is the result of thermal oxidation from around 300 °C, while spalling and cracking may be due to thermal shock during either the fire or its extinction. Surface temperatures above α to β quartz transition (573 °C) increase the chance of granular disaggregation instead of spalling [1,5,7].

Figure 8. Visible rock surface decay features in the Cadalso de los Vidrios site as a result of the fire: (a) flaking of blackened surface and thick spalling at the bottom part of a boulder, possibly generated by thermal shock during aerial firefighting; (b) spall showing the surface black soot layer penetrating and clogging the fire-induced surface cracks, an intermediate thermally reddened portion, and seemingly unaffected rock; (c) completely shattered boulder as a consequence of intense thermal shock; (d) boulder showing a 1 m thick shattered portion at the bottom and spalling at the top, possibly due to prolonged heating caused by the burning of an adjacent log that appears to be completely burned; (e) reddened spall due to thermal oxidation of iron-rich micas; (f) boulder with extensive detached scaling and spalling, where a new “fresh” surface appears in the detached areas; (g) the clearer “fresh” surface formed after spalling is more abundant in areas that were totally covered by fire. Blackened surfaces of soot deposits appear in the area only partially affected by fire.

In Cadalso, the most intense damage, expressed as severe reddening and spalling, appears in boulders on the ground surrounded by vegetation, especially logs, in line with the findings of [46] and a densely burned forest mass (Figure 8). These boulders have been subject to prolonged high-temperature wood combustion [47]. The distribution and thickness of the detached spalling is consistent with data presented by previous research in

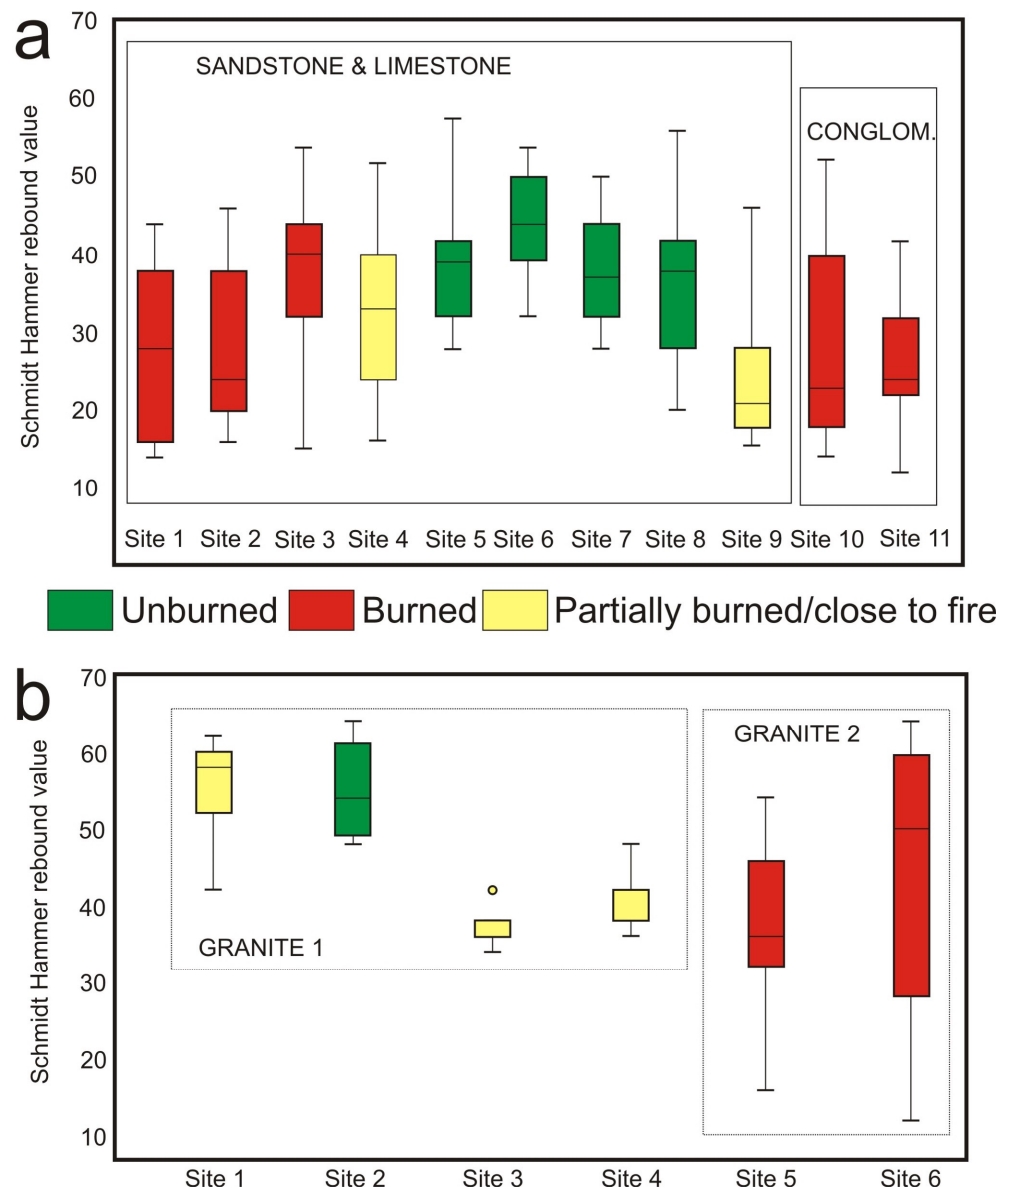
The Schmidt Hammer (SH) rebound numbers from the random grid at the bottom of both climbing areas show a clear relationship between the decrease in the rebound value and the observed mechanical damage features. The results from Oliana reinforce the idea of the increase in mechanical damage in the burned areas (Figure 9a) and also an increase in variability. The latter could be related to higher SH values measured in spalled areas in contrast with lower values in damaged areas not spalled during the fieldwork measurements.

Partially burned areas show a pattern with more variability and their characteristics and visual damage to the rock are sometimes similar to burned areas. Higher rock resistance values are found in unburned areas (green color).

There are two types of granite in Cadalso de los Vidrios, as seen in Figure 4b, each of them with different mechanical properties. Therefore, the results of these two granites cannot be compared with each other. Figure 9b shows the SH results for each of these granites. In the crags located in Granite 1 (corresponding to Unit 1 in Figure 4b), the highest SH values correspond to areas that do not show any feature resulting from fire (displayed with a green color), while the partially burned crags (yellow color) decrease the range of values. The two main crags located in Granite 2 (see Figure 4b, Unit 2) have been burned (red color), and the figure shows a wide range in the SH results, with more variability.

Figure 9. Schmidt Hammer (SH) values of the two studied areas: (a) Oliana with a clear variation of rebound values between sites visibly affected and non-affected by fire; (b) Cadalso de los Vidrios with two different granites along the various crags.

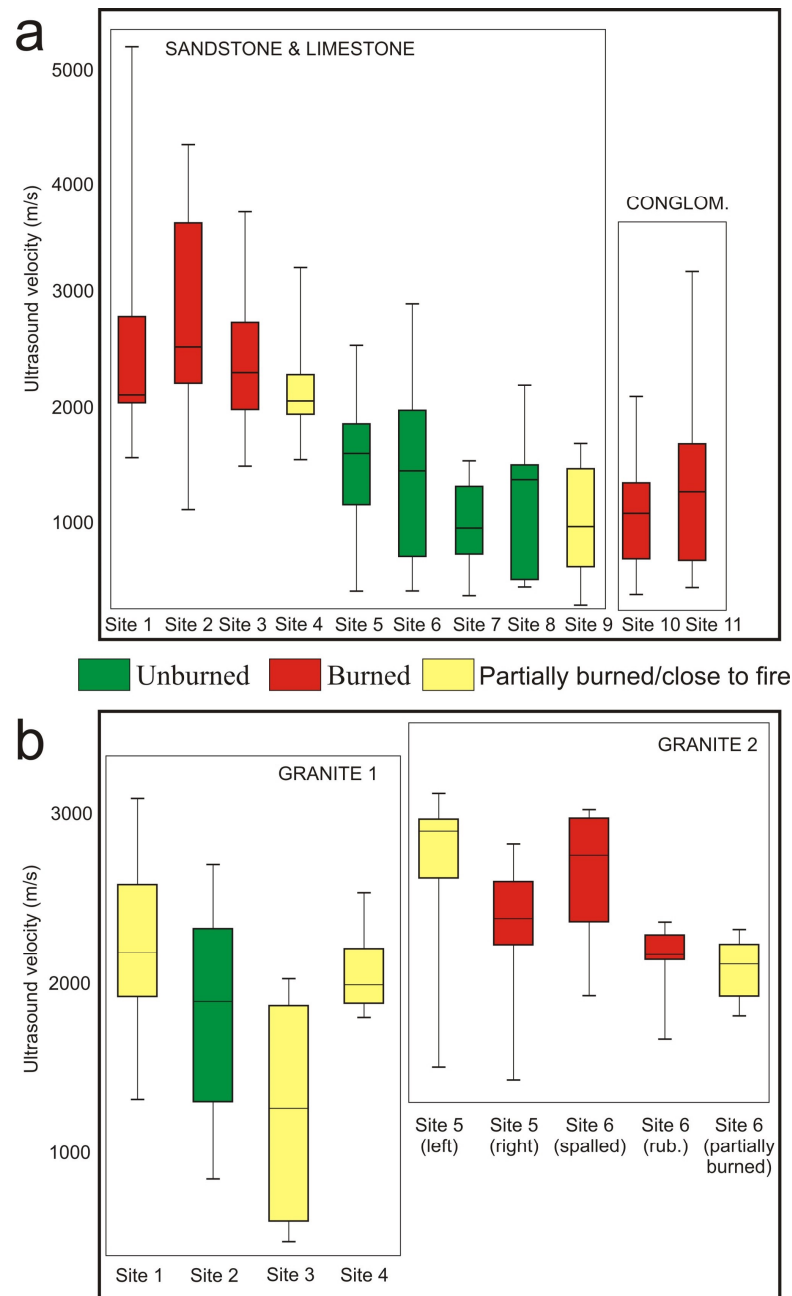
Figure 10 shows the UPV values for the random grid measurements obtained at the bottom of both climbing sites. Figure 10a shows the results displayed as a boxplot for the different climbing routes in the Oliana area. They are similar along the main wall, with the higher average values on the left side, which corresponds to the area with more visible effects caused by the fire, particularly blackened, soot-covered surfaces.

Figure 10b shows the results in the Cadalso de los Vidrios area. As mentioned for the SH values, the climbing walls occur in two types of granite; thus, the values are only comparable within each type of granite. These results do not show a clear relationship between those obtained in areas that were not affected and those that were either partially or totally affected by the fire. The comparison between the boxplots lacks statistical relevance (22.5% probability in Granite 1 and 5.6% in Granite 2 of relevant differences between data sets for a t-Student two-tailed test).

Figure 10. Ultrasound pulse velocity of the two studied areas: (a) Oliana across the entire climbing wall; (b) Cadalso de los Vidrios with two different granites along the various crags.

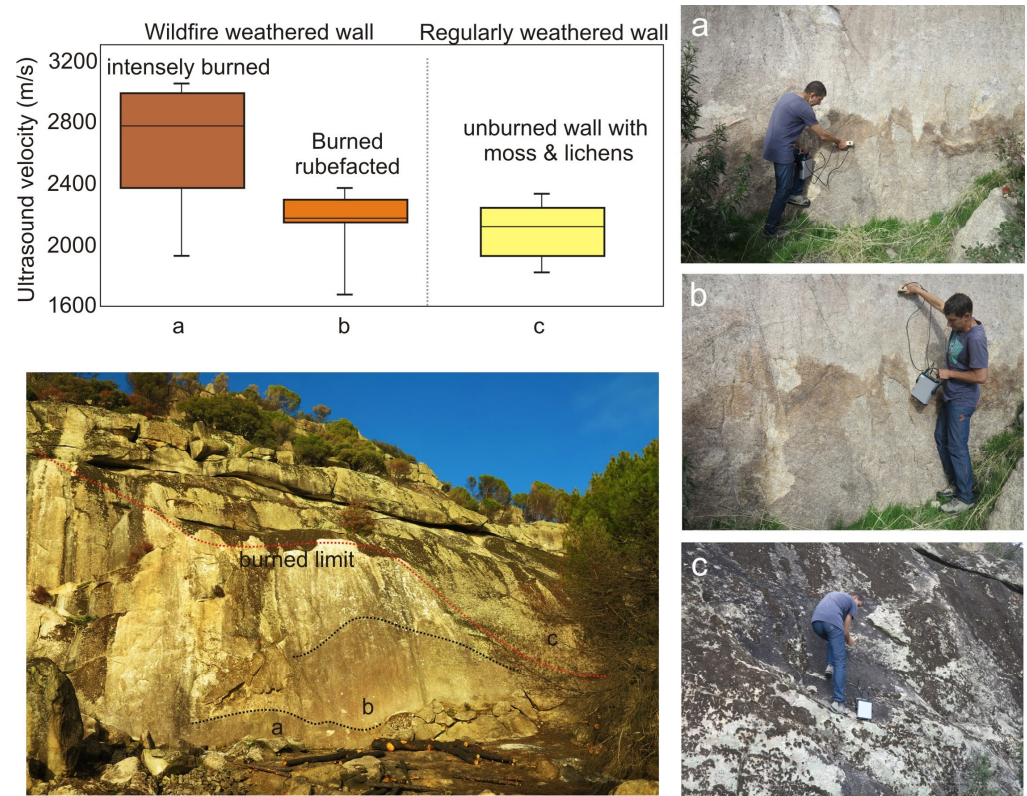
The large data dispersion and the lack of significant differences between the routes is not surprising, as fire dynamics, temperature, and fumes distribution are extremely complex and their effects may vary in different routes. Therefore, to assess the differences between areas with visible damage generated by fires, we chose a site in Cadalso de los Vidrios where a noticeable limit between different areas was identified (Figure 11). The bottom part of the wall up to 1.5 m high displays blackening due to soot cover and detached spalling (Zone a). Above this, a reddened area appears up to 5-6m height (Zone b). Close

by, on the right-hand side, is an area where preserved lichens and moss show clearly that it was not affected by the wildfire (Zone c).

The boxplot display of UPV in Figure 11 does not show highly relevant differences between “fresh” (Zone a) and reddened (Zone b) areas with 61.8 % probability of significant differences between data sets for a t-Student two-tailed test. UPV shows a significant increase in Zone c because of the combination of two effects generated by fire: detachment of spalling, which reveals new surfaces that were not affected by cracking during the fire event, and pore clogging due to the penetration of soot and fumes within the surface cracks.

Figure 11. Detailed UPV values in the Cadalso de los Vidrios climbing wall along two areas with different degrees of fire damage: (a,b) wildfire weathering. (a) Intensely burned area with a soot deposit and detached spalling at the bottom part of the wall; (b) reddened area, which occurs above one meter in height; (c) area on the right side of the wall with preserved lichens and moss, indicating that it was not affected by the fire.

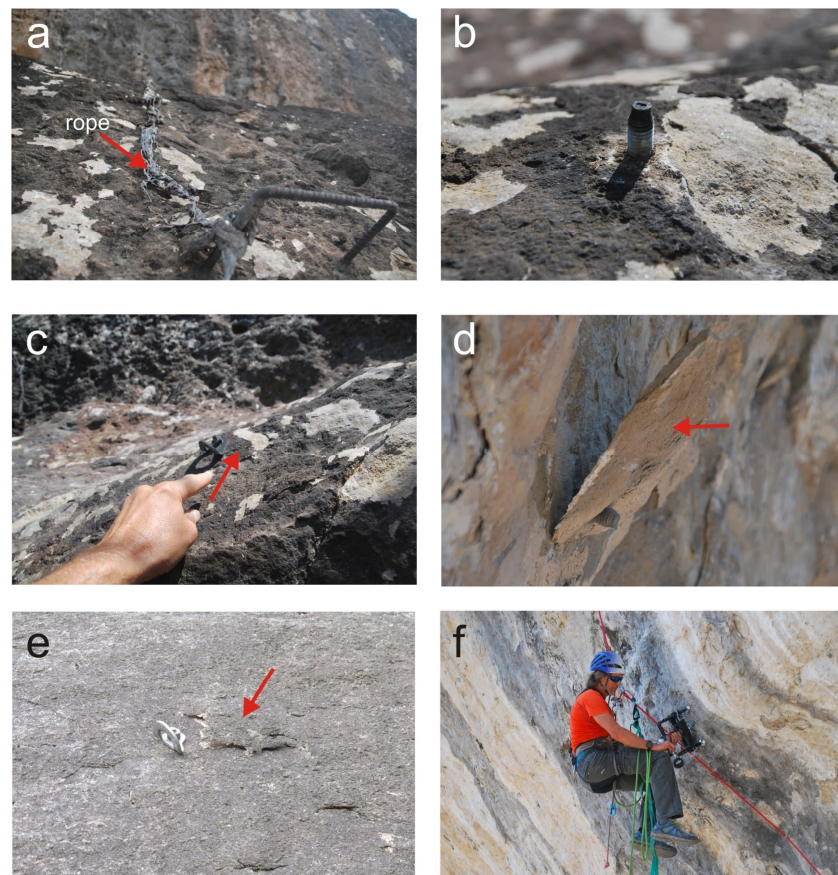
Figure 14. Impacts on climbing anchors: (a) remains of climbing ropes and iron stairs in Oliana; (b–d) spalling on anchors in Oliana; (e) exfoliation in Cadalso de los Vidrios near a bolt anchor; (f) anchor test in the “La Dura Dura” route.
