Explosion Shock Dynamics and Hazards in Complex Civil Buildings: A Case Study of a Severe Fuel Explosion Accident in Yinchuan, China

Abstract: Gas explosion accidents can easily lead to large-scale casualties and economic losses, significantly impeding the urban development. The purpose of this study was to comprehensively review and investigate a significant gas fuel explosion accident in Yinchuan City, China, and to conduct an in-depth discussion on process traceability, failure risk, hazard prevention, and urban development related to the accident. The research found that the accidental failure of double-valve liquefied petroleum gas cylinders and human error were identified as the direct causes of gas leakage. The numerical results indicated that the progression of the accident disaster was chaotic and highly destructive. The maximum explosion overpressure of 92 kPa resulted in severe shock-wave damage to personnel, leading to the complete destruction and collapse of the 0.2 m thick solid brick wall and obstructing the stairway for escape. The rapid change in temperature and oxygen levels caused by the explosion led to the risk of burns and asphyxiation for personnel at the sc

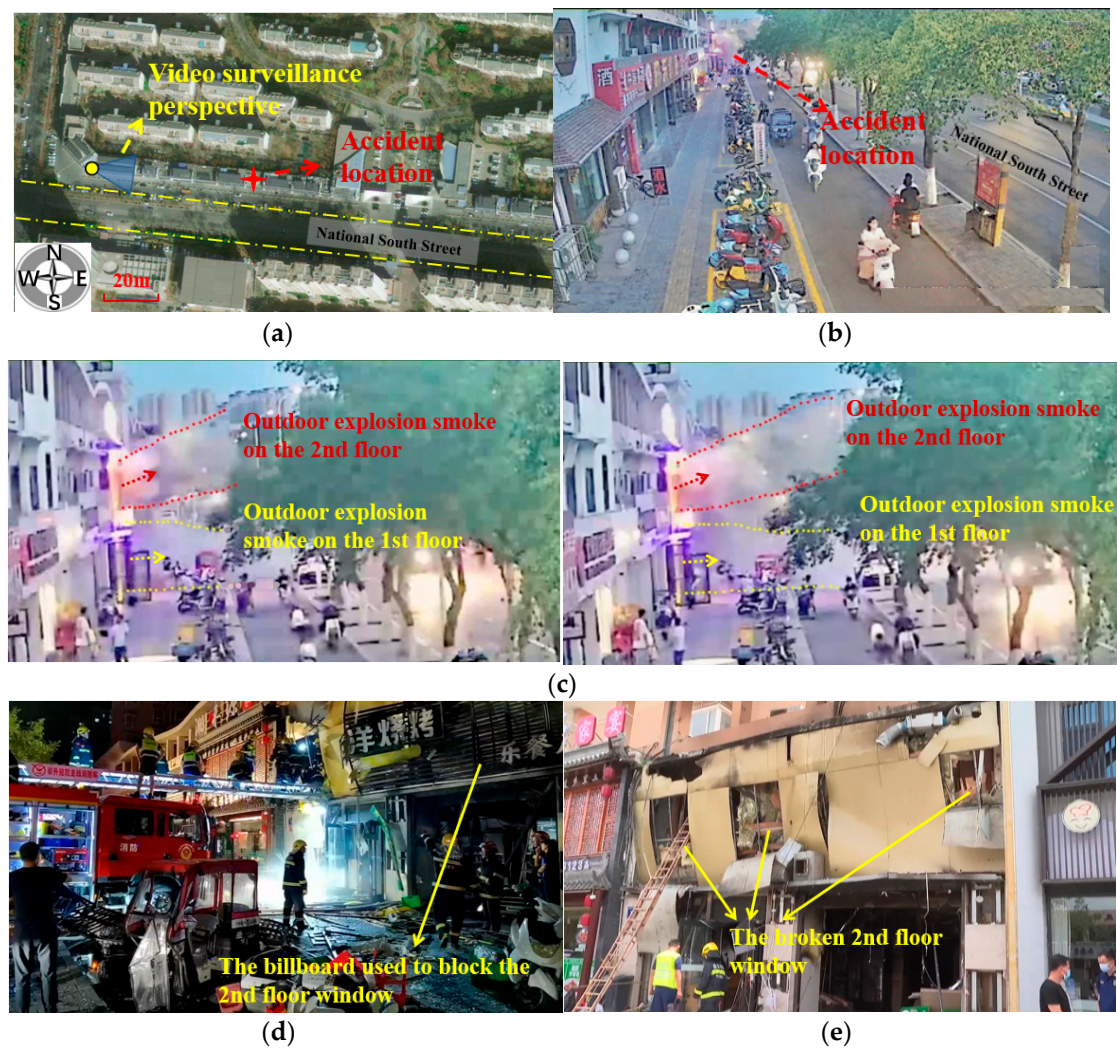
At 20:40 on 21 June 2023, an extremely serious LPG leakage explosion occurred at the 'Fuyang' barbecue restaurant in Minzu South Street, Xingqing District, Yinchuan City, Ningxia Hui Autonomous Region, China. Figure 2a,b shows the specific accident location. The accident resulted in a total of 38 casualties, including 31 fatalities and 7 injuries (1 critically ill, 2 with moderate burns, 2 with mild injuries, and 2 with glass scratches), with a direct economic loss of 51.145 million yuan. This disaster has garnered significant attention from people across the country due to the extremely serious casualties. The accident occurred in a two-story building. At the time of the accident, a surveillance camera outside captured the entire explosion process. The explosion shock wave, accompanied by a large amount of dust and smoke, was released into the external space at a high speed, as shown in Figure 2c. The power system of all the merchants on the entire street failed instantly, and windows up to 30 m away were shattered by high-speed fragments.

Figure 2. Peripheral pictures of the accident building: (a) accident spot; (b) video surveillance camera; (c) local magnification of the surveillance camera; (d) accident rescue scene; (e) accident scene after rescue.

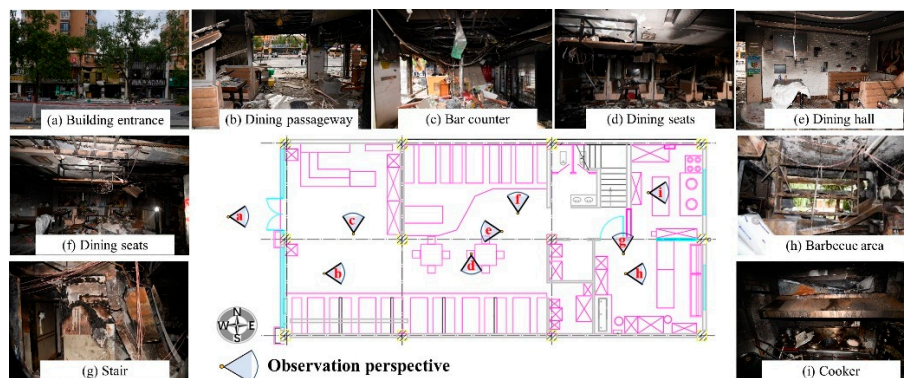
The restaurant involved in the accident was a two-story building with a total floor area of 366.56 m². The first floor comprised a kitchen (barbecue area and cooking area), a bar, two storage rooms, a toilet, and 9 dining tables. The second floor included nine rooms equipped with karaoke facilities, a storage room, and a toilet. Following a thorough on-site examination, the specific post-destruction conditions at the location are depicted in Figures 3 and 4. The severity of the damage was most evident on the 1st floor, as shown in Figure 3. All doors, windows, and glass components were shattered (Figure 3a,e); the aluminum decoration of the roof was damaged by impact (Figure 3c,f); a large section of the wall on the east side of the barbecue area collapsed outward (Figure 3h); the 0.2 m thick brick wall on the west side of the cooking area collapsed towards the west, obstructing access to the 2nd floor (Figure 3g); the self-constructed non-load-bearing walls on the east and west sides of the storage room completely collapsed; and cracks and deformations were observed on the north wall of the cooking area, with an outward displacement of approximately 0.10–0.15 m.

Figure 3. Explosion damage on the 1st floor inside the building.

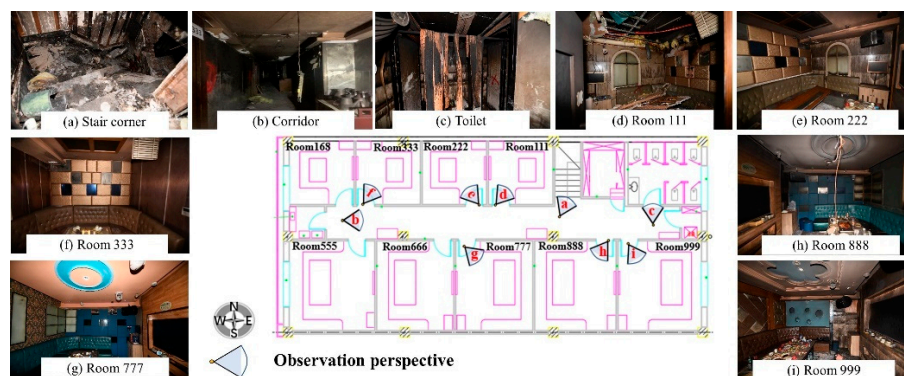
Figure 4. Explosion damage on the 2nd floor inside the building.

The second floor exhibited significant fire and smoke damage across most areas. Near the stair corner, the ceramic tiles on the wall surface showed signs of detachment, with the decorative surface charred by fire (Figure 4a). The corridor roof had collapsed, and the floor of the storage room situated at the mezzanine level of the stairs showed localized burn damage. Room 111 on the west side of the stairs displayed cracks in the composite wall core plate, along with fire traces. The top of the door in Room 111 exhibited clear wood decoration carbonization (Figure 4d). The door of Room 999 opposite the stairs was destroyed (Figure 4i), and some decorative ceramic tiles inside Room 888 had fallen off (Figure 4h). The corridor (Figure 4b) and the majority of rooms (Figure 4e–g) remained relatively intact.

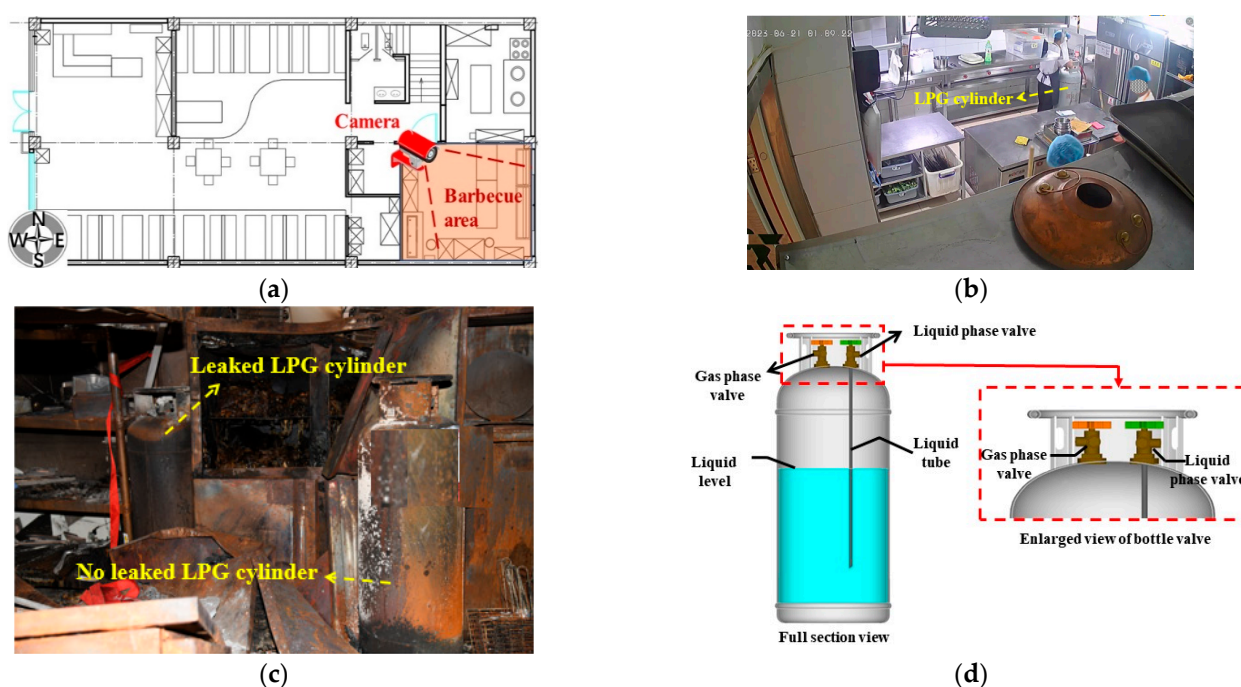
Based on monitoring data and on-site investigations, it was determined that the liquefied petroleum gas cylinders located at the southeast corner of the kitchen barbecue area were the sole gas source responsible for the accident, as illustrated in Figure 5a,b. Two 50 kg LPG cylinders were identified at the explosion scene, with one cylinder found to be leaking while the valve of the other cylinder was closed, as shown in Figure 5c. Following the investigation, it was determined that the two gas cylinders left at the scene were double-

valve cylinders equipped with gas phase valves and liquid phase valves. These cylinders served as LPG storage equipment for gasification devices. The liquid phase pipe within the cylinder was linked to the liquid phase valve. LPG was released from the bottom of the gas cylinder via the liquid phase pipe and the outlet of the liquid phase valve. Subsequently, after undergoing gasification by the gasification device, it was connected to gas equipment through the pressure regulator for utilization. The naturally gasified gas located above the liquid level was released from the gas phase valve and directed through the pressure regulator to the gas consumption equipment. The gas phase valve was equipped with a self-closing device, whereas the liquid phase valve did not feature a self-closing device. The structural composition of the gas–liquid double-valve LPG cylinder is depicted in Figure 5d.

Figure 5. The double-valve LPG cylinders involved in the accident scene: (a) the area where the LPG cylinders were located; (b) LPG cylinder in the barbecue area before the explosion; (c) LPG cylinder in the accident scene; (d) schematic diagram of the double-valve LPG cylinder.

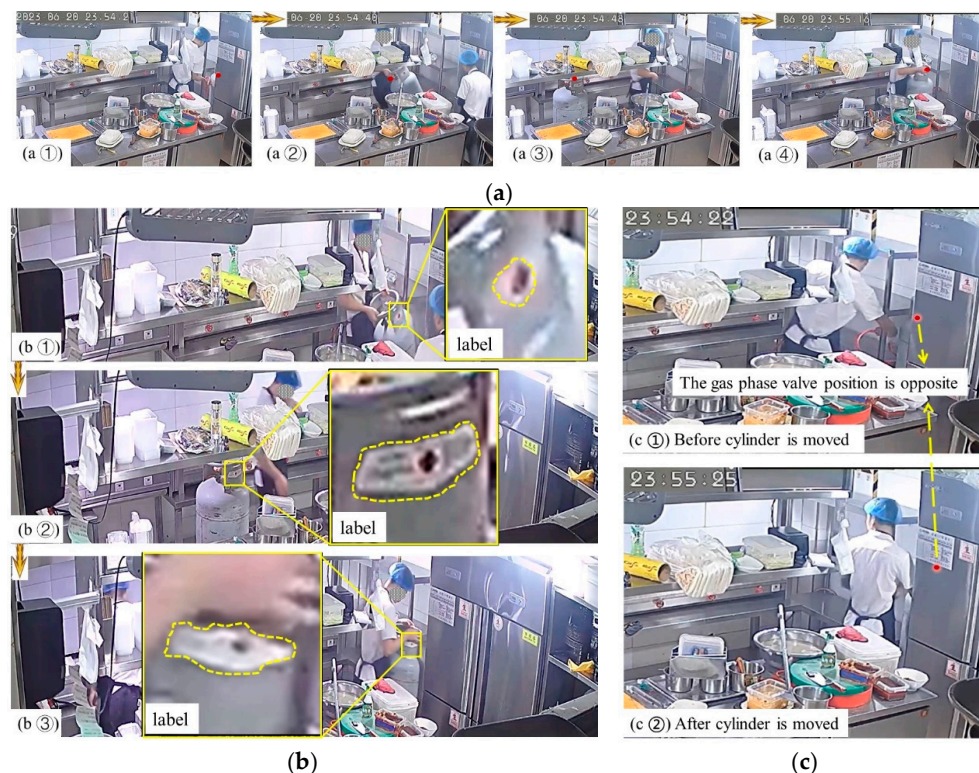
On 20 June (the day before the accident), at 23:49, while cleaning, a clerk unloaded the pressure regulator connected to the gas phase valve on the LPG cylinder (Figure 6(a①)). The clerk then proceeded to move the cylinder out and rotate it for a week, causing the orientation of the valve to change (Figure 6(a②)). Upon pushing the gas cylinder back to its original position, the position of the liquid phase valve was mistakenly facing outward (Figure 6(a③)). Subsequently, the clerk mistakenly reinstalled the disassembled pressure regulator onto the outward-facing liquid phase valve (Figure 6(a④)).

The red dots highlighted in Figure 6a indicate the position of the gas phase valve on the gas cylinder, enabling the tracking of the gas phase valve's position change process before and after the cylinder was moved. By observing the size of the label on the cylinder, it can be inferred that the valve's position indeed changed before and after the cylinder's movement. In Figure 6(b①), the label on the cylinder appeared small before it was moved. After the cylinder was moved out, as shown in Figure 6(b②), the label became larger, indicating a shift in the direction of the two valves. Subsequently, the cylinder was translated back to its original position because the two labels in Figure 6(b②,b③) were of the same size.

Figure 6. Analysis of the position of the valve before and after the cylinder is moved: (a) process of the cylinder being moved; (b) comparison of the labels on the cylinder; (c) position comparison of the gas phase valve.

In Figure 6c, a comparison is made between the position of the gas phase valve before and after the cylinder is moved. The red dot's position in the two images differs, indicating a change in the orientation of the gas phase valve. Initially, the gas phase valve was facing outward, but after the cylinder was moved, it began to face inward. This observation suggests that the valve facing outward was the liquid phase valve. In conclusion, it could be determined that the clerk mistakenly installed the pressure regulator on the outward-facing liquid phase valve after moving the gas cylinder.

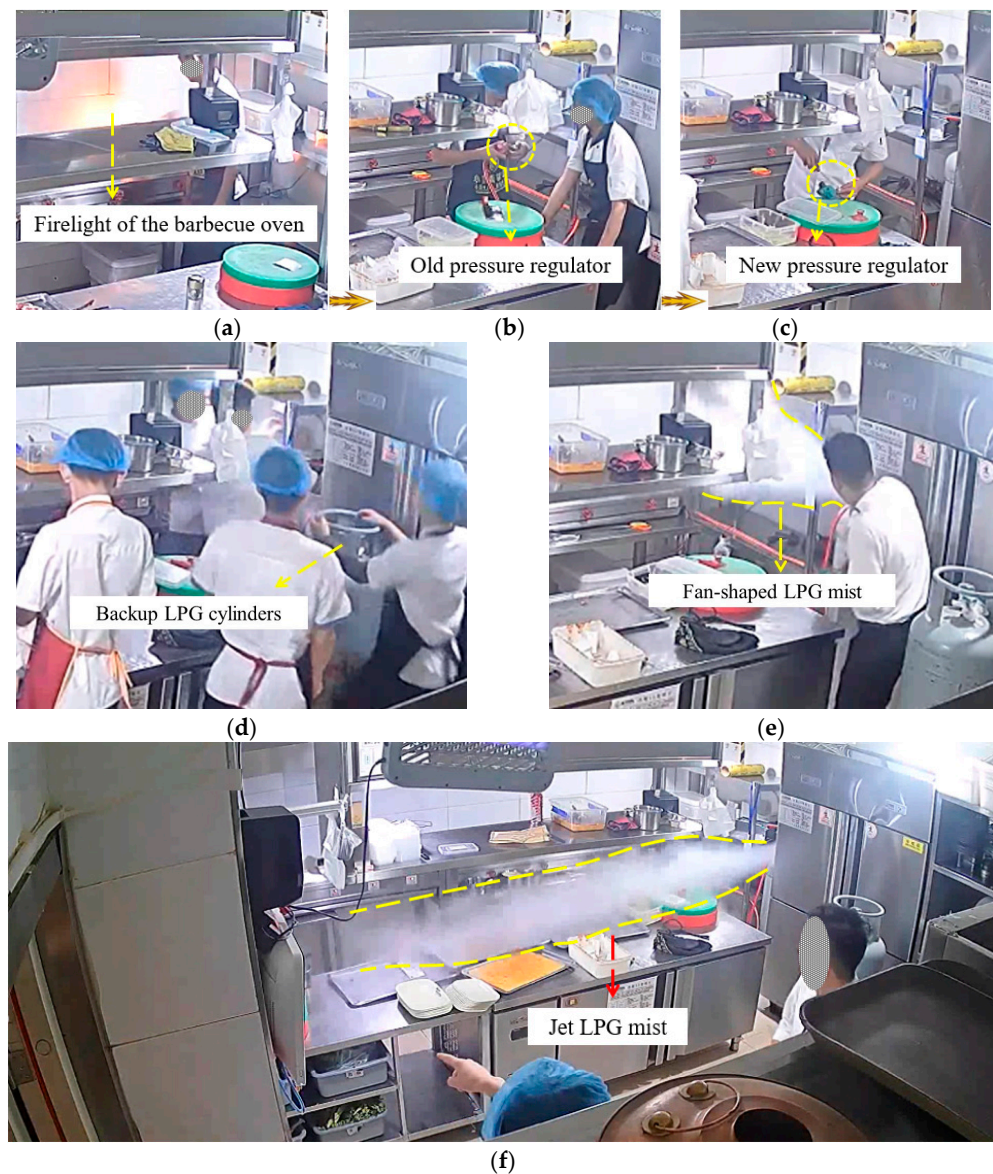
At 18:16 on 21 June (the day of the accident), the clerk opened the angle valve of the LPG cylinder and flipped the switch of the gas barbecue oven for the first time to begin the barbecue work. The observation of Figure 7a reveals that the strong light on the wall indicates the activation of the barbecue oven and the initiation of gas cylinder operation. After 80 min, the clerk noticed a gas leakage at the connection location between the angle valve and the pressure regulator. Then, the clerk disassembled and inspected the regulator attached to the liquid phase valve, discovering internal damage to the old regulator components, as shown in Figure 7b. At 20:29, the clerk purchased a new pressure regulator (later determined to be a counterfeit product) and incorrectly attached it to the liquid valve of the cylinder, as shown in Figure 7c. Despite the successful installation, multiple ignition attempts failed. At 20:36:24, the clerk rechecked the gas cylinder and removed the newly installed regulator in preparation for replacing the spare gas cylinder. At 20:36:42, a small amount of 'white mist' resembling LPG was emitted from the connection between the regulator and the liquid phase valve (the initial leakage), as shown in Figure 7d. The clerk promptly closed the valve, causing the 'white mist' to dissipate.

Figure 7. LPG leakage process caused by human operation error: (a) turning on the barbecue oven; (b) removing the old pressure regulator; (c) installing the new pressure regulator; (d) first small-scale LPG leakage; (e) second LPG leakage; (f) large-scale LPG leakage.

At 20:36:51, the clerk inadvertently turned the liquid phase valve in the wrong direction, causing the gas cylinder to release a fan-shaped ‘white mist’ (second leakage), as shown in Figure 7e. At 20:37:19, the clerk attempted to close the valve but was unsuccessful. Instead, he mistakenly pulled the hose connected to the regulator, altering the gas injection direction. This led to a change in the leakage direction from obliquely upward to horizontally flat, creating a jet-like ‘white mist’ approximately 3 m in length, resulting in a further escalation of the leakage, as shown in Figure 7f. Subsequently, no emergency measures were implemented to mitigate the ongoing large-scale LPG leakage until the explosion occurred.

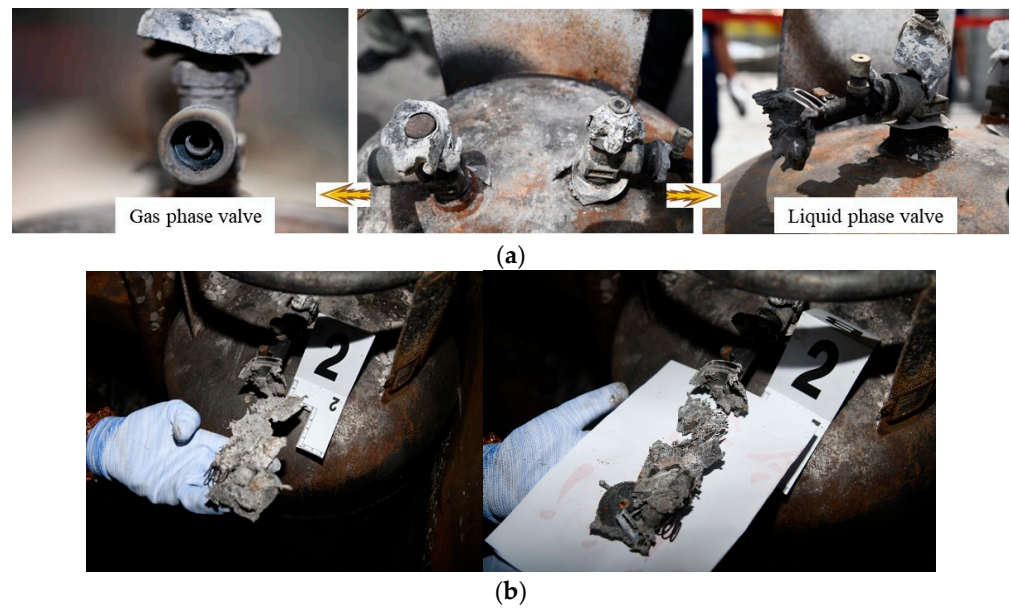
Following the accident, an examination of the damage to the two valves on the cylinder was conducted, as shown in Figure 8a. The gas phase valve exhibited nearly complete intactness. Conversely, the liquid phase valve sustained severe damage, with only a small portion of the regulator remaining connected to it, while the remainder of the regulator was completely destroyed. By reconstructing and comparing the on-site conditions, the

approximate connection state between the pressure regulator and the liquid phase valve prior to the explosion was determined, as shown in Figure 8b.

Figure 8. The double-valve LPG cylinder and the traces after explosion: (a) the damaged cylinder double valve; (b) the completely destroyed pressure regulator.

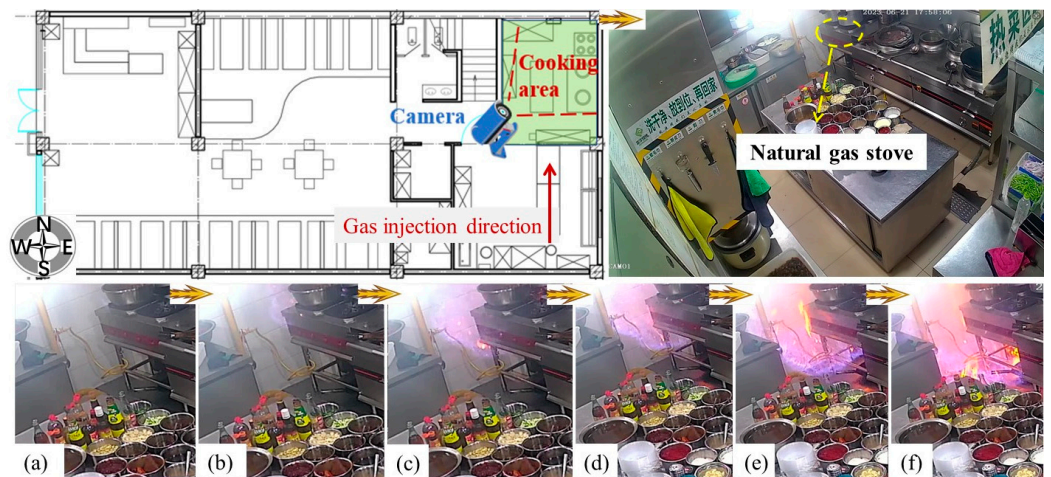
The kitchen of the restaurant where the accident occurred was divided into a barbecue area on the south side and a cooking area on the north side, separated by glass with open doors, allowing for the free diffusion of leaked LPG. As per Section 2.1.3, the gas leakage direction in the barbecue area was from south to north. Consequently, the high-speed injection of the LPG mist rapidly vaporized into gas, expanding quickly and diffusing directly into the cooking area on the north side. The cooking area contained numerous closets, hanging cabinets, operating tables, various stoves, and tableware, creating a densely packed environment that facilitated the rapid accumulation of gas. This accumulation led to the gas reaching the explosion limit in a short period. At 20:37:54, one minute and three seconds after the LPG leak, the gas was ignited by a working gas stove in the northeast corner of the cooking area, a sequence captured by surveillance cameras, as shown in Figure 9.

Figure 9. The video surveillance process of the leaked LPG ignited by a natural gas stove.

From Figure 9a–c, it is evident that when the LPG was ignited by the stove, the initial combustion flame appeared light blue, indicating a low gas concentration. Due to the heavier nature of LPG compared to air, the initial flame propagated downward first. As the flame spread, the middle and base of the flame transitioned to yellow and red, as shown in Figure 9d–f, signifying insufficient oxygen for the combustion reaction. Additionally, it indicated that the closer the proximity to the barbecue area, the higher the concentration of leaked gas. These six frames of monitoring images illustrate the development process of the initial flame, captured by a standard household camera with a low frame rate, highlighting the slow progression of the flame in the initial stages of the explosion. Influenced by numerous obstacles, the flame rapidly extended along the channel towards the barbecue area, triggering a more intense explosion effect, ultimately leading to this severe accident disaster.

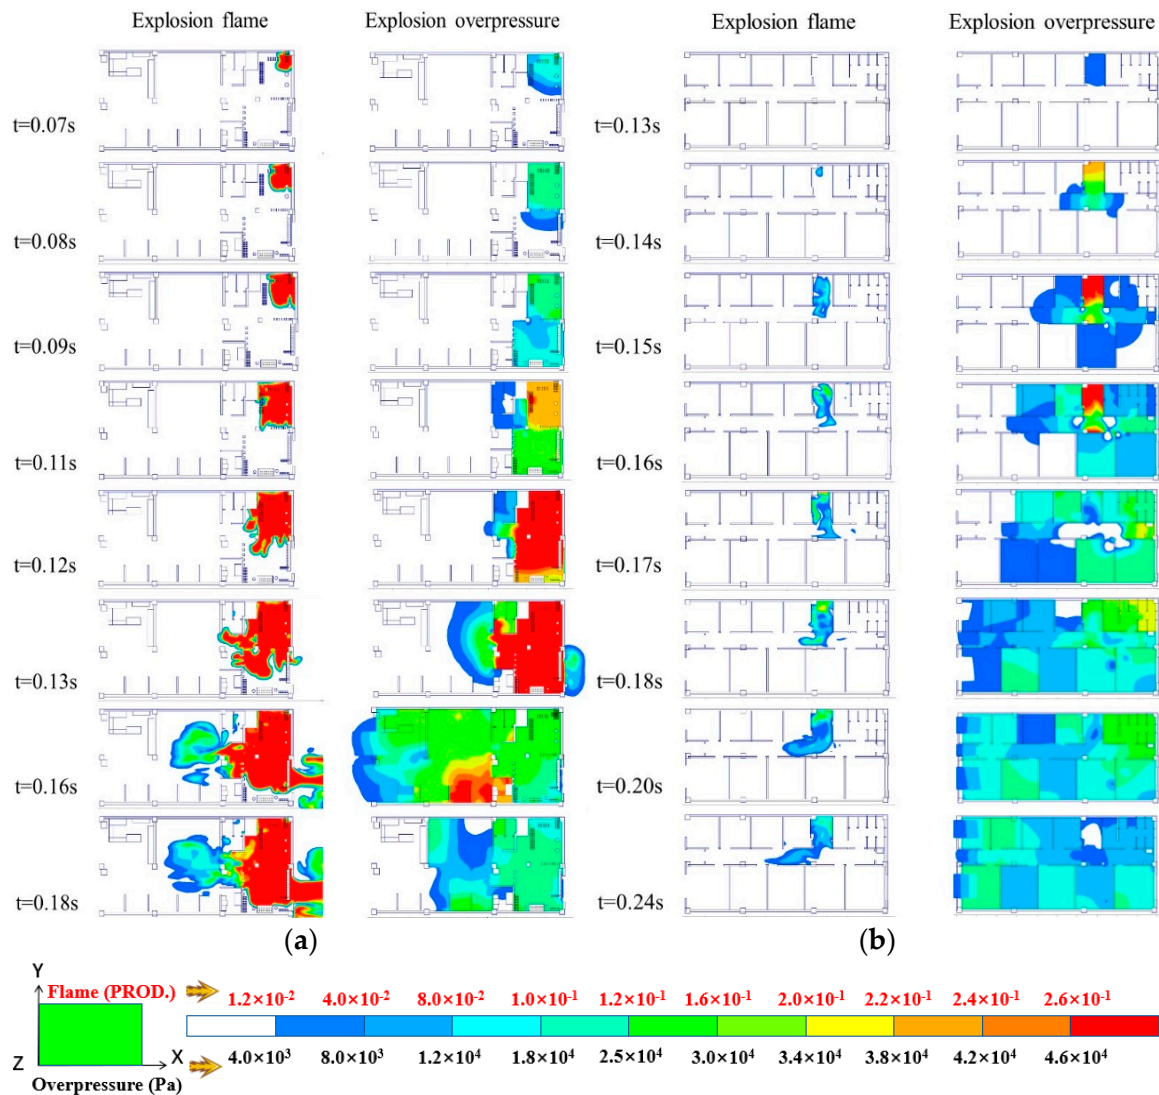
Figure 12 illustrates the evolution of the explosion flame and overpressure observed on the horizontal plane of the first floor and the second floor over time. The volume fraction of combustion products was used to replace the observation of flame shape and propagation. In Figure 12a, it was evident that the leaked LPG was ignited by the open flame of the natural gas stove in the northeast corner of the kitchen cooking area on the first floor. The laminar flame spread and expanded, forming the initial shock wave. At a time of $t = 0.07 \text{ s}$, the simulated flame extent effectively encompassed the area of the natural gas stove, aligning with the flame shape depicted in Figure 9f of the video. This observation indicated a degree of consistency between the numerical predictions and the actual flame development pattern. Consequently, the accuracy of the numerical results in forecasting the flame evolution was validated to a certain extent. As the flame propagated to the operating floor ($t = 0.08 \text{ s}$), the rapidly increasing barrier blocking rate caused unburned gas in front of the impact wave to escape quickly, leading to the formation of high-intensity turbulence in the gas wake. This turbulence promoted the rapid conversion of the laminar flame into a turbulent flame, allowing the pressure wave to swiftly reach all the cooking area ($t = 0.11 \text{ s}$) and propagate to the barbecue area.

When $t = 0.12 \text{ s}$, the shock wave entered the barbecue area after destroying the glass partition wall between the cooking area and the barbecue area. It accelerated its propagation in the narrow path containing obstacles such as the operation platform and the barbecue grill, causing the pressure in the barbecue area to rise rapidly as a whole. Consequently, the pressure in the barbecue area became significantly higher than that in the cooking area due to the accelerated propagation and obstruction of the shock wave in the confined space of the barbecue area. At this point, the pressure near the wall on the west side of the cooking area adjacent to the stairs further increased, leading to the collapse of the wall in a westward direction. The explosion shock wave was rapidly released through the channel between the kitchen and the dining hall. Some of the shock waves entered the dining hall, while others propagated along the stairs to the second floor. Approximately 0.13 s later, the self-built walls on both sides of the storage room and the external wall on the east side of the barbecue area collapsed simultaneously, creating a two-way explosion-venting state in the barbecue area on the east and west sides. Around 0.03 s later, the west door and glass wall of the dining hall were damaged and thrown westward due to the force of the explosion. As the explosive medium was completely consumed and the explosion-venting action was completed, the indoor overpressure level gradually decreased when $t = 0.18 \text{ s}$.

Approximately 0.13 s after the explosion on the first floor, the explosion shock wave reached the stairway and entered the second-floor corridor, spreading in both directions when $t = 0.14 \text{ s}$. At $t = 0.15\text{--}0.16 \text{ s}$, the overpressure accumulation in the narrow staircase space increased, leading to the destruction and shedding of the tile decoration near the staircase. This resulted in cracks and a small amount of displacement in the north wall due to the force of the shock wave. Subsequently, the shock wave and flame propagating along the stairs to the second floor acted on the light partition wall on the east side of Room 111, causing the core plate in the partition wall to crack and penetrate into the room when $t = 0.17 \text{ s}$. The shock wave in the corridor entered the interior of each room through the doors when $t = 0.18 \text{ s}$. Within the next 0.06 s , the shock wave propagated to the machine room on the westernmost side of the corridor, causing partial damage to the windows and depressurization in that area.

Figure 12. The evolution of the explosion flame (left) and explosion overpressure (right) with time: (a) the explosion propagation path of the first floor; (b) the explosion propagation path of the second floor.

In Figure 12b, the development of explosion overpressure in the second-floor corridor was primarily concentrated in the stairway area, with the maximum overpressure occurring near the wall directly facing the stairway. The overpressure levels in the machine room and toilet exceeded 20 kPa. In Room 111, the overpressure was mainly localized in the southeast corner, where wall cracks were present. Comparatively, the toilet experienced a higher accumulation of overpressure than the corridor. To investigate the progression of the explosion flame on the second floor, Figure 13 presents a cloud map of the explosion temperature observed on the horizontal section over time. The white areas in the cloud map indicate regions on the second floor that were not significantly impacted by the explosion flame. The flame development was most pronounced in the stair area, where the explosion temperature reached its peak. The maximum explosion temperature in the corridor was near the wall opposite the stairway, aligning with the maximum overpressure distribution. The flames extended along the east and west sides of the corridor, creating a high-temperature zone of approximately 10 m with temperatures exceeding 400 K in the east–west direction. At $t = 0.18$ s, the fire from the stairwell breached the wall crack and entered Room 111, leading to a rise in internal temperature.

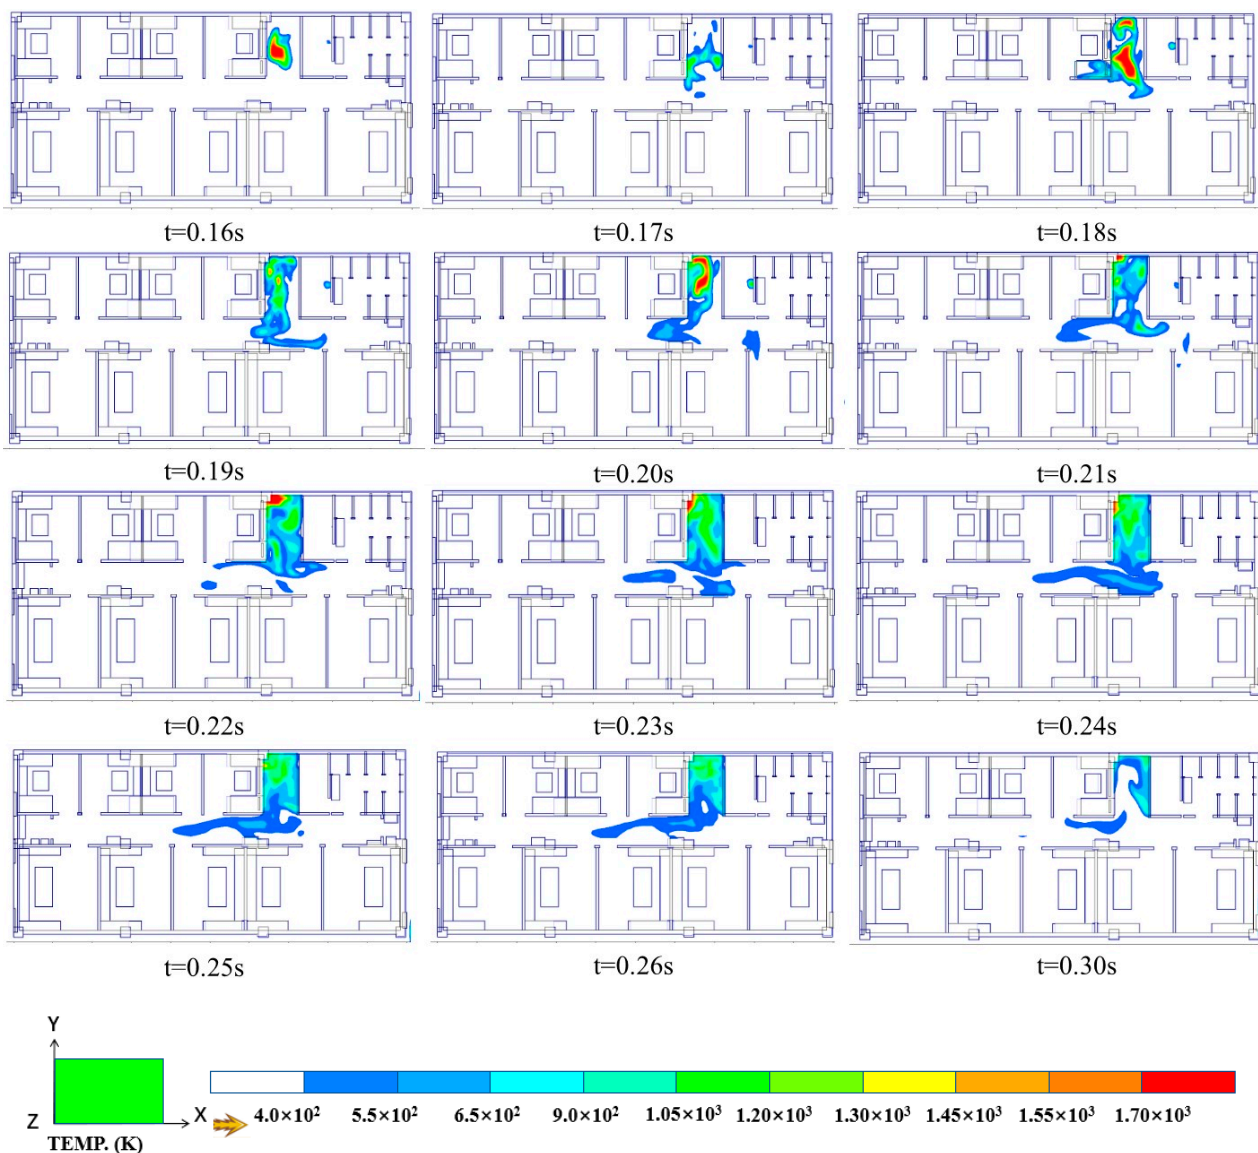
Figure 13. The evolution of explosion temperature over time on the horizontal section of the second floor.

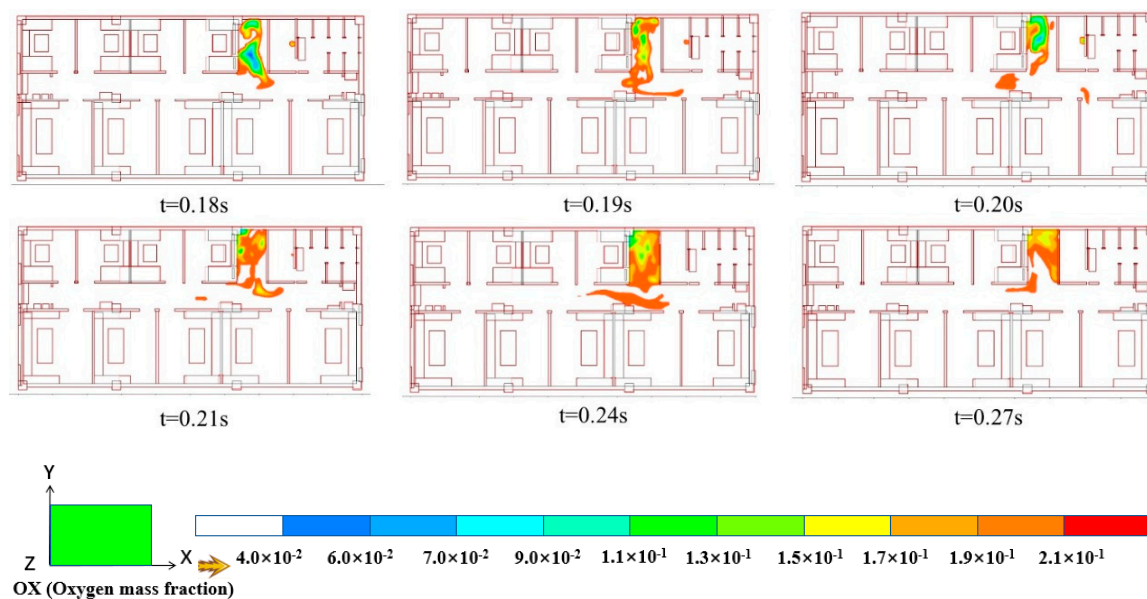
The analysis of the air oxygen content on the horizontal observation surface of the second floor over time provides insights into the correlation between the cause of death of individuals and the risk of explosion asphyxia, as shown in Figure 14. Following the explosion, the oxygen levels in the stairwell of the second floor experienced a significant decrease, with the minimum oxygen content dropping below 3.6% (volume fraction). Prolonged exposure to such a hypoxic environment could lead to shock, unconsciousness, heart failure, and ultimately death. In the corridor area near the staircase, the oxygen content was recorded at a minimum of 14.4% (volume fraction), with an anoxic range extending approximately 6 m in the east–west direction. Individuals within this range may remain conscious but experience reduced judgment capabilities. The oxygen content in the vicinity of Room 111 decreased to 16.2% (volume fraction), significantly impacting human muscle coordination and causing slow movement. As the accident progressed, the high-temperature toxic smoke and dust from the kitchen on the first floor were expected to rapidly spread to the second floor, leading to a substantial reduction in oxygen concentration. This severe asphyxiation scenario was likely to result in the death of most individuals on the second floor.

Figure 14. The evolution of air oxygen content over time on the horizontal section of the second floor.
