Failure Analysis of API 5L Grade B Underground Crude Oil Transfer Pipe [†]

Abstract: An underground transfer pipe was utilized to deliver crude oil from the BDA gathering station to the A main gathering station. The transfer pipe made of API 5L grade B has a diameter of 6 inches and a length of 18,000 m. The pipe has a design life of 20 years, but after being operated for five years, 41 points of leakage were found in the area of KM 14 to KM 16. Visual inspection of the leakages in the pipe indicates general corrosion as the main issue. Nevertheless, failure analysis is required to investigate the root cause of the problem in this area. Several characterization methods were performed, including ultrasonic testing, to measure the distribution of pipe thickness. SEM and EDS testing were conducted to understand the hole formations that led to leakage and study their elemental changes around the leakage point. XRD and FTIR characterization were carried out on the deposit found on the inner diameter of the pipe. The ultrasonic thickness measurement indicates gradual pipe thinning until a hole was formed. Deposit analysis revealed wax composition at the upper level of the pipe formed du

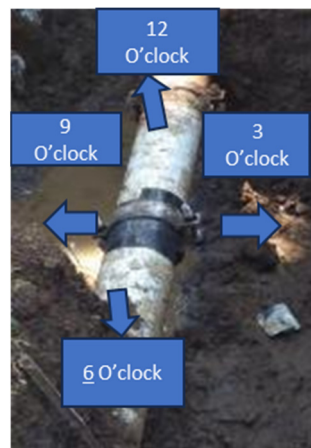
A leak is indicated by the release of fluid on the ground surface and then temporary clamping is carried out as in Figure 1. The leak points are spread between KM 14 and KM 16.

Figure 1. Pipe leak condition after temporary clamping is carried out.

When there is a pipe leak, excavation is carried out for temporary clamping. When installing the clamping, it was discovered that the leak point was at the bottom of the pipe with an orientation of 4 to 8 o'clock and thus initiated general corrosion. There were indications that, at this position, the flowing fluid had a lot of water content. This can be seen in the excavation hole when carrying out a temporary clamp, as shown in Figure 2.

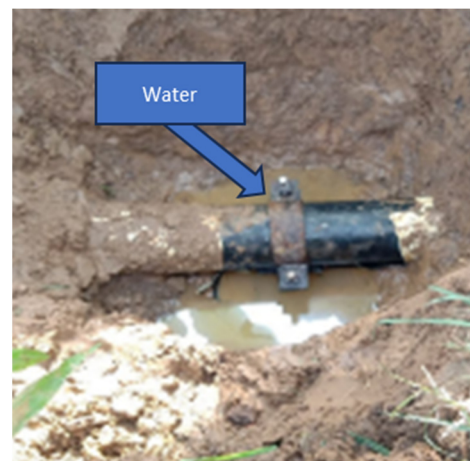
Figure 2. Water out of the leak.

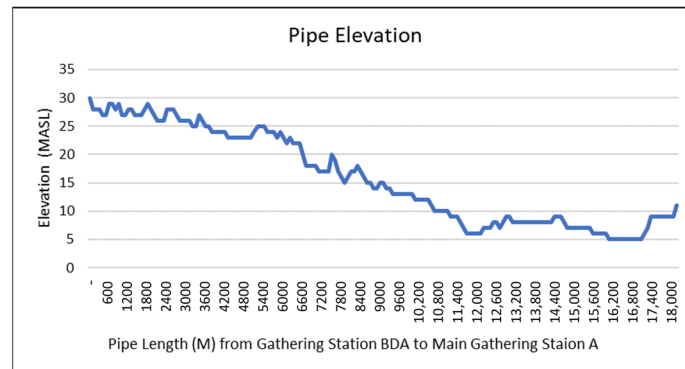
The flow regime may cause accumulation of water at pipeline low spots or, depending on the product type, accumulation of water-wetted solid particles at the pipeline bottom, typically downstream of over-bends, thereby forming corrosion “hotspots” [10]. The transfer pipe from BDA Gathering Station to Main Gathering Station A is in an underground position with varying heights above sea level. Fluids flow from BDA Gathering Station which has a higher elevation (30 MASL) to Main Gathering Station A which has a lower elevation (11 MASL). Pipe elevation data are obtained from the as-built drawing, as shown in Figure 3.

Figure 3. Transfer pipe elevation.

At the pipe length points KM 11.2 to KM 16.8, there is a pipe elevation at the lowest point, 5 to 9 m above sea level (MASL). At the end of the pipe at KM 18, there is an increase in pipe elevation so that when pumping stops, the fluid in the pipe cannot be flushed, so the fluid is stuck in the pipe. This causes sediment to form in the pipe due to the fluid being stationary for 7 to 9 h per day.

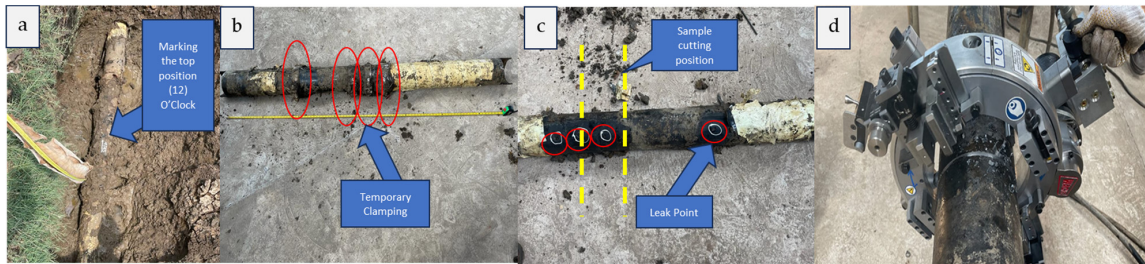
out before cutting using a cutting torch. After excavation, a mark was made on the top of the pipe to ensure the clock direction of the pipe leak as shown in Figure 5a. After the pipe sample was lifted to the surface, the pipe was taken to the workshop with the temporary clamp still attached as shown in Figure 5b. The temporary clamping was released to see the leak point as shown in Figure 5c. It can be seen that the position of the pipe leak was uniform and tended to occur in a straight line, namely at the bottom of the 4 to 8 o'clock transfer pipe. The pipe was cut using a cold cutting machine (Figure 5d) at the yellow line position (Figure 5c).

Figure 5. Pipe sampling. (a) Marking on pipe samples before cutting; (b) Temporary clamping; (c) Sample cutting position; (d) Sample cutting.

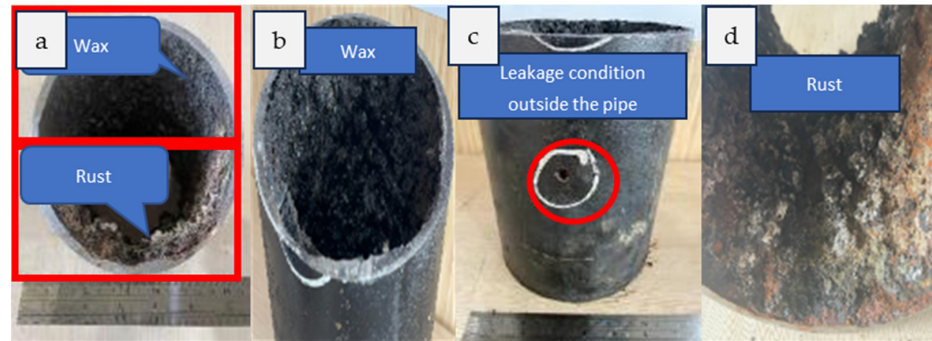
After taking the sample, it was discovered that there was sediment in the pipe. The deposits on the inside of the upper pipe were shaped like wax, while the deposits on the inside of the lower pipe were shaped like a scale as shown in Figure 6.

Figure 6. Visual Inspection. (a) Visual inspection of samples; (b) Visual inspection of wax; (c) Leakage condition outside the pipe; (d) Visual inspection of rust.

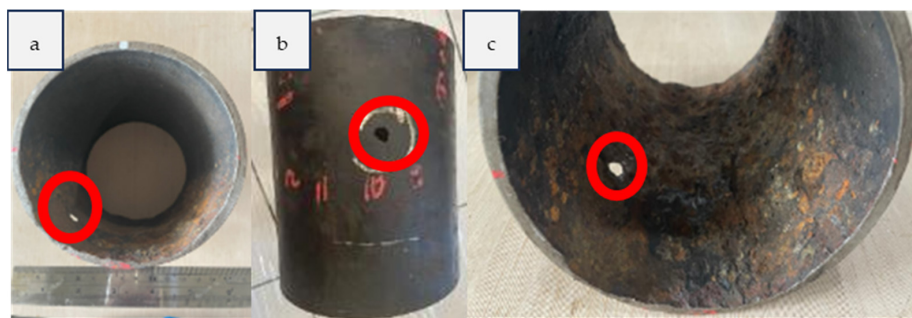
From visual inspection, it can be seen that there is no visible corrosion on the outside of the pipe. Corrosion that occurs in the crude oil transfer pipe from Gathering Station BDA to Main Gathering Station A occurs on the inside of the pipe as shown in Figure 7.

Figure 7. Pipe hole position (in red circle) after cleaning deposits. (a) View of the hole from inside the pipe; (b) view of the hole from outside the pipe; (c) Detail a.

The crude oil transfer pipeline from Gathering Station BDA to Main Gathering Station A began operating in December 2014 using a new condition pipe with a diameter of 6 inches (Schedule 40), which has a new pipe wall thickness of at least 7.11 mm. In January 2021, a leak started to occur; the pipe wall thickness was 0 mm. The pipe corrosion rate is as follows:

The corrosion rate of 1.3987 mm per year is higher than the pipe design corrosion rate of 0.1016 mm per year. It can be concluded that the corrosion rate that occurred was 13.77 times faster than the design corrosion rate.

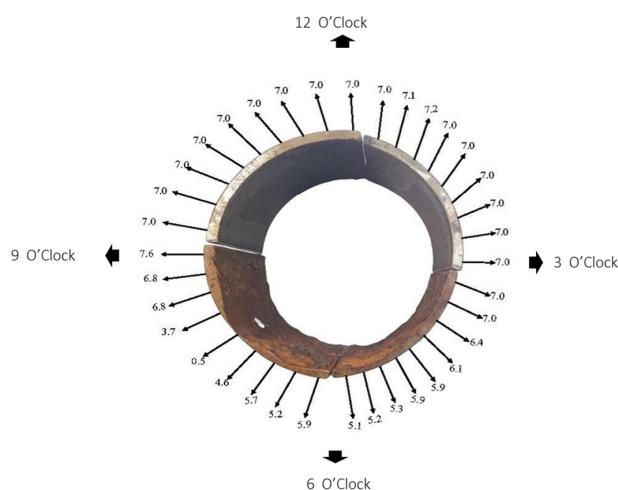
Figure 8. Wall Thickness.

Wall thickness measurements were carried out on the pipe diameter circle, which contained 36 leak points in positions as shown in Figure 8. From the measurement results, it can be seen that the position of the inside of the upper side pipe does not experience much thinning with a thickness of 7 mm. Meanwhile, the inside position of the bottom side of the pipe experienced thinning with a pipe thickness of up to 0.5 mm. This thinning occurs in areas where there are deposits in the form of rust.

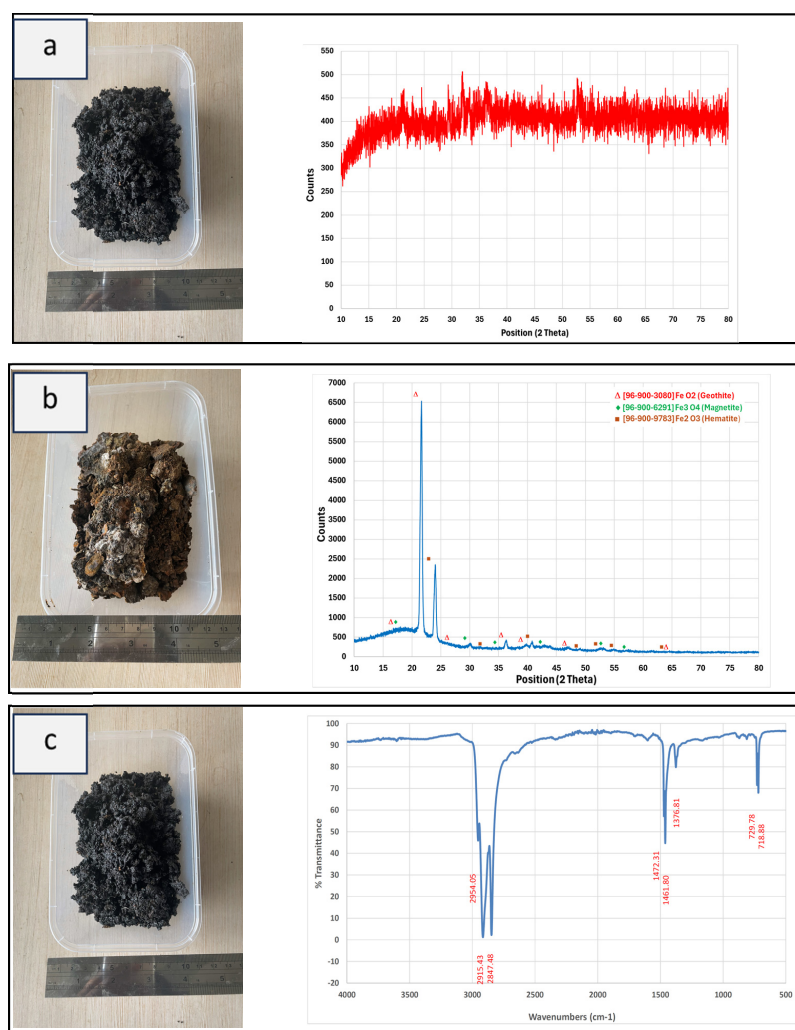
Figure 9. XRD and FTIR test result: (a) XRD test results of deposits in the upper pipe; (b) XRD test results of deposits in the lower pipe; (c) FTIR test results of deposits in the upper pipe.

FTIR test results show that the upper deposit is an aromatic compound as wax was formed during transfer of crude oil due to environment condition (1.5 m below the ground). While the bottom deposit characterization reveals main element of FeO₂ (Geothite), Fe₂O₃ (Hematite), and Fe₃O₄ (Magnetite) which further identified as corrosion products.

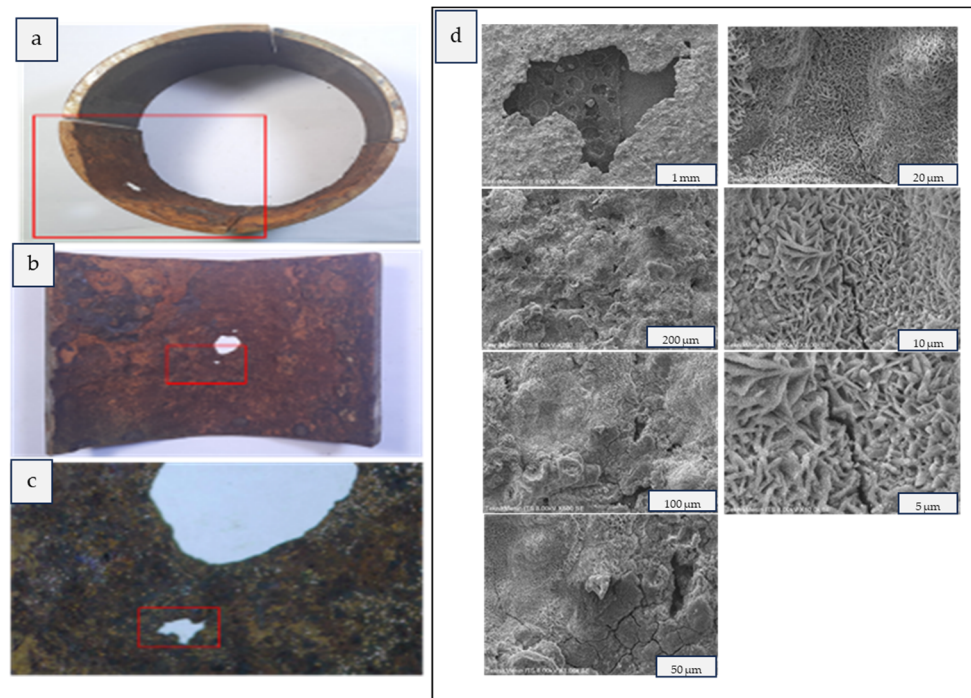
SEM (Figure 10) testing was carried out on the bottom pipe sample where there was a pipe leak. From the SEM test results, it can be seen that the surface morphology of the pipe contained corrosion varies, with irregularities and smooth rod-like shapes with different directions.

Figure 10. Scanning electron microscope (SEM) in red box area. (a) SEM pipe samples; (b) Detail a; (c) Detail b; (d) SEM test results.

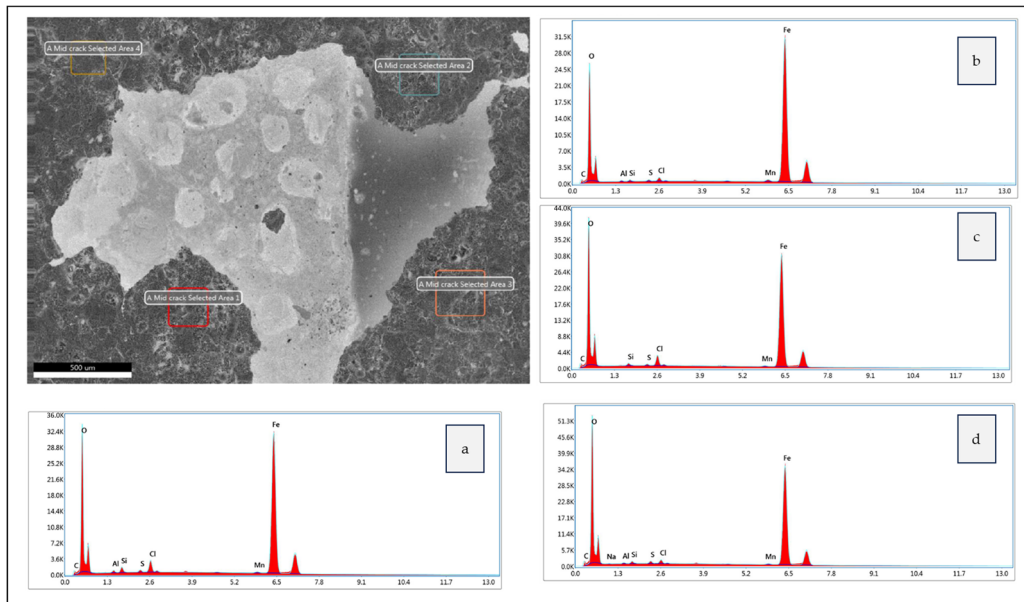
Figure 11. EDS test area and results: (a) EDS test Results area 1; (b) EDS test Results area 2; (c) EDS test Results area 3; (d) EDS test Results area 4.

The EDS test results (Table 4) show that the location around the leak is rich in iron (Fe) and oxygen (O). The iron content has a value of 63.26% by weight to 75.27% by weight, and the oxygen content is 20.52% by weight to 30.82% by weight.

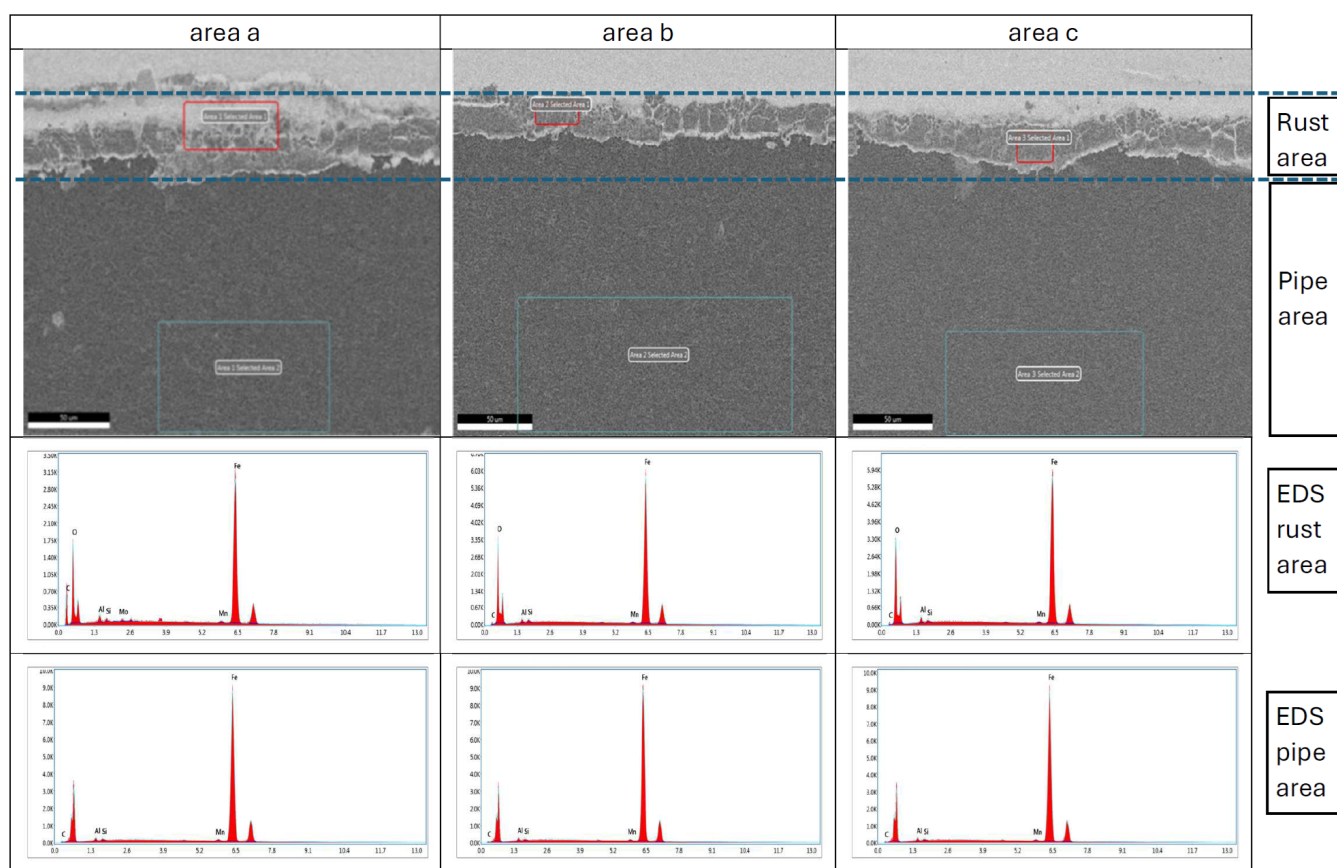
Figure 12. SEM and EDS Results on Pipe Cross Sections.

SEM and EDS testing is also carried out on the cross sections of the pipe as shown in Figure 12. SEM and EDS were carried out in three areas. Area a is close to the leak point; area b is slightly far from the leak point; and area c is far from the leak point.

growth is 40–110 °F (5–43 °C), with a maximum temperature limit of 120 °F (49 °C). The temperature of the formation water and crude oil at GS BDA is >141 °F (60 °C), so at this temperature, SRB cannot develop. Based on the SEM test results on the cross section of the pipe (Figure 11), no traces of pitting corrosion were found, so the corrosion that occurred was not caused by SRB.

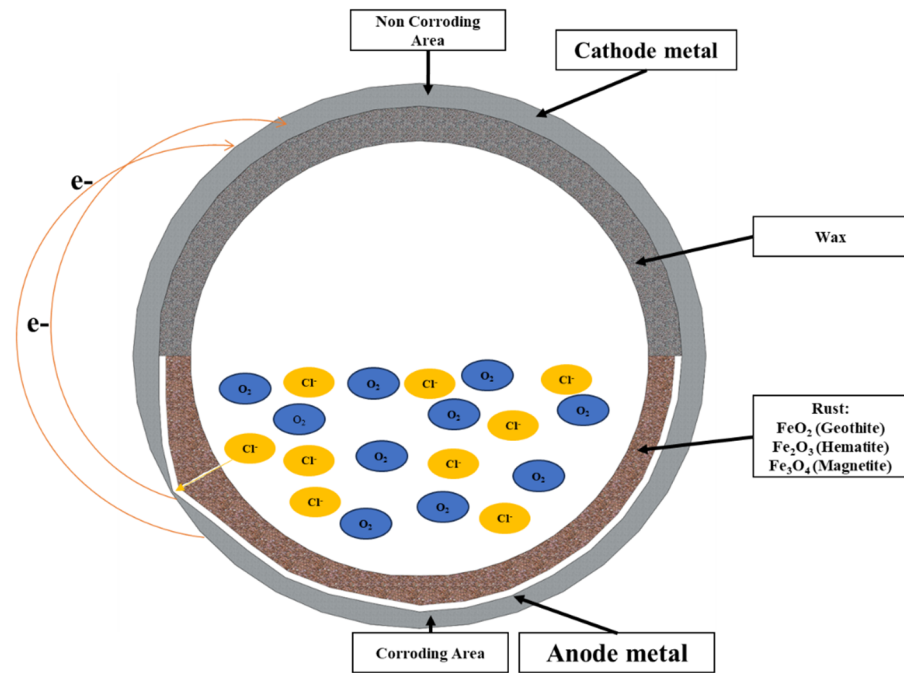
Figure 13. Oxygen-Influenced Corrosion Mechanisms.

The results of the produced water test show that the dissolved oxygen at the GS BDA was 3.96 ppm (3960 ppb) and the dissolved oxygen in the formation water at the MGS A was 1.37 ppm (1370 ppb), which means it is far above the limit level in API 571 (maximum 20 ppb) [16]. The dissolved oxygen causes corrosion on the surface of the pipe that is in contact with the produced water (3 o'clock–9 o'clock). The results of the produced water test showed that there was a chloride (Cl⁻) content of 9968 mg/L at the GS BDA and 10,043 mg/L at the MGS A. SEM results (Figure 9) show that there are gaps on the corrosion surface. High chloride concentrations cause the movement of ions towards the bottom of the deposit through gaps in the deposit, resulting in under-deposit corrosion (UDC). The mechanism that occurs is a combination of oxygen corrosion and UDC, as follows:

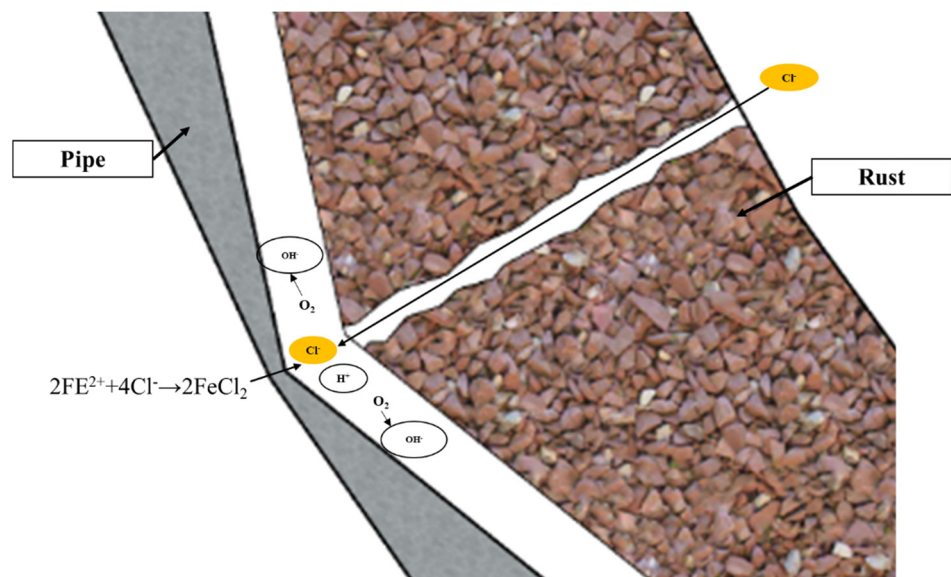
Figure 14. Under Deposit Corrosion (UDC) mechanism.

The formation of hydroxide ions (OH⁻) causes the electrolyte under the deposit to have a more positive charge compared to the area above the deposit, causing chloride ions to enter under the deposit through the deposit gap to form FeCl₂ as follows:

The FeCl₂ formed is hydrolyzed by water to form a weak base solution of Fe(OH)₂ and H⁺ ions. H⁺ ions have stronger acidic properties than the Fe(OH)₂ solution, so the area below the deposit experiences more rapid corrosion.

- Based on the spectrometry test results, the crude oil transfer pipe can be confirmed to be an API 5L Grade B pipe.
- The main cause of pipe failure is under-deposit corrosion. Deposits are formed due to oxygen-influenced corrosion, which forms corrosion products. Corrosion products contain cracks that form gaps, causing chloride (Cl⁻) to enter the deposit and causing under-deposit corrosion.
