CT-Scans: Game-Changer in the Maintenance of PVC Drinking-Water Mains[†]

Abstract: CT-scans were successfully used to—for the first time—detect inclusions of foreign material in the pipe walls of PVC pipes. This is of interest because these formerly undetectable inclusions dominate the main failure mechanism of PVC: crack growth. The technique unlocks a step forward in the condition assessment of PVC pipes in several ways: it provides researchers with a new way to investigate crack growth in PVC pipes; it provides drinking-water utilities with a method for destructive condition assessment; and CT provides the industry with the reference knowledge needed to develop relevant in-line inspection techniques for PVC mains.

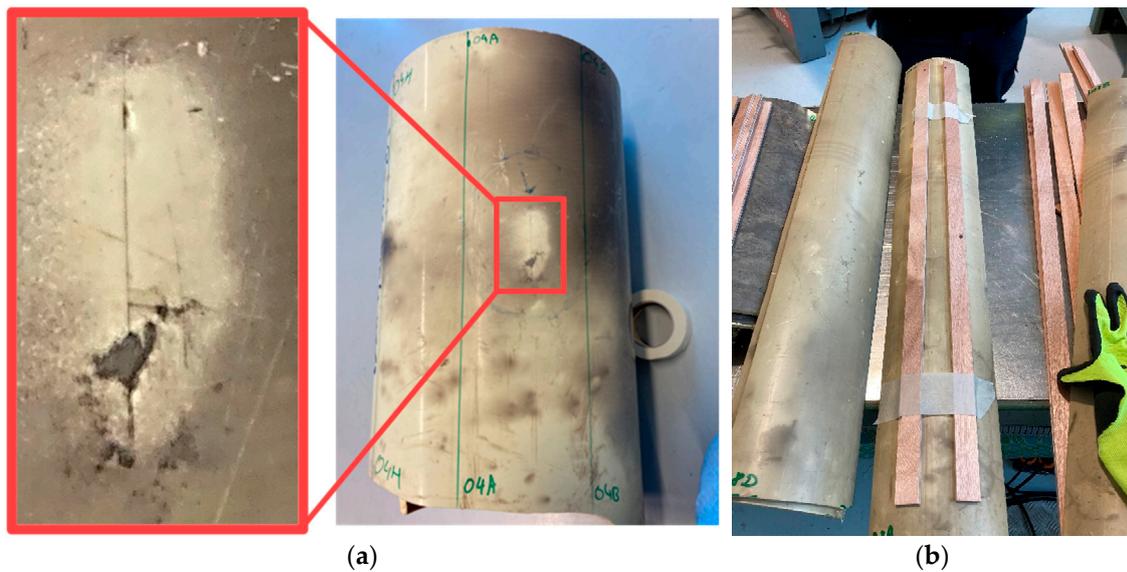
Figure 1. Example of one of the field samples: (a) Sample 04, a 400 mm pipe from 1973, as it was collected by the utility. The inset shows the leak that was the reason for the replacement of this piece; (b) Sample 04 was cut into ribbons 1 m long and 0.15 m wide to fit into the CT-scanner.

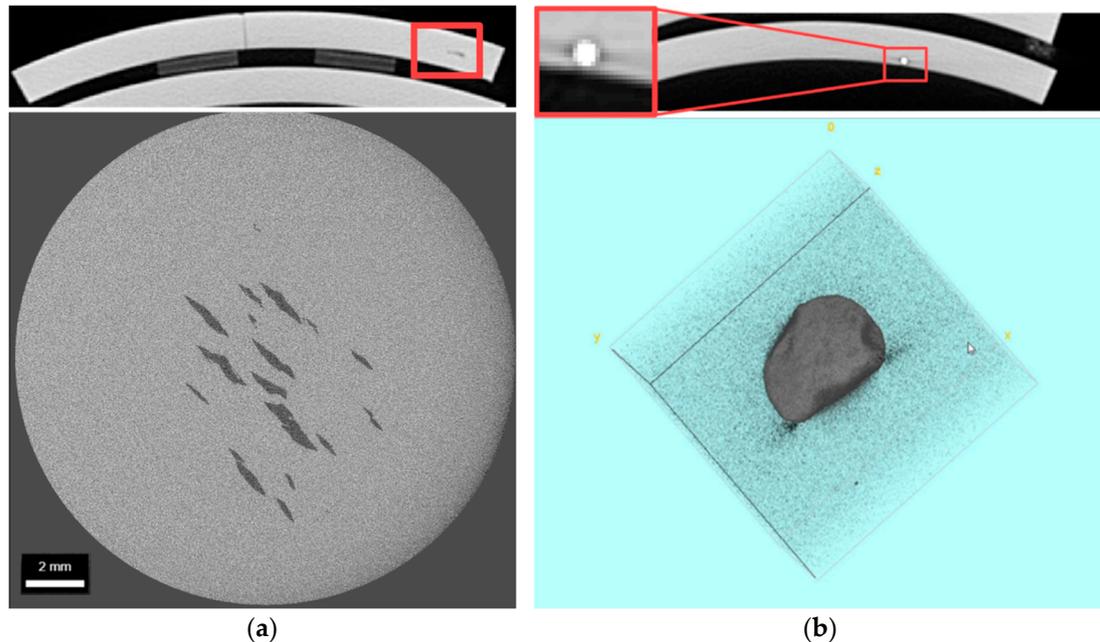
In Sample 04, three peculiarities were encountered in the scans with the medical CT. Figure 2a shows a dark spot in the low-resolution medical CT (top, marked with the red square). A dark spot presumably indicates a void or an inclusion of very low density. Note that, similarly, the crack in the pipe is also visible as a dark vertical line through the center of the sample. The micro-CT was used to zoom in on the presumed void (bottom), showing that the peculiarity rather is a cluster of smaller voids that seem to be aimed along the same direction. The nature of these voids is unclear.

Figure 2b shows a high-intensity (high-density) inclusion encountered in Sample 04 (top, marked with the inset). The inclusion has a diameter of about six pixels, which corresponds to approximately 2 mm. A scan with the micro-CT (bottom) provides a clearer view on the inclusion and shows that, in fact, the inclusion has a length scale of around 1 mm, indicating that the image of the medical scanner is distorted (presumably due to a combination of the high density of the inclusion and its length scale compared to the resolution of the scanner).

Figure 2. Peculiarities encountered in the pipe wall of Sample 04: (a) a low-density void is visible in the medical CT (top, red square) and in the micro-CT (bottom); (b) a high-density inclusion is visible in the medical CT (top, red square and inset) and in the micro-CT (bottom).

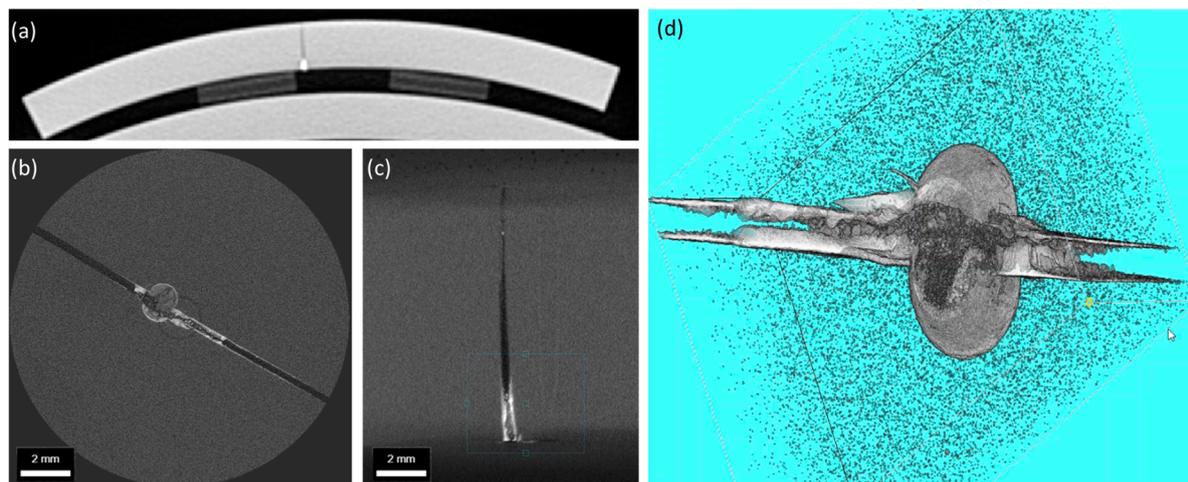
A third peculiarity encountered in Sample 04 is shown in Figure 3. A high-density inclusion is visible in the crack, close to the inner pipe wall, in the center of the crack along its length (a). The cross-sections made with the micro-CT (b, c) and the 3D reconstruction

(d) show a spherical particle, broken in two, with some of its material spread out along the crack. In all likelihood, this is the inclusion that originally served as the initiation point of the crack. In the micro-CT images, the inclusions shown in Figures 2 and 3 have gray values of around 50,000 and 20,000, respectively, indicating that they consist of different materials.

Figure 3. Peculiarity encountered in the pipe wall of Sample 04: (a) a high-density particle is visible in a crack in the inner pipe wall, imaged with the medical CT; (b) and (c): Micro-CT cross-sections of the same particle; (d) volume reconstruction of the particle based on all micro-CT cross-sections.
