Analyzing Traditional Building Materials: A Case Study on Repair Practices in Konuralp, Düzce-Türkiye

Özlem Sallı Bideci ^{1,*}

and Büşra Sabuncu ²¹ Faculty of Art, Design and Architecture, Düzce University, 81600 Düzce, Türkiye² Graduate School of Natural and Applied Sciences, Düzce University, 81600 Düzce, Türkiye; busrasemercioglu@duzce.edu.tr

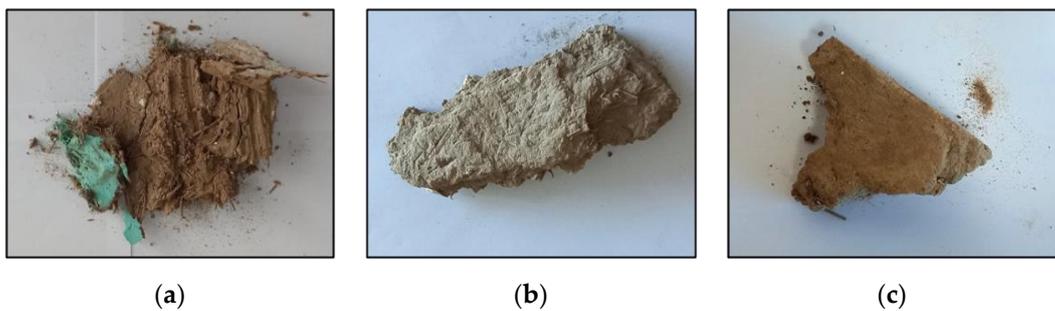
The general structure of the building consists of a wooden filling between wooden frames. Filling mortar was used as the binder in the parts built with filling wood. A sample of filling mortar between timbers was taken from the eastern façade of the building, exterior plaster was taken from the northern façade, and interior plaster was taken from the interior. The samples taken are shown in Figure 3.

Figure 3. Mortar and plaster samples of building number 1766: (a) interior plaster number H5, (b) exterior plaster number H6, and (c) filling mortar number H7.

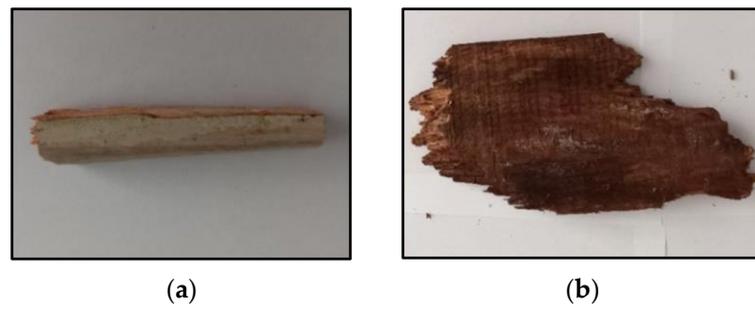
In traditional Turkish houses, there are often areas called loaders/built-in wardrobes next to the stoves, which are usually located in the rooms. These built-in wardrobes were included in planning during construction. Samples were taken from the building to determine the type of wood used in the wardrobe of one of the rooms. The stone base of the building is not high enough, which caused the floor covering to be built too close to the ground and, in some places, the floor coverings have collapsed and rotted. A floor covering sample was taken from one room of the building to determine its type. The wood samples are shown in Figure 4.

Figure 4. Images of wood samples: (a) cabinet joinery and (b) floor covering.

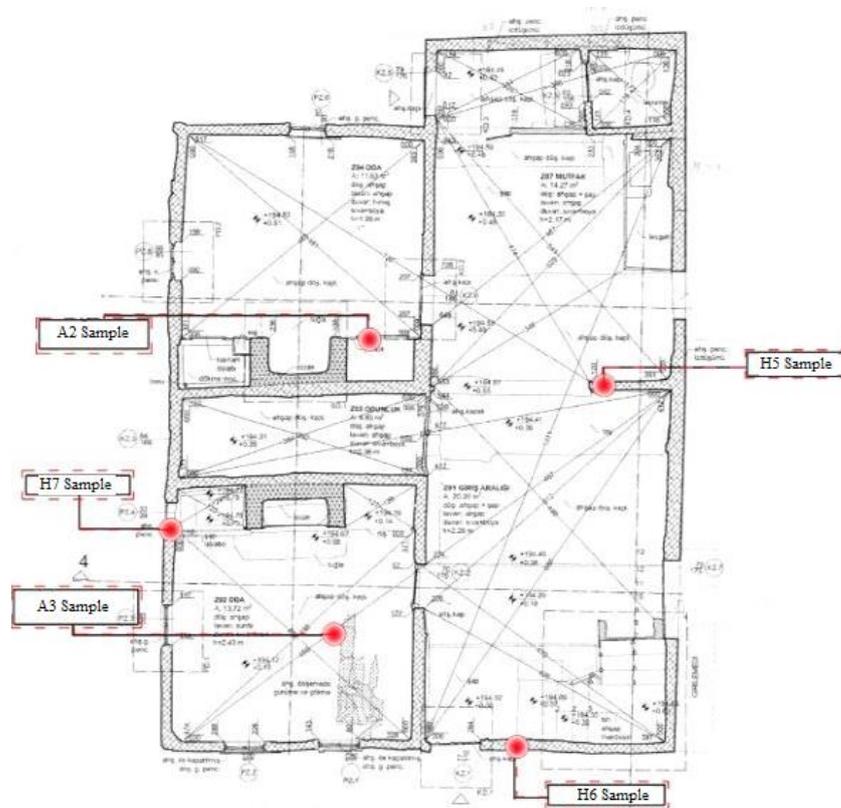
Figure 5. Plot 1766. Ground floor sampling numbers are given on the blueprint.

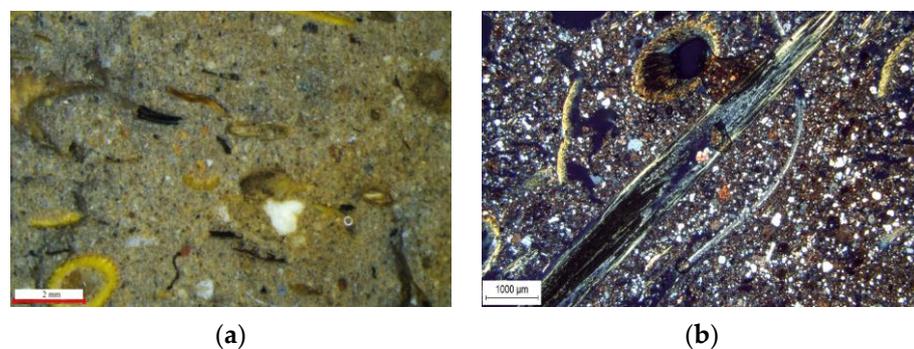
Sample H5, taken from the ground floor interior partition wall of the building numbered 1766, was a brown-colored, weak plaster sample with abundant tows, and its binder was determined to be 5–10% hydrated lime-reinforced abundant clay soil. Approximately 3–5% of the sample aggregates were ash, 3–5% were carbonated rock fragments, and all the remaining aggregates were abundant clay soil formed by the decomposition of potassium-based feldspars. The minerals were mainly quartz, feldspar, and small amounts of mica and amphibole. It was determined that 8–10 kg of tow was used per cubic meter of mortar. Stereomicroscope and polarizing microscope images of the sample are shown in Figure 7.

**Figure 7.** (a) Stereomicroscope and (b) polarizing microscope images of sample H5.

Based on the findings of the study and the recommendations in the KUDEB report [24], the H5 repair plaster mortar recommended for use in the areas represented by the samples could consist of one part of slaked lime putty and six parts of locally sourced clay-rich soil, sieved under 1 mm. In the preparation of the mortar, approximately 8 kg of crushed straw fiber should be added per cubic meter (m^3) of material. Furthermore, the straw fiber aggregate should be mixed in while dry, without adding lime, and then slaked lime should be added, continuing the mixing process.

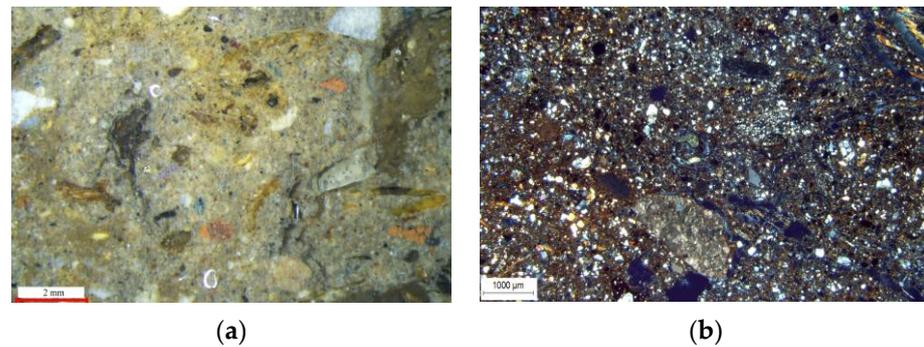
Sample H6, taken from the ground floor east facade of the building numbered 1766, was a brown-colored, weakly structured exterior plaster sample with abundant tows and white masses, and its binder was determined to be 15–20% hydrated lime-reinforced

abundant clay soil. Approximately 3–5% of the sample aggregates were ash, 3–5% were limestone and marble fragments, and 1–2% were brick crumb particles in the mortar content as impurities; all the remaining aggregates were abundant clay soil of terrestrial origin formed as a result of the decomposition of potassium-based feldspars. The minerals were mainly quartz, feldspar, and a small amount of mica. It was determined that 2–2.5 kg of tow was used per cubic meter of mortar. Stereomicroscope and polarizing microscope images of the sample are shown in Figure 8.

Figure 8. (a) Stereomicroscope and (b) polarizing microscope images of sample H6.

For the H6 repair plaster mortar, it is stated that the mixture should consist of one part of slaked lime putty and five parts of locally sourced clay-rich soil, sieved under 1 mm. During the preparation, approximately 2 kg of crushed straw fiber should be added per cubic meter (m^3) of material and, similar to the H5 mixture, the straw fiber aggregate should be mixed in dry before adding the slaked lime and continuing the mixing process.

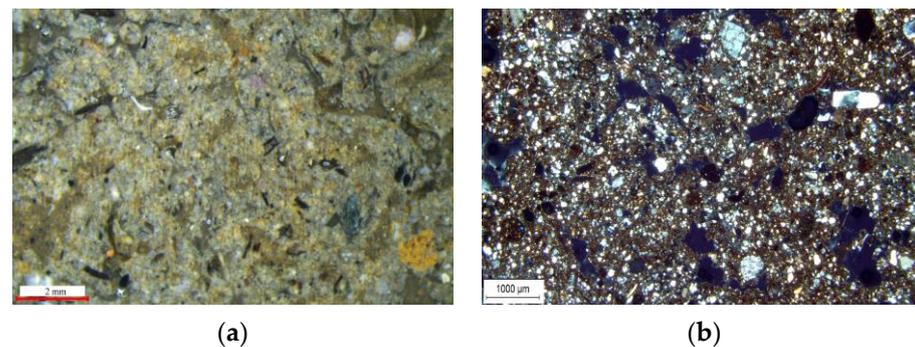
Sample H7, taken from the ground floor south facade of the building numbered 1766, was a brown-colored, dispersed mortar sample containing sand aggregates, white masses, and a small number of tows; its binder was determined to be 10–15% hydrated lime-reinforced abundant clay soil. Approximately 5–8% of the sample aggregates were ash, 2–3% were carbonated rock particles, and the remaining aggregates were all terrestrial abundant clay soil formed as a result of the decomposition of potassium-based feldspars. The minerals were mainly quartz, feldspar, and a small amount of amphibole. Tow fragments were detected in the sample. Stereomicroscope and polarizing microscope images of the sample are given in Figure 9.

Figure 9. (a) Stereomicroscope and (b) polarizing microscope images of sample H7.

For the H7 repair mortar, it is recommended that the mixture consist of one part of slaked lime putty and six parts of locally sourced clay-rich soil, sieved under 1 mm. Since these components are prepared using local materials, they are both suitable for the local conditions and provide a practical solution for the restoration process.

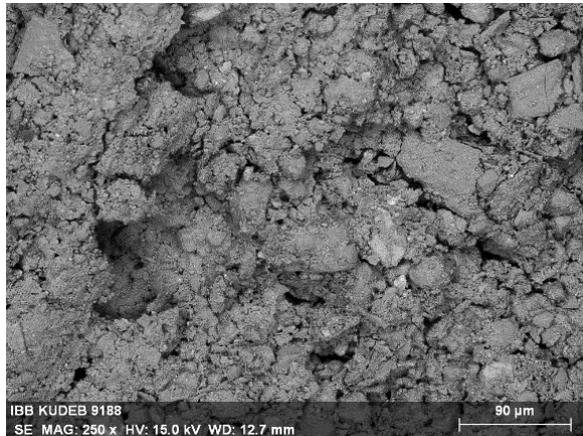
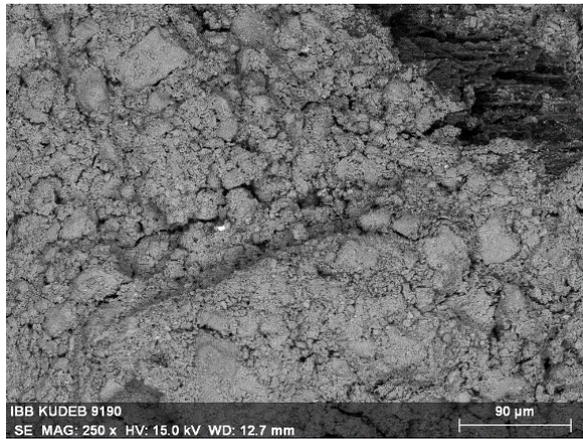
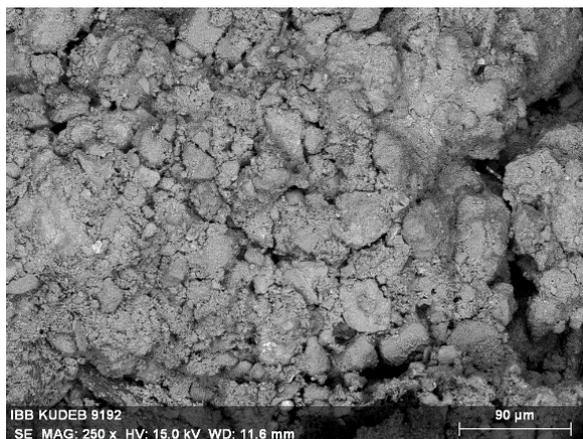
Figure 10. SEM images and EDX analysis element and oxide ratios of the (a) H5, (b) H6, and (c) H7 samples.

As shown in Figure 9, the binder of the H5 plaster mortar sample was calcium carbonate of lime origin at about 5–10%, and 90–95% was abundant clay soil of terrestrial origin formed by the decomposition of potassium-based feldspars. The sample contained 57.37%

silicon from clay and lesser amounts of aluminum, iron, calcium, potassium, magnesium, sodium, and titanium. The binder of the H6 plaster mortar sample was calcium carbonate originating from lime in the range of approximately 8–10%, and 90–92% was abundant clay soil of terrestrial origin consisting of decomposition of potassium-based feldspars. The sample was determined to contain 57.67% silicon from clay and aluminum, iron, calcium, potassium, magnesium, sodium, and titanium in smaller amounts than this element. The binder of the H7 filling mortar sample was calcium carbonate of lime origin in the range of approximately 10–15%, and 85% was abundant clay soil of terrestrial origin formed by the decomposition of potassium-based feldspars. The sample contained 53.85% silicon from clay and smaller amounts of aluminum, calcium, iron, potassium, magnesium, titanium, and sodium.

According to the results of the SEM-EDX analysis, mortars H5, H6, and H7 had very high silica content due to the high clay content.

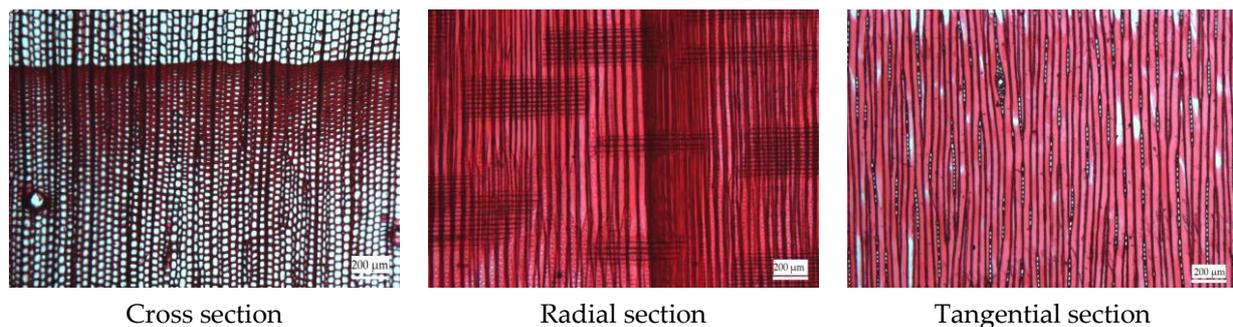
Figure 11. Thin section images of A2 sample.

The cross-sectional properties of sample A2, a fungal-damaged wood sample with a white paint layer from the cabinet part of building numbered 1766, were examined (Figure 11). It was observed that the annual ring boundaries were clear, the transition from spring wood to summer wood was rapid, and resin channels were present in its structure. In the radial section characteristics, it was observed that the marginal passages on the radial walls of the longitudinal tracheids were single-row, the medullary rays were heterogeneous, and the tracheid cell walls were coarsely toothed. It was also observed that the meeting place passages were of a large window type. In the tangential section characteristics, it was determined that the medullary rays were mostly 1–12 cells high. As a result of the macroscopic and microscopic examinations, the genus of the A2 sample taken from the cabinet joinery was determined to be yellow pine (*Pinus sylvestris* L.).

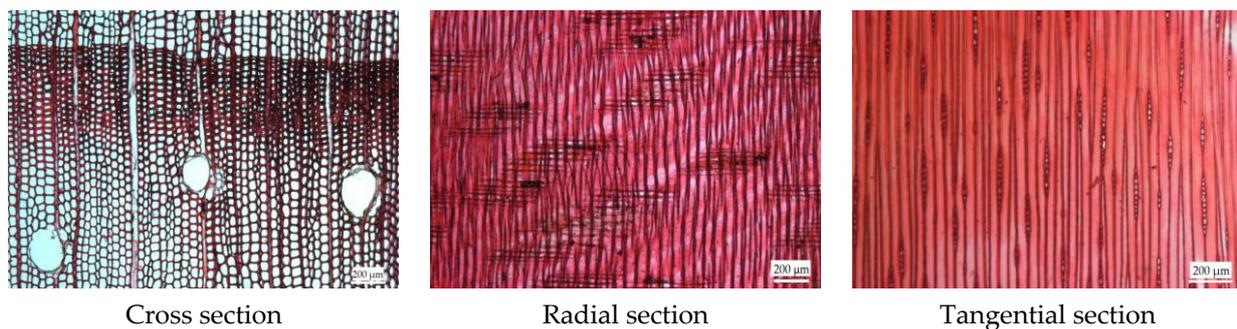
Figure 12. Thin section images of sample A3.

The cross-sectional properties of sample A3, a wood sample taken from the floor covering of building 1766 that has no paint layer and has been damaged by fungus and insects, were examined (Figure 12). It was observed that the annual ring boundaries were clear, the transition from spring wood to summer wood was rapid, and resin channels were present in its structure. In the radial section characteristics, it was observed that the marginal passages on the radial walls of the longitudinal tracheid cells were single-row, the medullary rays were heterogeneous, and the walls of the tracheids were coarsely toothed. It was also observed that the meeting place passages were of a large window type. In the tangential section characteristics, it was determined that the medullary rays were mostly 1–12 cells high. As a result of macroscopic and microscopic examinations, the species of the A3 sample taken from the pavement was determined to be yellow pine (*Pinus sylvestris* L.).
