# Analysis of CFRP Joints by Means of T-Pull Mechanical Test and Ultrasonic Defects Detection

Caterina Casavola <sup>1,\*</sup>, Fania Palano <sup>2</sup>, Francesco De Cillis <sup>1</sup>, Angelo Tati <sup>3</sup>, Roberto Terzi <sup>2</sup> and Vincenza Luprano <sup>2</sup>

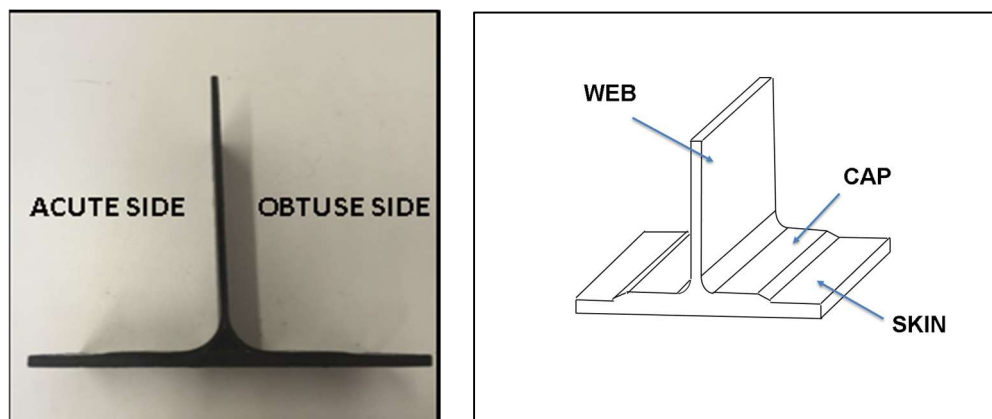
**Figure 1.** T-Pull specimen and technical nomenclature.

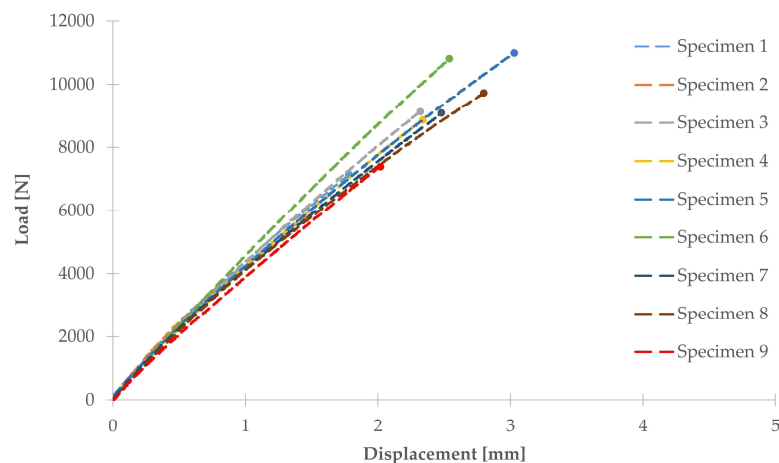
Figure 6. Load versus displacement curves.

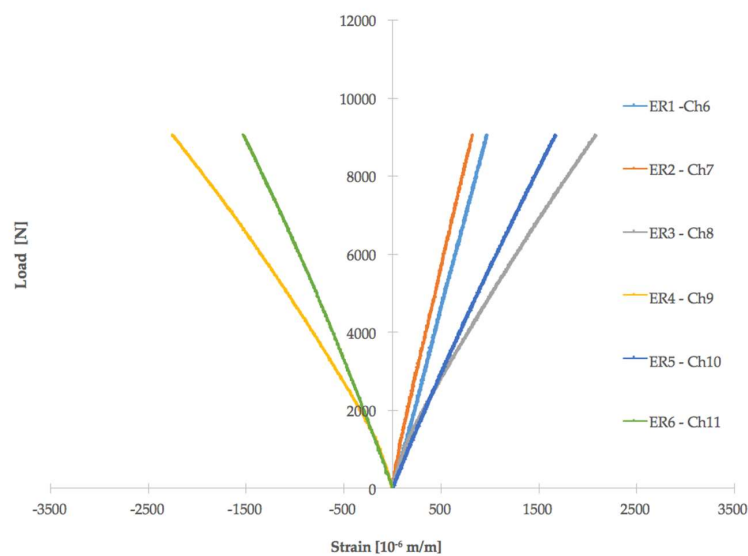
Figure 7. Strain gages value recorded during mechanical tests for specimen number 3.

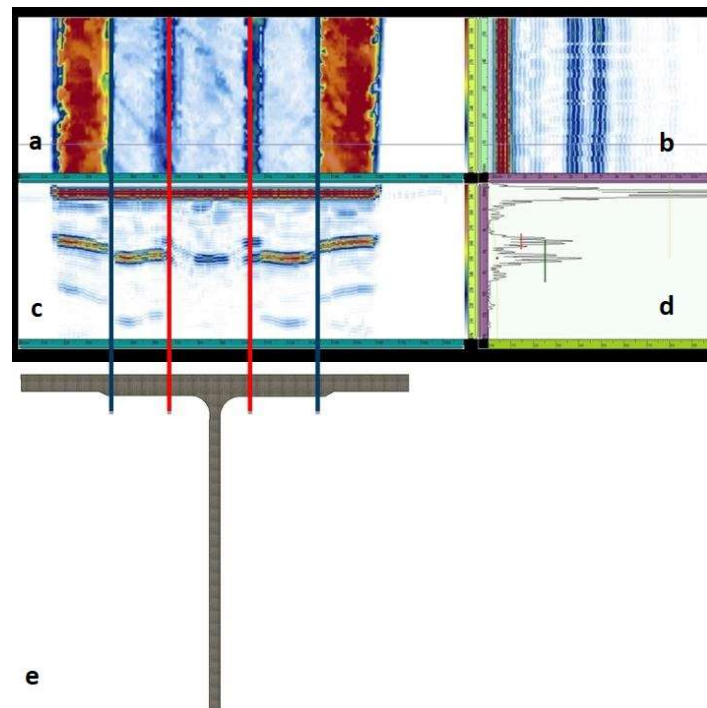
**Figure 8.** Correspondence between ultrasonic images and specimen typical geometry: (a) C-scan; (b) D-scan; (c) B-scan; (d) A-scan; and (e) specimen geometry. Red lines localize the defects position and blue lines correspond to the thickness variation at the skin-cap interface.

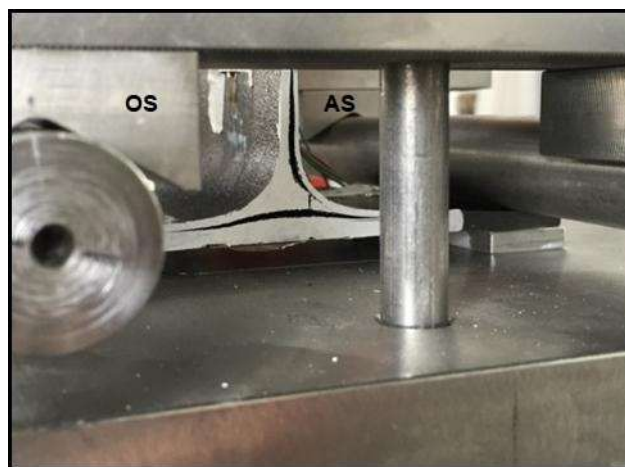
An irregular defectiveness area was detected on the acute side (Figure 10b, C-scan left side), that could have influenced specimen breaking on the acute side at a low failure stress value (Table 1).

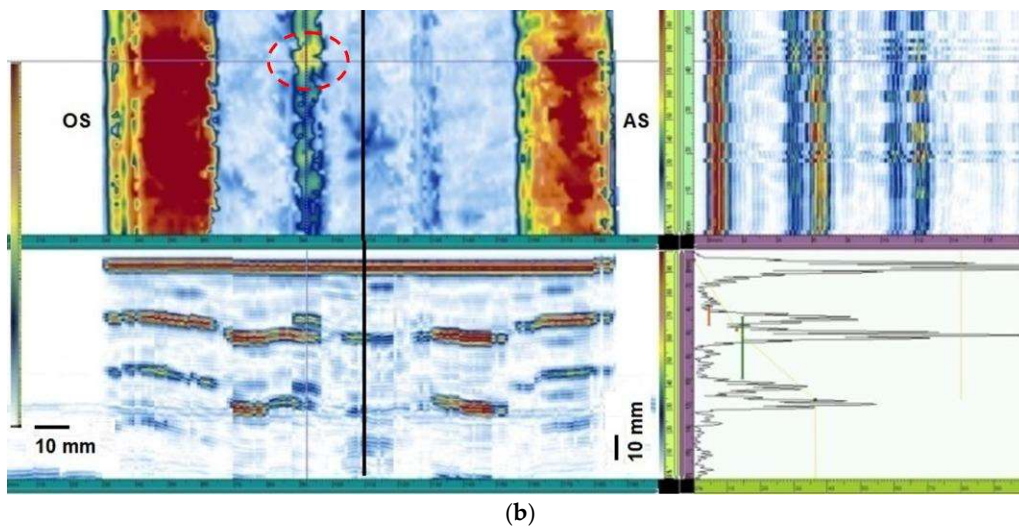
**Figure 9.** (a) Specimen 3 after delamination fracture; (b) ultrasonic testing (UT) images before the breaking; the red circle shows an irregular defected area.

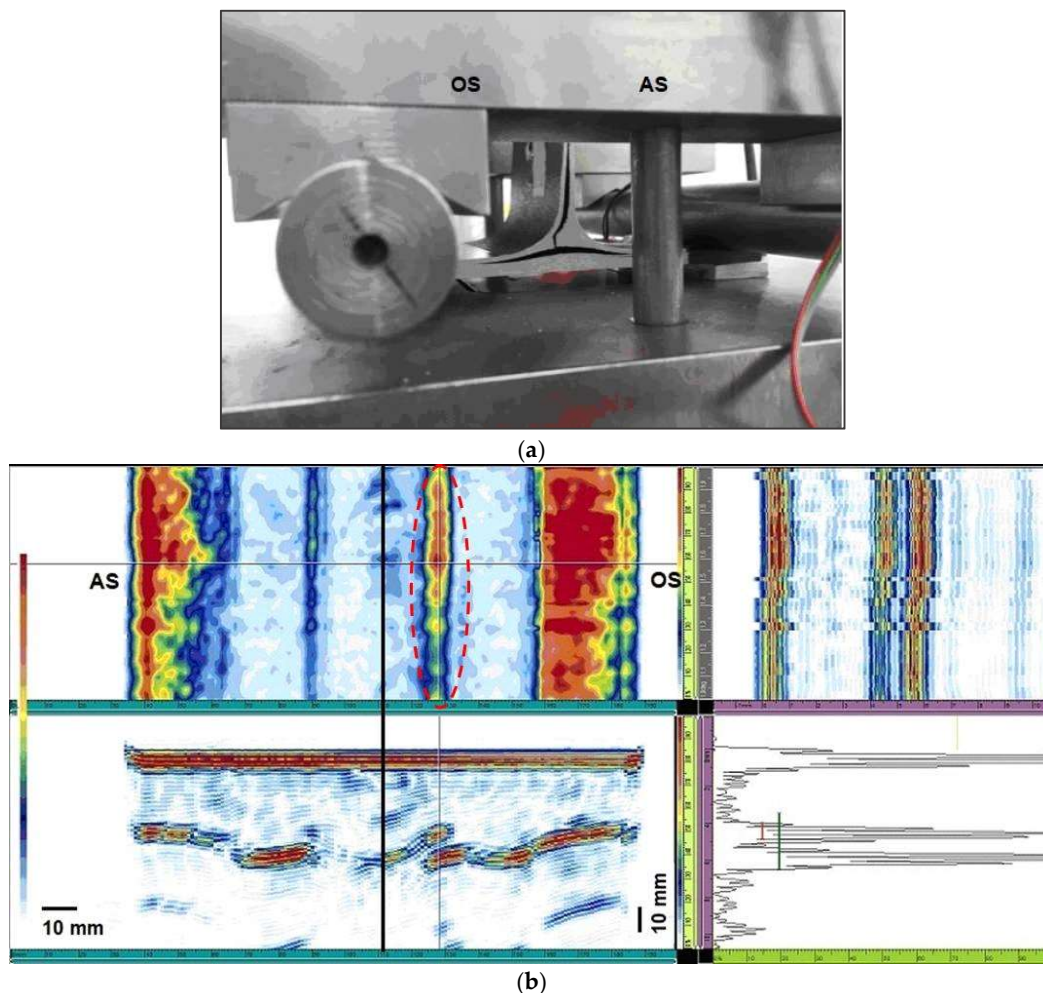
**Figure 11.** (a) Specimen 9 after delamination fracture; (b) UT images before the breaking; the red circle shows the continuous defected area.

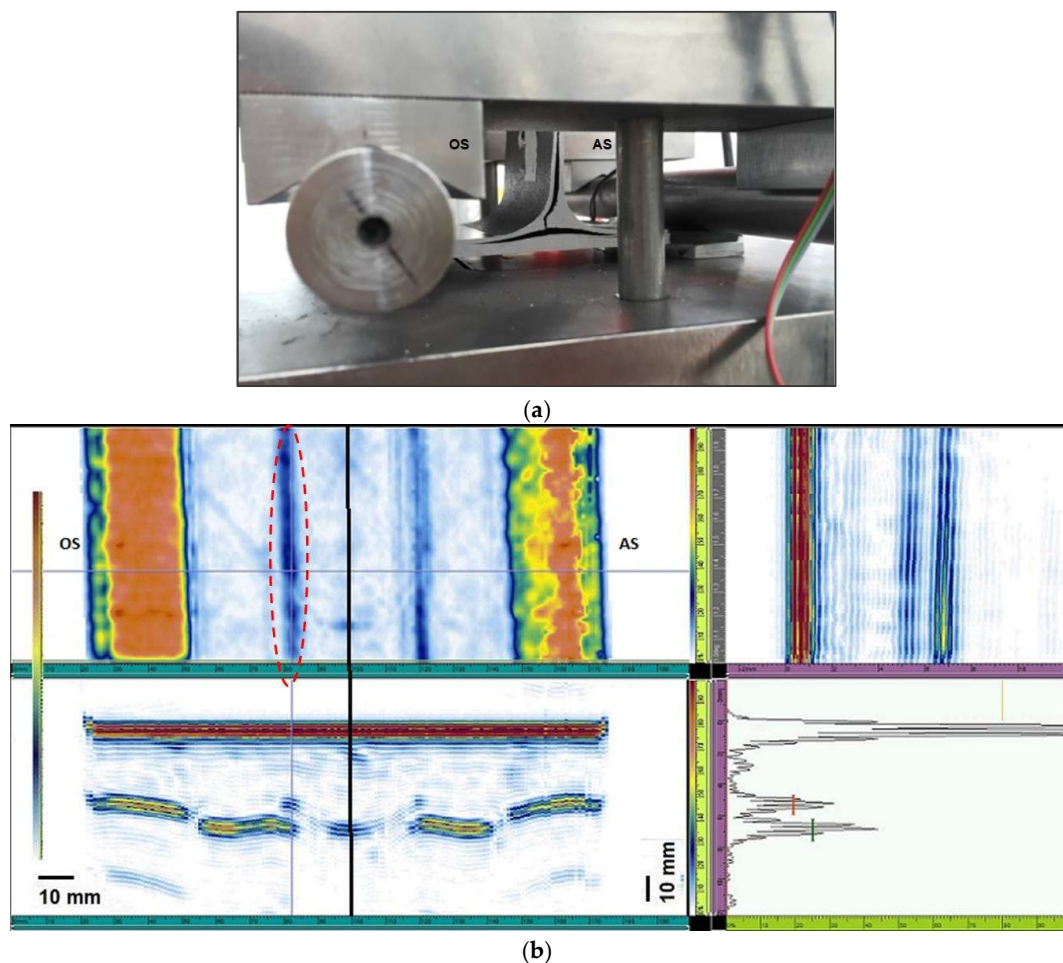
**Figure 12.** (a) Specimen 7 after delamination fracture; (b) UT images before the breaking; the red circle shows the continuous defected area.
