## Article

# Study on the Influence of Defects on Fracture Mechanical Behavior of Cu/SAC305/Cu Solder Joint

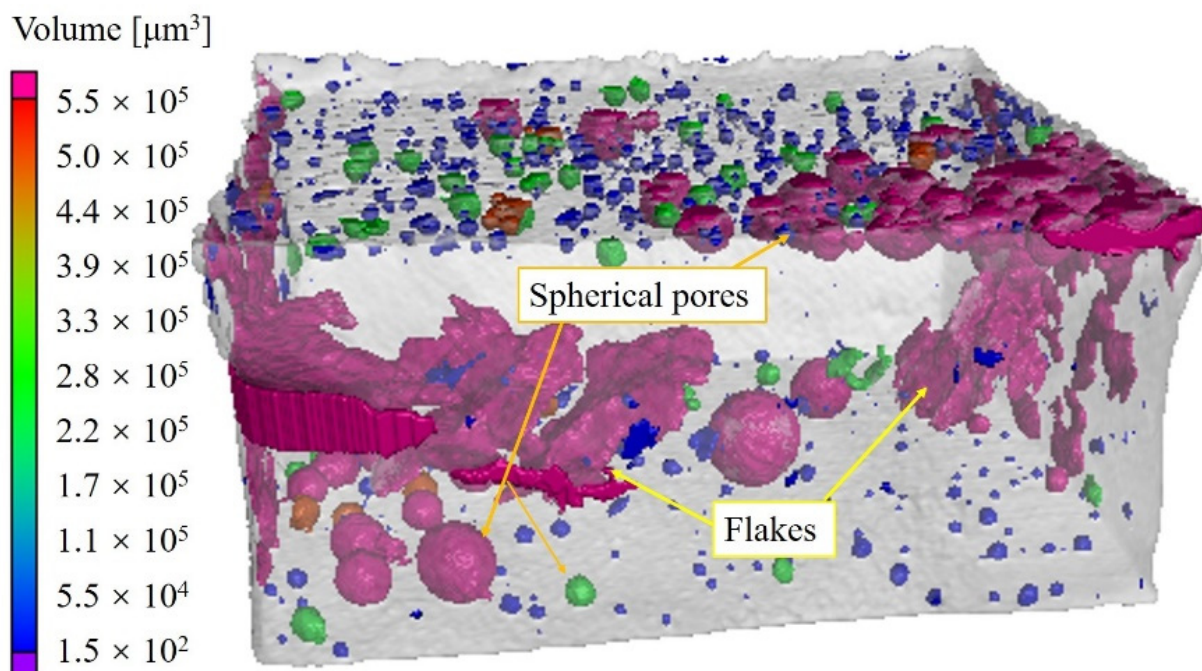
**Figure 2.** Reconstructed structure of defects in the Cu/SAC305/Cu solder joints.

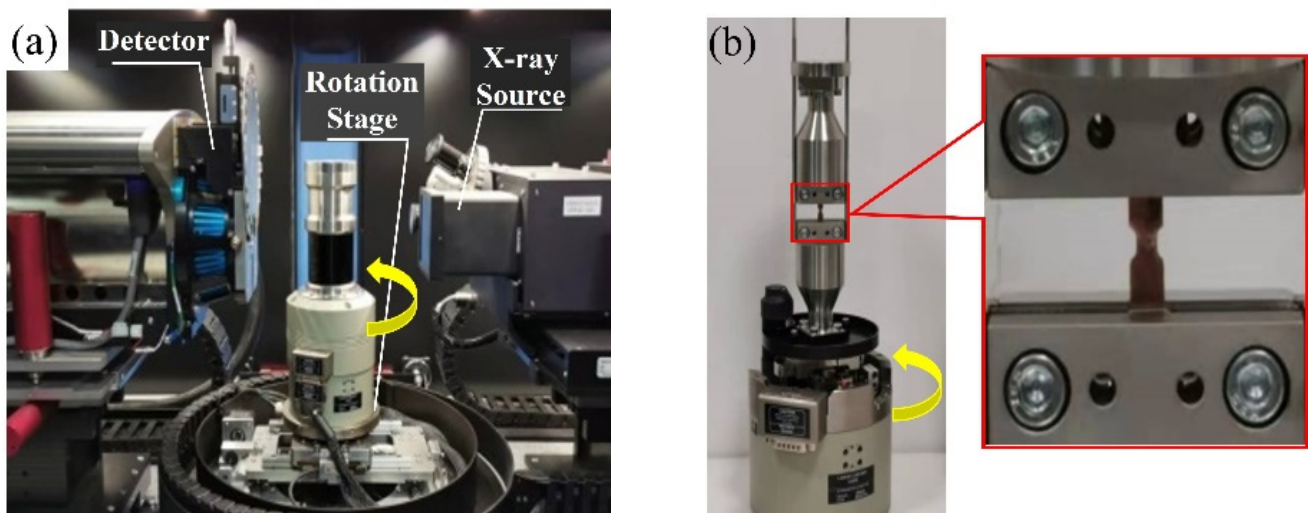
**Figure 3.** (a) Setup of in situ X-ray  $\mu$ -CT; (b) tensile setup capable of rotating with  $\mu$ -CT test piece table.

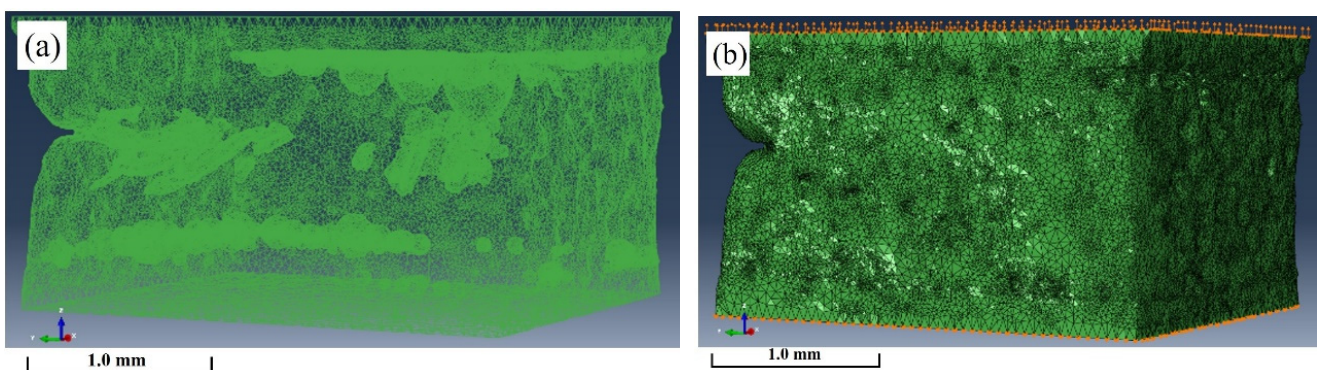
**Figure 4.** (a) Three-dimensional FE mesh model considering real internal defects; (b) boundary conditions and displacement loading of FE model.

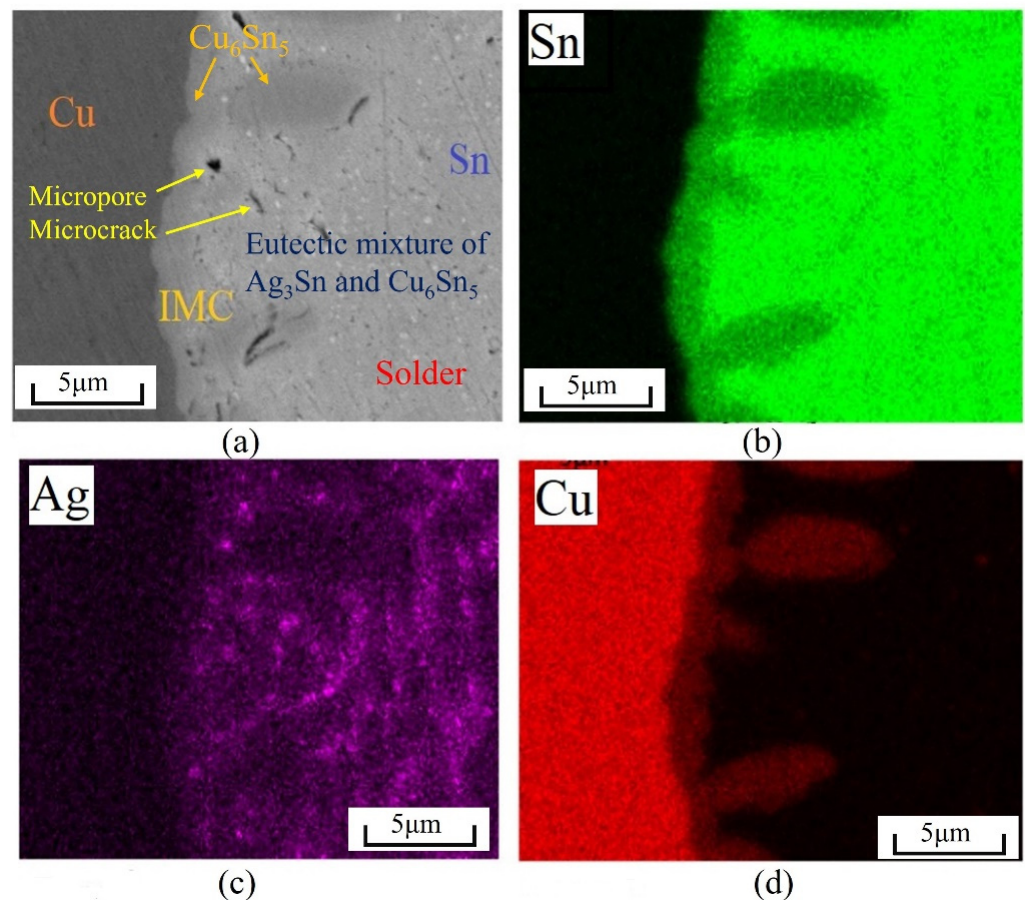
**Figure 5.** Microstructure and EDS mapping of surface of SAC305/Cu interfaces after polishing. (a) initial microstructure; (b) Sn element; (c) Ag element; (d) Cu element.

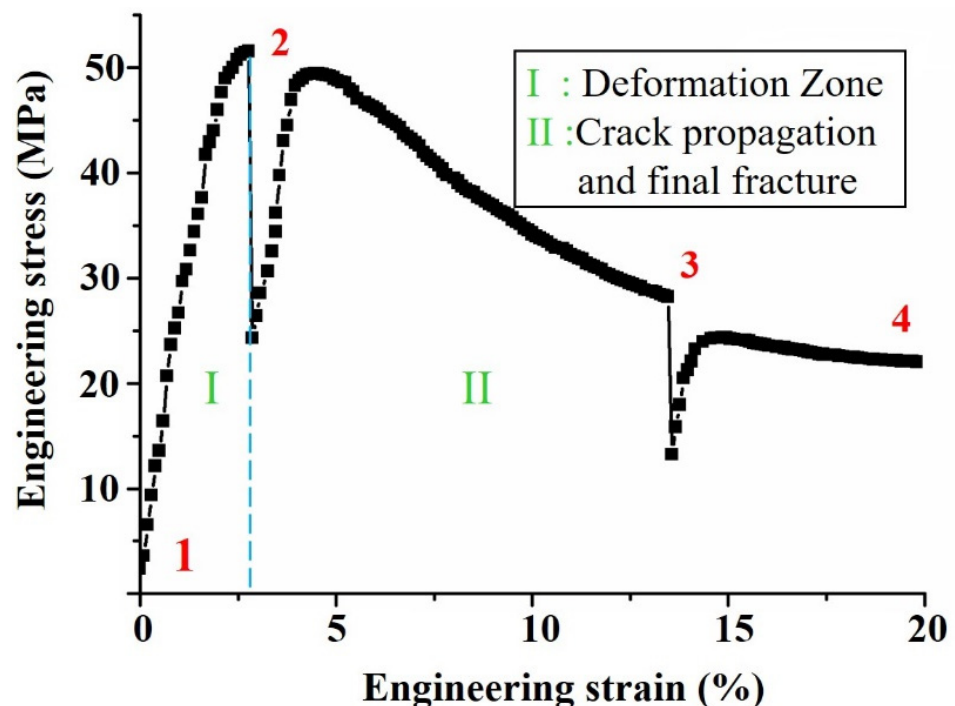
**Figure 6.** Engineering stress–strain curve of Cu/SAC305/Cu solder joint obtained by in situ tensile test. Positions 1, 2 and 3 represented the suspending points, and 4 represented the fracture point.

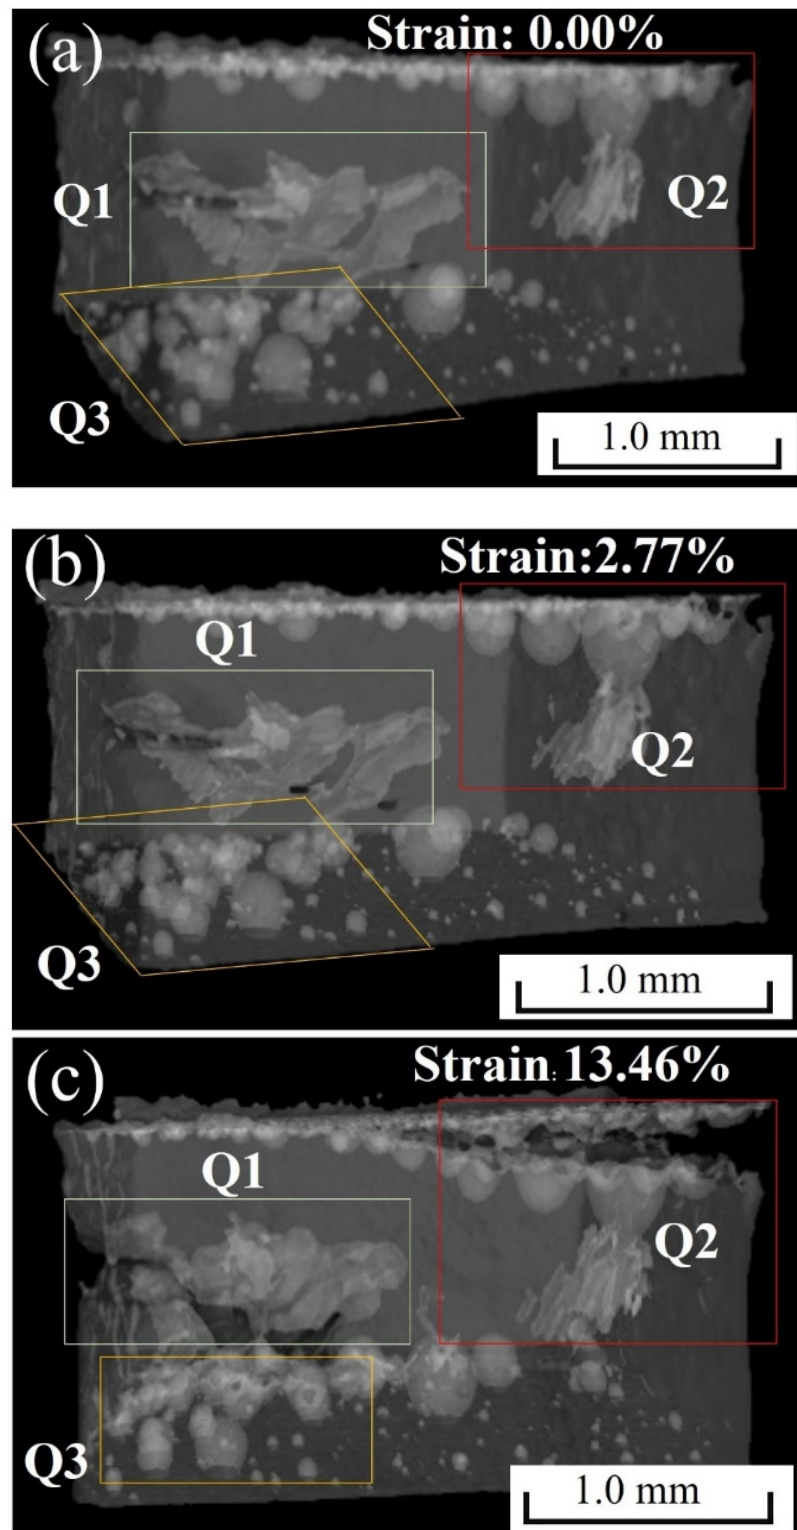
**Figure 7.** Three-dimensional internal defects in microstructure of solder joints at the strain of: (a) 0.00; (b) 2.77%; (c) 13.46%.

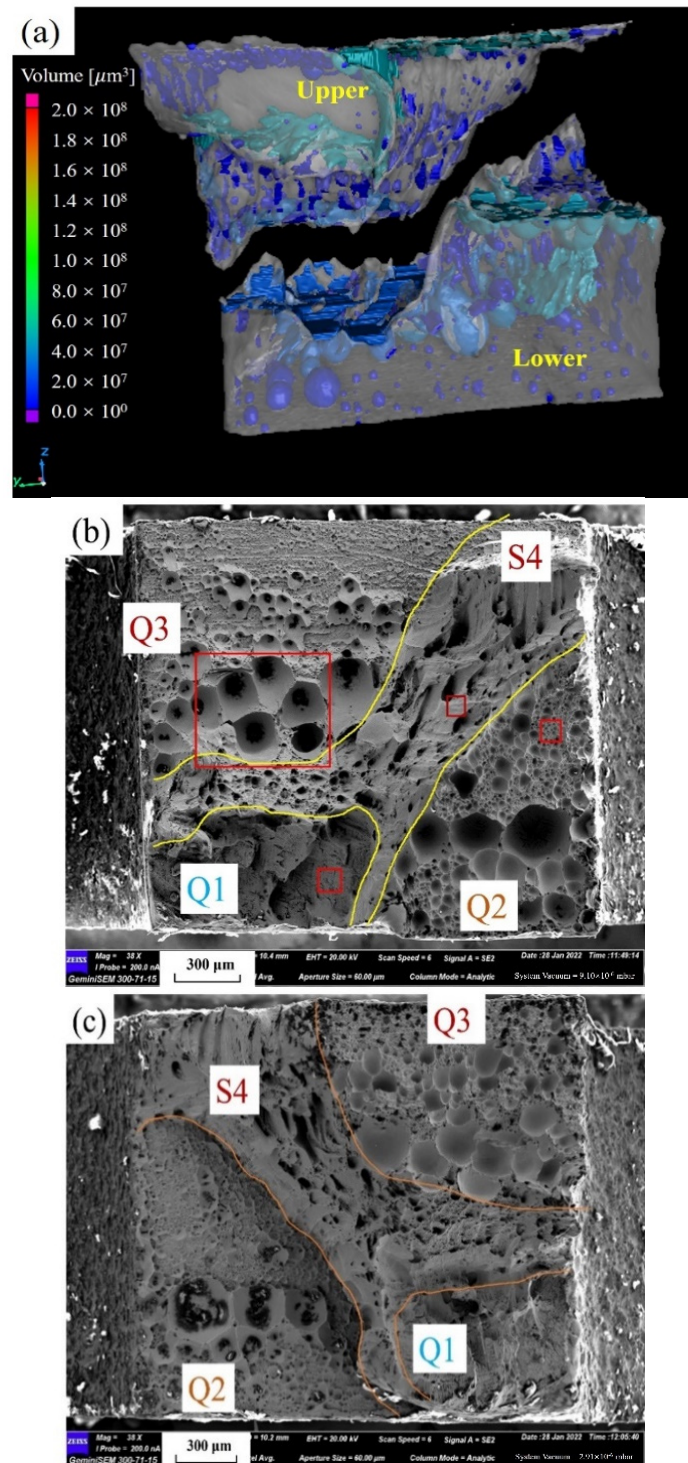
**Figure 8.** (a) Reconstruction of 3D internal structure of solder joint after fracture; (b) SEM fracture morphology of lower part; (c) SEM fracture morphology of upper part.

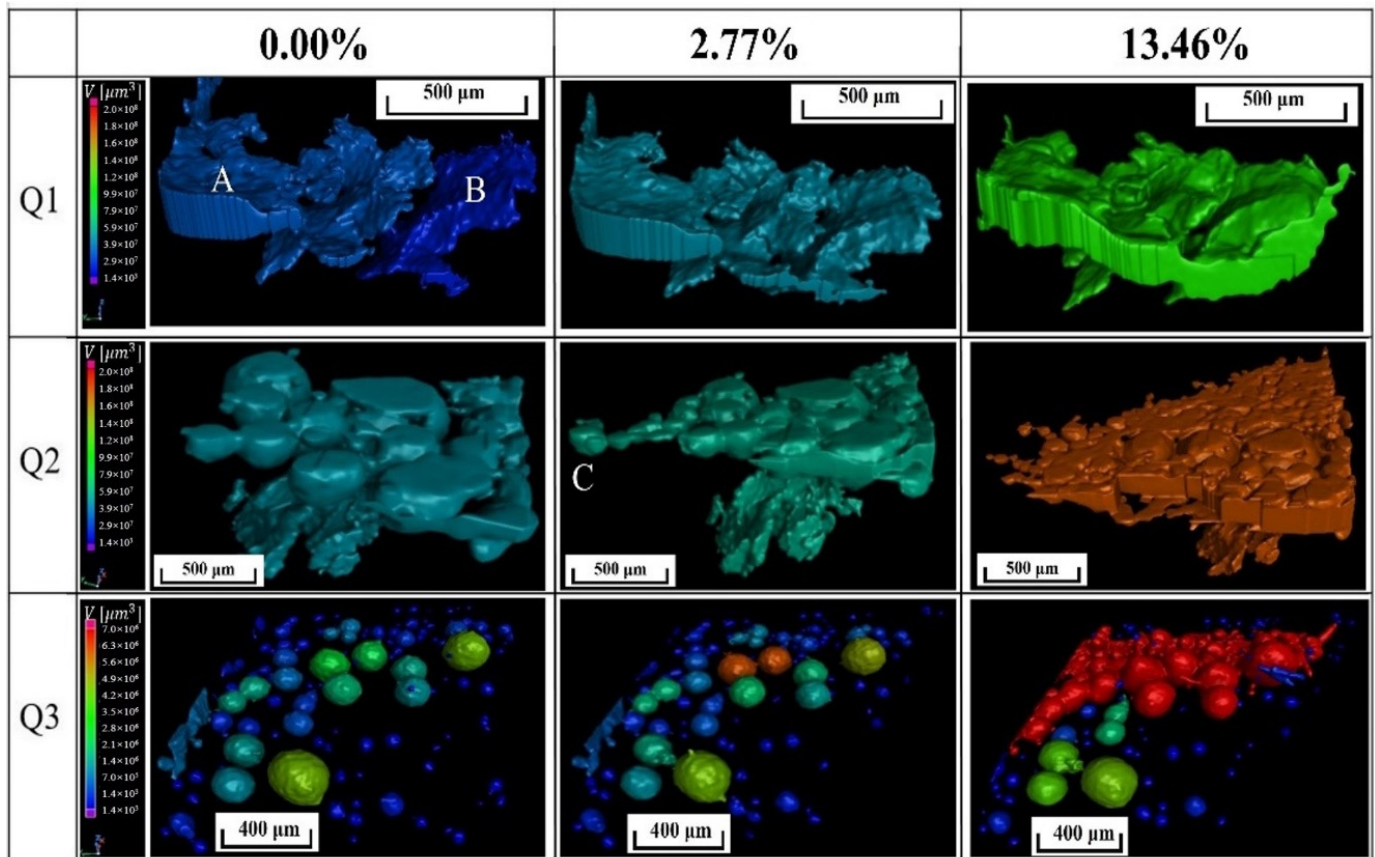
**Figure 9.** Evolution of 3D defects as strain increased in three regions of solder joints.

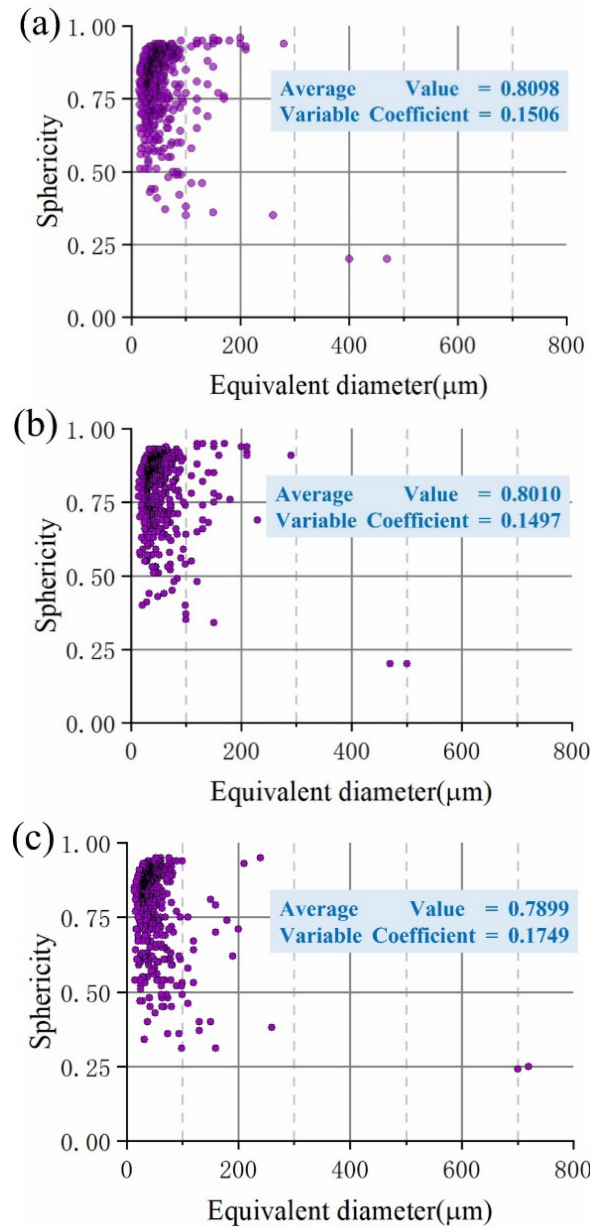
**Figure 10.** Sphericity distribution of defects at solder joints under different deformation states: (a) 0.00%; (b) 2.77%; (c) 13.46%.

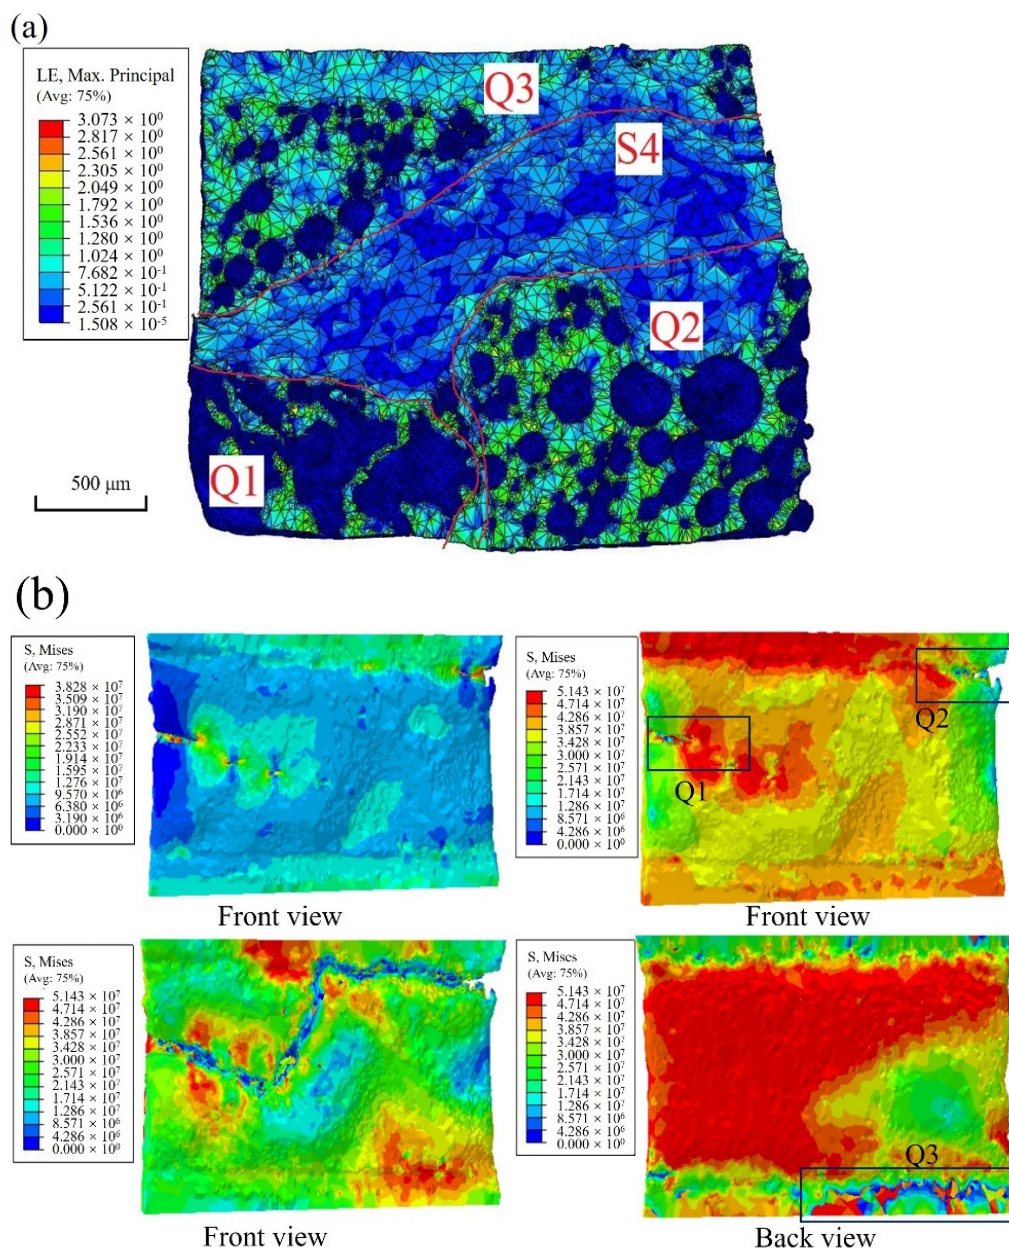
**Figure 11.** FE simulation results: (a) fracture morphology of solder joints; (b) process of crack initiation and propagation for solder joints.

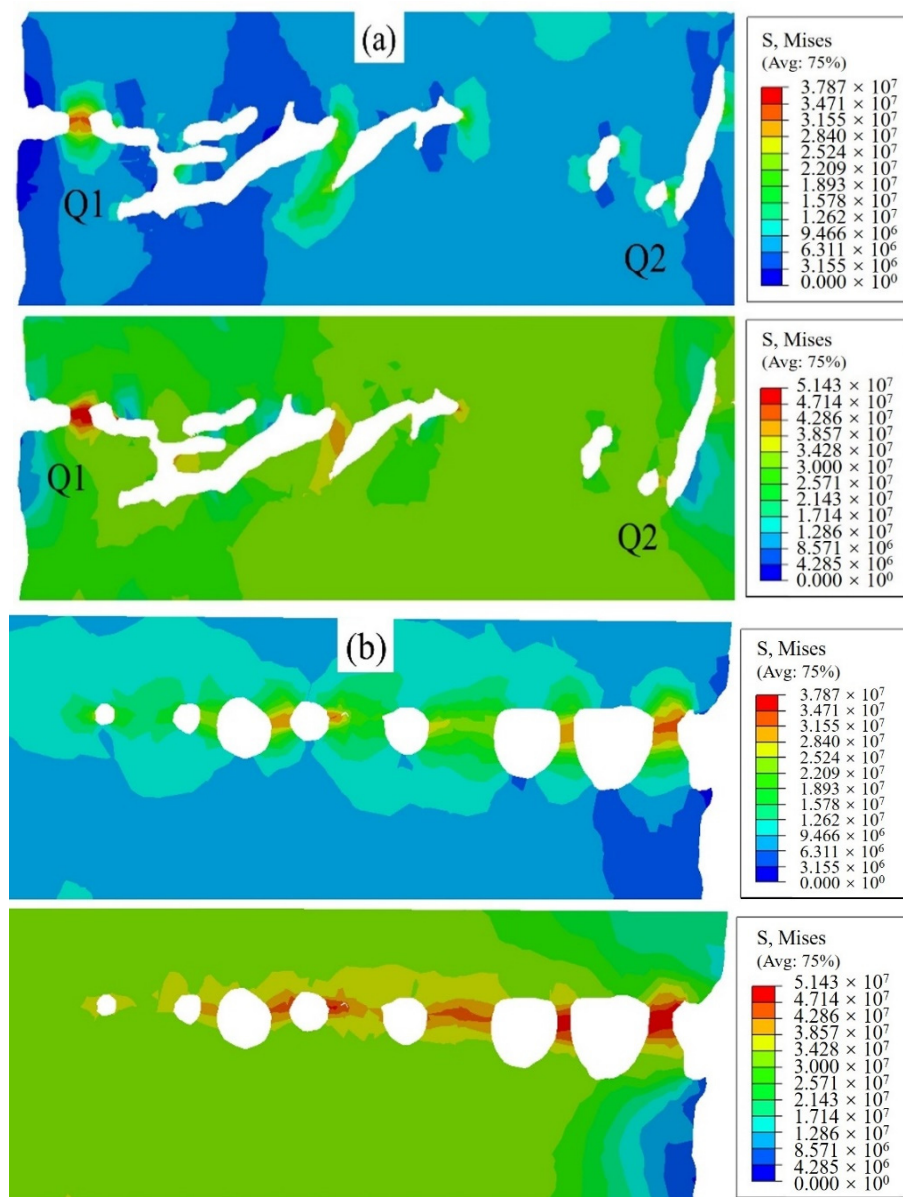
**Figure 12.** Stress distribution (a) near flaky cracks in regions Q1 and Q2 and (b) near aggregation pores in region Q2, under different external loads.

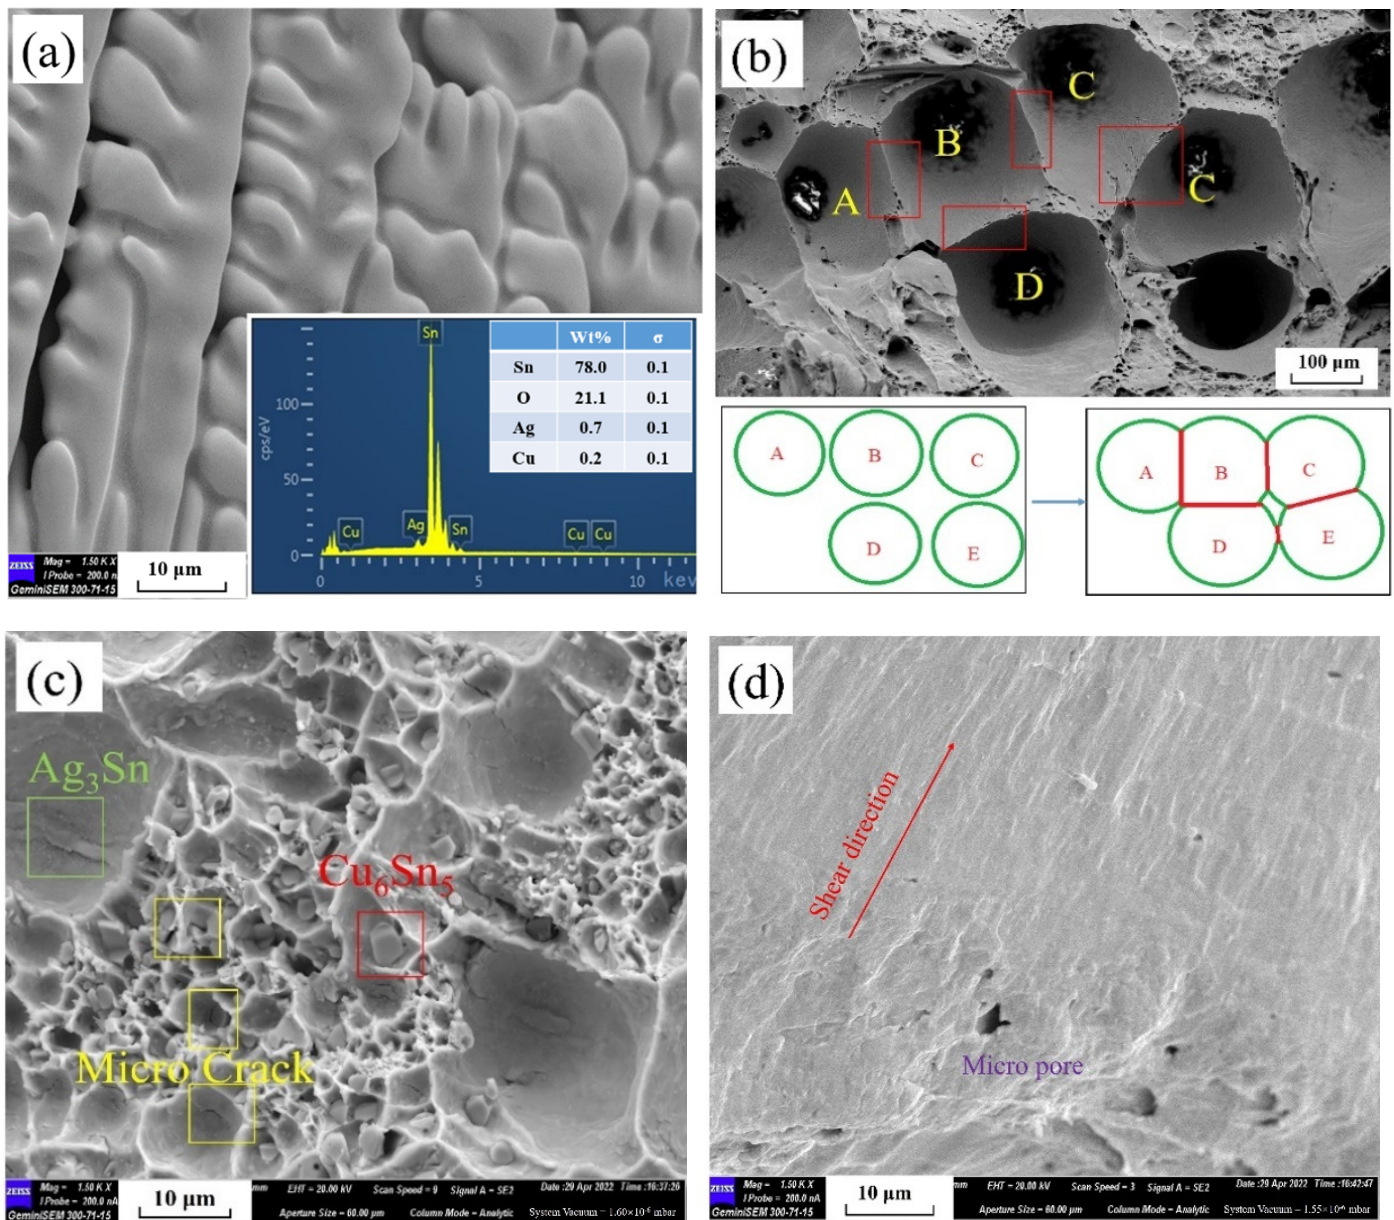
**Figure 13.** Partially enlarged image: (a) Q1 region; (b) pores in Q3 region; (c) fracture surface of IMC layer in Q2 region; (d) S4 region.

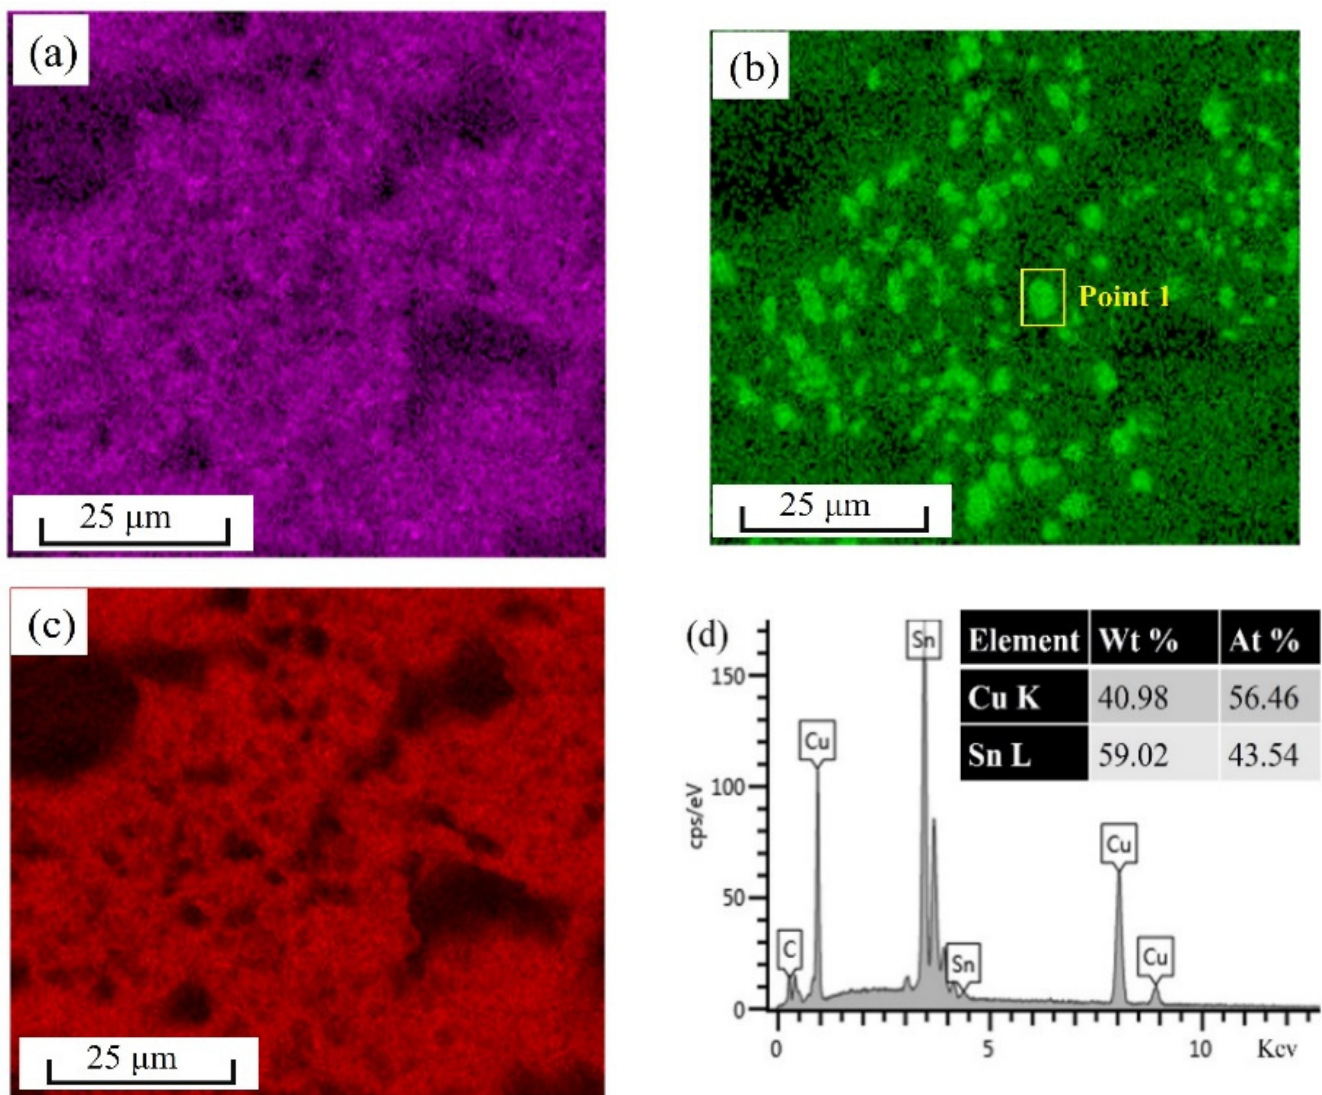
**Figure 14.** EDS mapping of fracture surface of IMC layer in Q2 region: (a) Ag element; (b) Cu element; (c) Sn element; (d) component ratio of prism particles at point 1.
