## Article

# 3R Composites: Knockdown Effect Assessment and Repair Efficiency via Mechanical and NDE Testing

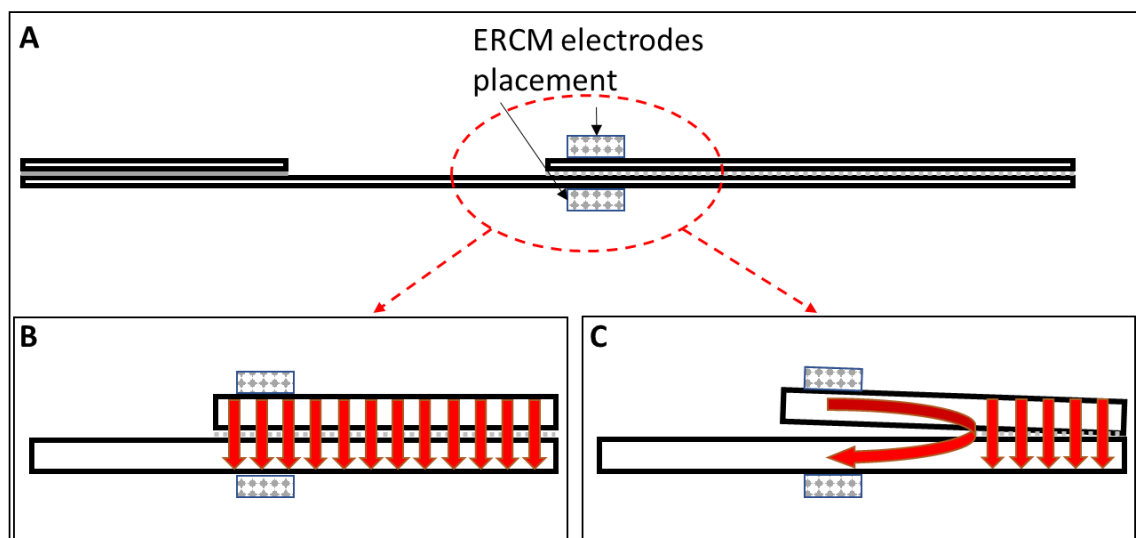
**Figure 2.** (A) Setup of the lap strap specimens for ERCM, (B) the current path marked with red arrows before damage, and (C) the current path after debonding of the lap from the strap.

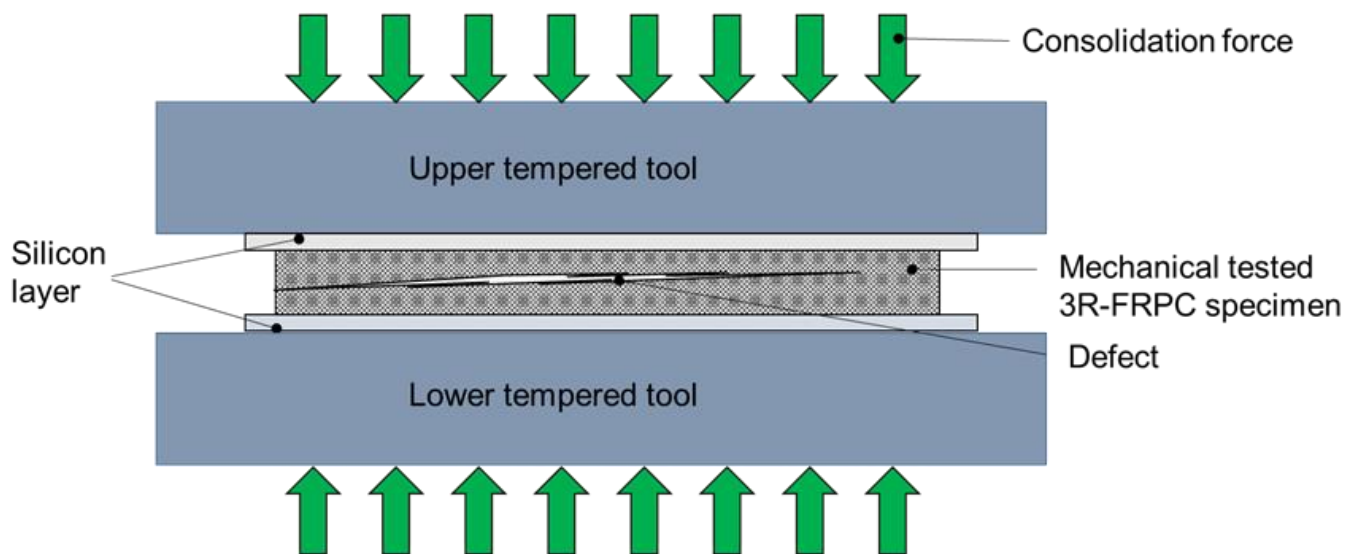
**Figure 3.** Schematic of the setup used for the repair process.

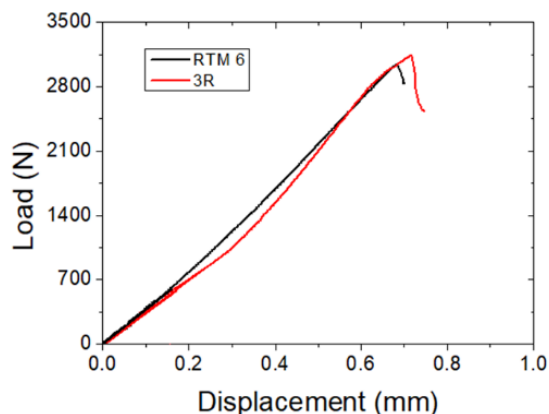
Type of CFRP Specimen	Strength (Mpa)	Knockdown effect
Conventional Resin (RTM6)	$52.52 \pm 2.15$	
3R Resin	$50.56 \pm 1.31$	<b><math>-3.7\%</math></b>

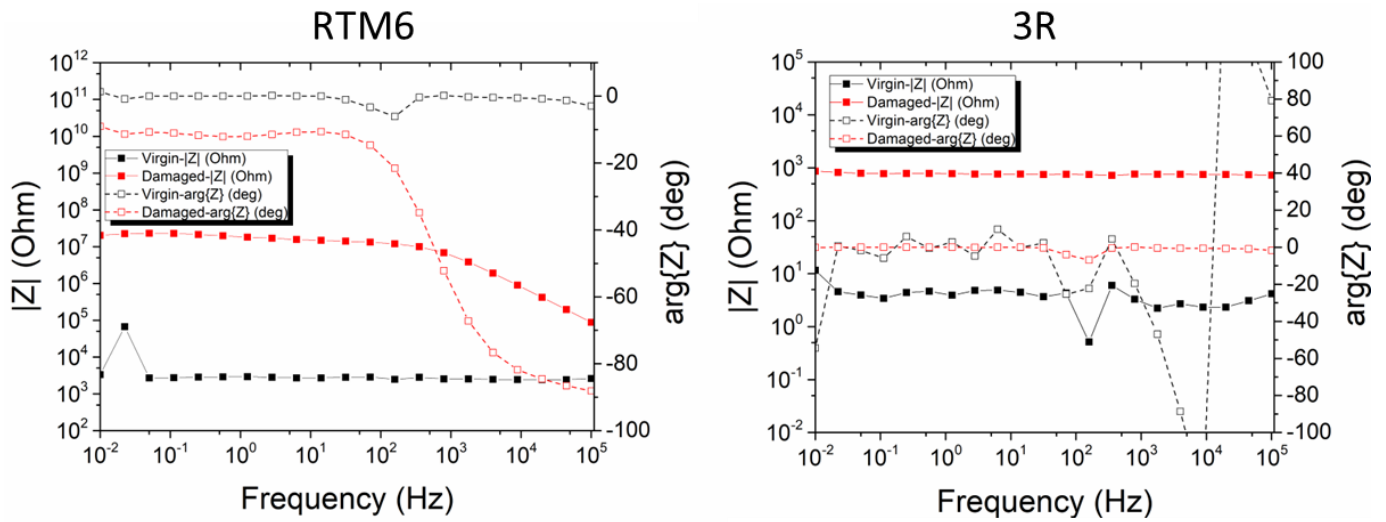
**Figure 5.** IS scans of (left) a representative RTM6 ILSS specimen before (black) and after damage (red), and (right) a 3R specimen before (black) and after damage (red).

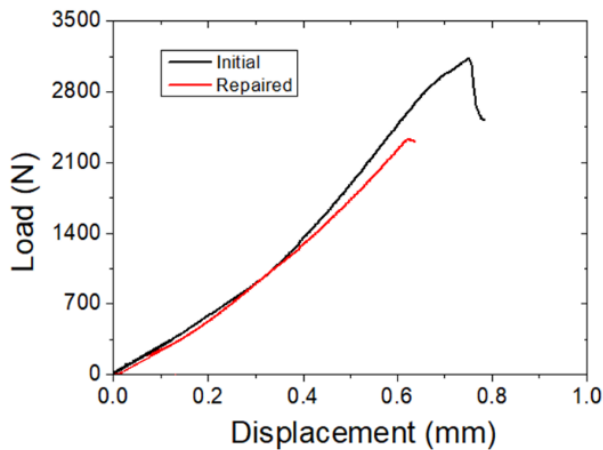
Type of CFRP Specimen	Strength (MPa)	Repair efficiency
3R Initial	50.56 ± 1.31	
3R Repaired	36.40 ± 2.46	<b>72.0%</b>

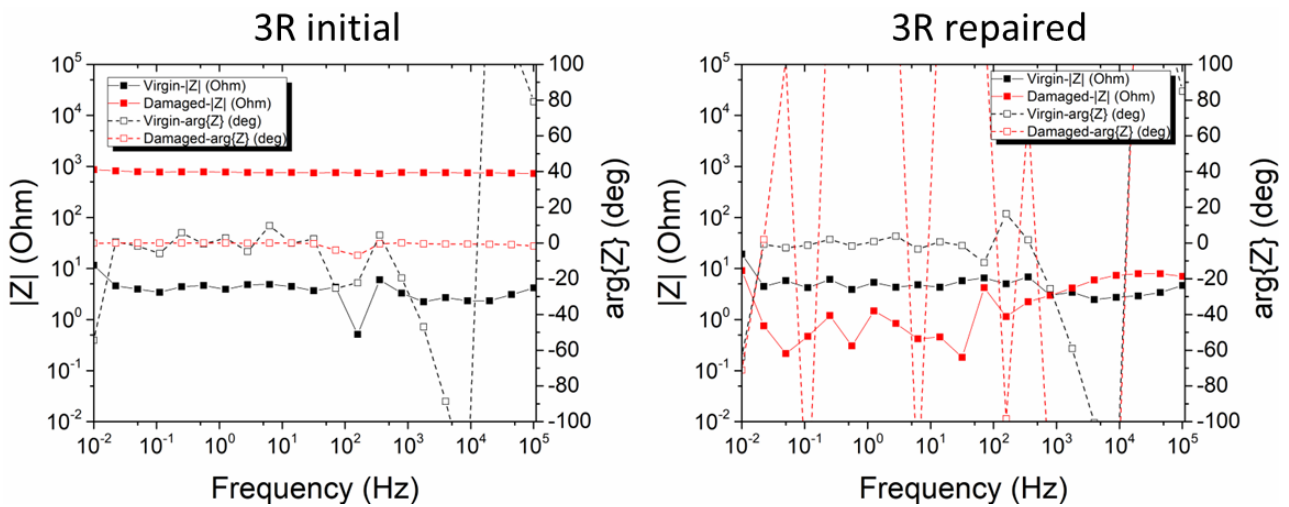
**Figure 7.** Impedance measurements of the 3R ILSS specimens before (left) and after (right) the repair process.

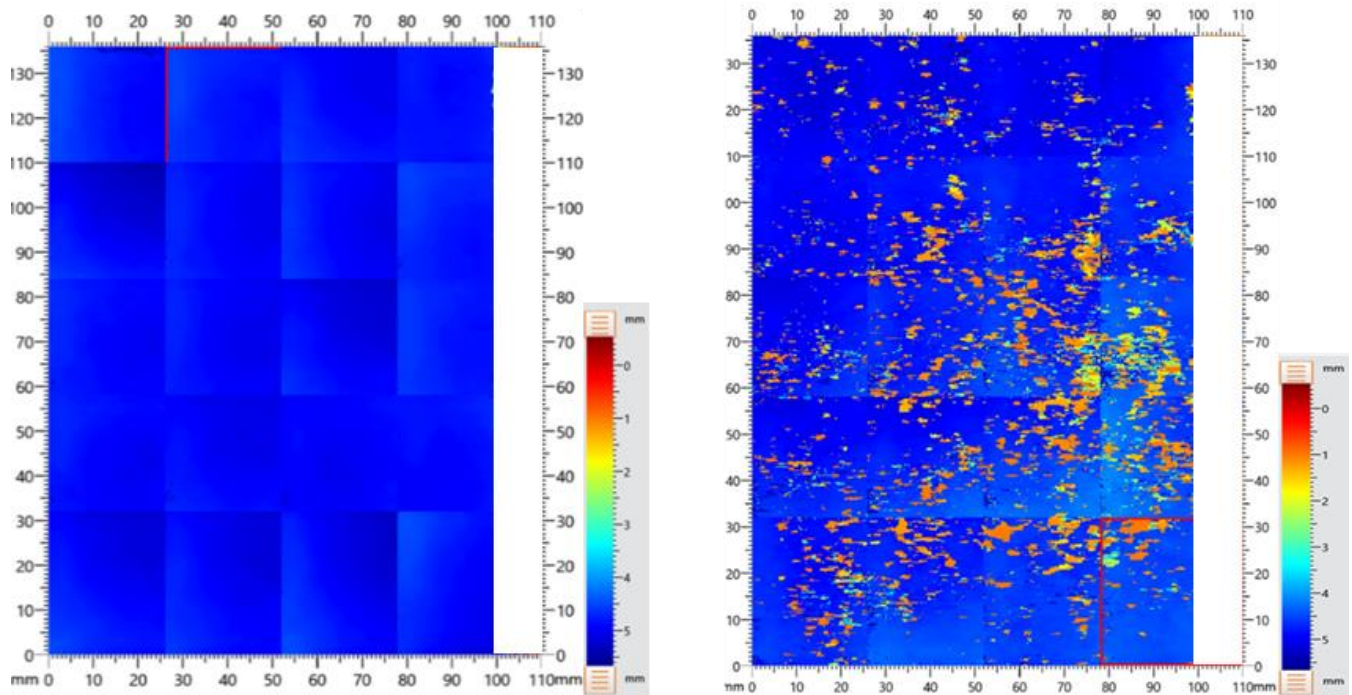
**Figure 11.** Reference c-scan of a representative RTM6 (left) and 3R laminate (right).

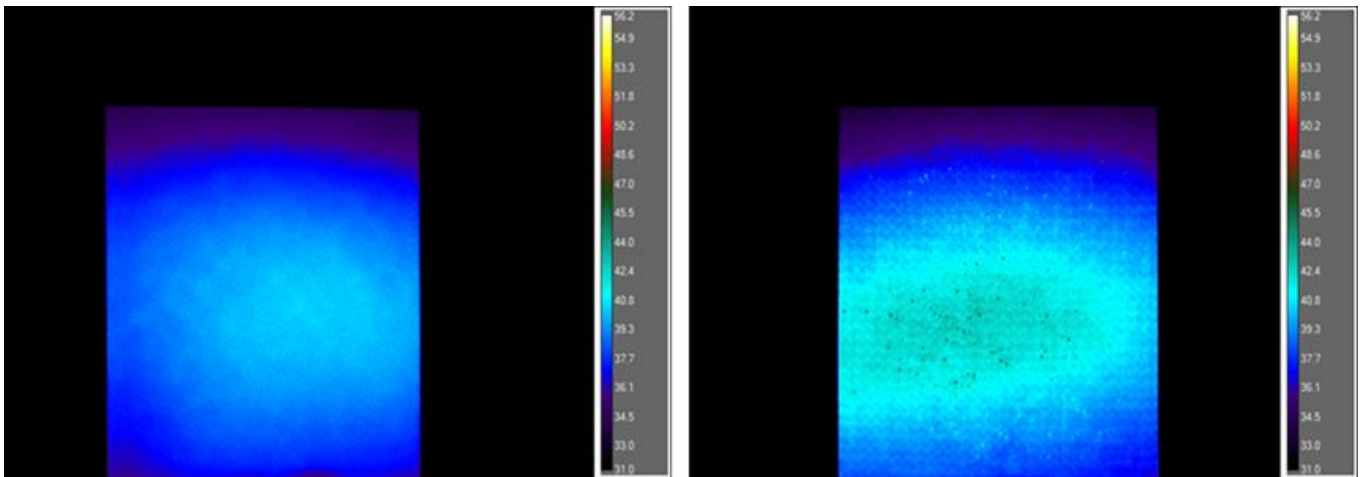
**Figure 12.** IR thermography of RTM6 (left) and 3R (right) laminates.

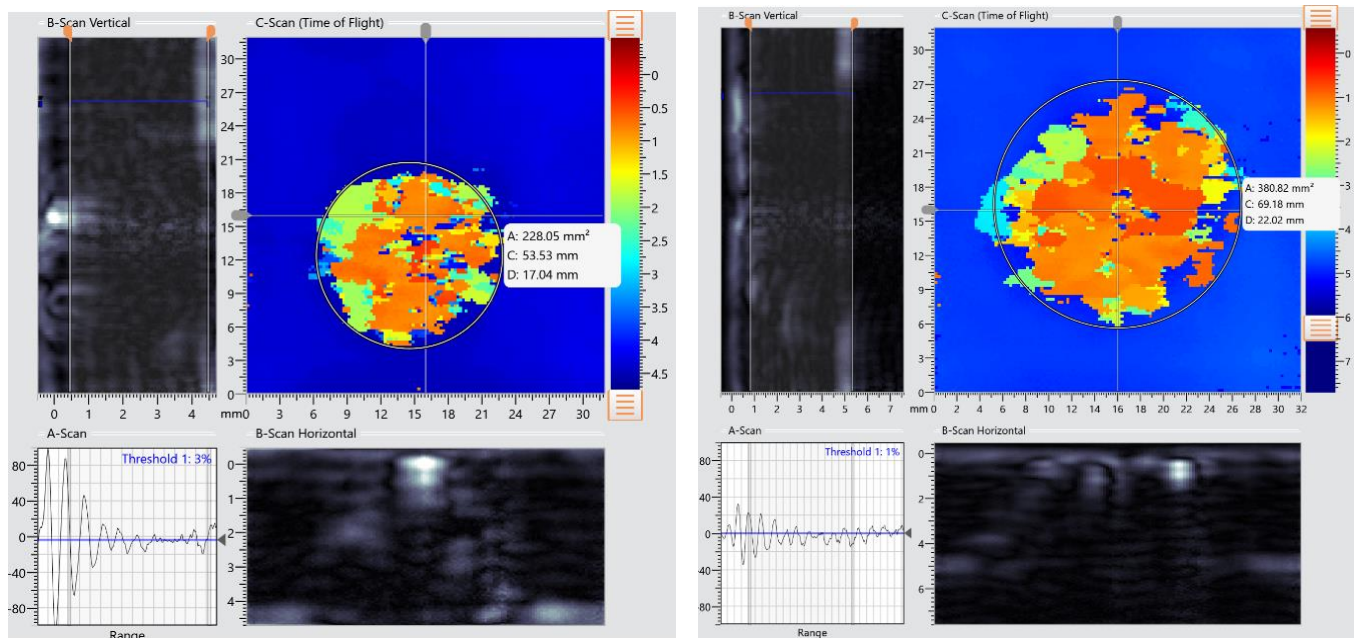
**Figure 13.** A-scan, B-scans, and C-scan of RTM6 laminate after 9 J (left) and 15 J (right) low-velocity impact (A is the area, C is the circle length and D is the diameter of the circle).

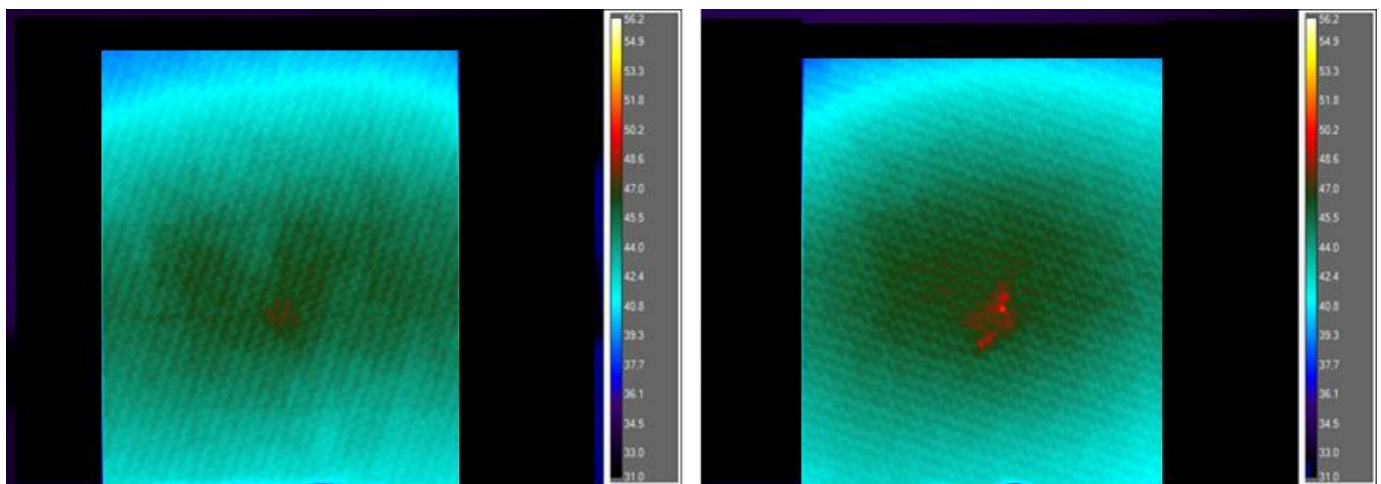
**Figure 15.** IR thermography of damaged RTM6 laminates at 9 J (left) and 15 J (right).

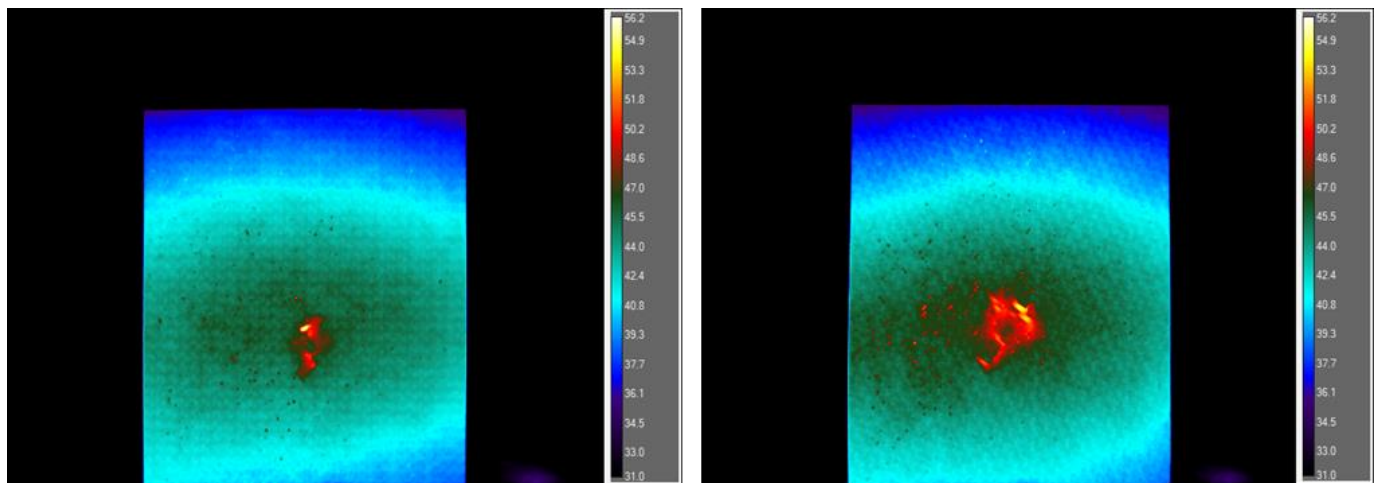
**Figure 16.** IR thermography of damaged initial 3R laminates at 9 J (left) and 15 J (right).

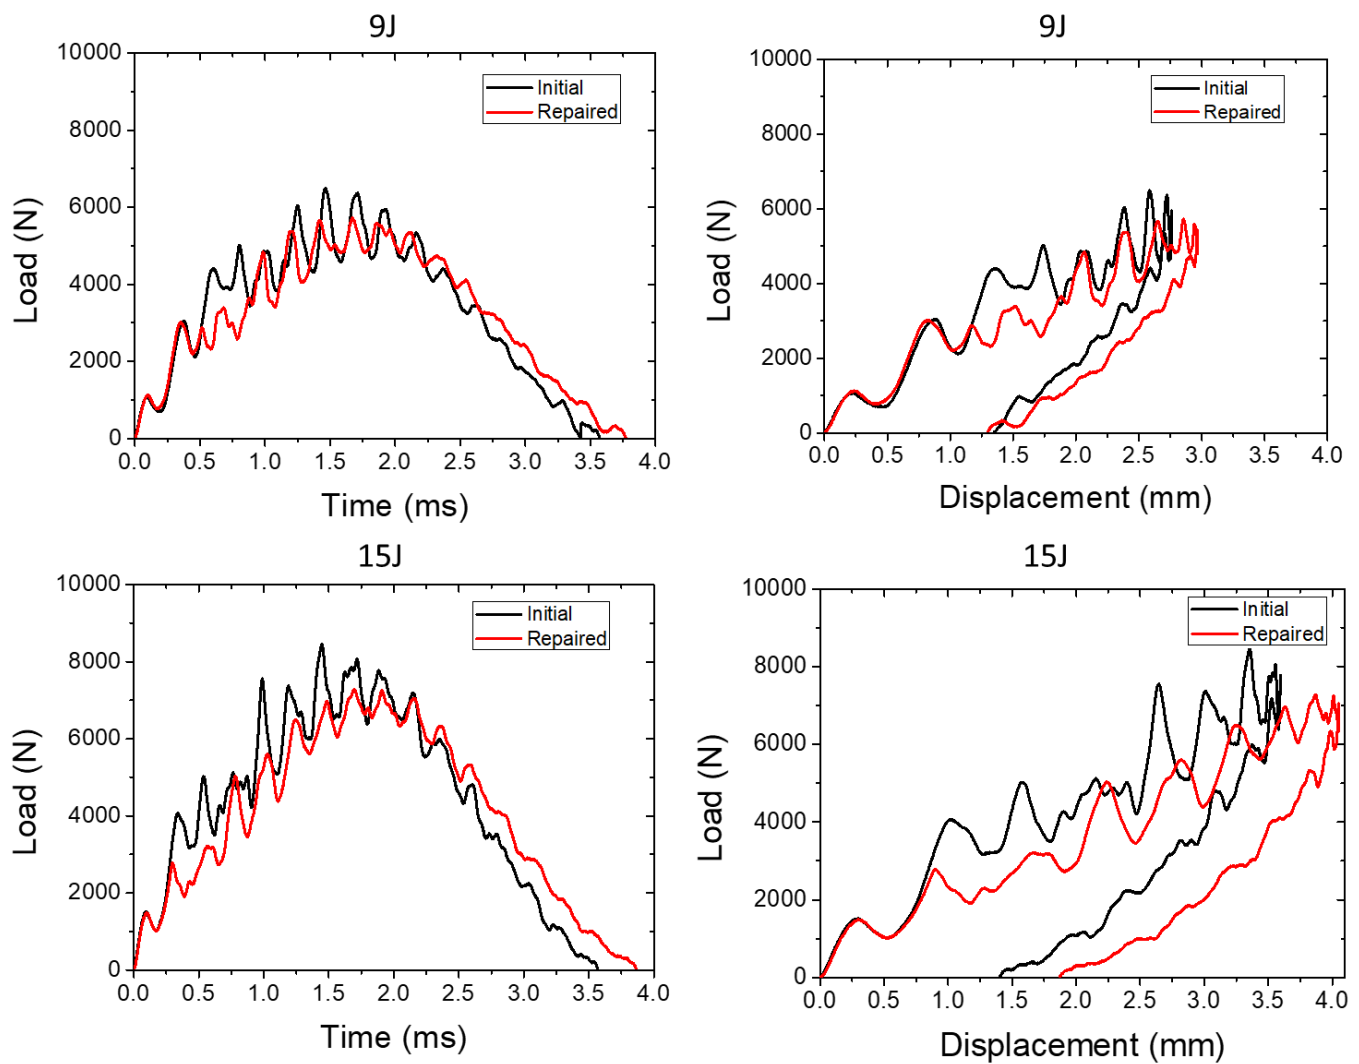
Figure 17. Representative load/time and load/displacement plots of impacts at 9 and 15 J of initial and repaired specimens.

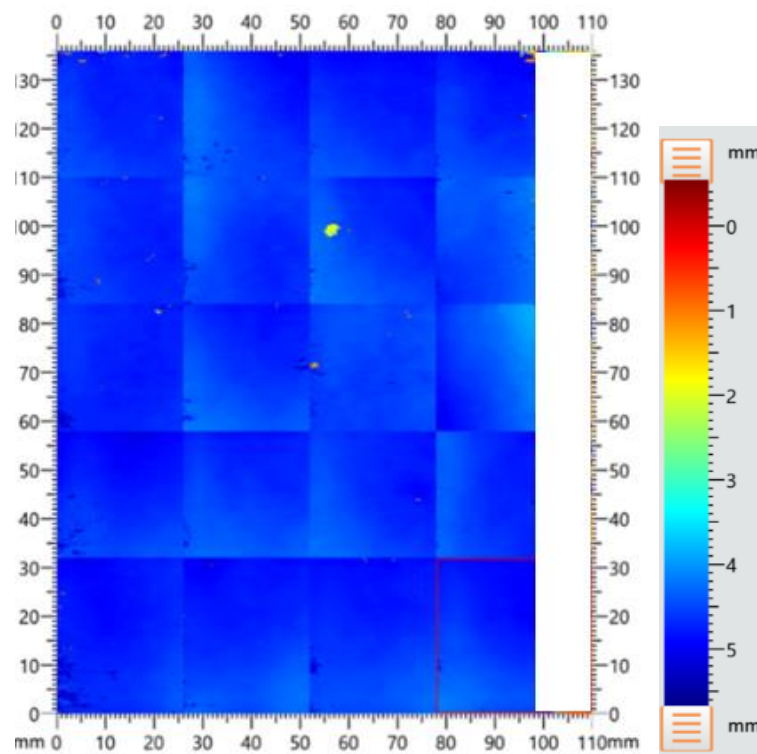
Figure 18. Repaired 3R laminate: C-scan of a representative specimen.

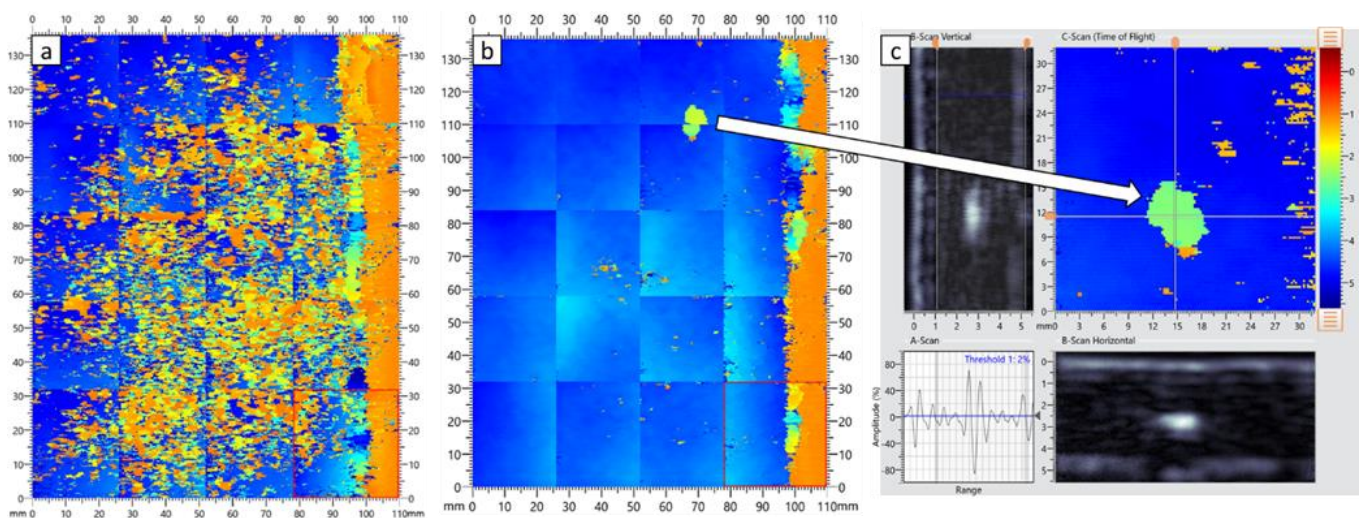
Figure 19. 3R laminate (a) initial, (b) repaired, and (c) a-scan, b-scan, and c-scan of defects.

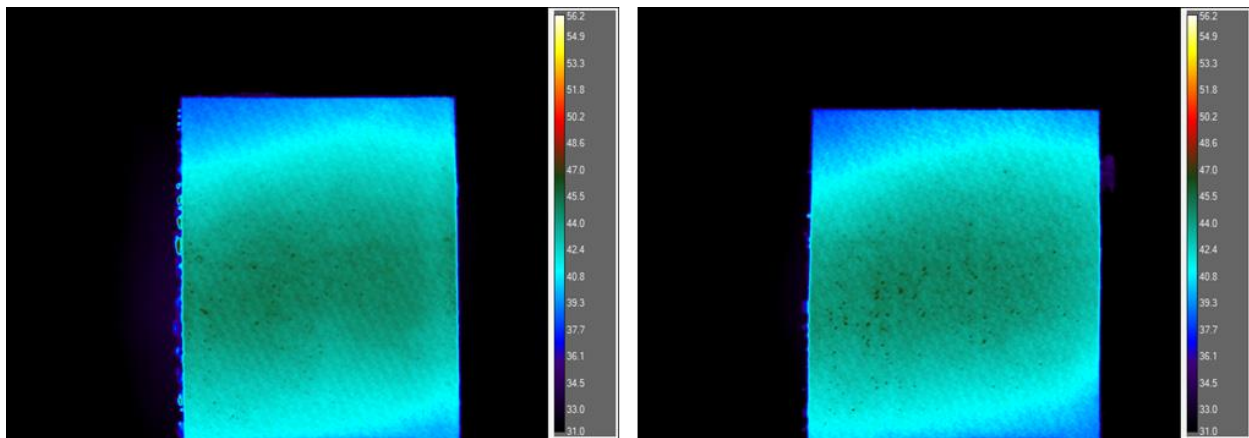
Figure 20. IR thermography pictures of the repaired 3R laminates after impact at 9 J (left) and 15 J (right).

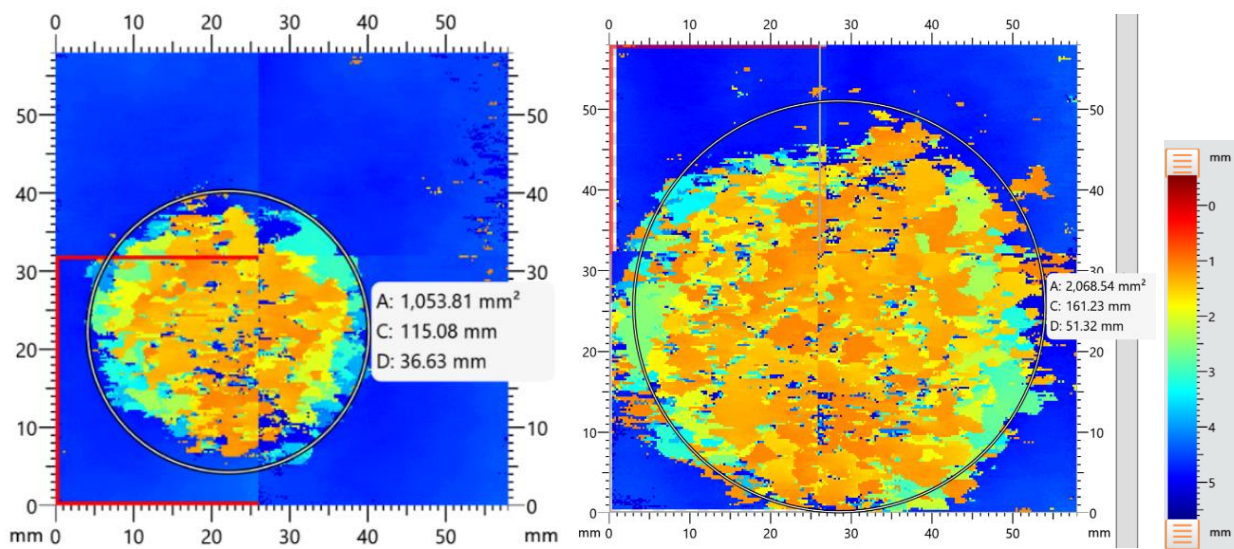
Figure 21. C-scan of repaired 3R laminate after 9 J (left) and 15 J (right) low-velocity impact (A is the area, C is the circle length and D is the diameter of the circle).

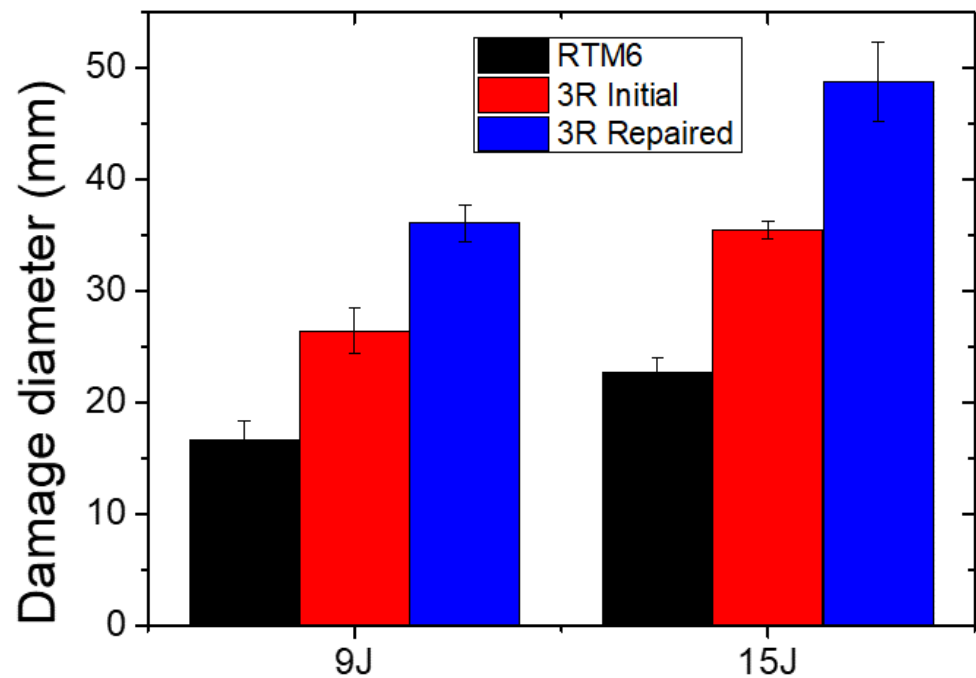
Figure 22. Damage diameter comparison.

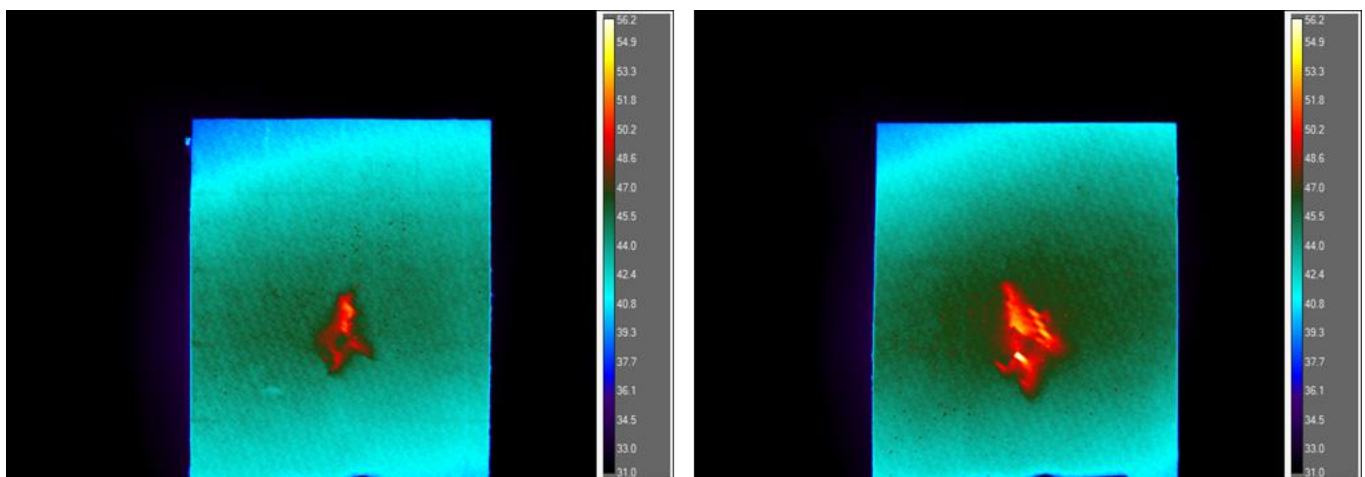
Figure 23. IR Thermography of damage on repaired 3R laminates at 9 J (left) and 15 J (right).

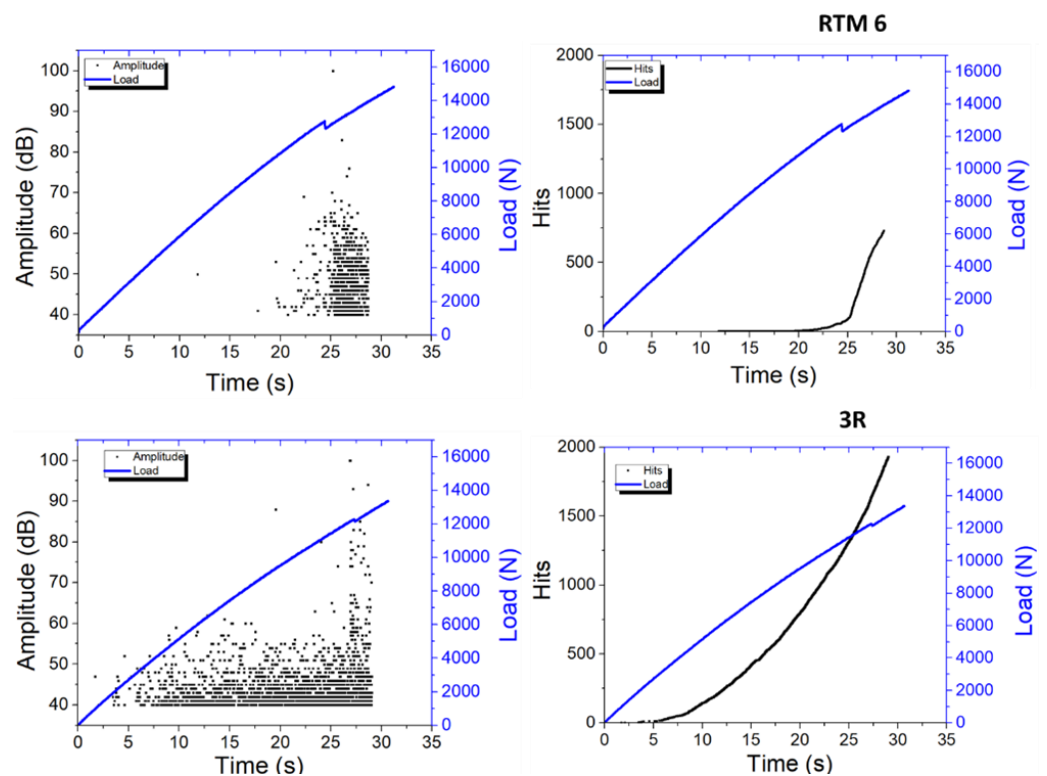
**Figure 25.** Representative plots of amplitude (left) and AE hits (right) on RTM6 (top) and 3R (bottom) lap strap specimens.

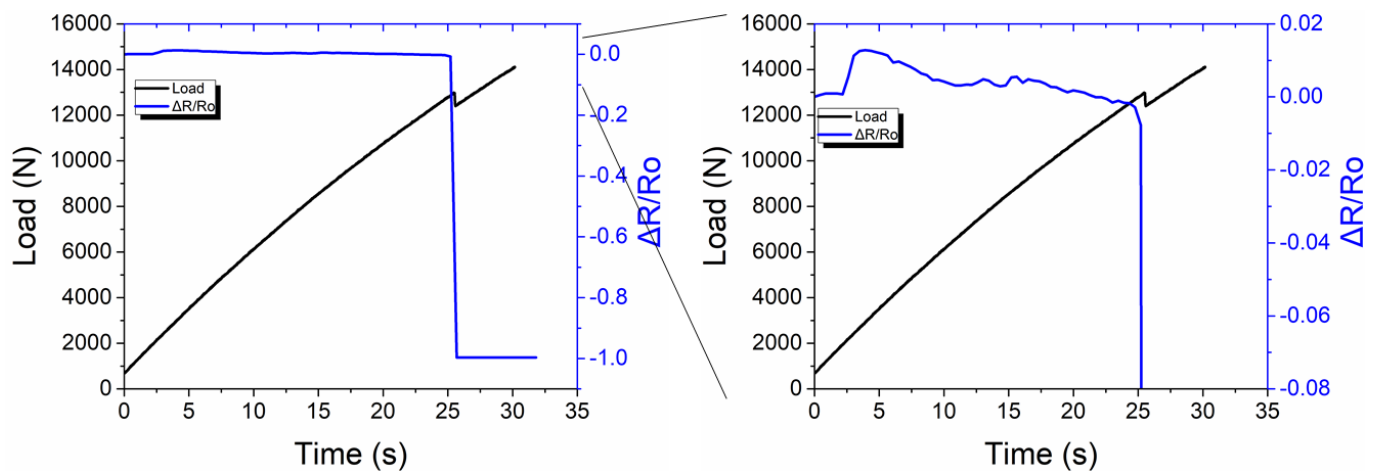
**Figure 26.** Representative lap strap test of RTM6 composite and ERCM monitoring (left) and zoom in the resistance before failure (right).

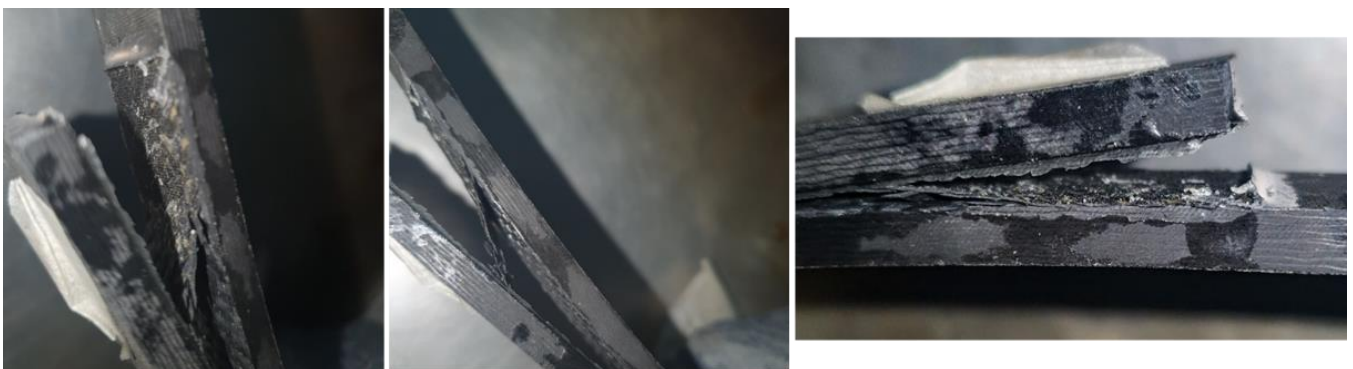
**Figure 27.** Images from fractured surfaces of RTM6 lap strap specimen.

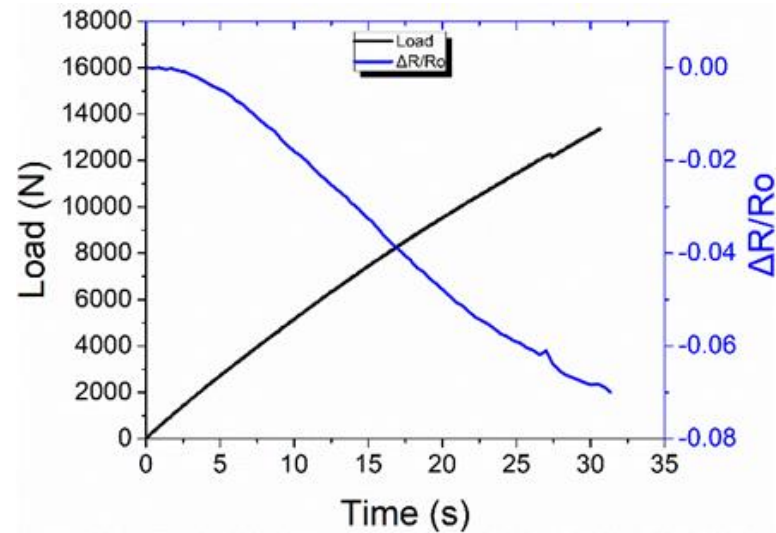
**Figure 28.** Representative lap strap test of the 3R composite with ERCM monitoring.

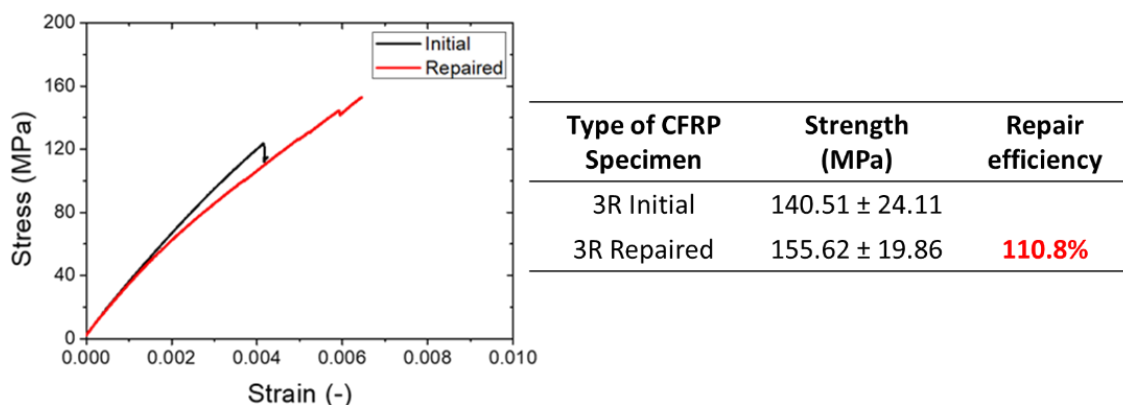
Figure 29. Representative stress–strain plots (left) and repair efficiency values (right) of lap strap specimens.

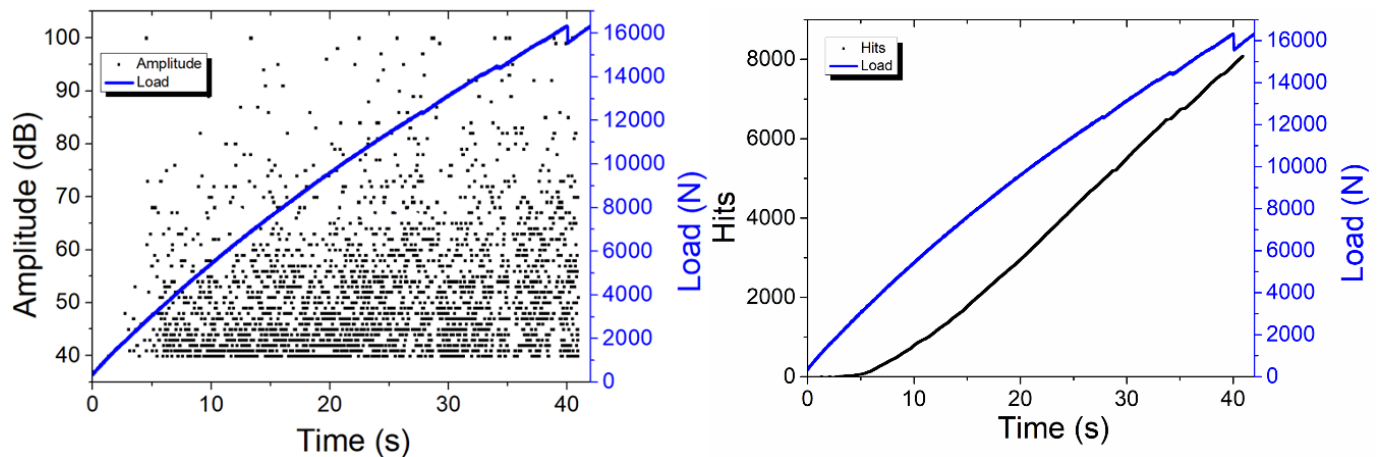
Figure 30. Representative plots of amplitude (left) and AE hits (right) of repaired lap strap specimens.

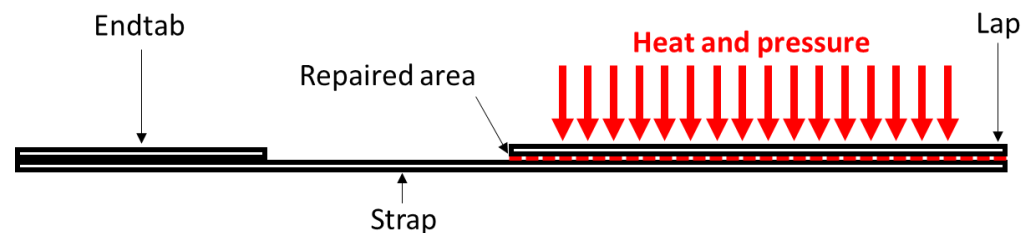
Figure 31. Schematic of lap strap repair.

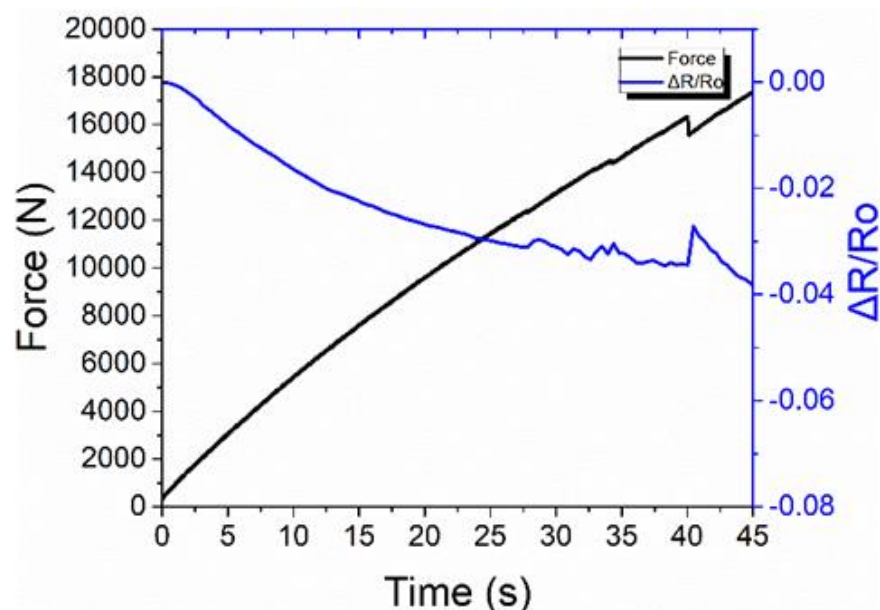
Figure 32. Representative lap strap test of the repaired 3R composite with ERCM monitoring.
