Gradual Failure of a Rainfall-Induced Creep-Type Landslide and an Application of Improved Integrated Monitoring System: A Case Study

Jun Guo ^{1,*}, Fanxing Meng ² and Jingwei Guo ¹¹ Hunan Institute of Geophysics and Geochemistry, Changsha 410014, China² Hunan Institute of Nuclear Geological Survey, Changsha 410011, China; qinyu_dzy@163.com

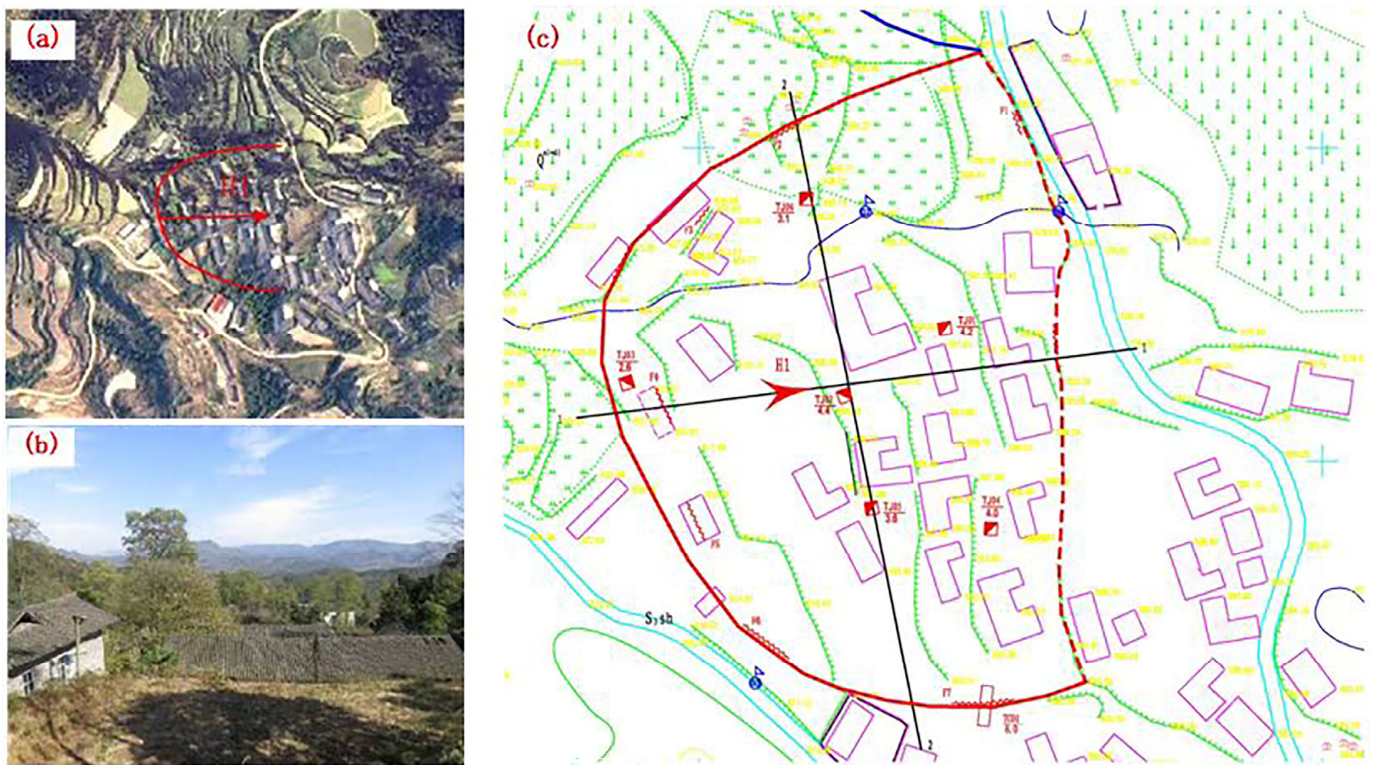
Figure 1. Distribution of landslide and the threatened area: (a) remote sensing image, (b) threatened building, (c) topographic of the landslide area.

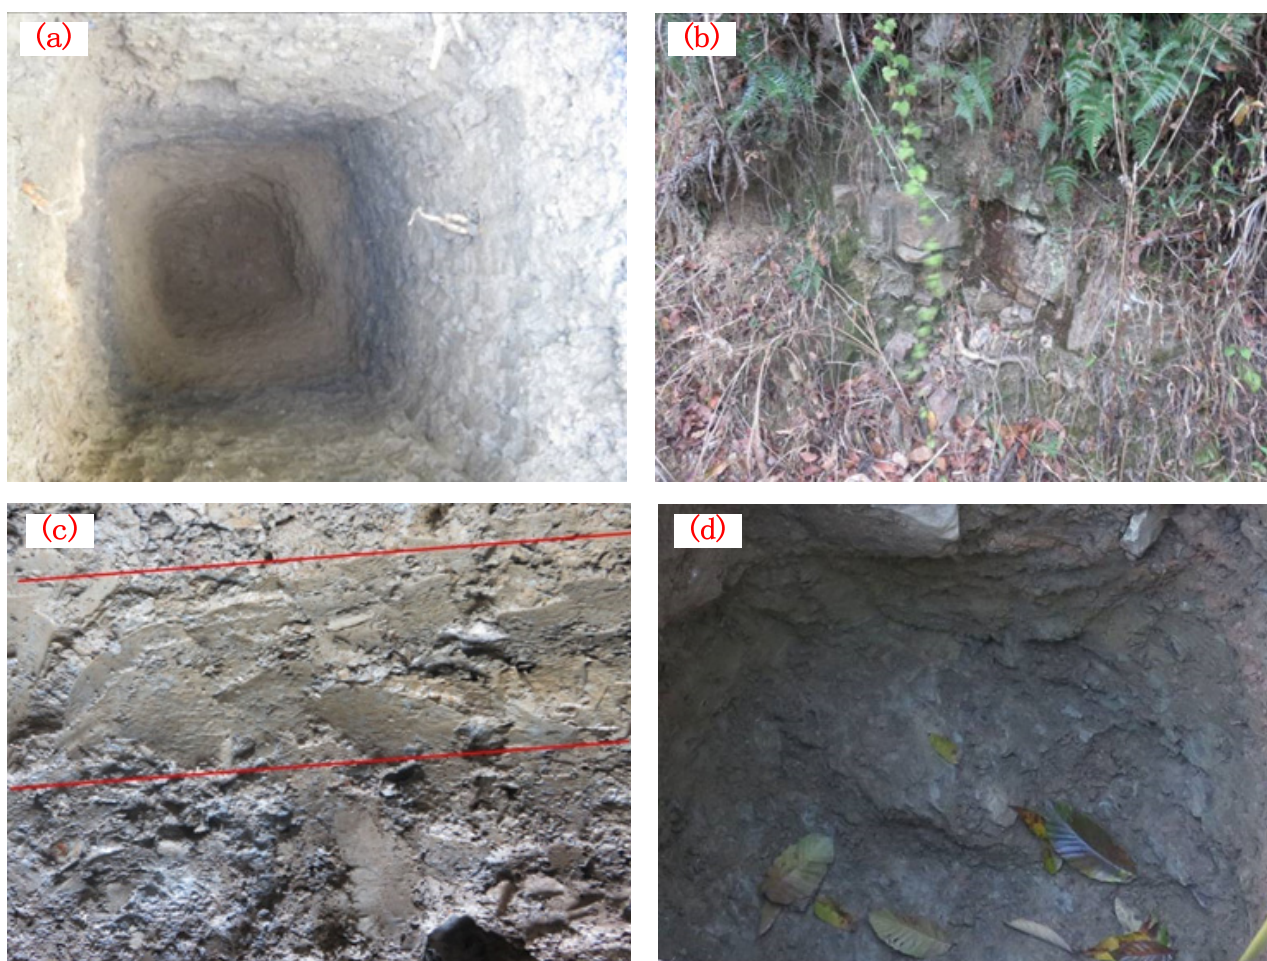
According to the on-site survey results as shown in Figure 2, the predominant geological strata in the affected area consist of Quaternary residual slope deposits (Q), as depicted in Figure 2b, which include fine-grained clay and gravelly soil. Additionally, there are Silurian upper Shamao Group (S3sh, Figure 2c) formations characterized by gray-green, gray-white, and purple-red mudstone, sandy shale, and quartz sandstone. The Silurian middle Luoreping Group (S2Lr, Figure 2d) is also presented as siltstone and sandstone. The geomorphological type of the landslide area falls under the category of low mountain fold-valley terrain, with an overall west-high and east-low topography (Figure 2). The composition of the landslide's soil includes gravelly clay and soil forming a single-layer structure with relatively loose characteristics. The rock formations in the area range from weak to moderately hard and vary in thickness including laminated clastic rocks such as shale, slab-like shale, sandy shale, and mudstone. The rocks exhibit a strongly weathered condition, and there is extensive development of joint fractures within the rock layers, resulting in considerable fragmentation. Consequently, the rock strata exhibit relatively low resistance to deformation.

Figure 2. (a) Exploratory pit, (b) Quaternary residual layer, (c) the Upper Silurian Gauze Hat Group, (d) the Middle Silurian Luojiaping Group.

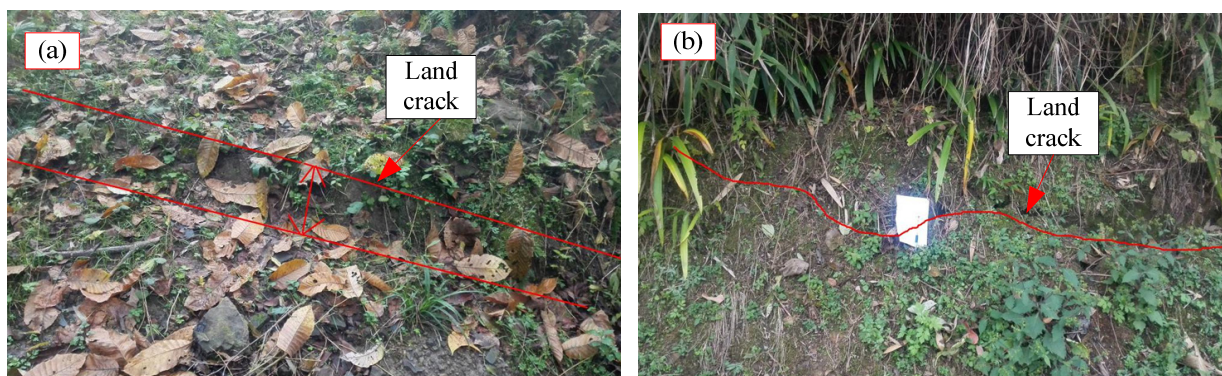
As shown in Figures 3–6, numerous cracks of varying sizes are now visible in the site located at the rear of the landslide. These cracks typically measure between 1 and 5 cm in width and 3 and 10 m in length. Among them, the most severe crack spans about 5 m in length and 0.5 m in width, causing noticeable leaning in the central part of the housing affected by the landslide. Additionally, tensile cracks emerged at the rear and sides of the landslide, ranging from 5 to 20 m in length, 0.1 to 0.2 m in width, and with displacement distances ranging from 0.1 to 0.3 m. At the front, shear cracks have become apparent, leading to the bulging and collapse of several dry-stone walls. These cracks are distributed around the landslide and form the sliding range on the surface after coalescence. At the top of the landslide, tensile cracks are the main type (Figure 3), while tensile shear cracks are more common on both sides of the landslide body (Figure 4). At the front edge of the landslide body, soil swelling cracks are the main type (Figure 6). And obvious inclination could be seen in the buildings on the landslide (Figure 5). All these phenomena indicate that the landslide was in a sliding stage. When cracks rapidly expand, it indicates that the landslide is accelerating its sliding.

Figure 3. Cracks induced by landslide: (a) Cracks in rear edge of landslide, (b) Cracks in front edge of landslide.

Based on investigations and field surveys, the primary deformation characteristics of the landslide mass manifest as cracks at the rear (Figure 3), sides (Figure 4), and bulging (Figure 6) at the front edge. The mechanism behind this formation primarily includes several factors: unstable slopes formed due to human-induced slope cutting at the front, the loading of residential houses at the rear and on the landslide mass, saturation of the soil due to rainfall and water infiltration, and increased weight of the landslide mass resulting in decreased shear strength, leading to gradual creeping towards the free edge under its own weight. This process exerts pressure on the soil at the front edge, causing it to press against the dry-stone retaining walls and resulting in their bulging. Additionally, the soil at the rear edge of the landslide mass, under the influence of gravity and artificial structures, pushes against the soil at the front edge, resulting in tension cracks at the rear and partial cracking at the front, thereby forming potential geological hazard points.

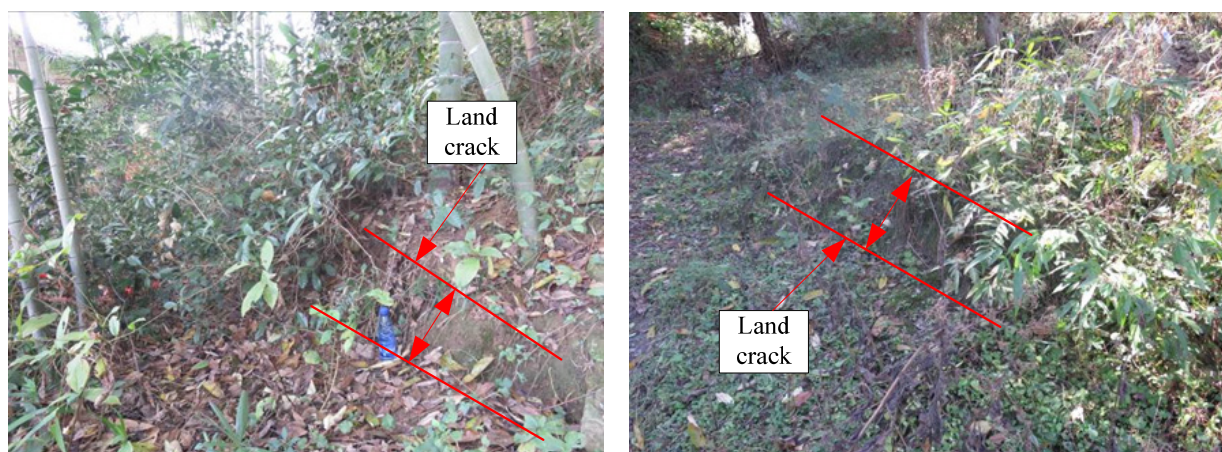
Figure 4. Cracks in side edge of landslide.

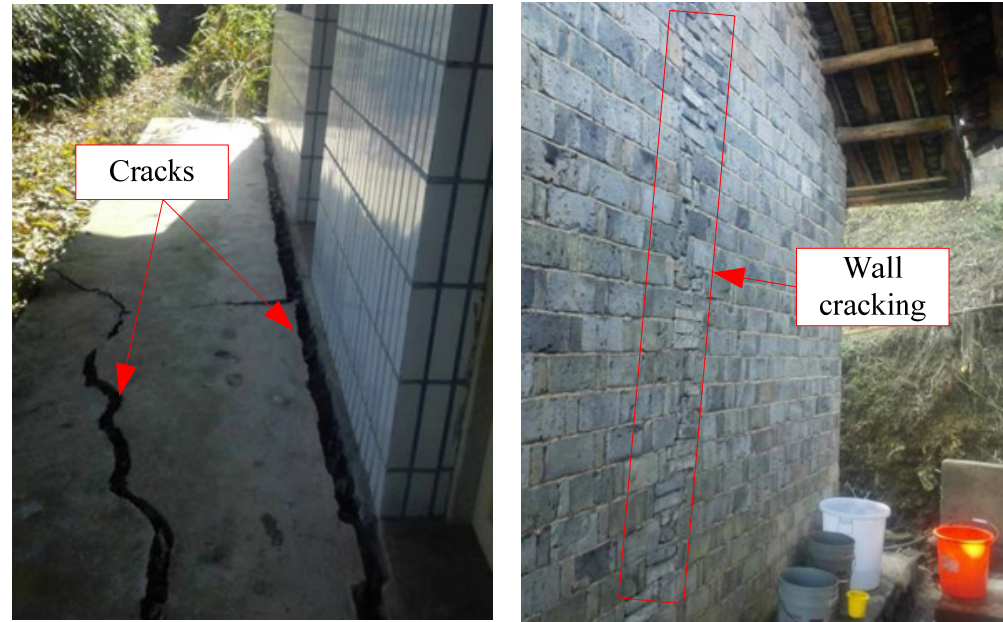
Figure 5. Cracks on wall and ground.

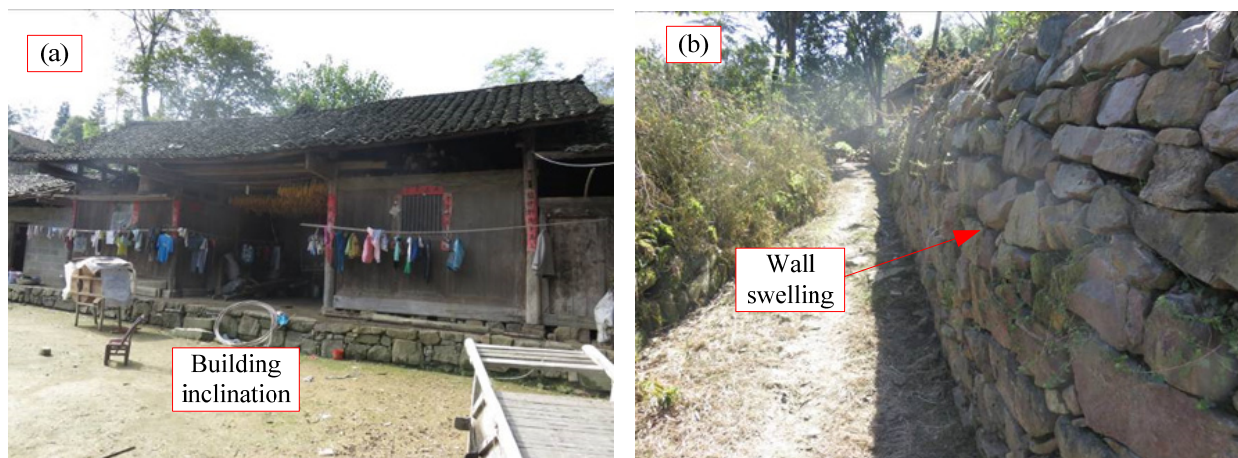
Figure 6. Phenomenon in front of landslide, (a) Building inclination, (b) Wall swelling.

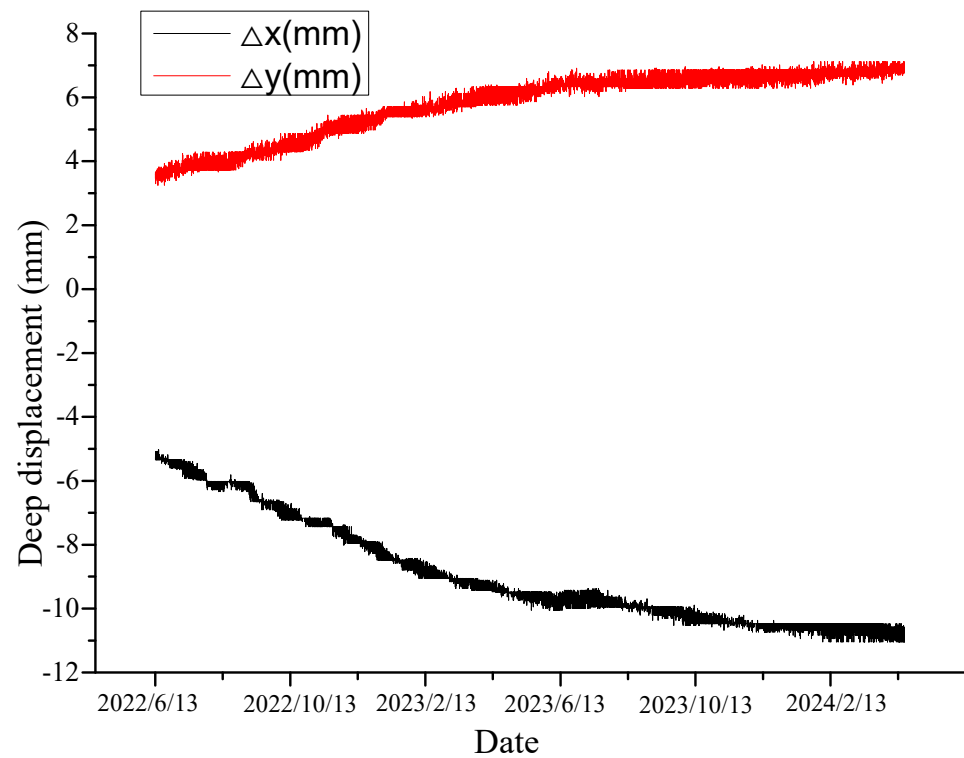
Figure 9. Deep displacement.

As shown in Figure 9, illustrating the deep-seated displacement–time curve, and Figure 10, showing the surface displacement curve, both the surface and deep-seated displacements of the rock–soil mass have continuously increased over time following the disturbance caused by excavation, gradually stabilizing afterward. This suggests that the deformation of the deep-seated rock–soil mass was effectively controlled following the completion of the supporting structure. At this juncture, all reinforcement facilities of the slope amalgamated into an organic whole, successfully regulating the displacement

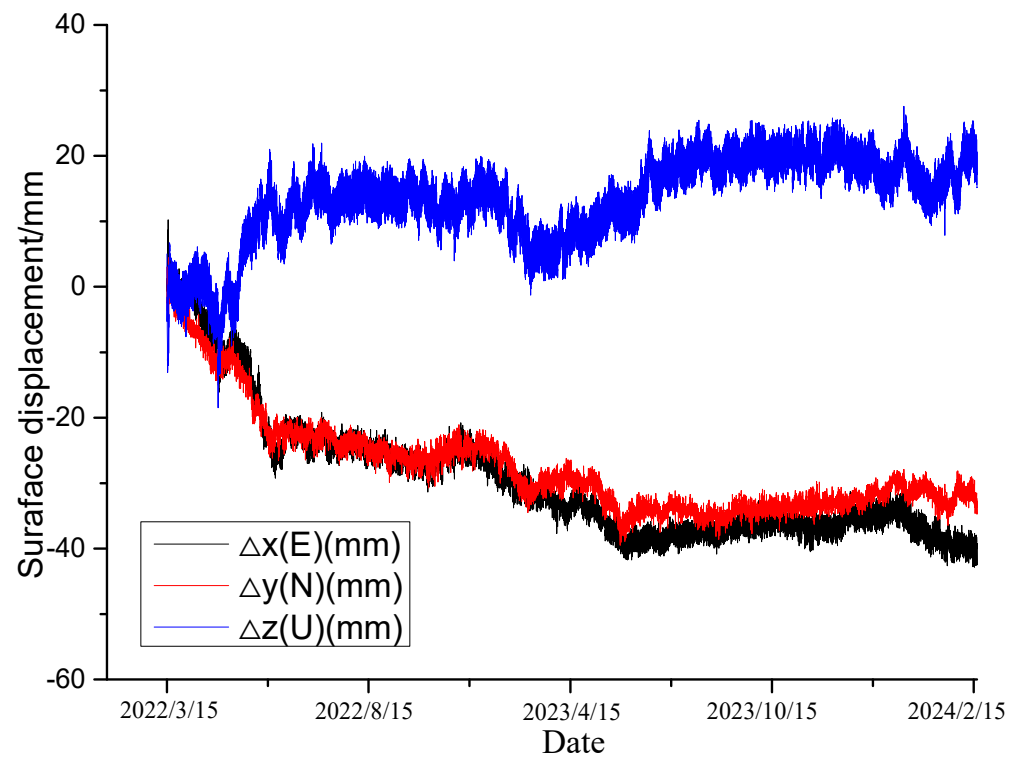
Figure 10. Surface displacement.

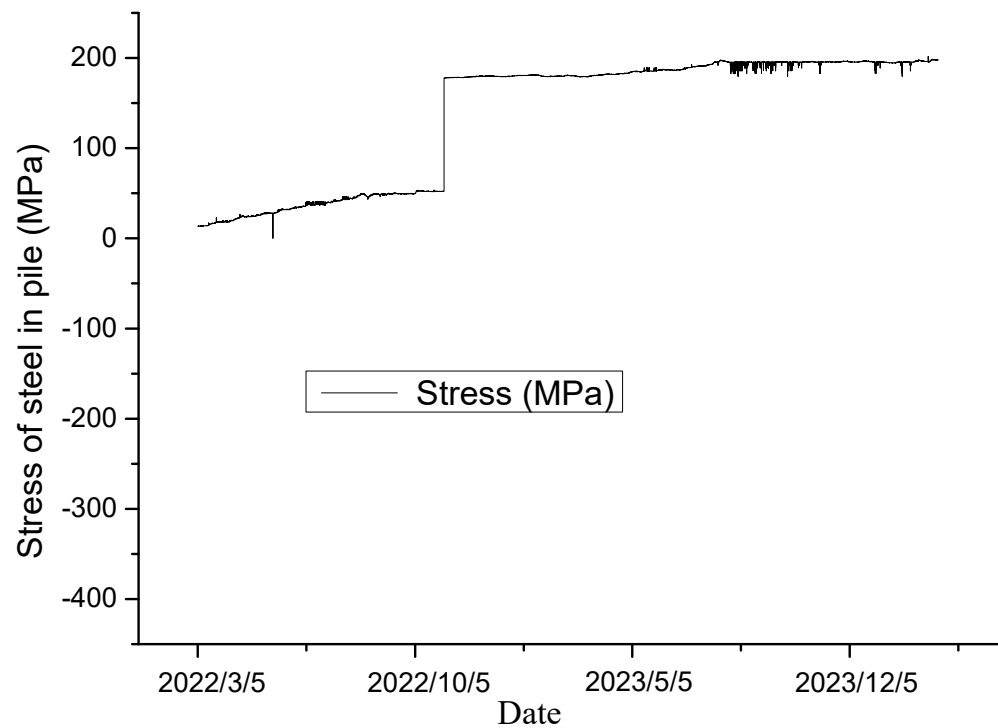
Figure 11. Stress of steel in pile.

rate of the slope. The change pattern of the monitoring system data can accurately reflect the real-time working status of each reinforcement facility. The monitoring results of the stress monitoring (Figure 11) indicate that it began to exert the most significant effect after the completion of the anti-sliding pile. A considerable change in stress was observed in early November 2023, followed by gradual stabilization. This suggests a reduction in slope deformation under the support of the anti-sliding piles and approaching a stable state.

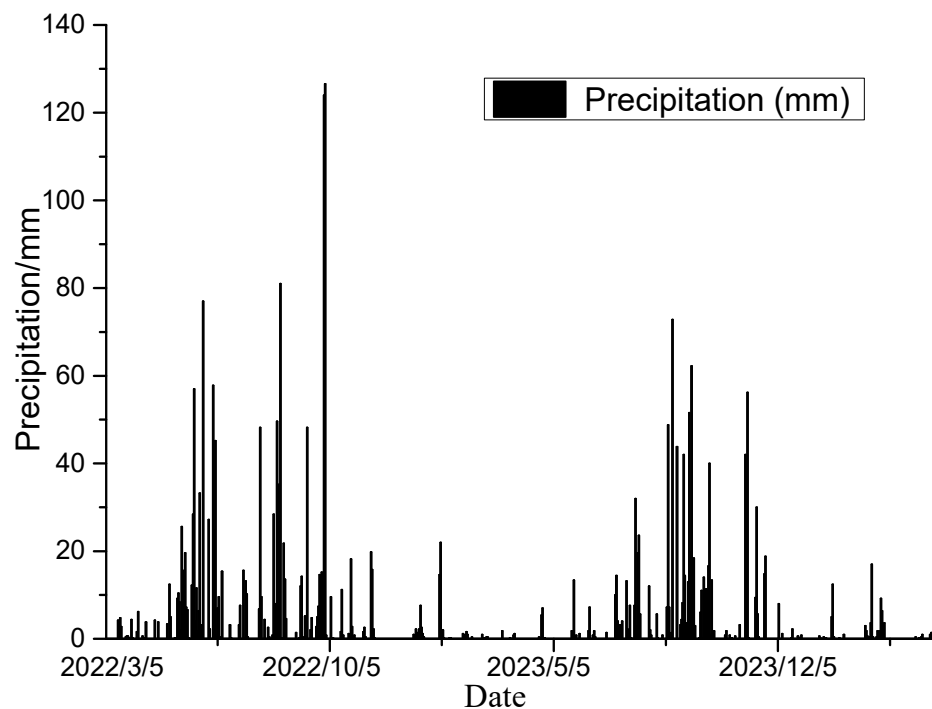
Figure 12. Monitored precipitation.

The rainfall monitoring results depicted in Figure 12 automatically trigger warning messages when the rainfall exceeds the predefined threshold value within a short period. The threshold values for daily rainfall are set as follows: 55 mm for a blue alert, 60 mm for a yellow alert, 80 mm for an orange alert, and 100 mm for a red alert. Since its establishment, the system has issued warnings 13 times, each corresponding to rainfall exceeding 55 mm. Following the issuance of the warning, the system automatically provides recommendations for on-site observation of the slope status, along with continuous warning alerts. On-site observations reveal that the slope boasts a well-functioning drainage system. Although rainfall does have some influence on surface displacement, it has not reached a level that threatens the overall stability of the slope.
