Article

Design and Construction of a New Metering Hot Box for the In Situ Hygrothermal Measurement in Dynamic Conditions of Historic Masonries

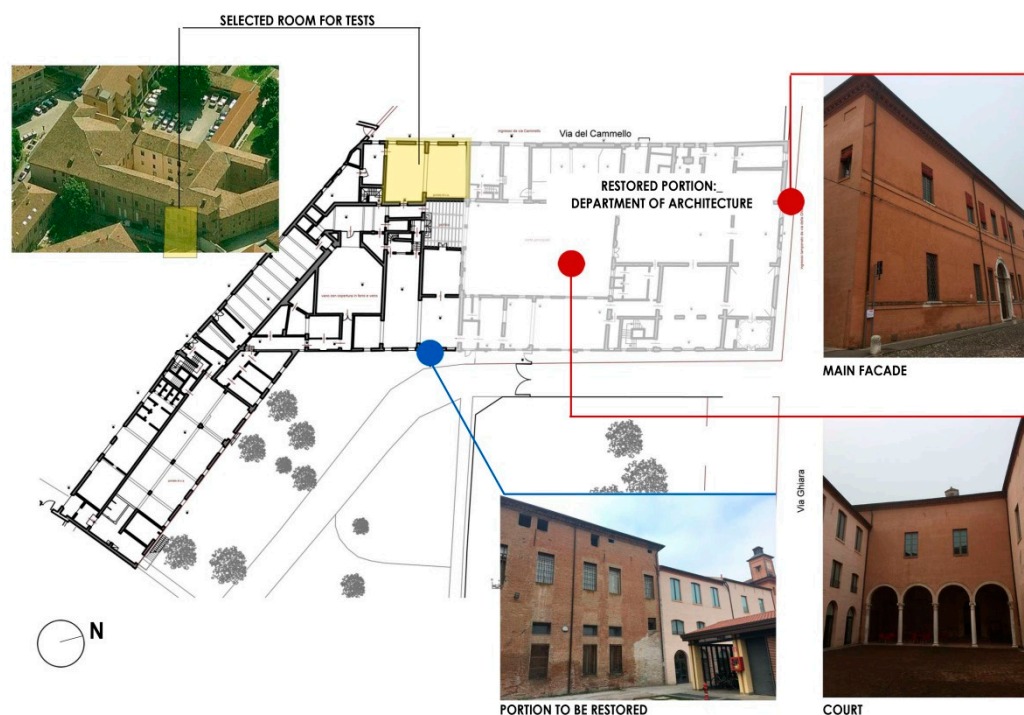
Figure 1. Ground floor plan of Palazzo Tassoni and location of the room where the experiment is carried out. External views of the surrounding buildings.

The room (700 m³) and the wall under-study are part of this complex and are located on the ground floor of an area that has not been refurbished yet, currently unoccupied and without any HVAC system (Figures 1 and 2).

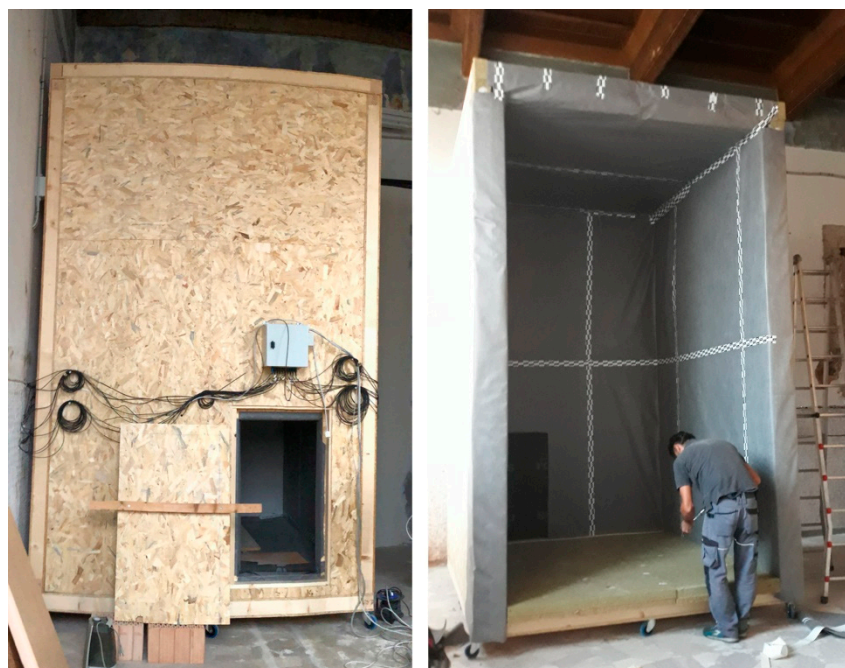
One of the main objectives of the HeLLo project, besides the general scientific final goal to make actors of buildings sector aware of strengths and weaknesses of the most common energy retrofit technical solutions when applied to historic buildings [32], was the development of a very wide and structured program of dissemination. The idea was to open the door of the laboratory to other different stakeholders and involve them in the project activities. Among this open Labs program, in the one called SchoolLab activity, in a unique didactical approach, students of the 2nd year of the Degree of Architecture were involved in the activity of the box constructing—Figure A1 in Appendix A unveils some of the steps of the box construction. During this phase, only the ‘outer-shell’ was executed (the platform frame structure), being later internally coated with 10 cm high-density stone wool, covered by a vapor barrier, Figure 5.

Figure 5. Box finishing: Thermal insulation and vapor barrier application.

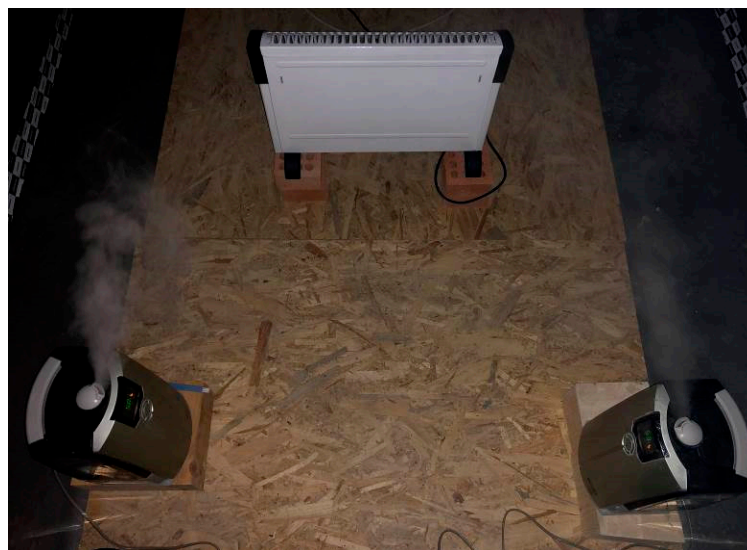
The metering box was provided with a 2000 W heating convector (with 3 power levels), locally controlled by its own sensor (PID, as described below) and 2 ultrasonic humidifiers, (argo HYDRO digit), 30W/each, self-regulated, which guaranteed indoor air parameters at the desired setup conditions ($T \approx 20\text{ }^{\circ}\text{C}$, $\text{RH} \approx 55\%$), Figure 6.

Figure 6. Box indoor hygrothermal control equipment.

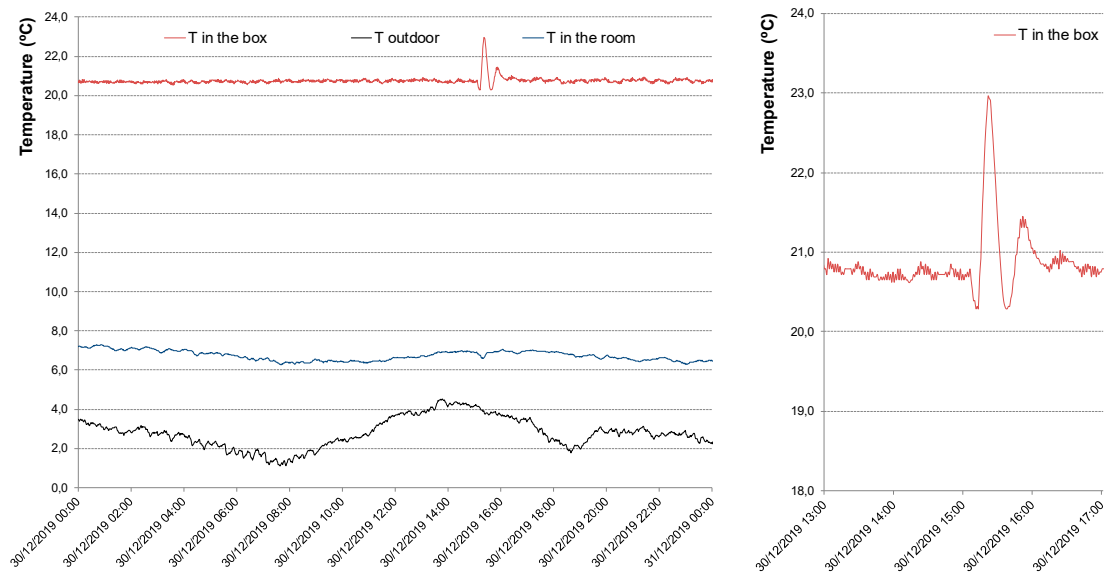
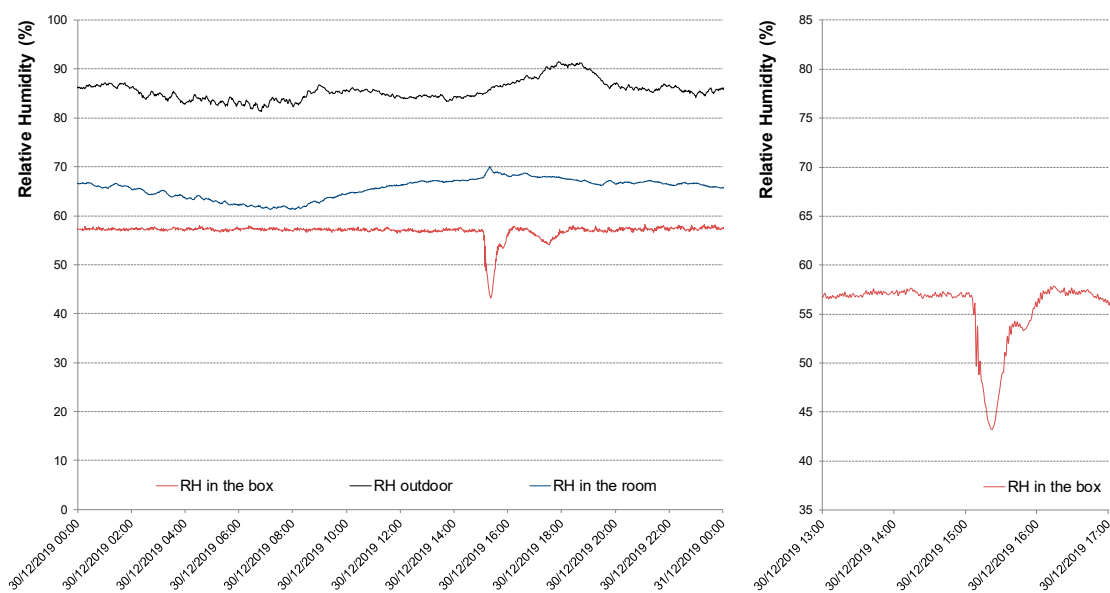
Figure 10. Graphical representation of the monitored parameters [T (°C) and RH (%)] values on 30 December 2019.

As declared, the door of the box was opened twice during this period, on the 30 December 2019 and 6 January 2020, i.e., the experiment might need to be controlled on-site up to once a week. Nonetheless, this action interferes with almost nothing with the continuity and stability of the indoor conditions. Looking at the most noticeable peak, registered on the 30th December, Figure 10, from the moment the door was opened, the indoor temperature suffered a maximum variation of 2.7 °C. Likewise, $RH \Delta_{max} = 15\%$.
