Analysis of the Thermal Retrofitting Potential of the External Walls of Podhale's Historical Timber Buildings in the Aspect of the Non-Deterioration of Their Technical Condition

Abstract: The paper discusses thermal quality improvement in historic buildings. It is based on a case study of a wooden historical building in an architectural style typical of Zakopane, located in the Podhale region of Poland. The building's historical value and timber structure prevent the application of typical thermal retrofitting solutions. This paper presents an analysis of the possibilities of the improvement of energy performance of a historic building (villa) which included: a review of the available energy performance improvement solutions applicable to this type of building, with a particular focus on applying internal insulation; a technical condition assessment using non-invasive methods, the identification of problematic areas in terms of the thermal retrofitting of buildings with timber walls and decks; in situ tests: thermovision tests which showed the places with temperature distribution field disturbances in the building's envelope, focusing on thermal bridges; measurements of actual the

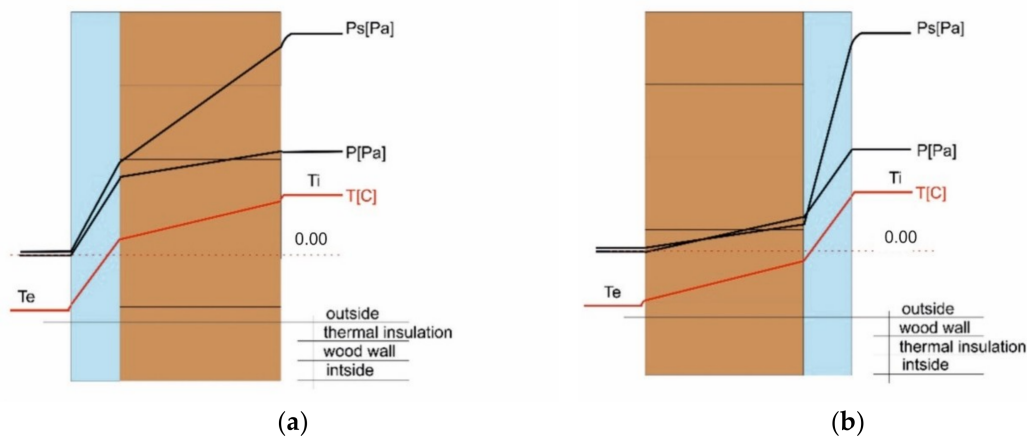
Figure 1. Temperature and vapour pressure charts, calculated as per PN-EN ISO 13788: 2013-05 [26] for applying thermal insulation to an external wall (no condensation) from inside (a) and outside (b) (problems with inter-layer condensation). $P_{s,i}$ —saturated vapour pressure, P —actual vapour pressure, T_i —indoor temperature, T_e —outdoor temperature.

Figure 1 shall present sample actual and saturated vapour pressure charts for the extant state of the building and vapour pressure for standard external thermal insulation (Figure 1a), and internal thermal insulation (Figure 1b). In the first case, there is no inter-layer condensation, while in the

second, this problem can occur when materials are poorly paired. Both charts were prepared as an initial estimate, intended to analyse momentary inter-layer vapour condensation within a building partition as per PN-EN ISO 13788: 2013-05 [26]. In the authors' opinion, this analysis does not provide a sufficient basis for design-stage action in the case of historic buildings that are to have internal insulation applied.

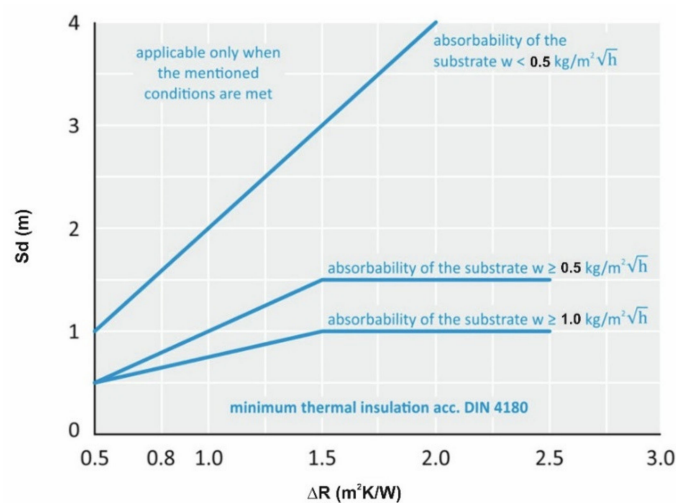
Figure 2. Minimal requirements for the thermal insulation layer depending on the thermal resistance of the insulation for bases displaying different capillary activity [33].

These solutions lead to a cooling of the wall's structural section and thereby reduce the drying potential for the building's existing structure. Internal thermal insulation reduces a wall's accumulative properties, leading to faster temperature decreases, resulting in a high risk of condensation in the layer between the existing structure and the newly applied insulation. Both effects can lead to greater damp penetration of the wooden layer. The presented procedure allows a simplified (graphical) estimation of a given material solution's correctness in the context of the water absorptivity of the existing partition and its external layer. The first element is determining the impact of rain on the wall's external layer, i.e., determining its water absorptivity expressed as $W_w \text{ kg/m}^2\text{h}^{0.5}$. Provided there is sufficient protection from rain compliant with DIN 4108 (part 3), it is typically sufficient. Otherwise, one should use the diagram below (Figure 2).

If the limit values and boundary conditions for S_d vapour diffusion resistance, the improvement in thermal insulation ΔR , and base capillarity/absorptivity are maintained, the condensate should not precipitate near the boundary layer between the old surface of the wall and the back side of the internal insulation (situations that can be detected using this simplified method are therefore practically devoid of condensation, as water is largely bound within the structural material). However, this means that wall structures in which condensation can occur cannot be analysed using the simplified verification method. Modern numerical methods are required in such cases. The scheme can only be used when:

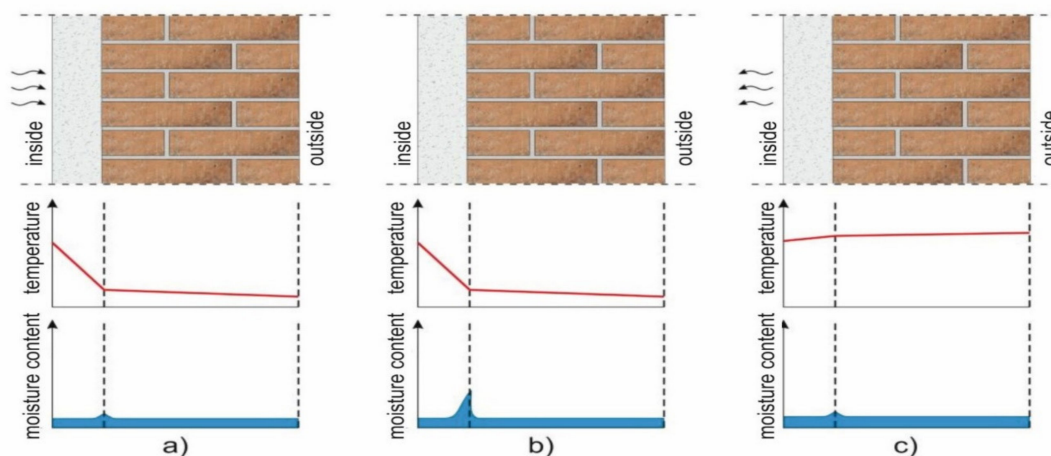
Figure 3. General principle of the functioning of partitions insulated from the inside using aerated concrete panels. (a) Late autumn period, (b) transition from winter to spring, condensation of water vapour inside the partition, (c) spring/summer, the partition becomes dry [35].

The most popular material used for the internal insulation of external walls is comprised of mineral insulation panels. They are made from a very light variant of aerated concrete. Their density is 115 kg/m^3 , which gives them high thermal insulation properties while retaining the major advantages of aerated concrete. The insulation panels are compliant with the ETA-05/0093 European Technical Assessment. It is a material with a high vapour permeability ($\mu = 3.0$). The panels' mechanism of action assumes the possibility of vapour condensation inside the panels during winter and drying during summer. The capacity to absorb vapour by the panels limits the phenomenon of precipitation occurring on the internal surface of the walls and the risk of mould development. The volume density of the panels is $\rho < 115 \text{ kg/m}^3$, while their thermal conductivity coefficient in a dry state is $\lambda = 0.042 \text{ W/(mK)}$, their diffusion resistance is $\mu = 3.0$ [35]. Figure 3 shall present the general principle of the functioning of partitions insulated from inside using aerated concrete panels.

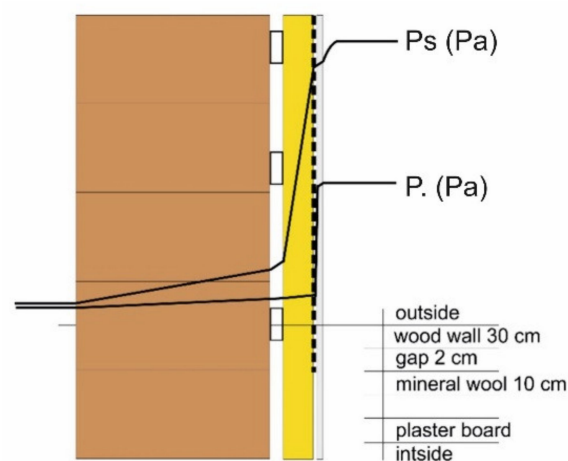
Figure 4. Cross section of a wall with traditional internal thermal insulation and actual vapour pressure charts P and saturated vapour pressure Ps.

Polymer coatings with fillers and enhancing admixtures are also used to insulate partitions from the inside. The coatings include aerogel additions. The insulating components are typically aerogel and glass microgranules. The coatings improve and maintain a higher indoor thermal comfort due to reflecting heat and providing high thermal capacity. The use of this spackle affects wall surface temperature and lowers the amount of condensed vapour, particularly in corners and other places where surface temperature can fall below the dew point. The thickness of a single layer is between 0.8 and 1 mm. The principle of action, as stated by the manufacturer, is based on reflecting the heat stream and improving the thermal insulation properties of the partition. It ensures a V2 class water vapour permeability and is therefore average, while the thermal conductivity coefficient λ is 0.047 W/mK, and diffusion resistance is $S_d = 0.19$ m. The coating creates an anti-condensation layer on the wall surface. It thus protects the surface from excessive water condensation from the air and eliminates the causes of fungus and mould contamination. The lack of damp on the wall surface also increases the durability of the finish and improves the thermal insulation properties of the entire partition [38]. Studies performed by the Engineering and Research Institute of Construction in Prague on two geometrically identical rooms demonstrated that energy consumption for heating during the measuring period (4 days) in kWh while maintaining the same temperatures were 18% lower in the room that had such a coating applied to its internal walls. A beneficial impact on microclimate maintenance was also observed. The speed of heating the room from a temperature of 15 °C to 23 °C was 27% better in the case of rooms with a coating, while the cooling speed from a temperature of 23 °C down to 20 °C after shutting down the heating installation was lower by as much as 85% [38]. The technologies presented above are new. Time and testing are required to determine their impact on the structure of historic buildings. The simplest and traditionally most often used method is applying thermal insulation from the inside using mineral wool, which is separated from the wall by an air gap that allows the condensate to evaporate. Another method of countering water vapour penetration of the partition is the use of vapour barriers applied from the inside (Figure 4).

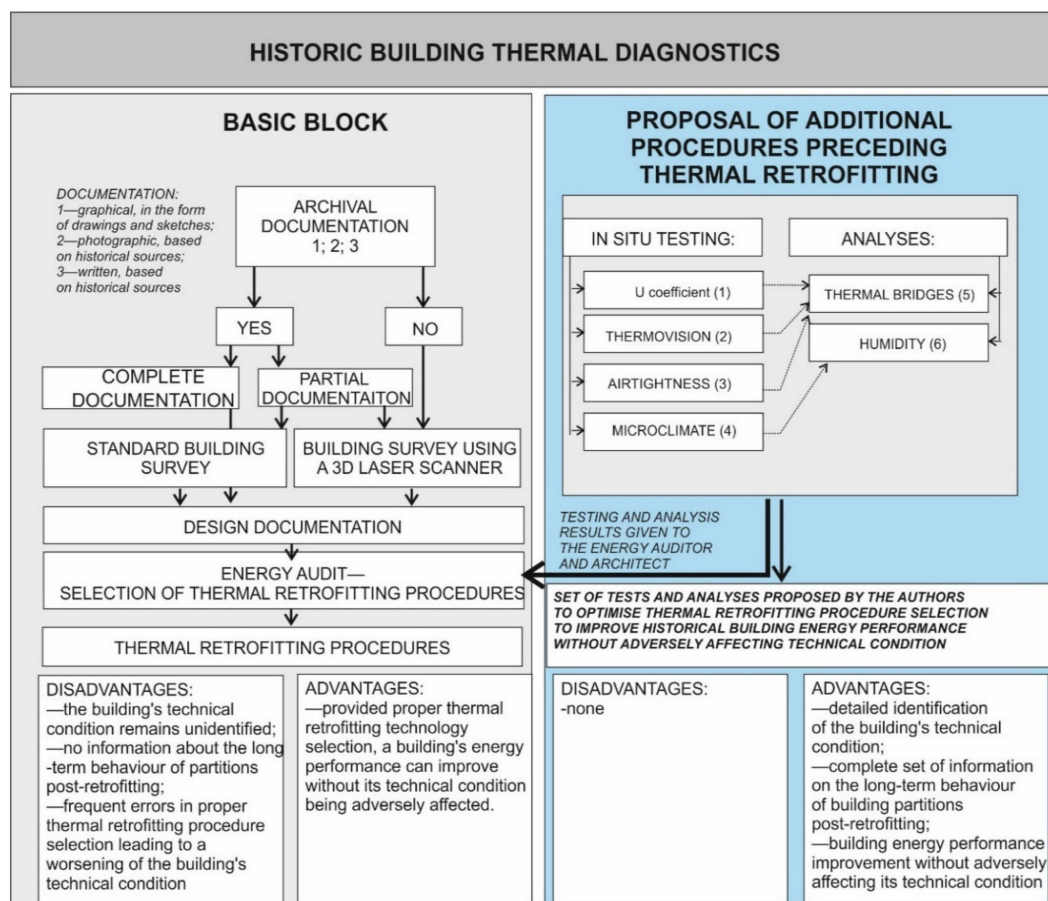
Figure 5. Standard procedure for thermal diagnostics of historic buildings and a new procedure proposed by the authors.

The scheme lists the tests proposed by the authors, which are discussed in greater detail further in the paper:

- identification of the actual U heat transfer coefficient (1);
- thermovision testing to diagnose qualitative defects in structural elements (2);
- airtightness testing to identify air penetration of the building's envelope (3);
- microclimate testing (4).

All the proposed tests should form a basis for in-depth thermal (5) and moisture analyses (6) of historical building envelopes and analyse heat loss through thermal bridges. The findings, based on tests and analyses, which also show the actual condition of the historical building under analysis, shall form a basis for defining the scope of optimal thermal retrofitting procedures that are not to adversely affect the building's technical condition or user comfort. Figure 1 also shows the advantages and disadvantages of the standard approach and the new method proposed by the authors.

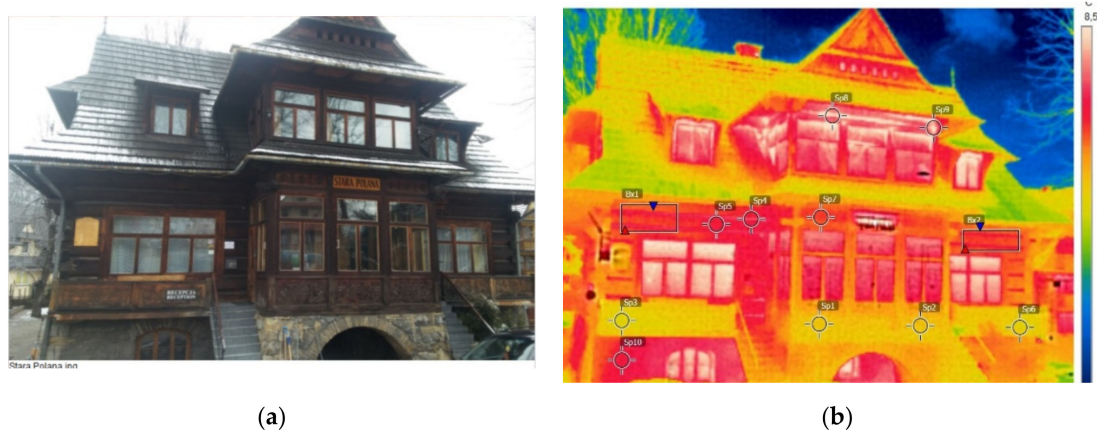
Figure 6. (a) Front facade. (b) General thermovision analysis of the Stara Polana building using a FLIR camera.

Figure 6 shows the front view of the building and its thermal imaging.

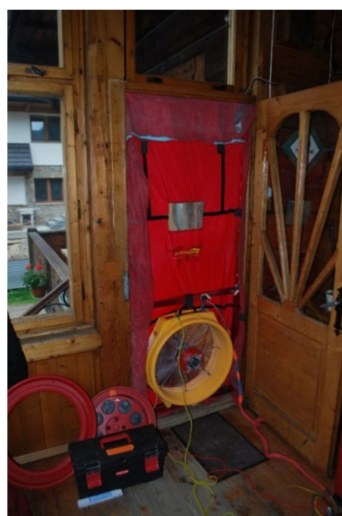
Figure 7. Envelope airtightness test performed on the Stara Polana building. Location of the Blower Door device in the entrance door. Reproduced from [22].

The general analyses performed on the building clearly indicated the need to perform airtightness measurements. The measurements were performed following the methodology outlined in ISO 9972:2015 [49]. The envelope airtightness analysis was performed using a pressure measurement method using the Blower Door device. The test was performed on 18 April 2019 at 13:00, under the following weather conditions: barometric pressure 91.95 kPa, wind strength 3 (weak breeze), external temperature 15 °C, internal temperature 19 °C. Figure 7 shows how to perform the envelope airtightness test.

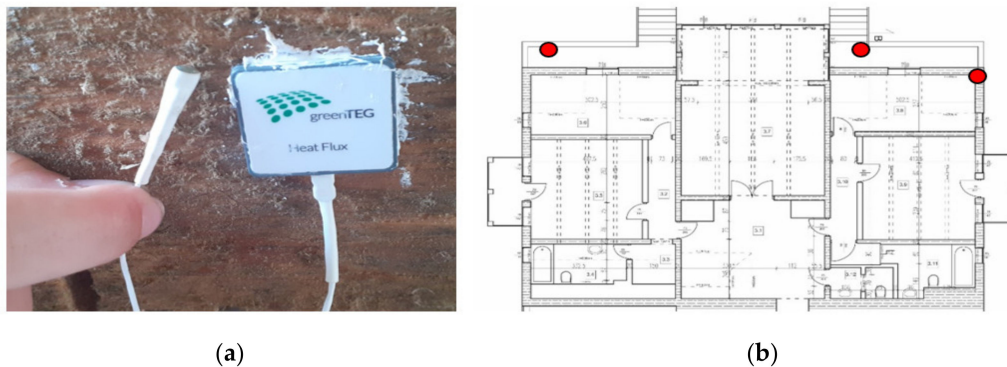
Figure 8. Measurement of the thermal transmittance coefficient in wooden log walls (a) with locations of measurement equipment marked on a part of the building plan (b).

The tests were performed using the greeTEG system, composed of two temperature sensors (an internal and an external one), as well as a heat stream density sensor (Figure 8).

The placement of measurement stations was initially determined using prior thermovision analysis findings.

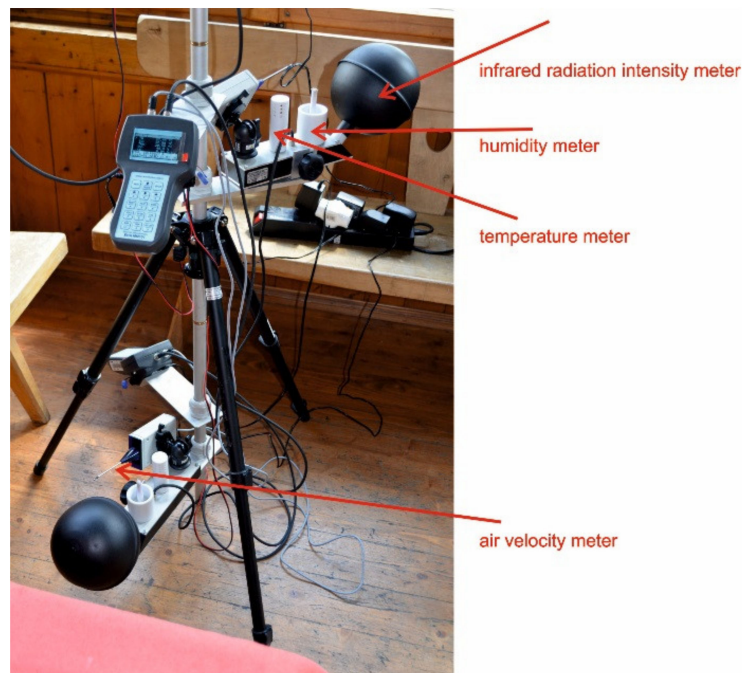
Figure 9. Microclimate measurement station in the Stara Polana building in a south-facing, glazed hall. Reproduced from [22].

The methodology for determining thermal comfort was based on the standard entitled PN-EN ISO 7730; Ergonomics of the thermal environment—Analytical determination and interpretation of thermal comfort using calculation of the Predicted Mean Vote (PMV) and Predicted Percentage Dissatisfied (PPD) indices and local thermal comfort criteria [55] (the standard was replaced by [52] and later by [51]). The measurement methodology was based on the PN ISO 7726 Ergonomics of the thermal environment—Instruments for measuring physical quantities standard [56]. The measuring equipment used was a microclimate metre (Figure 9). The height at which the measurement was taken was in accordance with standard 7726. The measurement was taken in the hall where users usually stand and

for this reason the sensors were placed on three levels: at about 1.7 m, at about 1.1 m and at about 0.1 m above the floor. This information is given in the text in line 521 on page 14. The metrological performances of sensors are compliant with EN ISO 7726. The measurement device was placed in a guest room of the Stara Polana hostel. Clothing insulation was assumed at $I_{clo} = 0.7$ clo as a value for a transitory season and indoor clothing.

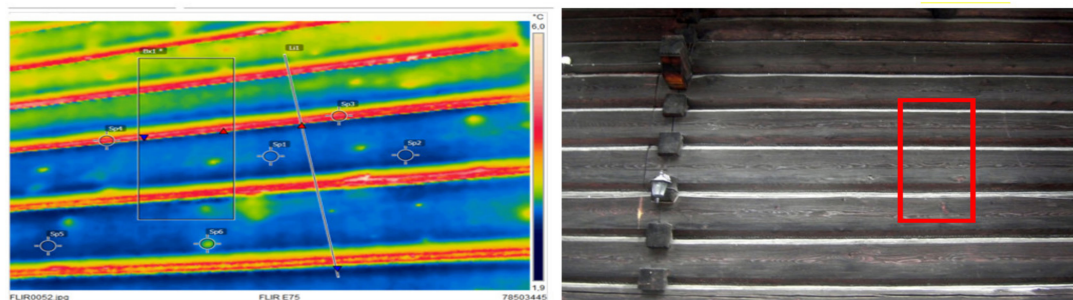
Figure 10. Detailed thermovision analysis of the Stara Polana building using a FLIR camera. Fragment of an external wooden log wall.

The authors subjected the external wooden walls of the building and the joints of wooden elements with external walls, including window mounts, to high-precision analyses (Figures 10–13).

Thermovision testing revealed a series of defects in the building's envelope and near windows, including:

- Airtightness breaches at points where external walls connected with wooden decks,
- Airtightness breaches at points where wooden windows connect to the walls,
- Lower thermal insulation at the joints between external wall beams (logs), seals in the form of a 'plait' woven from wood shavings were observed to have crumbled in some places. Slight cavities in the seals were observed,
- No damp was observed on the thermograms and during macroscopic examination.

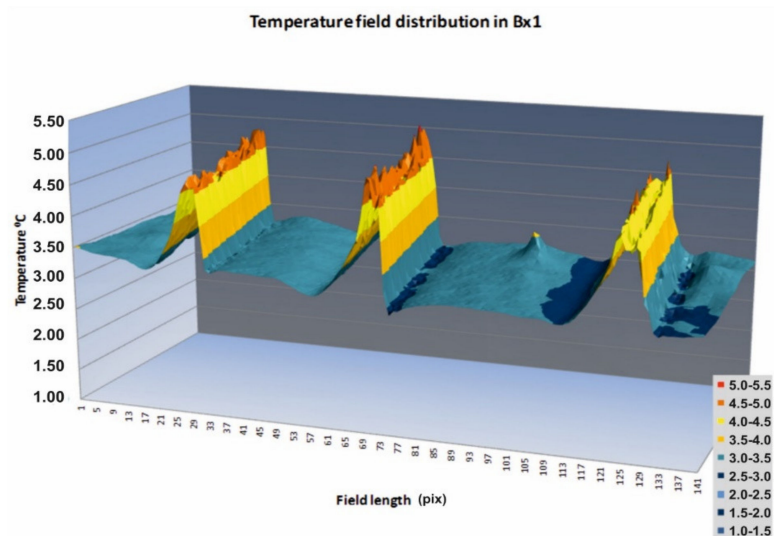
Figure 11. Analysis of a selected temperature distribution field for a wooden log wall.

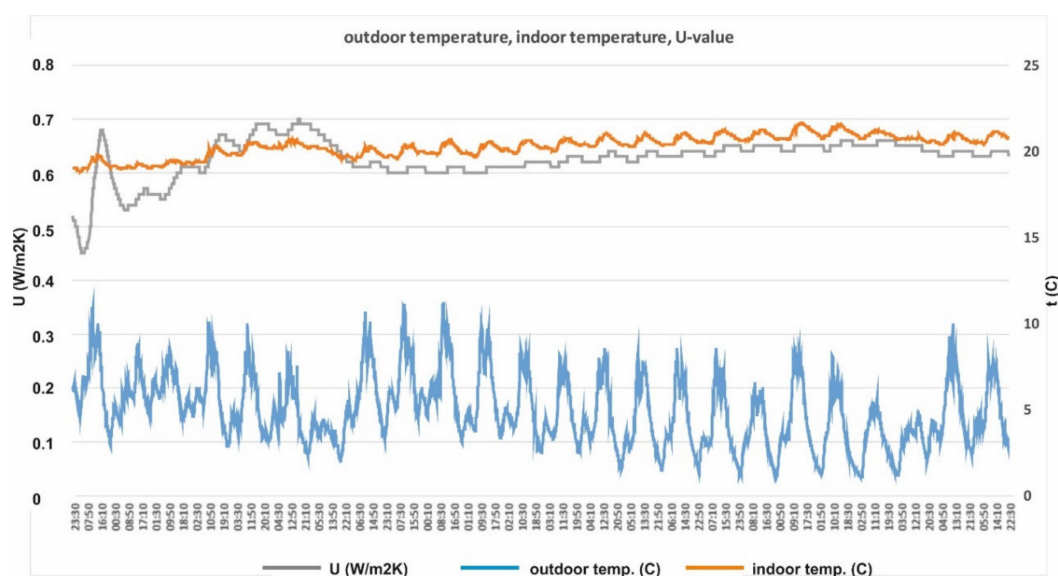
Figure 14. Results of testing intended to determine the actual U thermal transmittance for a wall made from wooden logs, located on the ground floor of the Stara Polana building. Temperature and heat stream density measurements.

The tests intended to determine the actual U thermal transmittance for the external walls made from wooden logs were performed between 23 March 2019 and 16 April 2019. Figure 14 shall present sample internal and external temperature measurements and a conversion U thermal transmittance for wooden log walls located on the ground floor of the Stara Polana building.

After initial fluctuations during the first days of measurement, the measured U thermal transmittance stabilised within the 0.60–0.65 W/(m²K) range. This value is around 30% greater than the value obtained via calculations (0.50 W/(m²K)). Due to a lack of a final stabilisation of the heat transfer coefficient, an additional high-precision method was used, which utilised data (temperature and heat stream density measurements) obtained from three measurement points.

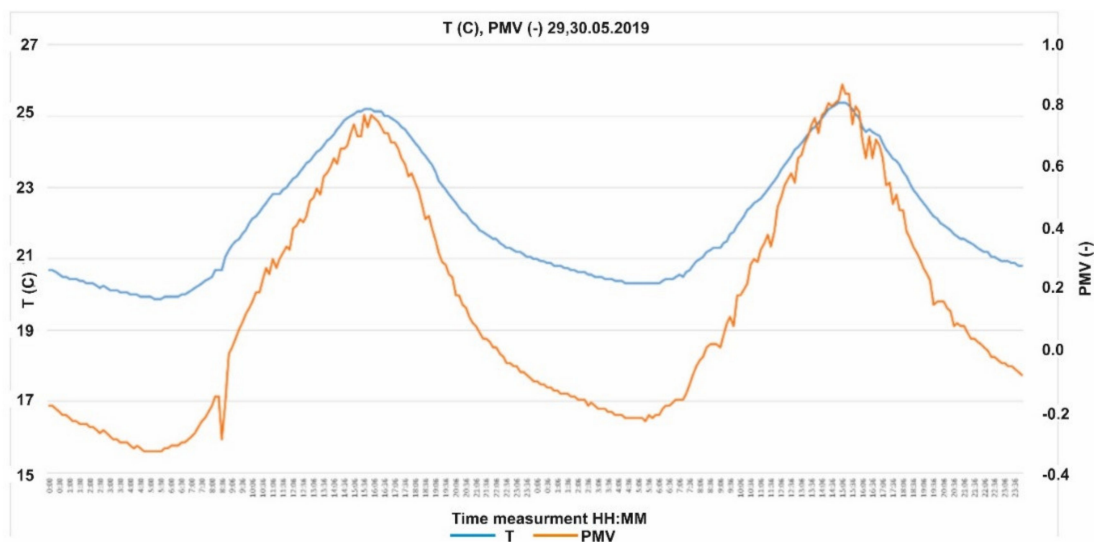
Figure 15. Indoor temperatures and Predicted Mean Vote (PMV) coefficient.

Figure 15 shows a diagram of the indoor temperatures and the PMV calculated from measurements according to Equation (1).

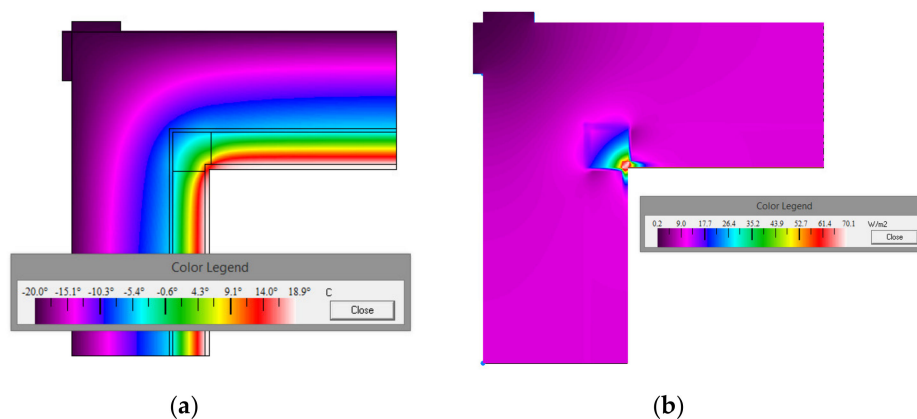
Figure 19. Comparison of calculation results for a wall corner with a thermal insulation layer 11 cm thick (**a**—isotherm layout, **b**—heat stream density distribution).

The assessment of the partitions in question began with a numerical analysis including the calculation of the U thermal transmittance for a non-uniform partition and calculating basic parameters describing a corner-type thermal bridge. The calculations were performed for a partition made from wooden logs with a thickness of 30 cm with a 11 cm thick layer of mineral wool insulation (Figures 16–19). The material parameters are listed in Table 5.

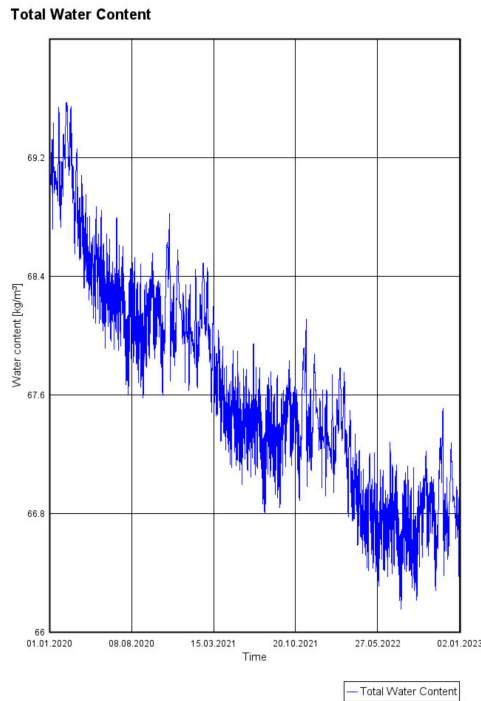
Figure 20. Changes in water content—partition insulated with mineral wool.

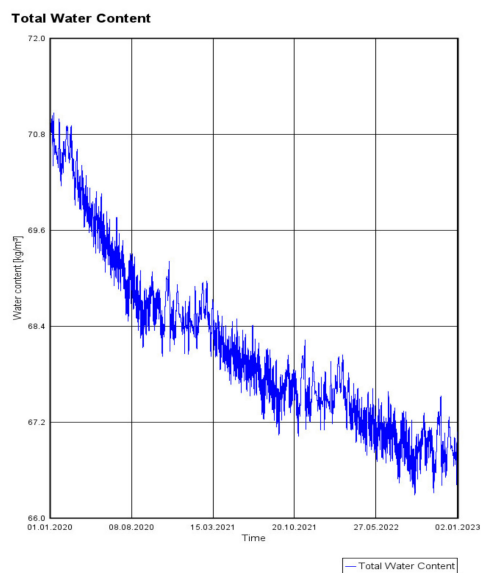
Figure 21. Changes in water content—partition insulated using light aerated concrete.

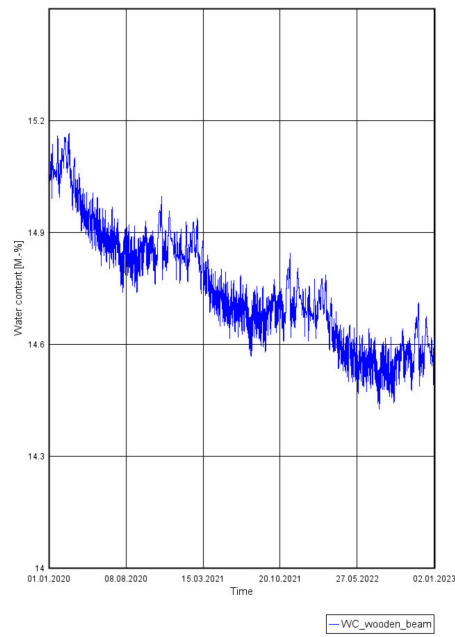
Figure 22. Changes in water content in a wooden beam—partition insulated with mineral wool.

- No water increase was observed for any type of design solution (mineral wool insulation or light aerated concrete insulation) (Figures 26–29). The level of water content decreased by about 66 (kg/m³) after one year of simulations in the local climate for each type of the wall insulation (Figures 20 and 21);
- A decrease in water content to the level of 14% of the mass humidity was observed for the wooden log walls after one year of simulation. This level is safe in the context of the risk of the development of biological corrosion, which occurs in wooden elements at over 20% of their mass humidity, Figures 22 and 23;

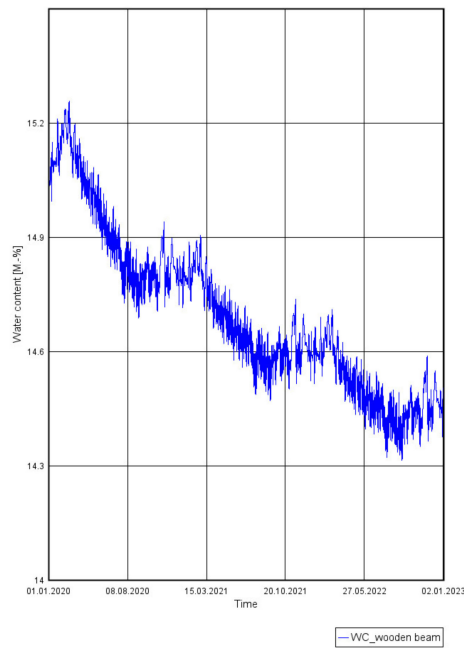
Figure 23. Changes in water content in a wooden beam—partition insulated using light aerated concrete.

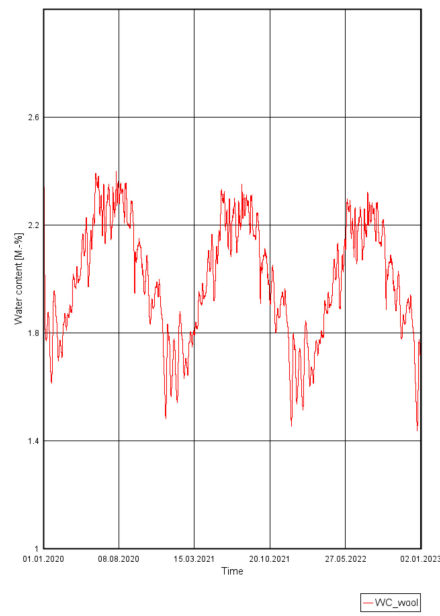
Figure 24. Changes in water content in the insulation material layer—mineral wool.

- In the case of the assessment of the behaviour of the insulation material in a wall layout, no increase in dampness was observed after one year in the assumed conditions of future use. A decrease in water content was observed for both insulation materials, Figures 24 and 25;

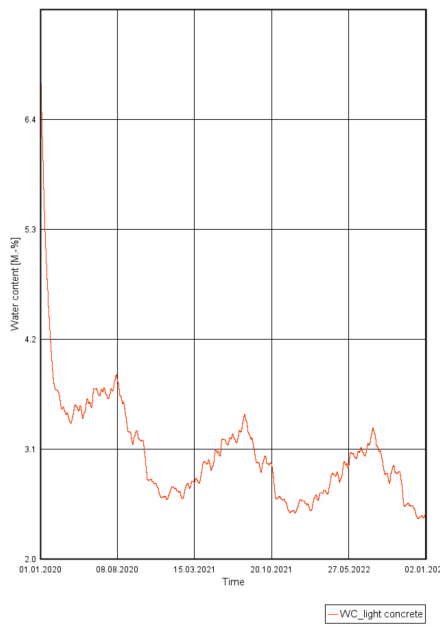
Figure 25. Changes in water content in the insulation material layer—light aerated concrete.

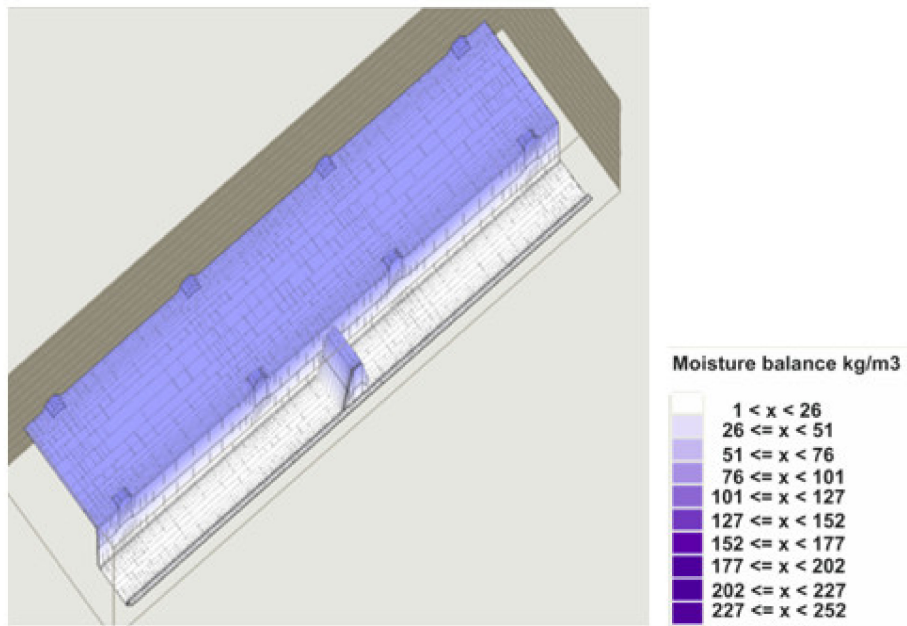
Figure 26. Wall insulated using mineral wool—initiation time (0 h).
