Article

Thermal Performance and Comfort Condition Analysis in a Vernacular Building with a Glazed Balcony

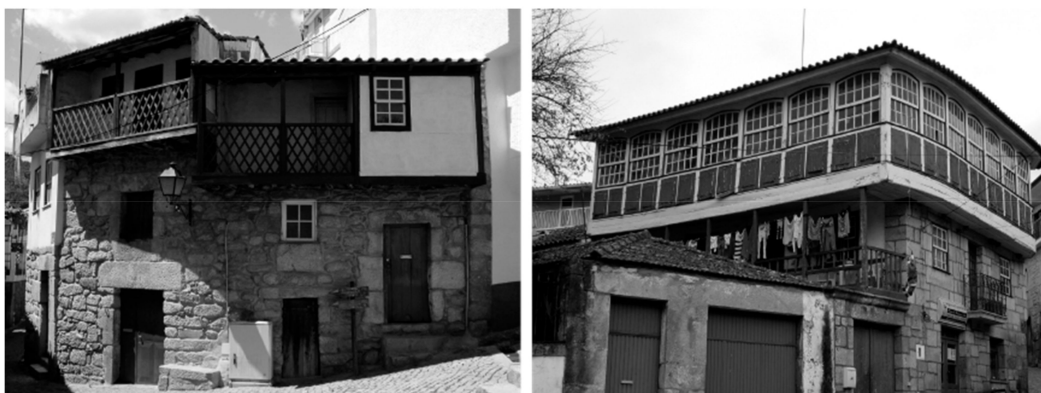
Figure 1. Balconies in the vernacular architecture of Beira Alta, Portugal.

In this context, some authors, like Ascione, et al. [22] defend that the building orientation and its passive design can positively affect the energy and environmental performance of buildings. For instance, glazed balconies act as a sunspace (Figure 1) and are a vernacular design solution that can contribute to the thermal performance of buildings during the heating season, since the sunspace heats the adjacent rooms, not compromising the thermal behavior of the building during summer [23]. This technique also has great potential to be used in contemporary buildings to improve energy efficiency, as shown by the case of the rehabilitation of the residential complex of Dornbirn, in Austria. The option of introducing this type of solution in the south-facing facades has increased the floor area of the dwellings and significantly reduced the heating energy bill [24]. The operation of these balconies as a buffer space allows the simultaneous capture and trapping of solar gains and reduction of heat losses. By being physically separated from the interior spaces of the dwellings, in situations where heat gain is undesirable, the balcony space can act as a shading device and promotes natural ventilation [24].

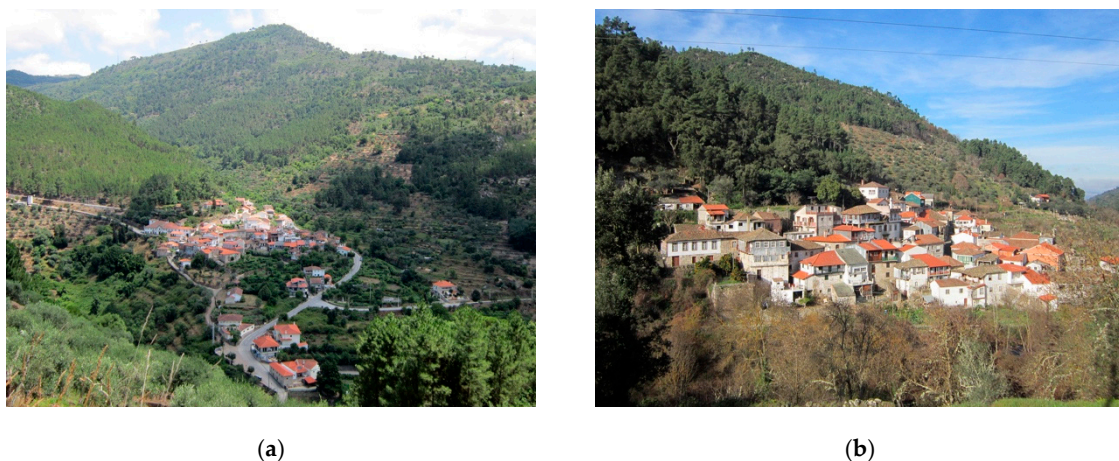
Figure 3. Granja do Tedo. (a) Upper part; (b) lower part.

The village has a compact urban layout with narrow and winding streets, and most of the built area is implanted on a rocky massif (Figures 2 and 3), sparing the fertile agriculture land near the watercourses.

- The organic and compact urban layout, suited to the topography, can also be considered a passive strategy since the compactness of constructions allows to minimize the area of the envelope exposed to outdoor conditions and therefore reduce heat losses. The narrow and winding streets allow reducing wind speed, and in some places, the streets form small ‘public-patios’ sheltered from the prevailing winds (Figures 2 and 3).

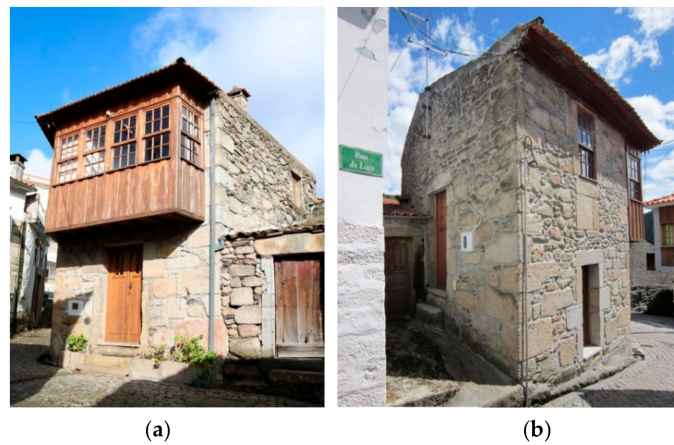
Figure 7. External views. (a) southwest and southeast façades; (b) northeast and west façades.

The building is a semi-detached single-family house, integrated into the urban mesh (Figure 7). It has an irregular floor plan and the main façade with the balcony is facing southwest, while the others are facing northeast, southeast, and west (Figure 8). As other constructions in regions with cold winters, and apart from the balcony that has the purpose of harvesting solar gains, the building has

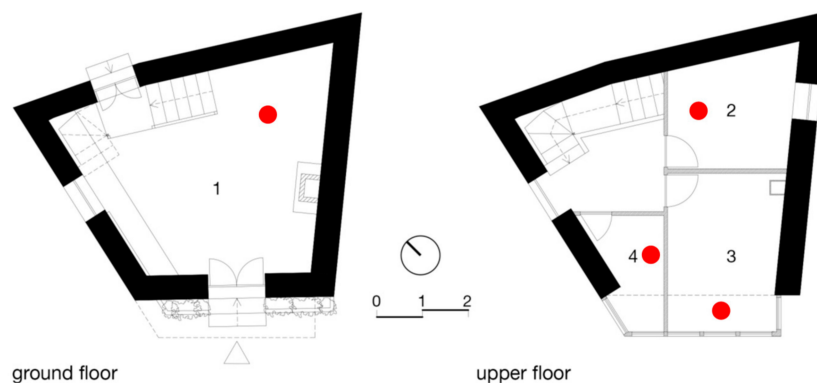
Figure 8. Floor plans showing the location of measuring instruments (1—living room/kitchen; 2—bedroom; 3—bedroom with balcony; 4—bathroom).

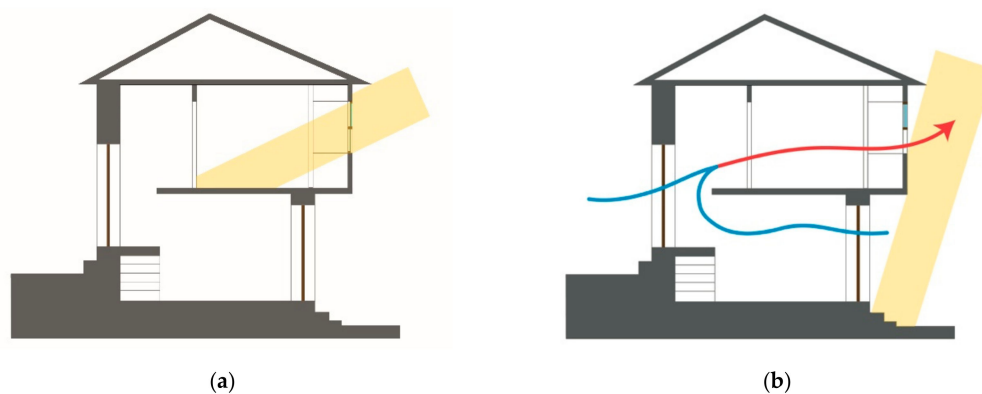
Figure 10. Schematic section of the glazed balcony operation. (a) Winter solstice; (b) Summer solstice.

- Balconies are an architectonic feature and identity of Northern Portugal vernacular architecture. It has to be taken into consideration that most of these buildings had low daylight levels and comfort conditions. Therefore, balconies were spaces used to enjoy the sun, work with daylight, and to heat the adjacent spaces, particularly on sunny winter days. The glazed balcony is an improved version of a balcony, that acts as a sunspace, allowing to harvest solar gains and reduce heat losses (Figure 9c). In the case study, the larger area of the balcony is facing southwest, with

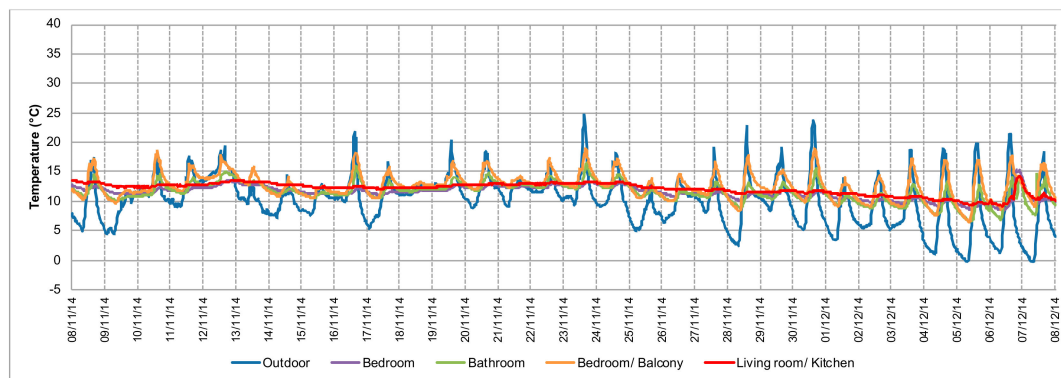
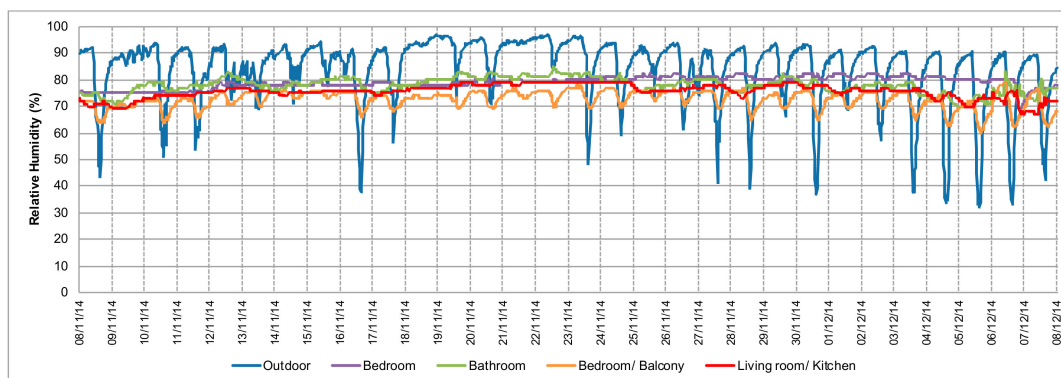
Figure 11. Autumn monitoring: (a) Indoor and outdoor air temperature profiles; (b) Indoor and outdoor air relative humidity profiles.

Figure 11a shows that indoor temperature remained stable in the rooms with a smaller glazing area, with a mean temperature of 12.1 °C in the living room/kitchen and 11.5 °C in the bedroom (Table 4). The reduced glazed area and the high thermal inertia of the building envelope allow stabilization of the indoor temperature in these rooms. On 7 December, when the outdoor temperature reaches a minimum value of 1.2 °C, it is possible to observe how building occupants can take correcting measures to improve the indoor thermal comfort conditions. The increase of the indoor temperatures in the living room/kitchen and bedroom (Figure 11a) is due to the use of the heating system (closed wood-burning

In the rooms where the glazing area is predominant, bedroom/balcony and bathroom, it was observed that the indoor temperature was not stable as it is strongly dependent on the outdoor climate conditions. The maximum temperature recorded in the bedroom/balcony was of 18.9 °C while in the bathroom was of 16.4 °C (Table 4). In these rooms, during the day, the indoor temperature followed the trend of the outdoor temperature (Figure 11a). The temperature profiles in both rooms were quite similar, but since the bedroom/balcony has a larger glazed area than the bathroom, it presented higher temperatures. The bedroom/balcony had the highest indoor temperature throughout the monitoring period, reaching temperatures close to the comfort threshold temperature. These results highlight the effect of the glazed balcony as a strategy to capture solar gains.

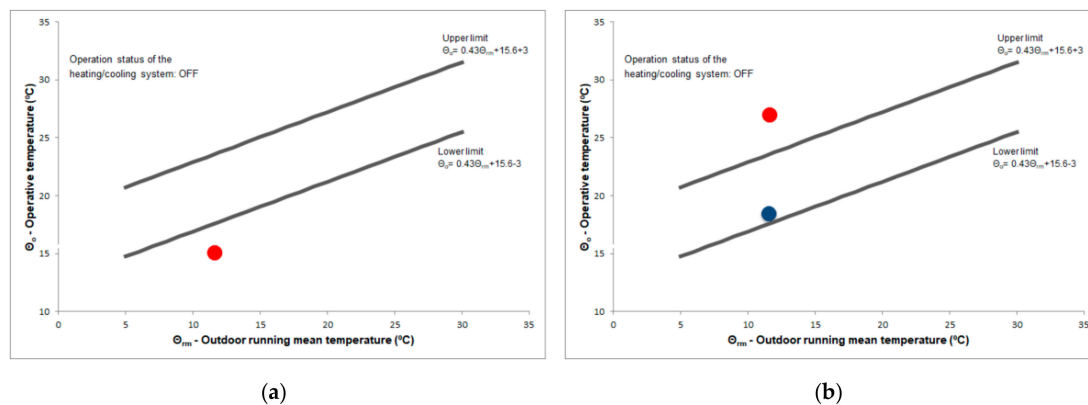
Figure 12. Adaptive comfort chart during a representative autumn day: (a) Thermal comfort temperature (operative temperature) in the living room/kitchen; (b) Thermal comfort temperature (operative temperature) in the bedroom/balcony for open curtains (red dot) and closed curtains (blue dot).

Regarding the assessment of the thermal comfort, the measurements in the living room/kitchen and bedroom/balcony were carried out when the heating system was not used. The influence of the curtains on the thermal comfort in the bedroom/balcony was also evaluated. In autumn and without the use of the heating system, the results showed that the thermal comfort conditions in the living room/kitchen were below the lower comfort limit (Figure 12a). In the survey, the two inhabitants answered as being “slightly cool” (1.0 met; 0.91 clo) and one as being “cool” (1.0 met; 0.95 clo), confirming the objective measurements. In what concerns the assessment of the thermal comfort conditions in the bedroom/balcony, it was possible to verify the influence of the glazing area. In this room, when the curtains were closed, the comfort conditions were within the thermal comfort limits, but close to the bottom threshold (blue dot in Figure 12b). In the survey, the two occupants answered as being ‘neutral’ (comfortable) (1.0 met; 0.91–0.95 clo), i.e., results were in line with the objective assessment. When the curtains were open, the solar gains increased the operative temperature, and thermal conditions were above the upper thermal comfort threshold, showing an overheating period (red dot in Figure 12b).

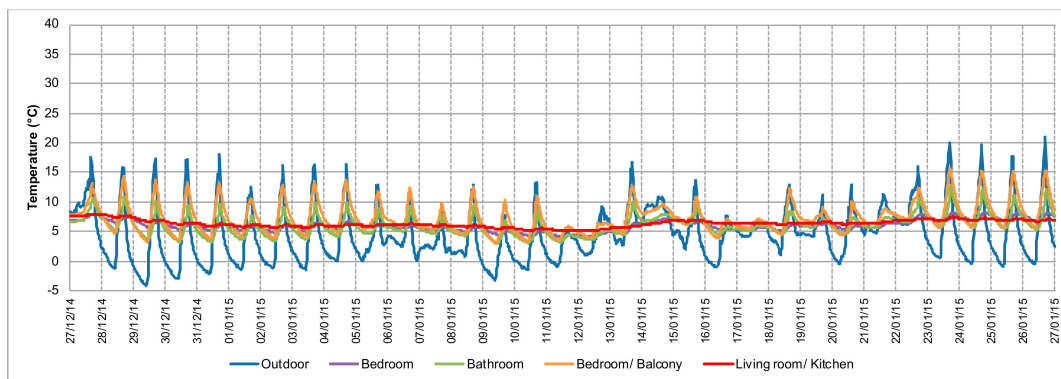
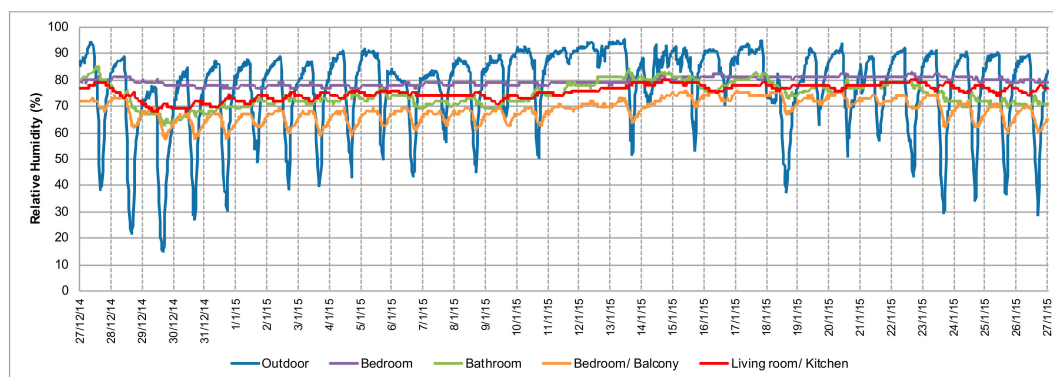
Figure 13. Winter monitoring: (a) Indoor and outdoor air temperature profiles; (b) Indoor and outdoor air relative humidity profiles.

From the analysis of Figure 13a, it is possible to conclude that the living room/kitchen and the bedroom (the rooms with smaller glazed area and not in contact with the glazed balcony), showed a stable profile with low daily thermal variation and a mean temperature of 6.0 °C and 6.4 °C, respectively (Table 5). Beyond the reduced glazed area, the thermal inertia of the envelope is the main reason for this steady behavior. The fact the building was not occupied during this period of the monitoring campaign explains the lower temperature values and their uniformity during the period, since there was no human action to achieve thermal comfort conditions (i.e., active heating to increase the indoor temperatures). Although considerably below the comfort limits, even in a free-running mode, it has to be highlighted that indoor mean temperature was always higher than outdoors.

Both in the bedroom/balcony and the bathroom, it was observed that temperature profiles were not stable and followed the outdoor temperature variation during the day (Figure 13a). The maximum indoor temperature recorded was of 15.7 °C in the bedroom/balcony and 12.8 °C in the bathroom, both in days with higher outdoor temperatures. Due to the large glazed area of the balcony, the effect of sunny days is visible in temperature peaks close to the thermal comfort boundary, even with this strategy not being used with full potential, since the opaque curtains were closed and therefore part of solar radiation was reflected. Consequently, in days with more incident radiation and if the curtains were open, it was expected that temperature would reach or be much closer to the comfort boundaries (similar to the condition measured during autumn and shown in Figure 12a, where active heating was only necessary as a backup). Nevertheless, there is also a drawback resulting from the greater glazed area, since these rooms also have more heat losses and therefore the minimum temperature recorded is lower than in the ground floor (Table 5). Moreover, the lack of thermal mass to store the heat gained during the day is a disadvantage, since the rooms have lightweight wooden floor and walls (as the original earth-filled timber frame walls—*tabique*—were replaced by plasterboard walls).

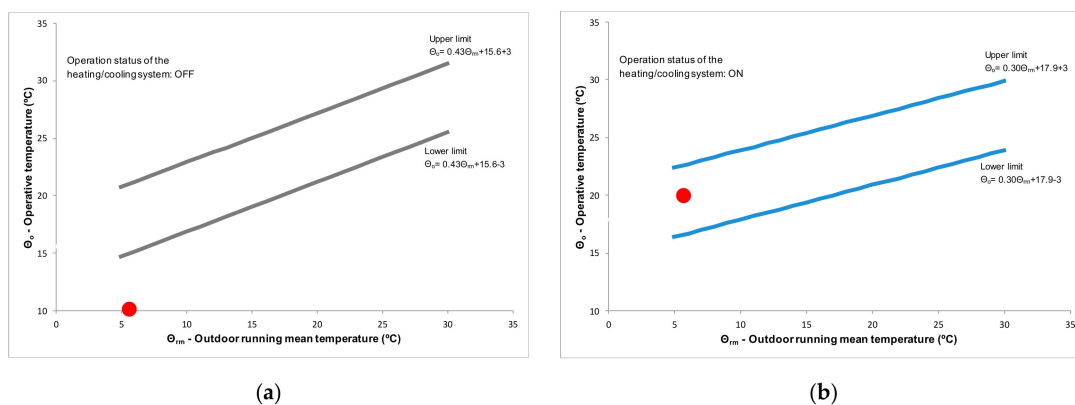
Figure 14. Adaptive comfort chart during a representative winter day: (a) Heating system OFF—Thermal comfort temperature (operative temperature) in the living room/kitchen; (b) Heating system ON—thermal comfort temperature (operative temperature) in the living room/kitchen.

Regarding the assessment of the thermal comfort (Figure 14), the measurement of the thermal environment conditions was performed during a typical winter day, in the bedroom/balcony and in the living room/kitchen. In the living room/kitchen, the analysis was carried out for two situations: (i) when the heating system was not in operation (Figure 14a); and (ii) when the heating system was in operation (Figure 14b). Results showed that when the heating system was not in operation the thermal environment was very uncomfortable (Figure 14a). The influence on the thermal comfort of using the closed wood-burning fireplace is quite evident, since when the heating system was in operation, the living room/kitchen had a comfortable thermal environment (Figure 14b). In the survey, the occupants also expressed their thermal sensation for the same two situations. When the heating system was not in operation, one occupant (1.0 met; 1.48 clo) answered as being “cool” and the other (1.0 met; 0.92 clo) as being “cold”. When the heating system was in operation, one occupant (1.0 met; 1.48 clo) answered as being “neutral” and the other (1.0 met; 0.92 clo) as being “slightly cool”. These results confirm the ones from the objective measurements. The differences between the answers of the two occupants are related to the different clothing insulation levels, which influenced their thermal sensation.

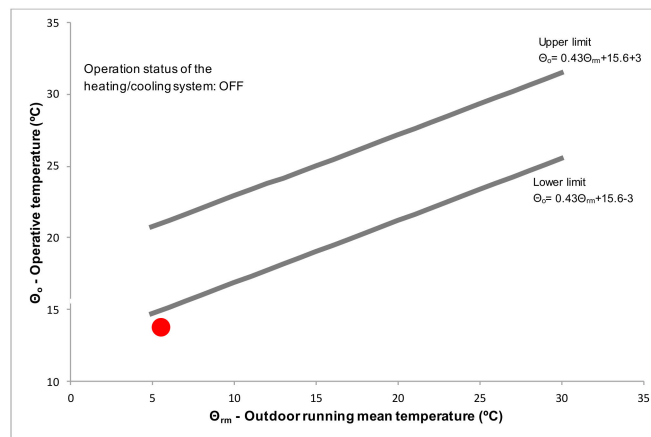
Figure 15. Adaptive comfort chart during a representative winter day. Thermal comfort temperature (operative temperature) in the bedroom/balcony.

In the bedroom/balcony, the measurements were carried out only when the heating system was not in operation. The thermal comfort conditions in this room were outside the comfort boundaries (Figure 15). Although the operative temperature was outside the comfort limits, it was very close to the lower comfort threshold. It is likely that the regular building occupation and, consequently, the appropriated use of the glazed balcony, would lead to an operative temperature within the comfort limits. It must be stressed that during the measurements, the sky was cloudy and thus solar gains were very low. In the survey, the two occupants answered as being “slightly cool” (1.0 met; 0.92–1.48 clo), which confirms the objective measurements.

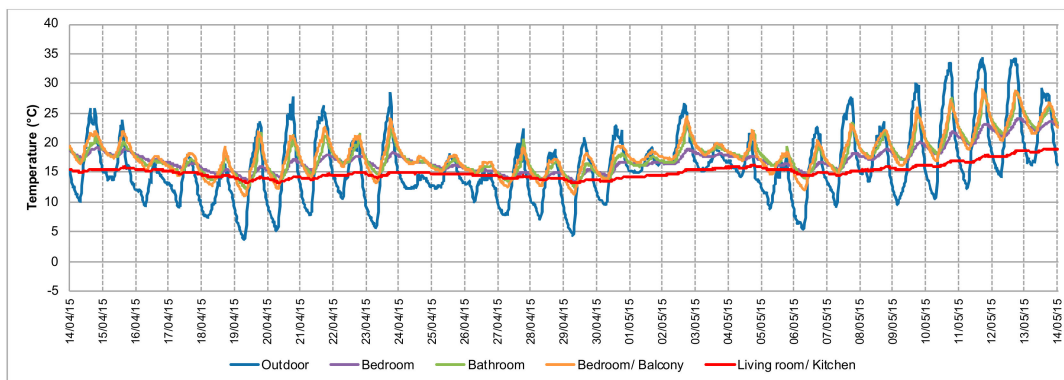
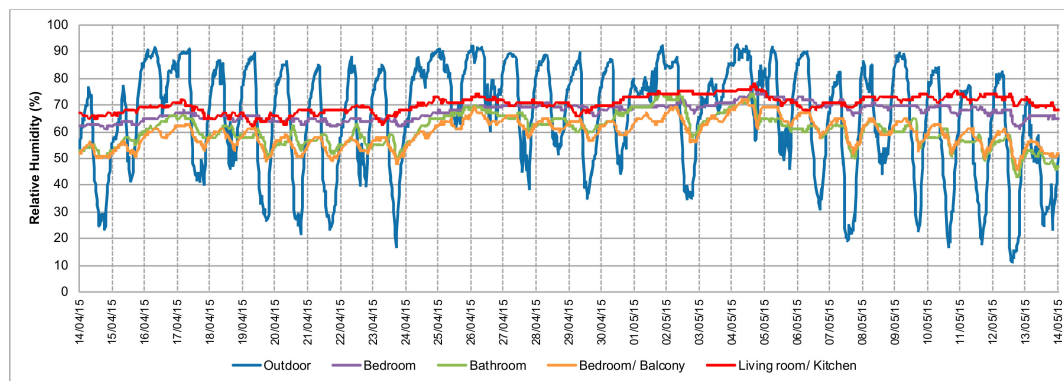
Figure 16. Spring monitoring: (a) Indoor and outdoor air temperature profiles; (b) Indoor and outdoor air relative humidity profiles.

In the spring, it was observed a relevant difference between the indoor air temperatures of the rooms located on the ground floor and those on the upper floor. Concerning the ground floor, the living room/kitchen had a very stable indoor temperature during the monitoring period, with a mean air temperature of 15.2 °C (Table 6). In the upper floor, it was observed that the indoor temperature was less stable, particularly in the rooms in the glazed balcony. The increase in the outdoor temperature and the number of hours of solar radiation had a strong influence on the temperature of these rooms. The bedroom had a more stable temperature profile, since it has fewer solar gains through the windows and higher thermal inertia due to the granite walls. The bedroom/balcony had the highest indoor temperature in the building during the monitoring period. The maximum temperature in the bedroom/balcony always remained below the outdoor temperature, since during the monitoring period, the curtains were closed. Nevertheless, from May onwards, when the outdoor temperature begins to rise, closing the curtains is the right decision to reduce solar gains. However, since the glazed area is protected by an inside shading device (opaque curtains), it is difficult to avoid overheating both in the bedroom/balcony and in the bathroom, as shown in Figure 16a).

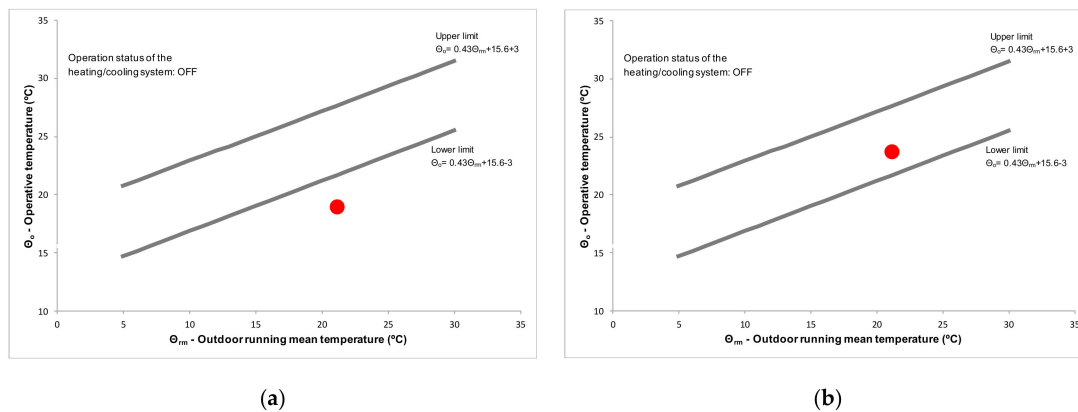
Figure 17. Adaptive comfort chart during a representative spring day: (a) Thermal comfort temperature (operative temperature) in the living room/kitchen; (b) Thermal comfort temperature (operative temperature) in the bedroom/balcony.

charts, it is possible to conclude that the thermal comfort conditions in the living room/kitchen are below the lower comfort limit (Figure 17a), even with an operative temperature of 18.9 °C and an outdoor running mean temperature above 20 °C. The low heat gains and mainly the high thermal inertia of the envelope are the main factors affecting these results. In the survey, the two occupants (1.0 met; 0.44–0.58 clo) answered as being “slightly cool”.

In contrast, the bedroom/balcony had a thermal condition within the comfort range. The operative temperature was higher than in the ground floor due to the heat gains provided by the glazed balcony. In the comfort survey, the two occupants (1.0 met; 0.44 and 0.58 clo) answered as being “neutral”, which confirms the measurements.

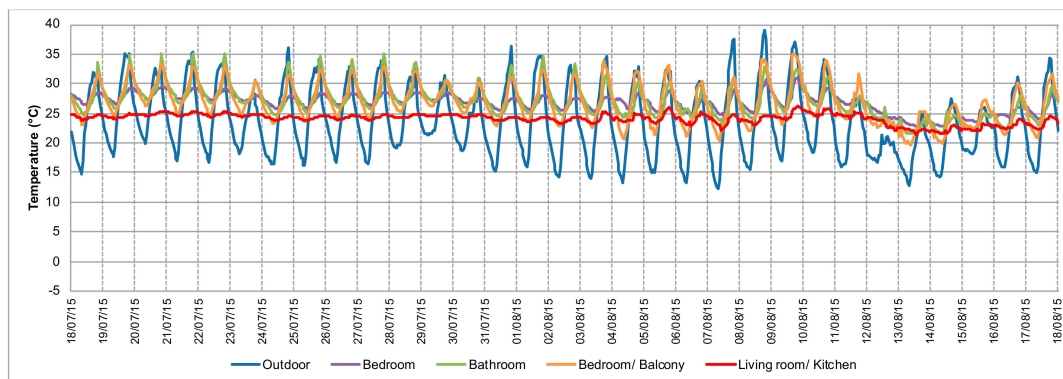
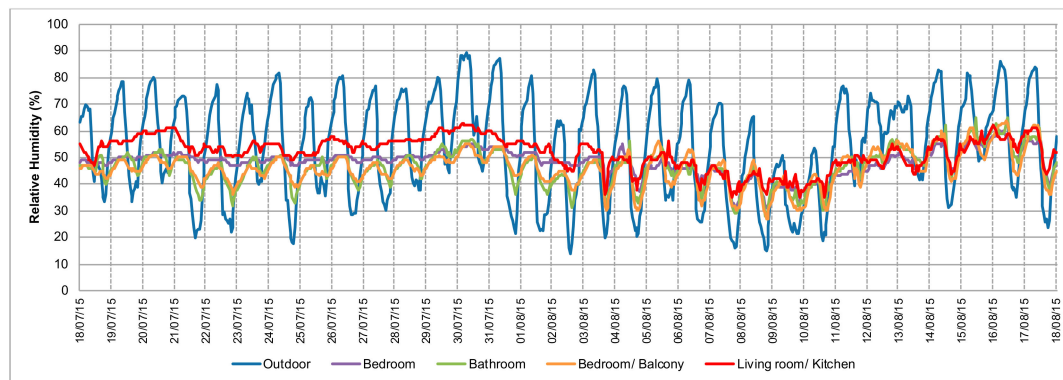
Figure 18. Summer monitoring: (a) Indoor and outdoor air temperature profiles; (b) Indoor and outdoor air relative humidity profiles.

From the analysis of Figure 18, it is possible to conclude that the living room/kitchen had the most stable temperature profile, with a mean temperature of 24.1 °C (Figure 18 and Table 7). This is due to the higher thermal inertia and lower direct solar gains of the room. As mentioned before, this room

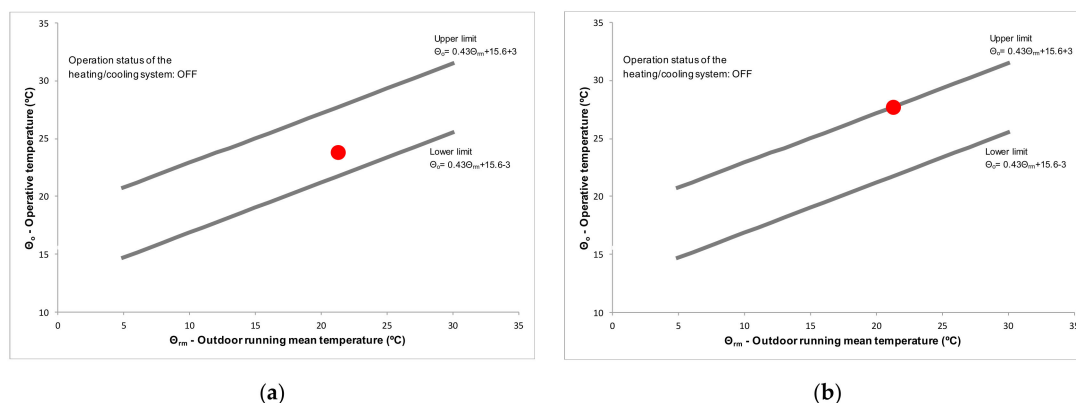
Figure 19. Adaptive comfort chart during a representative summer day: (a) Thermal comfort temperature (operative temperature) in the kitchen/living room; (b) Thermal comfort temperature (operative temperature) in the bedroom/balcony.

In the thermal comfort assessment, the living room/kitchen and the bedroom/balcony showed a thermal environment within the comfort range (Figure 19a). The operative temperature in the living room/kitchen is more stable due to the higher thermal inertia, and therefore this room had a better thermal condition during the summer. The results of the survey confirmed the measurements, since the two occupants (1.0 met; 0.27–0.43 clo) answered as being “neutral”.

In the bedroom/balcony, the operative temperature was close to the upper comfort limit, mainly due to the solar gains through the glazed envelope (Figure 19b). In the survey, one occupant (1.0 met; 0.43 clo) answered as being “slightly warm” and the other (1.0 met; 0.27 clo) as being “neutral”. The difference between the answers is mainly related to different clothing insulation levels.

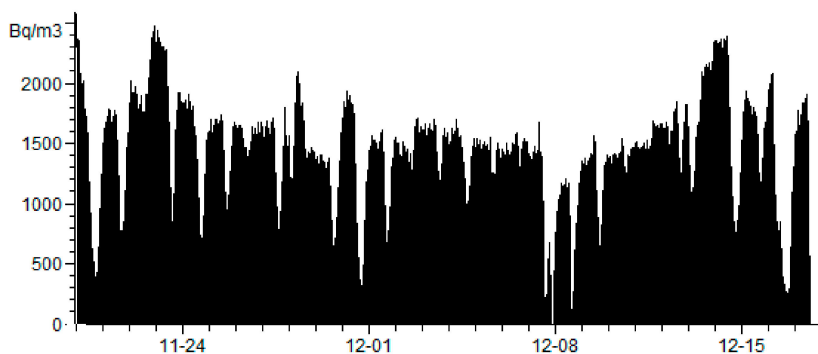
Figure 20. Concentrations of radon in the living room/kitchen during the winter period.

In the case study, the concentration of radon was measured during the heating season, when the ventilation rate was lower. The living room/kitchen was the room chosen for the measurements since it has the lower ventilation rates, has granite walls, is located in the ground floor, and it sits on a granitic massif. The measurements took place during 28 days, with integration periods of 10 min, started after a period of stabilisation of the radon sensor (about 60 days). Figure 20 shows the results of the measurements. It is possible to see an irregular distribution of values with several peaks. The peaks in the radon concentration are considerably above the maximum defined by the Portuguese law (400 Bq/m^3) [42], with a maximum of 2660 Bq/m^3 , and an average concentration of 1432 Bq/m^3 . Although the concentration of radon was high, it has to be taken into consideration that the building was unoccupied most of the time and thus had low ventilation rates.

During a short period of occupation, 7 and 8 December, even with low ventilation rates (windows and doors were only open sporadically), as it was winter, the concentration of radon sharply fell to values below 300 Bq/m^3 , as recommend by the Directive 2013/59/EURATOM [44]. Although the air change rate of the case study building was not measured, results show that the way the occupants use the building is sufficient to maintain the radon concentrations within the mandatory values. Therefore, ventilation must not be neglected in this type of buildings, particularly after renovations when the airtightness of the envelope increases due to the replacement of windows and doors, and no other measures are implemented to mitigate the ingress of radon into the building. In buildings located in granitic areas, it is necessary to maintain a minimum hourly air change rate to remove radon or to renovate the ground floor, by introducing, for example, a waterproofing membrane that does not allow the flux of radon gas from the ground to the indoor environment. In the renovation of this case study, measures to prevent the ingress of radon gas into the building were not introduced and therefore ventilation is the only way to control the radon gas concentration.
