Article

Run to Failure: Aging of Commercial Battery Cells beyond Their End of Life

Abstract: The aim of this work is to age commercial battery cells far beyond their expected lifetime. There is a gap in the literature regarding run to failure tests of lithium-ion batteries that this work intends to address. Therefore, twenty new Samsung ICR18650-26F cells were aged as a battery pack in a run to failure test. Aging took place with a constant load current and a constant charge current to accelerate capacity decrease. Important aging parameters such as capacity and internal resistance were measured at each cycle to monitor their development. The end of the test was initiated by the explosion of a single battery cell, after which the battery pack was disassembled and all parameters of the still intact single cells were measured. The distribution of all measured capacities and internal resistances is displayed graphically. This clearly shows the influence of the exploded cell on the cells in its immediate vicinity. Selected cells from this area of the battery were subjected to computed tomography (CT) to detect internal defects. The X-rays taken with computed tomography showed clear d

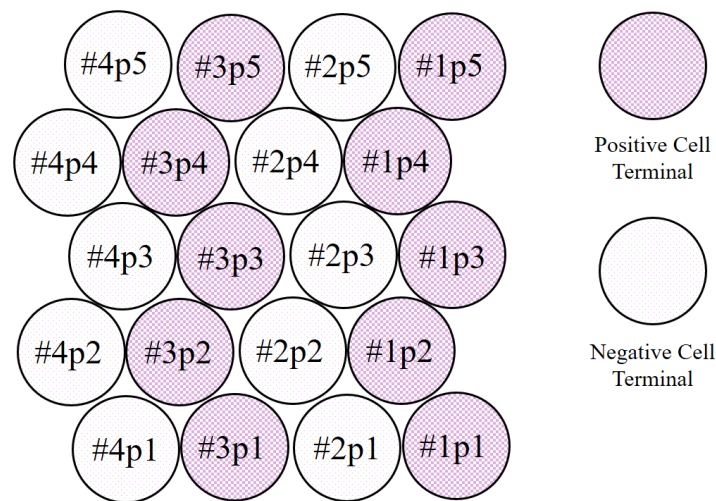
Figure 1. Top view on the mechanical cell configuration as a 4s5p (4 cells in series with 5 cells in parallel each) battery. The numbering of the cells contains information about their position. For example, Cell #1p3 is the third cell from Cell Level 1.

Twenty new Samsung ICR18650-26F cells were configured into a battery pack with a 4s5p (4 cells in series with 5 cells in parallel each) setup. These cells had a nominal capacity of 2.6 Ah and used a carbon anode and an Lithium-nickel-manganese-cobalt-oxide (NMC) cathode. The cell type could be assumed to be high energy. The resulting nominal battery pack capacity was therefore 13 Ah with a nominal voltage of 14.8 V. The battery was equipped with a passive Battery Management System (BMS) that operated during the constant voltage phase of the charging process. It discharged cells with a voltage greater than 4.175 V by switching one of its 33 Ω balancing resistors in parallel with the battery cell. Balancing ended as soon as the voltage of the balanced cells dropped below 4.175 V. The configured battery with the associated cell numbering is shown in Figure 1.

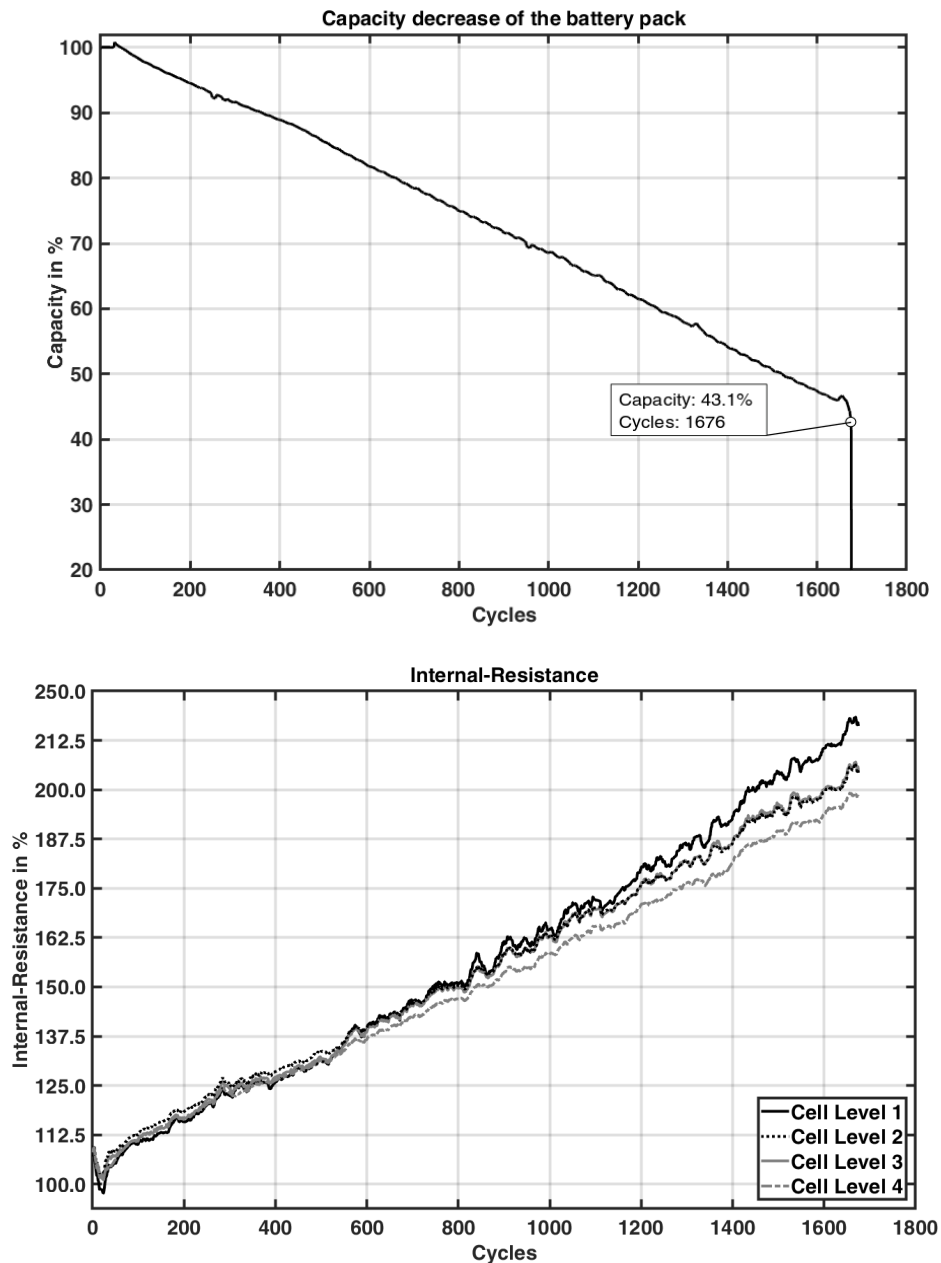
Figure 2 shows the development of the discharge capacity in percentage and DCIR in relative values over time. An internal resistance of 100% was thereby the starting value of 16 m Ω . An internal resistance of 200% meant that the resistance had doubled to 32 m Ω . The capacity value of 100% was calculated with help of the first five measured discharge capacities and resulted in an average capacity of 12.28 Ah. Due to calendar aging of the battery of 24 months, the capacity had already decreased by 0.72 Ah. The pack voltage during storage was 16.3 V. The voltage was evenly distributed on all cell levels.

Figure 2. Capacity and internal resistance during cyclic aging.

The test was terminated by a thermal event after 1676 cycles and a capacity of 43.1% (5.287 Ah). Cell Level 1 showed a defective behavior. After the charging process, in the resting period, the voltage of the mentioned cell level fell slowly until the voltage finally dropped abruptly to 0 V. One cell in the affected level built up high pressure inside so that the safety valve was triggered. This thermal event was recorded by the independent temperature measurement of the test chamber in the form of a short and sudden rise in temperature.

Level 1 already turned out to have the lowest capacity in comparison to the other cell levels after the first 20 cycles. It triggered the end of the discharge process by reaching the minimum permissible cell voltage of 3.0 V first in every cycle. Similarly, Cell Level 1 first reached the final charge voltage of 4.21 V during the charging process. If one cell level within a battery pack was the first to reach both end of discharge voltage and end of charge voltage, its capacity was lower in relation to the other cell levels.

Apart from the mentioned voltage deviation, there were no other signs indicating an upcoming fault. Overall, the capacity degradation developed as expected. Two aging mechanisms could be identified. At first (until about 420 cycles), a slower degradation rate could be observed, which was referred to lithium loss. After 420 cycles, the degradation rate increased due to active material loss [17]. Overall, Figure 2 shows the aging behavior of the whole battery pack.

The value of internal resistance at the beginning of cyclic aging was approximately 17 m Ω (relative value of 112.5%) for each cell level. This indicated a slightly increased starting value, which could be

explained by calendar aging of 24 months. The average value of a single cell was thus 85 m Ω . New cells of the same type had a typical value of about 50 m Ω .

Although the voltage of Level 1 looked conspicuous, this was not reflected in the DCIR. Up to about 500 cycles, this level had even the lowest internal resistance. In the further progress of the test, however, this cell level developed the highest DCIR. After that, a clear dispersion between Level 1 and the other levels developed, which could be an indication of the imminent error.

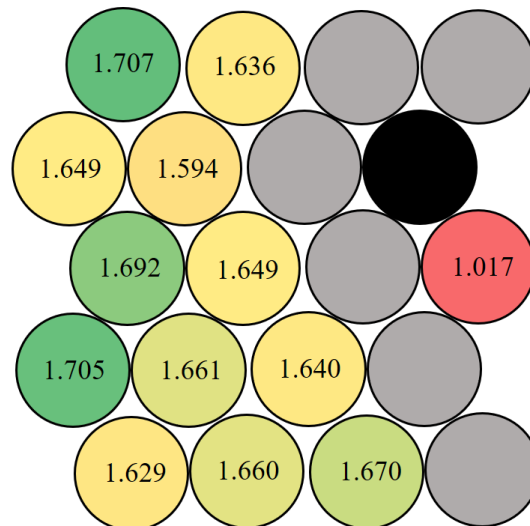
After disassembly, seven of 20 cells were not able to be measured. One of the seven cells was totally destroyed (1p4), whereas the remaining six cells had a measurable voltage of 0 V at the terminals. Figures 3 and 4 show an overview of the measured discharge capacity and DCIR with respect to the topology of the battery. In addition, each cell is marked with a color scheme. All grey cells had a measurable voltage of 0 V. The black cell could not be measured anymore, due to the triggered safety

valve. All other cells are colored according to their capacity or their DCIR value. Red marks the worst cell, whereas dark green marks the best cell. The coloring makes it possible to recognize a trend in this case. In the left outer area is the level with the largest capacity (Level 4). This was due to the higher temperature inside the pack, which led to a stronger aging of the inner cells according to Waldmann et al. [18]. However, this trend was not reflected in the DCIR values.

Figure 3. Results of the single cell measurement. Capacity in Ah.

The only measurable cell from the immediate neighborhood of the destroyed cell had a significantly limited capacity and an enormously high internal resistance. The capacity was 38.5% below the average, and DCIR was even 70.8% above the average of the measurable cells. To express the cell-to-cell variation numerically, the variation coefficient could be used, defined by $\kappa = \sigma/\mu$, where σ is the standard deviation and μ the expected value. In this experiment, the cells (the cell 1p3 excluded) had a respective $\kappa = 1.97\%$. According to Oeser et al. [19], a battery with an SOH of 78% has a respective $\kappa = 1.09\%$. The variation coefficient had a slightly higher, but nevertheless similar value to the related literature. The value was not unusually high, which could be associated with a comparable aging process in terms of cell-to-cell variation. In this case, the work of Oeser et al. was used as a short assessment to illustrate that the development of the cell-to-cell variation of this experiment was comparable to other experiments in the literature, although in this case, only one battery was tested.

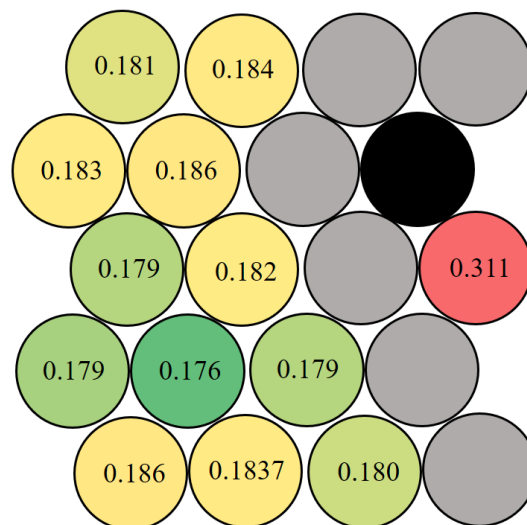
Figure 4. Results of the single cell measurement. Internal resistance in Ω .

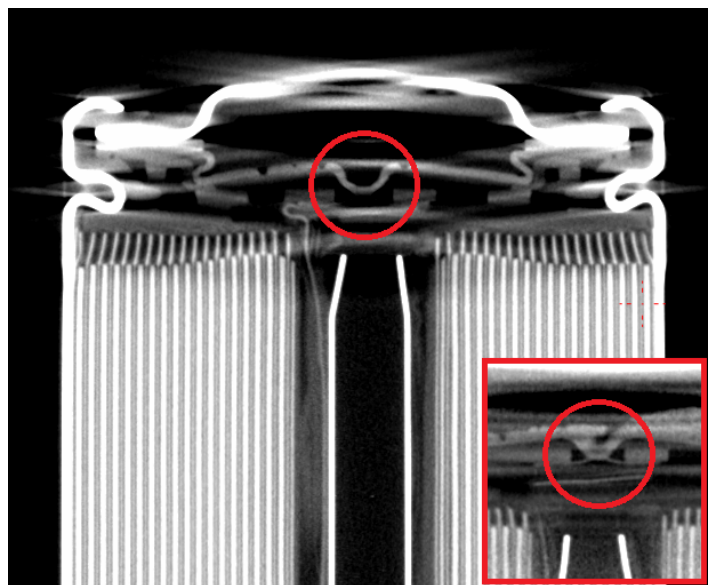
The CT images revealed that all cells with 0 V at the terminals had a triggered CID (see Figure 5). Since the CID could only be triggered by overpressure in the cell, a chemical reaction must have taken place, which was triggered by the neighboring, destroyed cell 1p4.

Cells at the same level could not have taken the damage of high currents resulting from one missing cell in the parallel setup, because during the thermal event, cells were in the relaxation phase, and no current was flowing. Probably the heat spread over the metal to the cells of the same and adjacent level, which led to the triggering of the CID of the remaining cells.

Figure 5. CT scan of the cell 1p5 with 0 V at the terminals. In the upper part, a triggered CID can be seen in the red circle. The non-triggered CID of the cell 1p3 for comparison is shown at the bottom right.

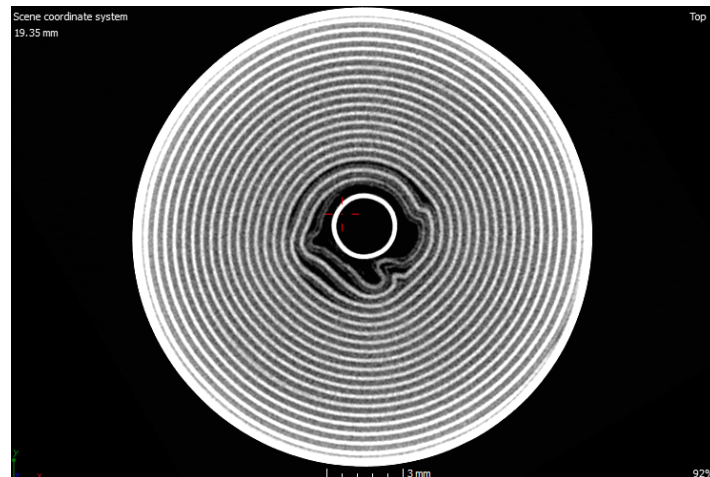
Cell 1p3, which was a direct neighbor, was surprisingly still functional. Its CT scan revealed that the CID had not been triggered yet, but it already had a larger bulge. The pressure inside the cell was not high enough to lead to a complete triggering. As well as the incipient curvature and the significantly worse electrical parameters, this cell was also significantly affected by the thermal event. When looking at the scan of the cell 1p3 more precisely, it became clear that the damage in the form of deformations inside the jelly roll was predominant. These deformations were mainly located at the beginning of the jelly roll near the mandrel (see Figure 6). These deformations led to a slight propagation into the surrounding area. However, there were no deformations in the outer area of the jelly roll. The described mechanical changes could be observed over the whole length of the jelly roll.

Figure 6. Top view CT scan of the cell 1p3. Structural changes of the jelly roll can be clearly identified.

The mentioned structural changes in the jelly roll have already been observed by other research teams. The formation of the deformation was dependent on various factors. In the investigations of Pfrang et al. [14], the position of the cathode tab, which was connected in the middle of the jelly roll, played an important role. The deformation always took place in the direction of the cathode. The reason for this was the mechanical inhomogeneity created by the cathode tab. In this work, also, the deformations were located directly at the cathode tab. As there was no inhomogeneity within the jelly roll due to the placement at the beginning of the wrap, other reasons may be responsible for the deformation in our case. The position of the anode tab did not play a significant role as it was located at the outer area of the metal housing. In this work also, the anode tab did not seem to have any influence. Another important factor influencing the deformation of the jelly roll, which was examined by T. Waldmann et al. [15], is the load current of the cell. While little to no deformation occurs at low cyclic current or during storage, a cyclic high current load has a strong influence. High loads cause thermo-mechanical stress that benefits deformation. In this experiment, the current for the cells used was chosen at 0.77 C. According to the data sheet, the cells can be discharged with 2 C and charged with 1 C. The recommended standard charge is 0.5 C. The cells therefore charged slightly faster than recommended by the manufacturer. After such a high number of cycles as in the experiment performed, deformations were therefore expected.

Due to the deformations, the compression of the active material increased in some areas. The authors concluded that at these areas of increased compression, active material was lost by detachment from the current collector or by destruction of the active material structure. These areas therefore posed an increased risk of lithium plating and dendrite formation, which could lead to cell destruction, like in the case of the cell 1p4.

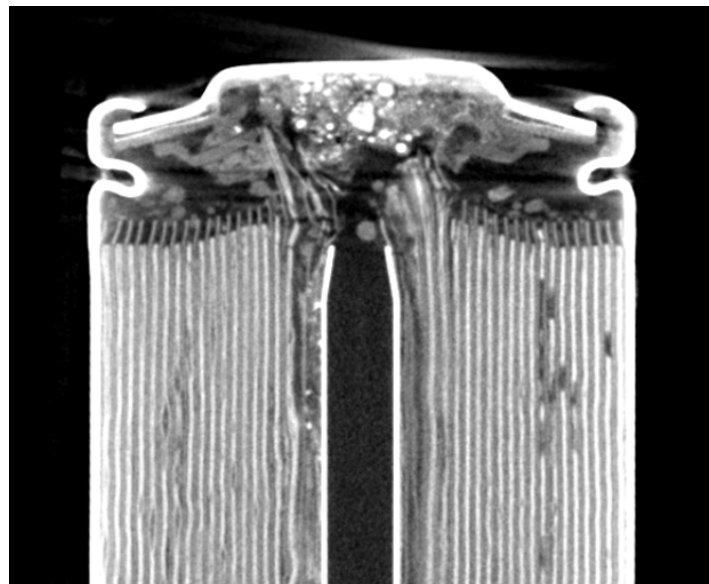
Figure 7 shows the defective cell (1p4). The jelly roll showed clear deformations caused by the thermal event. The connection point between the cathode and positive terminal was completely destroyed. The gas, which was under high pressure, dissolved parts of the material as it flowed out of the cell. Parts of the material were deposited directly under the positive terminal. Furthermore, the high pressure arched the positive terminal upwards.

The reason for the incident could be the current that was not adapted to the diminishing SOH. After significant loss of lithium and active material during the long test, lithium plating could lead to the growth of dendrites that could destroy the separator and short-circuit the cell, leading to a chain reaction.

Figure 7. CT scan of the defective cell (1p4). All security mechanisms in the upper part of the cell were destroyed. The cell winding shows a multitude of damages.

Since there were no further indications that could elucidate a malfunction at an early stage, it is advisable to use such batteries only up to 70% SOH. Furthermore, it is not clear whether a reduction of the current at lower SOH, adapted to the aging conditions, would have delayed the failure of the test and still has to be investigated. There is also the possibility that an active balancing system could have prevented the failure through targeted energy redistribution. The advantages of such a system have already been demonstrated [20].
