Article

Slope Stability Numerical Analysis and Landslide Prevention of Coal Mine Waste Dump under the Impact of Rainfall—A Case Study of Janina Mine, Poland

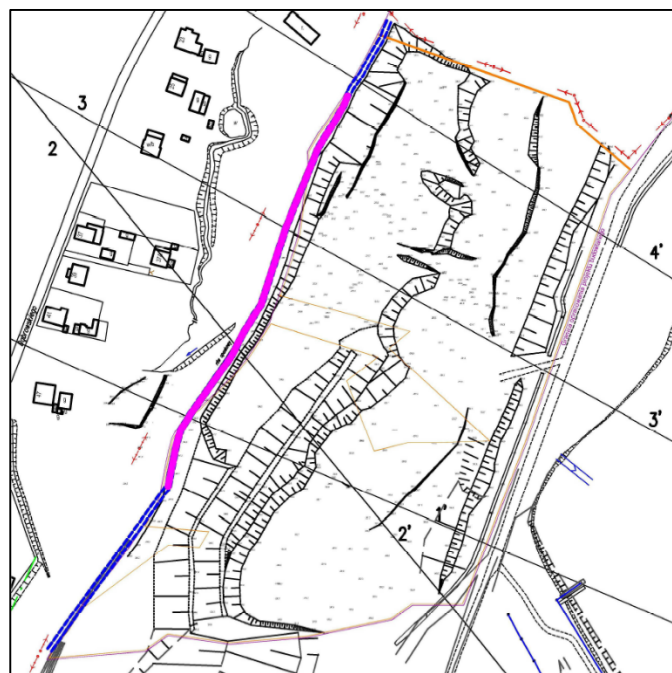
Figure 1. Location of ditch failure with a section of 300 m long, marked in pink.

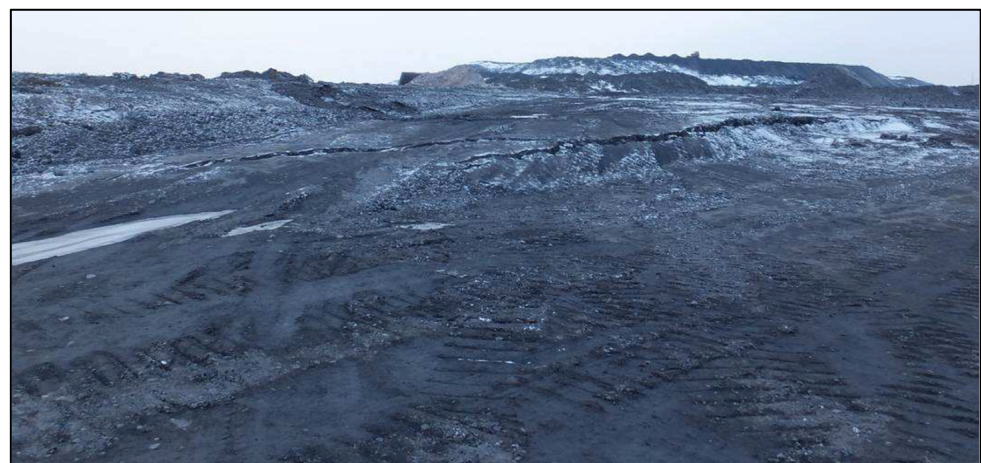
Figure 2. The failure observed on the surface of the Janina mine waste dump (10 February 2017).

In Poland, coal mine waste dumps mostly contain multi-grain sizes of claystones, mudstones, sandstones, conglomerates, carbonates, carbonaceous shales, and pyrite-bearing carbonaceous rocks [24–26]. The Janina coal mine commenced construction operations related to depositing its mining waste on the slopes in mid-2006. In the period August–November 2016, movement of the mine waste dump slope was observed in the north-western part, i.e., an approximately 300 m section of ditches has been moved away relative to the designed boundaries to the built-up areas at Dąbrowski street (Figure 1). As an element of landslide prevention, depositing operation has been stopped. In general, the geodetic measurements showed that the slope movement process has been completely slowed down. However, the increase in displacements of slope has been observed at some measuring points, where the rainfall and snowmelt water migration in the subsurface layers occurred. The effects on the slope surface started to be visible in 2017 (Figure 2).

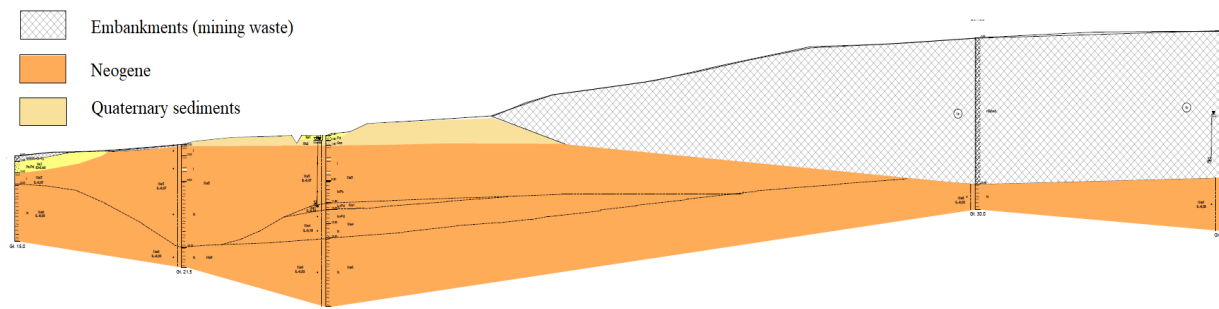
Figure 4. Overburden profile of the studied site at the Janina mine waste dump [38].

In the studied area, there are Quaternary anthropogenic sediments, embankment soils included in series I, the native Quaternary sediments represented by glacial formations included in series II, and sediments of the older Neogene subsoil, which were included in the geotechnical series III (Figure 4).

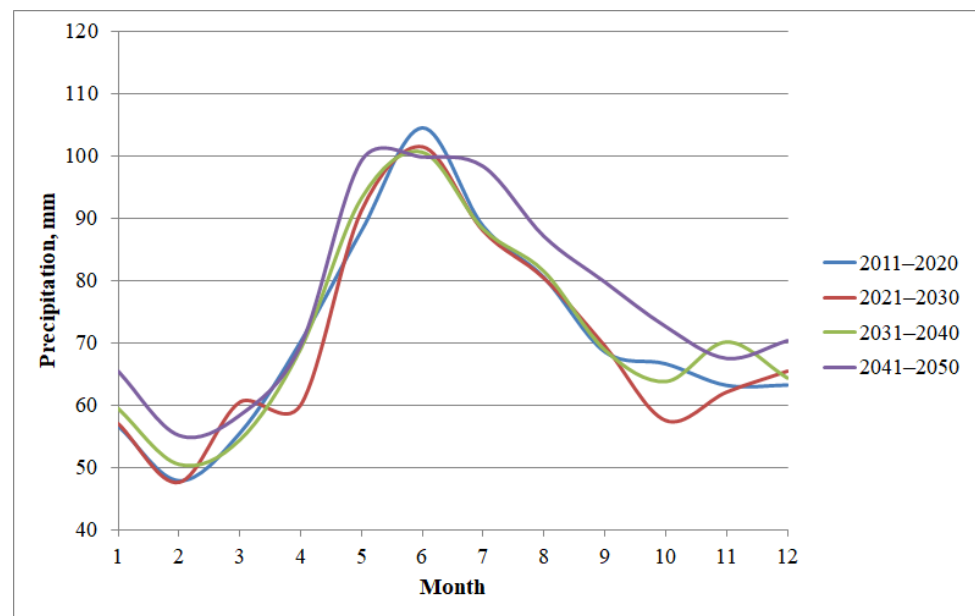
Figure 5. Average monthly amount of precipitation by decade in the Janina mine waste dump region (Chrzanowski county, Poland).

In Chrzanowski county, the average annual amount of precipitation is predicted to reach 900 mm to 2050. Maximum precipitation occurs in three months: May, June and July with the monthly value of approximately 100 mm (Figure 5).

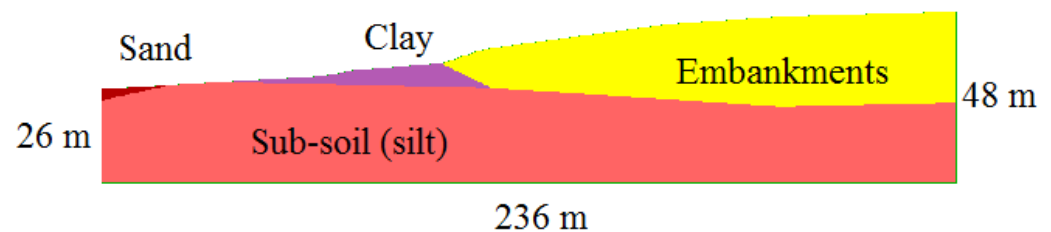
Figure 6. Model 2D and location of soil layers in slope.

Based on the given geological profile (Figure 2), a model 2D has been constructed in FLAC2D. Figure 6 shows the model 2D dimension and the location of soils that build the mine waste dumps slope. The study site includes a 236 m long (x-axis) and 26 ÷ 48 m high (y-axis) with 4 major built-in soils. All models were conducted, following typical boundary conditions for slope stability analysis: the bottom was fixed, a roller was applied to the sides of the model and the top surface was set free. The model was originally developed as an elastic model to achieve the initial stress state. Then, the displacement and velocity vectors were reset. In the next step, the initial saturation and pore pressure with a constant infiltration rate of intensity (Equations (5) and (6)) were assigned and the model was recalculated.

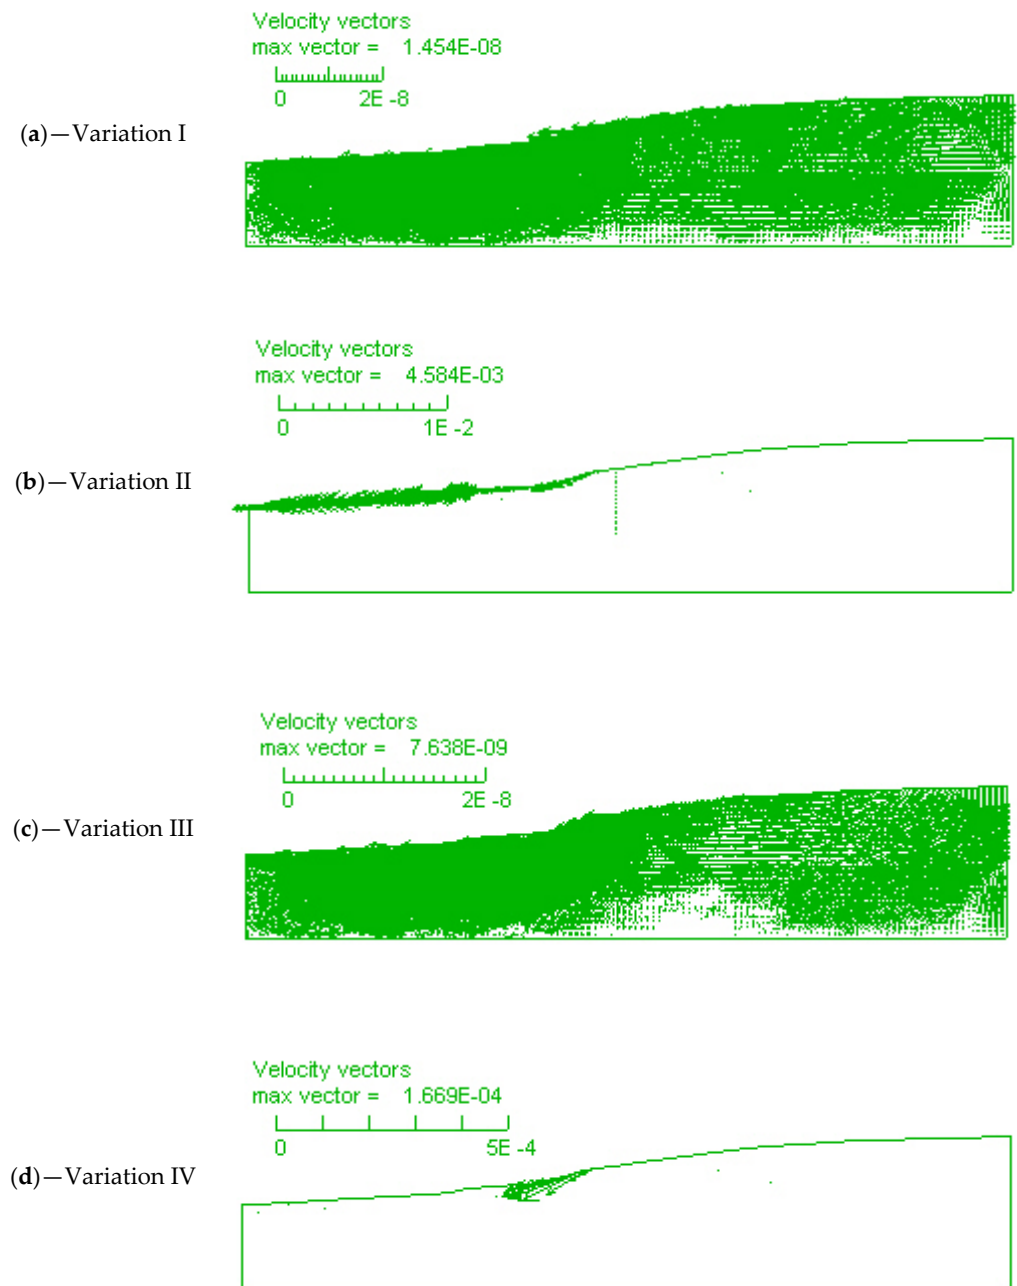
Figure 7. Maps of velocity vectors.

Values of velocity vectors for Variation I and Variation III are much less than the permissible value (10^{-5}), while values of velocity vectors for Variation II and Variation IV are greater than the permissible value (10^{-5}) (Figure 7). With the initial saturation of 0.84 (Variation IV), the potential landslide is observed on the toe of mine waste layer (Figure 7d), while in variation II, with the initial saturation of 0.89, the potential landslide occurred along the lower part of entire slope (Figure 7b). Maps of velocity vectors indicate that the slope is still stable at the end of the rainfall events in Variation I and Variation III and unstable in case of high rainfall intensity, such as variation II and IV. Moreover, higher rainfall intensity can cause a larger landslide.

Maps of velocity vectors and saturation contours are shown in Figures 7 and 8, respectively.

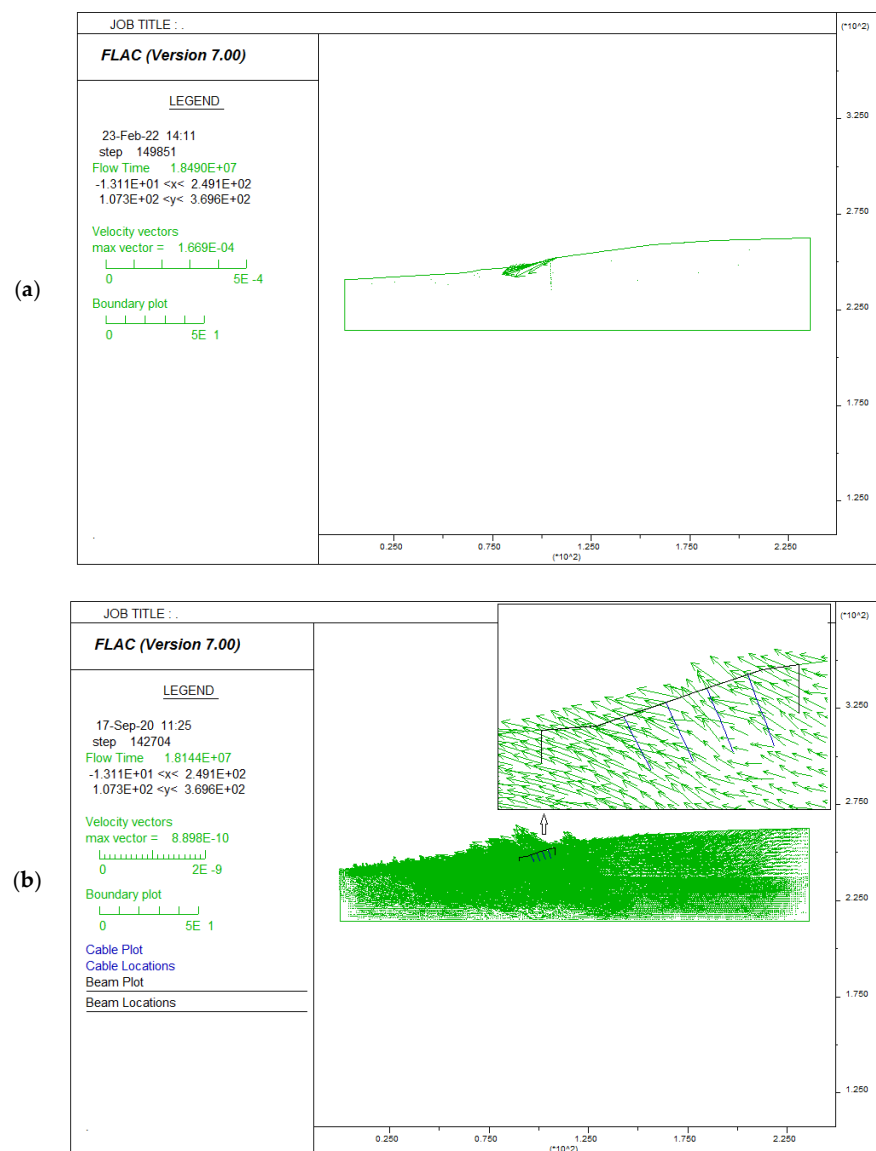
The numerical modeling results indicate the loss of slope stability under the impact of high rainfall intensity in short duration (Figure 10a)—value of velocity is higher than permissible value (10^{-5}), while slope is considered stable in case of using selected slope reinforcement (Figure 10b)—value of velocity is much lower than the permissible value.

Figure 10. Maps of velocity vectors in Variation IV as an example: (a) without any slope protection, (b) with slope reinforcement using nailing and steel mesh.

The Janina mine waste dump slope is considered stable at the end of the high intensity of rainfall in short period of time with application of selected slope reinforcement.

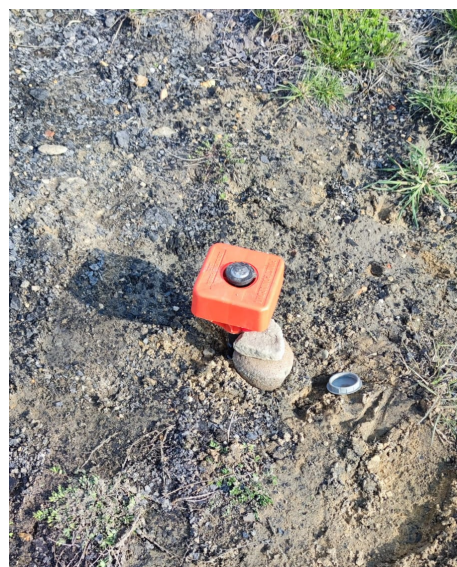
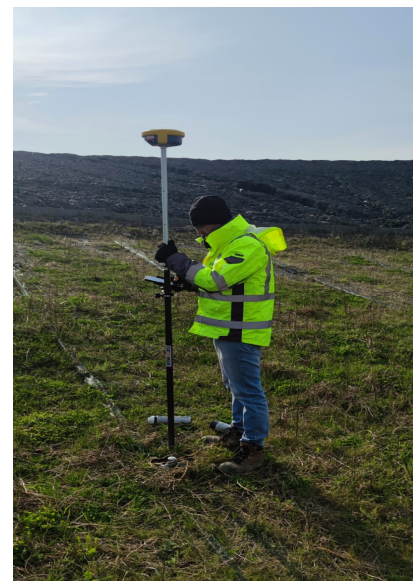
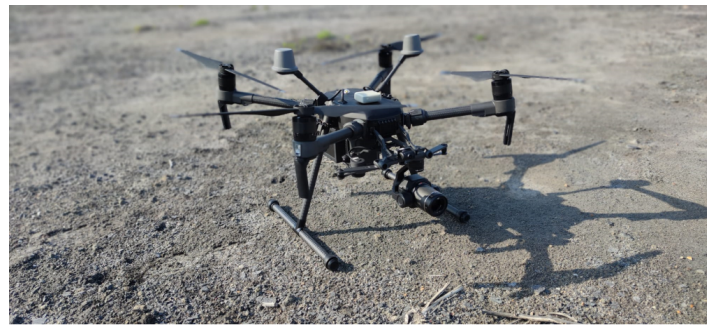
Figure 11. Slope monitoring devices: (a) Photo point, (b) GEOMAX Zenith 40 receiver, (c) Phantom 4 RTK Quadcopter.

In order to fit the point cloud into the Polish Coordinate System 2000, 11 photo points were established in the studied site (Figure 11a), then measured in 20 epochs with the GEOMAX Zenith 40 receiver (Figure 11b). After the photo points were installed, an autonomous photogrammetric flight with the Phantom 4 RTK Quadrocopter (Figure 11c) was performed from a ceiling of 40 m.

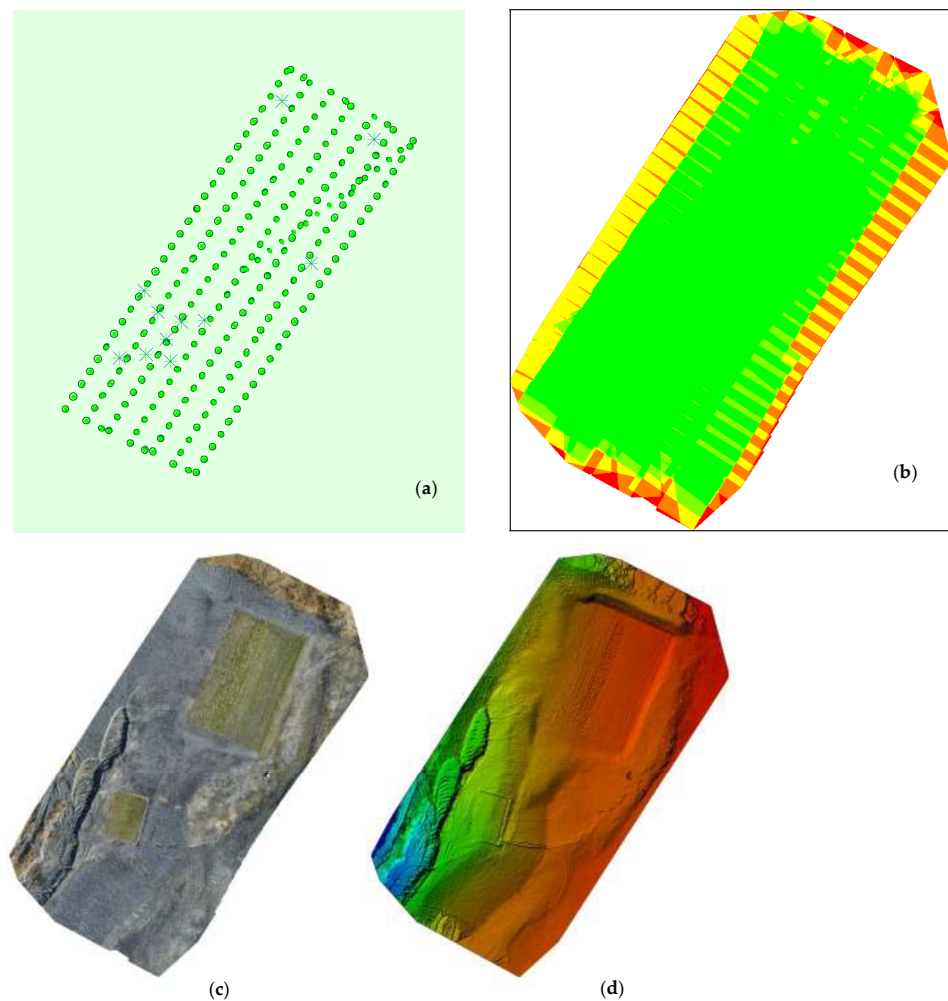
Figure 12. An example of photo processing: (a) Initial Image Positions, (b) Overlap between images (c) Orthophoto map, (d) Numerical model of studied area coverage (19 April 2022).

As a result of the photo processing from the photogrammetric flights (19 April–11 August 2022), the following results were obtained: number of photos: $217 \div 220$, median of the characteristic points found in the photos: $75,115 \div 78,484$, difference between the initial and calculated camera parameters: $2.85 \div 2.89\%$, median of the common points found per photo: $43,418.9 \div 49,612.2$, average cloud fit error: $6.8 \div 7$ mm (Figure 12).

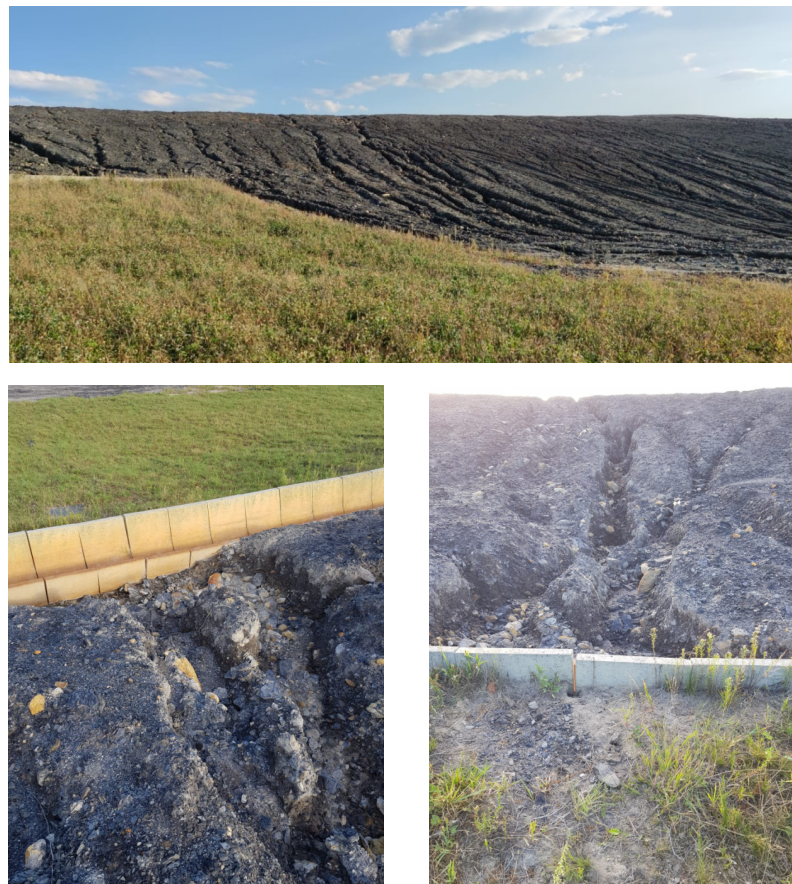
Figure 14. The applied reinforcement has prevented rainfall-induced soil erosion.

In the reinforced part of slope, no soil erosion event was observed, while in the unreinforced part of the slope, strong soil erosion was clearly noticed on the slope surface. It is the presence of raised grasses and water ditch that has stopped the discharged water from the upper part of the slope (Figure 13). The results from slope monitoring indicate that the selected landslide measures, including water drainage and anti-erosion geogrid along slope surface with humus soil and grass seeding, can prevent rainfall-induced soil erosion (Figure 14).

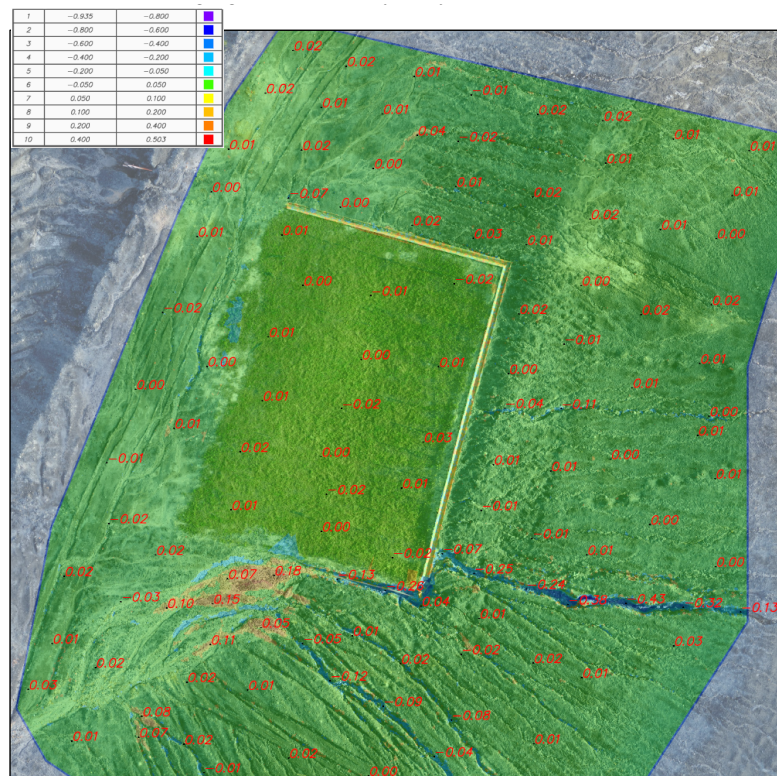
Figure 15. Map of size of increases (+) and decreases (−) on the mine waste dump slope (m).

Comparison of size of movements on the mine waste dump slope in the period from 19 April to 11 August 2022 is presented in Figure 15. It can be noted that strong soil erosion was occurred in the unreinforced part of the slope, with the size of decreases up to 0.43 m (upper part)—dark blue. The soil was displaced and accumulated around the channel of water drainage and the lower unreinforced part with the size of increases in a range of 0.2 ÷ 0.4 m (orange and yellow). A slight soil erosion was observed in the reinforced part (studied site) with the size of movements less than 0.03 m. Probably, it is due to the presence of raised grasses. It can be stated that after the rainy season (May, June and July) with an average monthly value of 100 mm rainfall, no significant movement was observed on the slope surface at the studied site, where slope reinforcement has been applied. The monitoring results confirm the numerical modeling results, i.e., slope at the studied site is considered stable after a high rainfall intensity in a short period of time, and the selected slope reinforcement is considered a proper landslide prevention method during high rainfall intensity (rainy season).
