# Insulation Degradation Mechanism and Diagnosis Methods of Offshore Wind Power Cables: An Overview

**Keywords:** offshore wind power; mechanical stress; torsion-resistant cable; submarine cable; deterioration mechanism

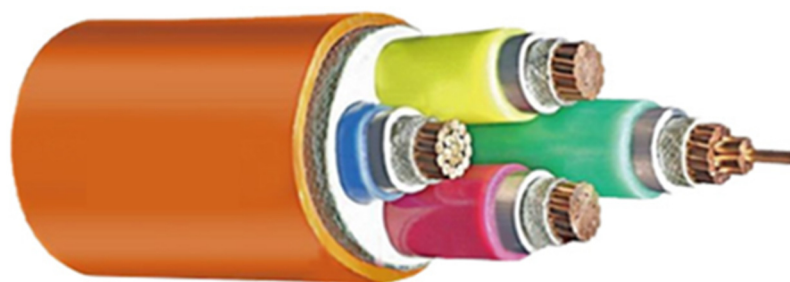
**Figure 2.** Torsion-resistant cable for wind power generation.

Offshore wind turbines are located in a very complex and harsh marine environment, subject to a variety of random loads that vary with time and space, including strong winds, currents, tides, etc., and are also subject to the threat of earthquakes and the impact of human activities. Wind power cables in the long-term torsion process, the main insulation due to fatigue stress cracking, seriously affect its service life. Cables for wind turbines are divided into power cables, control cables, and grounding cables, which are mainly used for the transmission of electrical energy as well as control signals and safety protection of the unit in the generator, control cabinet, and box transformer [9]. The semi-conductive shield is an important structure of the cable, which plays the role of a uniform electric field and makes the connection between the conductor and the insulation layer tighter, and is an indispensable part of the cable [10]. The semi-conductive layer of the cable is highly susceptible to damage during twisting, resulting in damaged insulation. Therefore, the cables used in wind turbines must have excellent performance to ensure that they can maintain excellent electrical transmission performance and mechanical properties in the harsh external environment. Figure 2 shows the current torsion-resistant cables produced by domestic manufacturers.

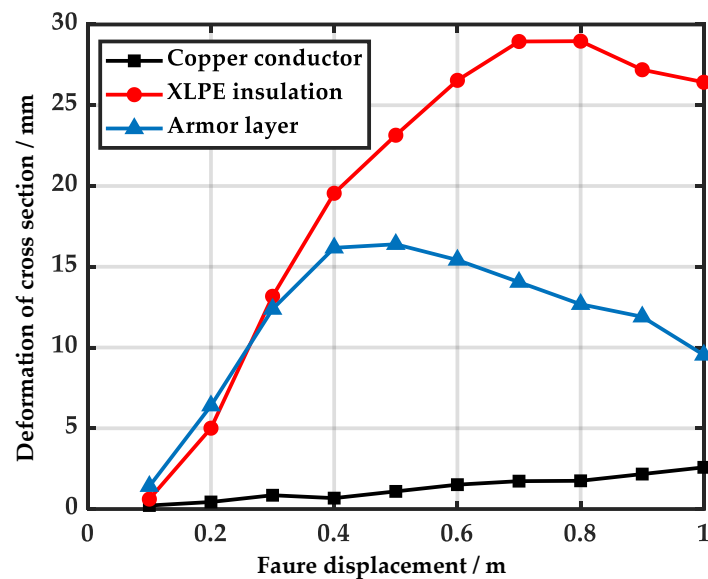
**Figure 5.** Deformation of submarine cable cross-section at the fault surface [22]. The black curve indicates the copper conductor, the blue curve indicates the galvanized armor layer, and the red curve indicates the XLPE insulation. When a slip fault occurs, the structural deformation of each layer of the submarine cable is different, and the damage caused to it is also different.

When the fault displacement is less than 0.3 mm, the cross-sectional deformation of the XLPE insulation layer and armor layer is roughly the same region, but with the increase of the misalignment displacement, the deformation of both is not synchronized. The stiffness of galvanized armor layer is larger than that of the insulation layer, so it is not easy to deform, and the amount of misalignment displacement is too large, which will

lead to delamination between the main insulation and the armor layer of the cable, forming uneven electric field and affecting the electrical performance of the submarine cable.

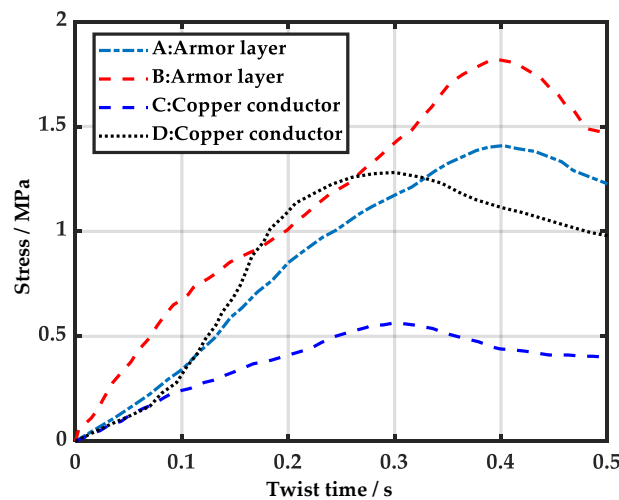
**Figure 9.** Submarine cable structure stress time course curve [41]. The A curve is the stress time course curve for the counterclockwise twisting of the armor layer. The B curve is the stress time course curve for the clockwise twisting of the armor layer. The C curve is the stress time course curve for the counterclockwise twisting of the copper conductor. The D curve is the stress time course curve of the copper conductor twisted clockwise.

During the clockwise twisting process, the structural stresses show a trend of increasing and then decreasing, reaching the maximum value at 0.39 s and 0.28 s, respectively. During the counterclockwise twisting process, the structural stresses also show a trend of increasing and then decreasing, reaching the maximum value at 0.40 s and 0.30 s, respectively, while the peak value of the armored wire is larger than that of the clockwise twisting result, and the peak value of the copper conductor is the peak value of the armor wire is larger than the clockwise torsion result, and the peak value of the copper conductor is smaller than the clockwise torsion result.

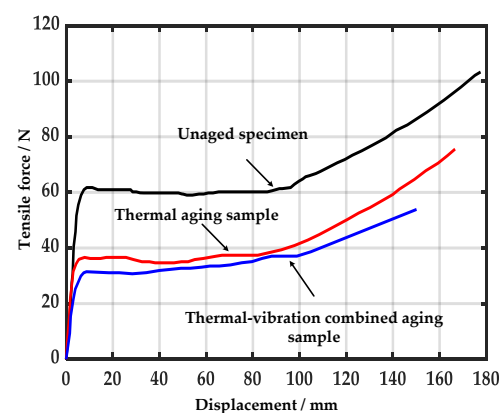
**Figure 10.** Tensile test results of XLPE samples under 1440 h aging [55]. The black curve indicates the specimen without aging, the red curve indicates the thermal aging specimen, and the blue curve indicates the combined thermal-vibration aging specimen. The mechanical stress generated by vibration will cause the aging of XLPE, which makes the XLPE specimen less elastic and easy to be destroyed.

Tensile tests were conducted on the constant temperature-vibration samples and constant temperature samples under the aging time of 1440 h, and the results are shown in Figure 10.

Under the action of vibration load, the XLPE cable is aged, resulting in the molecular bonds of the material being shifted, and when deformation occurs, some of the molecular chains in XLPE stretch and fracture due to stress. The material hardens and is easily destroyed, and the cable specimens' mechanical properties decline significantly.

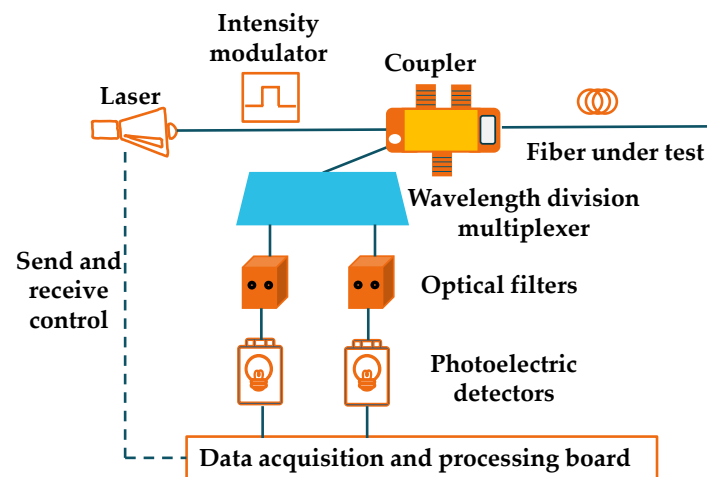
Figure 13. The typical system architecture of ROTDR.

During actual operation, the temperature of the cable body changes, affecting the characteristics of the insulation [64,65]. When a cable fails, the temperature at the defect rises, and early warning of abnormal cable temperatures can prevent its long-term operation in an overheated state, and Raman optical time-domain reflection technology can measure the temperature of optical fibers in submarine cables in real time. Figure 13 shows the structure of the temperature measurement system.

Raman scattering is the frequency shift of scattered light when injected photons interact with fiber molecules, including Stokes scattered light and Anti-Stokes scattered light. Among them, Anti-Stokes is more sensitive to temperature, and the light intensity is linearly related to temperature, so Anti-Stokes can be used as a signal channel and Stokes as a comparison channel, and the ratio of the two intensities is applied to adjust the temperature, and the absolute temperature value can be calculated. When using Raman optical time domain reflection technology to monitor the cable temperature, the measurement distance can reach 60 km, and the control unit triggers the laser to generate light pulses through the coupler into the fiber; the wavelength division multiplexer separates the backscattered light into Anti-Stokes component and Stokes components after filtering the photodetector collects the characteristic signal with temperature, and finally, after filtering, the photodetector acquires the characteristic signal with temperature and finally obtains the real-time temperature.

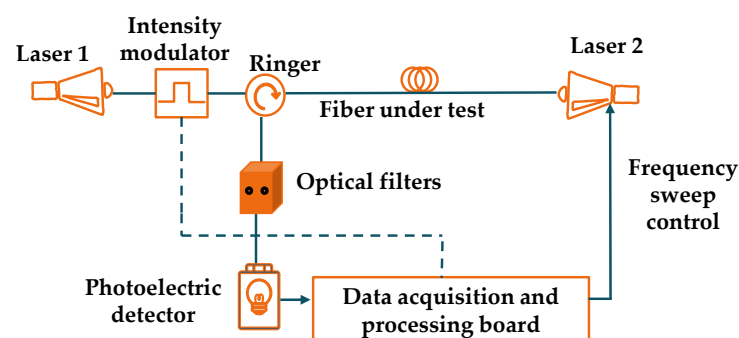
Figure 14. Typical system structure of BOTDA.

External forces can cause local stress anomalies in submarine cables, and Brillouin optical time domain analysis technology can measure and locate the temperature and strain of optical fibers in submarine cables. Backward Brillouin scattering in optical fibers is the scattering caused by the interaction of incident light with acoustic waves in the fiber, and the scattered light undergoes a frequency shift called Brillouin frequency shift [66]. Scattering can be divided into spontaneous Brillouin scattering and excited Brillouin scattering, and thus distributed fiber optic sensing techniques based on backward Brillouin scattering can be divided into optical time-domain reflectometer and optical time-domain analyzer. The optical time-domain analyzer utilizes the exciting Brillouin scattering principle, which improves the signal-to-noise ratio and enables a significant increase in monitoring distance and accuracy.

The magnitude of the Brillouin frequency shift is proportional to the speed of sound in the fiber, and both the refractive index and the speed of sound in the fiber are related to factors such as the temperature of the fiber and the stress to which it is subjected, which makes the Brillouin frequency shift vary with temperature and stress [67]. The system structure of the Brillouin light time-domain analysis technique is shown in Figure 14, where laser 1 at both ends of the fiber under test generates pump light, and laser 2 generates probe light injected into the sensing fiber. When the frequency difference between the pump light and the probe light is close to the Brillouin frequency shift of the fiber to be measured, the power of the pump light is transferred to the probe light based on the Brillouin effect, and then the Brillouin frequency shift of the fiber to be measured can be obtained by sweeping the probe light so that the strain distribution at the scattering location can be obtained according to the linear relationship between the frequency shift and the strain [68].

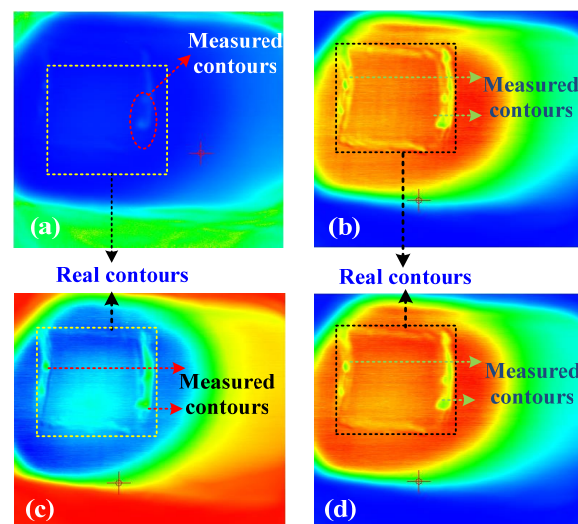
**Figure 21.** Top-view of time-domain THz images of the testing sample under different modes [75]. (a) Absorption spectrum imaging at 0.476 THz; (b) Maximum-peak imaging; (c) Minimum-peak imaging; (d) Peak-peak imaging. At the same time, this delamination also leads to moisture intrusion, causing the insulation of the cable to deteriorate with moisture and form water dendrites. After a long period of operation, the dendrites develop and eventually lead to the breakdown of the main insulation of the cable terminals. Shuaibing Li et al. similarly used the terahertz technique to detect the moisture inside the insulation [73]. In the inspection of the samples, it was found that the results of the terahertz frequency domain spectrum test could determine the presence of moisture inside the insulation, but the region of moisture could not be determined, so terahertz imaging was used to determine the region of moisture. In their study, the imaging bands were chosen to be 0.623 THz and 1.648 THz. The imaging results of samples with different viewing angles are shown in Figure 22.

To accurately locate the defective region of air gap delamination, the homemade samples were imaged in the time domain with maximum-peak imaging, minimum peak imaging, and peak-peak imaging, respectively, and compared with the imaging results in the frequency domain. The test results using these four imaging modes are shown in Figure 21. The time-domain imaging results are much better than the frequency-domain imaging results in achieving the characterization of the defect size, as the contours of the air gap delamination defects can be found in the figure.

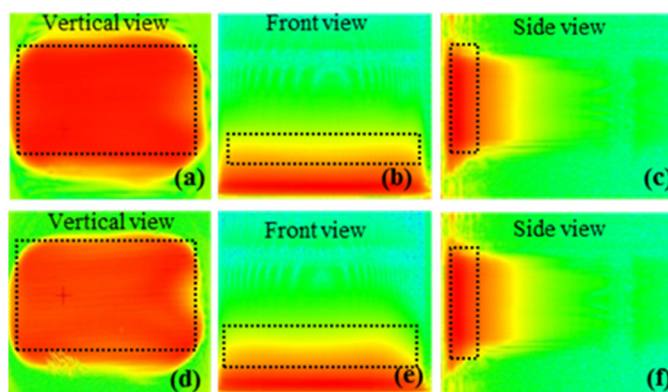
**Figure 22.** Frequency-domain imaging for artificial test samples [73]. (a–c) Three-view imaging results at 0.623 THz; (d–f) Three-view imaging results at 1.648 THz.

The red region is the region where the moisture is located due to the strong absorption of terahertz waves by moisture or water, resulting in a weak intensity of the reflected terahertz waves. The geometry of the moist region can be reflected from different angles by the three-view of the frequency domain imaging, which is shown by the black dashed rectangle in Figure 22. In practice, the area of the imaging result is larger than the actual area due to the diffusion of moisture in the sample. To further show the diffusion of moisture inside the insulation, absorption spectral imaging, maximum-peak imaging, minimum-peak imaging, and peak-peak imaging were also performed. The imaging results are shown in Figure 23.

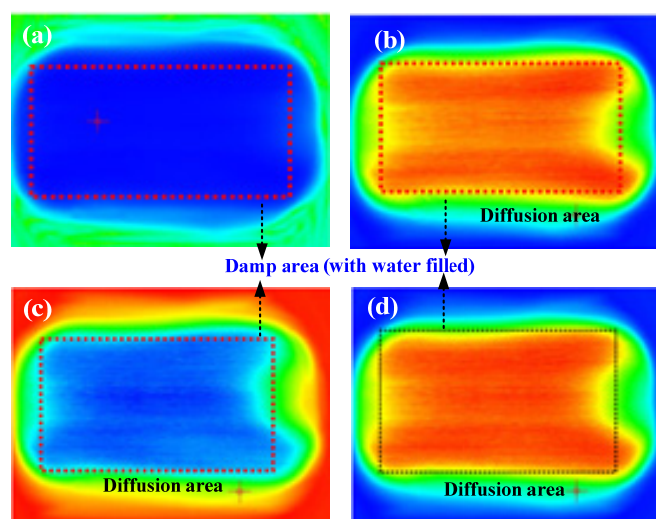
**Figure 23.** Terahertz images of the test sample under different imaging modes at 0.842 THz [73]. (a) Absorption spectrum imaging; (b) Maximum peak imaging; (c) Minimum peak imaging; (d) Peak-peak imaging.

The yellow area and the green area are the moisture diffusion area. Absorption spectral imaging, maximum peak imaging, and minimum peak imaging can show the actual moist area and the water diffusion areas.
