Article

Analysis of Physical and Mechanical Properties of the Mortar in the Historic Retaining Wall of the Gediminas Castle Hill (Vilnius, Lithuania)

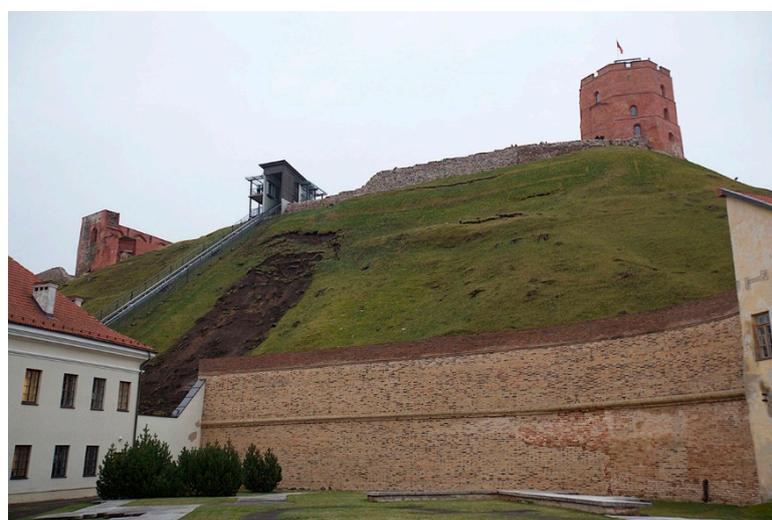
Figure 1. Restored Gediminas Castle Hill retaining wall and its cross section [20]: (a) restored Gediminas Castle Hill retaining wall; (b) wall section: 1 is the remaining part of the wall, 2 is the restored part of the wall, and 3 is the surface of the hill; and (c) locations of boreholes (1V, 2V, and 1H).

The retaining wall of the Gediminas Castle Hill is a gravity wall of variable thickness. The length of the wall leaning into the hill is approximately 42 m. The thickness of the wall is 3.2 m at the bottom and 2.8 m at the top. The height of the wall including the parapet is approximately 9 m [20]. The section drawing of the retaining wall is presented in Figure 1 [6]. The retaining wall was restored in 1962 according to the design of architect Sigitas Lasavickas [20].

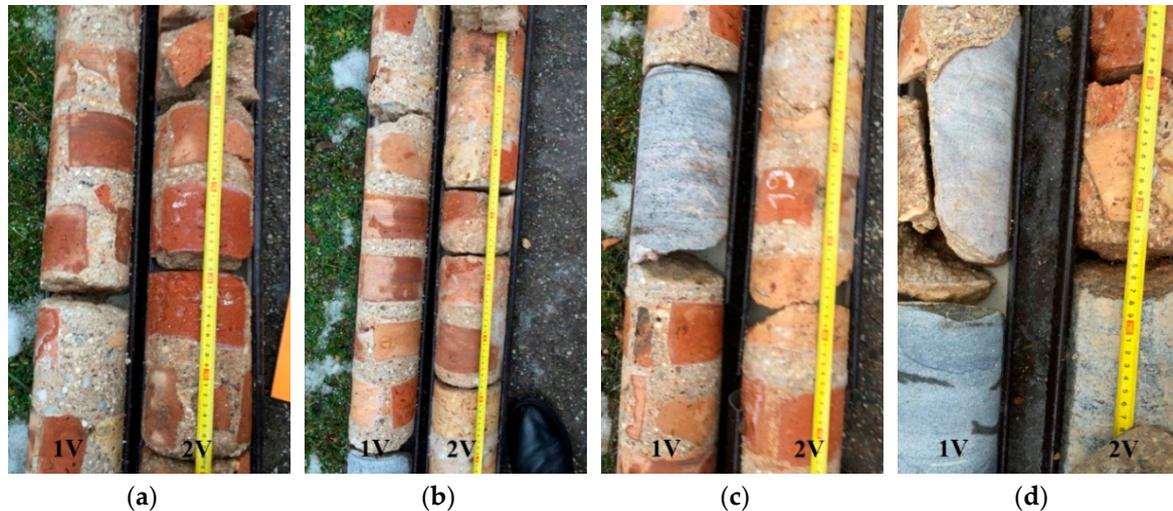
Figure 2. V1 and V2 bore samples. Depth of the borehole for the samples: (a) 2.6–3.0 m, (b) 3.0–3.7 m, (c) 3.7–4.2 m, and (d) 5.7–6.0 m.

Two vertical boreholes (1V and 2V) were drilled approximately 9 m deep along the entire height of the wall (pictures of the core samples are illustrated in Figure 2) and one horizontal borehole (1H) was drilled along the entire width of the wall (Figure 3).

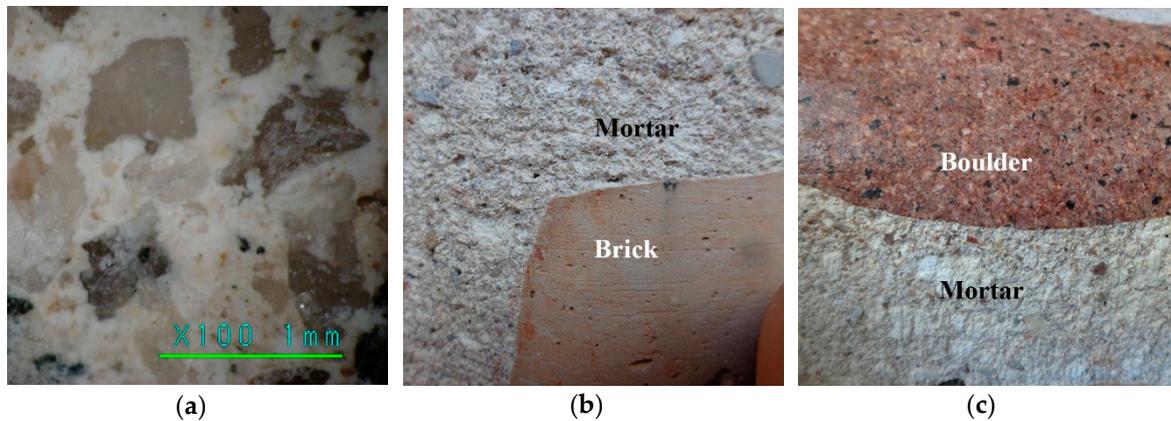
Figure 4. Contact zone between bricks, boulders, and mortar: (a) aggregates and lime mortar, (b) lime mortar and bricks; and (c) lime mortar and boulders.

The analysis of the core samples revealed good contact between the binding material and aggregates and very good coverage of the aggregate particles within the binding material layer. This can

be seen from picture done with portable digital microscope DG-3x (Scalar Corp., Tokyo, Japan). in Figure 4a. The same can be said about the quality of the contact between mortar and bricks (Figure 4b), and mortar and boulders (Figure 4c) from pictures taken by a Sony digital camera (Sony Corp. DSC-W730, Shenzhen, China).

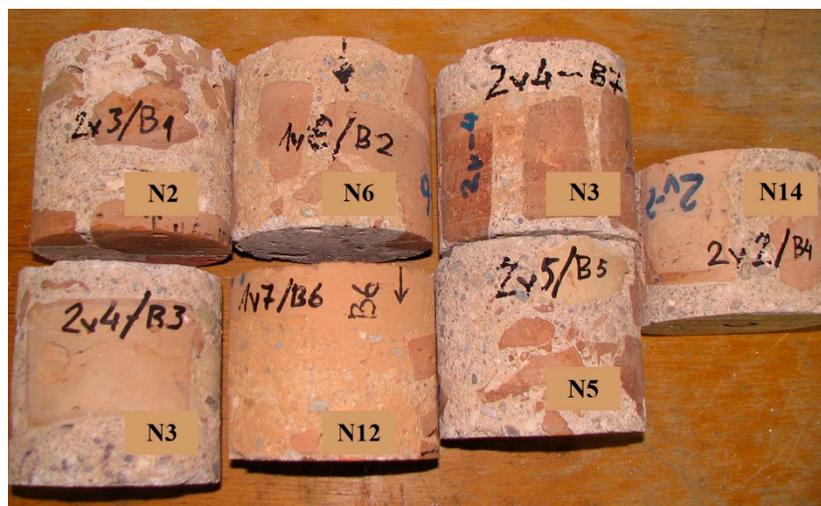
Figure 5. Specimens for compressive strength testing.

Test specimens of mortar containing brick crumble aggregates, bricks and mortar (Figure 5) were cut from the core samples (Figure 3). The compressive strength of the mortar containing brick crumble aggregates was measured by testing specimens 115 mm in diameter and 115 mm in height (Figure 5) according to LST EN 12504-1 standard [21], while the density was measured according to LST EN 12390-7 standard [22].

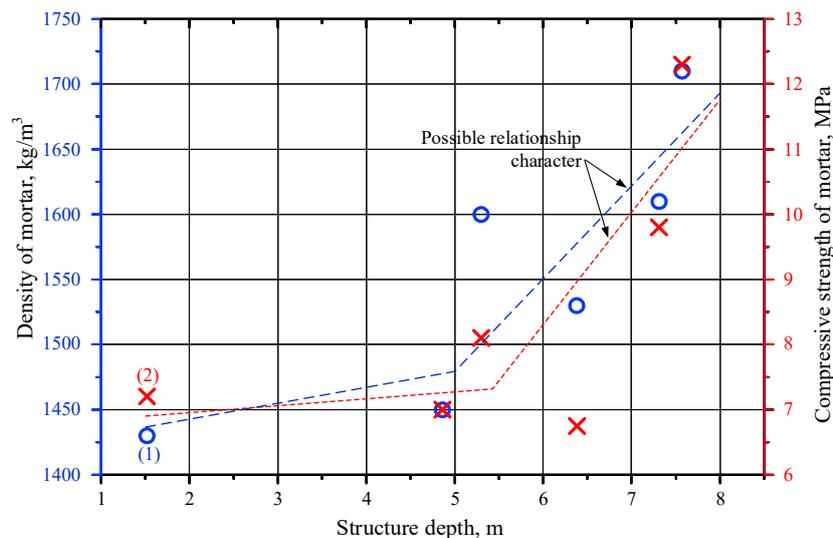
Figure 6. Relationship between mortar density and structure depth (1), and compressive strength and structure depth (2).

The average compressive strength of the mortar was 8.5 MPa (variation 25%). Mortar specimens cut from core sample N11 (borehole 2V) obtained from a 7.31–7.57 m depth had the highest compressive strength of 12.3 MPa. Tests of mortar specimens cut from core samples obtained from different depths revealed that the density and compressive strength of the mortar from the deeper layers were higher (Figure 6). We observed an increasing trend for the density and compressive strength of the mortar as the collection depth of the sample increased.

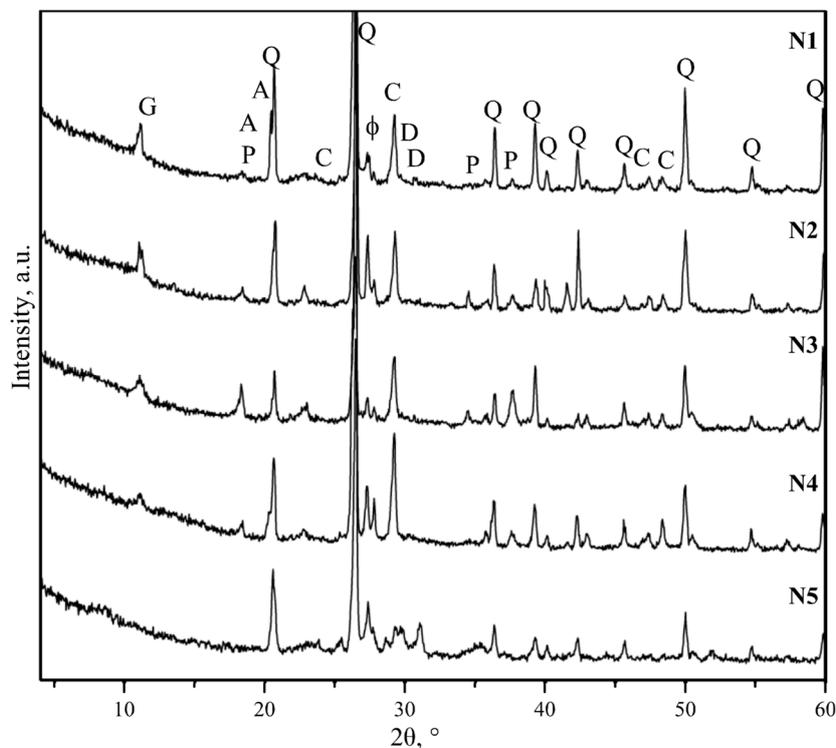
Figure 7. Diffraction curves of tested specimens (N1–N5): C—calcite, Q—quartz, ϕ —feldspar, G—gypsum, P—portlandite, A—gibbsite, and D—dolomite.

The qualitative phase analysis of the mortar (Figure 7) showed that the same minerals were clearly identified in all specimens: quartz (SiO₂), calcite (CaCO₃), portlandite (Ca(OH)₂), gypsum (CaSO₄·2H₂O), feldspars (KAlSi₃O₈–NaAlSi₃O₈–CaAl₂Si₂O₈), gibbsite (Al(OH)₃), and dolomite (CaMg(CO₃)₂). Weakly expressed amorphous hump between about 20° and 30° 2θ also observed in all samples. This hump apparently indicates the presence of poorly crystalline calcium silicate hydrate phase (C-S-H) [27].

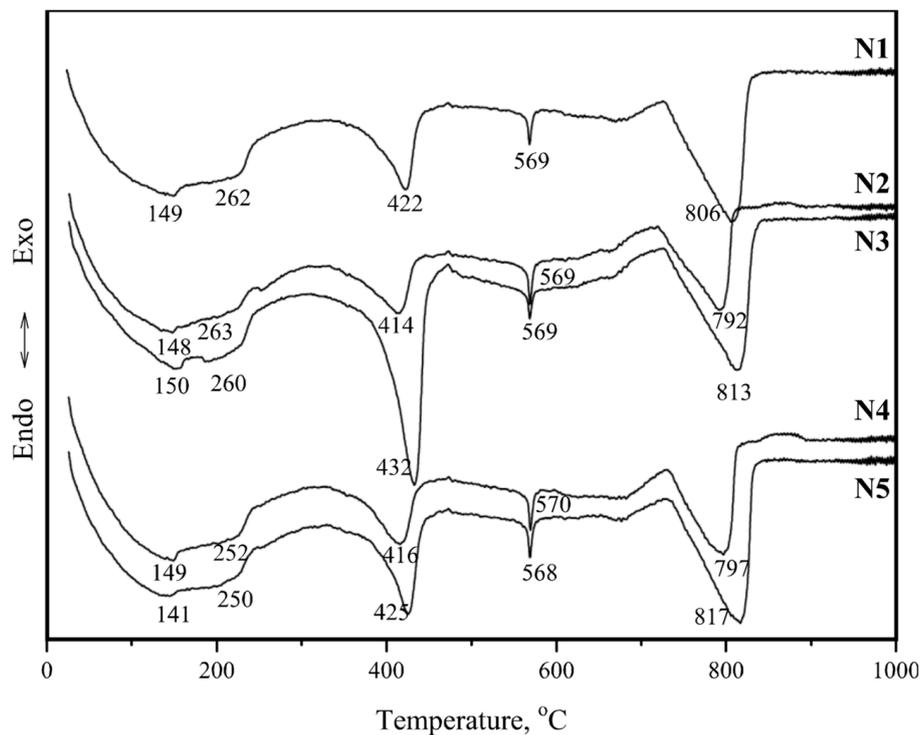
Figure 8. DTA curves of tested specimens (N1–N5).

Figure 8 illustrates the differential thermal analysis (DTA) curves of the mortar specimens. The weight loss values in different temperature ranges obtained from the thermogravimetric (TG) curves are presented in Table 5. All tested specimens produced five endothermic peaks in the 140–150, 250–263, 410–430, 568–570, and 790–820 °C temperature ranges (Figure 8).

According to Moropoulou, et al. [28], the endothermic peak at approximately 100 °C was related to the removal of the physically absorbed water. The endothermic peak at 120–200 °C was characteristic for gypsum dehydration. The first endothermic peak at 140–150 °C might be seen as the total (cumulative) effect corresponding to the removal of hygroscopic water and gypsum dehydration. The weight losses of the specimens (Table 5) indicated that approximately 1% of the hygroscopic water was removed from the specimens in the 50–120 °C temperature range and approximately 1% was removed in the 120–200 °C range, apparently due to gypsum dehydration.

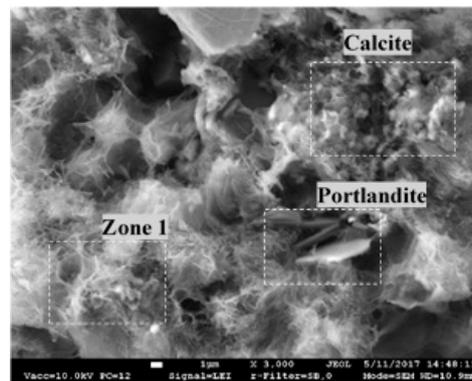
Figure 9. Representative image of the binding material in the tested mortar specimens.

A representative image of the binding material in all specimens obtained by SEM analysis is presented in Figure 9. The image reveals the prevalence of rhomboid-shaped calcite minerals, and fibre-shaped low crystalline C-S-H or C-A-S-H (Zone 1). Plate-shaped formations typical for portlandite are also observed.

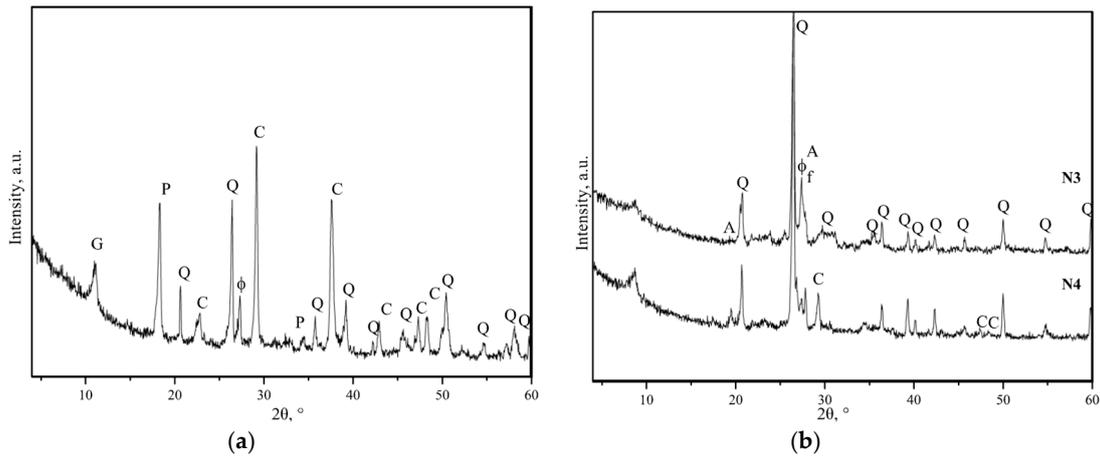
Figure 10. Diffraction curves of aggregates in the mortar: (a) white inclusions and (b) ceramic brick crumbles: C—calcite, Q—quartz, φ—feldspar, G—gypsum, P—portlandite, A—gibbsite, and D—dolomite.

Calcite, quartz, feldspars, gypsum, and portlandite were identified by subjecting the specimens to diffraction analysis (Figure 10a). The results suggested that the white inclusions in the mortar could have been caused by lime lumps (as well as previously defined in historic buildings [6]).

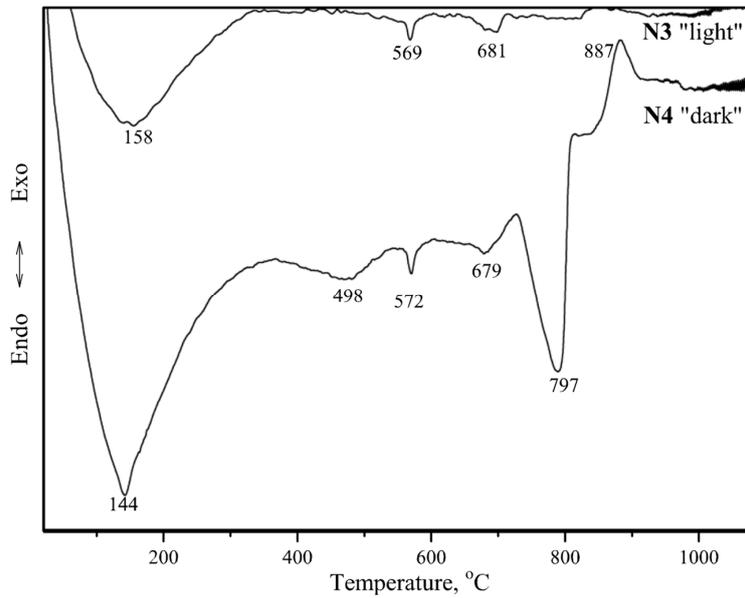
Figure 11. DTA curves of brick crumbles.

The DTA curves of the tested specimens (Figure 11) revealed five endothermic peaks (at approximately 140, 500, 570, 680 and 800 °C) and one exothermic peak at 887 °C for the dark-coloured ceramic brick crumbles, specimen N4, and only three endothermic peaks at approximately 160, 570, and 680 °C for the light-coloured brick crumbles, specimen N3. The endothermic peak at 800 °C in the DTA curve of specimen N4 could be attributed to the calcite decomposition, which was also identified by X-ray tests (Figure 10b). This mineral was not identified in the light-coloured brick crumbles used as mortar aggregates. Thus, the light-coloured ceramic was fired at high temperatures (the calcite present in the clay disintegrated), while the dark-coloured ceramic was apparently fired at temperatures below 800 °C (calcite was still present). Studies on the clay extracted from Lithuanian quarries [36] indicated that the local clay fired at 600 °C presented pozzolanic properties.

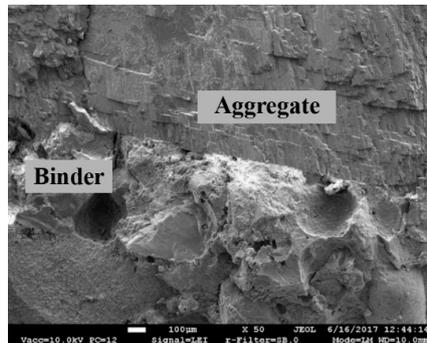
Figure 12. Contact zone between the brick crumble aggregate and binding material in the mortar (specimen N4).

The surfaces of crumbles investigated in this work demonstrated good pozzolanic activities and helped create good contact between the mortar and brick crumbles (Figure 12).
