Article

Effectiveness of Reinforcing Bent Non-Uniform Pre-Stressed Glulam Beams with Basalt Fibre Reinforced Polymers Rods

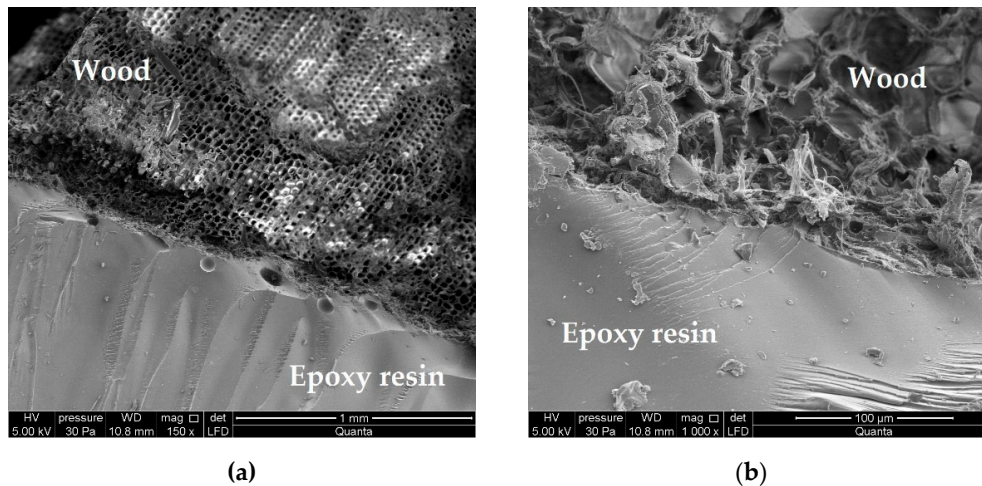
the tracheid with funnel-shaped lacunae is arranged in parallel, which strengthens the connection's adhesion. This is important in the scheme of junction destruction and the obtained shear bearing capacities. It can be added that the “wood–glue–rod” composition is caused by the non-uniform structure of wood, rod and the properties of the applied glues and by the transfer of shear forces to the beams' microstructural elements [45].

Figure 1. Microstructure of the connection of the LG 385 + HG 385 epoxy resin and *Pinus Sylvestris* L. wood in the beam reinforced with basalt rods, subjected to five-year atmospheric impact and biological degradation: (a) 150× zoom, (b) 1000× zoom.

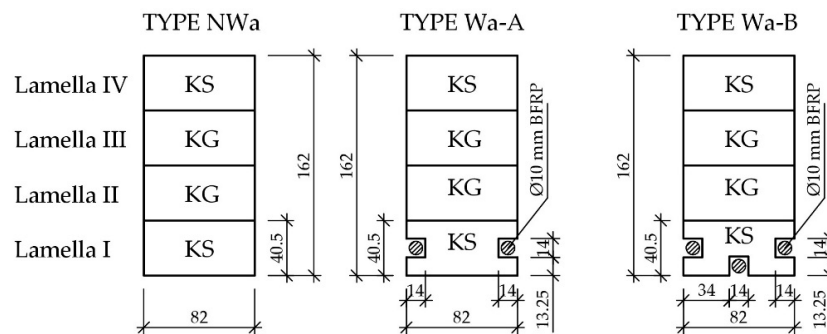
× 162 mm. They consisted of four sawn wood lamellas with various quality class configurations. The cross-sections of the analysed beams are presented in Figure 2.

Figure 2. Transverse cross-sections of “Wa” type beams [dimensions in mm, KS—medium quality class, KG—lower quality class].

The beams made from the elements with various wood quality configuration (see Figure 2 in Section 3) were characterised by structural and geometrical features that were catalogued separately for each testing model. An example of the testing elements' description is provided in Table 2 for one non-reinforced and one reinforced beam. The location of the extensometer bases on individual lamellas is shown in Figure 4 in Section 3.

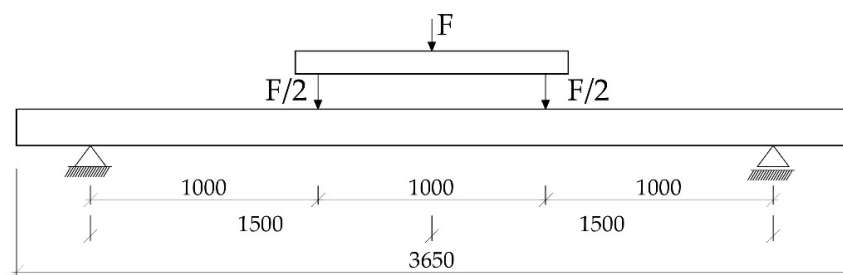
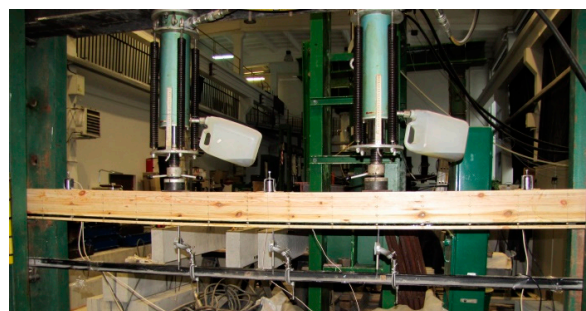
The beams supported freely on both ends were loaded symmetrically, in two points with concentrated forces. Figure 3 presents the wooden beams’ loading plan during the bending test. The vertical displacement measuring sensors were mounted after placing the beams on the strength testing machine’s supports. Each adopted load level featured a reading of displacements and deformations. Another reading was conducted after 20 min. Then, the testing featured relief to the earlier level and repeated reading, then the samples were loaded to the next force level [45]. This scheme was adopted considering the beam’s actual working and the displacement increment over time.

Figure 3. (a) Testing station plan: static scheme [dimensions in mm], (b) view of the test stand for the Wa-B2 beam.

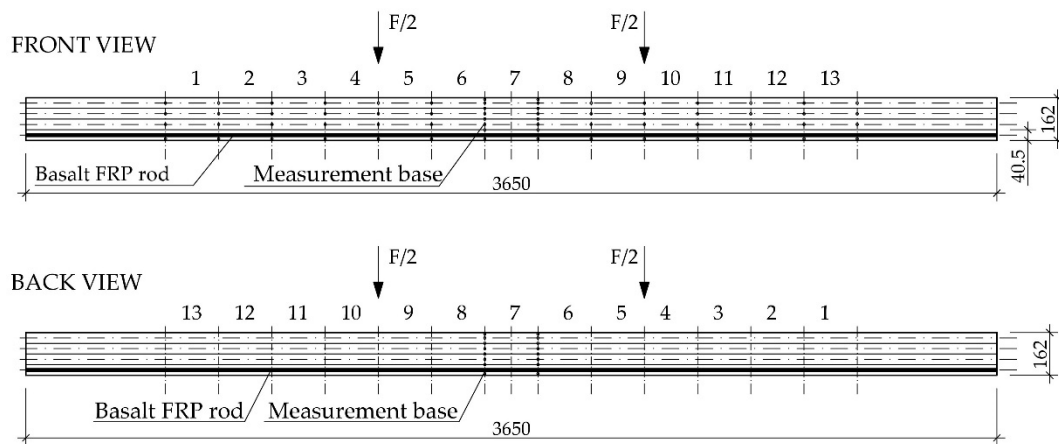
The testing featured recording of the loading force and displacement, in the midspan and symmetrically, in relation to the beam's centre in a 5 h span according to PN-EN 408+A1:2012 [59] (see Figure 5), for particular loading levels with simultaneous measurement of wood deformation and fibrous composites' deformation using a mechanical extensometer with the measuring base of 203.2 mm (8 inches), according to the distribution presented in Figures 4 and 5 [45].

Figure 4. Arrangement of measuring bases in the front and back of the reinforced beams [dimensions in mm].

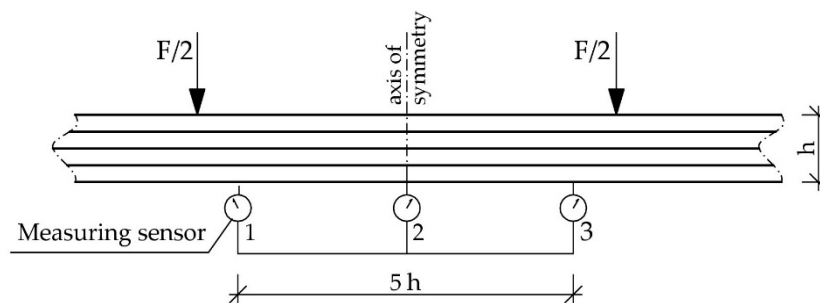
Figure 5. Arrangement of measuring sensors.

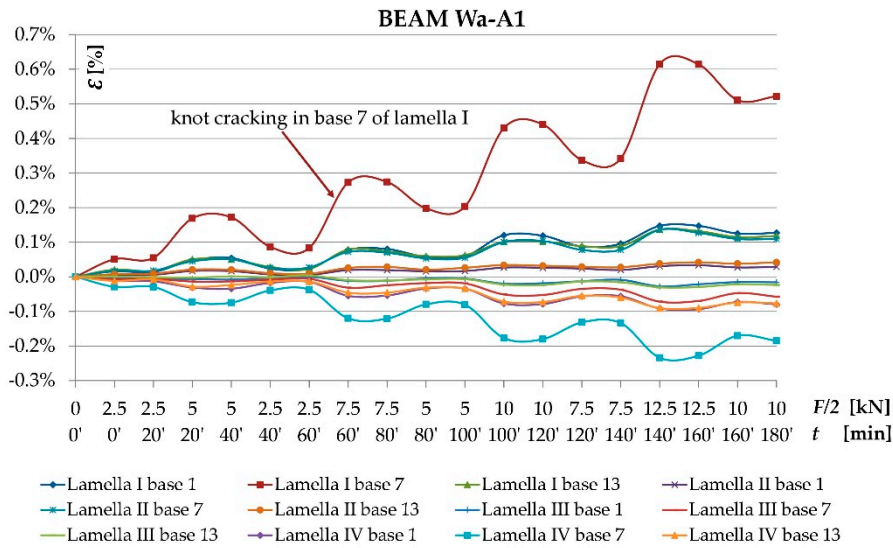
Figure 6 shows the dependence of tensile and compressive deformations on loading forces in time measured by extensometer at individual bases along the length of a wooden beam. Tensile deformations included lamellas I and II, while compressive stresses—lamellas III and IV. Bases 1 and 13 were located at the support zones, and base 7—at the center of the beam span. As can be seen, in the middle of the beam span (base 7) of the tensile zone (lamella I) there was a significant increase in tensile deformation of wood caused by the increasing knot cracking at 10 kN load.

Figure 6. Chart of ϵ [%] and $F/2$ [kN]—including time during loading dependency for the Wa-A1 reinforced beam.

The uneven distribution of deformations and normal stresses were caused by the occurrence of wood flaws, such as, among others, knots, spiral grain, burls, cracks, uneven growth ring width [Figures 6 and 8] and local loosening of glue from the rod [Figures 7 and 9]. In non-reinforced beams,

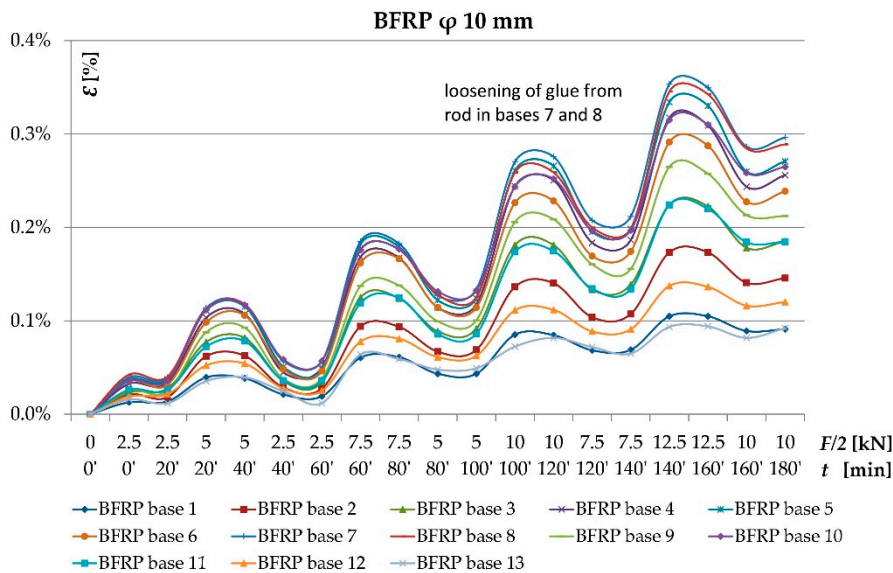
Figure 7 shows the dependence of tensile deformations on loading forces in time for all bases along the length of the basalt rod located in the lamella I. One can notice the uniform distribution of tensile deformations in the BFRP rod and the elastic work of the fiber composite despite the weakening in the wood. Only a slight increase in tensile deformations occurred at bases 7 and 8 (beam span center) at 20 kN load due to the adhesive detaching from the rod.

Figure 7. Chart of the BFRP rod's ϵ [%] and $F/2$ [kN]—including time during loading dependency for the Wa-A1 reinforced beam.

the wood flaws substantially affected the destruction form (especially in the beam's stretched zone), whereas in reinforced beams, it was the fibrous composites that substantially affected the beam's destruction form. The wood destruction was firstly visible in the compressed zone. The BFRP rod substantially limits the impact of flaws located in the beam's bottom part on the form of the beam's destruction. The fibrous composites intercepted the tensile forces and limited the deformations of lower wood fibres [45]. After visible plasticisation of the beam's compressed zone, the reinforced beams' destruction progressed through of loosening of glue from the rod [Figure 7].

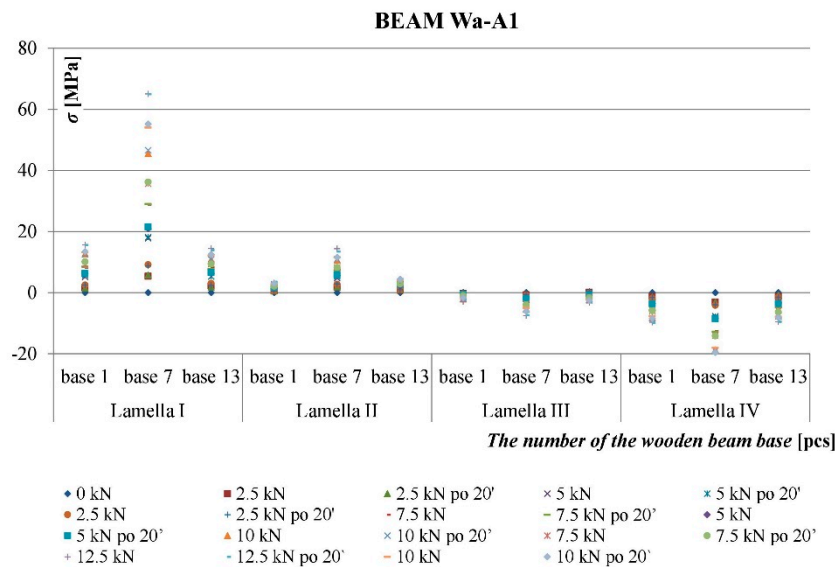
Figure 8 shows the distribution of normal tensile and compressive stresses for loading forces over time along the entire length of a wooden beam at bases 1 and 13 (support zones) and at base 7 (center of span). In the central part (base 7) of the lower part of the beam (lamella I), there is a visible increase in stresses in the wood resulting from a wood defect in the form of knots occurring in this place.

Figure 8. Distribution of normal stresses in the wood σ [MPa] along the entire length of the Wa-A1 reinforced beam.

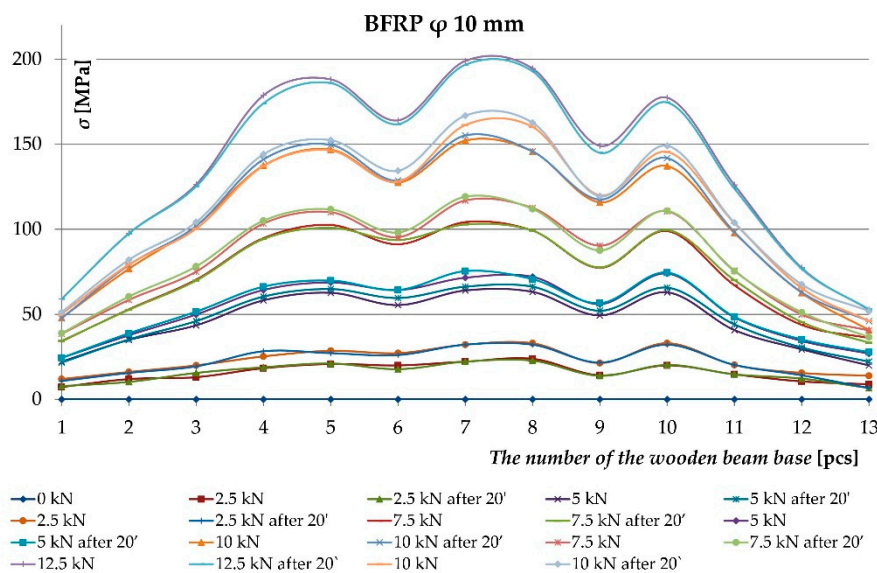
Figure 9 presents the chart of stresses along the BFRP rods' length. The charts present the impact of the wood structure on the stresses in the BFRP rod. The figure shows the uneven increase in stress in the BFRP rod under the influence of increasing loading forces. Visible significant increase in tensile stress occurring in the middle of the beam span. This was due to the epoxy adhesive peeling off from the basalt rod due to the defect in the lamella I. The BFRP rod effectively absorbed the tensile forces in the damaged bottom of the wooden beam.

Figure 9. Distribution of normal stresses in the BFRP rod σ [MPa] along the entire length of the Wa-A1 reinforced beam.

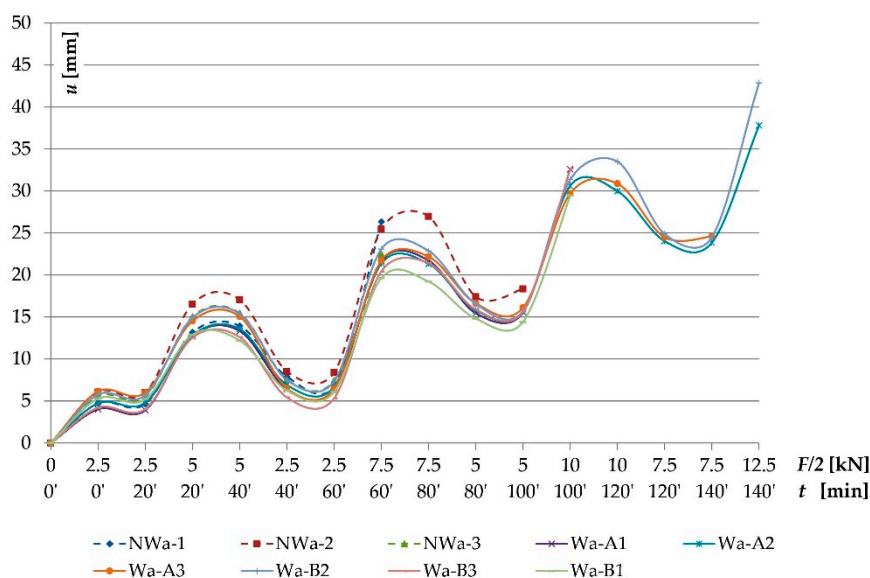
Figure 10 presents the chart of " u - $F/2$ —including time during loading" dependencies of the "Wa" type beams for sensor 2. For medium and lower quality class, in the "loading-relief" testing scheme (Wa-A, Wa-B types), the average values of deflections were lower than the values obtained for the Nwa type. For unreinforced beams (type Nwa), the highest deflection values were characteristic for the Nwa-2 beam (25.46 mm at 15 kN load). Considering the beams reinforced with two BFRP rods (type WaA), the Wa-A3 (21.7 mm) beam showed the highest deflection values at 15 kN load. Beams reinforced with three BFRP rods (type WaB) were characterized by smaller average deflection values than WaA beams.

Figure 10. Chart of " u - $F/2$ —including time during loading" dependencies of the "Wa" type beams for sensor 2 (beam's midspan).

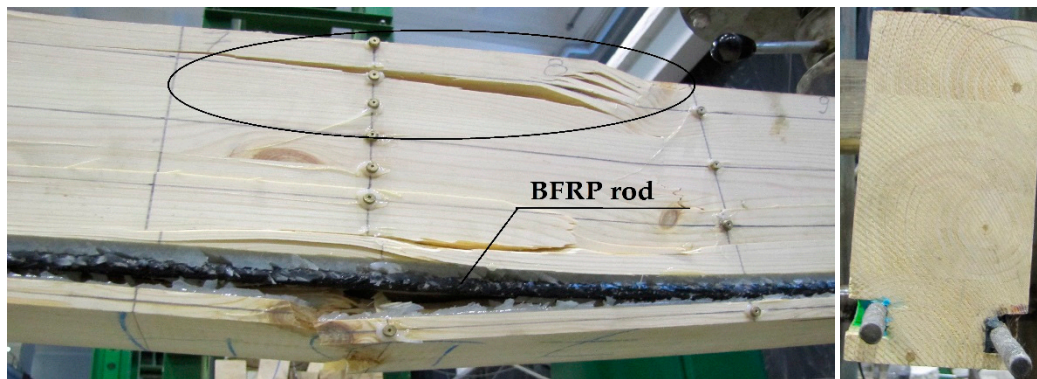
The examples of destruction images varied for specific beams (see Figures 11–14). Figure 11 presents the Wa-A1 beam's destruction in the compressed fibre zone, and then in the stretched fibre zone near the wood flaws (37 kN).

Figure 11. Example image of the Wa-A1 beam destruction in the stretched zone, visible plasticisation of the compressed zone (photograph by Wdowiak).

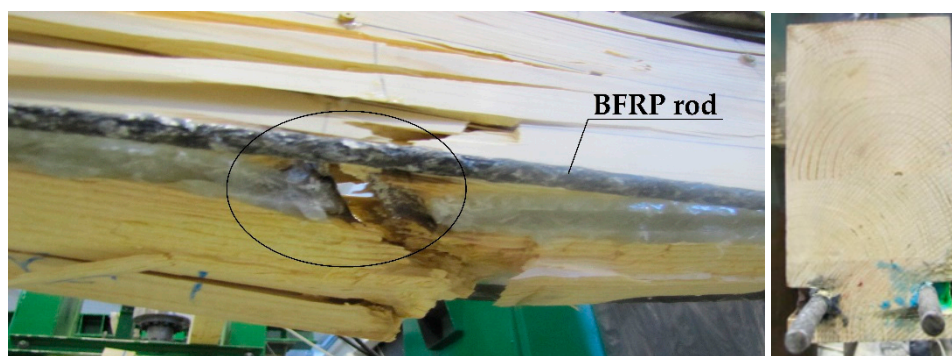
Figure 12 presents the propagation of wood fibre cracks in the Wa-A2 beam near the knots, which were followed by rupturing. The destruction occurred in the location of a hidden flaw (a knot), followed by loosening of epoxy glue from the wood (31 kN).

Figure 12. Image of the Wa-A2 beam destruction (photograph by Wdowiak).

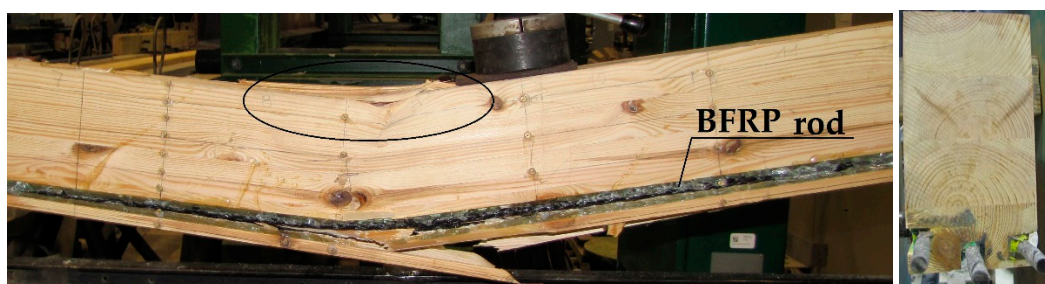
Figure 13 presents the crushing of the Wa-B1 beam's compressed zone, and then the destruction of the stretched zone near wood flaws (32 kN).

Figure 13. Crushing of the Wa-B1 beam's compressed zone and the destruction of the stretched zone near wood flaws (photograph by Wdowiak).

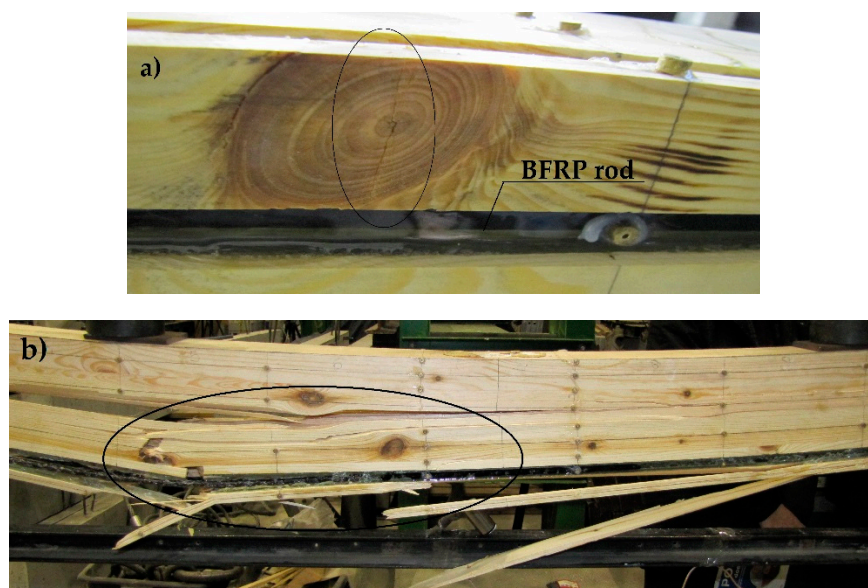
Figure 14 presents knot cracking that occurred at the load of 25 kN. Then, the cracking of burls near knots and spiral grains started to occur. The stretched zone's destruction occurred at the load of 41 kN.

Figure 14. Image of the Wa-B2 beam's destruction: (a) cracking of a deteriorating oval knot, (b) cracking of burls near knots and spiral grains (photograph by Wdowiak).
