Article

An Investigation on the Usability of Acceleration Test by Impressed Anodic Current for Evaluating Corrosion Behavior of Hot-Dip Galvanized Rebar in Concrete

Hong-bok Choe ^{1,*}, Yuhei Nishio ² and Manabu Kanematsu ^{2,*}

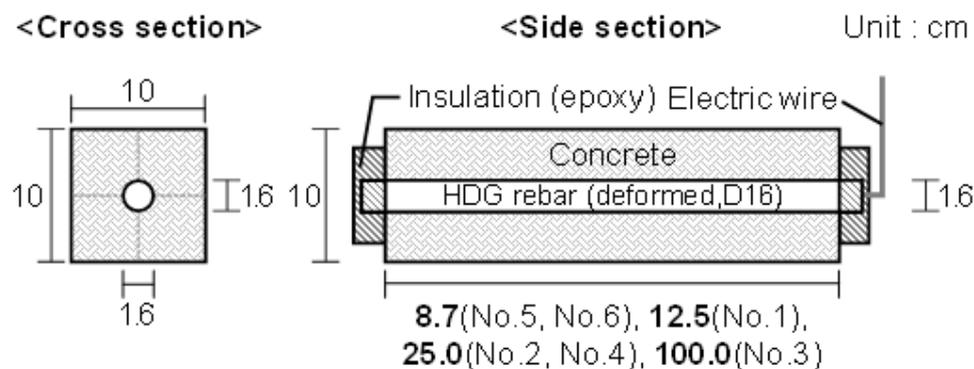
Figure 1 shows the specimen setup. Single deformed rebar was used in this experiment, and the nominal diameter was 15.9 mm (D16). On the concrete, $100 \times 100 \text{ mm}^2$ of the cross-section was made, and the length was prepared, considering the surface area of HDG rebar. On the cross-section of HDG rebar, an electric wire was connected to make the HDG rebar the anode in the acceleration test. After that, both sides were insulated by epoxy adhesive. Table 3 indicates the mix proportion of the concrete used for the specimen.

Figure 1. Specimen outline.

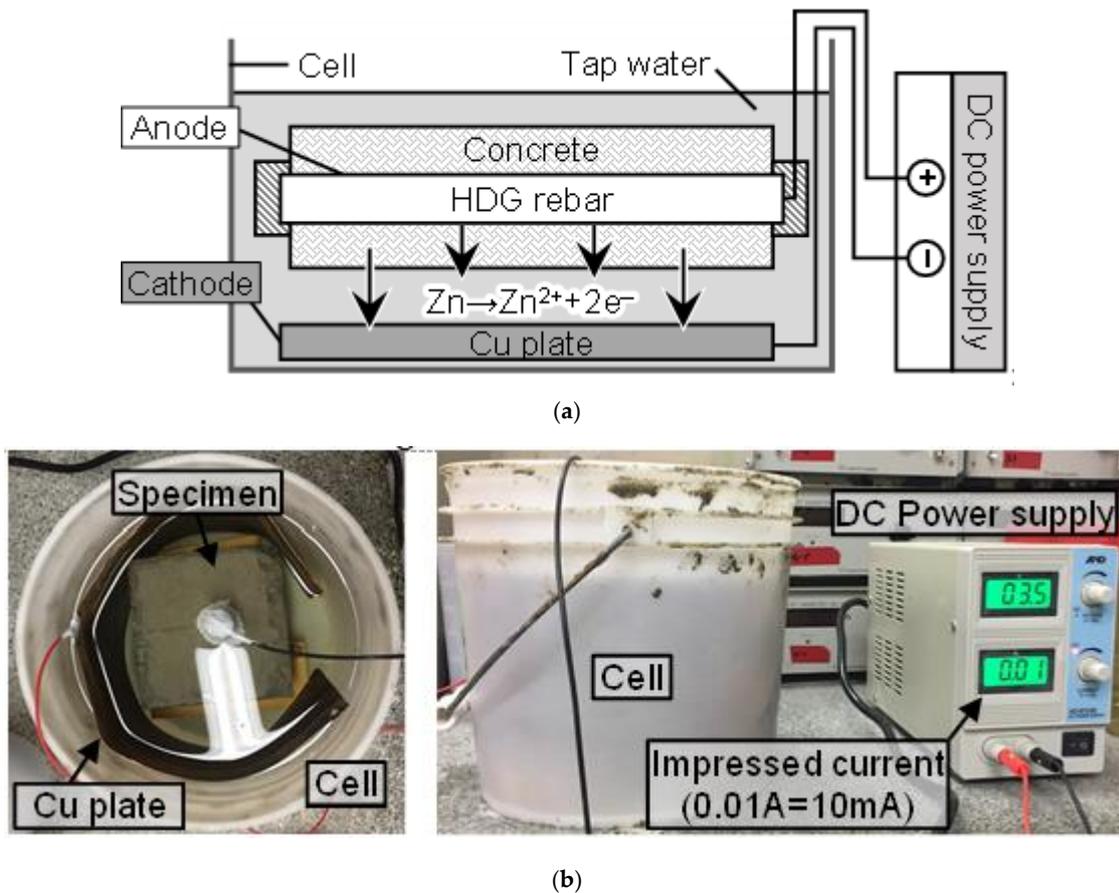
Figure 2 shows the composition of the acceleration test. Firstly, a Cu plate was used as a cathode and placed on the bottom of the cell. Secondly, the specimen was immersed in tap water at a certain distance from the plate. Thirdly, the specimen was connected to the (+) terminal, and the Cu plate was connected to the (-) terminal of the DC power supply. Finally, by turning on the device to impress the constant current (10 mA), the test was initiated. While the test was in progress, tap water was periodically supplied to the cell to maintain the wet condition of the specimen.

Figure 2. (a) Acceleration test; (b) View of the acceleration test as the current was impressed on the specimen.

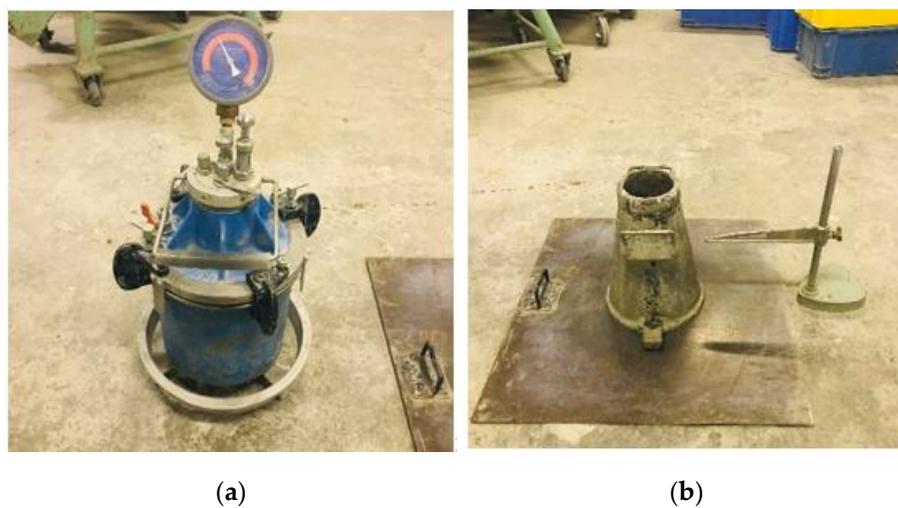
In Table 3, the air content (%) was measured by a concrete air meter, and the slump height (cm) and slump flow (cm) was measured by a slump cone. Figure 3 indicates the devices used in the measurement of fresh concrete for the specimens.

Figure 3. Devices used in the measurement of fresh concrete for the specimens. (a) Concrete air meter; (b) Slump test.

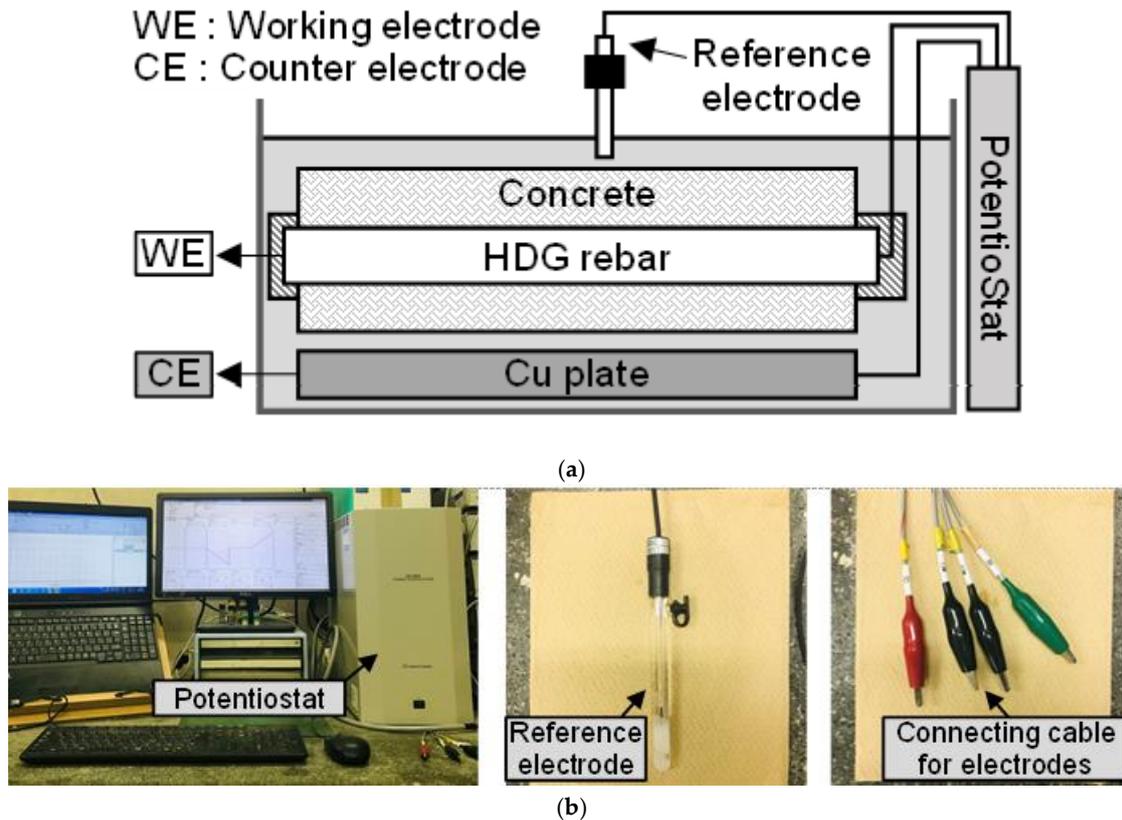
Figure 4 shows an outline of the polarization test, which was carried out after the acceleration test to evaluate the electrochemical behavior of HDG rebar. Employing the potentiostatic technique, three electrodes were used, which were the Ag/AgCl electrode (reference), HDG rebar in the specimen (working), and Cu plate (counter).

Figure 4. (a) Polarization test; (b) View of the polarization test outline and the main measurement devices.

Before polarization, the corrosion potential (hereafter, E_{corr}) was measured for 30 min. E_{corr} is defined as a potential, which is stable in its natural state. As a polarization condition, the scanning rate of the potential was 1 mV/s, the anodic polarization range was from E_{corr} to $E_{corr} + 250$ mV, and the cathodic polarization range was from E_{corr} to $E_{corr} - 250$ mV. The test was carried out in the order of anodic polarization → hold of polarization (300 seconds) → cathodic polarization. When the polarization was finished, a plot of the scanned potential (hereafter, E) and the measured current (hereafter, I) ($E - I$ plot) was drawn.

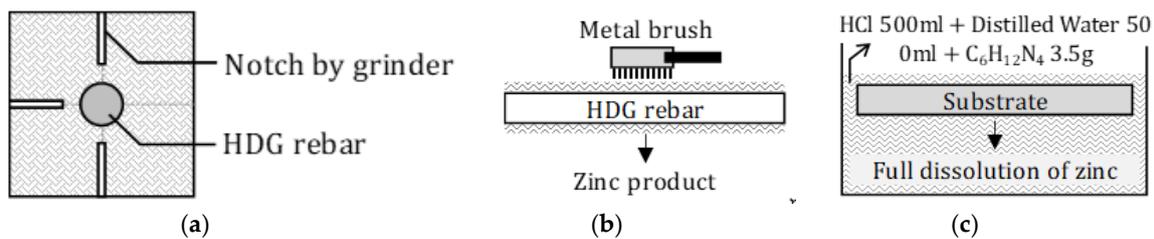
Figure 5 and Equation (4) indicate the process of measuring the remaining coating thickness. It compares the actual corrosion amount of zinc using DCA. Firstly, HDG rebar was taken out of the concrete. Secondly, referring to ISO 1460: 1992, weight measurements of HDG rebar, before (hereafter, W_1) and after (hereafter, W_2) the removal of the zinc coating, were conducted [32]. When measuring W_1 , the zinc product was removed using a metal brush. For the measurement of W_2 , a designated solution (more than 35 wt.% of HCl 500 mL + 500 mL of Distilled Water + 3.5 g of Hexamethylenetetramine ($\text{C}_6\text{H}_{12}\text{N}_4$)) was used to dissolve the full amount of zinc. After that, the surface of the substrate was dried, and W_2 was measured. Finally, the remained coating thickness (hereafter, $t_{remained}$) was calculated by Equation (4).

Figure 5. Specimen Treatment for Measuring the Remaining Coating Thickness. (a) Concrete cutting; (b) removing the zinc product and concrete on the surface (before measuring W_1); (c) removal of the remaining zinc coating on the substrate (before measuring W_2).

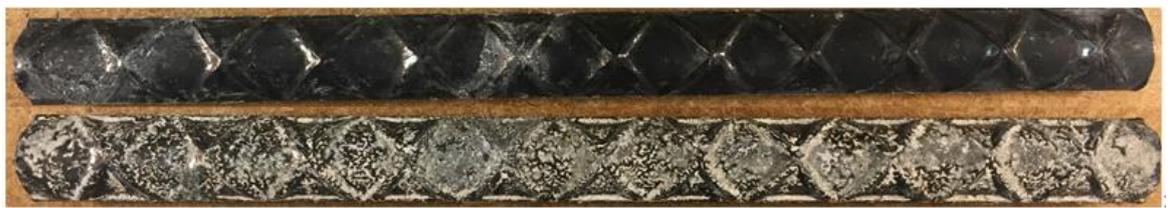
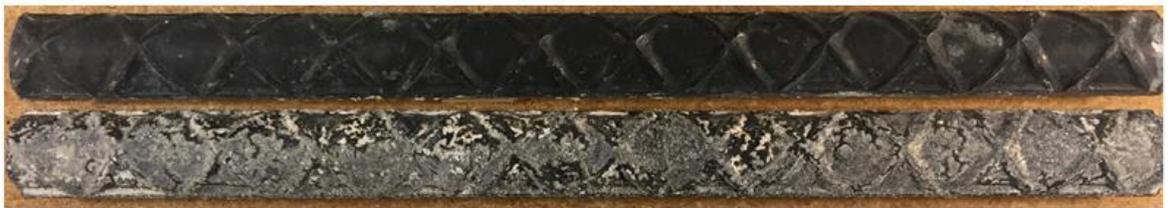
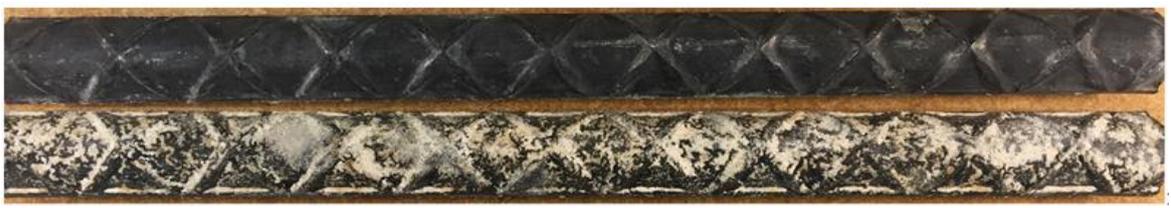
Figure 6 shows the surface of HDG rebar in $w/c = 50\%$ and 83.5% concrete, which corroded at 0.08 mA/cm^2 of applied current density. On each HDG rebar, the surface of both sides (top and bottom) were observed. Meanwhile, concerning other specimens that corroded at different applied current densities, the observation of the surface changes was similarly found to depend upon whether w/c is 50% or 83.5% .

DCA: 25% (26.32 mA × h/cm²)

DCA: 50% (52.63 mA × h/cm²)

DCA: 100% (105.26 mA × h/cm²)

From the specimens of $w/c = 50\%$ concrete, the black-colored film was formed over the entire surface of rebar, which is presumed to be an oxide film. From the observation of the cross-section, the oxide film covered the zinc coating with, for example, a thin layer. This film appeared when DCA was 25%, which is the lowest total current amount. Additionally, it was maintained in a stable condition, until the DCA was 100%. While the (silver-colored) zinc coating partially remained when DCA was 25%, this coating was unseen after DCA was 50%. Meanwhile, zinc product was mainly formed on one side of the surface by covering the oxide film, and it increased with the total current amount. However, no corrosion of the substrate was found on all specimens in $w/c = 50\%$ concrete. While the total current amount was designed to corrode the entire thickness of the zinc coating at 100% of DCA, the zinc coating remained, and thus the sacrificial anodic reaction effectively functioned.

In the specimens of $w/c = 83.5\%$ concrete, the oxide film appeared as well. However, comparatively more zinc product was formed than in $w/c = 50\%$ and was found on both sides. After that, the substrate (red product) also corroded where the zinc product was formed. Meanwhile, concerning the apparent amount of zinc product, no remarkable difference was seen between DCA = 50% and 100%. This result indicated that, when zinc product generates more than the threshold amount on a particular area, the anti-corrosion effect of zinc no longer functions, and the steel substrate starts to corrode intensively. While there was a remaining zinc coating in another area, a noticeable formation of zinc product did not occur.

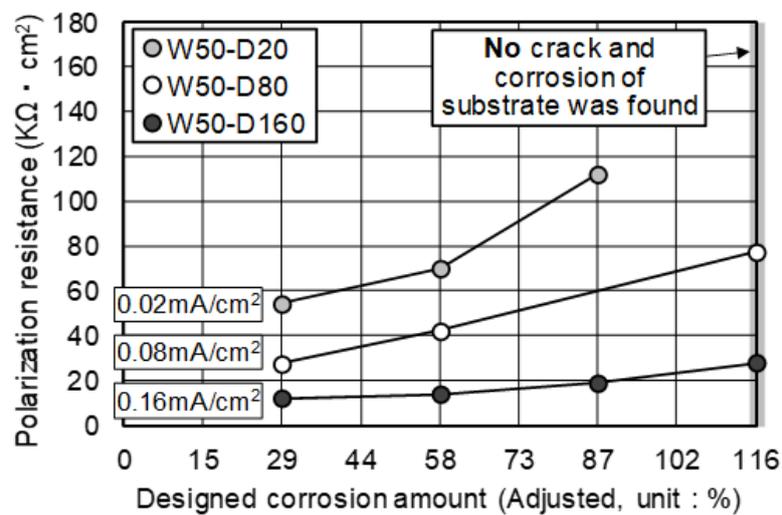
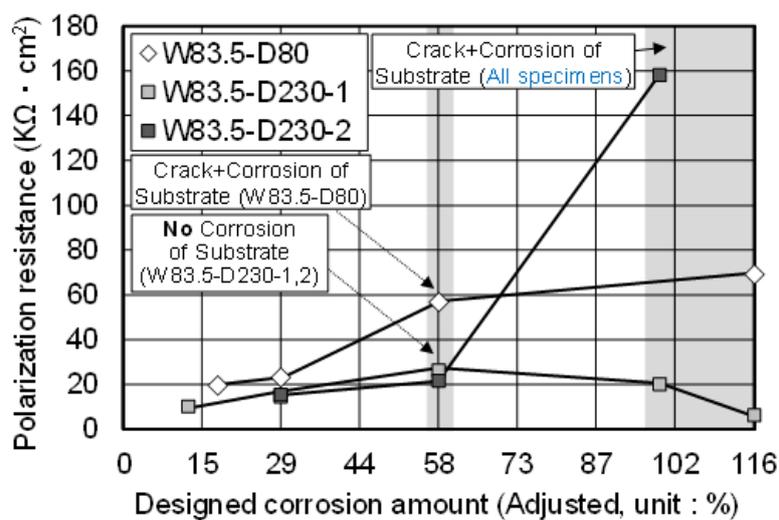
Figure 7. (a) Behavior of R_p (w/c = 50% concrete); (b) Behavior of R_p (w/c = 83.5% concrete).

Figure 7 indicates the behavior of R_p in all specimens. Before discussing the corrosion behavior, the adjustment of DCA was considered because of the measurement difference in the reference thickness. It was 180 μm , when measured by the thickness meter. However, when the weight difference was measured using $[W_0 - W_2]$, it was calculated and found to be 155 μm by Equation (4). In this study, it was decided to adjust the reference thickness to 155 μm . This is the coating thickness, measured by the same method for evaluating the actual corrosion amount and DCA. Thus, if the reference thickness changed from 180 μm to 155 μm , DCA is increased to 1.16 times this value, because the total current amount was provided for corroding 180 μm of zinc. For example, 100% of DCA is adjusted to 116%. The adjusted DCA is presented in Figures 7–9.

In the specimens of $w/c = 50\%$ concrete, R_p gradually increased with the DCA. Besides, when the DCA is the same, R_p was higher when the HDG rebar was corroded in the lower applied current density. In the measurement of R_p , the detected current is the reaction of the surface of the metal. Thus, if a substance that shows less conductivity is formed on the surface, R_p tends to be increased. In Figure 6, the zinc product became denser, as the DCA was increased. When the DCA was the same, it was observed that the W50-D20 specimen showed comparatively more zinc product on the surface.

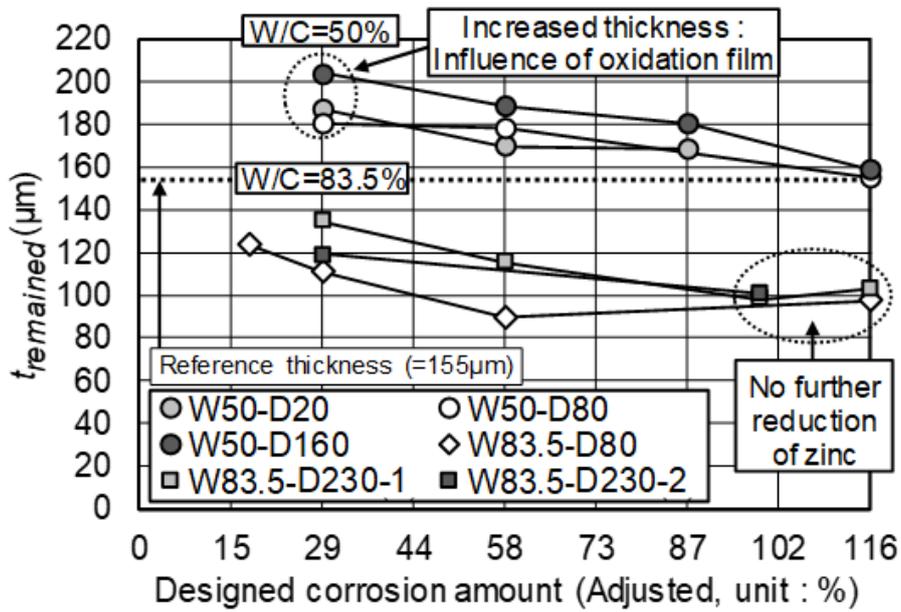
Figure 8. Remaining thickness of the zinc coating.

Figure 8 indicates the t_{remained} of all specimens, after the acceleration test. Meanwhile, in measuring t_{remained} , W_1 included the oxide film due to its adhesiveness. After the removal of the zinc product, it was uneasy to remove the oxide film using a metal brush. For this reason, t_{remained} included the thickness of the oxide film as well. In this graph, the thickness of the non-corroded zinc coating was presented as the reference (= 155 μm).

From the specimens of $w/c = 50\%$ concrete, t_{remained} was found to be higher than the reference thickness, but it decreased with the DCA. Besides, when DCA reached 116%, the t_{remained} of all specimens were almost similar, regardless of the applied current density. On the other hand, in $w/c = 83.5\%$ concrete, t_{remained} was lower than the reference thickness, although it included the oxide film. Additionally, when the decrease of t_{remained} reached 100 μm at DCA = 99%, despite the increase of DCA, there were no more noticeable thickness reductions.

The result of t_{corroded} was considered to indicate the behavior of t_{remained} . The value of t_{corroded} indicates that (+) is a decrease and (–) is an increase of the thickness, in relation to the initial thickness. From the result of $w/c = 50\%$ concrete, the increase of thickness at DCA = 29% was $-40.33\sim-54.29\ \mu\text{m}$ for each specimen. This increase was due to the oxide film, and it was mostly the maximum. Therefore, it is assumed that the oxide film was fully formed, before the active corrosion of zinc, as a delaying effect in the initial stage, and it is maintained at a constant thickness. In $w/c = 50\%$ concrete, the influence of the oxide film appeared when DCA = 29%. In $w/c = 83.5\%$ concrete, the delaying effect was assumed to exist when DCA was less than 29%. Therefore, referring to t_{corroded} , which appeared in $w/c = 50\%$ concrete at DCA = 29%, it is predicted that the thickness of the oxide film is 47.64 μm , regardless of the w/c .

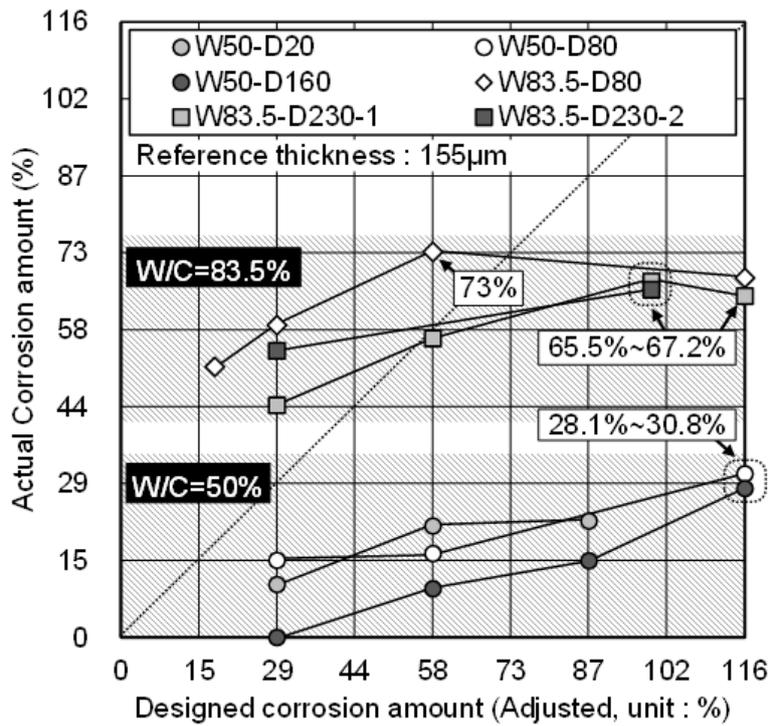
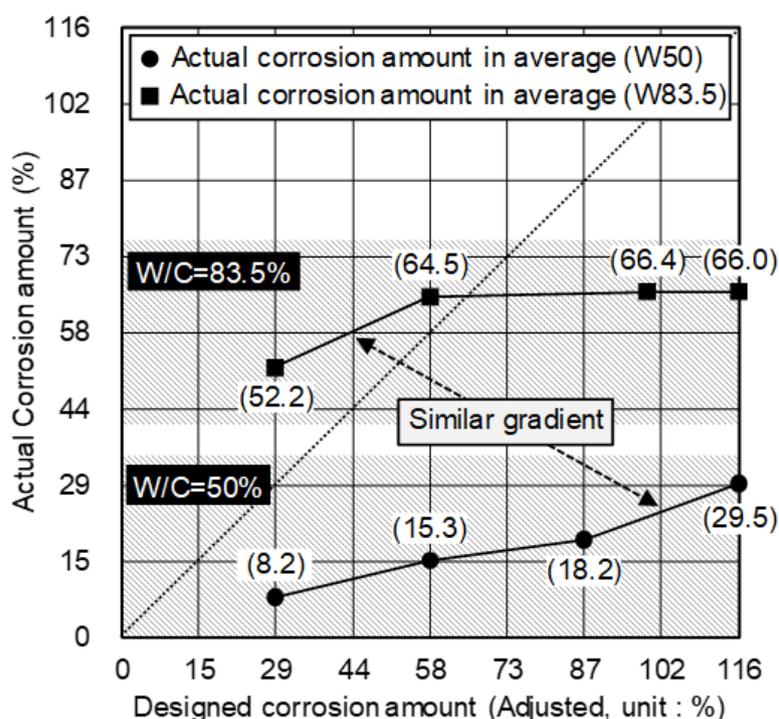
Figure 9. Comparison of the actual and designed corrosion amounts. (a) Result for each specimen; (b) Average.

Figure 9 shows a comparison of the actual corrosion amount and the DCA of all specimens. The actual corrosion amount was calculated by Equation (5), which considered the predicted thickness of the oxide film and the reference thickness. [$t_{\text{remained}} - 47.64 \mu\text{m}$] was chosen as a remained coating thickness of zinc, and 155 is the reference thickness (μm) of HDG rebar, which is not a corroded condition. In order to avoid a confusion of expression related to the corrosion amount, the (actual corrosion amount) is hereafter referred to as “ACA”.

In $w/c = 50\%$ concrete, the maximum actual corrosion amount (ACA) was about 29.5% against 116% of DCA. The ACA of zinc was lower than DCA over the entire period of the acceleration test. Besides, the average of all specimens at each DCA mostly showed an ACA that was about 1/4 times lower. Therefore, in the scope of this study, the HDG rebar in $w/c = 50\%$ concrete effectively protected the corrosion of the substrate and showed a constant anti-corrosion effect.

In $w/c = 83.5\%$ concrete, the ACA of zinc was higher than the DCA during 0%~58%. The reason was that the corrosion reaction quickly proceeded during 0%~29%. After 58% of DCA, the corrosion of zinc did not proceed noticeably and showed the end of the anti-corrosion effect. While there was a reduction of ACA on W83.5-D80 (DCA = 58% \rightarrow 116%) and W83.5-D230-1 (DCA = 99% \rightarrow 116%) specimens, it was regarded as an error due to the condition, which tested only a single specimen. Therefore, it is expected that the HDG rebar in $w/c = 83.5\%$ concrete reached the threshold amount of zinc corrosion, and it was about 66%.

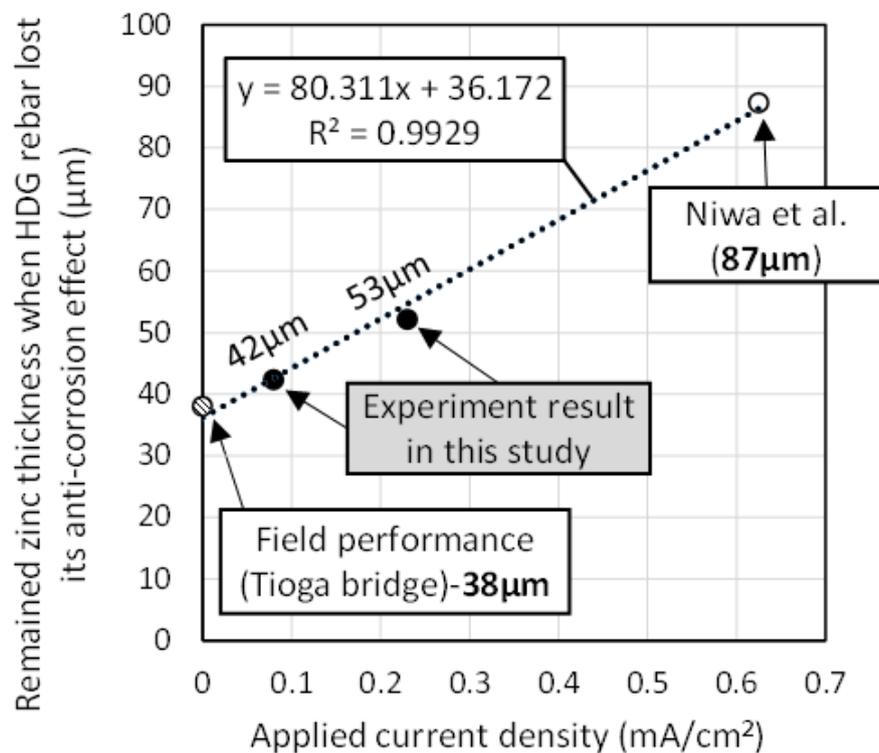
Figure 10 indicates the correlation between the applied current density and the remaining zinc thickness. In this graph, the result for the field performance was regarded as not being corroded by the impression of the applied current density ($=0 \text{ mA/cm}^2$). Concerning the results achieved in this study, 73% of ACA at 0.08 mA/cm^2 was converted to 42 μm of the remaining zinc thickness ($= 155 \mu\text{m} \times 0.23$). In the same way, 66% of ACA at 0.23 mA/cm^2 was converted to 53 μm ($= 155 \mu\text{m} \times 0.34$). Concerning the result of Niwa et al., 43% of ACA at 0.625 mA/cm^2 was converted to 87 μm ($= 153 \mu\text{m} \times 0.57$).

Figure 10. Correlation between the applied current density and the remaining zinc thickness in each corrosion environment (the acceleration test and the field performance).

As a result, the regression equation showed a well-fitted correspondence between the acceleration test and the actual corrosion environment in terms of the remaining zinc thickness, which was a linear relationship. Moreover, the extent of the applied current density was influential in causing the early end of the anti-corrosion effect. It is expected that lowering the applied current density will result in a more suitable test condition. In this graph, it is recommended that the acceleration test needs to be carried out below 0.1 mA/cm^2 . From this result, the acceleration test was found to be useful.
