Article

Use of Non-Linear Ultrasonic Techniques to Detect Cracks Due to Steel Corrosion in Reinforced Concrete Structures

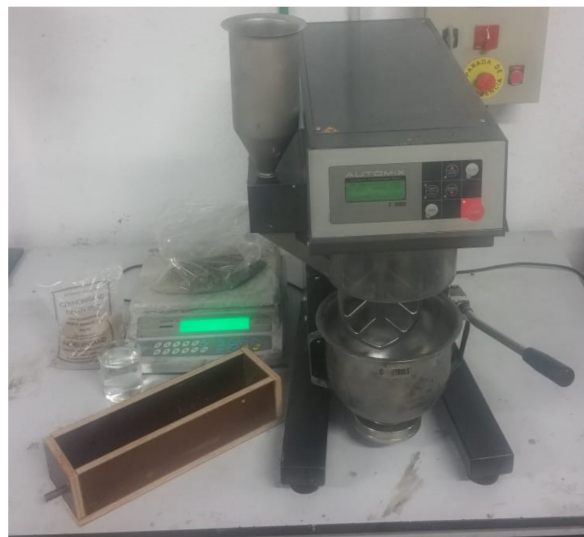
Figure 1. Photo of the wooden mold with the steel bar, the mortar mixer, and the materials used: cement (on top of the balance), siliceous sand, and water containing the proper amount of dissolved NaCl.

mixing water to obtain a content of 2% Cl^- relative to the cement weight in the hardened mortar. The composition details are given in Table 1. Figure 1 shows a photo with the wooden mold, the mortar mixer, and the materials used in the mix.

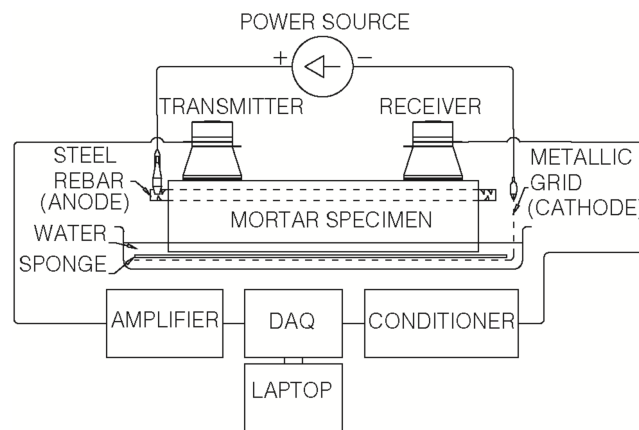
Figure 3. Schematic representation of the setup of the forced corrosion tests, also showing the system that is used for performing non-linear ultrasonic measurements.

The forced corrosion tests were performed by applying an electric field between the steel rebar (anode) and an external cathode, consisting of a galvanized steel grid. The tests, which lasted 23 days, were run in galvanostatic conditions (a constant anodic current density of $100 \mu\text{A}/\text{cm}^2$), using an electrophoretic power source. During the tests, the bottom of the mortar specimens were kept in permanent contact with tap water (the maximum height of the contact between water and mortar is 5 mm), in order to maintain an adequate level of electric conductivity for the material. The mortar specimen was put on top of the cathode, with a polypropylene sponge in between them (see Figure 3).

A schematic representation of the experimental setup used for the NLU measurements is shown in Figure 3. It consists of two piezoelectric ceramic ultrasonic transducers (UCE-UT-28100 PZT-8, Ucesonic, Beijing, China), a signal conditioner type 2698-A-0F4 (Brüel&Kjaer, Naerum, Denmark), an audio amplifier interM M-500 (South Korea), and a DAQ (data acquisition system, National Instruments, Austin, TX, USA) NI USB 6361 connected to a laptop (Lenovo Ideapad, Quarry Bay, Hong Kong, China). It is necessary to emphasize that NLU measurements were obtained through a contact-based technique. Both ultrasonic transducers are glued at each end of the upper face of the mortar specimen, one of them working as a transmitter, and the other as a receiver. The NLU technique involves the generation of a fundamental sinusoidal signal A_1 , which is amplified and sent to the transmitter. In this study, the fundamental signal frequency f_1 was selected at a value of 30 kHz. After propagation through the specimen, the ultrasonic wave reached the other transducer; the received

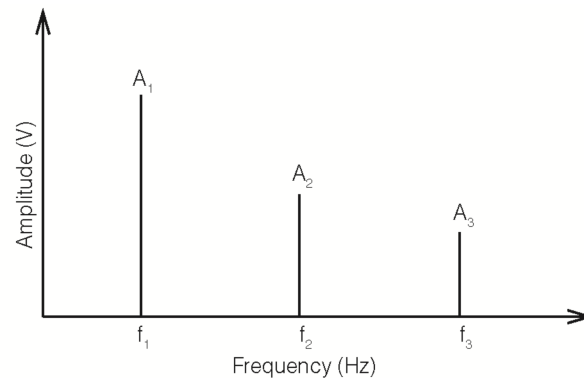
Figure 4. Frequency spectrum showing the emitted frequency (f_1), and two of the generated harmonics (f_2 and f_3).

signal was conditioned and post-processed so as to obtain its frequency spectrum (see Figure 4). This spectrum lets us obtain the variation of the amplitudes of the higher order harmonics (in our case, the second, A_2 , at a frequency $f_2 = 60$ kHz, and the third, A_3 , at a frequency $f_3 = 90$ kHz) to that of the emitted frequency (the fundamental, A_1), and thus obtain the parameters of nonlinearity [18,19,21], which are herein defined as:

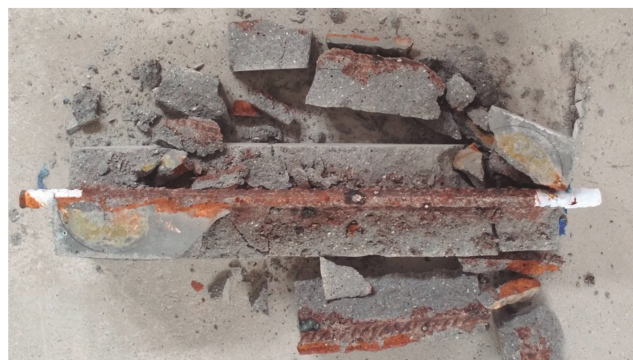
Figure 6. Photo taken after breaking the M1-reinforced mortar specimen at the end of the corrosion test.

At the end of the forced corrosion test, the mortar specimens were broken, and the steel bar was extracted. Figure 6 shows a photo that was taken just after breaking the M1 specimen. It is appreciable that the corrosion process had affected the whole steel bar. However, some spots of more intense corrosion (pits), were also observed. These pits were more clearly appreciable after cleaning the corroded bar to remove the corrosion products; see Experimental Procedures. The appearance of the steel bars after the corrosion tests of the other specimens was similar to that shown in Figure 6.

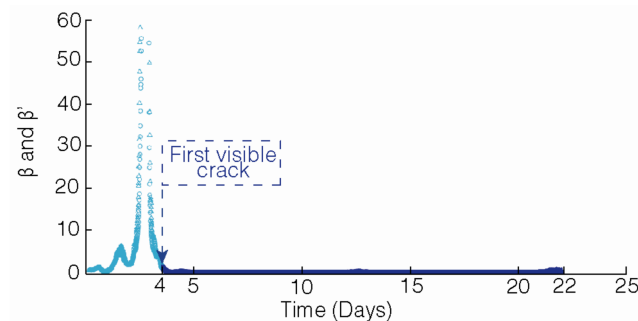
Figure 9. Evolution of the nonlinearity parameters (derived from the non-linear ultrasonic (NLU) measurements) along the duration of the forced corrosion test of specimen M3. β : \circ ; β' : Δ .

Figure 9 depicts the variation with time of the nonlinearity parameters that were derived from NLU measurements during the forced corrosion test of specimen M3. The abscissa axis of Figure 9 represents the time elapsed since the starting of passing current. It is appreciable from Figure 9 that both β and β' exceeded the established threshold of the 10-fold increase relative to the initial values, approximately two-and-a-half days after the beginning of the forced corrosion test. In this case, the first microscopic observation of cracking at the upper surface of the M3 specimen was at the fourth day after starting the test. Hence, these preliminary results seem to indicate that the microscopic observation of cracking of reinforced mortar due to steel corrosion was accompanied by a clear increase of the nonlinearity parameters. This finding is in agreement with the previous observations of other

authors [23,34]. For the rest of the tested mortar specimens, the behavior that was found is similar to that which is shown in Figure 9, although the corresponding figures are not shown here for the sake of brevity of the manuscript.
