Polypropylene as a Retrofitting Material for Shear Walls

Enea Mustafaraj ¹

Abstract: In recent years, on account of their excellent mechanical properties, composite materials (made of epoxy-bonded carbon, glass, or aramid fibers) have been used to reinforce masonry walls against in-plane actions. These materials have proven to be an effective solution for the strengthening of unreinforced masonry (URM) walls. Lately, research has shifted to the study of different types of fibers to avoid the use of epoxy adhesives, whose long-term behavior and compatibility with masonry are poor. This paper describes an experimental program that investigated the behavior of URM shear walls strengthened with two types of commercially available polypropylene products: short fibers (fiber length = 12 mm) and polypropylene nets. This investigation aimed to evaluate the influence of polypropylene reinforcement, embedded into an inorganic matrix, in terms of the improvement of the lateral load-carrying capacity, failure mechanism, ductility, and energy dissipation capacity of URM wall panels, where nine walls were subjected to in-plane loads using a racking test setup. The study showed that using two l

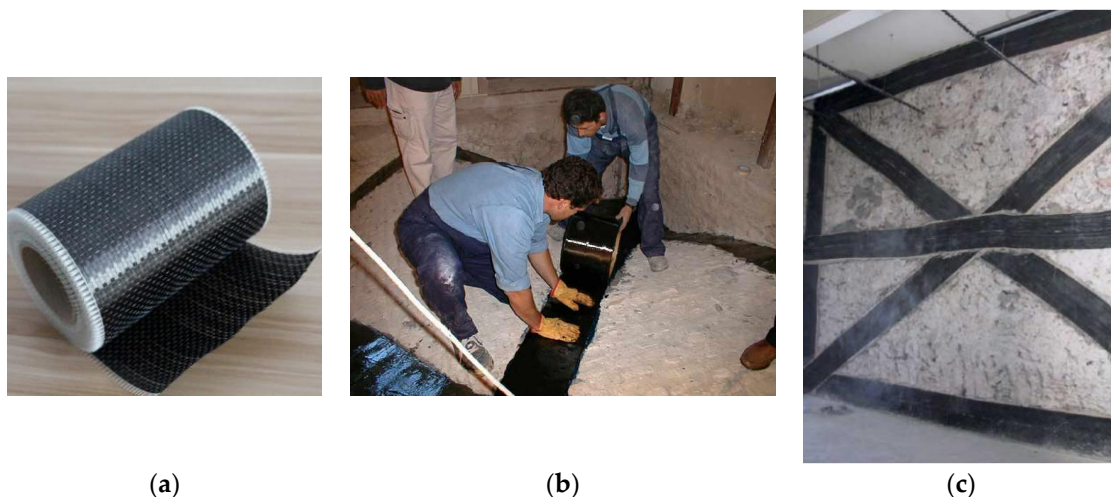
Figure 1. Application of a carbon-fiber-reinforced polymer (CFRP) sheet: (a) a CFRP bi-directional sheet, (b) use of epoxy-resins to bond the CFRP on the masonry surface, and (c) a reinforced wall panel.

Figure 1a shows a bi-directional carbon-fiber-reinforced polymer (CFRP) sheet. This material was the first to become popular in civil engineering in the 1990s to reinforce deficient reinforced concrete (RC) beams (direct application on the tension side) or RC columns (by wrapping). Its application is relatively straightforward: RC surfaces, following an accurate cleaning through the removal of any inconsistent material, are impregnated with an epoxy resin, which is used to glue the carbon fibers to the concrete material. In conservation work, CFRP sheets were initially used to reinforce masonry vaults (Figure 1b) and walls (Figure 1c) against the lateral loading induced by earthquakes [13–16].

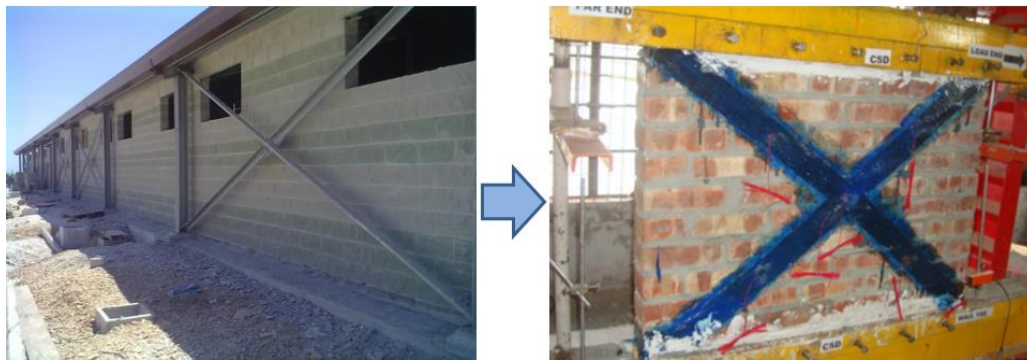
Figure 2. Statics of the resisting mechanism: from a steel structure to a CFRP-reinforced wall [13].

The in-plane reinforcement of wall panels aims to reproduce the concept of X and V steel bracings in metal structures (Figure 2). FRP sheets have the function of absorbing tensile stresses and transferring them to the foundations of the masonry structure. Masonry, similarly to concrete, exhibits a very low tensile strength and a high compressive strength. The low tensile strength also affects both the bending and shear strengths. These are typically very low for masonry. Because earthquakes produce tensile stresses in masonry, FRP reinforcement has been proposed as a retrofitting method. Its effectiveness highly depends on the bonding between the masonry material and the composite fibers, where the basic idea is to create a new “composite material” such that compressive stresses are absorbed by masonry and tensile ones by the FRP. A very large number of laboratory experiments [17,18], on-site applications [19,20], and theoretical studies [21,22] have been conducted in the last two decades using epoxy-bonded fibers.

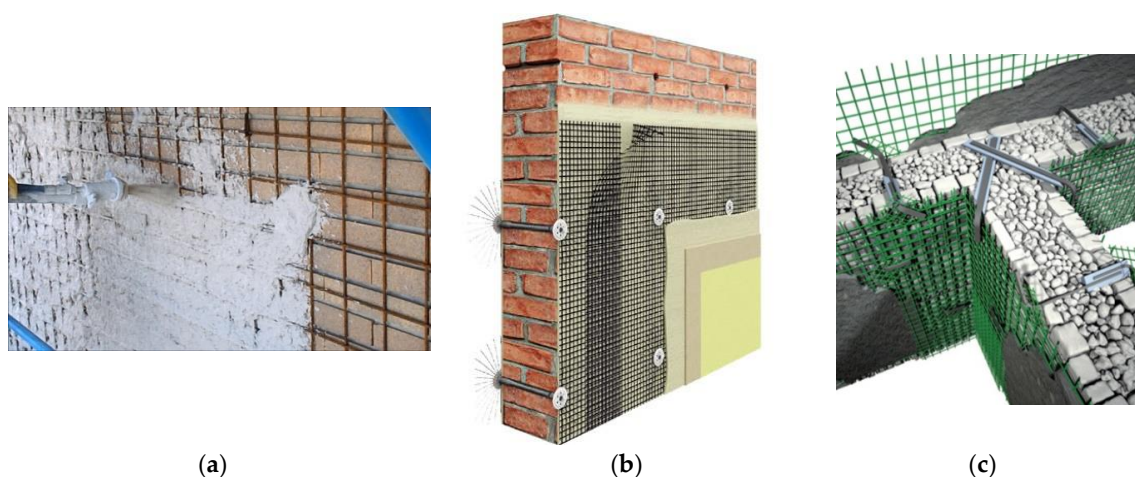
Figure 3. Traditional and innovative methods for the in-plane reinforcement of load-bearing walls: (a) steel-rebar-reinforced concrete jacket, (b) Fiber Reinforced Matrix (FRM)—flexible non-impregnated fiber meshes, and (c) FRM—impregnated (rigid) glass-fiber-reinforced polymer (GFRP) mesh embedded into a cementitious/lime matrix [30,31].

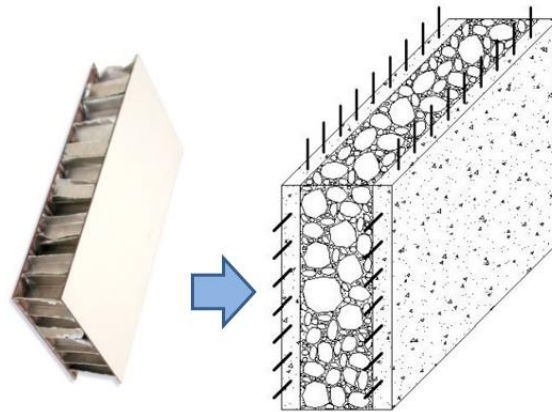
Figure 4. Statics of the resisting mechanism: from a sandwich panel to an FRM-reinforced wall.

The proposed solution was to apply FRP reinforcement using non-polymeric matrices; textile reinforced mortars (TRMs) have recently been studied and tested as an in-plane reinforcement of wall panels (Figure 3) [25–29]. The results demonstrated that it is possible to increase the masonry shear strength using FRP meshes embedded into a cementitious mortar or a plaster. The bonding between the masonry and the reinforcement is significantly weaker when non-polymeric matrices are used, but by increasing the bonded surface, it is possible to reduce the bonding stresses at the interface. The result is that entire wall faces are typically reinforced with TRMs. By doing this, there is a radical shift from the concept of X and V bracings that are typically adopted for epoxy-bonded FRP reinforcements to the scheme of a sandwich structure, where the two thin and stiff skins are made with the TRM and the thick core is the masonry (Figure 4).

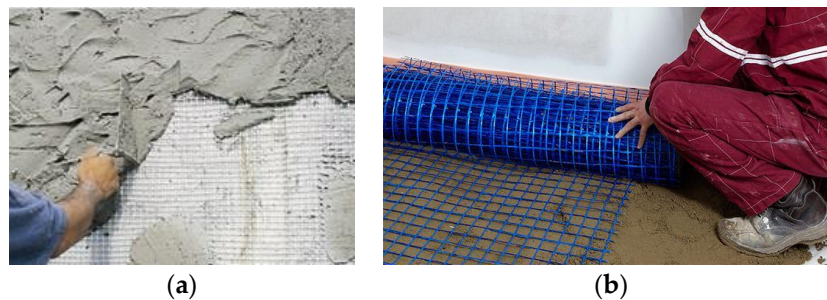
Figure 5. Non-structural applications of polypropylene nets: (a) repairing of deteriorated plasters and (b) stabilizing the screed before the application of the floor finish.

Propylene was first polymerized to a crystalline isotactic in 1954, which led to large-scale commercial production of isotactic polypropylene by the Italian firm Montecatini from 1957 onwards. Polypropylene nets and meshes became popular in the 1970s for many structural applications, such as sheets of yacht sails, fishing and agricultural nets, and safety fencing. In civil engineering, the applications are typically non-structural, where polypropylene nets are often used for the repair of deteriorated plasters and floors in old buildings (Figure 5) [37–40].

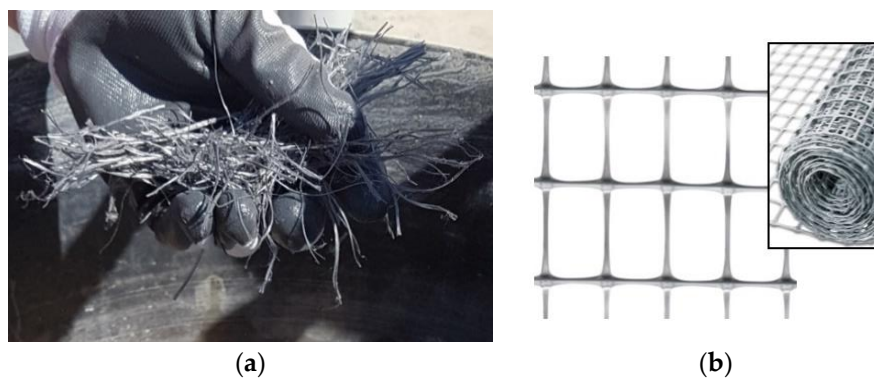
Figure 6. (a) Polypropylene fibers used for the panel reinforcement. (b) Polypropylene netting used for the panel reinforcement (spacing 30 mm × 45 mm).

In this experimental work, polypropylene fibers (PF) with a circular cross-section (Figure 6a) and polypropylene nets (PNs) (Figure 6b) were studied and tested as a structural method for reinforcing the shear wall of old buildings.

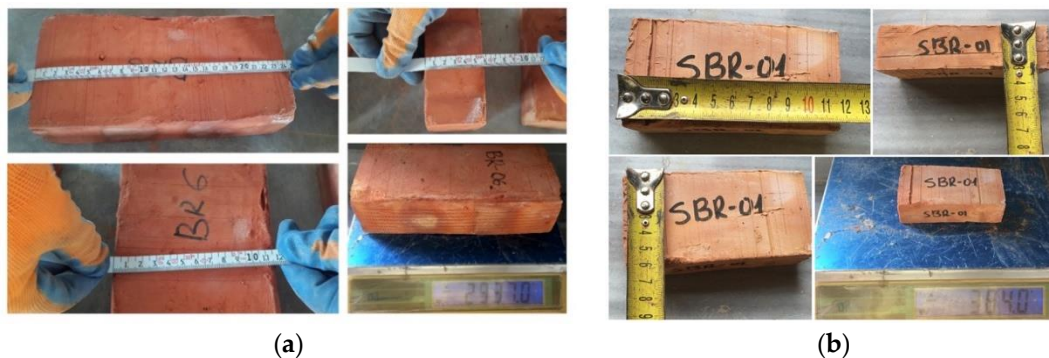
Figure 7. Solid fired clay bricks used for the construction: (a) full-dimension and (b) half-size.

Both types of solid bricks were made of fired clay. The average full-dimension brick (BR) size was 244 mm × 116 mm × 56.5 mm with a weight of 2778 g on average. The half-size brick (sBR) was 119 mm × 58 mm × 30.6 mm and weighed 372 g on average (Figure 7). The two types of brick were tested in compression and in tension: the mechanical properties of BR were found to be about 20% higher compared to sBR. The compressive and tensile strengths of BR bricks were 24.3 and 4.53 MPa, respectively (Table 4). The coefficient of variation of these results ranged between 10% and 16%.

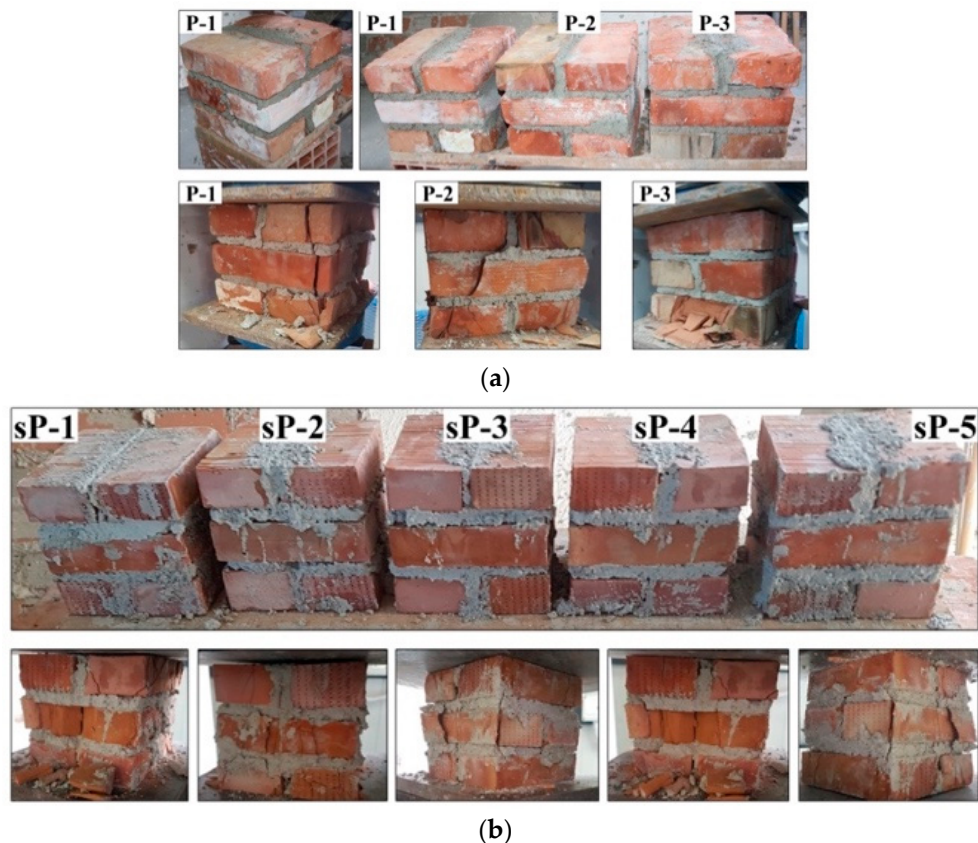
Figure 8. Masonry prisms tested in compression (before and after testing): (a) full-scale brick and (b) half-scale brick.

The masonry compressive strength was determined by compression testing small prisms made of the same bricks and mortar mix as the panels. The masonry prisms made of full-dimension bricks are shown in Figure 8a, where the prisms are shown before and after the test. As seen in Table 2, the average compressive strength for masonry prisms is 8.36 MPa. On the other hand, the compressive strength of the prisms made of half-scale bricks was 13.69 MPa (Figure 8b).

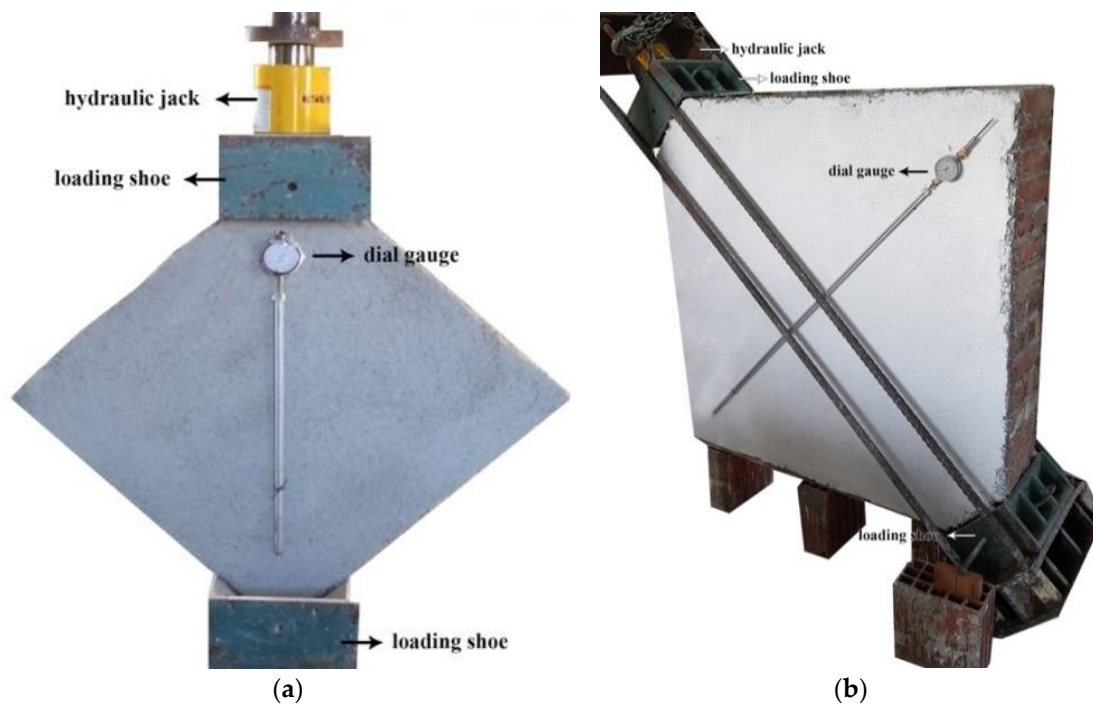
Figure 9. Diagonal compression test setup: (a) half-size wall panel and (b) full-size wall panel.

The determination of the diagonal tensile strength (shear strength) was done according to the ASTM E 519-02 standard [42]. According to this standard, it is required that the panel is rotated by 45° and a vertical compressive load is applied along the panel diagonal. For the small wall panels, the test setup consisted of two steel loading shoes placed at the top and bottom corners of the rotated panel, along with a 50-tonne-capacity hydraulic jack. On both sides, two dial gauges were used to measure the shortenings and elongations of the panel under shear loading (Figure 9a).

For the full-scale panels, to avoid damaging or disturbing the overall conditions of the wall, the brickwork specimens were tested in place, whereas the loading mechanism was rotated, as shown in Figure 9b. The test setup was made of two loading steel shoes placed at the top and bottom edges of the loaded wall diagonal, where two steel profiles that were mutually connected by four high-strength steel ties, used to contrast the diagonal load. This was applied using a 50-tonne-capacity hydraulic jack, which was placed between a steel profile and a shoe. The jack was connected to a hydraulic pump and a one-way valve permitted oil to flow due to pressure from the pump to the jack and to lift the load, compressing the wall diagonally. The load was increased gradually until failure. As in the small panels, the deformations were recorded using two dial gauges positioned on both sides.

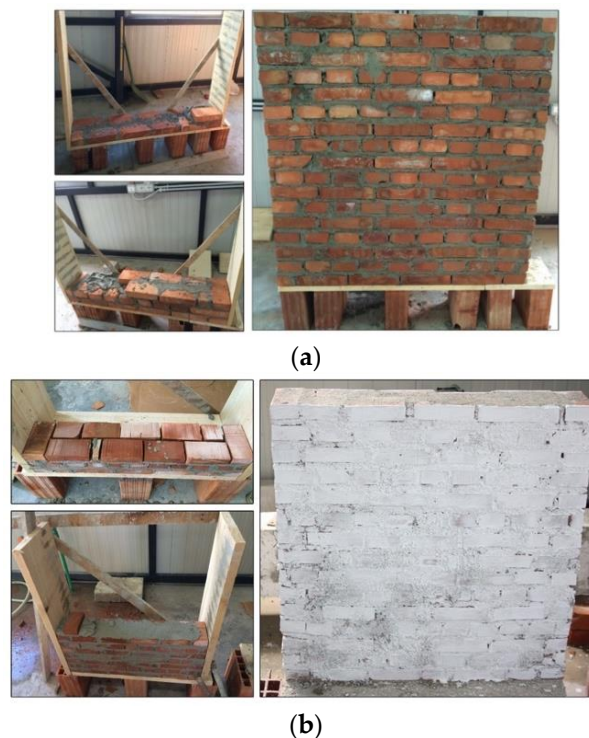
Figure 10. Construction of unreinforced panels: (a) full-scale (W-series) and (b) half-scale panel (SW-series).

The wall panels were built at the Civil Engineering Laboratory of Epoka University by an experienced brickwork masonry worker using the English bond pattern: only one course of stretchers was applied over a course of headers, i.e., this bond type has two alternating courses of stretchers and headers. The mortar joint thickness for large-scale panels was 15 mm, whereas for the half-scale panels, a 10 mm thickness was used. The walls were left to cure for 28 days. Before testing, a layer of white paint was applied to better visualize the cracks during the tests (Figure 10).

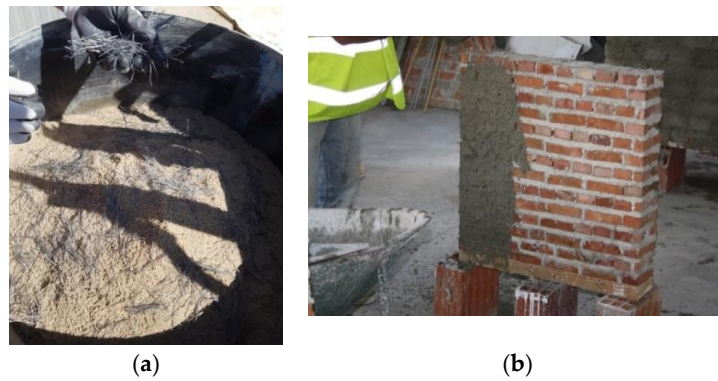
Figure 11. Reinforcement preparation: (a) mixing polypropylene fibers with sand and (b) application.

Twenty-eight days after construction, the wall panels were reinforced with PF. The method consisted of applying a plastering layer that was 25 mm thick (full-size panels) or 15 mm thick (small panels) with a mortar mix of cement:sand volumetric ratio of 1:4, with a water:cement ratio of 0.4 plus 2% of fibers in volume. The preparation of the mix was done by dry mixing PF with sand and cement; then, by adding the water, a plater mix with medium workability was produced. After reinforcement, the panels were left to cure for another 28 days. Similar to the URM panels, a layer of white paint was applied to better visualize the cracks (Figures 11 and 12).

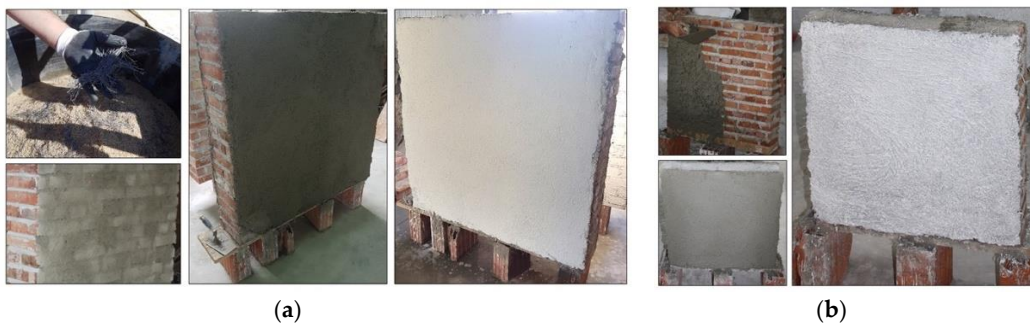
Figure 12. Application of the retrofitting with polypropylene fibers: (a) full-scale (W-series) and (b) half-scale panel (SW-series).

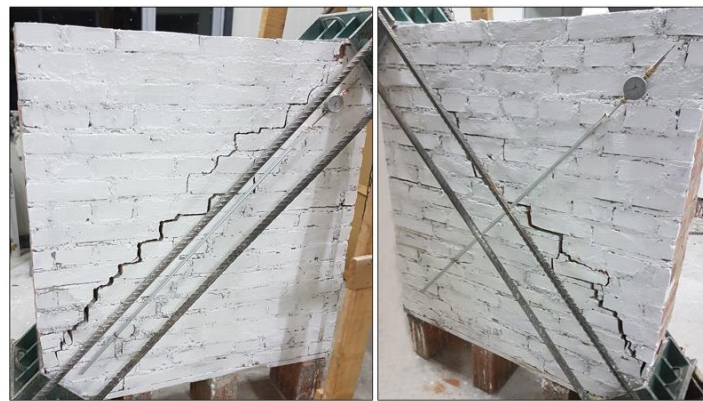
Figure 13. Failure mode of wall panel W-1-URM.

After the tests, it was observed that the overall failure mode of the URM panels could be categorized as shear (in-plane) failure; a step-like crack developed along the loaded diagonal through the mortar joints. The main crack started from the center of the wall panel and propagated along the mortar joints toward the panel's corners. At the same time, some other cracks appeared parallel to the main crack (Figure 13). Since the bricks had much higher tensile and compressive strengths compared to the mortar, the failure occurred only on the mortar bed and head joints and at the interface between the mortar and bricks. The formation of the shear crack, i.e., the failure, was sudden, and all URM panels exhibited a very brittle behavior. The failure mode was similar for both URM full-scale and small panels: in the half-scale panels, the crack and gravity caused a splitting of the wall panel into two halves (Figure 14).

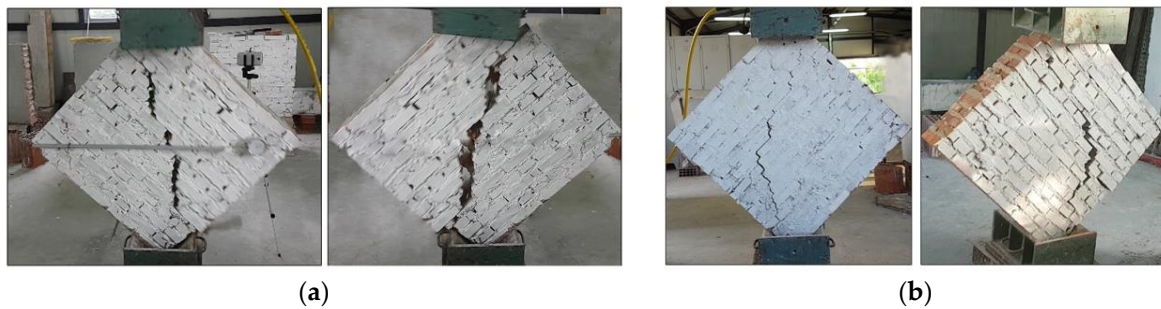
Figure 14. Failure mode of the half-size URM wall panels: (a) SW-1-URM and (b) SW-2-URM.

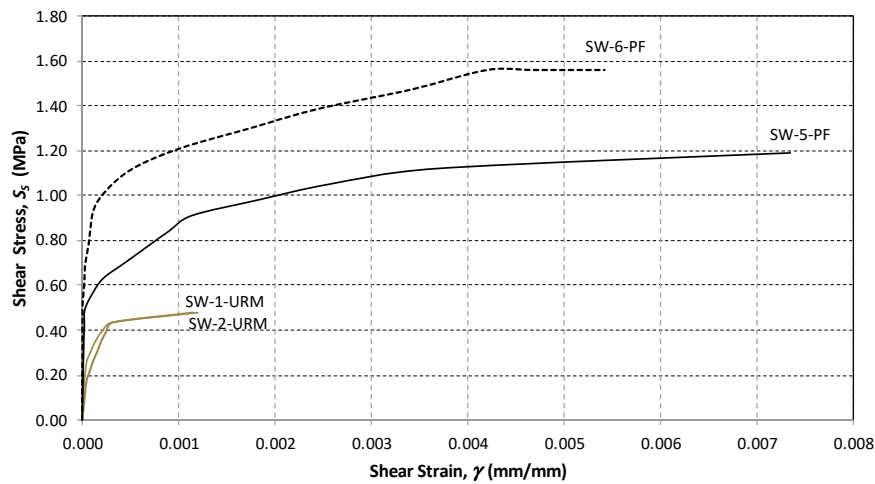
Figure 15. Shear stress versus shear strain plot (half-size panels).

the relationship was approximately linear before the crack initiation, followed by a nonlinear response up to the maximum shear capacity (Figures 15 and 16).

For comparison purposes, some of the graphs are plotted to a scale of a maximum angular strain of 0.008. For the polypropylene-reinforced panels, the full-size wall, namely W-6-PF, exhibited a lower shear strength and a lower deformation capacity when compared to the half-size panels. SW-3-PF and SW-4-PF had similar behavior (Figures 15 and 16).

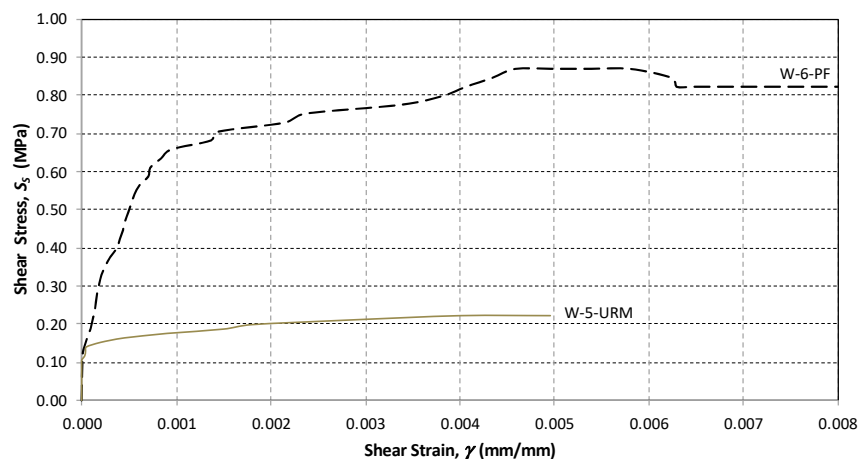
Figure 16. Shear stress versus shear strain plot (large-size panels).

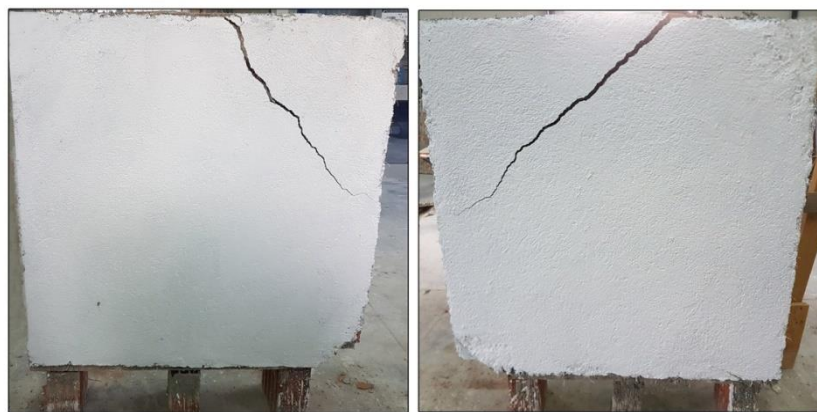
**Figure 17.** Failure mode of W-6-PF.

The full-size panel reinforced with PF, namely W-6-PF, had a diagonal crack in the upper portion of the wall, starting at the middle of the upper side and ending at the middle of the left side at a clear 45° (Figure 17). This type of failure was not very common in other experimental studies conducted by the authors with TRM reinforcements, where the failure had occurred due to a crack along the loaded diagonal or debonding between masonry and the reinforcement [43].

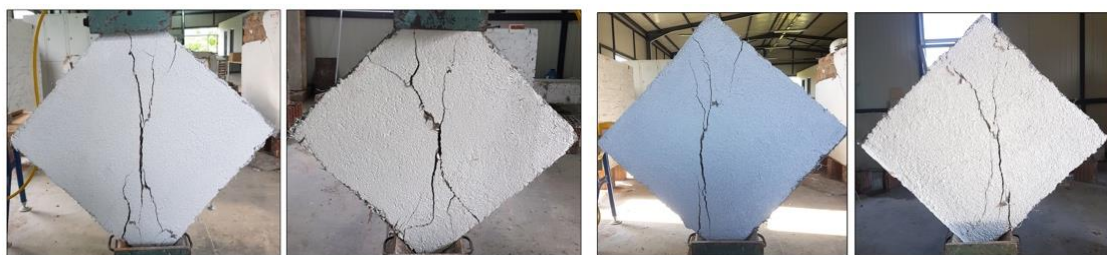
**Figure 18.** Failure mode of SW-3-PF.

Additionally, it was also observed that the full-scale panel was more ductile than in previous studies, probably due to the different mix of the mortar coating [44,45]. However, the half-size panels had a similar failure mode: a deep vertical crack along the compressed diagonal followed by minor cracks parallel to it (Figure 18).

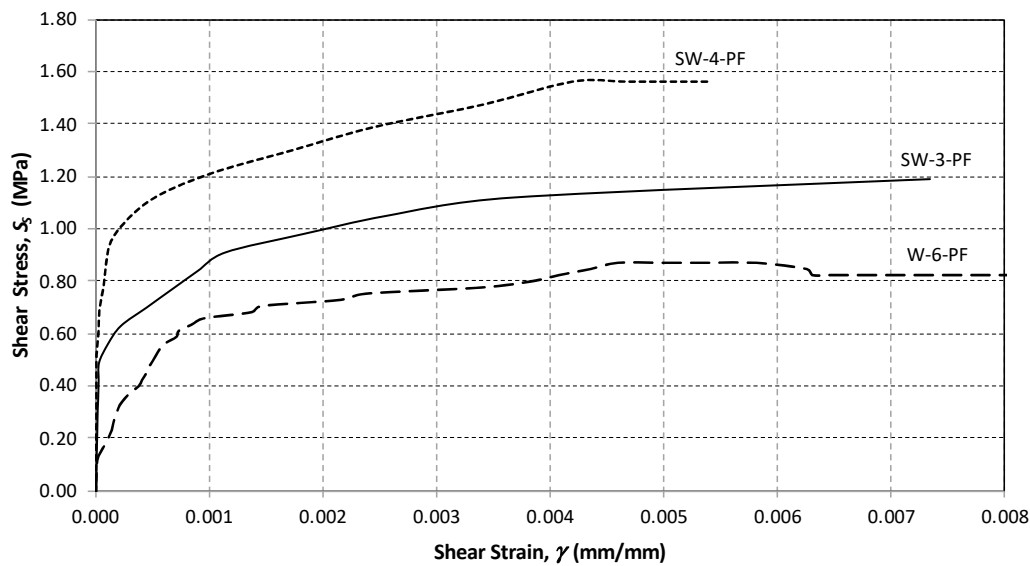
Figure 19. Shear stress versus shear strain plot (wall panels reinforced with polypropylene fibers).

The panels SW-3-PF and SW-4-PF reinforced with polypropylene failed at loads 169.4 and 179.3 kN, respectively. The average shear strength was 1.518 MPa and the ultimate drift 0.418%. W-2-PF failed at 249.1 kN, achieved a shear resistance of 0.587 MPa, and an ultimate drift of 0.434% (Figure 19).

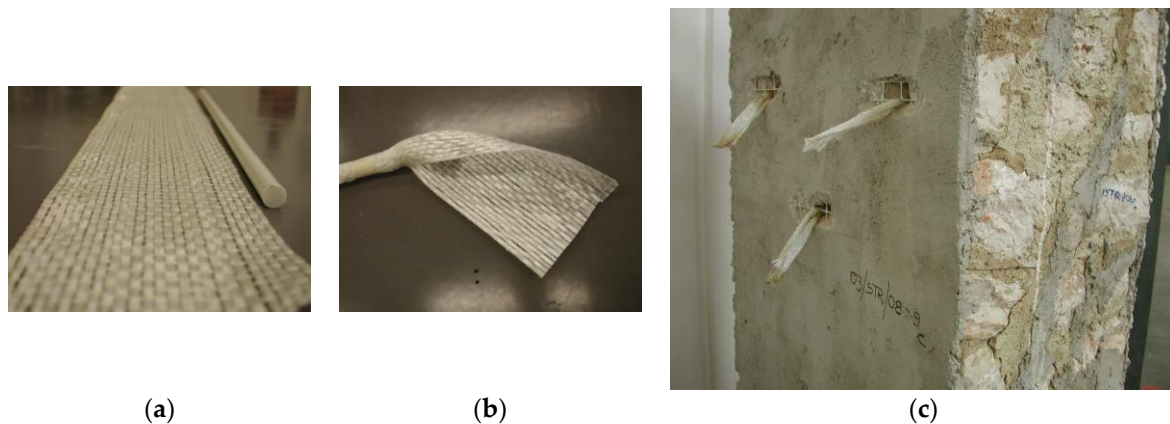
Figure 20. GFRP through-bars were used to connect the two polypropylene jackets. The GFRP bars were wrapped using a fiberglass sheet. This was epoxy-bonded to the polypropylene net: (a) GFRP bar and fiberglass sheet, (b) wrapping, and (c) insertion into the through-holes.

as shown in Figure 20c. The mortar coating was applied by hand to a thickness of 15 and 25 mm for the brick and stone panels, respectively.

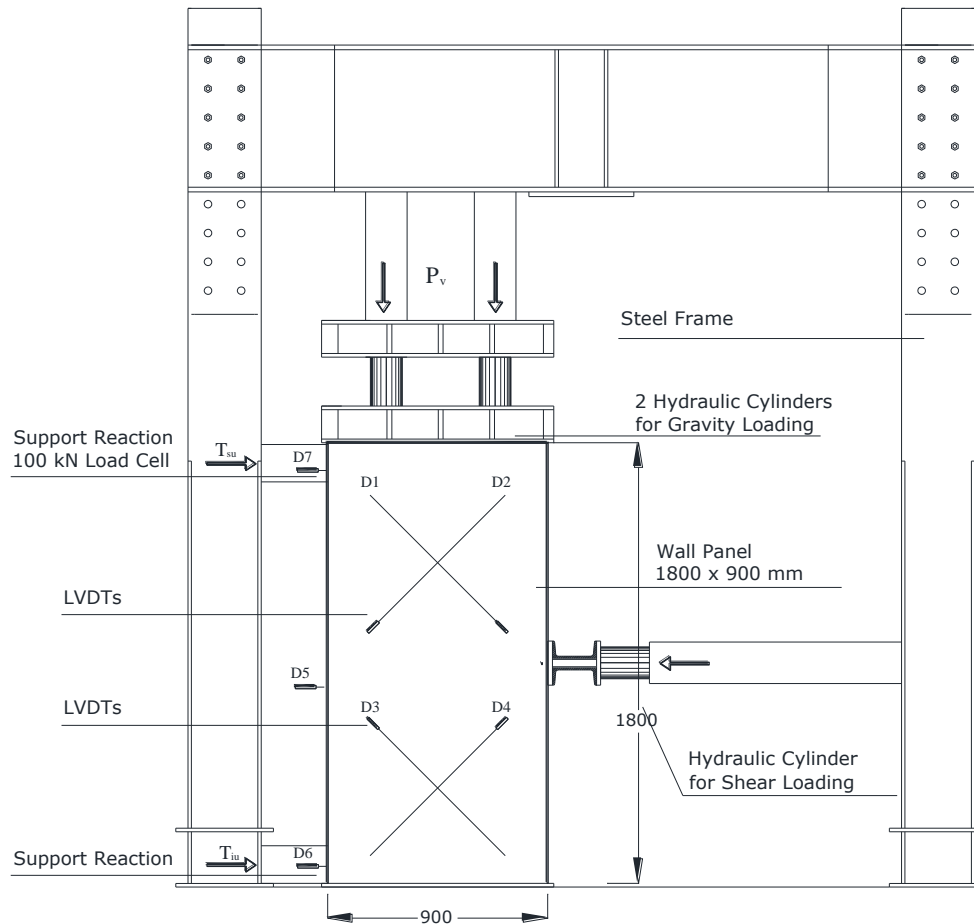
Figure 21. Shear compression test setup (dimensions in mm). LVDTs: Linear Variable Differential Transformers.

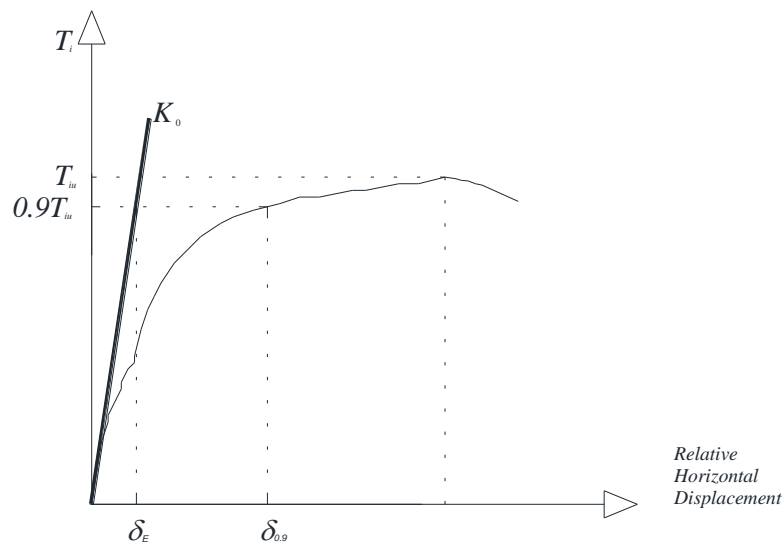
Figure 22. Method used for the calculation of δ_E .

where t and h are the thickness and height of the masonry panel, respectively; E is the Young’s modulus, and δ_E is the relative horizontal displacement between the bottom and middle points of the panel; it was calculated as indicated in Figure 22.

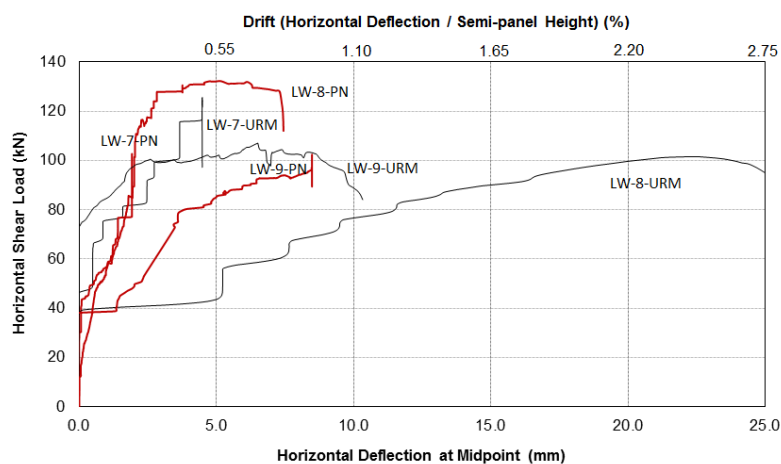
Figure 23. Total shear load versus horizontal deflection/drift (black lines: URM panels, red lines: repaired with PN).

If the total shear load was used for the analysis (Table 6 and Figure 23), it can be noted that the stonework URM walls failed at an average shear load of 113.6 kN, and after repair, at 117.5 kN. The PN repair was not able to increase the load capacity but only restored the original capacity of the unreinforced masonry. A similar result can be noted for the brickwork panel (shear capacity tests LW-9-URM: 107.1 kN and LW-9-PN: 102.4 kN). The test results remained similar if the shear capacities in the semi-panel, where the failure was recorded, were more properly used to assess the effectiveness of the PN repair (bold numbers in Table 6). The stone semi-panels exhibited a load capacity of 82.6 kN, while repaired ones had a load capacity of 72.2 kN. For the brick panels, the load-capacity of LW-9-URM was 61.3 kN, and for LW-9-PN, it was 63.4 kN.

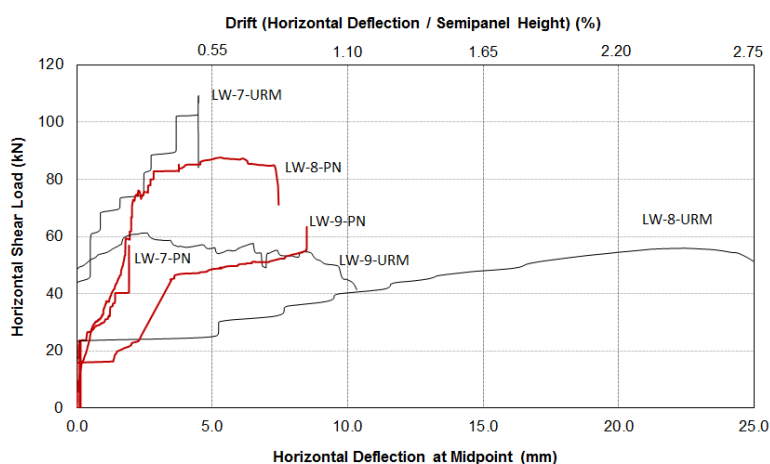
Figure 24. Shear load versus horizontal deflection/drift (black lines: URM panels, red lines: repaired with PN); the graphs are plotted using the shear loads of the semi-panels where failure occurred.

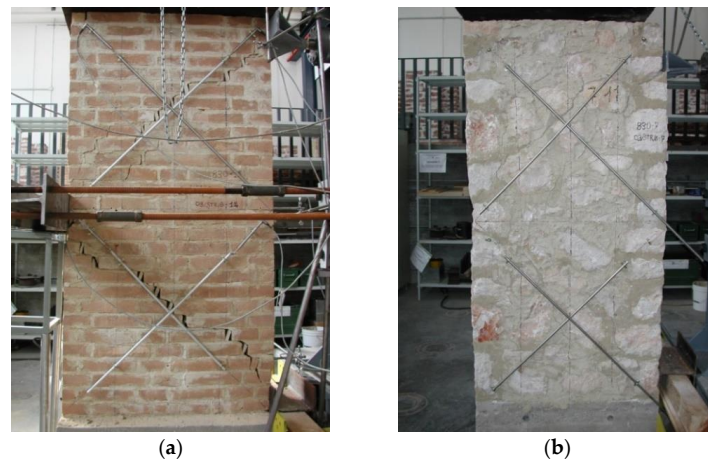
Figure 25. Typical failure mode of the URM wall panels: (a) brickwork panel and (b) stonework panel.

The failure mode of the URM walls was due to the formation of stepped diagonal cracks in one or both semi-panels. For brickwork masonry, these cracks usually appeared along the mortar joints between the brickwork and followed the mortar joints diagonally upward in a staircase pattern (Figure 25a). The cracks typically first appeared in the lower semi-panel as a consequence of the cited lack of symmetry in terms of the semi-panel's constraints. For stonework panels, the cracks had a more diagonal orientation (diagonal crack at 45° along the semi-panel's diagonal in compression). The shear capacity was clearly governed by the mechanical characteristics of the mortar used for construction and its bonding properties with the stone and the bricks. It seems that the mechanical properties of the stone and bricks had little influence on the structural response of the shear walls.

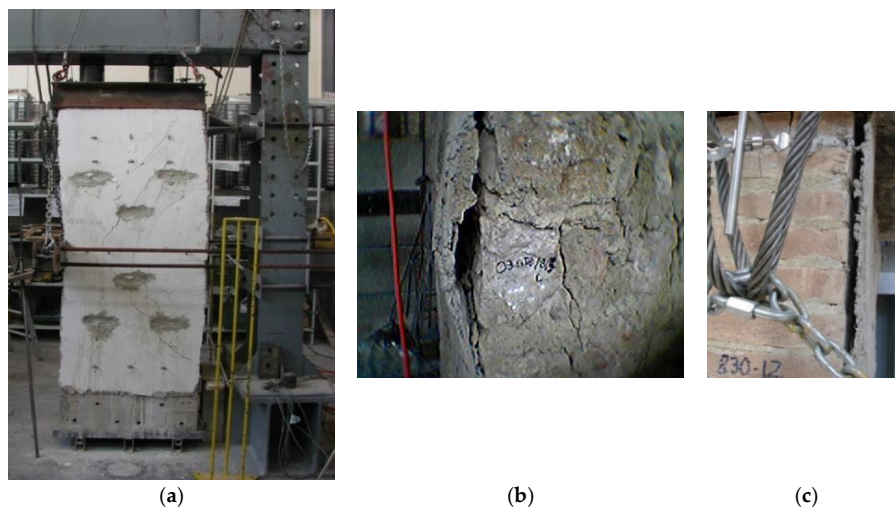
Figure 26. Typical failure mode of repaired wall panels: (a) stonework panel, (b) detail of the failure mode (stonework panel), (c) brickwork panel.

Because the wall panels were already cracked along their diagonals, the PN acted to stitch the cracks, but the very different deformation capacity of the PN (very high deformation capacity, low Young's modulus) and the mortar used for the jacket (very low deformation capacity, high Young's modulus) meant that the tensile stresses in the region of the shear cracks were essentially absorbed by the more stiff mortar. Extensive cracks re-opened in the masonry and also formed in the mortar jacket (Figure 26a). By increasing the shear load, the PN-reinforced jacket extensively detached from the masonry for both the stonework and brickwork (Figure 26b,c, respectively).
