# Non-Destructive Testing of the Longest Span Soil-Steel Bridge in Europe—Field Measurements and FEM Calculations

**Abstract:** The article describes interdisciplinary and comprehensive non-destructive diagnostic tests of final bridge inspection and acceptance proposed for a soil-steel bridge made of corrugated sheets, being the European span length record holder (25.74 m). As an effect of an original concept a detailed and precise information about the structure short-term response was collected. Periodic diagnostics of bridge deformations was done one year after it was built. Load test design was based on numerical simulations performed by means of finite element method (FEM). In situ measurements were done with the aid of: inductive sensors, optical total station, and terrestrial laser scanner. The results produced by terrestrial laser scanning were used to build a precise image of structure deformation in 3D space during the tests. The accuracy of laser mapping was significantly increased using the information coming from total station and inductive sensors. These have higher accuracy and therefore can be used as reference. Thus, new quality in measurements is introduced. Good

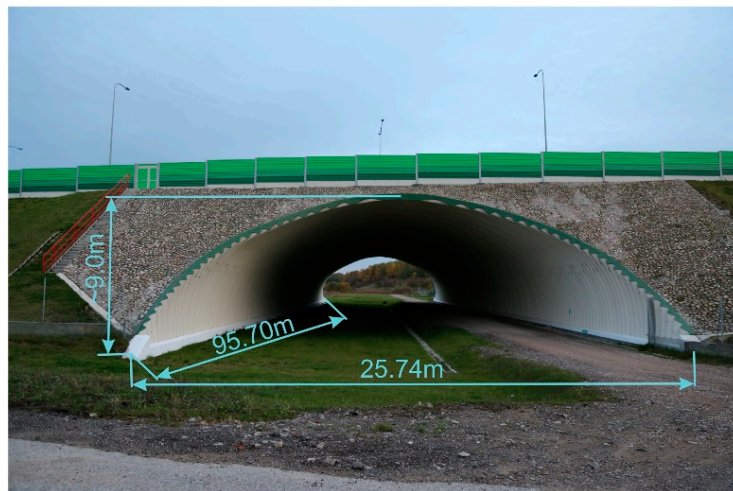
The considered soil-steel bridge is a new one, built in 2017. It is a single-span arch structure, as shown in Figures 1 and 2. The steel shell is made from UltraCor, 9.5 mm thick, corrugated sheets, produced by ViaCon Polska Ltd. company ([36]) (Rydzyňa near Leszno, Poland), which are shown in Figure 3. The corrugated sheets are connected to each other with bolts. S315MC steel was used to produce the shell. The bridge foundations are built of Franki piles. The UltraCor structure is covered by soil compacted in a way that its relative density is not less than 98% of the maximum density determined in the laboratory. In the close vicinity of steel sheets, the compaction is not less than 95%. The steel arc span length is 25.74 m, whereas the total length of the bridge equals 95.70 m. The arc sagitta equals 9.0 m. These basic dimension, characterizing the structure, are depicted in Figure 1.

**Figure 1.** Soil-steel bridge side-view taken in October 2019.

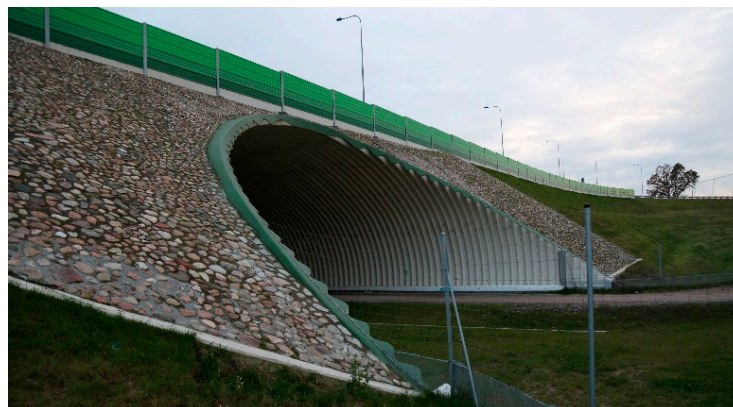
**Figure 2.** Close up of one of the bridge sides taken in October 2019.

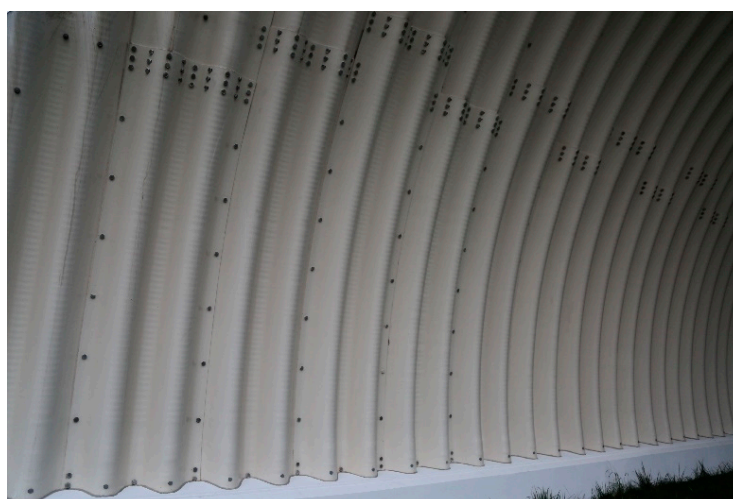
**Figure 3.** The corrugated steel sheets and their bolt connections.

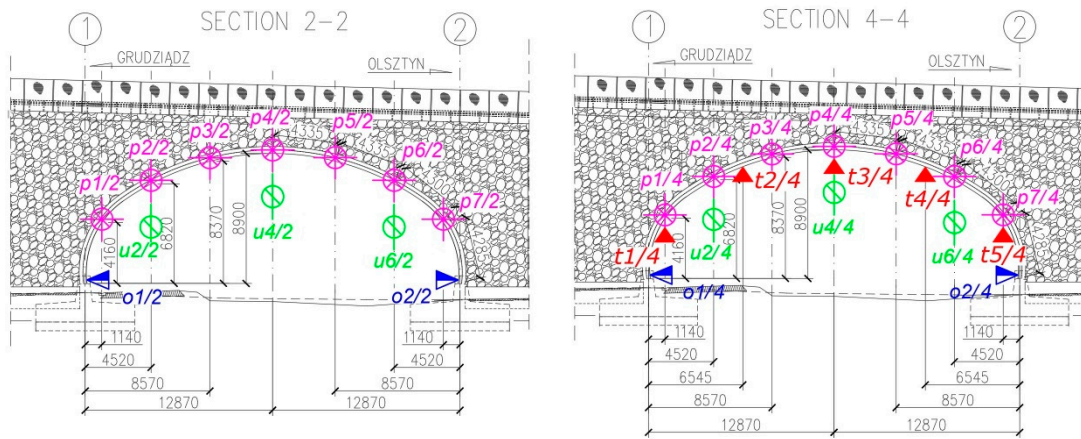
Figure 6. Location of the network of sensor used to collect the data during the static tests. sections 2-2 and 4-4 (dimensions in (mm)).

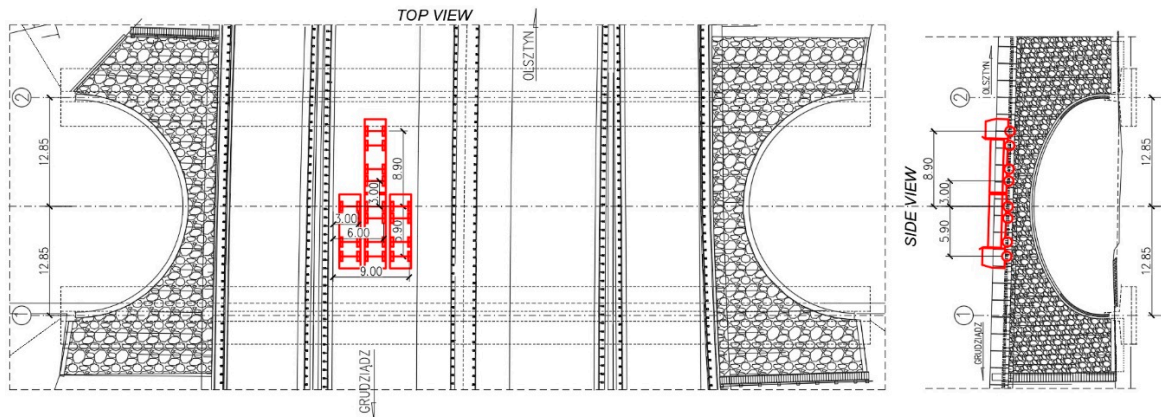
Figure 7. Schematic drawing of trucks locations during the S1 test configuration (dimensions in (m)).

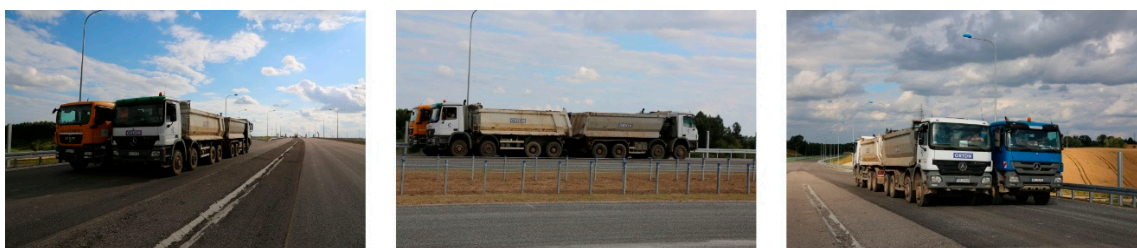
**Figure 10.** The trucks, positioned during the S2 test configuration. Views from three different perspectives.

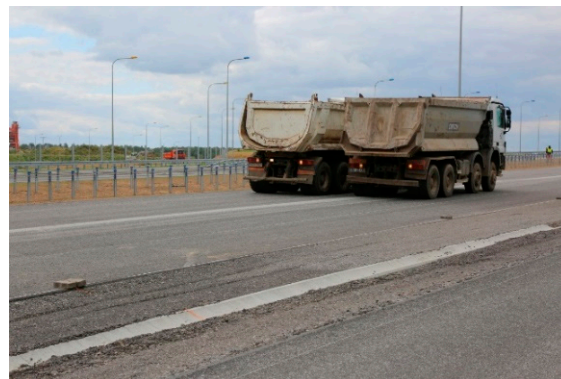
**Figure 12.** The trucks moving between M23 and M24 testing positions.

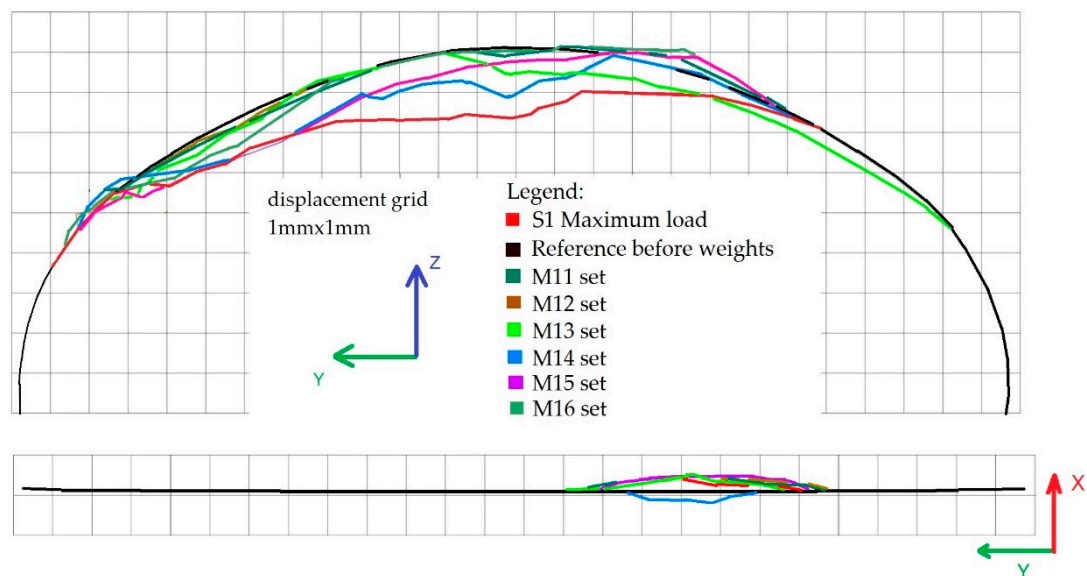
**Figure 13.** Deformations of the bridge cross section 2-2 in the Y-Z (top) and X-Y (bottom) planes under loading schemes S1 and M11–M16.

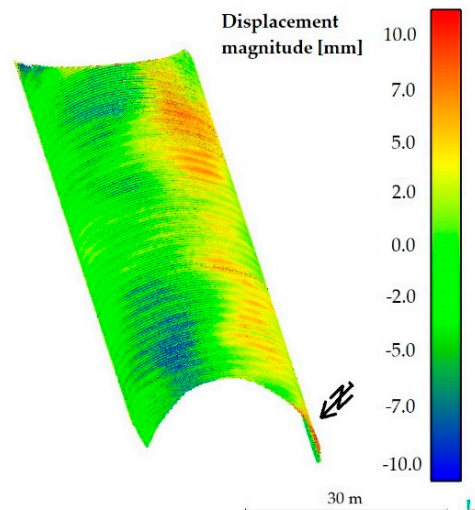
The results of the calculations presented in Figure 16 reveal that the upper part of the bridge has moved to the south up to 7 mm, while the shell in the vicinity of foundation remained undeformed. To check the accuracy of the obtained deformations a series of statistical tests, based on the Gaussian normal distribution, were run. Figure 17 presents the statistics of the Gauss function corresponding to the calculated distance uncertainties. On this basis it can be stated that the results were correctly determined in relation to the reference shown in Figure 15.

**Figure 16.** Periodic diagnostics of bridge deformations (displacement magnitude) measured one year after the final acceptance and inspection.

Owing to the above, the uncertainty of the measured deformations (Figure 16) equals approximately 2 mm (within the computed  $\sigma$  from alignment). This means that the laser scanning enabled to register all of the points characterizing the largest geometric changes. Nevertheless, this uncertainty suggests that some discrepancies of the measurements occurred during the scanning. These resulted possibly from the standard issues connected with stabilization of points, their indication, and establishment. However, because of the fact that the measurements were repeated one year after the final acceptance tests and during this period of time the construction works were still ongoing, such an accuracy of measurements is to a large extent satisfactory. For example in paper [51] laser scans of an external system were done using other techniques and the resulting precision and accuracy was not as good as here.

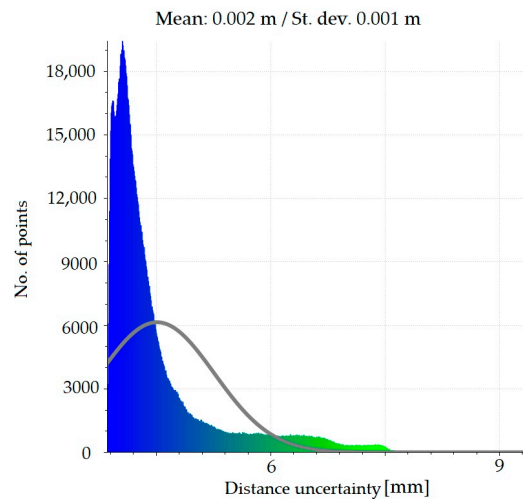
**Figure 17.** Distance uncertainty statistic.

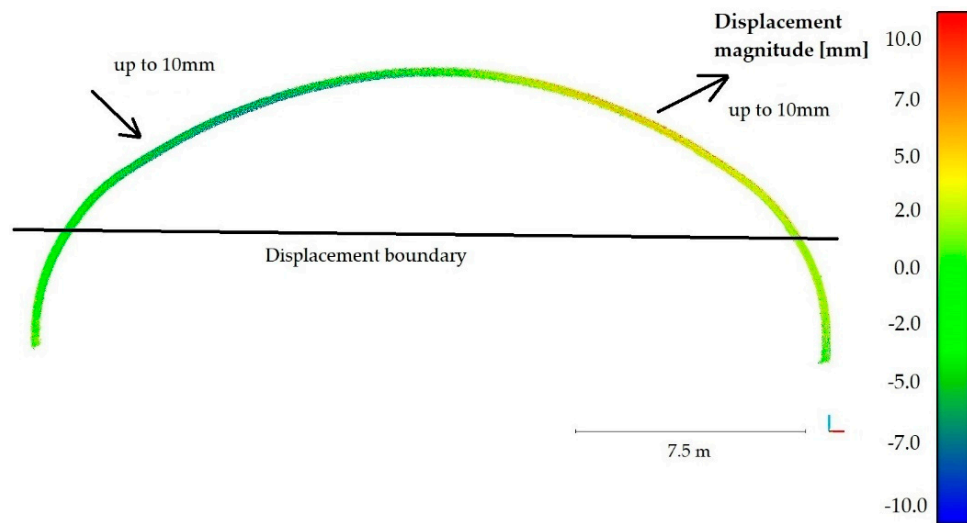
**Figure 18.** Displacements of the unloaded steel shell 2-2 section one year after the final acceptance and inspection tests.

The aforesaid results reveal, that during one-year period of time, the bridge did not exhibit deformations below the black border line, marked in the figures and named as “displacement boundary”. In view of that, we noticed a certain negative feature of the computed periodic diagnostics deformations (see Figures 16, 18 and 19). Despite attaining satisfactory result of calculations, the displacements were not obtained in the lower parts of the steel shell. However, because of the measurement accuracy, their exact values are not so certain and may rather indicate the displacement tendency. Similarly, this could have resulted from the properties of the algorithm used. On the other hand, what also is interesting, the “displacement boundary” intersects the shell approximately at the same height at which bolt connections were done (refer to Figure 3). As one year passed since the date of final acceptance tests, slippage of this connections could have occurred and some rotations of the shell have become possible in this areas. This may explain why displacements of the upper part of the shell are only observed. Hence, a research gap has been identified here. These aspects will be analyzed and addressed in further studies.

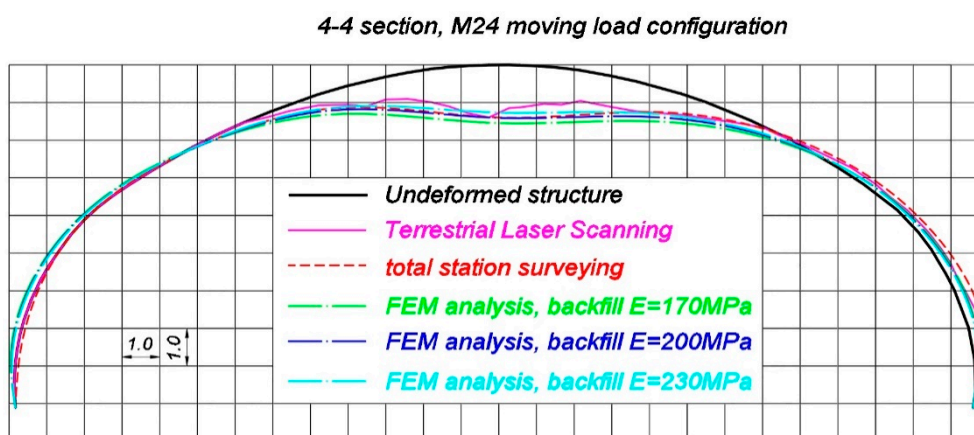
It is seen in Figures 22–24 that the FEM estimations, even for different variants of the backfill elastic modulus, are generally in accordance with the measurements with regard to their quality and quantity. The backfill elastic modulus is an important parameter that affect the bridge response. It is a bit underestimated, when  $E = 170 \text{ MPa}$ . Better quality results are obtained for  $E = 200 \text{ MPa}$  and  $E = 230 \text{ MPa}$ . In order to investigate displacements of the steel shell in detail, now, the extreme vertical displacements, that were obtained in the p4/2 point for the test S1, p4/4 for the test S2 and the corresponding FEM values (for different backfill material properties) are analyzed in Table 3. In Table 3 both total ( $U_{\text{in-situ,tot}}$ ) and elastic ( $U_{\text{in-situ,el}}$ ) in situ measured displacements are presented to highlight the issue of the shell shape change when the bridge was unloaded.

**Figure 24.** Comparison of the deformed shapes of the bridge in 4-4 section during the moving load M24 configuration, measured using terrestrial laser scanning, total station, and estimated by means of FEM (deformations in (mm) are 1000 times scaled).
