Correction

Correction: Czapik, P. Microstructure and Degradation of Mortar Containing Waste Glass Aggregate as Evaluated by Various Microscopic Techniques. *Materials* 2020, 13, 2186

Przemysław Czapik

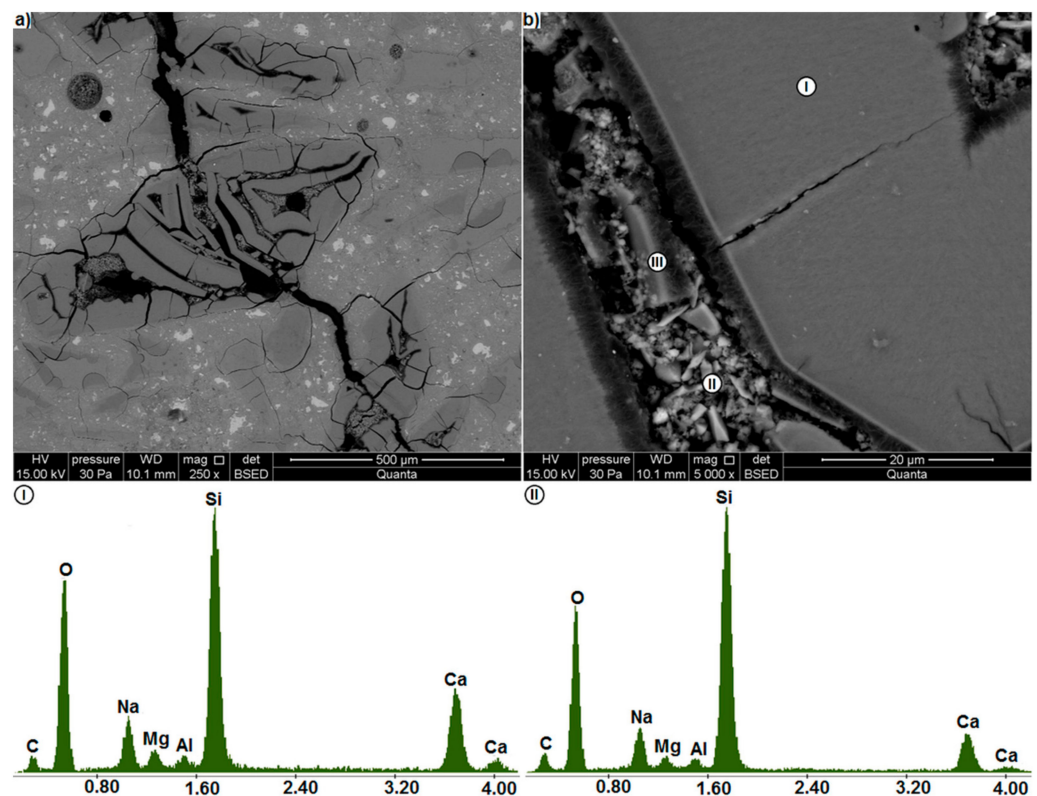
Figure 9. (a) extensively cracked region in the microstructure of the mortar containing waste glass (b) region of porous gel (BSE); EDS analysis at points I and II, (c) cracks in the gel.

The author wishes to make the following correction to this paper [1]. Due to the duplication of the same diagrams in Figures 8 and 9, replace

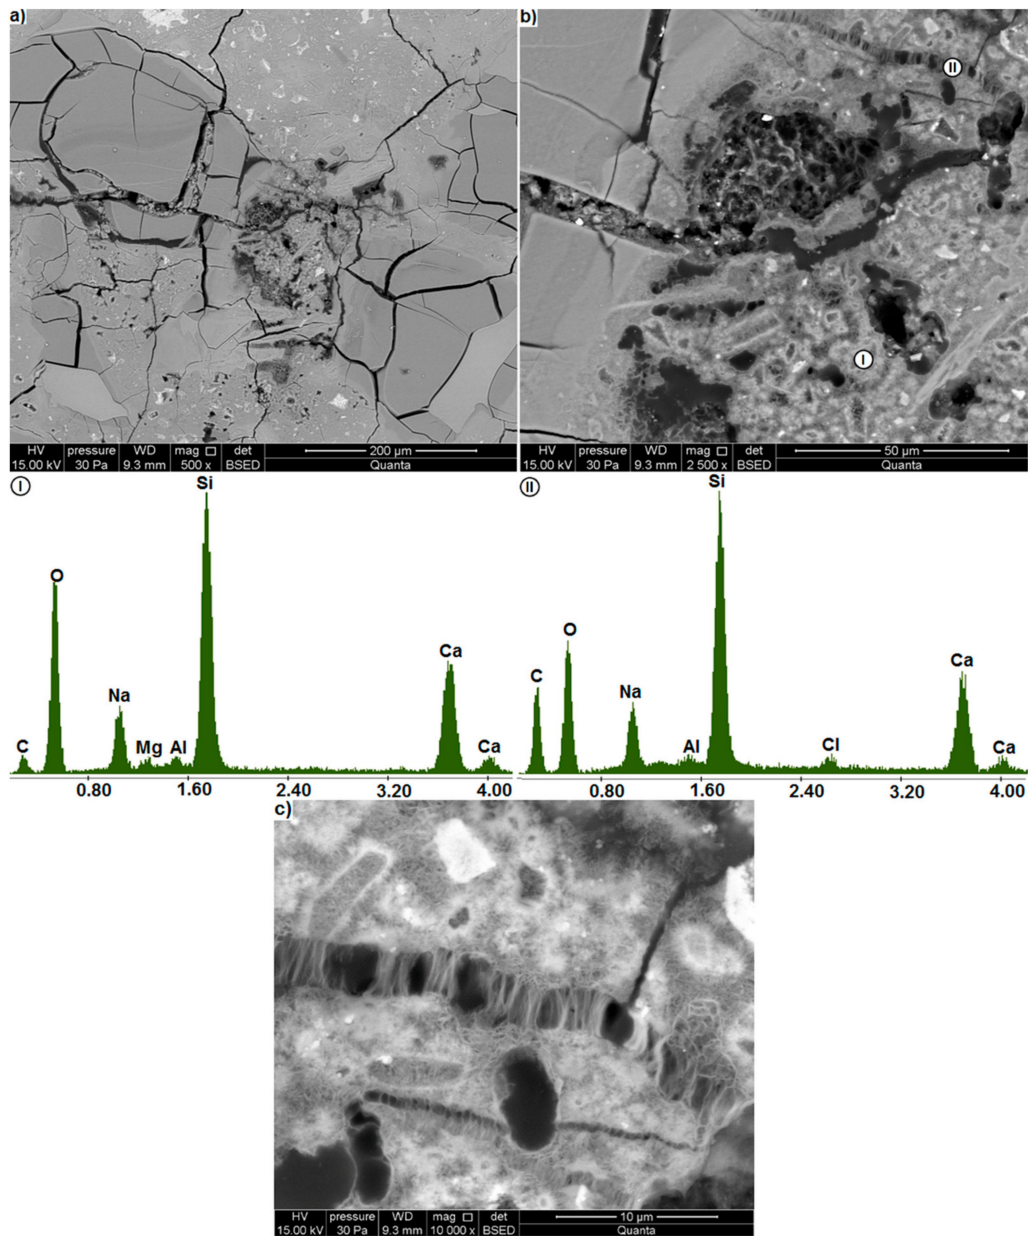
Figure 9. (a) extensively cracked region in the microstructure of the mortar containing waste glass (b) region of porous gel (BSE); EDS analysis at points I and II, (c) cracks in the gel.
