# Semi-Destructive and Non-Destructive Tests of Timber Structure of Various Moisture Contents

**Abstract:** The condition of heritage and historic timber constructions depends on how they are exploited. Numerous environmental factors degrade the physical and mechanical properties of timber and hence, affect the load-bearing capacity of constructions. As a result, frequent evaluations of their technical condition become necessary. Currently, modern technologies allow for extensive diagnostics of timber constructions using non-destructive and semi-destructive methods; yet, in contrast to classical laboratory tests, there is insufficient knowledge of the impact of individual factors on the results of such studies. This article presents an assessment of the influence of the moisture content of timber elements on the results of ultrasonic stress wave, sclerometric, and resistance drilling tests. Additionally, computed tomography scans were performed on selected samples to demonstrate the destruction mechanism occurring during the semi-destructive tests. The research involved three types of wood: pine, spruce, and fir of different moisture contents. The results reveal a strong relation

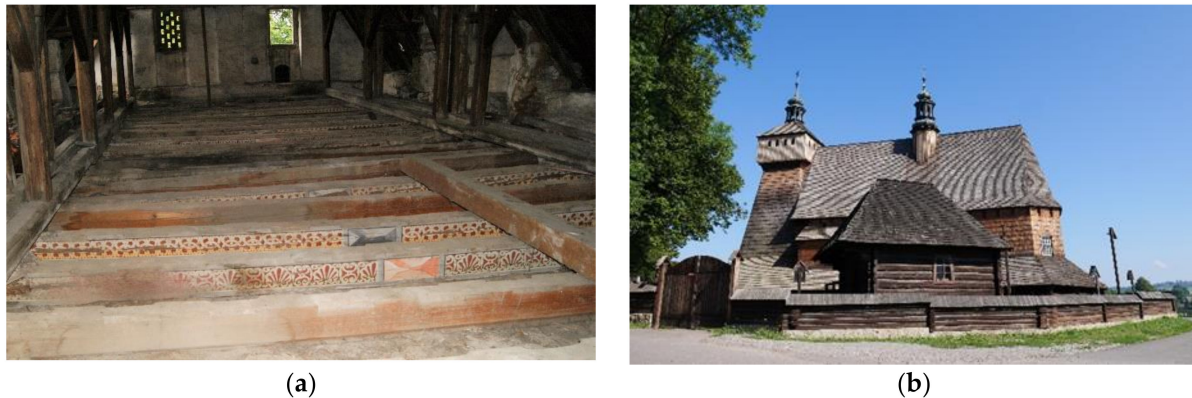
**Figure 1.** (a) The beam ceiling of the Gorzanów Palace—high humidity of the elements resulted from long-term leakage in the roofing; (b) The church in Haczów—repeatedly flooded by floods.

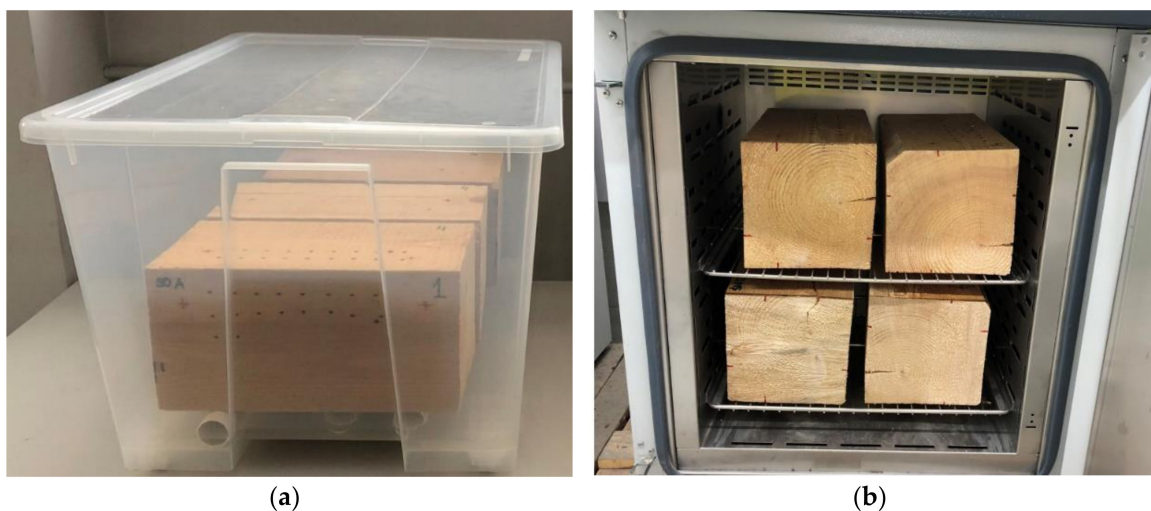
**Figure 2.** Seasoning of samples: (a) moisture-rise chamber; (b) wood-drying chamber.

The samples were divided into two groups: the group in which the moisture content was increased and the group in which the moisture content was decreased, starting from the air-dry state. Each group comprised three samples of each species. Individual samples were tested a minimum of three times at different moisture contents. The first group, after a reference test in the air-dry state, was seasoned in climatic chambers at a temperature of 25 °C and air humidity of 95% until the required moisture content level was reached (Figure 2a). Having exceeded the fibre saturation point, a part of each sample was completely immersed in water with an average temperature of 25 °C and was seasoned in this way for the next twelve months. The second group of samples, after the reference test in the air-dry state, underwent a process of gradual drying at a temperature of 45 °C, and next at a temperature of 65 °C in laboratory dryers without forced air convection to an absolute-dry state at a temperature of 100 °C. All the tests on the samples in this group were carried out after cooling in a desiccator to room temperature and after control mass measurements.

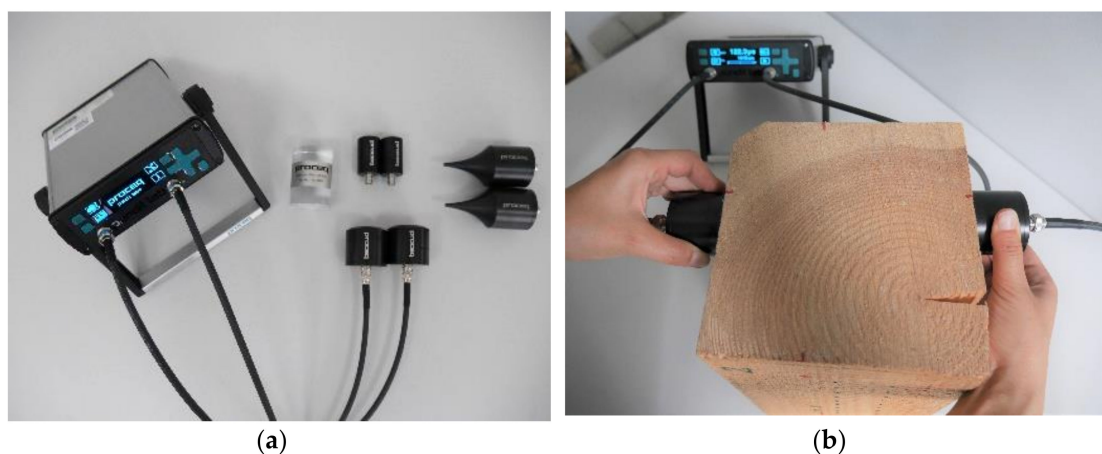
**Figure 5.** Apparatus for non-destructive test (NDT) studies: (a) PunditLab Proceq with accessories; (b) Sample under investigation.

Ultrasonic tests were carried out using a PunditLab set produced by Proceq (Schwyz, Switzerland) with transducers operating at a frequency of 54 kHz with an automatic transmitter voltage. Before each use, the device was calibrated on the dedicated calibration rod with an ultrasonic wave passage time of 25.4  $\mu$ s. The measurements were taken using a coupling agent in the form of a chemically passive polyacrylic gel and both transducers were coated with a thin layer of the gel before each measurement. For each sample, 4 test cross-sections were selected in places found macroscopically to be defect-free (two areas on each side). For each test cross-section of a sample, 3 measurements were taken and the average values were used as the results of the ultrasonic wave propagation velocity between the transducers, i.e., the opposite sides of the sample. The apparatus used in the measurements and an example sample undergoing the test are presented in Figure 5.

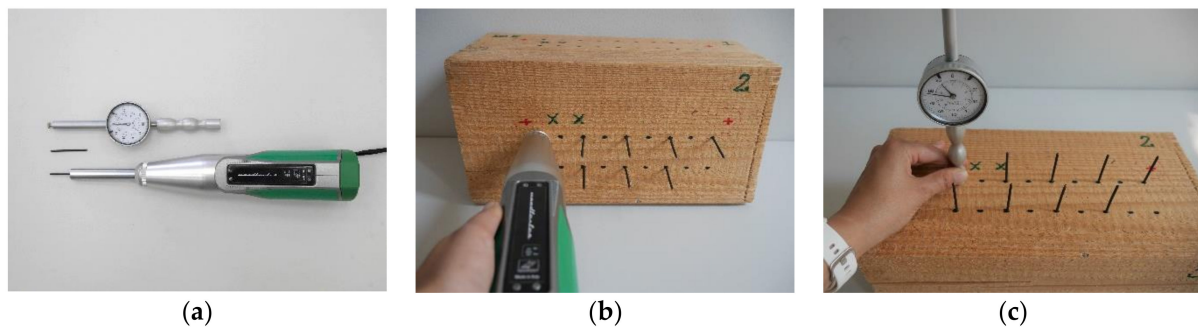
**Figure 6.** The device used for semi-destructive test (SDT) studies. (a) Woodtester Novatest and accessories; (b) Dynamic insertion of sclerometer pins; (c) Penetration depth readout.

Sclerometric studies were performed using a Woodtester device from Novatest (Ancona, Italy) with an impact energy of 2.4 J, equipped with steel pins having a hardness of 60 HR and a diameter of 2.5 mm with a cone-shaped tip inclined at an angle of 35 degrees and a length of 50 mm, and a clock sensor offering measurement accuracy of 0.01 mm. The device was calibrated on a testing anvil characterized by hardness of >52 HRC. Marking was done on the device in a horizontal position. The quantity measured was the remaining part of the pin that had not penetrated into the material, and the measurement result was taken as the difference between the pin length and quantity measured. The maximum possible pin penetration depth after a fivefold impact, as recommended by the producer, is 40 mm. However, for the species of wood used in the experiment with a high moisture level, three impacts produce a cavity which is greater than the measurement limitation of the device, hence a decision was made to consider the results of a single (PD<sub>1</sub>) and double (PD<sub>2</sub>) hammer impact. After readouts of the first and second impact, the pins were removed using hand tools. For each sample, three test fields were selected on its three sides in places macroscopically evaluated as defect-free. In each field, 18 points were selected for tests under different moisture levels and no fewer than 9 measurements were taken for

each area and each moisture level. The device used and an example of a specimen in the middle of testing are shown in Figure 6.

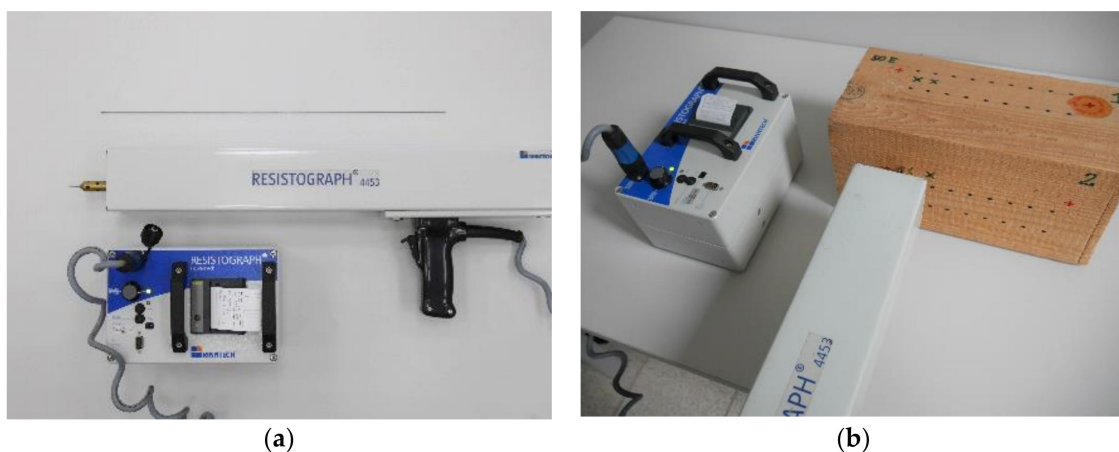
**Figure 7.** The device used for SDT studies. (a) RinnTech resistograph for resistance drilling tests; (b) Device conducting a test.

The resistance drilling test was carried out by a means of a 4453-S resistograph device produced by RinnTech (Heidelberg, Germany) with a drilling rate of 40 cm/min and a resolution of 1/100 mm dedicated to tests of wood of average density and equipped with a drill bit with a diameter of 1.5 mm and a head of 3.0 mm. The torque required to keep a constant drilling rate corresponds to wood resistance and is recorded and plotted versus the drill bit penetration depth. The tests were conducted perpendicularly to fibres, away from the defect-occurring zones. The results of the measurements were taken as the quotient of the area under the resistance drilling curve and the drill depth (RM) [40], as a dimensionless quantity dependent on the device used. For each element, 2 reference cross-sections were selected for which resistance drilling tests were performed in the air-dry state, whereas subsequent measurements were taken at various moisture contents in cross-sections situated 15 mm away from the previous one. The apparatus and an example of a specimen in testing are shown in Figure 7.

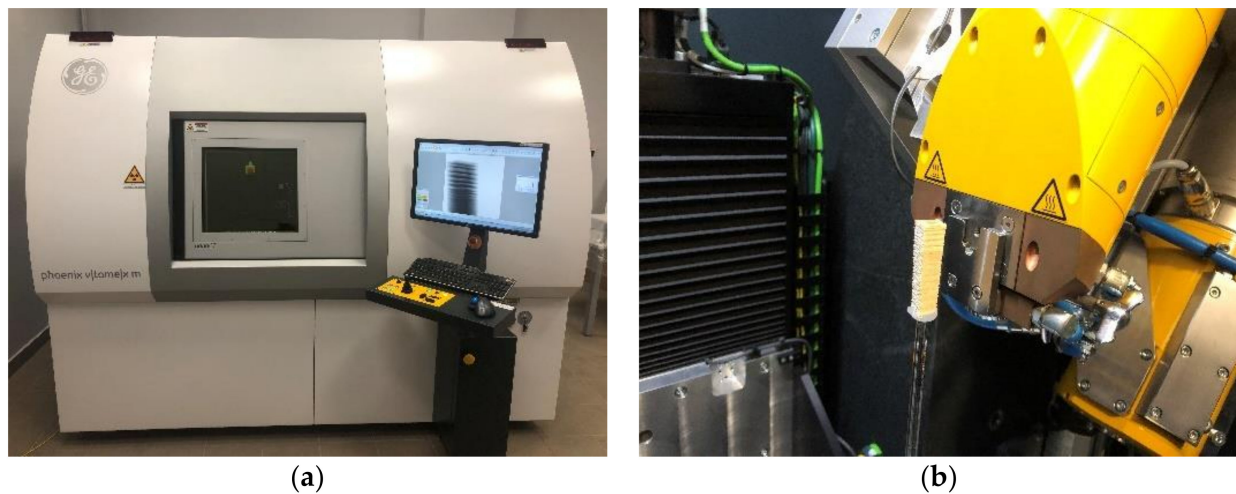
**Figure 8.** X-Ray CT studies. (a) GE Phoenix v-tome-x m device performing a test; (b) Sample prepared for a tomography test positioned inside the device.

For a selected pine specimen, X-ray computed tomography was performed in place of the sclerometric and resistance drilling tests to picture the damage to the wood fibre structure. The tests focused on sections with dimensions of  $15 \times 15 \times 40$  mm containing holes formed as a result of the SDT carried out at the aforementioned moisture contents  $MC \approx 12\%$  and  $MC \approx 100\%$ . Tomography of the sections was performed in their air-dry state ( $MC \approx 12\%$ ) and in the full FSP ( $MC \approx 100\%$ ) using a GE Phoenix v-tome-x m device (Figure 8a).

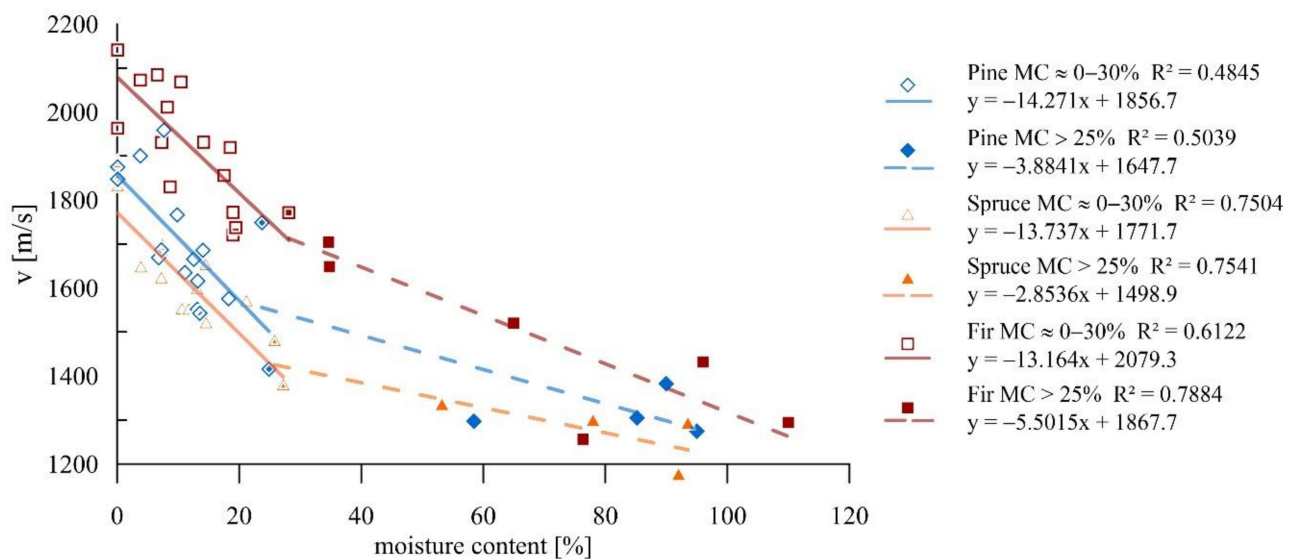
**Figure 10.** Ultrasonic wave testing for samples of different moisture levels.

The analysis was carried out on the results obtained for the individual species of wood. Generally, there was a decrease in the velocity of the ultrasonic wave passage as the moisture increased. Regardless of the wood species, this drop was more significant in the moisture range below the FSP than above the FSP. A strong correlation was found for spruce and fir timber and a slightly weaker one was for pine timber. The results of the study with defined trend lines and corresponding coefficients of determination are presented in Figure 10.

For all wood species in the moisture range below the FSP, the drop in velocity of the wave passage with a moisture change of one percentage point was 13.7 m/s on average. This represents approximately a 1.0% change in the result with a moisture change of 1% for pine and spruce and 0.8% for the fir. The smallest decrease in the moisture range above FSP was recorded for spruce samples, which was about 2.8 m/s per one percentage point of moisture increase; in this range, the highest decrease was recorded for fir samples and reached 5.5 m/s, which is 0.24% and 0.42% respectively.

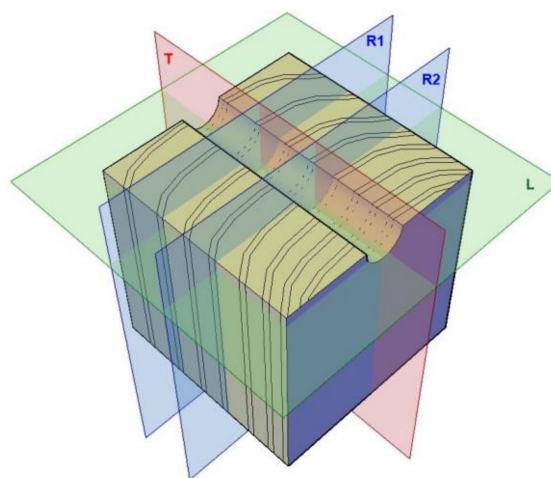
**Figure 12.** The schematic view of considered sections: R, T, and L.

Figures 13 and 14 present X-ray images of the damage structure in the wood that occurred during the sclerometric test of the samples in the air-dry state and the state of full fibre saturation with water. The naming convention of the sections is given in Figure 12.

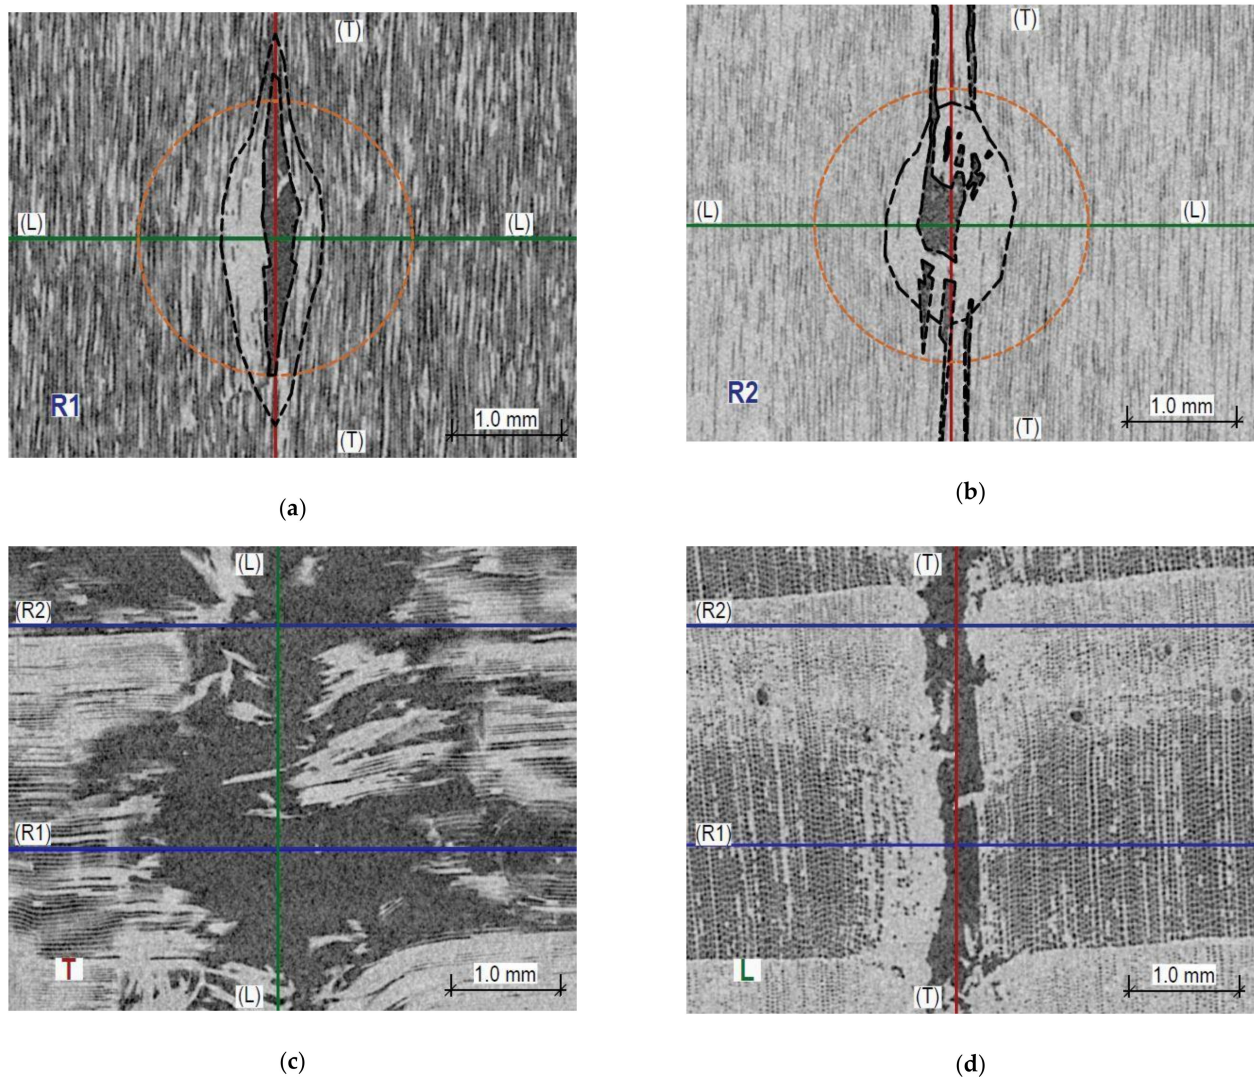
**Figure 14.** Sections through the opening resulting from the sclerometric test on the sample in the fibre saturation state. (a) Cross-section within earlywood R1—tangential section of wood can be seen; (b) Cross-section within latewood R2—tangential section of wood can be seen; (c) Longitudinal section T—radial section of wood visible; (d) Longitudinal section L—cross-section of wood visible.

In turn, penetration of the sclerometer pin through the saturated wood causes mostly elastic deformation of individual fibres and pronounced cracking along the fibres. Both in earlywood and latewood, the impact hole in a tangential direction is much smaller than the diameter of the sclerometer pin, whereas the fractions in a longitudinal direction are much larger than the pin diameter. In earlywood and latewood, they extend to 1.8 and 3 mm from the opening axis, respectively. In Figure 14a,b, the black dashed line corresponds to the

zone of fibres that sustained damage and the area of the compressed fibres is comparable in both cross-sections. The test hole in a tangential direction is considerably smaller than a transverse cross-section of the sclerometer pin (the sclerometer pin cross-section is shown in Figure 14a,b in orange).

An interesting source of information on the influence of this testing method on the microstructure of wood is the CT scanning. Figures 13 and 14 demonstrate typical images obtained for various samples. There is a significant difference in the nature of microstructure destruction for air-dry samples and in the state of full saturation. The dynamic penetration of the sclerometer needle in the air-dry samples caused destruction in the form of a clear tightening of the lumen of the cells (tracheids) of the earlywood, and in the latewood, it was accompanied by significant cracking (Figure 13d). The tightened cells accumulated on the boundary of the annual growth ring. In a completely different way, the destruction took place in the wood in the state of fibre saturation; there is no brittle cracking between the wood cells (Figure 14d) but only a slight accumulation along the hole left by the sclerometer needle. However, there was a separation in the transverse direction of individual wood fibres over a long distance, as shown in Figure 14a,b. This was most probably caused by water occurring between the micelles, which reduces the cohesion forces between them. This different character of cellular structure destruction below and above the FSP indicated a varying influence of moisture on the sclerometric test results in these ranges. Up to the fibre saturation point, the cohesion forces decrease with increasing moisture content and thus the influence of moisture on sclerometric test results is significant. At the point of fibre saturation, the cohesion forces reach the lowest level; further penetration of free water does not significantly change the mechanical properties of the wood, which is reflected in a reduced effect of moisture on the results of these tests. This further, although much smaller, impact of moisture on the results of the tests could be explained by the decreasing friction forces associated with the presence of increasing amounts of free water. For the dynamic character of this test, the free water contributes to the slip of the smooth surface of the sclerometer needle within the wood fibres with minimal cohesion.

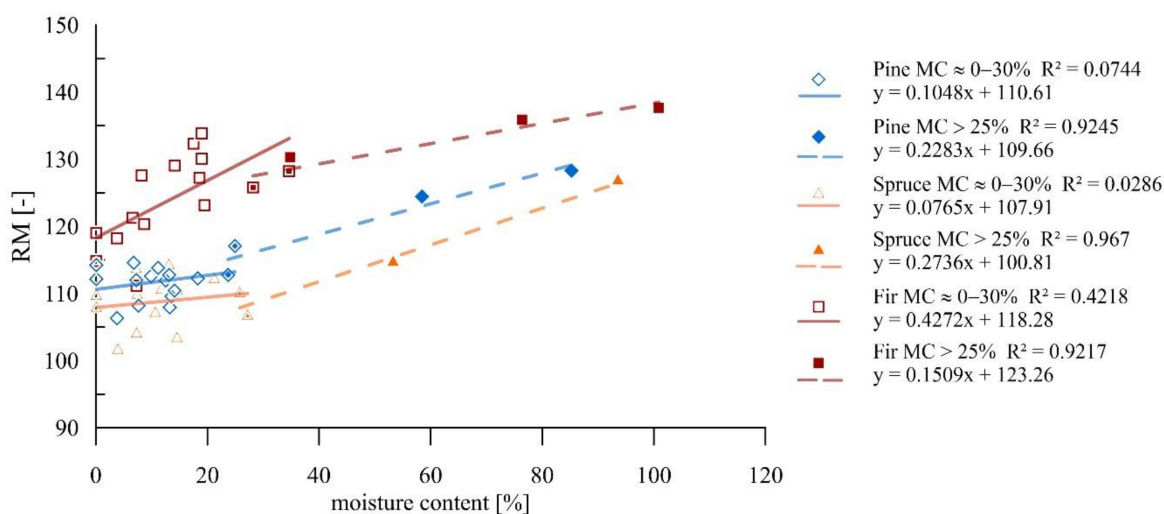
Figure 15. Resistance drilling tests for samples of different moisture contents.

The research indicated a general trend of the development of drilling resistances as the moisture content increases. Nevertheless, the weak correlations in the range below the FSP suggested a weak dependence of drilling resistances on the moisture content in this spectrum, whereas above the FSP, these correlations are very strong. The results of the study with defined trend lines and corresponding coefficients of determination are given in Figure 15.

Below the FSP for fir wood, an increase in moisture content of 1 percentage point contributed to an increase in drilling resistance of about 0.3%. The coefficients of determination obtained in this range for pine and spruce wood did not indicate a significant relationship. In the range above the FSP, an increase in moisture content by 1 percentage point caused an increase in drilling resistance of about 0.2% on average for all wood species.

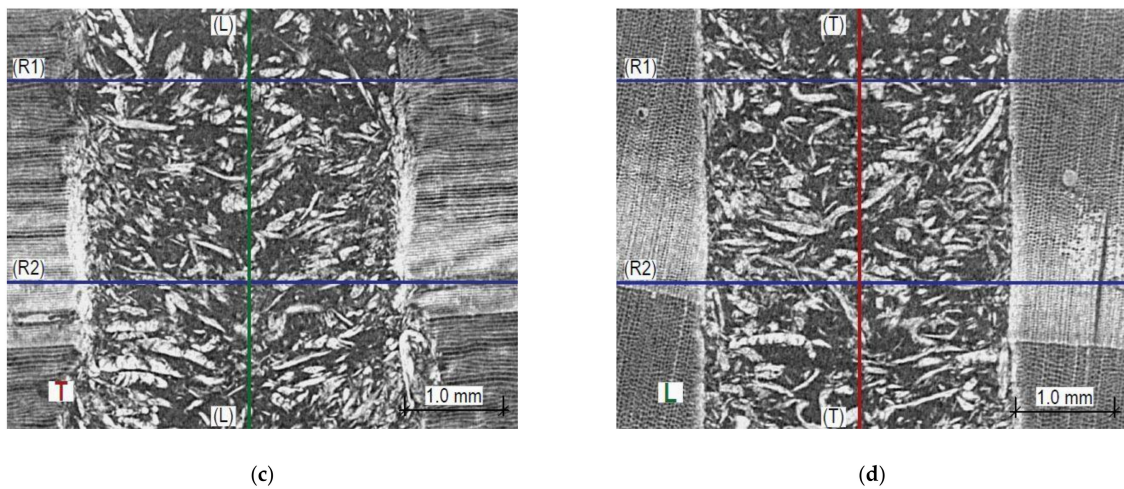
**Figure 16.** Sections through the opening after the resistance drilling test of the sample in the air-dry state. (a) Cross-section within earlywood R1—tangential wood surface visible; (b) Cross-section within latewood R2—tangential wood surface visible; (c) Longitudinal section T—radial wood surface visible; (d) Longitudinal section L—wood cross-section visible.

In Figures 16 and 17, X-ray images illustrate the wood structure damage that was caused in the resistance drilling tests of the air-dry samples and fully water-saturated samples. The naming convention of the sections is given in Figure 12. In resemblance to the sclerometric tests, it can be seen that the damage character of the microstructure differs both within the earlywood and latewood of a given sample and for different moisture levels.

The damage zone in Figure 16a,b is marked with a black line; the distance between the edge of the damaged fibres, in a direction along the fibres, is on average 4.0 mm in earlywood, whereas in latewood, the distance is 3.5 mm. The test borehole is uniformly filled with fragments of drill cuttings. The zone of the drill operation is shown in Figure 16a,b in orange.

Analysis of the tomographic images showed the different types of destruction for ranges above and below the fibre saturation point. The resistograph bit penetration through earlywood in the air-dry sample causes fibre destruction, most of all along the fibres. In this zone, characteristic fibre displacements following the drill's rotational movement are visible. In latewood, the damage type is similar, but its extent is much lesser. The penetration of the resistograph drill bit through the wood in the state of full saturation causes fibre damage to a much greater extent than in the case of air-dry wood. Characteristic displacements of fibres are visible in a direction consistent with the drill bit rotation manner, but the image is not as clear as for the samples in the air-dry state. Both in earlywood and latewood, there is a compaction of drill cuttings at the borehole walls. In latewood, the damage zone in a tangential and longitudinal direction is comparable. In turn, in earlywood, the greatest damage occurs along the fibres.
