Article

Seismic Behavior of Stone Masonry Joints with ECC as a Filling Material

Abstract: This paper investigates the seismic behavior of novel stone masonry joints using ductile engineered cementitious composite (ECC) as a substitute for ordinary mortar. Ten stone masonry joints with different types of mortar/ECC were tested under axial and cyclic loads. The filling materials of mortar joints tested included ordinary mortar, polymer mortar, ECC, and composite mortar with two combination proportions of ECC and ordinary mortar. The test results indicated that ECC specimens exhibited a more stable hysteretic response as well as an improvement in strength, deformation, energy dissipation, and strength degradation. The ECC mortar joints maintained integrity during the entire loading process due to the “self-confinement” effect of ECC. A partial substitution of mortar with ECC could provide effective reinforcement and confinement to prevent mortar failure and peeling, thereby allowing such specimens to approach the seismic performance of ECC specimens. Based on the trend of shear strength variations, a corresponding failure process is defined for ECC/mortar joints under cyclic and axi

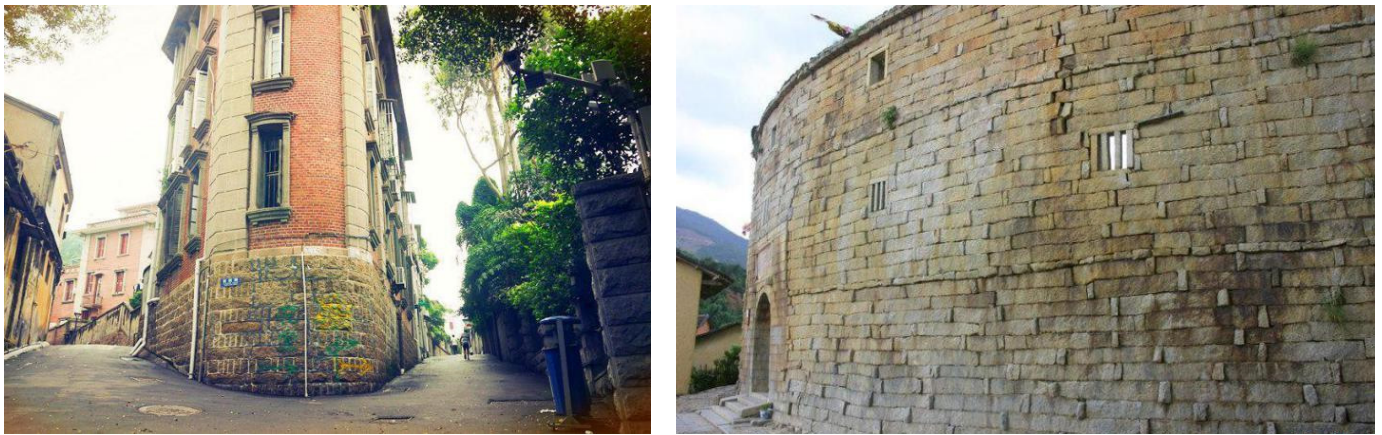
Figure 1. Stone masonry structure in an actual building.

Stone structures are widely used in historical and residential buildings around the world (Figure 1), but their seismic performance has received limited attention. Different from other traditional masonry structures, the strength of the stone is far higher than that of the filling material in mortar joints. By combining experimental and analytical approaches, as well as field investigations of earthquake damage to stone structures, it has been found that the mortar joint of a stone wall is the weakest zone under earthquake [1,2]. Despite past literature having developed different strengthening options of stone masonry joints [3–8], the seismic behavior has not yet been assessed. Due to the diversity of masonry technology, the complexity of mortar joint composition, and the difference in material properties, the seismic behavior of stone mortar joints is more complex than that of common masonry mortar joints [2,9]. Therefore, understanding the seismic behavior of stone masonry is of great significance to further protective repair and seismic damage assessments of stone structures.

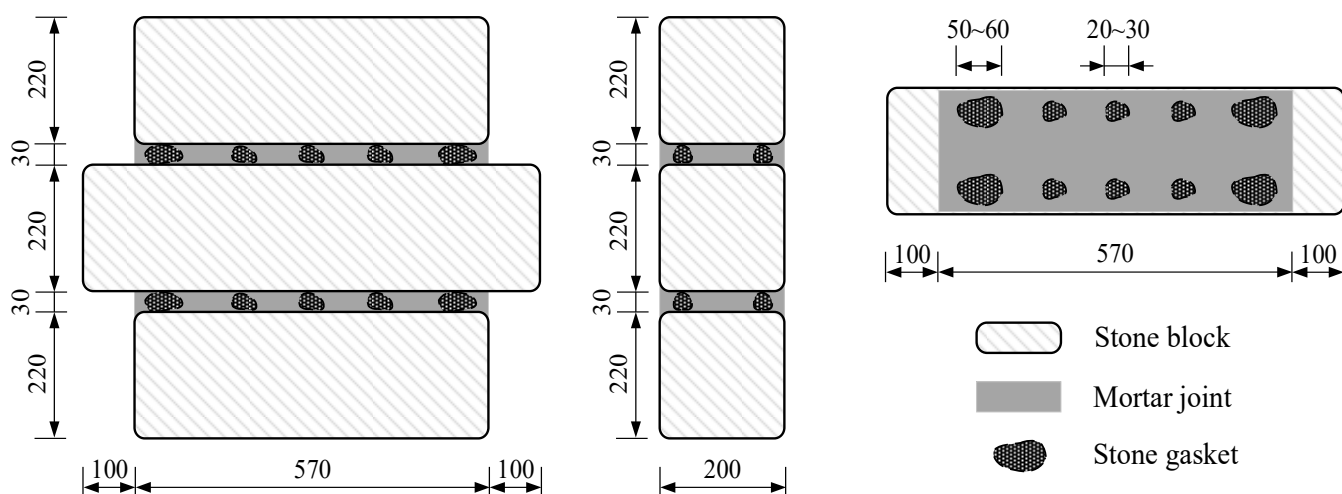
Figure 2. Detailed size of the specimens (unit: mm).

The experimental study examined the seismic behavior of stone masonry joints with different types of mortar under axial compressive stress. The mortar types included ordinary mortar (M), polymer mortar (PM), ECC, and composite mortar with ECC and ordinary mortar (CM). To evaluate the effectiveness of ECC in improving the seismic performance of stone masonry joints, a total of 10 specimens of the same size were constructed and tested under displacement-controlled cyclic loading. The test specimen consisted of three main stone blocks ($200 \text{ mm} \times 220 \text{ mm}$) with different lengths (570 mm for upper and lower blocks and 770 mm for the middle one), two mortar joints (30 mm in thickness for each) between the adjacent stones, and ten stone gaskets inside each mortar joint. The detailed size of the specimen shown in Figure 2.

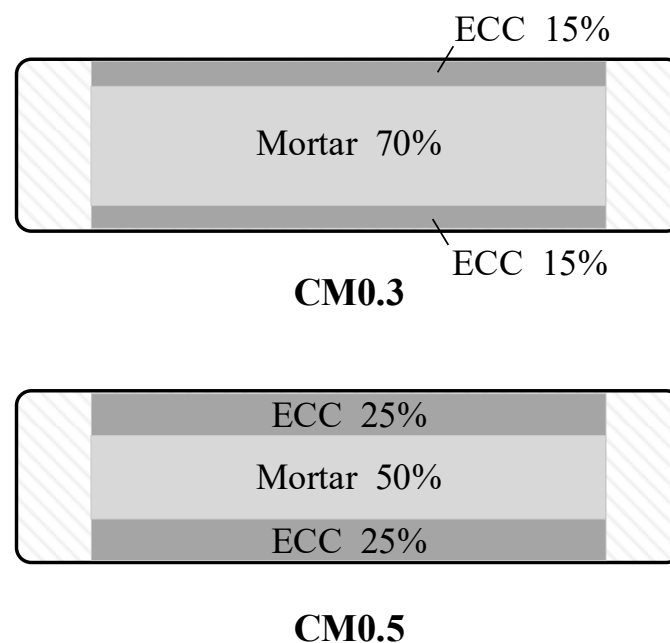
Figure 3. Details of composite mortar.

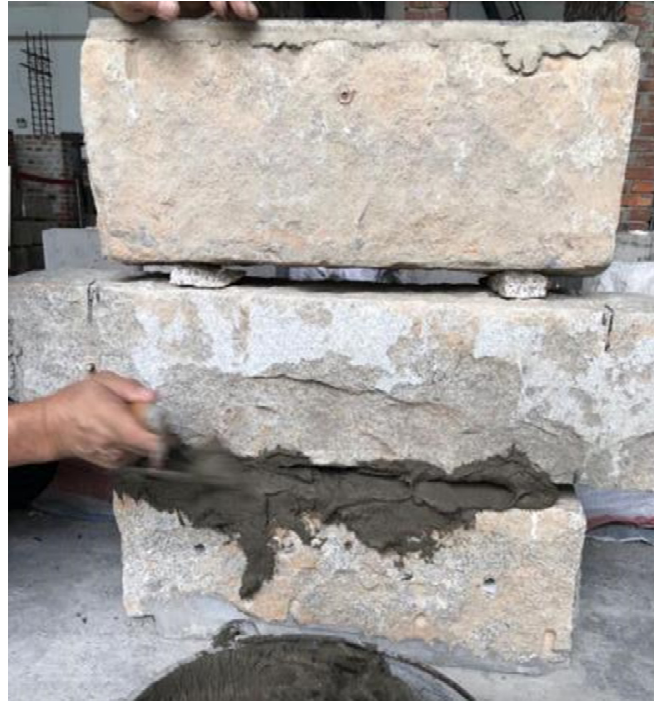
Figure 4. Filling the joints with mortar.

The stone blocks (kind of coarse granite material, collected from the historical unreinforced buildings of stone structure) were stacked with the support of stone gaskets before filling in with the mortar (Figure 4). The mortar was mixed and poured in the laboratory; then, it was filled evenly into the gap between the stone blocks. We pressed properly to ensure the density of mortar. After the completion of the mortar joint masonry, water spray

curing was conducted on the surface of the mortar joint for 7 days, following a natural curing time of 28 days before the experiment. In addition, the upper and lower ends of the specimen are leveled with concrete for installation.

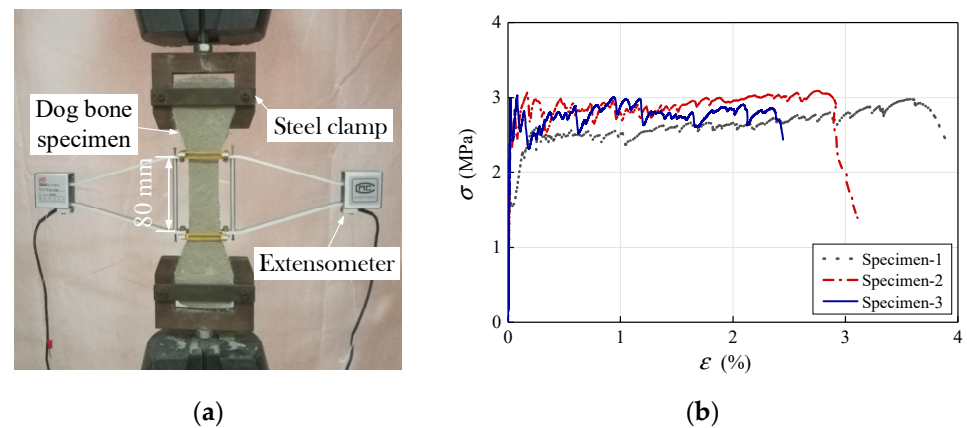
Figure 5. (a) Tensile tests on ECC dog bone-shaped specimens; (b) Tensile stress–strain curves of ECC specimens.

The compressive strength was tested using four 100 mm cubes following the relevant Chinese standard JGJ/T70-2009 [25]. The average cubic compressive strength of the M, PM, and ECC at the time of column testing was 2.1 MPa, 34.8 MPa, and 22.8 MPa, respectively. “Dog bone”-shaped tensile specimens with an 80 mm long testing region were loaded at a rate of 0.2 mm/min to obtain the tensile strength (Figure 5a), following the relevant Chinese standard JC/T 2461-2018 [26]. The tensile stress–strain curves of ECC shown in Figure 5b) exhibit pseudo strain-hardening behavior. The rupture strain was above 2.5%, demonstrating an excellent tensile ductility. The average tensile strength of ECC was 2.7 MPa.

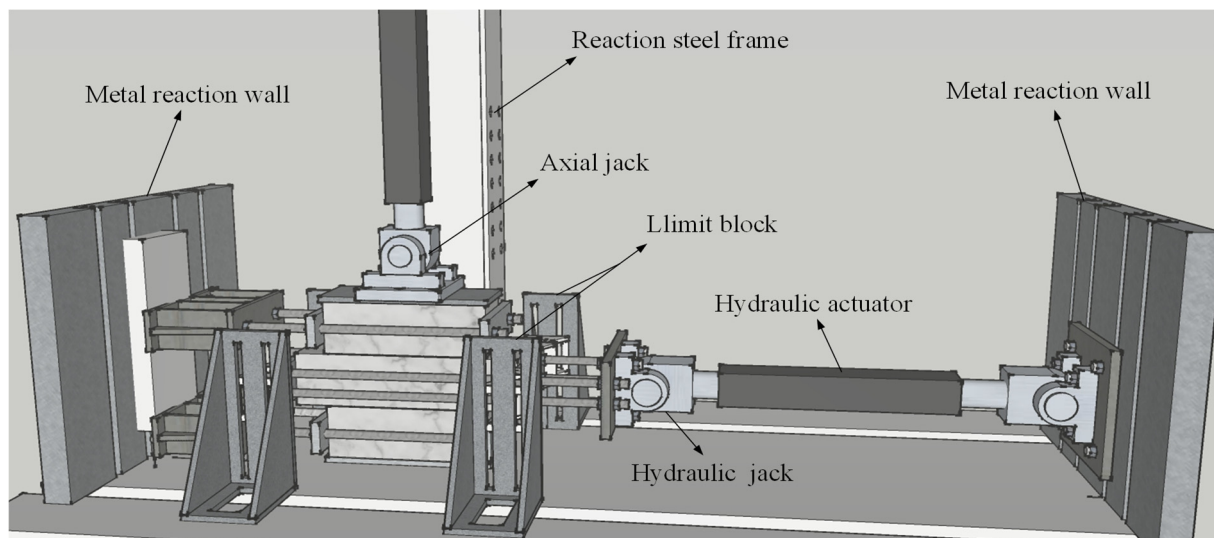
Figure 6. Details of testing rig.

The specimens were tested under displacement-controlled cyclic loading using a 500 kN servo-controlled hydraulic actuator with a stroke length of ± 100 mm, as shown in Figure 6. The upper and lower stone blocks were fixed on a metal reaction wall through four screws with steel plates on each side, avoiding moving with the horizontal load. Four limit blocks with a roller were applied to limit the anti-plane displacement of specimens.

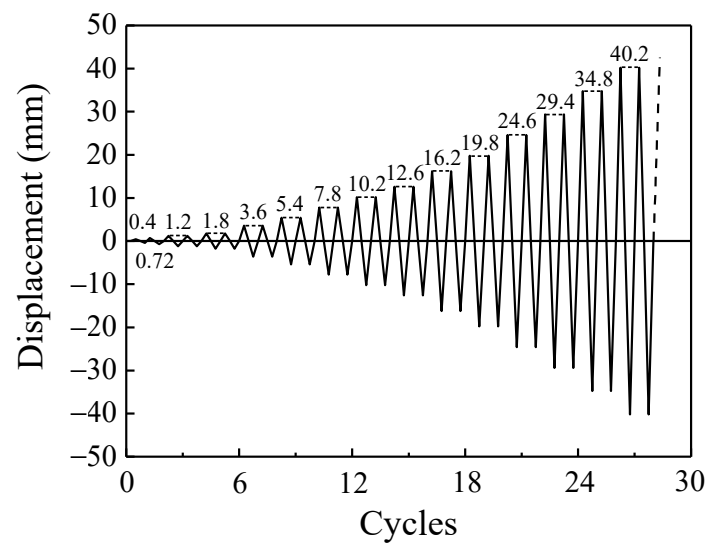
Figure 7. Loading protocol.

The specimens were loaded in two stages: elastic stage and plastic stage following the recommendations of JGJ/T101 [27] and ISO 16670 [28], until the mortar joint attained significant damage or failure (the vertical displacement of the specimen exceeds 40% of the mortar joint's thickness). Each load cycle was applied only once in the elastic stage of the specimen. Two repeated cycles for each displacement level were applied in the second stage until the specimens were severely damaged. The specific loading protocol is shown in Figure 7.

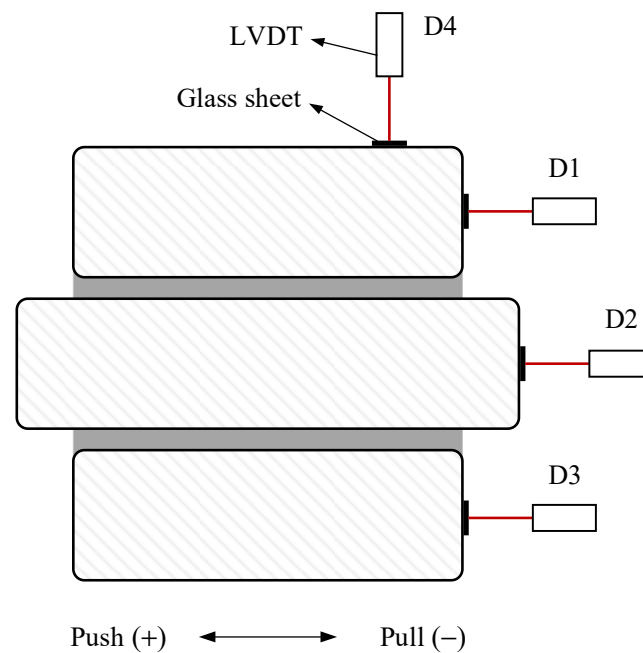
Figure 8. Locations of LVDTs.

The axial load was applied on the top of the specimens, which was kept constant during the entire test. Specimens were instrumented with linear variable differential transducers (LVDTs) and load cells in the actuator arm. As seen in Figure 8, the lateral deformations of the specimens were recorded using LVDTs at the centerline of stone blocks (D1, D2, and D3). One vertical LVDT (D4) was installed on the top of the upper stone to measure the vertical deformation of the specimen.

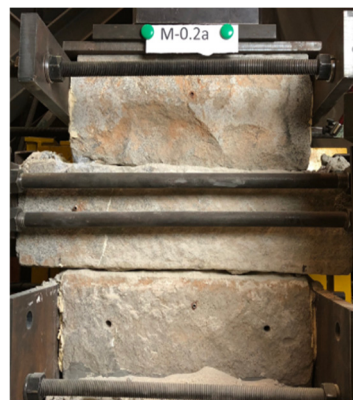
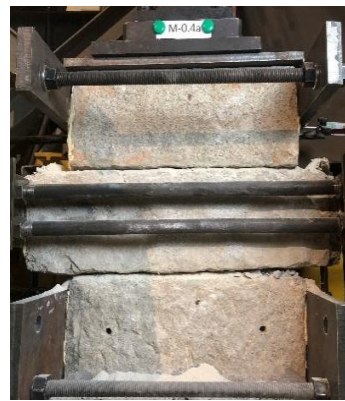
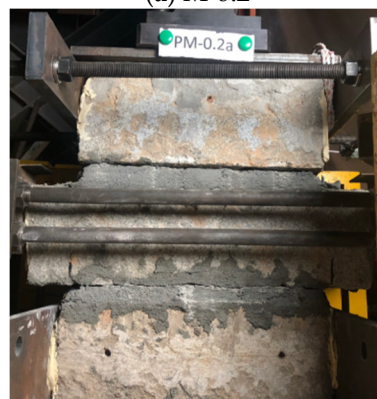
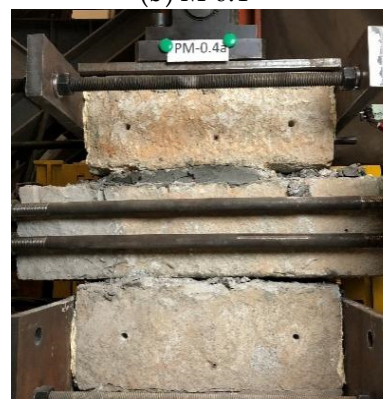
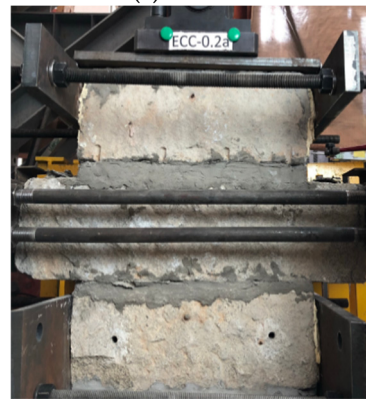
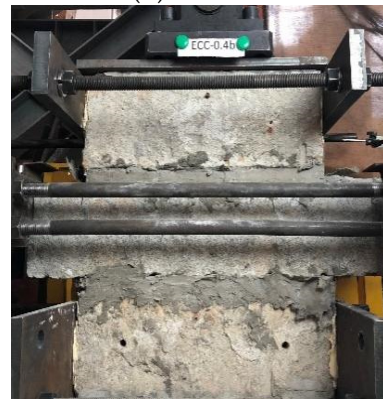
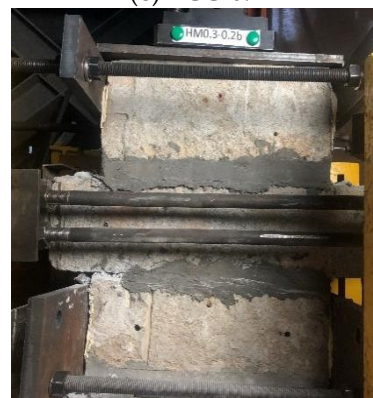
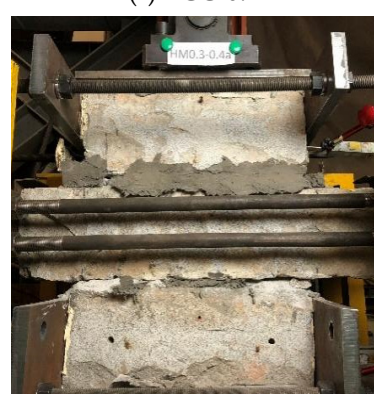
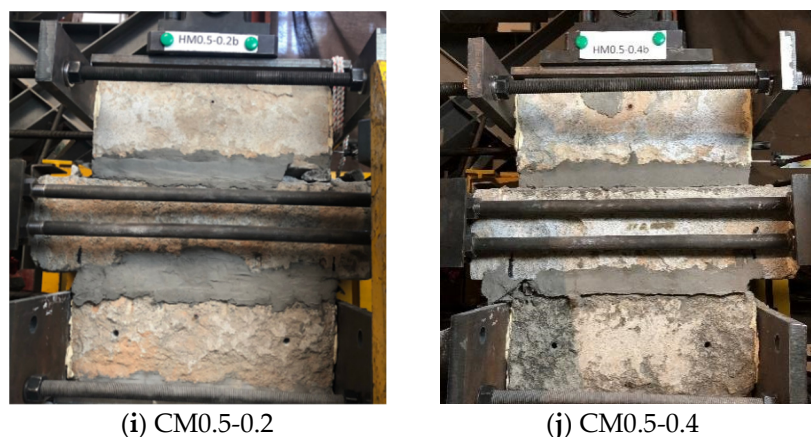
Figure 9. Final damage state of specimens after the test: (a) M-0.2, (b) M-0.4, (c) PM-0.2, (d) PM-0.4, (e) ECC-0.2, (f) ECC-0.4, (g) CM0.3-0.2, (h) CM0.3-0.4, (i) CM0.5-0.2 and (j) CM0.5-0.4.

The experimental observations of the specimens were discussed based on the types of mortar (M, PM, ECC, CM0.5, CM0.3) considering the difference of the initiation of cracks followed by their proliferation and final failure mechanisms. Figure 9 shows the damaged state of specimens. For the case of the specimens M-0.2 and M-0.4 under the axial compressive stress of 0.2 MPa and 0.4 MPa, the mortar and stone gasket of the mortar joint have been evidently crushed and extruded. As for PM specimens, a similar failure appearance can be observed under the axial compressive stress of 0.4 MPa, while a relatively intact mortar joint without obvious axial deformation was available to specimen PM-0.2. All the specimens with ECC (ECC, CM0.3, and CM 0.5) maintained the integrity of the mortar joint after the termination of the test, only with a small amount of ECC extruded at both ends of the mortar joint.

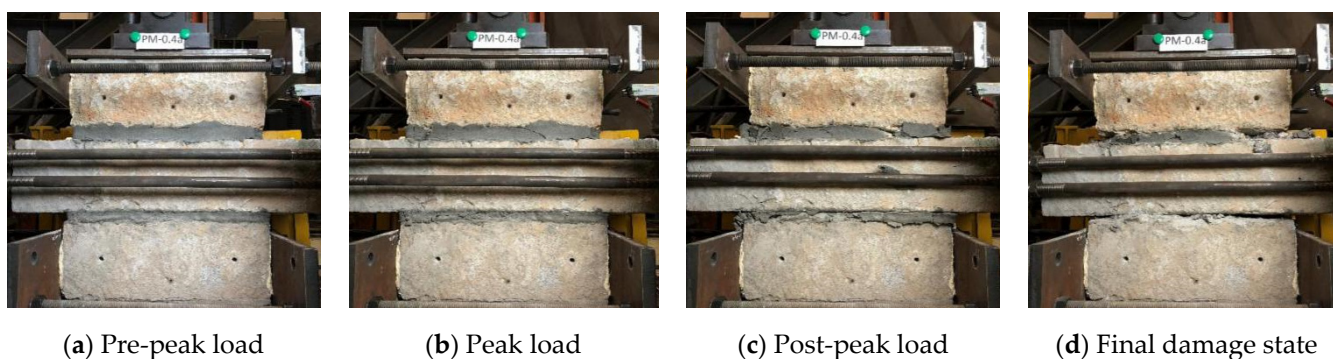
Figure 10. Typical failure process of M/PM specimens (PM-0.4): (a) Pre-peak load, (b) Peak load, (c) Post-peak load and (d) Final damage state.

Considering the similarity of the initiation of cracks followed by their proliferation and final failure mechanisms, all specimens were divided into three groups according to the type of mortar. For the case of specimens with ordinary mortar (M and PM), as seen in Figure 10a, the reduction of initial elastic modulus happened at a displacement level of 1.8 mm, when the interface failure of the mortar joint has already occurred. Cracks were initiated as inclined cracks about 45 degrees appeared on the surface of the mortar joint at a displacement level of 3.6 mm, and the lateral load reached the peak load at the same time (Figure 10b). As the displacement level increased (3.6–7.8 mm), the inclined cracks on the surface of the mortar joint gradually developed into inclined network cracks as the lateral load decreased significantly (Figure 10c). At a displacement level of 3.6 mm, the mortar and stone gaskets in the mortar joint were crushed gradually, along with the lateral load tending toward stability. The test was terminated after 19.8 mm displacement when large-scale crushing and extrusion of mortar joint was observed (Figure 10d).

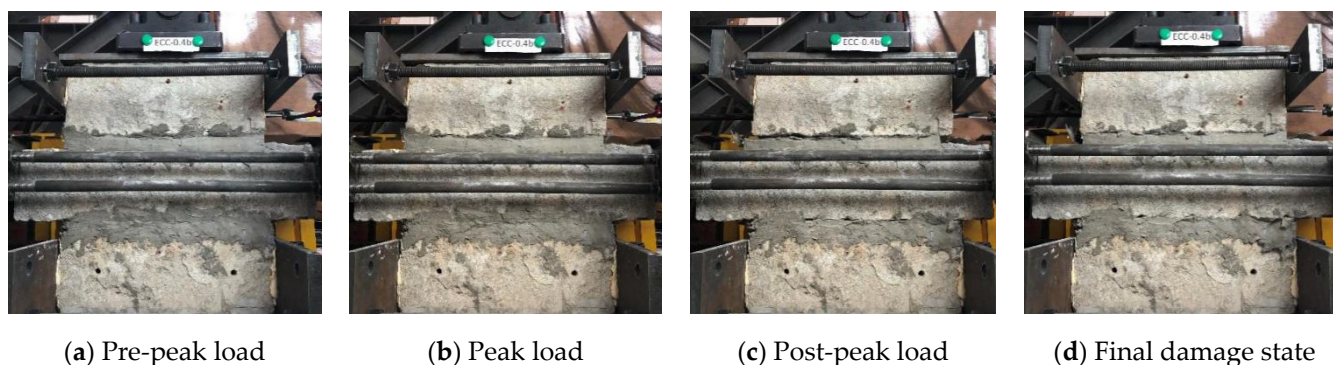
Figure 11. Typical failure process of ECC specimens (ECC-0.4): (a) Pre-peak load, (b) Peak load, (c) Post-peak load and (d) Final damage state.

In the specimens with ECC mortar joints (Figure 11), the reduction of initial elastic modulus happened at a similar displacement level (1.8 mm) with ordinary mortar specimens. The peak lateral load of the specimens was initiated at 2.8 mm displacement in ECC-0.2, whereas the peak value was reached at the displacement of 5.2 mm in ECC-0.4. Minor hairline diagonal shear cracks on the surface of the mortar joint were initiated slightly before the peak load's corresponding displacement. As the monitored displacement level increased, the width of cracks developed within a small range and maintained the integrity of the mortar joint (Figure 11a). In addition, in ECC specimens, the sound of fracturing fibers was noted during the widening and propagation of cracks. The self-confinement effect of fibers in ECC retained the transmission of tensile stress before forming major

cracks, thus limiting the crack width and showing high ultimate tensile strain [29,30]. As a result, the cracks of ECC specimens were dense until the end of the test (Figure 11b–d).

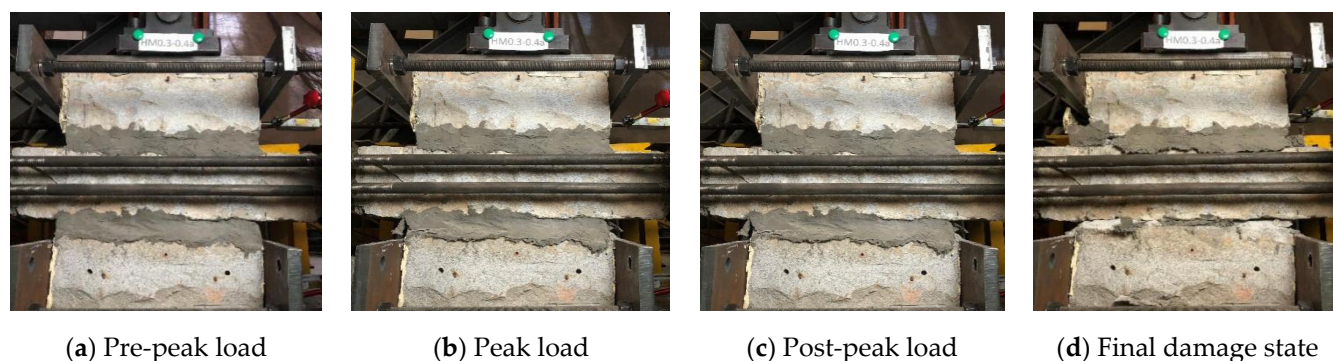
Figure 12. Typical failure process of CM specimens (CM0.3-0.4): (a) Pre-peak load, (b) Peak load, (c) Post-peak load and (d) Final damage state.

For the case of composite mortar specimens, as the ECC on both sides of the mortar joint protected the mortar in the middle, these specimens could also show prominent integrity as well as good performance. Early experimental phenomena were similar to that of ECC specimens (Figure 12a) until reaching the peak load (Figure 12b). For the CM0.3 specimens, minor shear cracks were initiated first on the surface of ordinary mortar in the middle, which was followed by ECC being gradually squeezed out due to the expansion of mortar inside (Figure 12c), and then, the tests were terminated (Figure 12d). In CM0.5 specimens, a higher proportion of ECC formed stronger confinement to the mortar in the middle. As a result, the whole composite mortar joint remained complete without ECC peeling off.

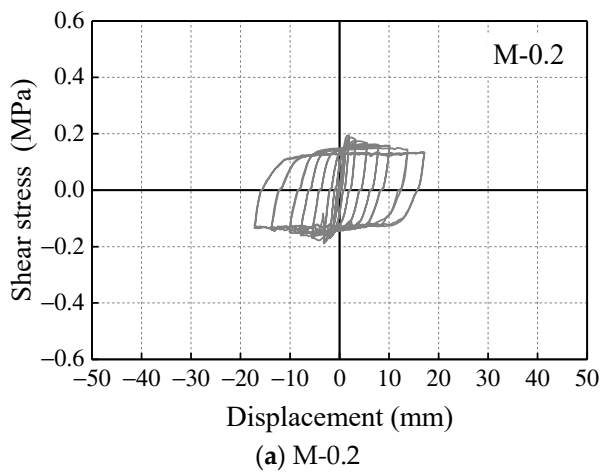
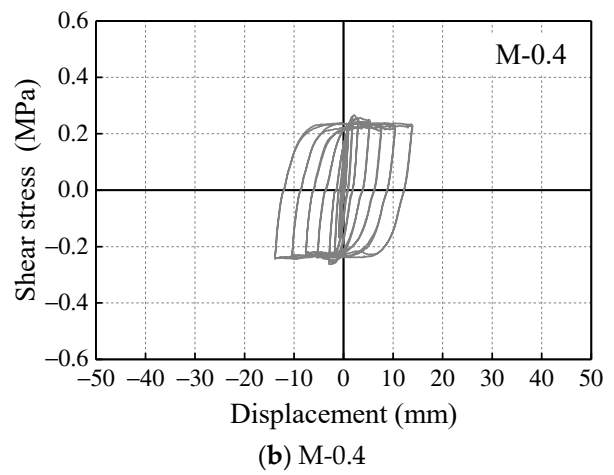
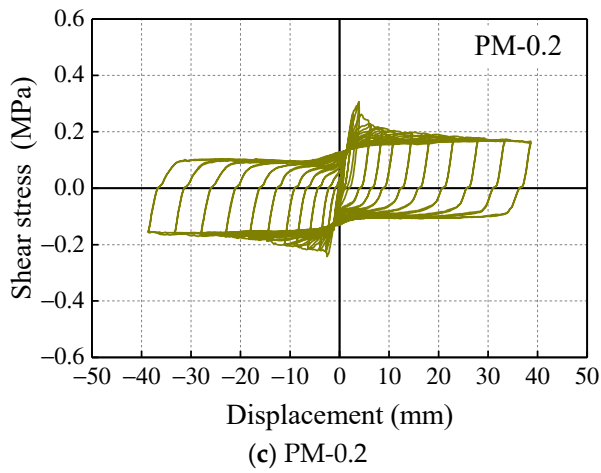
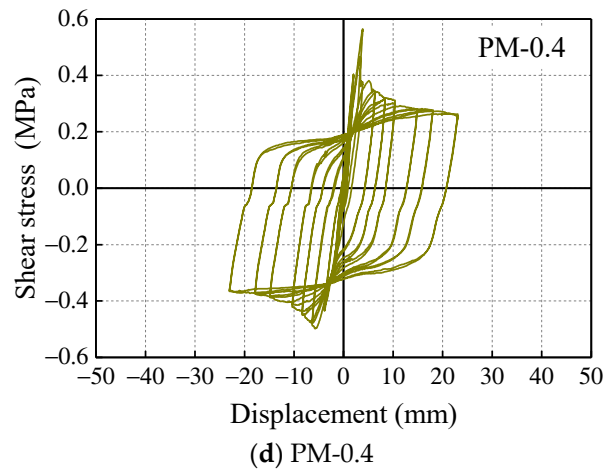
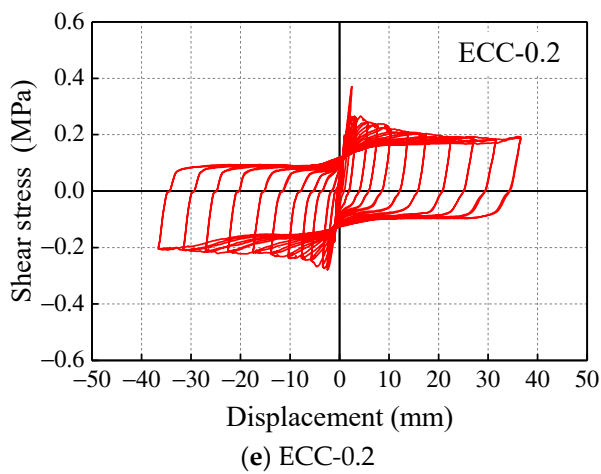
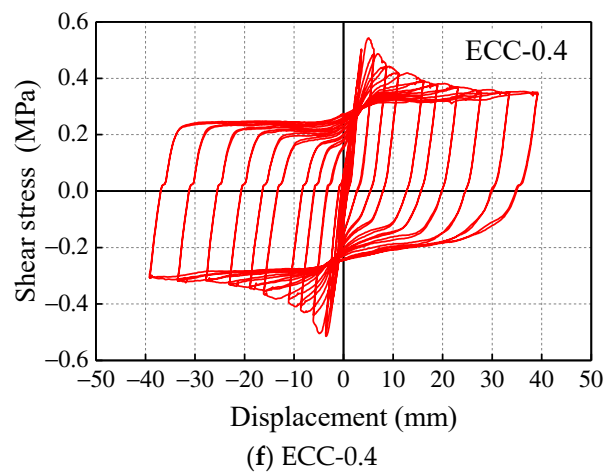
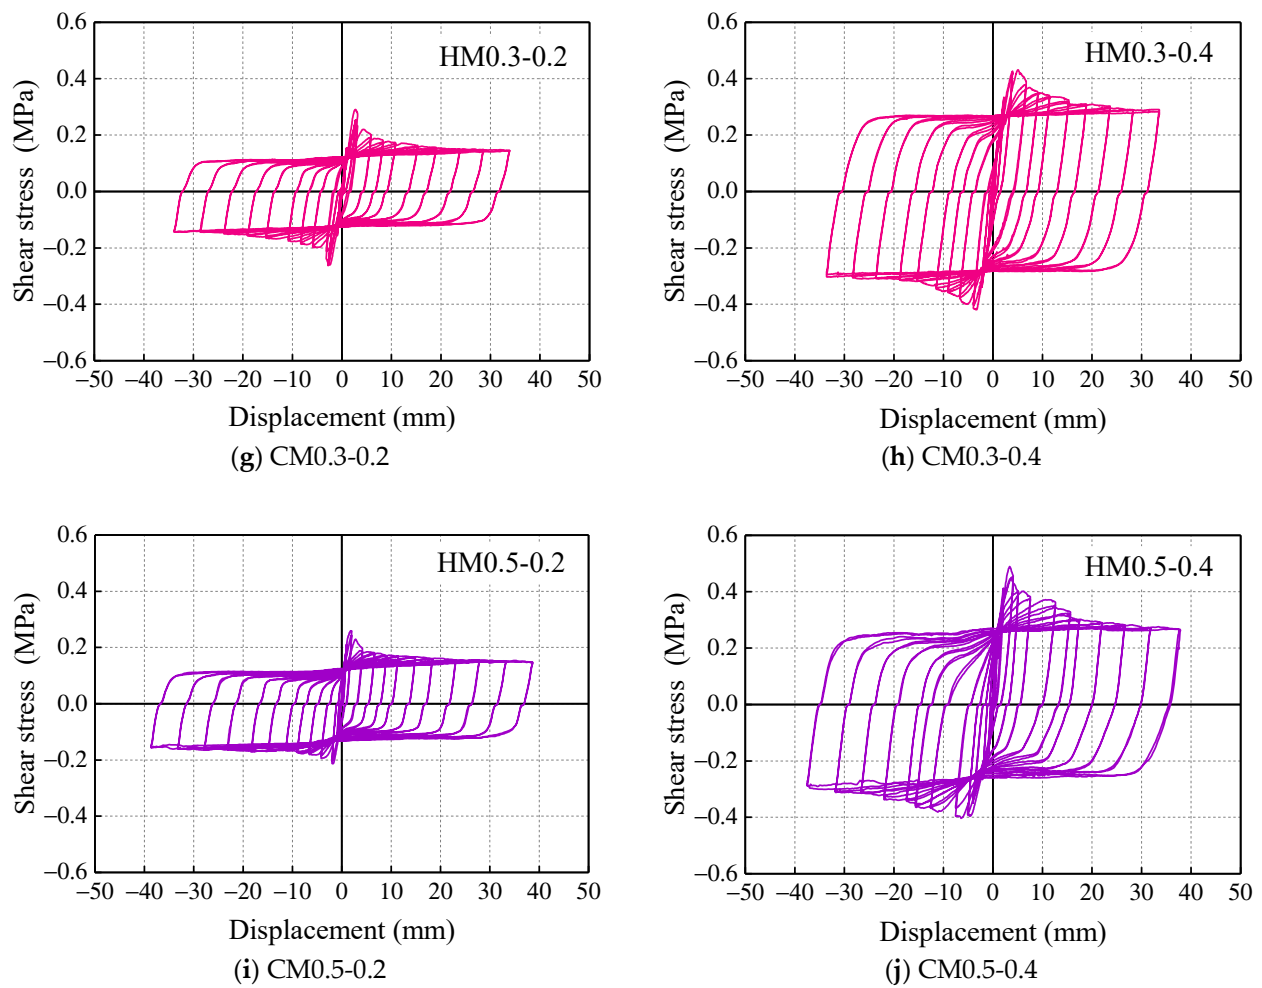
Figure 13. Hysteretic response of specimens: (a) M-0.2, (b) M-0.4, (c) PM-0.2, (d) PM-0.4, (e) ECC-0.2, (f) ECC-0.4, (g) CM0.3-0.2, (h) CM0.3-0.4, (i) CM0.5-0.2 and (j) CM0.5-0.4.

The hysteretic response of all the specimens is shown in Figure 13, and the experimental results of the tested specimens are summarized in Table 3. The compressive strength of mortar has hardly affected the shear strength of the specimens, which is mainly contributed by the axial compressive stress (see τ_m/σ_n in Table 3). Similarly, the ECC did not enhance the lateral load-carrying capacity of the specimens than the M and PM specimens, but the specimens exhibited a much more stable hysteretic response. For the case of M specimens, the spalling of the mortar joint happened quickly and led to a low displacement level (less than 20 mm). In addition, the extremely low compressive strength of mortar (2.1 MPa) limited the potential improvement of the shear strength of the specimen even under a higher axial compressive stress.

When it comes to PM specimens with higher compressive strength of mortar (34.8 MPa), PM-0.2 exhibited a stable hysteretic response without spalling of the mortar joint. However, a higher axial compressive stress seemed to be detrimental to PM specimens where the brittle failure happened again, and all the mortar joints have peeled off after the test. A similar phenomenon was observed in CM0.3-0.4 due to the low proportion of ECC in

composite mortar, which failed to provide adequate protection for inner mortar; a slight pinching appeared in the push direction of the hysteretic response curve. Correspondingly, ECC was extruded in the later stage of loading due to the cracking and swelling of mortar. Considering the integrity of the mortar joint in CM0.3-0.2, it follows that the mortar joint is more likely to fail with the increase in axial pressure. Moreover, in the same axial compressive stress specimens, CM0.5 observed a lesser amount of pinching and, consequently, higher deformation capacity and energy dissipation due to a higher ECC proportion in the composite mortar than CM0.3. In that case, the brittle nature of the conventional normal mortar and ECC ductile behavior was pragmatic from the hysteretic response comparison.

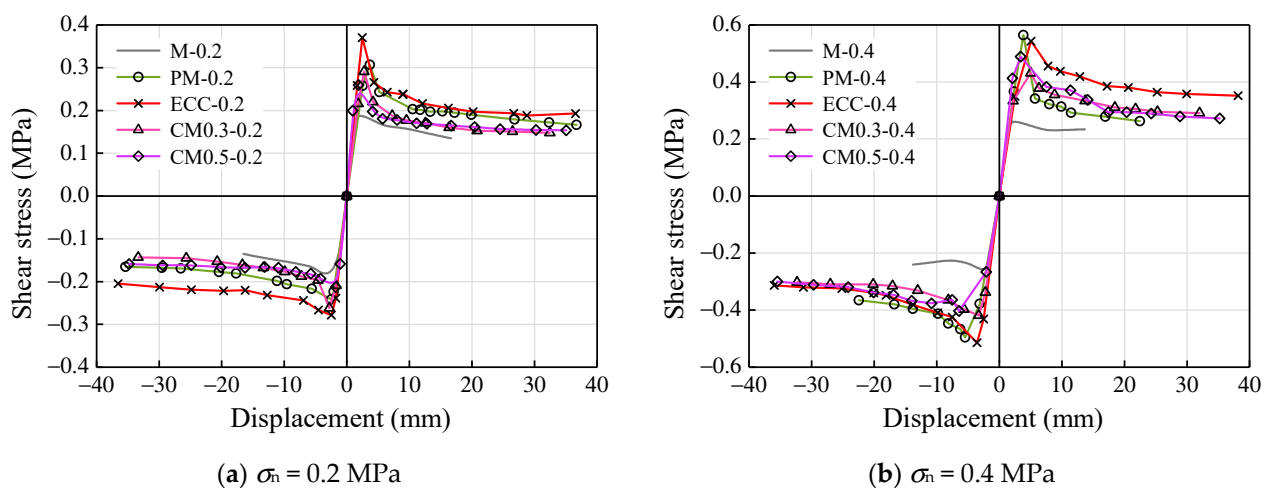
Figure 14. Shear stress–displacement responses: (a) $\sigma_n = 0.2$ MPa and (b) $\sigma_n = 0.4$ MPa.

Figure 14 shows the comparisons of the shear stress–displacement response of specimens. It was observed that specimens using ECC showed higher deformation ability, and an increase in the axial compressive stress increased the load-carrying capacity of the specimens. In the initial stage of the test, the skeleton curves of all kinds of mortar joints maintained linear growth, with the elastic modulus values very close to each other. ECC specimens saw the highest value of shear strength in all the specimens for 0.2 MPa axial compressive stress. As for high axial compressive stress (0.4 MPa), PM-0.4 and ECC-0.4 had a similar shear strength, while the degradation in strength in the ECC specimen was more gradual than that of the PM specimen (Figure 14b).

The self-confinement effect of fibers maintained the integrity of ECC in the post-peak region, and this effect preserves the transmission of stress through the fibers without any obvious degradation in strength. Compared to CM and M specimens, the partial substitution of ordinary mortar with ECC could increase the shear strength directly. Mortar reinforced by ECC presented the seismic performance gradually close to that of ECC specimens with the increase in mortar replacement ratio. As a further increase in displacement level, the shear strength of specimens tended to be stable, which meant the friction slip stage of loading.

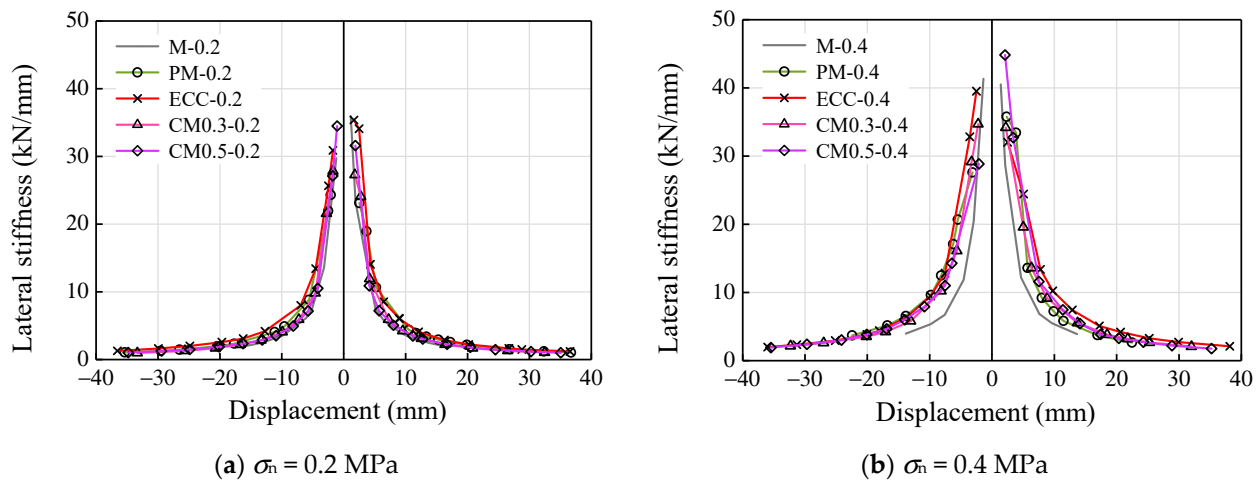
Figure 15. Lateral secant stiffness–displacement responses: (a) $\sigma_n = 0.2$ MPa and (b) $\sigma_n = 0.4$ MPa.

Figure 15 shows the secant stiffness of the specimens at different displacement levels. The initial lateral stiffness of all the specimens increased with an increase in axial compressive stress. This may be due to the higher axial compressive stress leading to a higher frictional force between the stone blocks and mortar joint, which improves the lateral resistance of specimens. As seen in Figure 15a, all the specimens tended to present adjacent trends as well as similar initial stiffness around 35 kN/mm under the axial compressive

stress of 0.2 MPa. For the case of the specimens under 0.4 MPa compressive stress, specimen M-0.4 exhibited a rapid stiffness degradation due to the low compressive strength of mortar. The application of ECC in composite mortar had significantly increased the lateral secant stiffness of specimens, while the degradation in strength was more gradual.

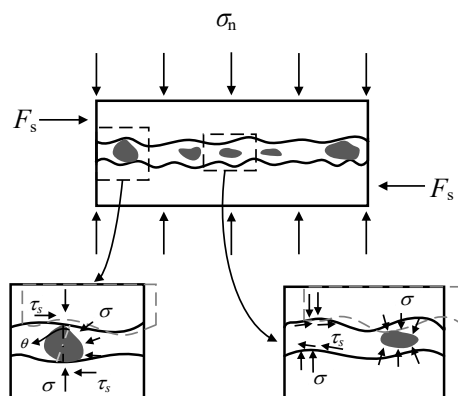
Figure 18. Failure mechanism of mortar joint before peak load (stages I and II).

(I) Linear elastic stage

For mortar and ECC specimens, before their shear strain reaches the cracking strain of mortar or ECC, some microcracks have already formed at the locations of internal defect in the cement matrix under compression. In this stage, interface bonding maintains integrity

among different components (mortar, stone block, and stone gasket), and the damage of materials is negligible.

(II) Crack-developing stage

As the lateral displacement increases, the principal tensile strain of cement-based materials increases. Under the combined action of axial pressure and lateral load, oblique tension cracks along 45 degrees emerge in the mortar joints. Due to the higher ultimate tensile strain of ECC, diagonal cracks appear later than that of ordinary mortar, which is usually around the peak load. In addition, the interface bonding force between the mortar joint and stone blocks gradually reached the maximum as the displacement increases, while the horizontal interface cracks occur locally at the same time. This effect leads to a lower lateral stiffness when approaching the peak load compared to the initial value. Considering that the axial compressive stress is the main contributor to the interface bonding force, the decrease in the lateral stiffness of the specimens is more prominent under higher compressive stress.

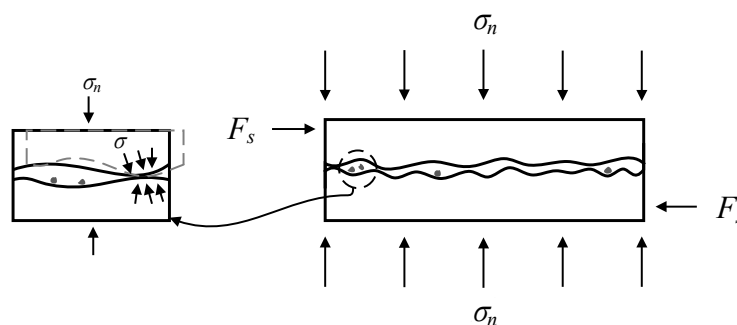
Figure 20. Failure mechanism of mortar joint in friction-sliding stage (stage IV).

(IV) Friction-sliding stage

In this stage, the interface bond is completely invalid and replaced by friction-sliding behavior. For specimens M-0.2, M-0.4, PM-0.4, and CM0.3-0.4, the mortar in the joint is destroyed and squeezed out, and the stone blocks on both sides of the mortar joint come into contact. Mechanical occlusion as well as friction slip occurred simultaneously in these specimens (Figure 20). For the case of other specimens without obvious mortar spalling, the sliding friction between the stone block and mortar joints is the main component of shear strength of specimens. In other words, the mortar joints have already quitted the work regardless of whether the mortar is peeling or not.

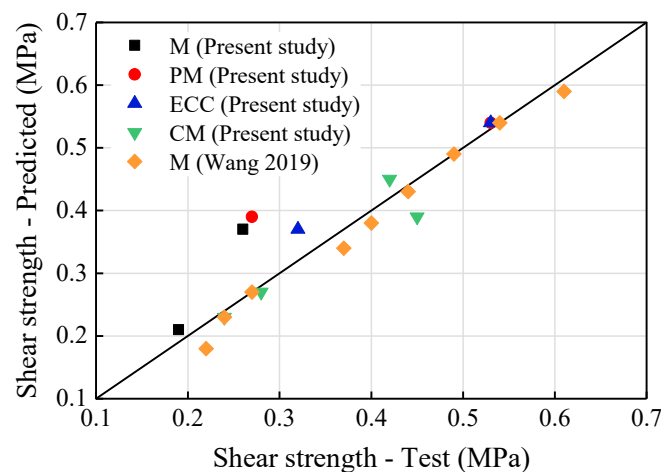
Figure 21. Comparison of the shear strength between the predicted results and the test data.

As seen in Table 5 and Figure 21, the shear strengths predicted by the proposed equations are in good agreement with the experimental values for most of the specimens. The equations overestimate the values for specimens M-0.4 and PM-0.2 by about 40%. This considerable difference may be due to the early damage caused by the internal defects inside the mortar joints. The predicted strengths of CM series are in good accordance with the measured ones, indicating that the shear stress in composite mortar joint is contributed by both the ECC and the mortar according to their proportions.

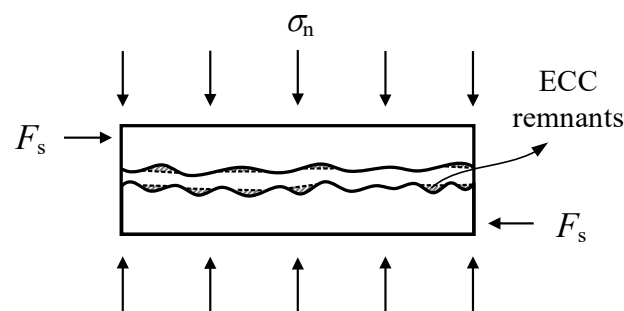
Figure 22. ECC remnants in the indentation of stone surface during stage IV.

Considering the potential change of surface roughness degree during the loading process, especially in stage IV, the geometric friction angle (ϕ) may have changed at the same time. For the case of ECC specimens, after the formation of horizontal joint cracks, the peeled ECC in the ECC–stone block interface remains bonded to the stone and fills the indentation of it. As a result, the regularity level of stone blocks tend to decrease to some degree (Figure 22). When assuming the geometric friction angle drops from 7.9 degrees to 0, then the internal friction coefficients for mortar and ECC are 0.578 and 0.795, respectively. The residual shear strengths considering geometric friction angle as 0 ($\tau_{p,r0}$) are calculated in Table 6. Owing to the mechanical occlusion behavior in ordinary mortar joint during stage IV (see Figure 20), the geometric friction angle in these specimens sees a higher value than that of ECC specimens. Therefore, combined with the results in Table 6, direct calculation by Equation (6) with deduction of cohesive force is suggested, while a reduction factor of 0.83 (the reciprocal of the average of $\tau_{p,r}/\tau_{e,r}$) for ECC ones is proposed when predicting the residual shear strength of mortar joints.
