Article

Use of a Handheld X-ray Fluorescence Analyser to Quantify Chloride Ions In Situ: A Case Study of Structural Repair

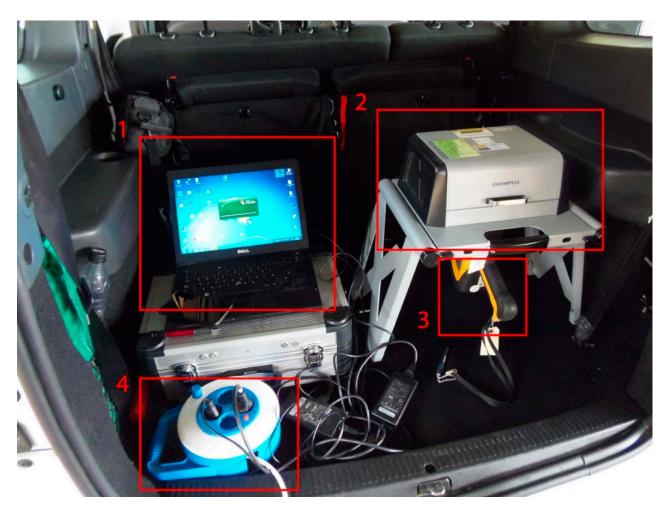
Figure 2. Experimental setup for in-situ chloride analysis. (1) Laptop computer; (2) Workbench; (3) Handheld X-ray fluorescence analyser (hXRF) analyser; (4) External generator (photo taken by S. Chinchón-Payá).

For the on-site inspection setup, depicted in Figure 2, the hXRF analyser was connected to a laptop computer and both were connected to an external generator. The entire suite fit in the boot of a passenger car. The energy furnished by the batteries in the devices was suffice for spot readings, and therefore there was no need for a generator.

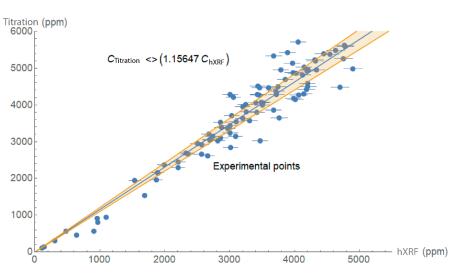
Figure 3. Chloride ions found by titration vs. chloride ions quantified by hXRF (correlation coefficient, $R^2 = 0.92$, 90.0% confidence interval).

The end-point potentiometric quantification findings for chloride ions [17] are compared to the hXRF readings for the 91 mortar and concrete samples, shown in Figure 3. The graph attests to the good correlation between the two analytical techniques ($R^2 = 0.92$) at a 90.0% confidence interval. Taking the end-point potentiometric value as an accurate measure, the calibration factor for hXRF was found to be 1.16. In other words, the chloride concentration in the structure was equal to the instrumental reading multiplied times 1.16.

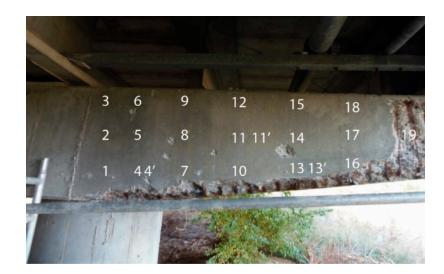
Figure 4. Points measured on the surface of the girder analysed (photo taken by S. Chinchón-Payá).

The corrosion potential and resistivity values data needed to map areas of the element with different degrees of corrosion are given in Table 3 along with the respective corrosion current densities for the points analysed. The table also lists the chloride concentration in the samples analysed and the equivalent in percentage by concrete in cement weight, assuming a cement content of 325 kg per m³ of concrete. The points analysed on the girder are marked on the photograph in Figure 4.

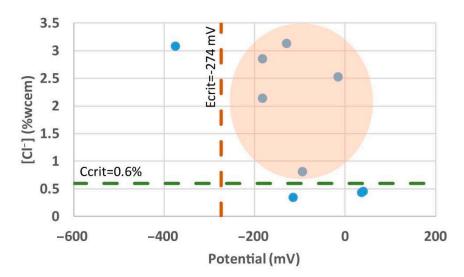
Figure 5. Chloride concentration vs. corrosion potential.

Figure 5 shows the graphs of chloride concentration by cement weight against corrosion potential with $Cu/CuSO_4$ as the reference electrode. The dotted lines indicate the critical chloride concentration (Ccrit = 0.6%) and critical corrosion potential (Ecrit = -274 mV). The safe area lies between the values <Ccrit and >Ecrit.

The findings revealed the existence of points (in the shaded area in Figure 5) that, while not activated in terms of corrosion potential (value > Ecrit), exhibited a chloride concentration higher than Ccrit. Although the corrosion potential was <10%, the respective areas were potentially at risk, since the presence of very high chloride concentrations might induce corrosion, sooner or later, prompting reinforcement deterioration.

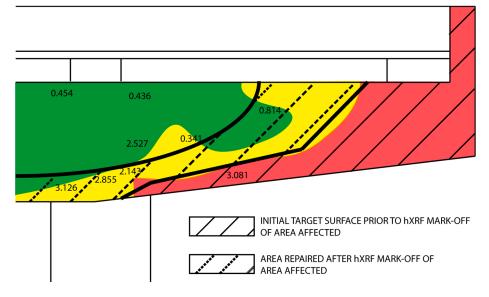
Figure 6. Electrochemical mapping (shading) and chloride concentrations in wt % cement (numbers). Initial (solid black lines) and final areas (dotted black lines) targeted for repair are also shown in straight and dotted lines, respectively.

The corrosion probability diagram, in Figure 6, was derived from potential corrosion and resistivity mapping, and shows the areas of low (green), intermediate (yellow), and high (red) likelihood of corrosion [34,35] on the girder analysed. Figure 6 also includes the chloride concentration values on the grounds of which the area marked off for rehabilitation was enlarged. The initial target and the area actually rehabilitated and repaired on the grounds of the information resulting from this study are shown in Figure 6.

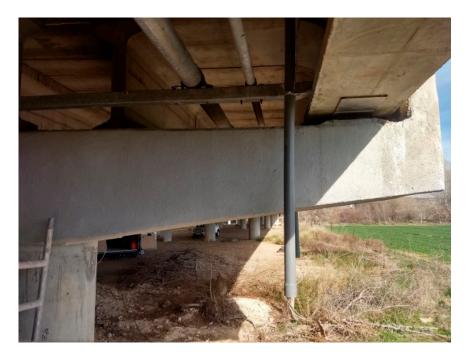
Figure 7. Photograph of concrete member 2 weeks after repair (photo taken by RETINEO).

Figure 7 shows the condition of the surface a few days after repair. The distinction between the areas rehabilitated and the original concrete is not visible because the entire surface was ultimately rendered with mortar. The downpipe visible in the photograph was installed to drain rainwater off the bridge to divert runoff away from the repaired surface.
