# The Influence of Biofilm on Selected Properties of Thin-Coat Mineral-Based Plasters on EPS Substrate

Monika Dybowska-Józefiak and Maria Wesołowska \*

Faculty of Civil and Environmental Engineering and Architecture, Bydgoszcz University of Science and Technology, 85-796 Bydgoszcz, Poland

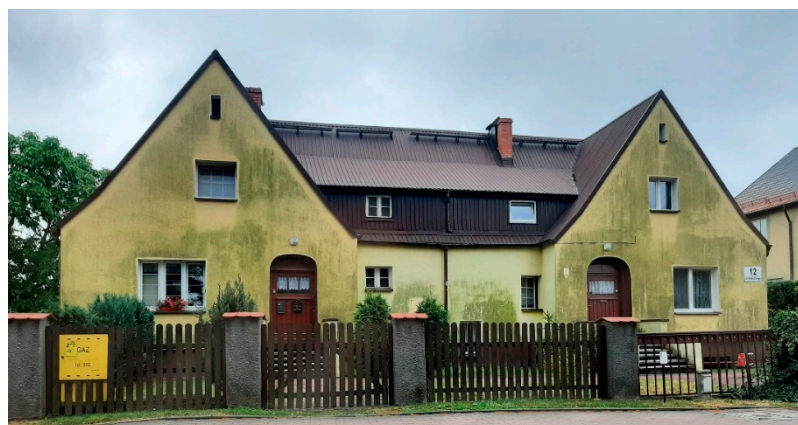
**Figure 1.** Changes in the exterior wall's finished surface (author's archives).

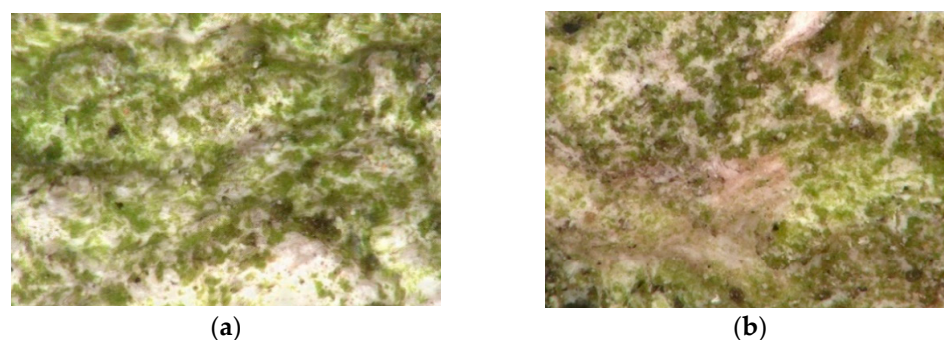
**Figure 2.** The surface of the (a) northern mineral-based dashed plaster—200× magnification photo taken with KEYENCE digital microscope (VHX-7000); (b) northern mineral-based filled plaster—200× magnification photo taken with KEYENCE digital microscope (VHX-7000).

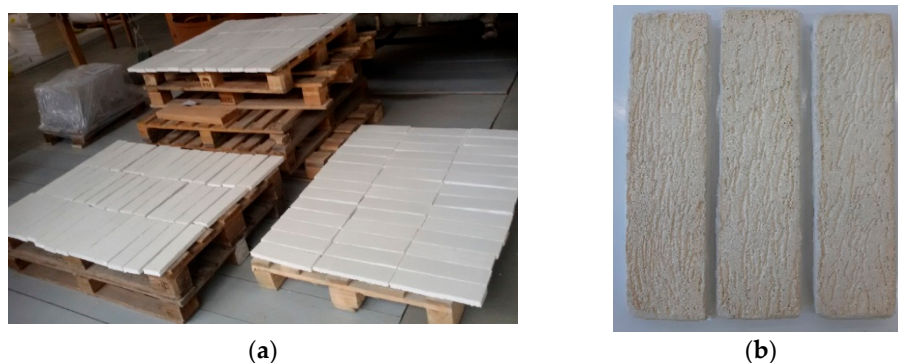
**Figure 3.** Plaster samples for laboratory tests: (a) sample conditioning method; (b) shape and sample texture (filled plaster).

Samples for laboratory tests (Figure 3) were prepared according to ETICS system specification on a 2 cm thick Styrofoam insulation layer with dimensions of 75 × 300 mm that ensure the required surface area of 225 cm<sup>2</sup>. The study was performed on a group of 2 × 6 samples conditioned for 28 days in laboratory conditions.

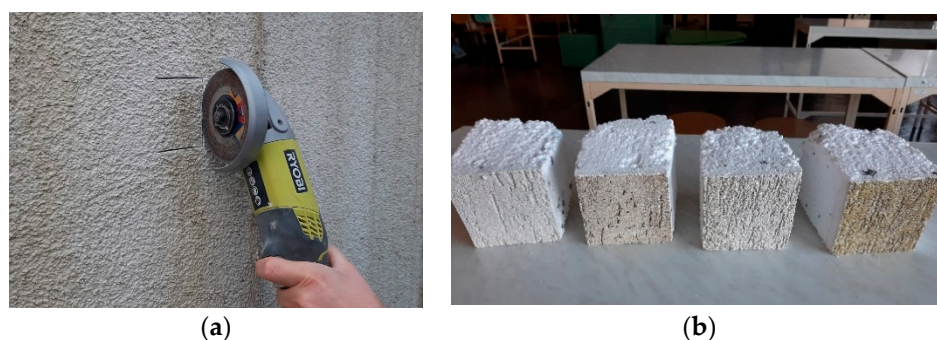
**Figure 4.** Sampling at the field site: (a) cutting the plaster surface; (b) samples that were cut out.

The test sample was obtained with the quartering method. To conduct the tests, samples of 10 cm  $\times$  10 cm were taken from the site, from the north and south elevations. Sampling began by cutting the plaster surface with an angle grinder and then using a knife to cut out the fragments along with the thermal insulation layer (Figure 4).

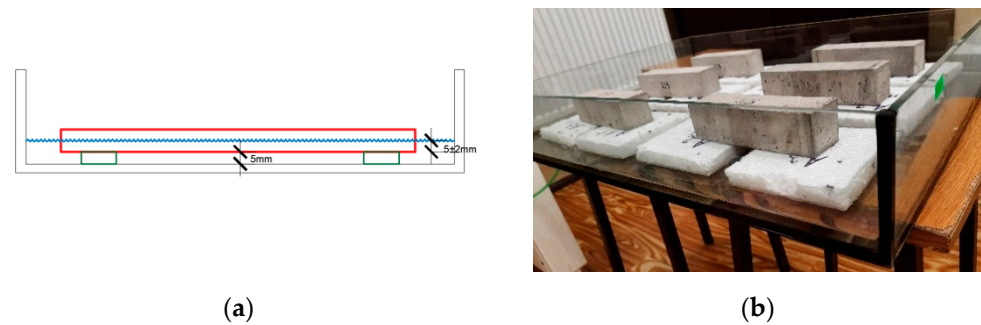
**Figure 5.** Test stand for tests of plaster water absorption: (a) schematic diagram; (b) view.

- A system to maintain a constant water level with an accuracy of  $\pm 2$  mm;
- A load to hold the sample in a particular position;
- Spacers to hold the sample at least 5 mm from the bottom (Figure 5).

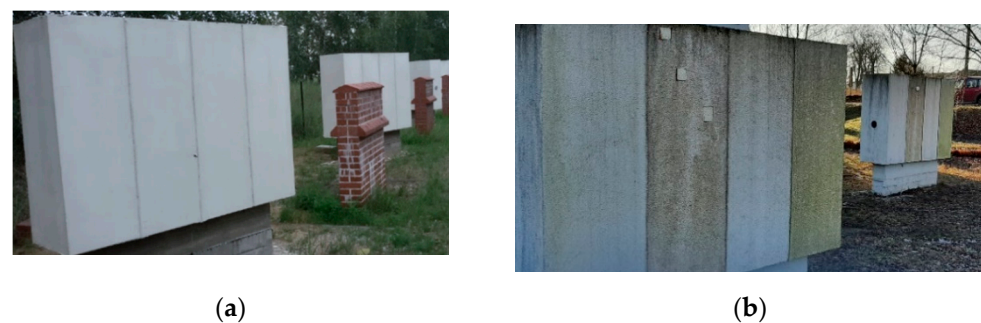
**Figure 6.** Test site for natural aging test: (a) 2016; (b) 2022.

Symptoms of biological corrosion occurred after two years, with varying degrees of severity depending on the orientation relative to the world directions (Figure 6).

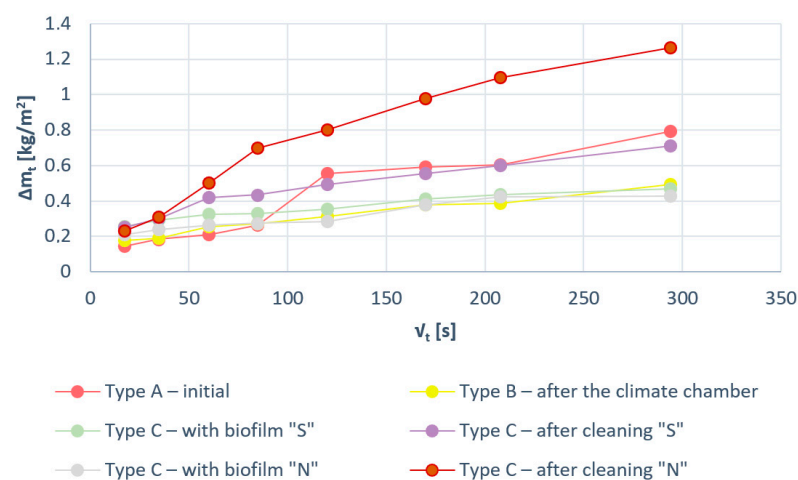
**Figure 7.** Graphs of  $\Delta m_t/F$  as a function of the time element  $t^{0.5}$  related to mineral-based plaster samples.

Large dynamic of water absorption in samples with biofilm removed can be observed in the N orientation from the beginning of the study (Figure 7); these changes are three times greater than the changes in the sample before cleaning. This relationship is not observed in the S orientation.

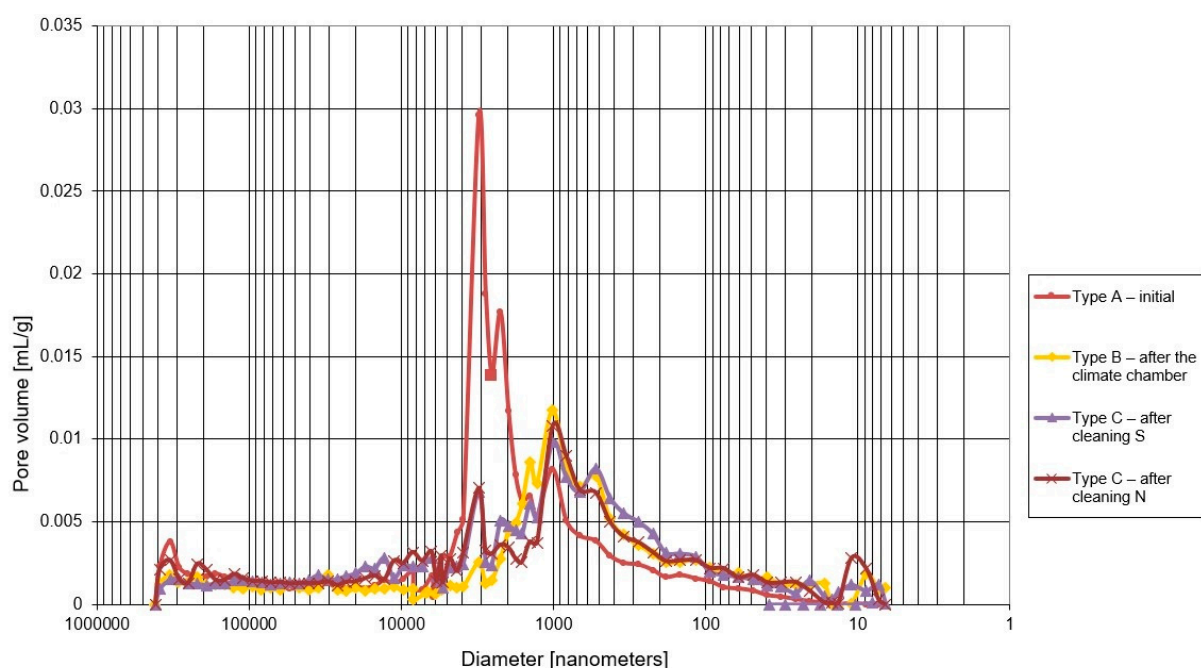
**Figure 8.** Differential curves of pore distribution for mineral-based plaster.

The microstructure results are shown in Figures 8 and 9 and in Tables 2 and 3.

samples show the highest share of pores related to capillary transport—87.7% of the total porosity. The dominant diameter of 3000 nm, determined from the differential pore size distribution, is within the range of capillary pores but outside the range of pores related to their freeze–thaw durability.

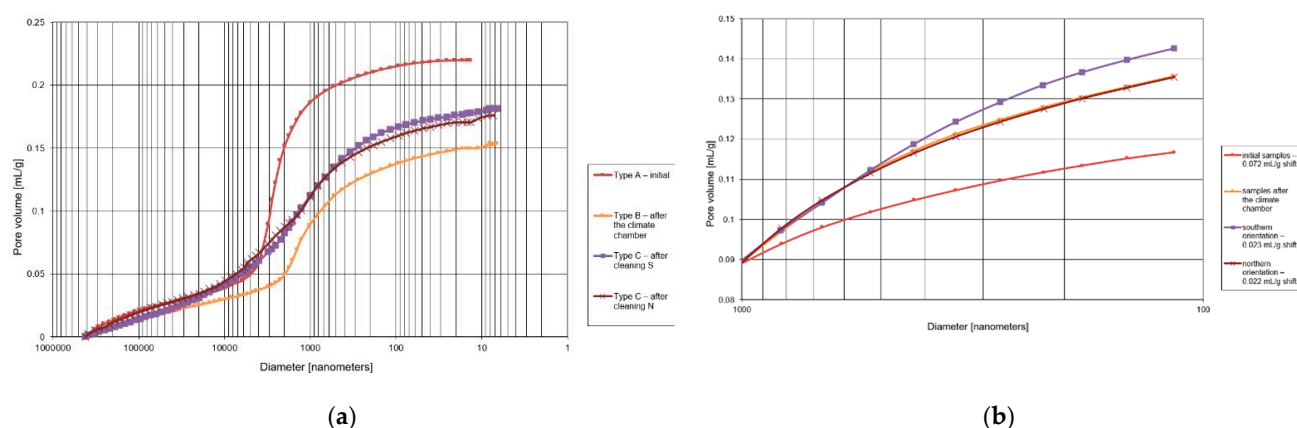
**Figure 9.** Integral curves of pore distribution for mineral-based plaster: (a) full measuring range; (b) pore range related to freeze–thaw durability (from 100 nm to 1000 nm).

on the analysis of the integral curves in the porosity range of 100–1000 nm (Figure 10), it was found that the pore volume in the dimension range of 300–1000 nm increased when compared with the initial sample.

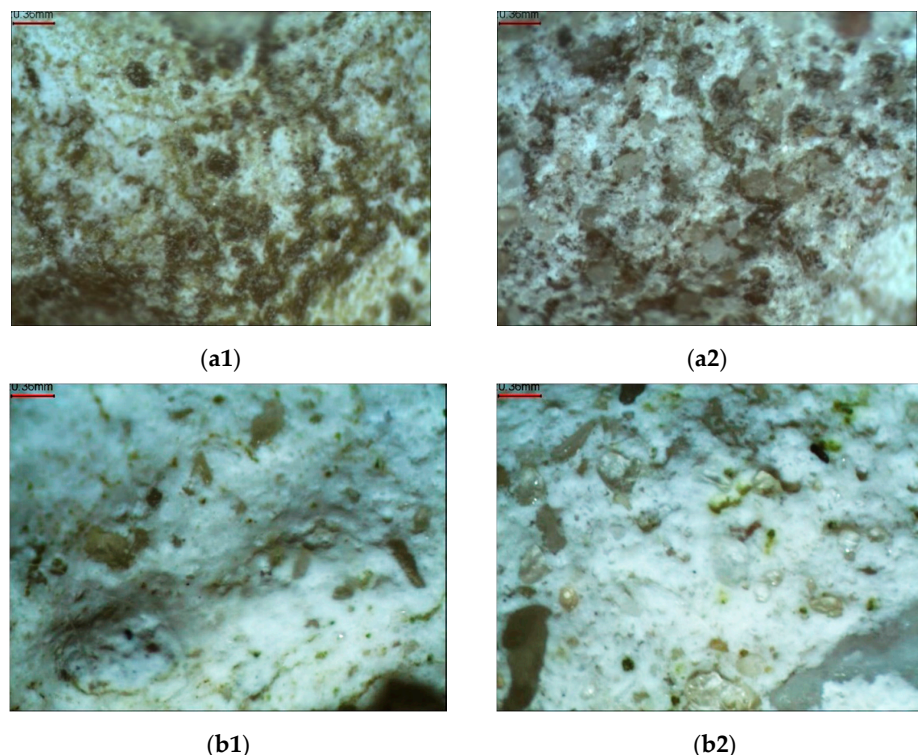
**Figure 10.** Photographs of the plaster surface with biofilm and after cleaning for the N and S orientation: (a1) N-oriented sample with biofilm; (b1) N-oriented sample after cleaning; (a2) S-oriented sample with biofilm; and (b2) S-oriented sample after cleaning.

Based on microscopic images, it was determined that the removal of biofilm from the N-oriented plaster compromises the plaster surface and texture (Figure 10).
