Experimental Test of Reinforced Timber of FRCM-PBO with Pull-Off Adhesion Method

Abstract: The article describes the results of pull-off adhesion strength of the FRCM-PBO (Fiber Reinforced Cementitious Matrix-p-Phenylene benzobis oxazole) composite adhered to the epoxy resin layer which is the connector with the timber beam. In addition, this paper shows the results of the tests of resistance to pull-off the epoxy resin layer from the pine beam. The tests were carried out based on the Polish Standard PN-EN 1542. The Pearson linear correlation analysis was also carried out in order to determine the correlation between the obtained results and the destructive forces. The factors that occurred during the test that may affect its results, such as the method of applying the bursting force, surface preparation of the tested elements and the types of substrate destruction, were also characterized. The experimental data show that in all the tested samples, non-initial adhesive destruction between the adhesive layer and the disc was observed.

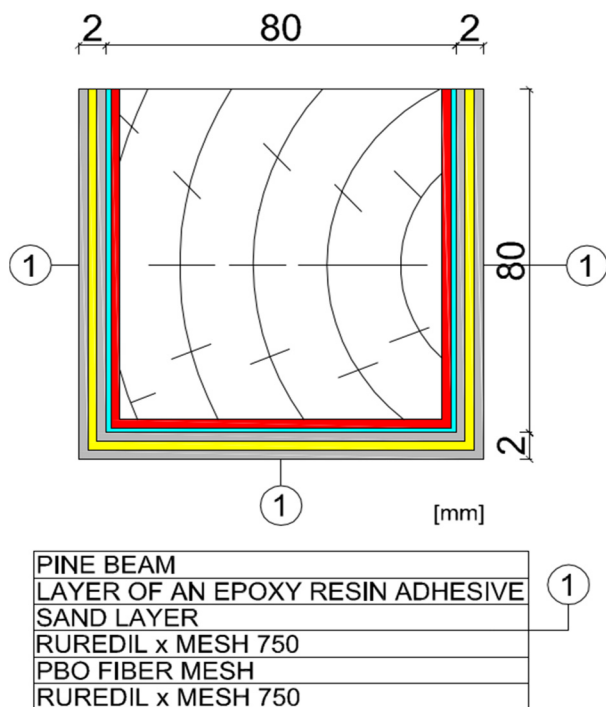
Figure 1. The strengthening a timber beam of research.

8 types of standard damage (Table 1) and indicates the cases when the measurement result should be rejected. The measurement is a fully correct result when the destruction (disc tearing off the tested material) occurs in the tested substrate Figure 1.

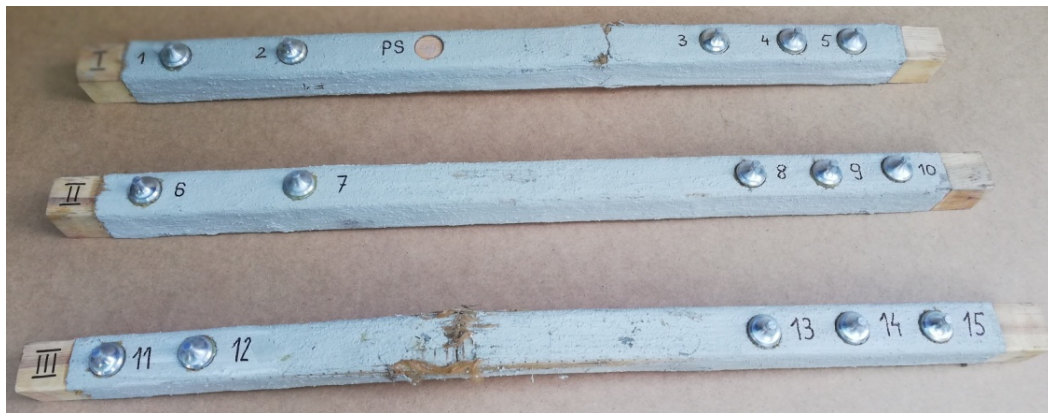
Figure 3. View of the tested samples for stage I.

For the first step, the pull-off strength of the epoxy resin layer, i.e., Resin 55 adhesive, from the timber substrate was determined. The first step was to clean the places of sticking the steel discs from the remnants of the mineral mortar to the layer of Resin 55 resin glue, (as shown in Figure 3) to a depth of 5 mm. The next step was to degrease the place of sticking the discs and to glue steel discs with a diameter of 50 mm directly into the surface of the tested material. The discs were glued with an adhesive based on Pattex epoxy resin. The thickness of the glue joint was 1 mm. The samples were placed in the same places as in stage I.

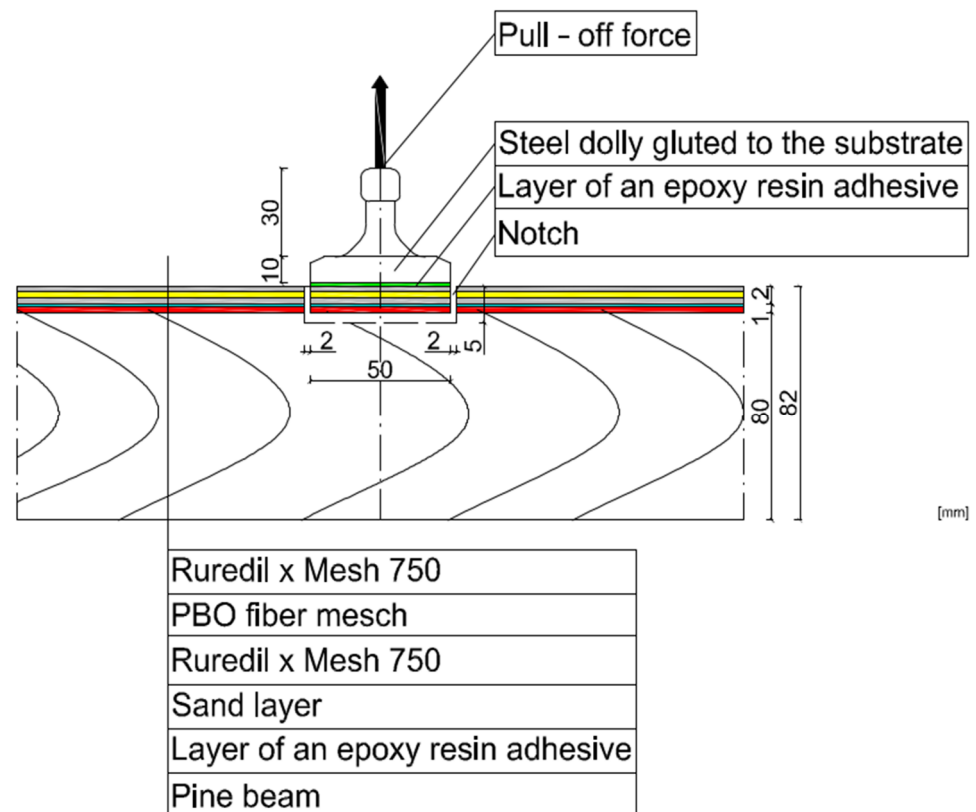
Figure 4. View of the tested samples from stage I.

Three timber beams made of pine with dimensions of 80 × 80 × 1600 mm, timber strength class C 24, reinforced with FRCM-PBO composite, glued to the layer of Resin 55 resin glue, which were additionally roughened with quartz sand, were used in the tests. The beam humidity ranged from 13.3 to 14.2%, while the density ranged from 0.59 to 0.61 g/cm³. Then, the composite layers were cut to a depth of 5 mm according to the assumptions of Formula (1) resulting from the standard [26]. After degreasing, steel discs with a diameter of 50 mm were glued with 5 Pattex glue on each of the beams (Figures 2 and 3). The test stand included the PosiTest AT-M Adhesion Tester with the detachment force recording software. The measuring instrument was set at an angle of 90° to the drilled surface, preventing it from changing its position during the test. The load

increased steadily and continuously at the rate of 0.05 MPa/s until failure occurred. The test scheme was presented in Figure 4.

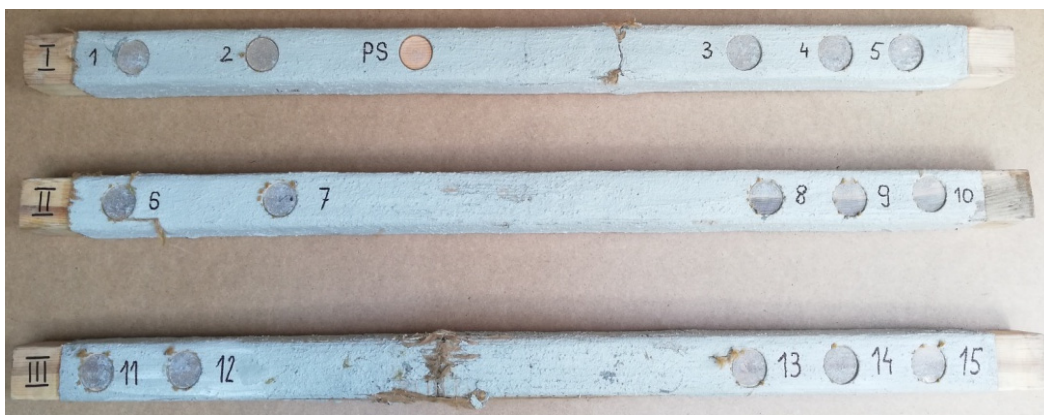
Figure 5. View of the tested samples from stage II.

After degreasing, 5 steel discs 50 mm in diameter were glued to each of the beams (Figure 5). The test stand included the PosiTest AT-M adhesion tester with the pull-off force recording software. The measuring instrument was set at an angle of 90° to the drilled surface, making it impossible to change its position during the test. The load increased continuously at a rate of 0.05 MPa/s until failure occurred. The test scheme was shown in Figure 6. The pull-off strength of the tested samples was calculated from the Formula (2).

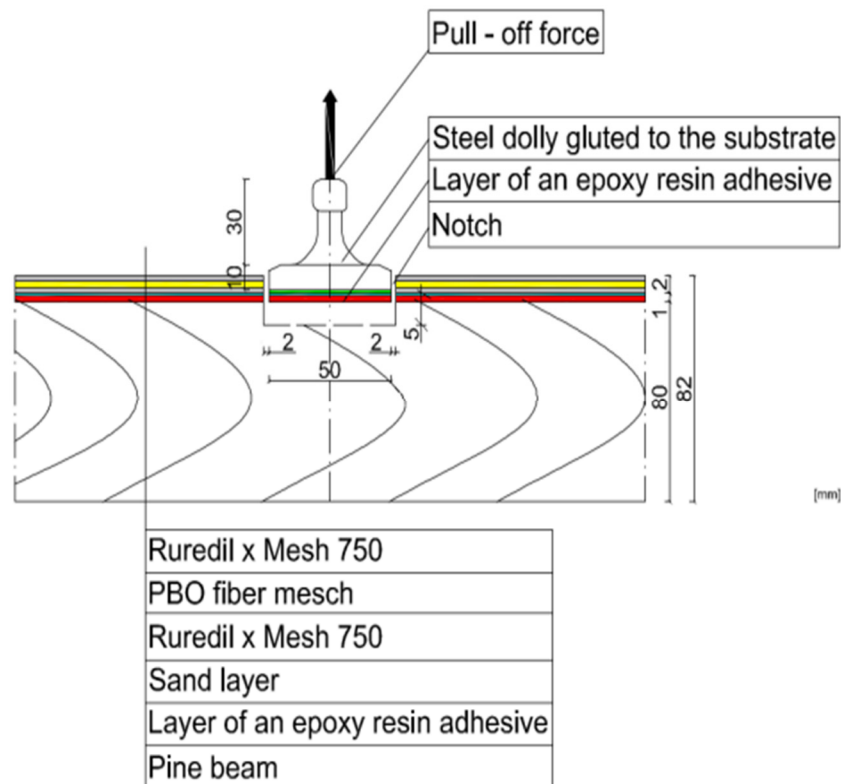
Figure 6. View of the tested samples for stage II.

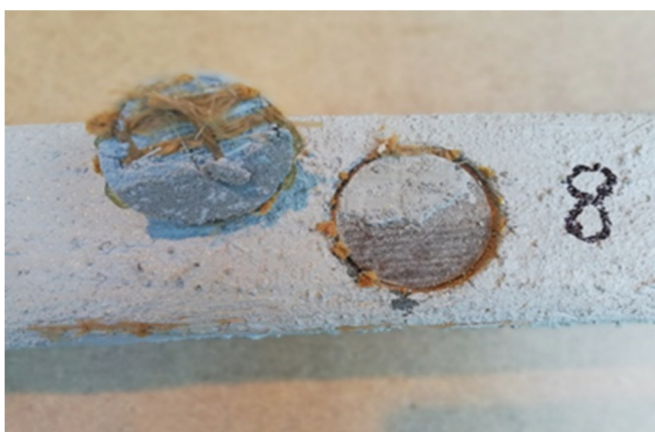
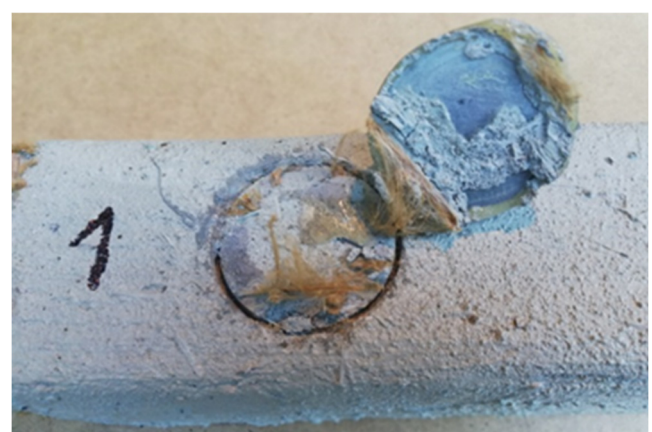
Figure 7. Y/Z—adhesive failure between: (a) the adhesive layer and the disc, (b) the adhesive layer and the disc 70%.

Table 2 shows the pull-off strength values with a description of the destruction for individual tested samples. In all cases, adhesive failure was observed between the adhesive layer and the 'Y/Z' disc. In five cases, the disc was detached from the resin substrate, which resulted in no damage to the mineral layer of the composite, which the standard [26] defines as "Y/Z—adhesive damage between the adhesive layer and the disc" (Figure 7). In ten cases, there was a non-standard—partial destruction in the composite layer, which resulted in the disc detaching from the composite substrate. In this case, the percentage of the damaged area was determined visually. Based on the research, the percentage of the damaged area between the adhesive layer and the disc was estimated in the range from 5 to 70% (Figure 7). Table 3 presents a summary of the statistical analysis of the test results. Figure 8 shows the graphical representation of the pull-off strength for the obtained failure type 'Y/Z'.

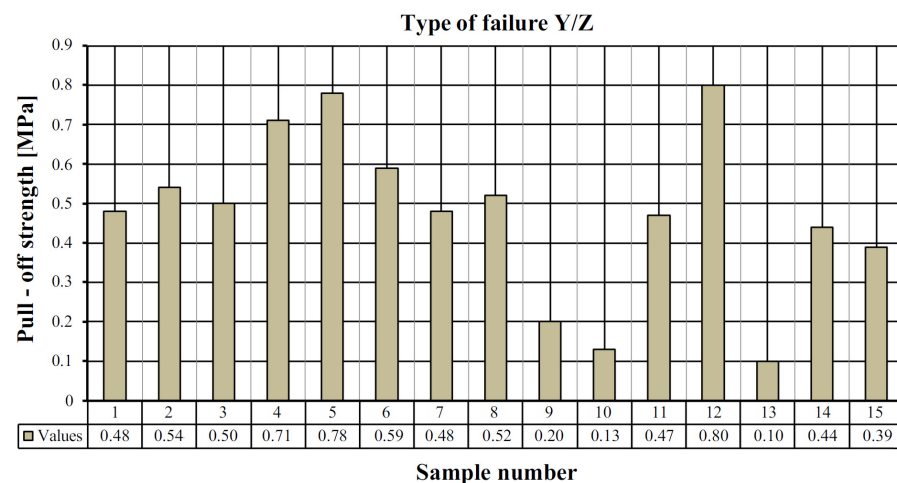
Figure 8. View of the tested samples for stage I.

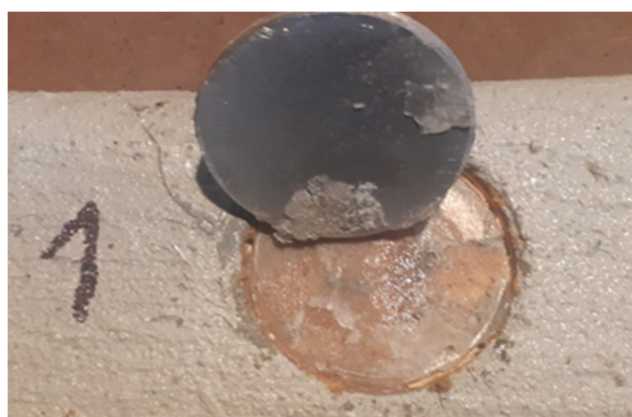
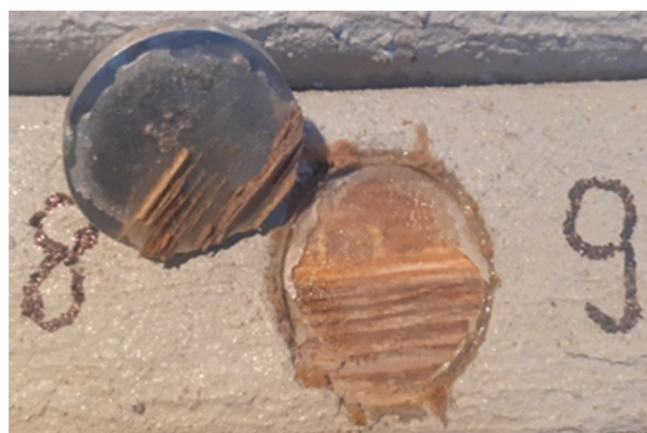
Figure 9. Y/Z—adhesive failure between: (a) the adhesive layer and the disc, (b) the adhesive layer and the disc 70%.

Table 4 shows the pull-off strength values with a description of the destruction for individual tested samples. As before, in all cases, adhesive failure was observed between the adhesive layer and the ‘Y/Z’ disc. In eight cases, the disc detached from the resin substrate, which resulted in no damage to the mineral layer of the composite, for which the standard is [26] defined as “Y/Z—adhesive damage between the adhesive layer and the disc” (Figure 9). In seven cases, there was a non-standard—partial destruction in the composite layer, which resulted in the disc detaching from the composite substrate. In this case, the percentage of the damaged area was determined visually. Based on the research, the percentage of the damaged area between the adhesive layer and the disc was estimated between 5 and 90% (Figure 9). Table 5 presents a summary of the statistical analysis of the test results. Figure 10 shows the graphical representation of the pull-off strength for the obtained failure type ‘Y/Z’.

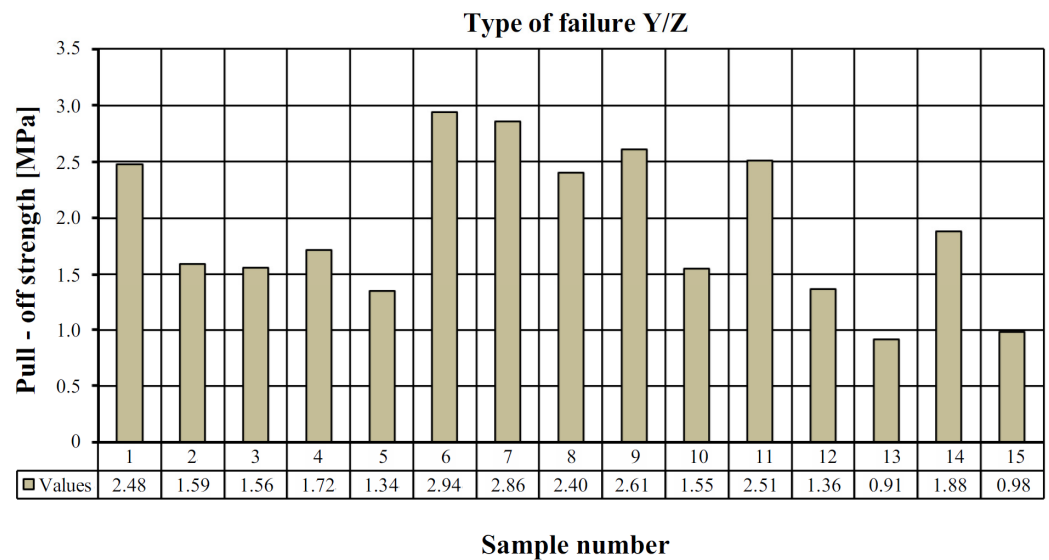
Figure 10. The values of the pull-off strength for the type of substrate failure “Y/Z”.

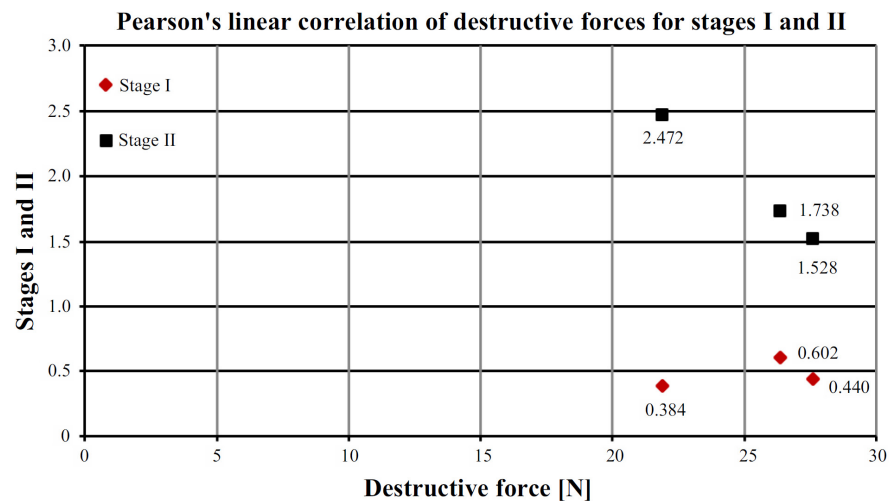
Figure 11. Pearson’s linear correlation for destructive forces and pull-off strength for stages I and II.

For the relationship, the breaking strength of the pull-off strength for stage I, the Pearson linear correlation coefficient “ r ” was positive and amounted to 0.535. This means a strong relationship between the examined features, i.e., with an increase or decrease in destructive forces, the tear strength increases or decreases analogously.

For the relationship, the force breaking the peel strength for stage II, the Pearson linear correlation coefficient “ r ” was negative and amounted to -0.999 . This means that as the destructive forces increase or decrease, the pull-off strength behaves in the opposite way and decreases or increases accordingly. The dependence of the force destroying the breaking strength of the Pearson linear correlation for stages I and II was shown in Figure 11.

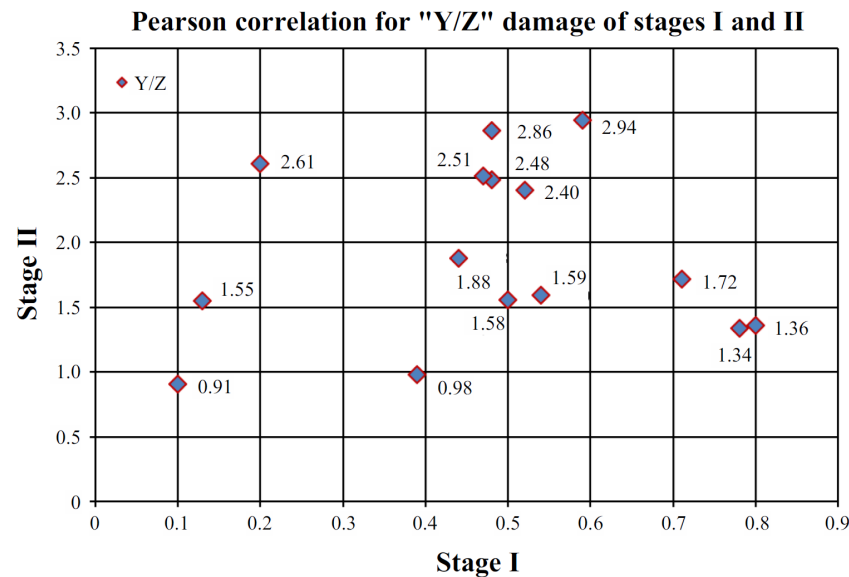
Figure 12. Pearson’s linear correlation for the “Y/Z” failure types for stages I and II.

The correlation coefficient “ r ” was calculated in the same way for stages I and II, which was 0.0534. This means that there was no correlation between Stage I and Stage II results. The plot of Pearson’s linear correlation for the “Y/Z” failure types was shown in Figure 12.
