# The Typical Damage Form and Mechanism of a Railway Prestressed Concrete Sleeper

**Abstract:** Prestressed concrete sleepers are an important track component that is widely used in railway ballast track. Prestressed concrete sleepers have high strength, strong stability, and good durability; thus, their operation and use in railways are beneficial. However, in different countries and regions, certain damage to sleepers typically appears. Existing research on concrete sleepers focuses primarily on the structural design method, the application of new materials, theoretical analysis, and bearing strength test research, while ignoring sleeper damage. There are a few sleeper damage studies, but they look at only one type of damage; thus, there is no comprehensive study of prestressed concrete sleeper damage. The damage forms of prestressed concrete sleeper damage are thus summarized in this study, and the theory of the causes of prestressed concrete sleepers is analyzed based on the limit state method for the first time. The findings indicate that sleeper structure design is the primary cause of its operation and use status, and that special measures should be considered based on slee

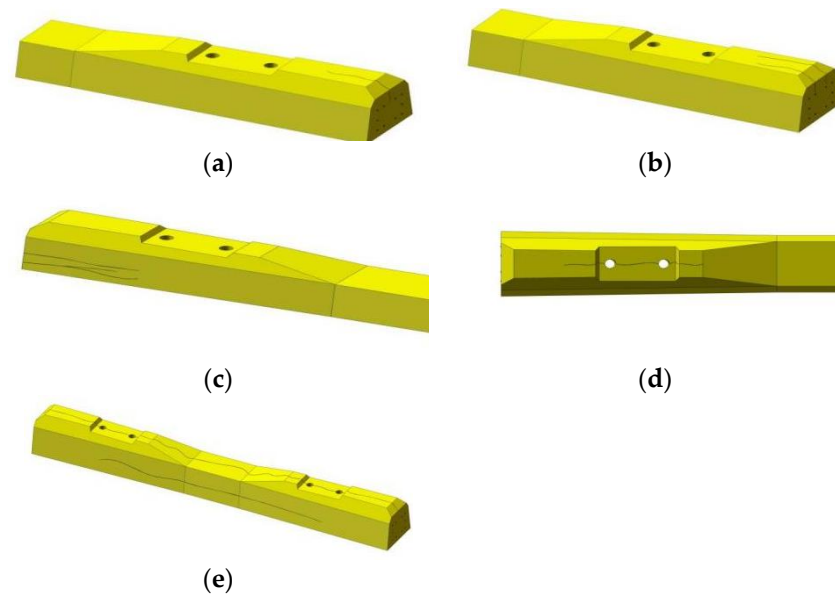
Cracks along the long axis of the sleeper are collectively referred to as longitudinal cracks. For the prestressed concrete sleeper, stress was applied to the concrete in the design, manufacturing, construction and maintenance links of improper treatment, which may lead to the occurrence and development of longitudinal cracks. A longitudinal crack in a sleeper is generally categorized as an end surface crack, a longitudinal crack on the upper surface, a horizontal longitudinal crack on the side, a longitudinal crack at the embedded parts and a longitudinal crack through the sleeper (as shown in Figure 3).

**Figure 3.** Longitudinal crack: (a) end surface crack; (b) longitudinal cracks on the upper surface of the end part (c) longitudinal crack at the embedded parts; (d) horizontal and longitudinal crack on the side; (e) the through longitudinal crack of the sleeper.

Longitudinal cracks in prestressed concrete sleepers have long been a source of concern. After the longitudinal crack appears, the sleeper's strength and durability decrease, as does its ability to maintain track geometry; thus, longitudinal cracks must be prioritize during maintenance work.

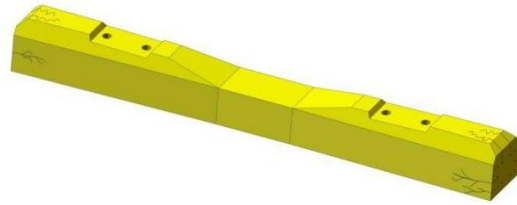
An irregular mesh of cracks on the surface of a sleeper is also called sleeper map-like cracks, as shown in Figure 5. Typically, a sleeper map-like crack is related to the materials, the manufacturing process and the environmental conditions used of the concrete sleeper. When a map-like crack appears in the early stage of sleeper curing process, the crack width

is small and generally appears on the sleeper's surface. With the extension of the width and range of the crack, it will continue to develop and eventually lead to the sleeper's life being markedly reduced.

**Figure 5.** Map-like crack of a concrete sleeper.

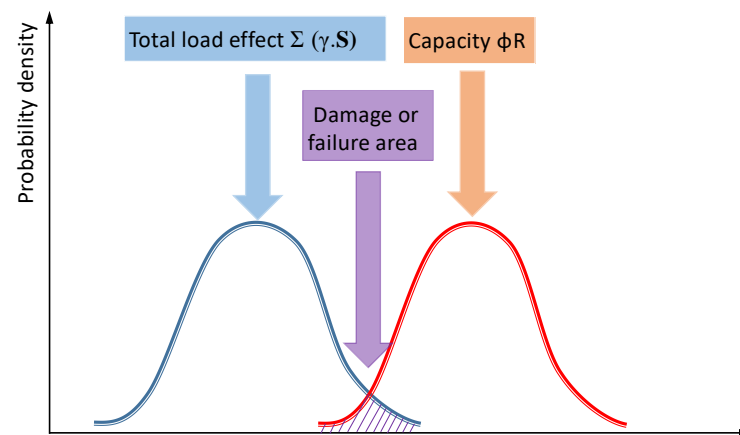
The damage phenomenon of prestressed concrete sleepers is contrary to the working condition considered in the design process due to the external load effect exceeding its resistance; however, the concept of its analysis is the same. The probability distribution curve of the total load effect, structural resistance and sleeper damage failure is shown in Figure 8. Therefore, the damage mechanism of prestressed concrete sleepers can be analyzed from the total load effect, internal resistance and comprehensive factors.

**Figure 8.** Schematic diagram of the distribution curve of sleeper damage or failure probability.

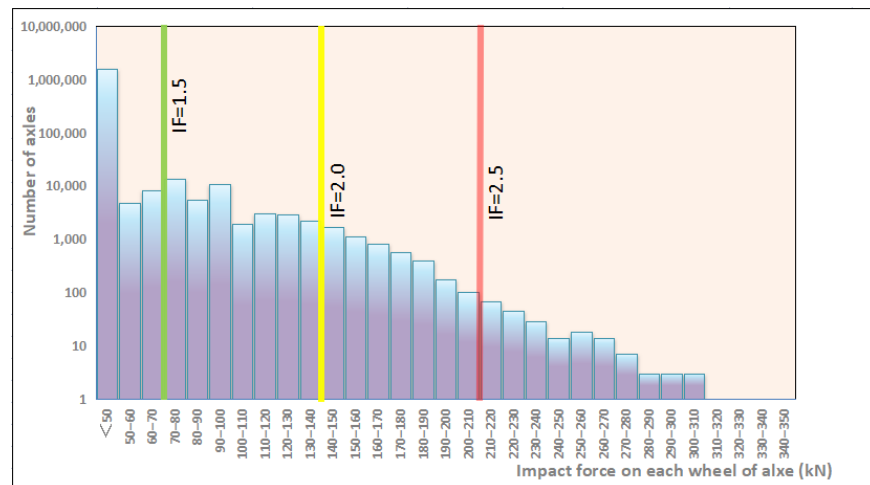
Queensland University of Technology in Australia tested the impact force of two separate sites, Braeside and Raglan [10,17]. At these two sites, the maximum static axle load of the operational vehicles is 28 tons. The field measurement data in Braeside is shown in Figure 9. The trainload of the sleeper has a wide fluctuation range.

**Figure 9.** Typical impact force statistical data on the track at Braeside. Note: Impact factor (IF) =  $1 + (\text{impact force}) / (\text{static wheel load})$ .

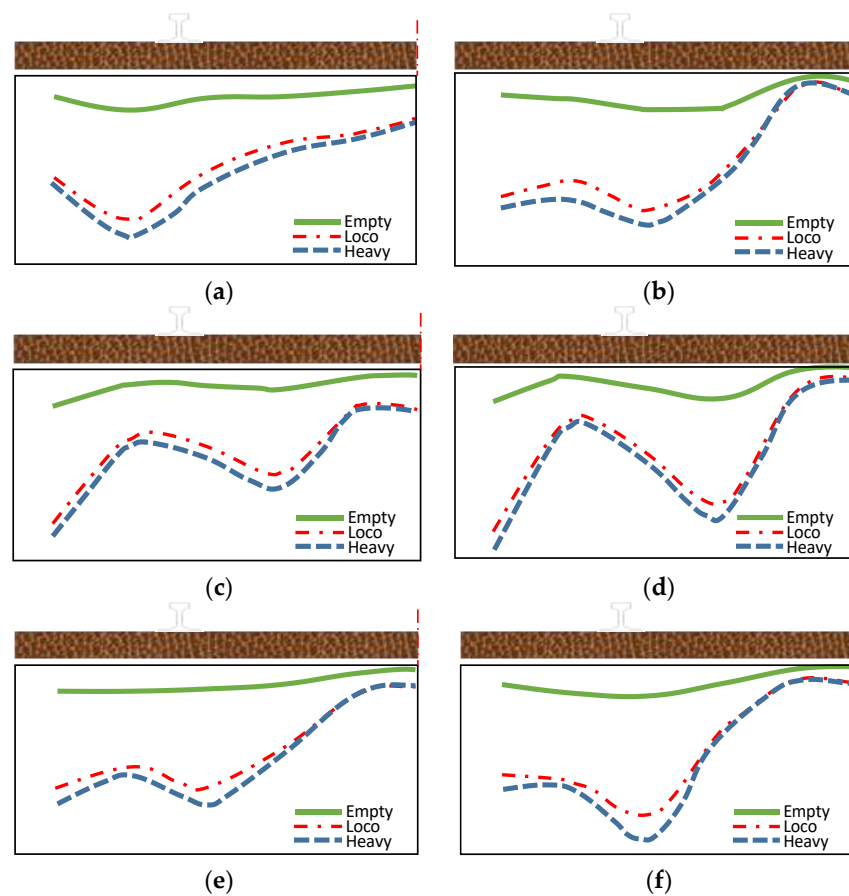
The bottom compression stress of the sleeper in various bed states is varied according to the measured findings of the compression stress at the bottom of the sleeper in those beds [26,28]; thus, the load-bending moment of the sleeper will differ appropriately, as shown in Figure 10.

**Figure 10.** Support conditions experimentally measured in the field. (a) moderate ballast 1; (b) moderate ballast 2; (c) new ballast 1; (d) new ballast 2; (e) fouled ballast 1; (f) fouled ballast 2.

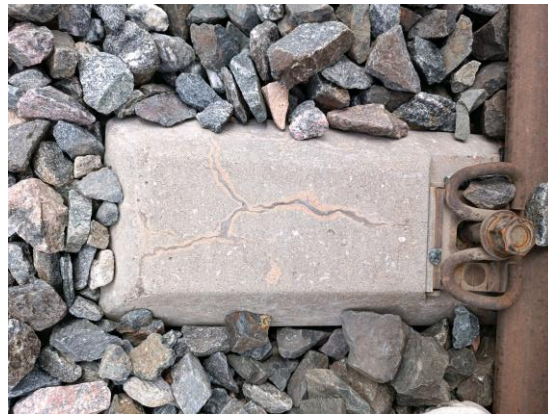
The alkaline-aggregate reaction (AAR) refers to the concrete hole solution by cement or alkali admixture, mineral admixture, and the environment released  $\text{Na}^+$ ,  $\text{K}^+$ ,  $\text{OH}^-$  and the aggregate of harmful active minerals in the expansion reaction, resulting in concrete expansion and cracking phenomenon [29]. Figure 11 shows the concrete sleeper's AAR damage.

**Figure 11.** AAR damaged the concrete sleeper. Note: These images also show other factors in addition to AAR.

- Select the inactive aggregate;
- Control the alkali content of cement ( $\text{Na}_2\text{O}+0.658\text{K}_2\text{O}$ ), which should not exceed 0.6%;
- Appropriate incorporation of mineral fine admixture reduces the amount of cement to reduce the temperature difference stress in the concrete caused by the heat of cement hydration.

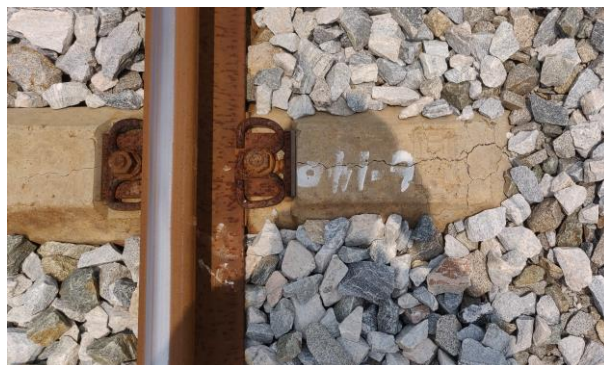
The Delayed Ettringite Formation (DEF) is a form of sulfate erosion in cement concrete with sulfate ions from the inside of cement concrete. Therefore, the definition of delayed alum rock can be considered as follows: in hardened cement concrete, not from the process of sulfate outside the cement concrete, the harm caused by delayed alum rock often appears only months or years later. The delay of slurry expansion caused by ettringite formation will cause cracks in the interface between the cement slurry and aggregate-cement slurry [30], which leads to cracks in the concrete sleeper (as shown in Figure 12).

**Figure 12.** DEF damaged the concrete sleeper. Note: These images also show other factors in addition to DEF.

- Determine the relationship between the temperature of the sleeper concrete and the surrounding air temperature throughout the process of the sleeper life cycle, and avoid a large temperature difference between the temperature of the sleeper concrete and the surrounding air temperature;
- The temperature change of the sleeper core should not exceed  $15\text{ }^\circ\text{C}/\text{h}$ , and the cooling rate should not exceed  $15\text{ }^\circ\text{C}/\text{h}$ ;
- The difference between the temperature of the sleeper surface and the outside environment when leaving the curing pool should not exceed  $15\text{ }^\circ\text{C}$ .

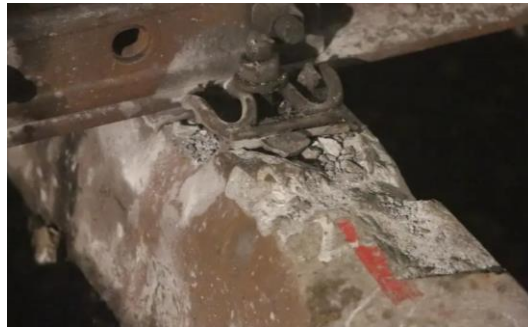
The load effect under accidental conditions must be taken into account in the sleeper design in addition to bearing the operating load of the design. In rare circumstances, these unintended load effects can harm the sleeper. When a train is derailed [31], the sleeper receives a very large impact load and may become damaged or even fail, as shown in Figure 13. Excessive bolt torque on the fasteners can also cause damage during sleeper laying and maintenance [32] (as shown in Figure 14). During sleeper laying and maintenance, the sleeper can also be knocked and damaged, as shown in Figure 15.

**Figure 13.** Damaged concrete sleeper in the derailment.

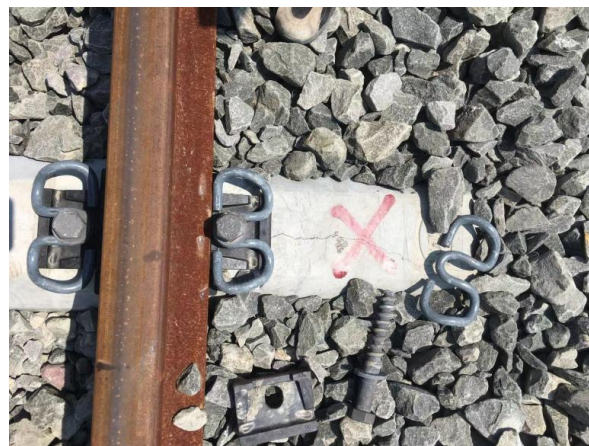
**Figure 14.** Excessive torque of the buckling bolt causes sleeper damage. Note: These images also show other factors in addition to the torque of the buckling bolt.

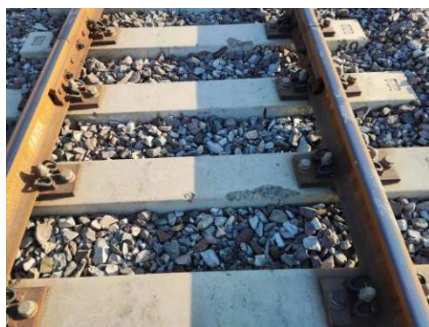
**Figure 15.** Impact load caused damage during construction of the sleeper.

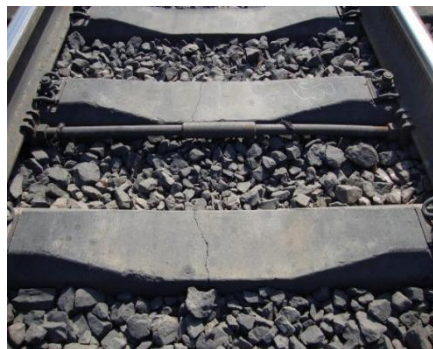
Sleepers are a track component in the ballast track structure when the track structure is in poor condition (e.g., the line appears empty hanging phenomenon, trackbed hardening, trackbed frost boiling) will also lead to sleeper damage or even failure, as shown in Figures 16 and 17.

**Figure 16.** Track bed hardening damages the concrete sleeper.

A concrete sleeper is a portion of the railway track, and the deterioration of the overall state of the track will inevitably lead to a sleeper bearing a greater load effect, which can lead to damage. Therefore, an important aspect of preventing sleeper damage is to keep the track in good condition, including but not limited to the state of fasteners, the ballast bed and track geometry.

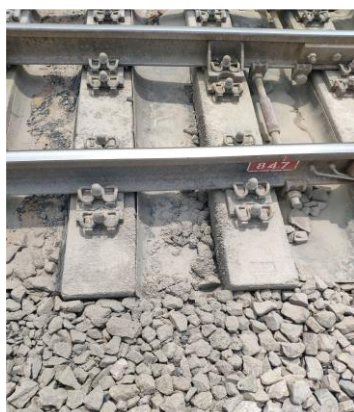
**Figure 17.** Track bed frost boiling damages the concrete sleeper.

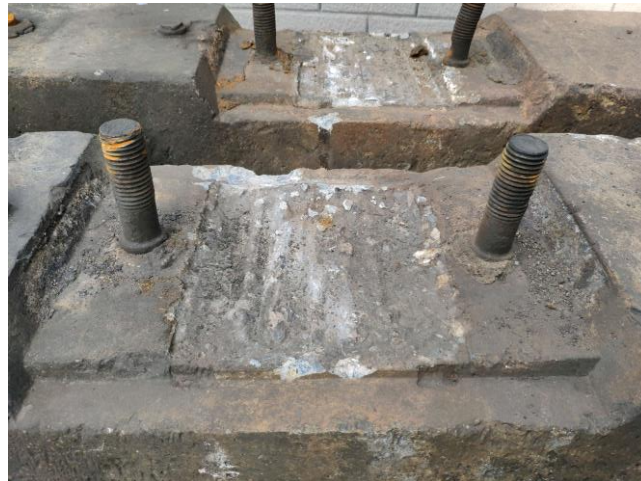
Figure 18. Concrete sleeper rail seat abrasion.

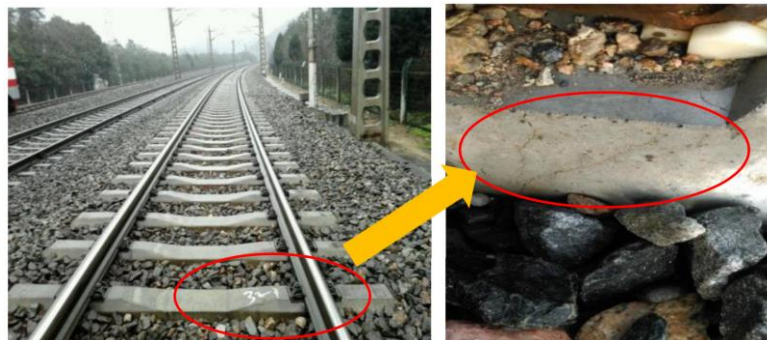
Typical sleeper damage caused by insufficient structural design strength is a transverse crack at the rail seat section, as shown in Figure 19, where a transverse crack in the sleeper (Figure 20) and a horizontal crack on the side of the sleeper occur (Figure 21).

Figure 19. Transverse crack in the rail seat section of the concrete sleeper.

Sleeper structure design is the fundamental cause of its operation and use status. An excellent structural design can avoid damage to a large extent and should consider the appearance size, reinforcement design, manufacturing, operation, maintenance systems and environmental conditions of the sleeper. Therefore, the prevention of concrete sleeper damage starts with improving the design quality of the sleeper structure.

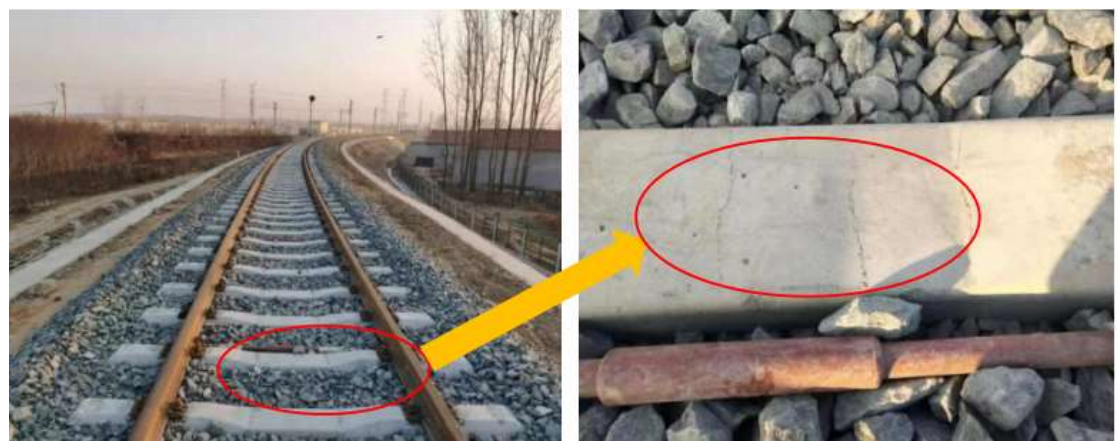
Figure 20. Transverse crack in the central section of the concrete sleeper.

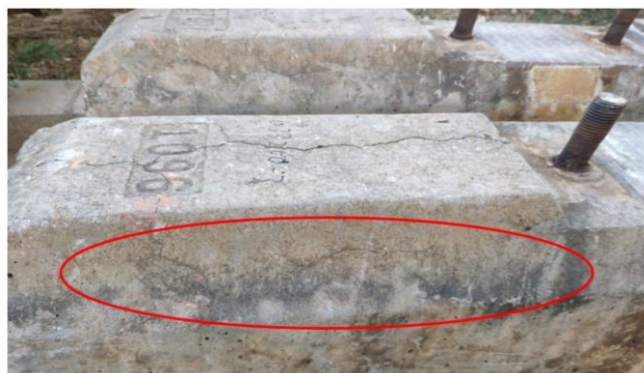
**Figure 21.** Horizontal crack on the side of the concrete sleeper.

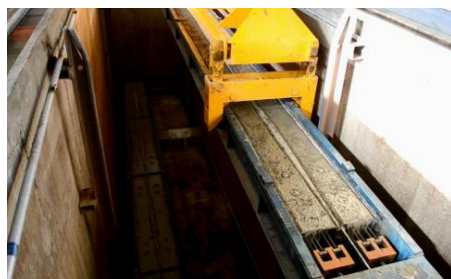
A prestressed concrete sleeper is typically made using steam curing, as shown in Figure 22. Steam curing is a type of hardening process that accelerates the development of concrete strength. During hardening, the hydration reaction of cement produces a large amount of hydration heat. Sleeper curing in the early stage is the most important period of health preservation. If the temperature in the curing pool is high, the temperature in the pool is higher than that inside the sleeper, and thermal hydration accumulation inside the pool is not easy to distribute. The gas and moisture inside the concrete mixture are heated and expanded. At this time, the concrete strength is low, and there is no resistance. However, internal stress causes concrete deformation and can even produce microfine cracks. This situation will lead to lower sleeper structural resistance. Thus, damage during operation affects a sleeper's service life. A reasonable sleeper curing system includes the following points:

**Figure 22.** Steam curing of the concrete sleeper.
