Article

Experimental Verification of Thermal Insulation in Timber Framed Walls

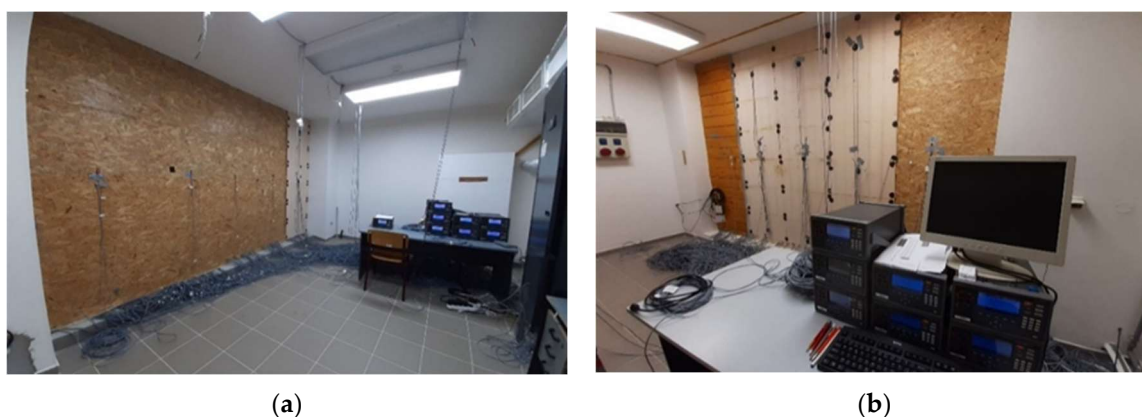
Figure 1. Research laboratory: (a) Wall oriented towards east; (b) Wall oriented towards south.

The direction of the experimental walls differs. One faces the southeast (15° deviation from the east), the other the southwest (15° deviation from the south) (Figure 1). Each monitored wall consists of five different structures (Figure 2). All ten are timber-framed, using various materials for thermal insulation and its order in-wall depth. Materials and their main physical properties are shown in Table 1. The two fragments are the same in both walls to compare different orientations. This enables us to determine the effect of wall orientation on their behavior.

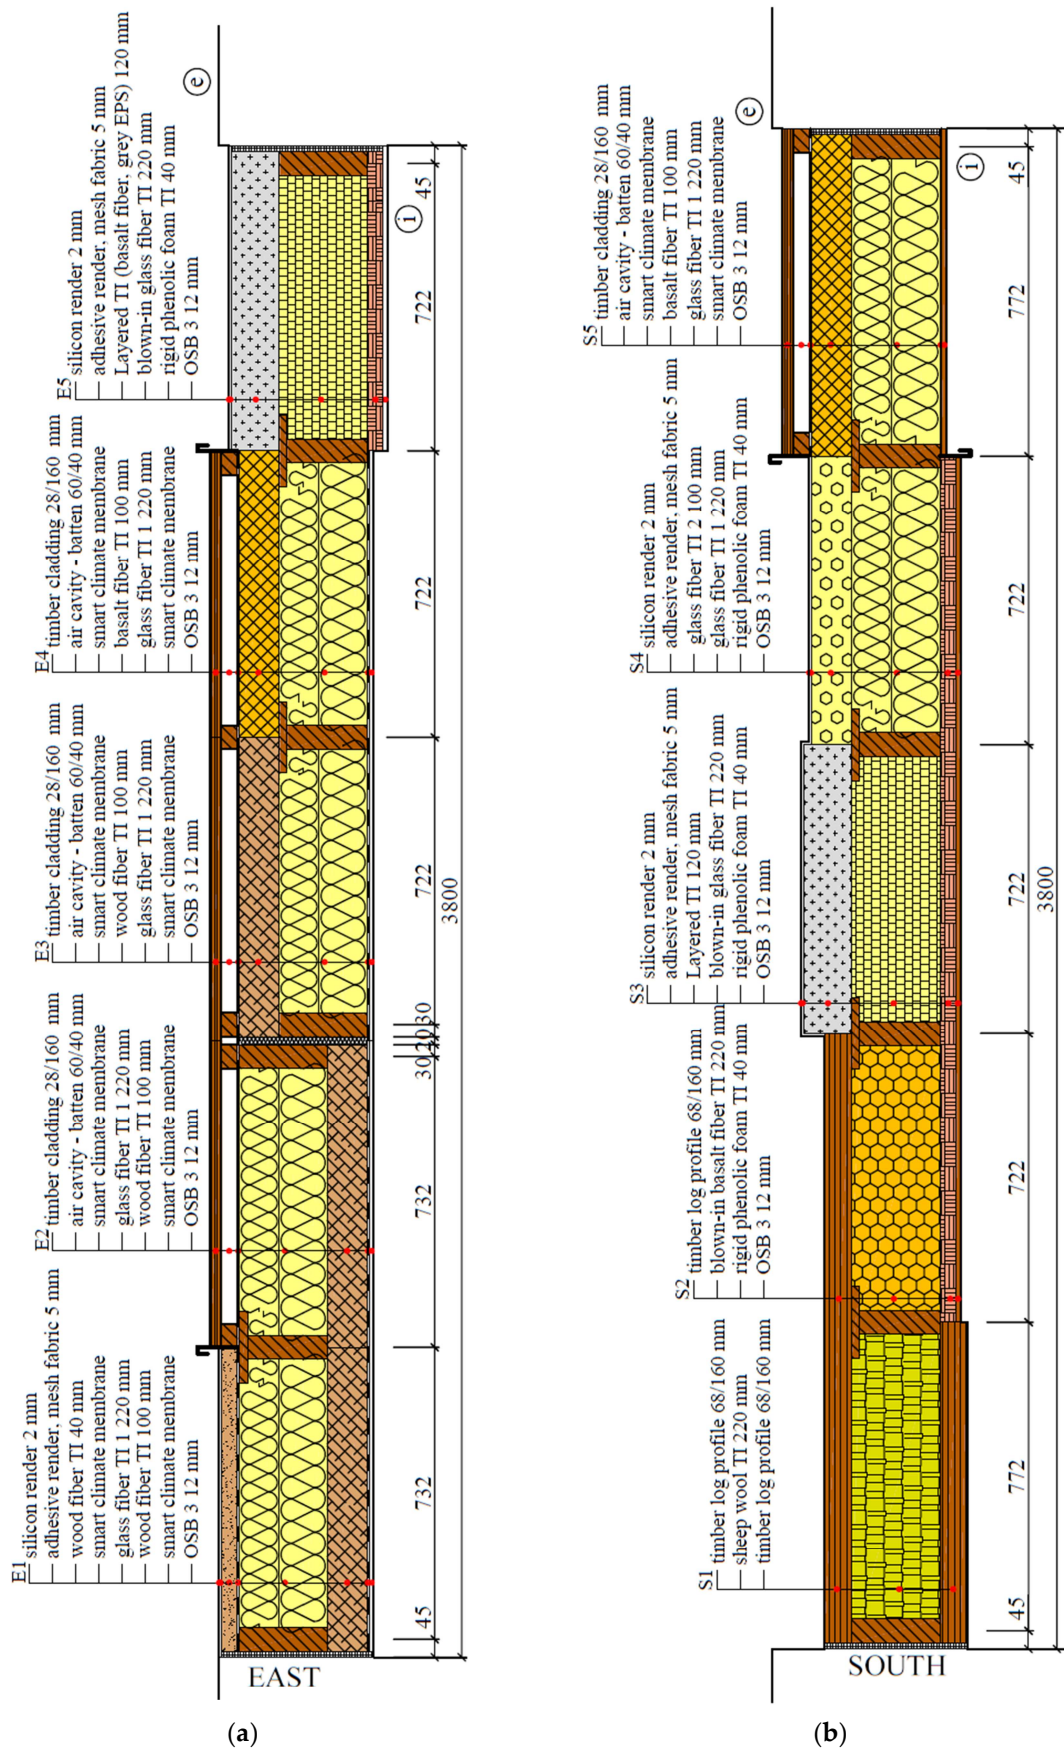
Figure 2. Timber-framed walls of the University of Zilina research center: (a) Wall oriented towards east; (b) Wall oriented towards south.

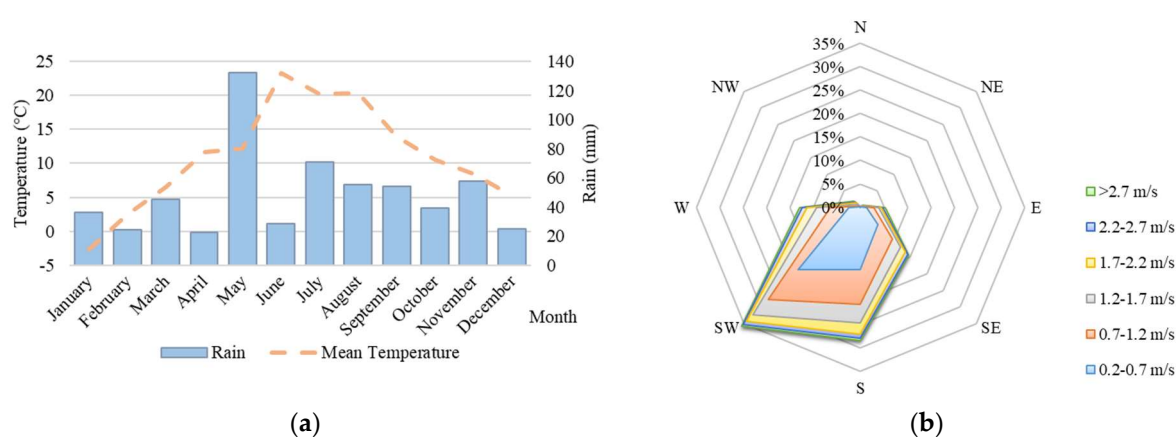
**Figure 3.** Exterior boundary conditions: (a) Rain and mean temperature; (b) Wind speed and direction.

Each wall fragment is separately removable for any future research or practice requirements. Temperature and humidity sensors are in three height levels on each structure. Other sensors monitor ambient temperatures and relative humidity. Air conditioning units adjust the indoor environment to a constant value of 20 °C temperature and 50 % relative humidity. The weather station on the laboratory building roof measures the parameters of the outdoor environment. Figure 3 depicts reference boundary conditions for the exterior. The prevalent rain is present in May, while the maximal mean temperature in this region is expected in June. Based on Figure 3b, the predominant wind speed is 2.2–2.7 m/s in the southwest direction.

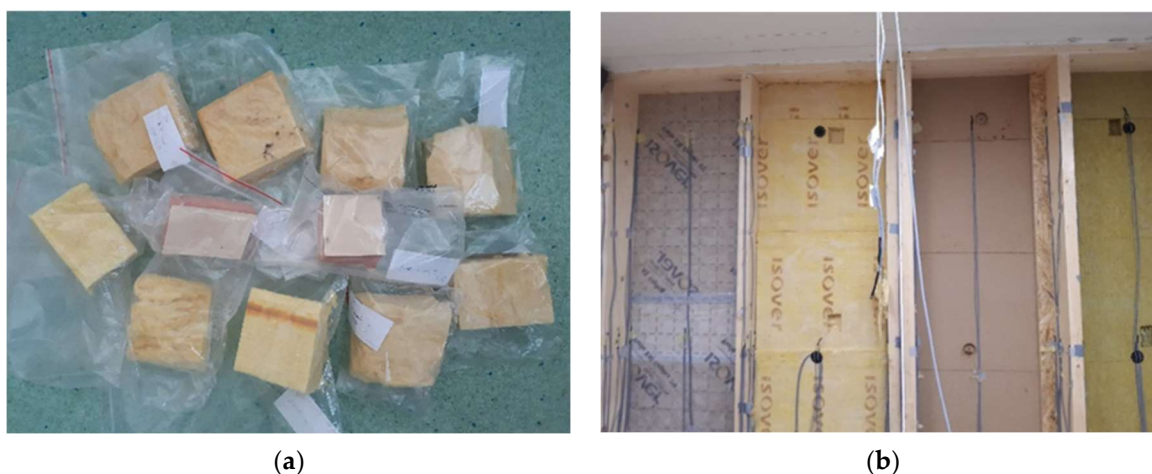
Figure 4. Process of wall disassembly (a) Part of samples collected from southern wall; (b) Photo of the eastern wall during the disassembly.

During the verification, we carried out three measurement sets. One of them was the mass moisture of the wooden elements—timber studs, wood fiber thermal insulation—performed in situ. The second set focused on thermal insulation from glass fibers and phenolic foam, measuring the mass moisture of collected samples (Figure 4a). The mea-

measurements of the thermal conductivity coefficient of thermal insulation comprise the last measurement set. Figure 4b reflects the process of disassembly of the eastern wall.

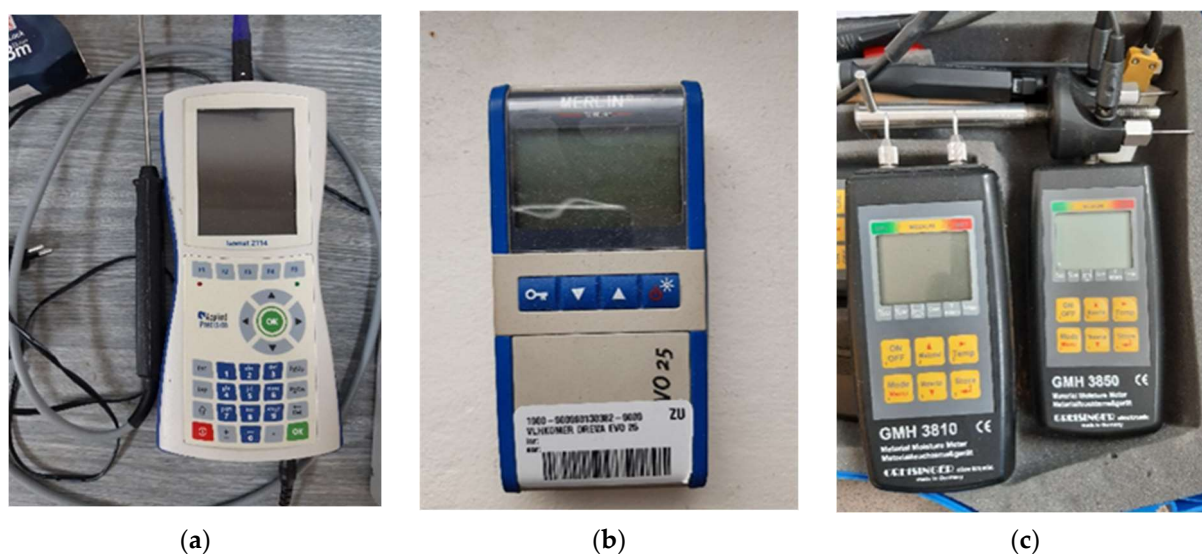
Figure 5. Measuring devices: (a) Isomet 2114; (b) Merlin EVO25; (c) Greisinger GMH 3810 and Greisinger GMH 3850.

The primary device for thermal conductivity measurements was Isomet 2114, with a needle probe displayed in Figure 5a. It operates with a dynamic temperature field based on the pulse method [21].

To ensure the accuracy of the outcomes, we measured the humidity of studs, log profiles, and wood fiber insulation with four devices. Two were capacitive probes for measuring wood moisture Merlin EVO25 (Figure 5b) and Testo. The other two were resistance humidity meters from the company Greisinger in two models—GMH 3810 with grooving tips and GMH 3850 with push-in tips (Figure 5c).

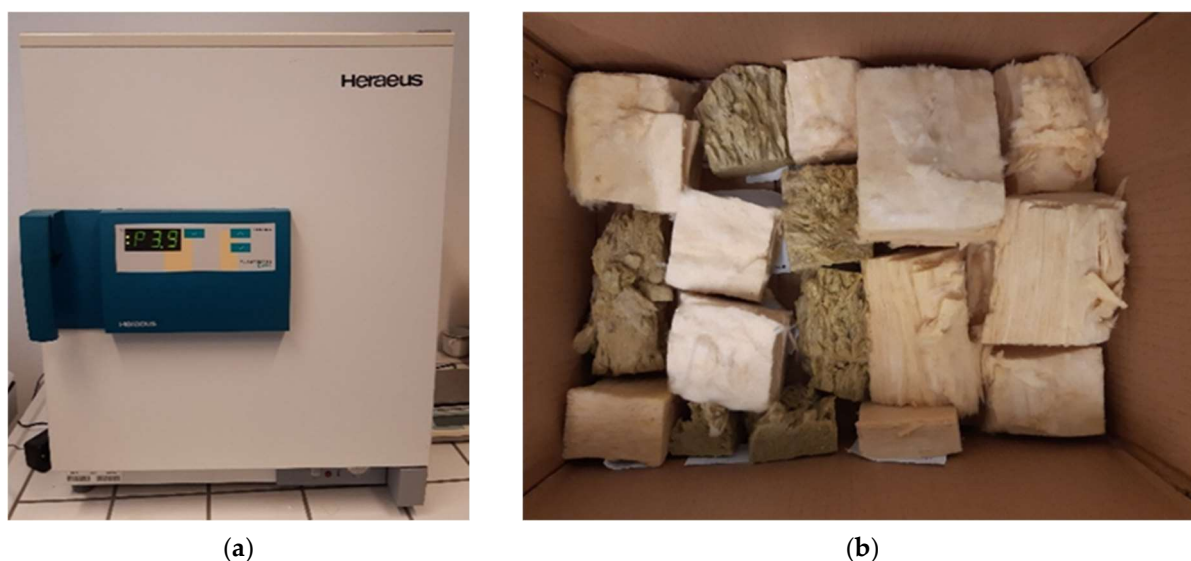
Figure 6. (a) Dryer Heraeus Function Line UT6P; (b) Samples after reaching a stable weight.

To measure the mass humidity of other materials, we collected samples at three height levels—below the ceiling, in the middle, and approximately 30 cm above the floor. Afterward, we transferred them to another laboratory room equipped with a dryer, ensuring their airtightness. We calculated the mass moisture by the gravimetric method thanks to weighing with an accuracy of 0.01 g and subsequent drying in a Heraeus Function Line UT6P device (Figure 6a) after reaching a stable weight (Figure 6b).

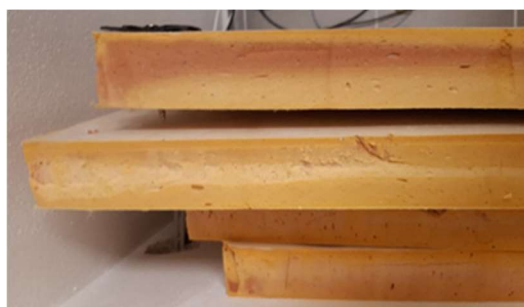
The individual materials did not show any visual changes, with the only exception being Phenolic foam boards. Their original color is pinkish brown. Throughout the years this changed to yellow. This modification is visible in Figure 7, where only the first board partly maintained the original color. However, the mass moisture content was low. Therefore, we concluded that the cause is natural degradation via oxidation.

Figure 7. Phenolic foam insulation after color change.

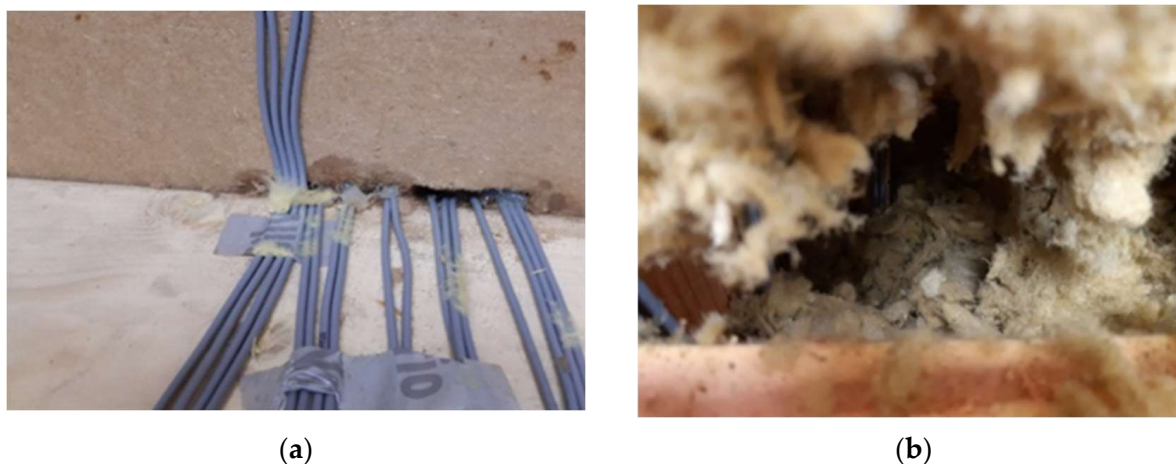
A more severe defect was detected at the threshold level in fragment E3 in wood fiber insulation. We discovered increased moisture originating in the cable network from the exterior that created a passage for water (Figure 8a). It is a challenging but crucial detail in properly executing weather barriers. In this case the leakage was substantial, while the moisture content measured with Greisinger GMH 3850 reached 18.6%. This problem turned out to only be local, as the boards' humidity dropped to 10.1%, just 10 cm aside. However, this was the only fragment with such an issue, whereas all of them were built simultaneously by the same team. Therefore, it is not plausible that this would be the only

wall with poor execution. More likely, this fact indicated the unsuitability of using this wood fiber material when more crossings are necessary, without the possibility of securing impermeable contact.

Figure 8. Detected defects: (a) Increased moisture transfer in fragment E3; (b) Air cavity in the middle of S2.

We revealed a severe shortcoming in fragments insulated with blown-in thermal insulation (based on mineral fibers—glass and basalt). We detected air cavities that would significantly reduce building energy performance due to the created thermal bridges. The cavities occurred on top of the walls under the ceiling, caused by the settlement. We measured 3 cm in S3, 8 cm in E5 (both glass fiber insulation), and 7 cm in S2 (basalt fiber insulation). However, these are experimental walls with an emphasis on their professional execution. Nevertheless, the cavities occurred not only on the top, but also in the middle of the structures' height. It occurred in the place of necessary wiring. Although the wire was thin, it prevented the blown material from filling the lower part sufficiently, thus creating a cavity visible in Figure 8b.

According to expectations, mineral fiber insulation remained in perfect condition. It is an inorganic and thus very durable material. The only issue occurred in fragments with loose filling. Even though many producers recommend this blown-in insulation for exterior walls, we would not support this statement. In our case, the execution was professional, focused only on three fragments. Nonetheless, the contractors could not ensure long-term, lasting conditions without additional thermal bridges caused by material settlement, often occurring by this material [23,24]. As a result, this could cause high thermal losses and eventually material degradation due to mold formation on the interior surface due to low surface temperature.

between mass moisture and thermal conductivity coefficient, causing discrepancies between design and actual values. According to our measurements, the value of the thermal conductivity coefficient throughout the years almost doubled—from value 0.045 to value 0.86—increasing by 90%. This factor further influences the thermal resistance of the whole building envelope, thermal losses, and thus final energy consumption. Another important discovery was the results in fragment E3 with penetrated climate membrane. The influence that this slight imperfection had on the whole layer was so significant that we would not advise using this material from the exterior side of the wall.

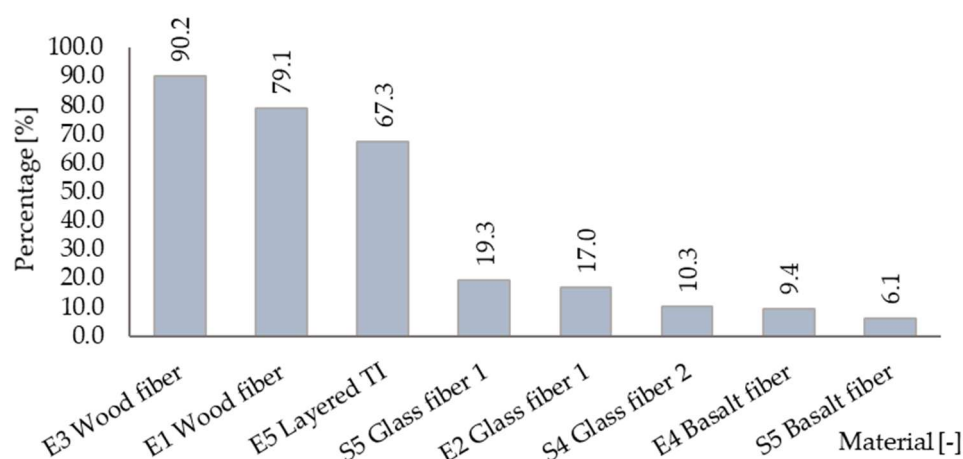
Table 2 presents the thermal conductivity coefficient, measured directly in-situ with an Isomet 2114 with a needle probe and their original design values. It also shows the percentage difference between the two values. Figure 9 displays this difference in a graphical form.

Figure 9. Percentage of thermal conductivity coefficient elevation in thermal insulation materials.

The most significant discrepancy was allocated in wood fiber insulation. The value almost doubled in fragment E3 due to the hygroscopic nature of the material. As stated in the previous section, we discovered imperfections in the weather barrier layer, which unavoidably leads to higher moisture content, causing a change in the thermal conductivity coefficient. We also detected a more than 65% increase in layered thermal insulation, consisting of 30 mm basalt fiber insulation combined with 90 mm of grey polystyrene. The other materials based on mineral fibers showed lower alterations than those mentioned above, thermal insulation of basal fibers being superior from this point of view.

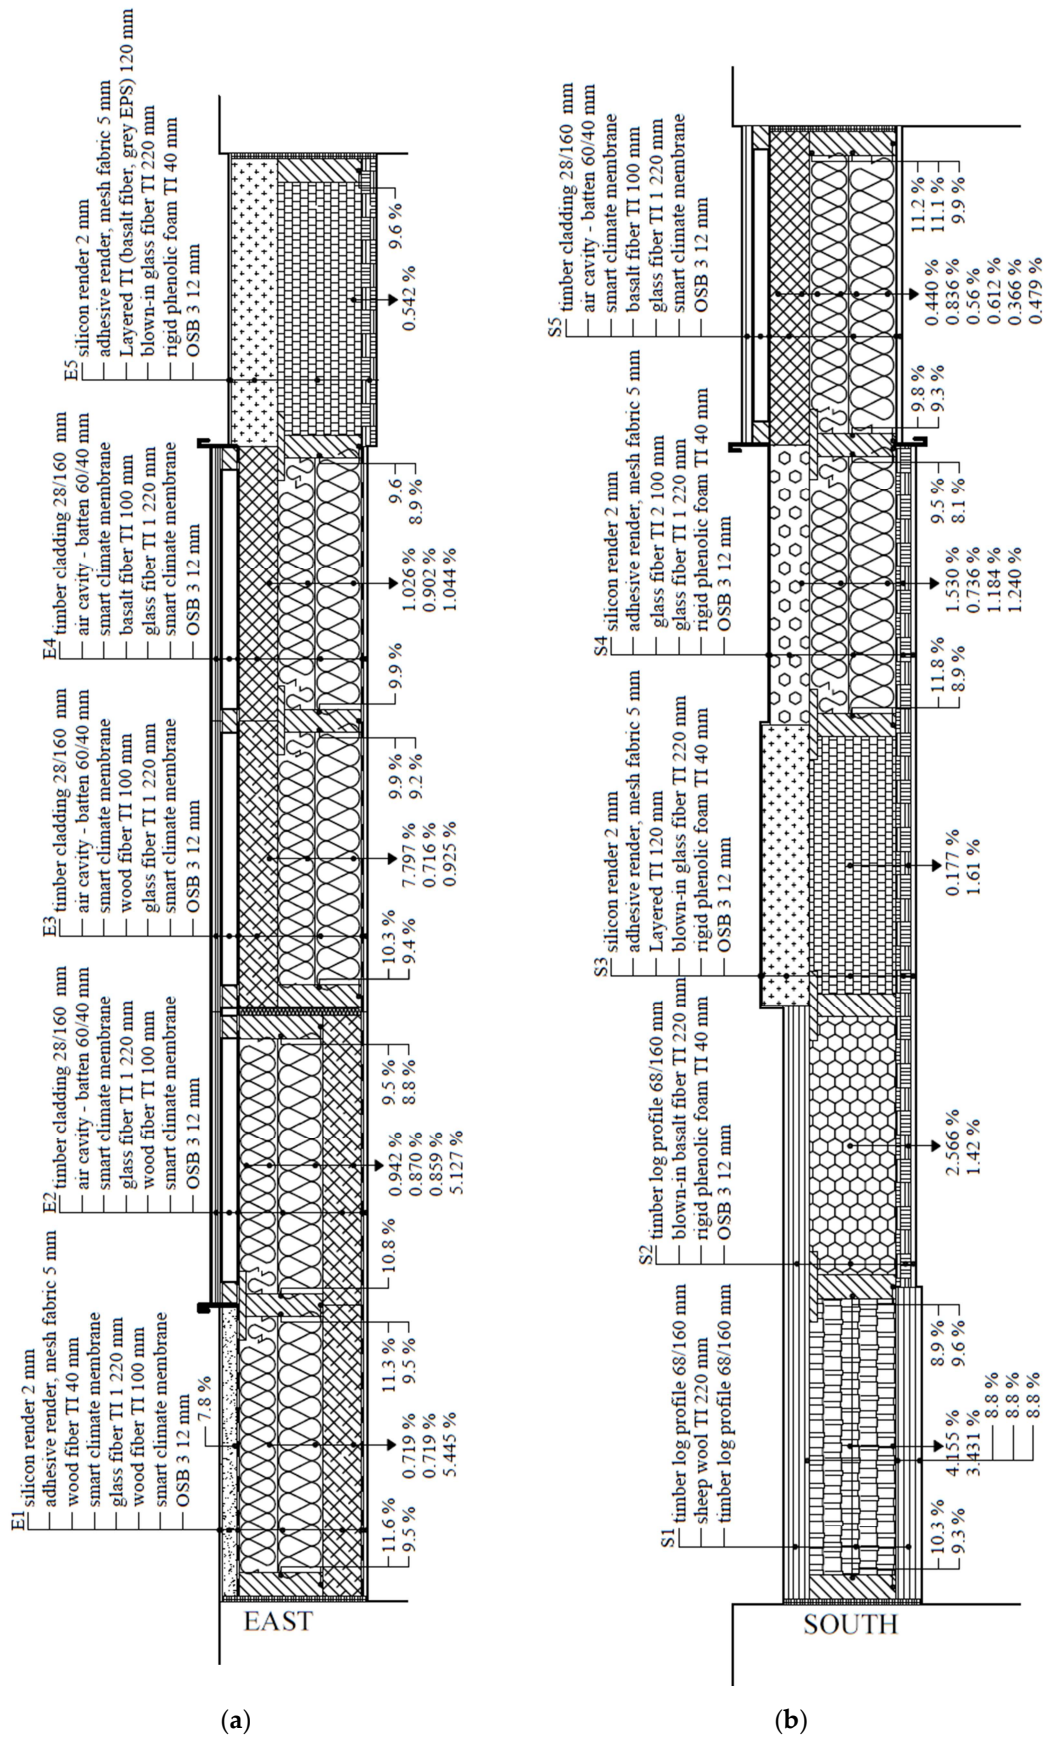
As mentioned, mass moisture of massive wooden components was measured in-situ with laboratory equipment. For other materials, the moisture was stated through simple calculations using their weight before and after the drying process. Figure 10 shows all obtained data. Values from calculations are marked with an arrow.

Sample collection and the in-situ measurements took place in three different height levels. Figure 10 represents only the maximum values of each material.

Figure 10. Mass moisture of individual materials: (a) Wall oriented towards east; (b) Wall oriented towards south.

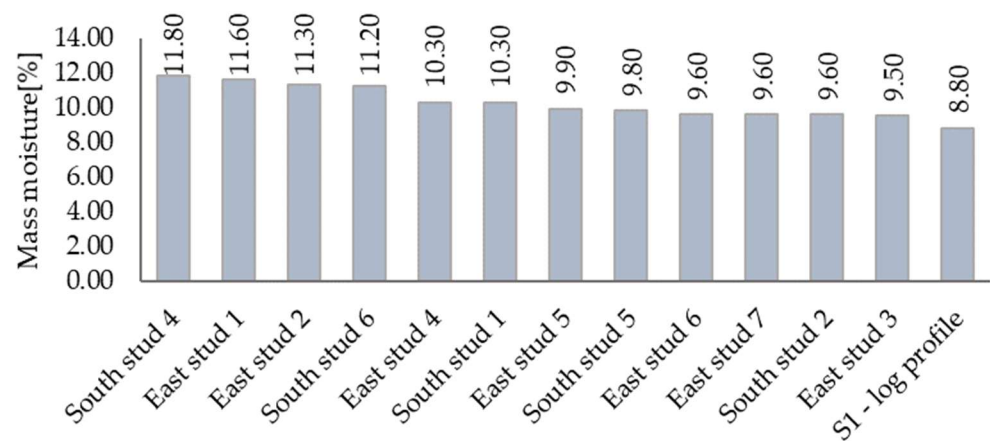
Figure 11 shows all measured data concerning mass moisture of timber components. Noteworthy is that the maximal value was 11.8%, indicating no potential danger in terms of mold growth or load-bearing capacity.

Figure 11. Mass moisture of built-in timber profiles.

The essential part of any building—the load-bearing structure—was faultless in terms of visual defects or increased moisture content. The maximum mass moisture was 11.8%, which means that there are no conditions supporting mold creation and development or any other moisture-related issue [22].

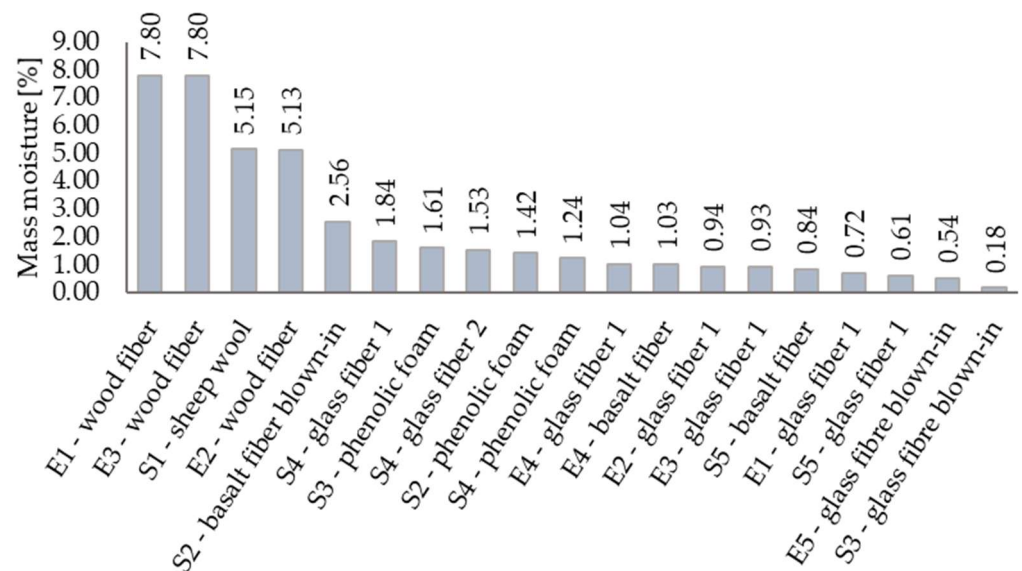
Separately, Figure 12 depicts the mass moisture of each thermal insulation. As indicated from previous sections, wood fiber insulation in fragments reached higher values of mass moisture, even though these are both diffusely closed wall assemblies.

Figure 12. Mass moisture of built-in thermal insulation.
