Article

Failure Mechanism and Control Countermeasures for Argillaceous Surrounding Rock of Horsehead Roadway under High Stress

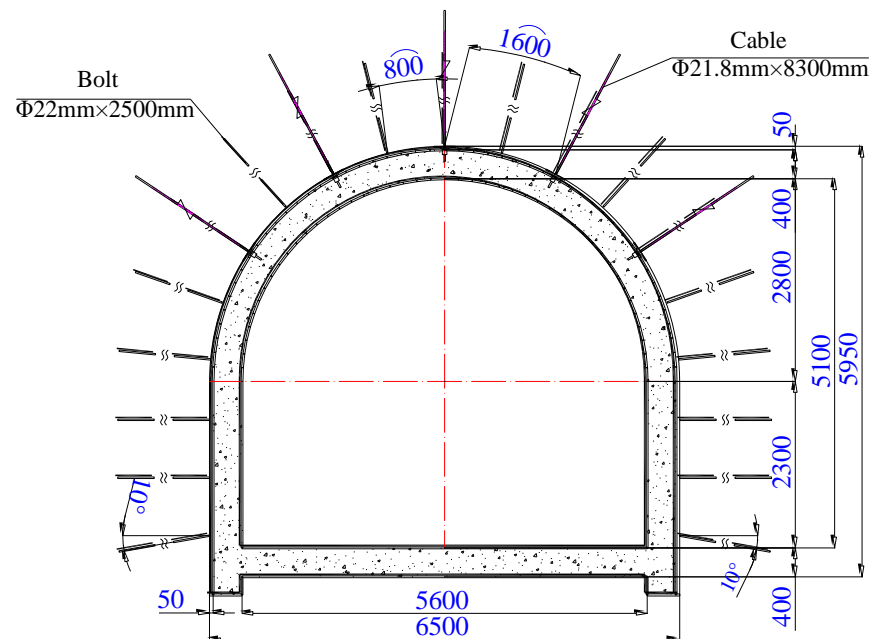
Figure 2. Support section.

The size of the excavation section of horsehead roadway was 6500 mm in width and 5950 mm in height. The excavation of the roadway was carried out in full section. The cycle

footage of the excavation and support is 1600 mm. The bolts and cables were carried out after excavation. The bolts and cables were 800 mm and 1600 mm away from the tunneling face, respectively. The original support scheme from the coal mine design institute was an anchor net spray support and reinforced concrete lining. The support parameters are shown in Figure 2. There were thirteen thread steel bolts in the roof and three on both sidewalls, each 22 mm in diameter and 2500 mm in length. The interval and spacing of the bolts were both 800 mm. There were five anchor cables in the roof, each 21.8 mm in diameter and 8300 mm in length. The interval and spacing of the bolts were both 1600 mm.

The thickness of the reinforced concrete lining was 400 mm. The concrete strength was C50. The size of the net section was 5600 mm in width and 5100 mm in height.

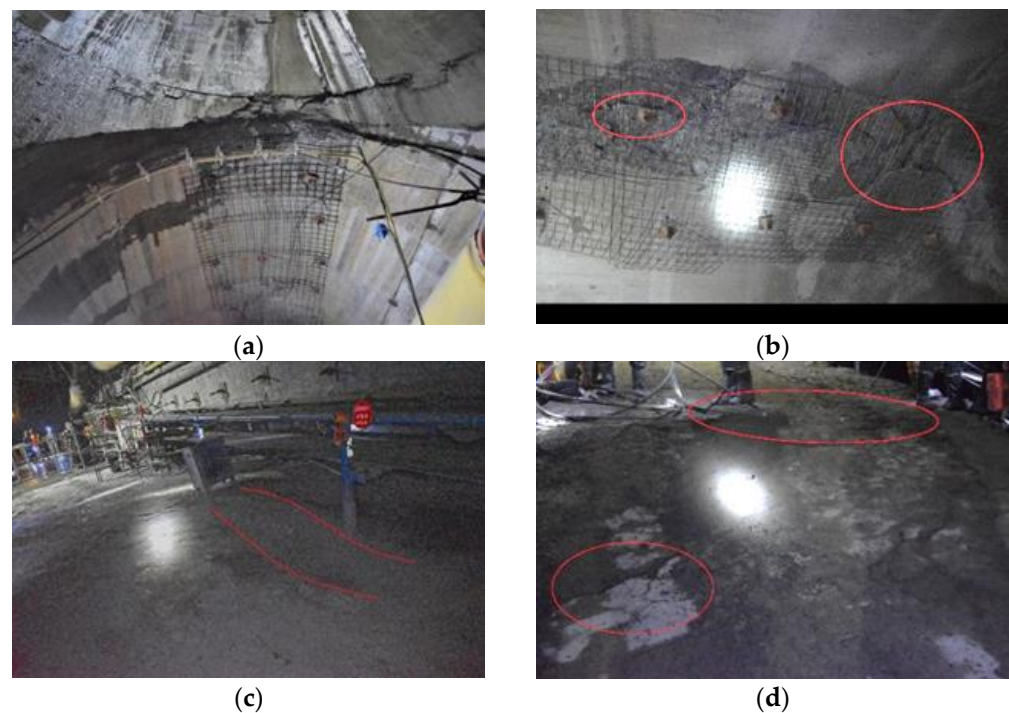
During the construction of the horsehead roadway, there was no obvious failure to the surrounding rock of the two sidewalls. In the middle of the roof, there were cracks in the shotcrete spraying, cracking and falling off of the arch lining, and roof sinking. The roof separation exceeded 45 mm. The floor cracked and heaved, despite multiple floor dinting. The cumulative floor heave was greater than 700 mm, which seriously affected the safety of the underground transportation and construction. The failure characteristics of the roof and floor of the horsehead roadway are shown in Figure 3.

Figure 3. Failure characteristics of the surrounding rock of the horsehead roadway. (a) Reinforced concrete lining cracking; (b) reinforced concrete lining cracked and falling off; (c) floor heave; and (d) reinforced concrete floor cracking.

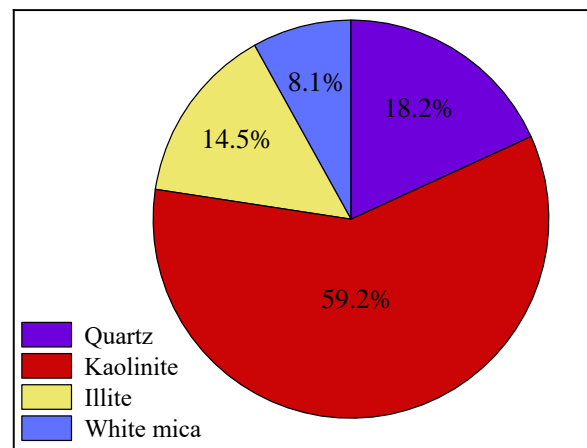
Figure 4. XRD results of the argillaceous surrounding rock.

Most of the surrounding rock is mudstone or sandy mudstone with a low strength and poor bearing capacity. Figure 4 shows the X-ray diffraction (XRD) test results of the roof mudstone samples of the horsehead roadway; the contents of the clay minerals kaolinite and illite in the surrounding rock are 59.2% and 14.5%, respectively. Due to the hydrophilicity of clay minerals, when water invades the rock layer, it can easily cause volume expansion and mud disintegration, resulting in a decrease in the overall strength of the surrounding rock. The weak and broken surrounding rock is prone to large deformation and failure. Figure 5 is the scanning electron microscope (SEM) experimental results of the surrounding rock samples. The surface of the rock sample is rough, the cementation is poor, the micropores are more developed, and there is considerable debris on the surface of the rock sample. The maximum width of the fracture is 6.82 μm when the fracture is magnified to 4000 times, and the weak cementation of the rock mass and the existence of the fracture seriously affect the long-term stability of the surrounding rock.

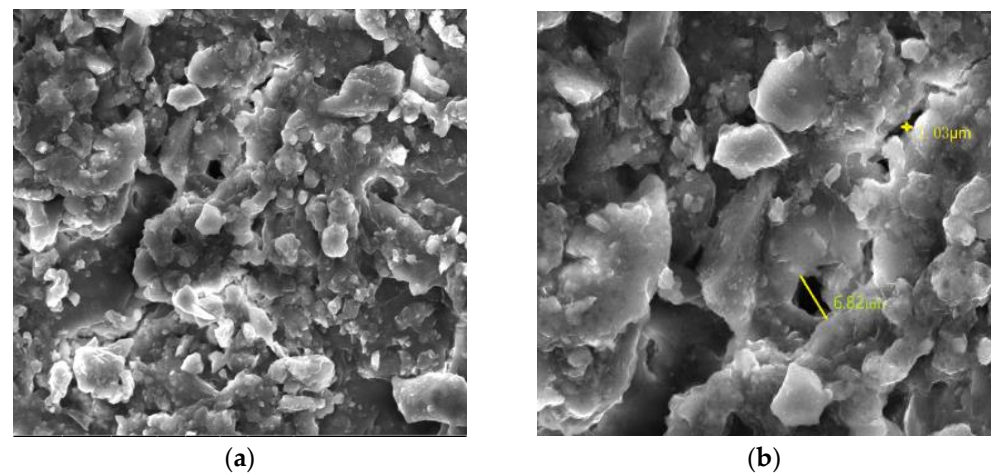
Figure 5. Microstructure of the argillaceous rock: (a) amplified 2000 times; and (b) amplified 4000 times.

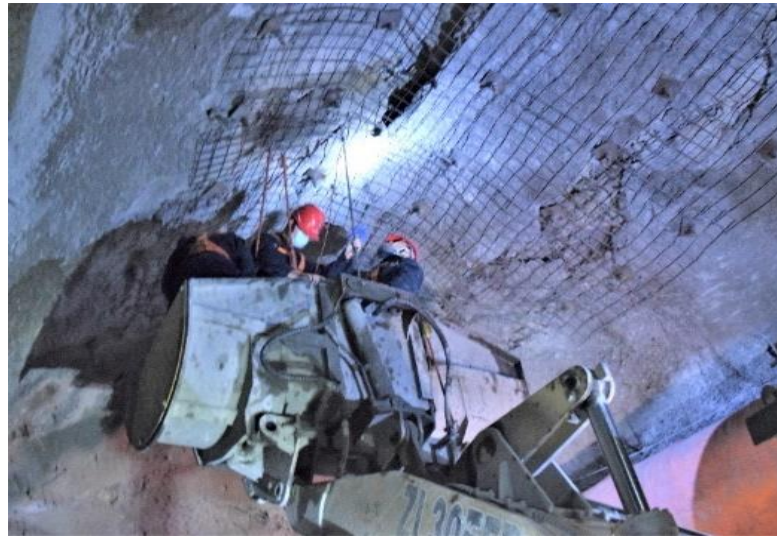
Figure 6. Borehole image monitoring of the surrounding rock of the horsehead roadway.

The ZKXG30 borehole image monitoring camera was used to detect the fracture distribution of the surrounding rock of the roof of the horsehead roadway (Figure 6).

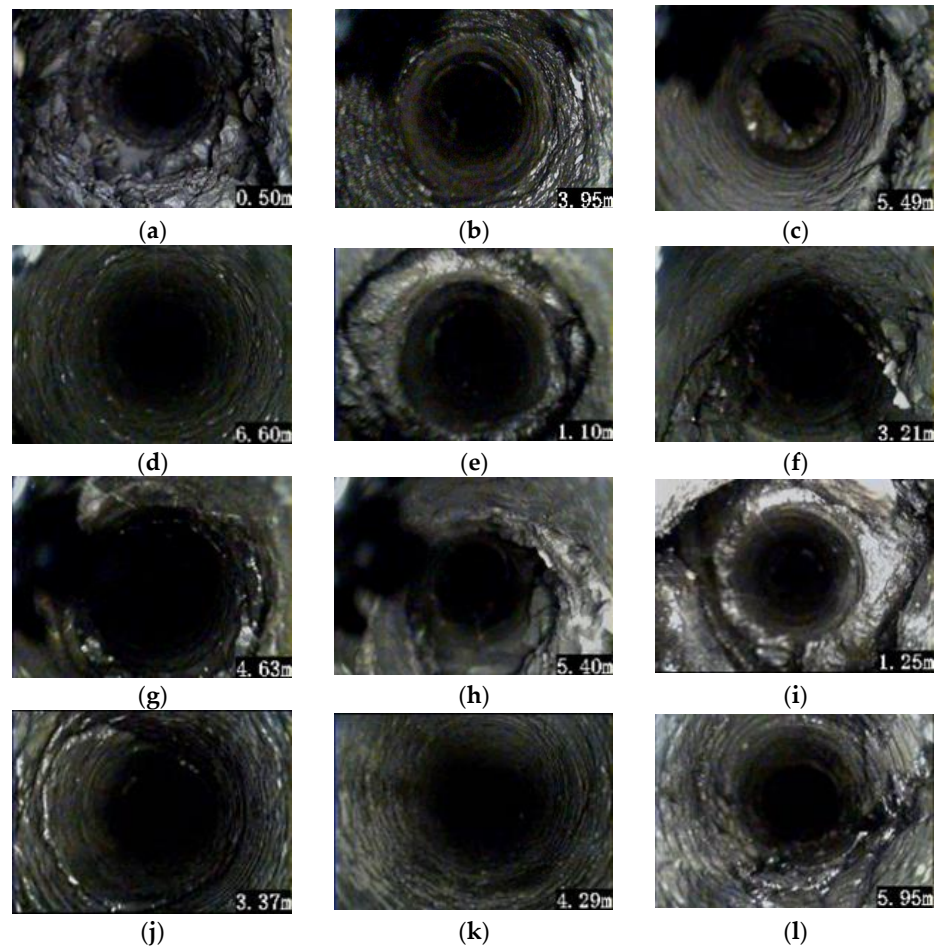
Using the results of the borehole image monitoring of the surrounding rock, the fracture distribution law of the mudstone roof was revealed, as shown in Figures 7 and 8. The fractures in borehole # 1 in the middle of the roof developed to a depth of 0–2.0 m, and the rock was broken. After that, large cracks appeared at the depths of 3.95 m and 5.5 m, and the rest was relatively complete. Borehole # 2 in the left shoulder of the roof showed a fracture zone with a depth of 0–1.1 m with considerable fracture development; larger fractures exist at 3.5 m, 4.5 m, and 5.3–5.7 m, and the others were relatively complete. The rock mass of borehole # 3 in the right shoulder of the roof were broken with a depth of 0–1.5 m. After that, there were fractures at 2.8 m and 3.5 m. There was a fracture at a depth of about 6.0 m. The rock with a depth exceeding 6.0 m was relatively complete with few cracks.

Figure 7. Borehole image of the fractures of the surrounding rock of the horsehead roadway: (a) shallow cracks in borehole # 1; (b) ring crack in borehole # 1; (c) deep fracture in borehole # 1; (d) deep rock of borehole # 1 is intact; (e) shallow cracks in borehole # 2; (f) longitudinal crack in borehole # 2; (g) ring crack in borehole # 2; (h) deep fracture in borehole # 2; (i) shallow cracks in borehole # 3; (j) ring crack in borehole # 3; (k) the surrounding rock of borehole # 3 is intact; and (l) deep fracture in borehole # 3.

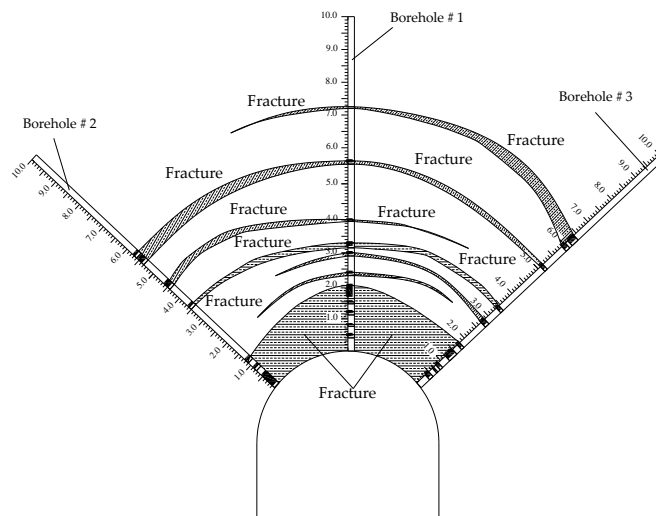
Figure 8. Distribution of the fracture circle of the mudstone roof.

The failure depth of the roof is greater than the anchorage depth of the bolt (2.5 m), which makes the anchorage fail with ease, and the active support of the bolt on the surrounding rock does not work. The borehole image monitoring shows that the separation occurs outside of the anchorage zone of the bolt, so the insufficient thickness of the roof anchorage layer is an important factor for roof failure.

- (1) The thickness of the anchorage layer should be increased. The drilling detection results of the muddy surrounding rock of the horsehead roadway's roof show that the surrounding rocks are broken within 3.5 m of the roof, and the separation layer appears outside the bolt anchorage zone. The muddy surrounding rocks of the bolt drilling can be broken easily and lead to anchorage failure. It is difficult to create an effective support for the roof using a conventional bolt support or increasing the support density. Therefore, the thickness of the anchorage layer should be increased, and the strength and integrity of the surrounding rock should be improved using prestressed full-length anchorage technology.

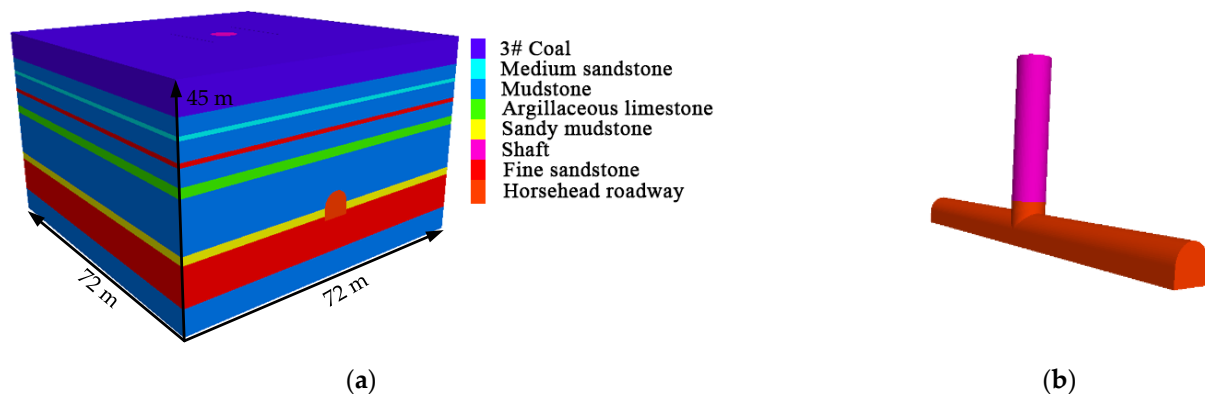
The FLAC3D numerical model was established, as shown in Figure 9, according to the actual engineering geological conditions of the horsehead roadway of the return air shaft in the Libi Coal Mine. The section size of the horsehead roadway is 6.5×5.95 m (width \times height), and the model size is $72 \text{ m} \times 72 \text{ m} \times 45 \text{ m}$ (length \times width \times height). A vertical stress of 12.85 MPa was applied to the upper boundary of the model, which represents the pressure of the overlying strata, with horizontal displacement fixed at the lateral boundary and both horizontal and vertical displacements fixed at the bottom boundary. The Mohr–Coulomb yield criterion was adopted. The entire model and the horsehead roadway model are shown in Figure 9, and the mechanical parameters of the rock mass are shown in Table 1.

Figure 9. Numerical model: (a) numerical model diagram and (b) the horsehead roadway.

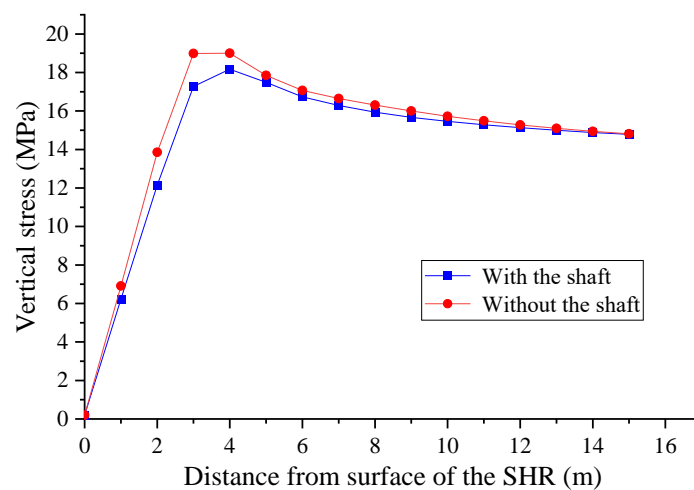
Figure 10. Vertical stress distribution of the surrounding rock of the horsehead roadway (SHR: sidewall of the horsehead roadway).

The maximum vertical stress of the surrounding rock without the shaft is 19.4 MPa, which is 3 m away from the surface of the roadway sidewall. When the shaft is present, the maximum vertical stress of the surrounding rock is 18.4 MPa, which is 4 m away from the surface of the sidewall of the horsehead roadway. The presence of the shaft has little effect on the vertical stress distribution of the surrounding rock of the horsehead roadway.

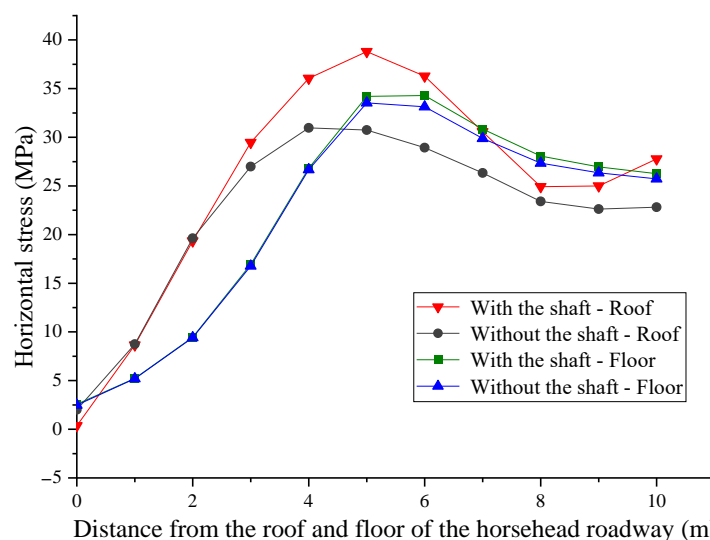
Figure 11. Horizontal stress distribution of the surrounding rock of the horsehead roadway.

After the excavation of the horsehead roadway, the horizontal stress of the roof and floor first increases and then decreases, finally approaching the in situ stress. The presence of the shaft has a great influence on the horizontal stress of the roof of the roadway. The maximum horizontal stress of the roof is 34.1 MPa when there is no shaft, whilst the maximum horizontal stress of the roof is 39.2 MPa when there is a shaft. The presence of the shaft makes the roof stress concentration more obvious and increases the distribution range of the high-stress areas, which can cause roof damage with ease. The difference between the horizontal stress variation curves of the floor in the two cases is not significant, indicating that the shaft has little effect on the horizontal stress distribution of the floor.

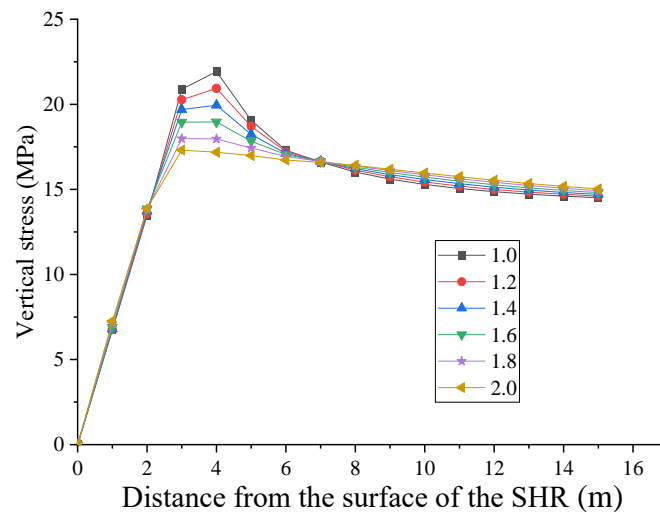
Figure 13. Vertical stress distribution of the surrounding rock under different lateral pressure coefficients (SHR: side of the horsehead roadway).

As the lateral pressure coefficient increases, the vertical stress peak of the surrounding rock gradually decreases, and the stress peak gradually approaches the roadway surface (Figure 13). The peak vertical stress reaches its maximum at 21.9 MPa with a lateral pressure coefficient of 1.0, at 4 m from the roadway surface. The peak vertical stress reaches its minimum at 17.3 MPa with a lateral pressure coefficient of 2.0, at 3 m from the roadway surface.

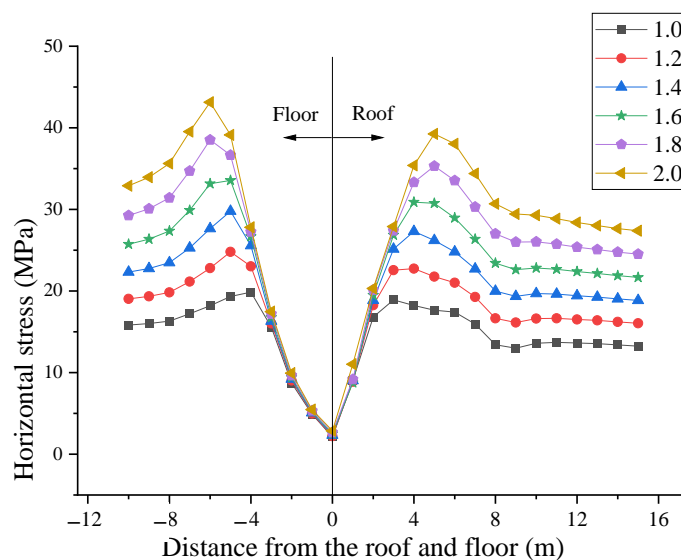
Figure 14. The horizontal stress distribution law of the surrounding rock under different lateral pressure coefficients.

As the lateral pressure coefficient increases, the peak horizontal stresses of the roof and floor also gradually increase, and the position of the peak stresses gradually move away from the roadway (Figure 14). In the process of increasing the lateral pressure coefficient from 1.0 to 2.0, the peak stress of the roof increases from 18.9 MPa to 39.2 MPa, and the position of peak stress increases from 3 m to 5 m from the horsehead roadway. The peak

stress of the floor increases from 19.9 MPa to 39.5 MPa, and the position of peak stress increases from 4 m to 7 m from the horsehead roadway floor.

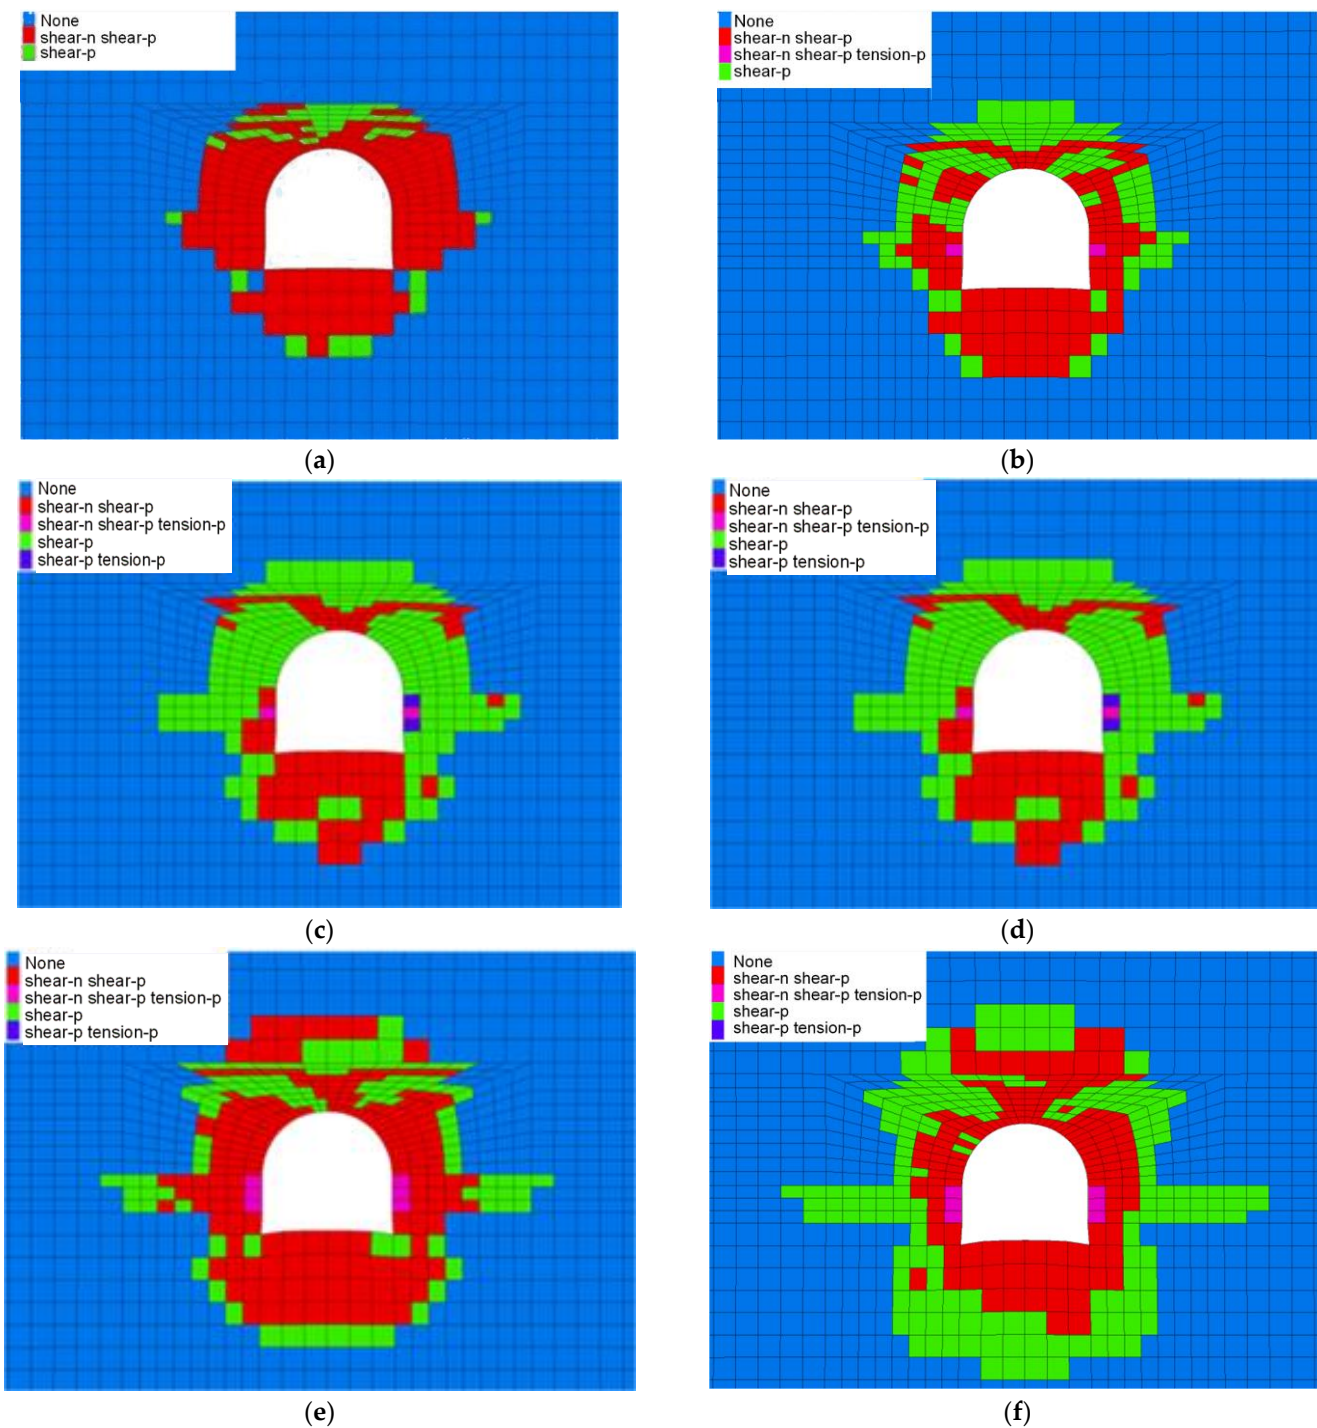
As shown in Figure 15, as the lateral pressure coefficient increases, the plastic zone range of the horsehead roadway roof increases from 3 m to 6 m, and the plastic zone range of the floor increases from 4 m to 6 m. The failure of the surrounding rock is mainly shear failure. When the lateral pressure coefficient is greater than 1.4, the zone of the tensile shear failure appears in the shallow surrounding rock of the two sides of the horsehead roadway.

Figure 15. Distribution law of the plastic zone of the surrounding rock under different lateral pressure coefficients. (a) 1.0. (b) 1.2. (c) 1.4. (d) 1.6. (e) 1.8. (f) 2.0.

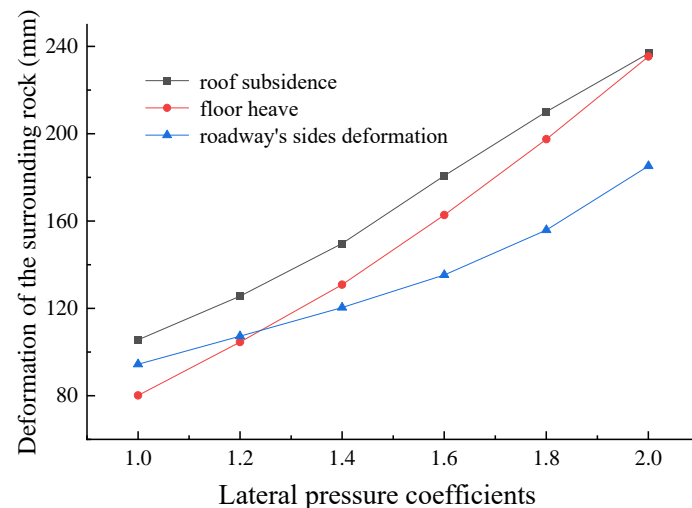
Figure 16. Displacement of the surrounding rock under different lateral pressure coefficients.

As shown in Figure 16, as the lateral pressure coefficient increases, the deformation of the surrounding rock gradually increases. In the process of increasing the lateral pressure coefficient from 1.0 to 2.0, the roof subsidence increases from 105.6 mm to 236.8 mm, the floor heave increases from 80.1 mm to 235.4 mm, and the deformation increases significantly.

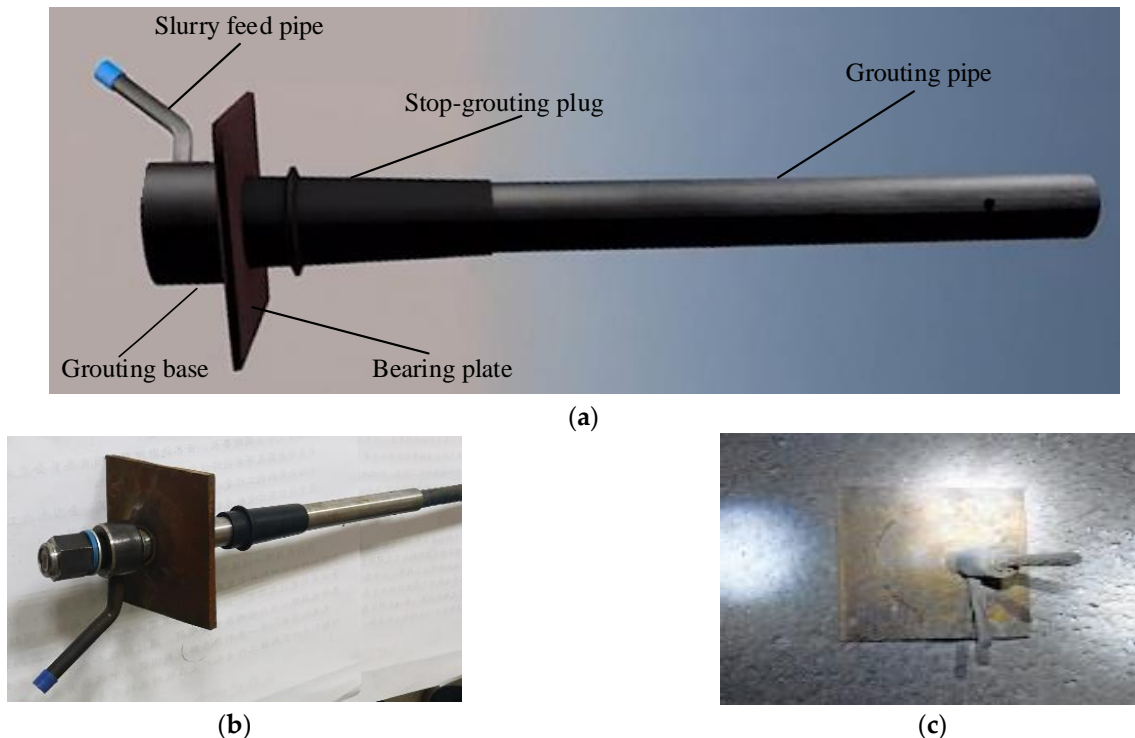
Combined with the borehole image monitoring results of the fracture distribution of the surrounding rock in the horsehead roadway, we propose the prestressed full-length anchorage technology of bolts or cables based on an innovative anchor-grouting device because the depth of the roof failure is greater than the depth of the bolt anchorage, so the thickness of the anchorage ring has to be increased and the strength and integrity of the rock mass have to be improved. The anchor-grouting device (Figure 17) was used with cables. As shown in Figure 17a, the anchor-grouting device mainly includes the grouting base, slurry feed pipe, stop-grouting plug, bearing plate, and grouting pipe. The pre-tightening force of the cables was first tensioned after anchoring using a resin agent, and then the full-length anchorage was completed with grouting through the grouting device. Compared with the traditional hollow grouting cable, there is no strength loss in the cable body for the prestressed full-length anchorage support technology. The combination of anchor-grouting devices with cable support plays three roles—pre-tightening, full-anchorage, and grouting, which can effectively construct the thick prestressed bearing ring and achieve the long-term stability of the surrounding rock.

Figure 17. Innovative anchor-grouting device for prestressed full-length anchorage: (a) structure of anchor-grouting device; (b) the innovative anchor-grouting device; and (c) field application.

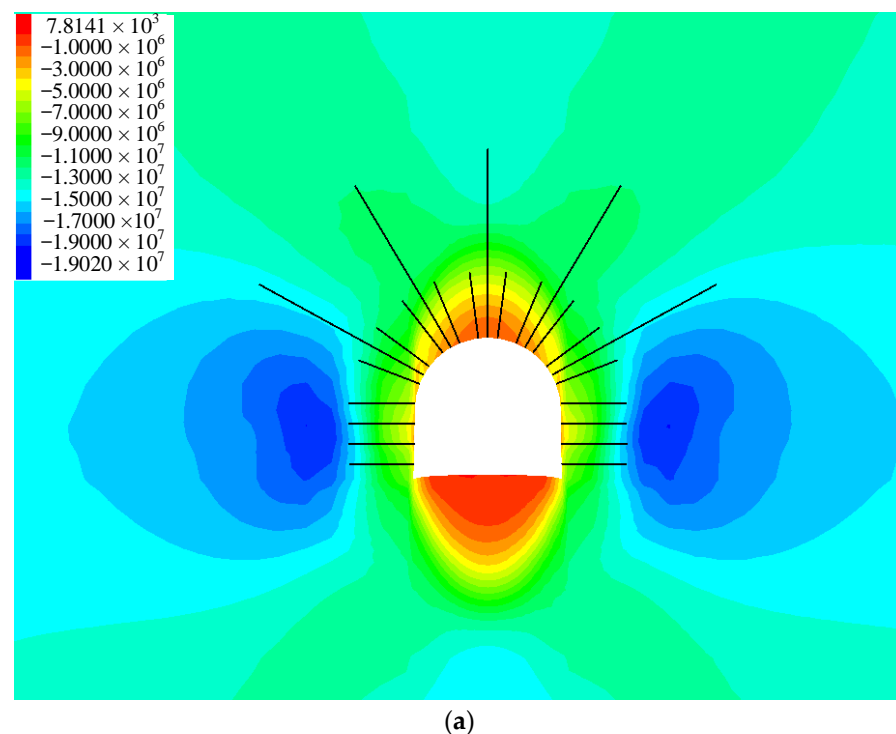
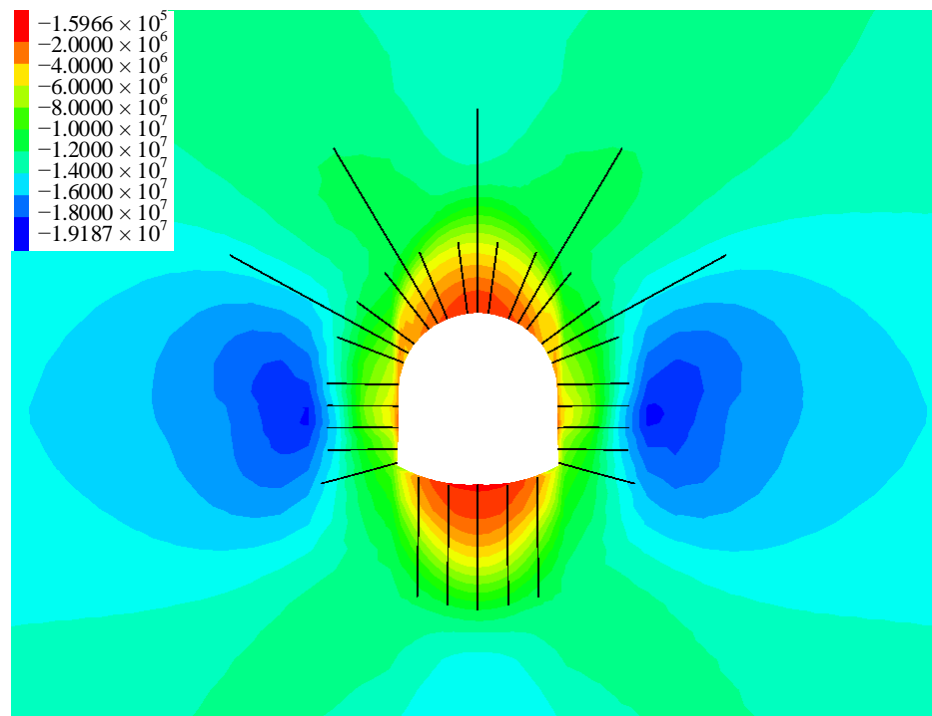
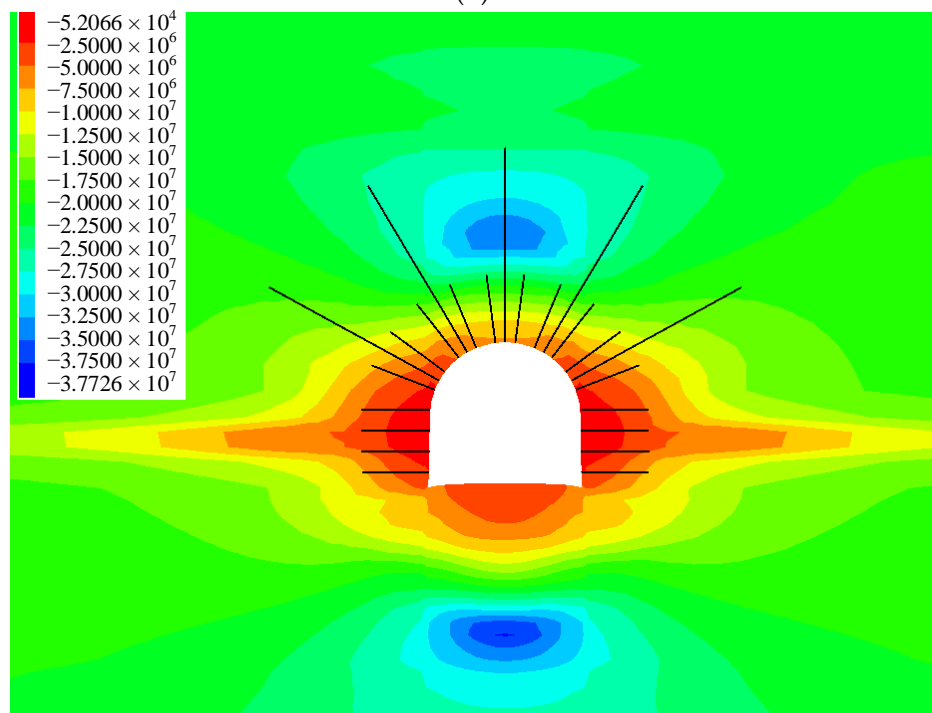
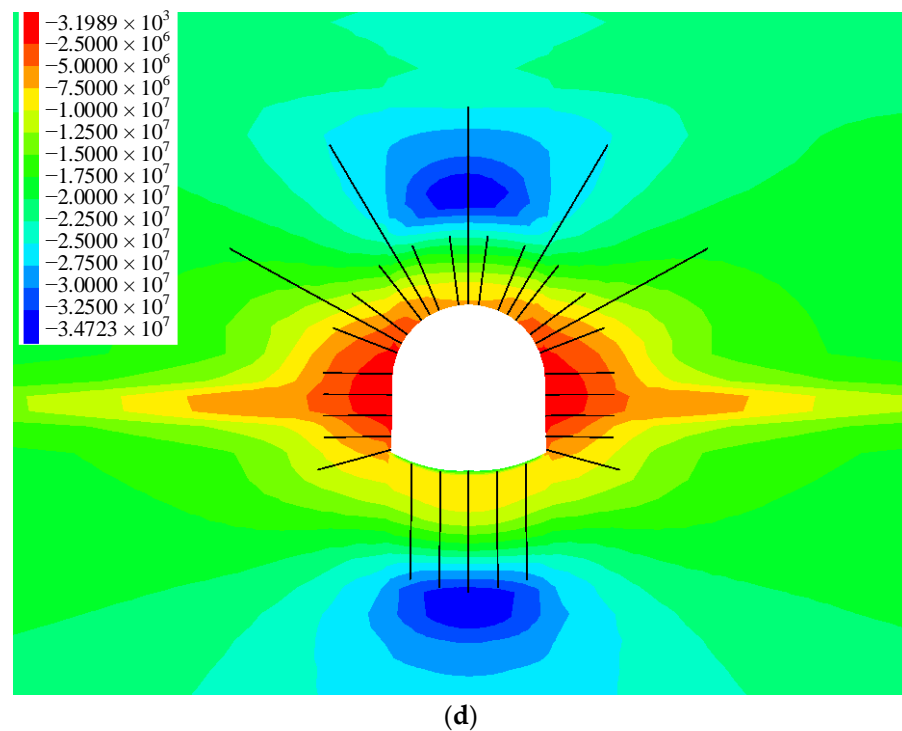
Figure 18. Stress distribution of the different supporting schemes at 5 m from the shaft (unit: Pa): (a) vertical stress for scheme 1; (b) vertical stress for scheme 2; (c) horizontal stress for scheme 1; and (d) horizontal stress for scheme 2.

From Figure 18, it can be seen that the peak vertical stress values of the surrounding rock in schemes 1 and 2 are 19 MPa and 19.2 MPa, respectively, with little difference. However, after supporting the floor, the tensile stress area of the floor disappears. As shown in Figure 18b, after the reinforcement of the floor, all the areas below the inverted arch become compressive stress areas, and the failure capacity of the floor is greatly enhanced. When the two different schemes are supported, the horizontal stress of the roof is not much different, but the horizontal stress of the floor is obviously different. The peak values of the horizontal stress of the floor are 37.7 MPa and 34.7 MPa, respectively, for the two schemes. Therefore, increasing the bottom corners bolt and the floor anchor cable not only improves the strength of the floor but also improves the stress environment of the floor and reduces the stress concentration of the floor, which is conducive to the long-term stability of the floor.

The nephograms of the vertical and horizontal stress distribution of the surrounding rock at 5 m from the shaft after using two different support schemes are shown in Figure 18.

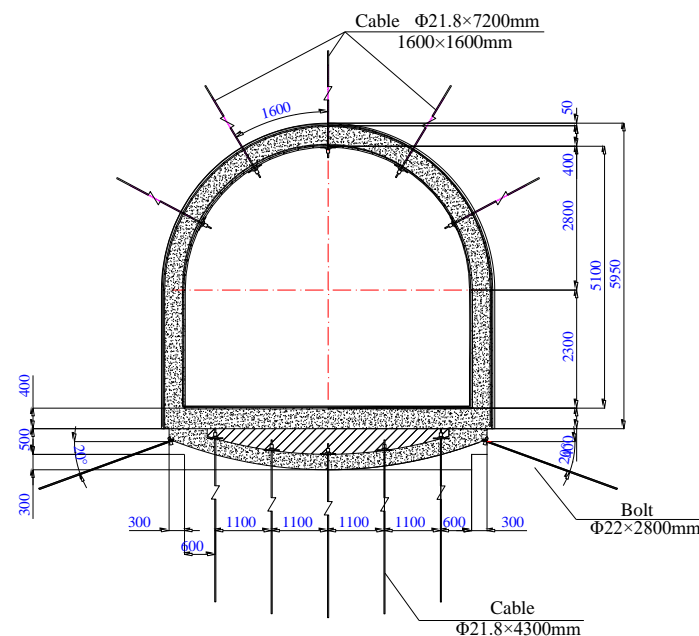
Figure 19. Reinforcement schemes for the horsehead roadway.

In order to control the large deformation of the surrounding rock of the horsehead roadway, the roof was reinforced using the prestressed full-length anchoring technique with the innovative anchor-grouting device, and, for the floor, the active and passive reinforcement technology of cables and inverse arch were adopted. The reinforcement scheme is shown in Figure 19.

The roof was fitted with 5 cables, each 21.8 mm in diameter and 7200 mm in length. Each cable was equipped with a set of anchoring devices. The interval and spacing of cables were both 1600 mm. Two MSZ2360 resin agents and one MSK2335 resin agent were used to anchor each cable. The pre-tightening force was not less than 180 kN. The full-length anchorage was achieved by grouting with the anchoring device.

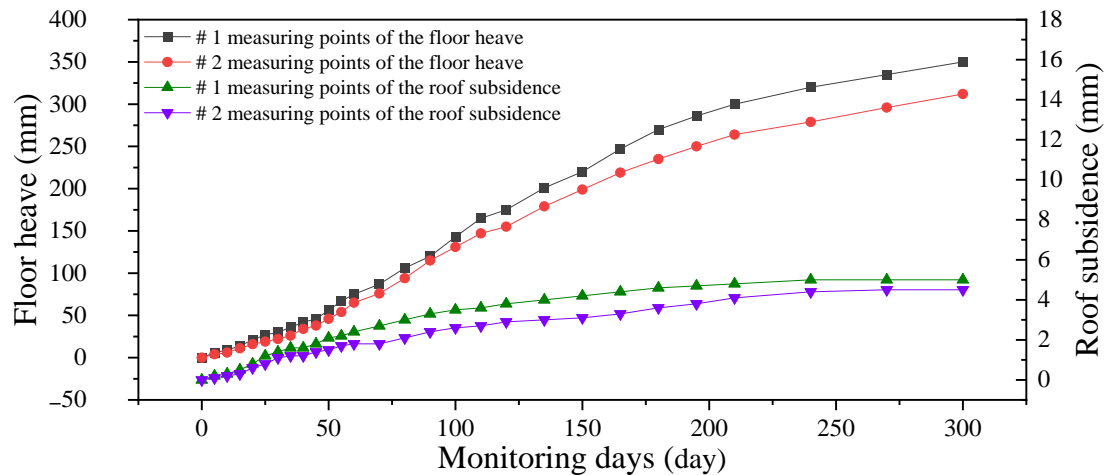
Figure 20. Displacement of the roof and floor of the horsehead roadway.

After the new prestressed full-length anchoring technology was adopted for the mudstone roof, the roof subsidence was only about 5 mm, showing the remarkable control effects of the new prestressed full-length anchoring technology. The reinforcement effect of the horsehead roadway is shown in Figure 21.

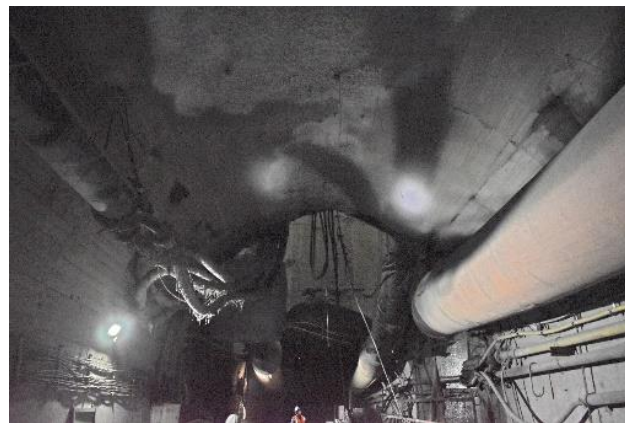
Figure 21. Maintenance of the horsehead roadway.

After being undercover several times, the amount of floor heave increased slowly. Considering the creep and rheological properties of the surrounding rock, after the bottom yard and main roadway are connected, the floor anchor cable and inverse arch active and passive reinforcement technology should be adopted to ensure the long-term stability of the surrounding rock of the floor of the horsehead roadway.
