Article

High-Temperature Tensile Behaviour of GTAW Joints of P92 Steel and Alloy 617 for Two Different Fillers

Abstract: This study explores the high-temperature (HT) tensile rupture characteristics of a dissimilar gas-tungsten-arc-welded (GTAW) joint between P92 steel and Alloy 617, fabricated using ER62S-B9 and ERNiCrCoMo-1 fillers. The high-temperature tensile tests were performed at elevated temperatures of 550 °C and 650 °C. An optical microscope (OM) and a field emission scanning electron microscope (FESEM) were utilized to characterize the joint. The high-temperature test results indicated that the specimen failed at the P92 base metal/intercritical heat-affected zone (ICHAZ) rather than the weld metal for the ERNiCrCoMo-1(IN617) filler. This finding confirmed the suitability of the joint for use in the Indian advanced ultra-supercritical (A-USC) program. The fracture surface morphology and presence of precipitates were analysed using an SEM equipped with energy dispersive spectroscopy (EDS). The appearance of the dimples and voids confirmed that both welded fillers underwent ductile–dominant fracture. EDS analysis revealed the presence of Cr-rich $M_{23}C_6$ phases, which

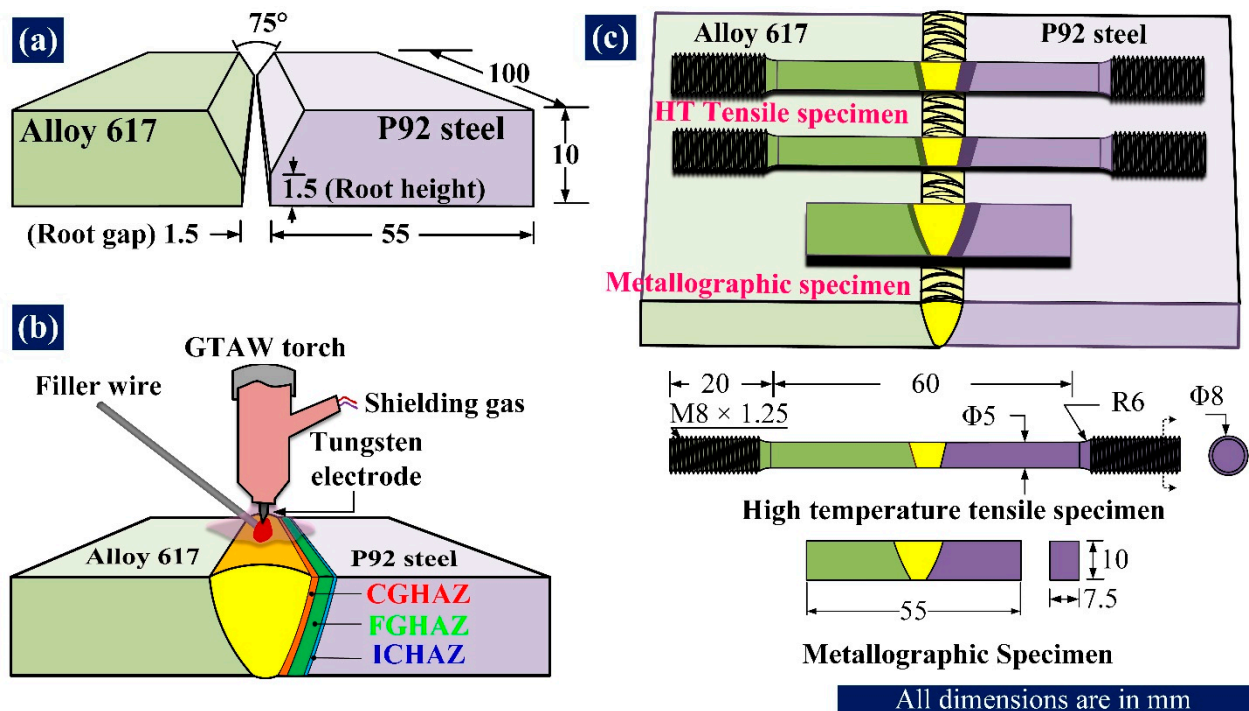
Figure 1. Schematic of (a) V-groove, (b) GTAW joint, (c) Welded plate and extracted samples with dimensions.

For this study, two 10 mm thick plates of P92 steel and Alloy 617 were welded together using the multi-pass gas tungsten arc welding (GTAW) process. The plates were cut and machined into dimensions of 100 mm \times 55 mm \times 10 mm. One side of the plates was machined as per the conventional V-groove of bevel angle 37.5° with a root face of 1.5 mm. All required dimensions related to the groove are illustrated in Figure 1a. Two joints were made: one joint with the P92 filler (ER62S-B9), and the other joint with the

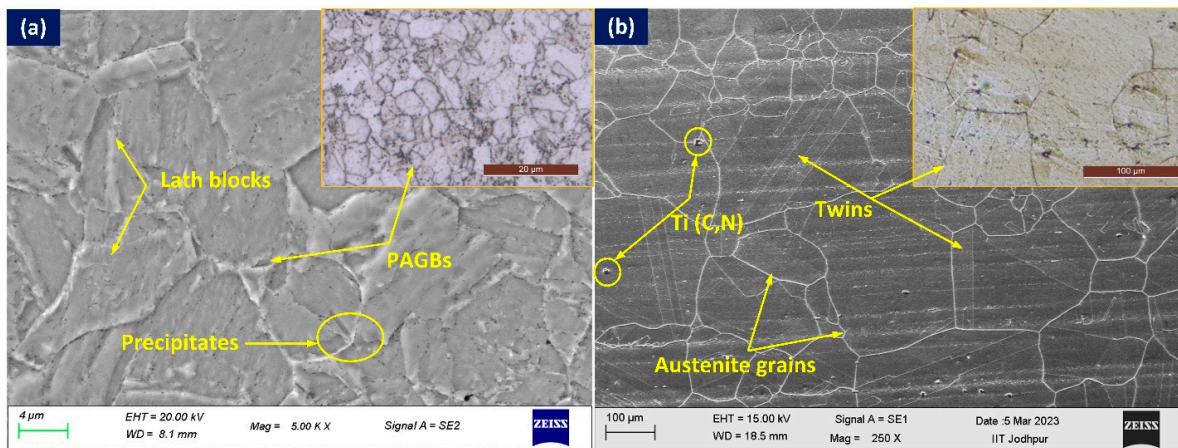
Figure 2. SEM and optical microstructure of (a) P92 steel BM and (b) Alloy 617 BM.

The microstructure of P92 steel BM is depicted in Figure 2a. The tempered martensitic microstructure consists of lath blocks, lath packets, packet boundaries, and prior austenite grain boundaries (PAGBs). The microstructure is strengthened through the presence of Cr, Mo, and W-rich coarse $M_{23}C_6$ precipitates, as well as V and Nb-rich fine MX (X: C, N) precipitates [24,25]. The microstructure of Alloy 617 BM consists of a solid solution that strengthens the matrix of austenite grain (Figure 2b) along with twins and carbides of Cr and Mo ($M_{23}C_6$), Mo-rich (M_6C), and Ti-rich (MX (X: C, N)) [24,25].

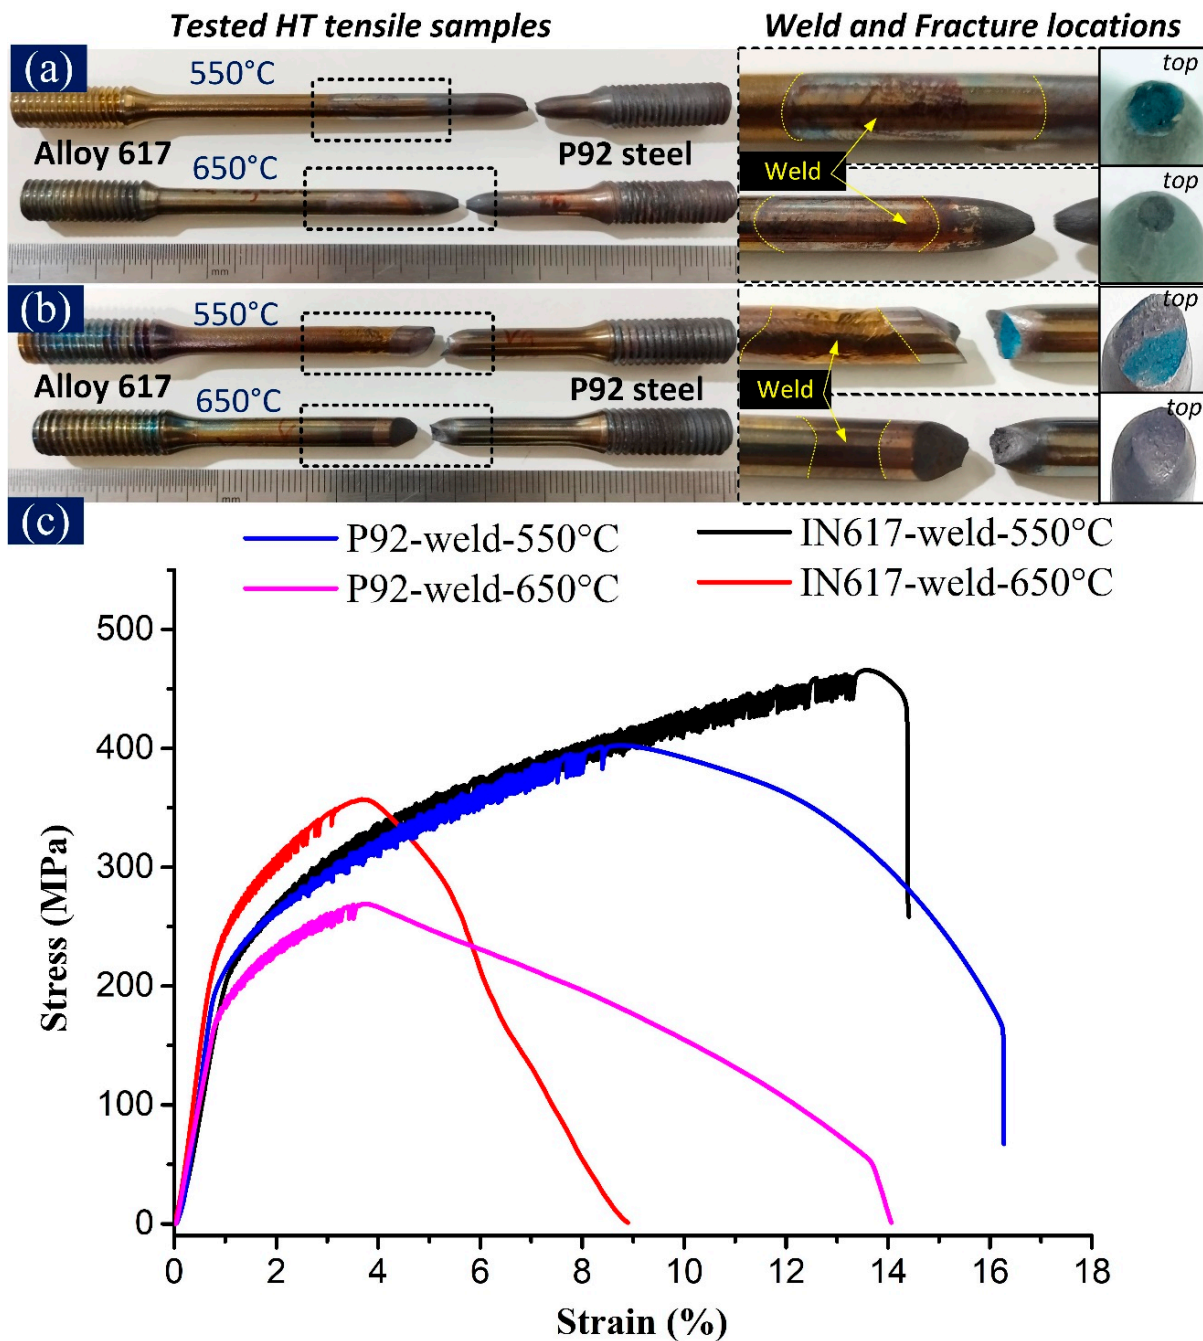
Figure 5. Tested HT tensile samples of (a) P92-weld (b) IN617-weld, and (c) HT tensile stress-strain curves.

The ultimate tensile strength (UTS) of P92 BM was 476 MPa at 550 °C and 319 at 650 °C, respectively. The UTS of the P92-weld-550 °C sample was 402 MPa, which is higher than the UTS (269 MPa) of P92-weld-650 °C. Similarly, the UTS of IN617-weld-550 °C was 466 MPa, which is higher than the UTS (357 MPa) of IN617-weld-650 °C. In another study, the IN617-weld joint of different diameters, the UTS of the welded joint measured 384 MPa and 263 MPa at 550 °C and 650 °C, respectively [23]. Table 1 indicates the UTS, yield strength, percentage elongation, area reduction, and fracture locations of HT tensile samples of the P92-weld and the IN617-weld. At higher temperatures, the thermal energy caused the atoms to vibrate more, which weakened the metallic bonds and resulted in a decrease in the strength and ductility of the material. In all tested samples, the tensile strength at 550 °C was higher than the tensile strength at 650 °C. Rahman et al. [26] and Rao et al. [27] observed curve-maintaining serrated flow behaviour for the strain rate of 10^{-4} orders tested from 600 °C to 800 °C and 300 °C to 700 °C, respectively. Considering the authors' findings, the HT tensile test was performed by keeping the strain rate in the order of 10^{-4} (2.7×10^{-4} /s). When Alloy 617 is tested at a high temperature (>500 °C), the serrated flow is caused by the diffusion of substitutional solute Cr, Co, and Mo atoms into the grains [27], where they interact with dislocations to create strain localization. This strain localization causes the formation of dynamic strain ageing (DSA) serration, which are regions of the material where plastic deformation occurs in a series of rapid bursts. At low temperatures, solute atoms are immobile and do not interact with dislocations. However, at higher temperatures, solute atoms become mobile and can cluster around dislocations,

which results in an increase in dislocation mobility. This, in turn, causes the dislocations to move more easily and interact with the solute atoms, creating strain localization. The strain localization results in a sudden increase in stress, followed by a decrease in stress as the material undergoes plastic deformation. This leads to the characteristic serrated appearance of the stress–strain curve during HT tensile testing. The serrated flow was observed in all welded samples with stress–strain curves tested at temperatures of 550 °C and 650 °C. Rodriguez [28] named this type of serration ‘type C’ serration. Sudden and repeated irregular stress drops below the overall level of the flow curve are regarded as type C serration. In the case of HT tensile testing of the P92-weld, the serrated flow (Figure 5c) was governed by the Alloy 617 side metal. On the other hand, for IN617-weld samples, the Alloy 617 side metal and nickel-based (ERNiCrCoMo-1) weld metal were responsible for the serrated flow behaviour (Figure 5c). The tested tensile samples of both welded samples, IN617-weld and P92-weld, are shown in Figure 5a,b along with the marked fracture location, weld location, and a top view of the fracture location.

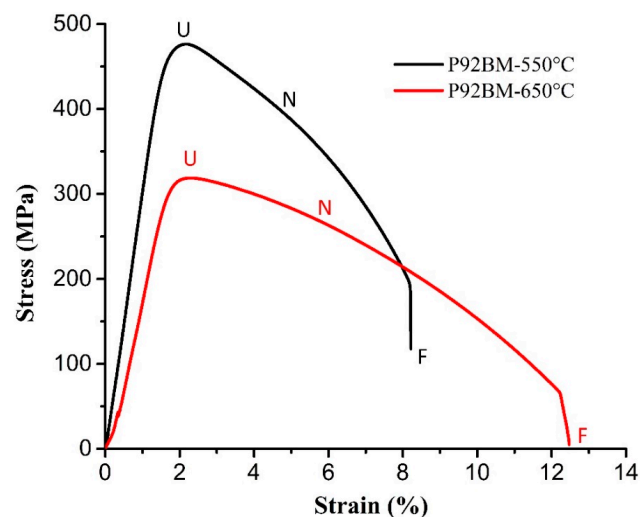
Figure 6. HT tensile characteristic of P92 BM at 550 °C and 650 °C.

Both P92-weld samples failed at the base metal of P92 steel. Thus, emphasis was also given to the stress–strain characteristic of P92 BM at high temperatures, as shown in Figure 6. During HT tensile testing of P92 BM at temperatures of 550 °C and 650 °C, P92 BM underwent work hardening up to point U (UTS point), followed by prolonged and steady softening from point U to N. During the softening stage, the stress decreased, with this reduction being more pronounced for lower strain rates (10^{-4} /s). Once the stress reached point N, a more substantial softening effect occurred, resulting in a change in slope that eventually led to fracture at point F. The material experiences softening at high temperatures, which leads to a decrease in its strength and hardness. This can make the material more susceptible to deformation and failure under stress [22]. The P92-weld sample displayed the same softening behaviour (Figure 5c) as P92 BM (Figure 6), with a softening curve changing the nature at point N, and a slope change up to the fracture point. The shape of the fracture appeared as a cup and cone type of fracture (Figure 7a). The softening stage of IN617-weld-550 °C was the smallest compared to IN617-weld-650 °C. As shown on the graph of IN617-weld-550 °C in Figure 5c, the softening curve (after the UTS point) first displayed ductile behaviour, and then sudden fracture occurred. On the other hand, the IN617-weld-650 °C sample showed smooth and elongated softening behaviour, indicated in Figure 5c. The blue colour in the partial fracture surface is also evidence of the partial brittle fracture in the partial area; an image of the sample is shown in Figure 5b.

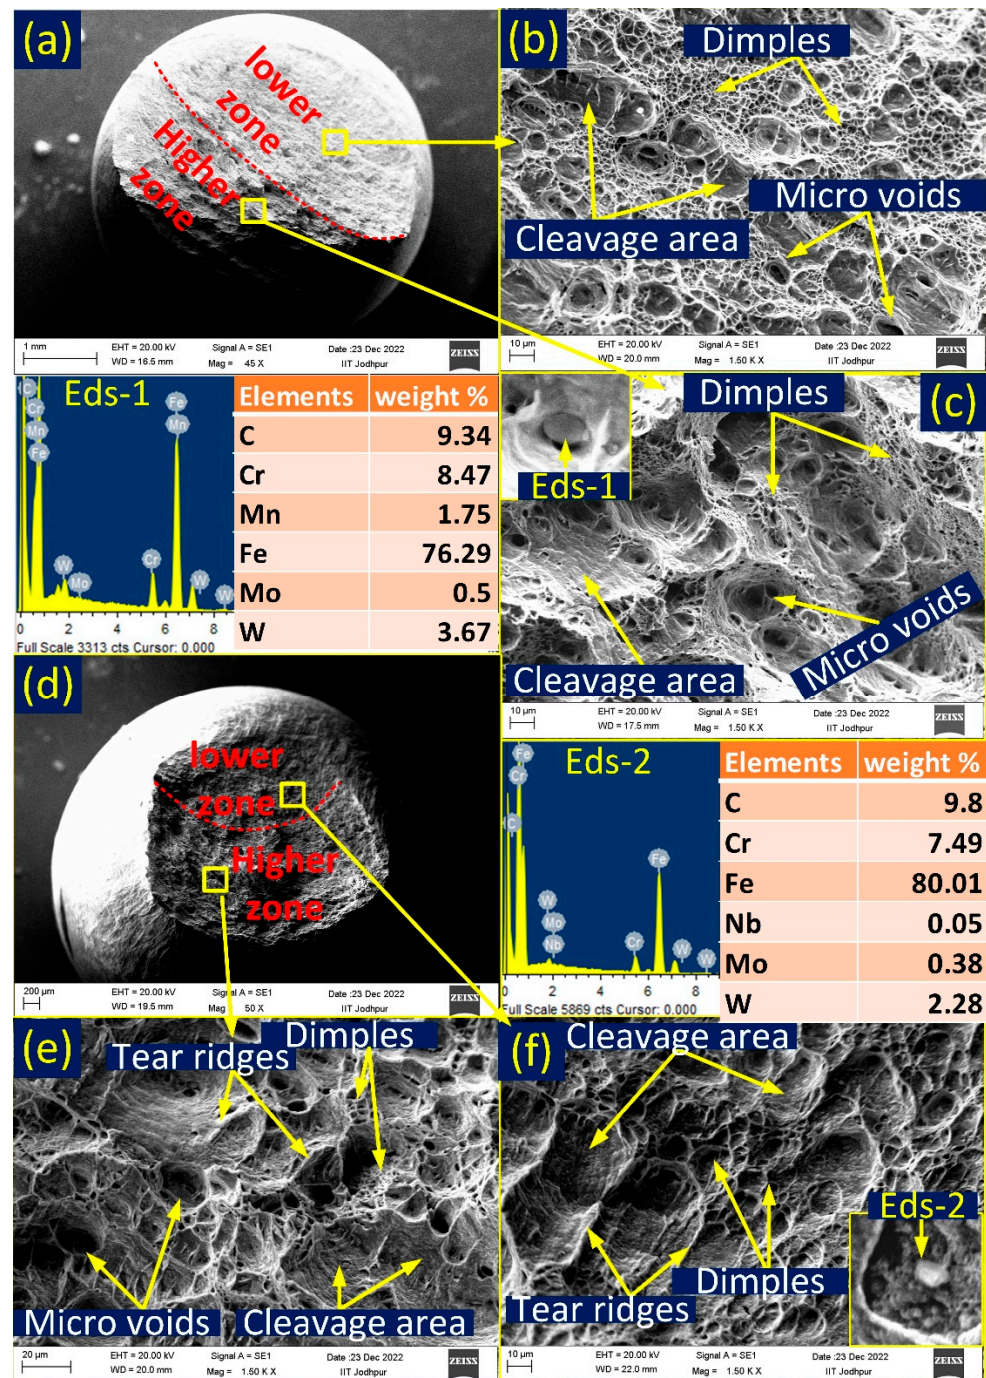
Figure 10. Fractographic SEM images of IN617-weld sample tested at 550 °C (a) top view, (b) lower zone detailed view, (c) higher zone detailed view and EDS of particles; sample tested at 650 °C, (d) top view, (e) higher zone detailed view, (f) lower zone detailed view and EDS of particles.

The fracture morphology of IN617-weld-550 °C and IN617-weld-650 °C samples is shown in Figures 10a–c and 10d–f, respectively. The fracture surface of both samples is divided into two zones: a lower zone and a higher zone. The lower fracture zone of IN617-weld-550 °C indicated a mixed mode (ductile + brittle) of fracture; microvoids, more dimples, and cleavage areas in Figure 10b show evidence of a mixed mode of failure. In the higher fracture zone, (Figure 10c) microvoids, less dimples, and cleavage area indicated a dominated mixed fracture mode. The IN617-weld-650 °C lower fracture zone (Figure 10e) specified shallow dimples and cleavage area, which indicates a brittle fracture mode, but the higher zone showed a mixed mode of fracture with microvoids, deep dimples, and cleavage areas, as evidenced in Figure 10f. From the morphology of the fracture, it can be concluded that the IN617-weld sample shows more ductile behaviour at 550 °C than at 650 °C during a test. It also provided good agreement with the observation made from the stress–strain curve (Figure 5c); the percentage of elongation of IN617-weld-550 °C was higher than the percentage of elongation of IN617-weld-650 °C, as shown in Table 1. The voids are nucleated from the secondary phase’s particles noticed in the fracture SEM images. Point EDS on the particles in the voids confirm the presence of Cr-rich carbide precipitate in the vicinity of voids. EDS-1 and EDS-2 confirm Cr-rich secondary phase presence in the vicinity of large voids seen in fracture images of IN617-weld-550 °C and IN617-weld-650 °C, respectively.

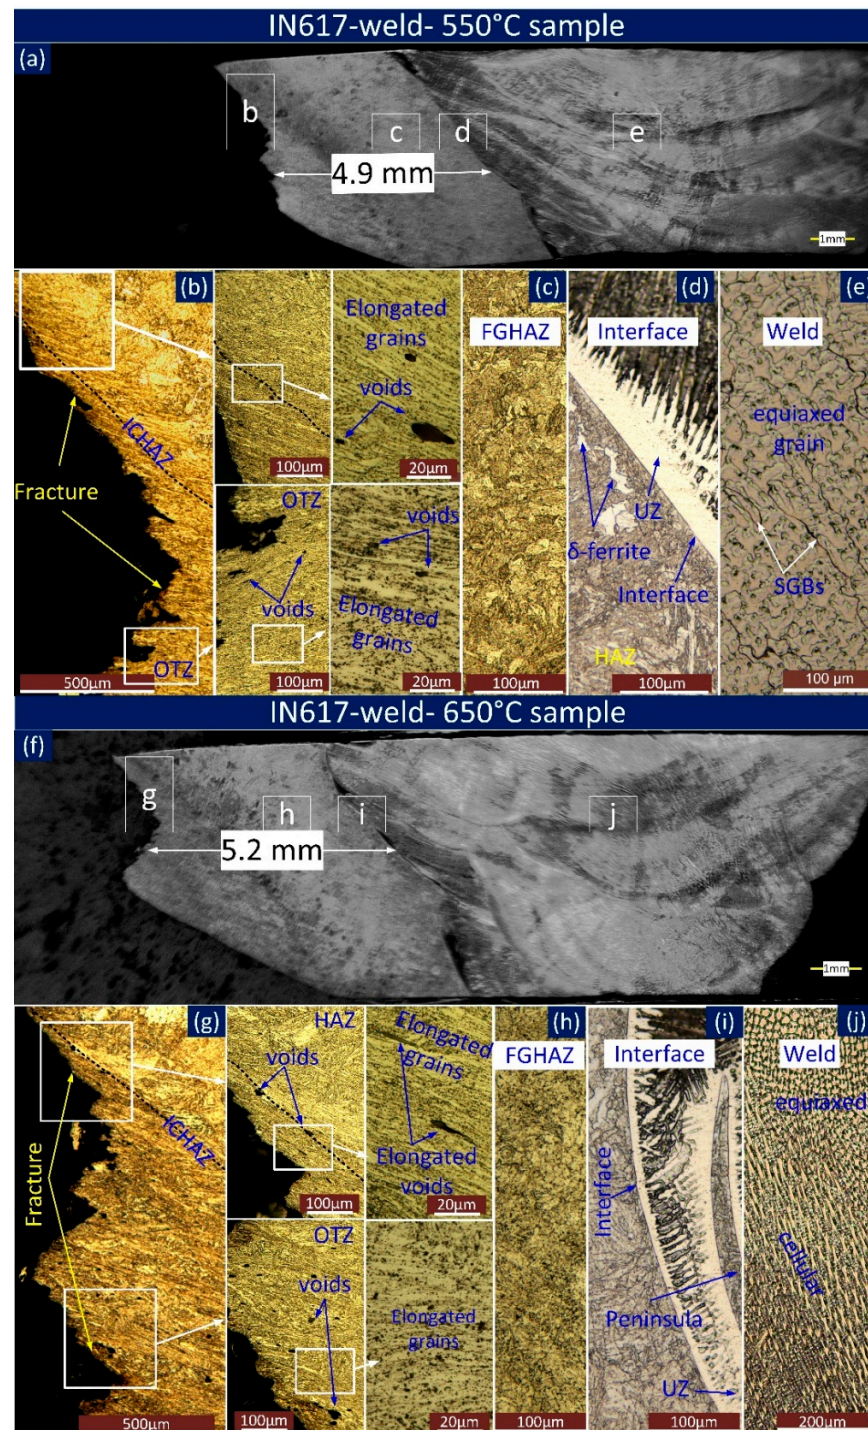
Figure 11. Macrograph and microstructure of longitudinal section of IN617-weld sample. (a) SEM image of fractured specimen IN617-weld-550 °C; optical image of various marked location of (a): (b) fracture tip (c) FGHAZ (d) Interface (e) weld; (f) SEM image of fractured specimen IN617-weld-650 °C; optical image of various marked location of (f): (g) fracture tip (h) FGHAZ (i) interface (j) weld.

An optical light image of the longitudinal section of macroscopic and microscopic characteristics of IN617-weld-550 °C and IN617-weld-650 °C was indicated in Figure 11. The macrograph (Figure 11a,f) indicates the fracture surface was 4.9 mm and 5.2 mm from the respective weld interface of IN617-weld-550 °C and IN617-weld-650 °C, respectively. The large-sized voids were observed just near the fracture location (Figure 11b,g). Near the fracture location, elongated grains and elongated voids were observed and no evidence of appreciable voids or elongation of grain was observed at the HAZ, interface, and weld of IN617-weld-550 °C (Figure 11c–e) and IN617-weld-650 °C (Figure 11h–j). Additionally, the voids and elongated grains seen in the optical image near the fracture are confirmed in the

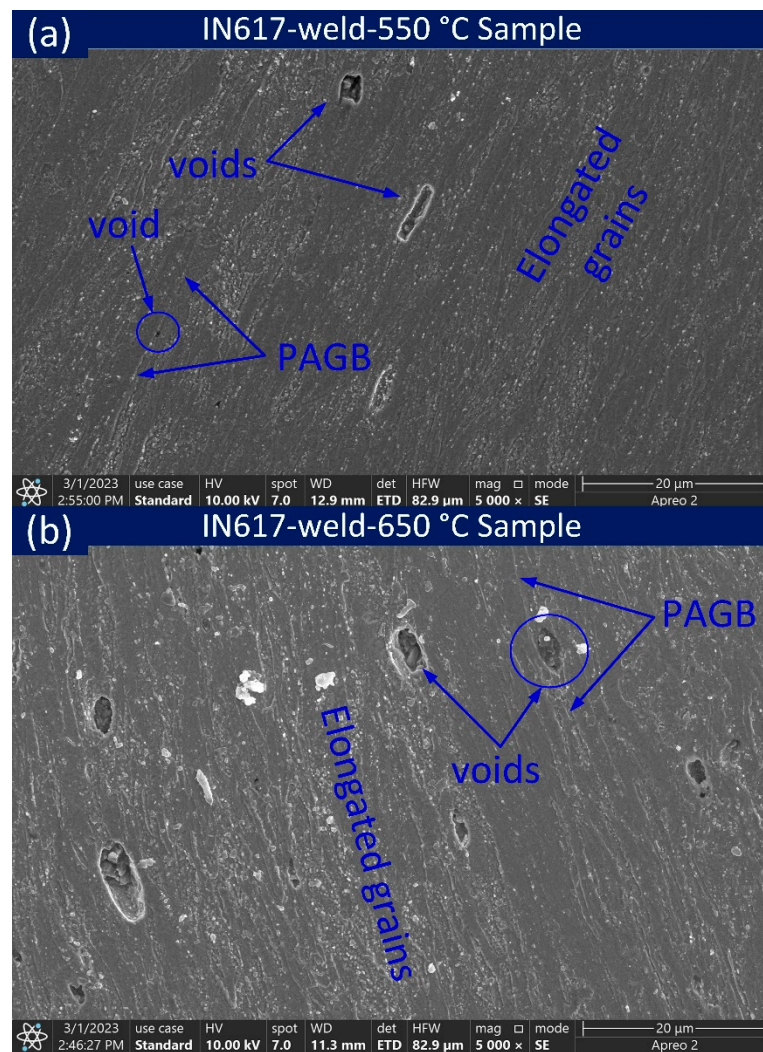
Figure 12. SEM images near fracture location of IN617-weld sample tested at (a) 550 °C and (b) 650 °C.

SEM image. Both coarse and fine voids were observed near the fracture locations. In ICHAZ, near the fracture location, fine voids were observed over the PAGBs, confirmed by the SEM images (Figure 12a) for IN617-weld-550 °C, and for IN617-weld-650 °C, comparatively coarse voids were noticed on the PAGBs (Figure 12b). The microstructure in Figure 12 also illustrated large particles distributed near the voids and along the grain boundaries.
