# Study of the Chlorine Influence on the Corrosion of Three Steels to Be Used in Water Treatment Municipal Facilities

**Abstract:** Many municipal facilities, such as pools and drinking water treatment facilities, are subject to ongoing maintenance due to the corrosion of their metallic materials caused by chlorine, leading to high costs and a possible risk to public health. A proper study of the employed product's effect could lead to the use of better materials, which significantly increase the lifetime of metallic equipment more attacked by corrosion, through studies evaluating their cost-effectiveness. This paper was carried out with the objective of studying the degradation of some metallic materials (AISI 316L, AISI 321 and Duplex 14462) used in the referred facilities in order to select the one that possessed a better behavior. It was observed that the introduction of some more adequate materials can drastically reduce maintenance operations, with Duplex 14462 showing the best results, ideal for greater chlorine concentrations, followed by AISI 321, which may be employed for components in less contact with chlorine, since it is more easily affordable.

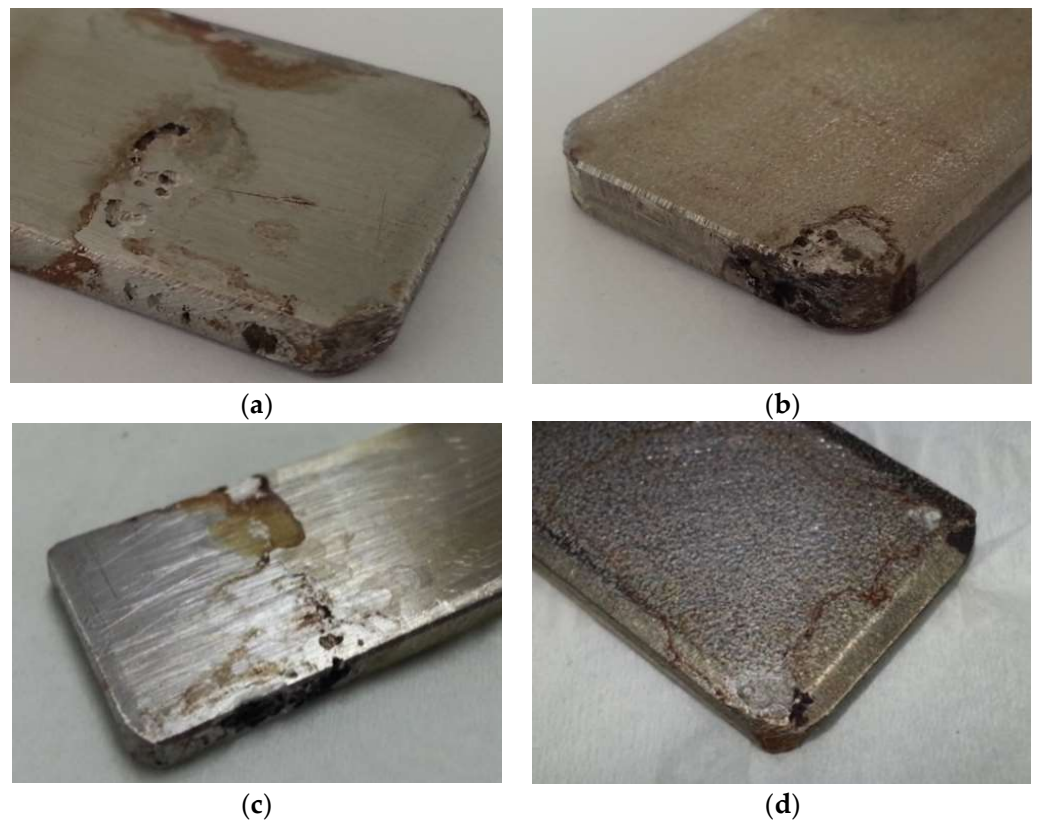
Figure 1. Dry samples of AISI 316L and AISI 321 after three weeks (a,b) and three months (c,d).

After three weeks of being immersed, the solutions changed in coloration to a pale yellow, a phenomenon that is explained by the beginning of the corrosion in the materials. Although the Duplex 14462 did not show any signs of being affected by the NaClO, the AISI 316L and AISI 321 have shown visible signs of accentuated corrosion, as well as a significant amount of corrosion product in the bottom of the containers. The samples were then removed from the vessels and washed. Afterwards, a visual evaluation was carried out, revealing localized pitting, as seen in Figure 1a,b.

After three months, the Duplex 14462 remained unaltered, presenting a great resistance to corrosion. On the other hand, the two stainless steels presented a greater advance in the degradation in comparison with the three weeks of immersion, as observable in Figure 1c,d, showing the other side of the samples, which was perfectly clean before.

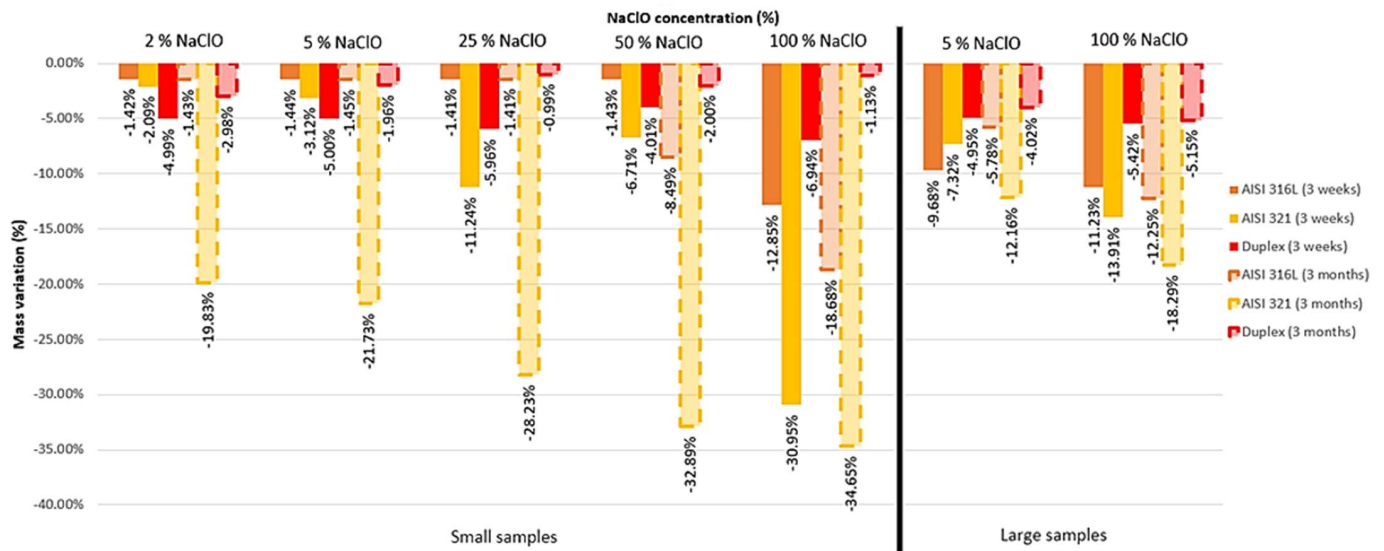
Figure 2. Mass variation of all the samples after three weeks and three months of immersion.

In Figure 2, the mass change suffered by the small and large samples after three weeks and three months is presented.

After three weeks of immersion, by analyzing the small samples, it can be concluded that there was a greater variation in mass for 25% and 100% NaClO, the latter being more accentuated, which proves that a high concentration of the disinfection solution causes greater corrosion. The AISI 321 stainless steel was the one that lost more mass, and the Duplex 14462 was the least affected by the degradation and, therefore, the one that reacts better to the attack. On the other hand, after three months, as the NaClO concentration increased, the mass loss of the AISI 321 became greater, which was strongly affected by the corrosion. The AISI 316, despite having higher strength, also showed significant mass

loss. Only the Duplex 14462 showed good resistance to degradation, having registered a reduced mass variation better than that after three weeks of immersion.

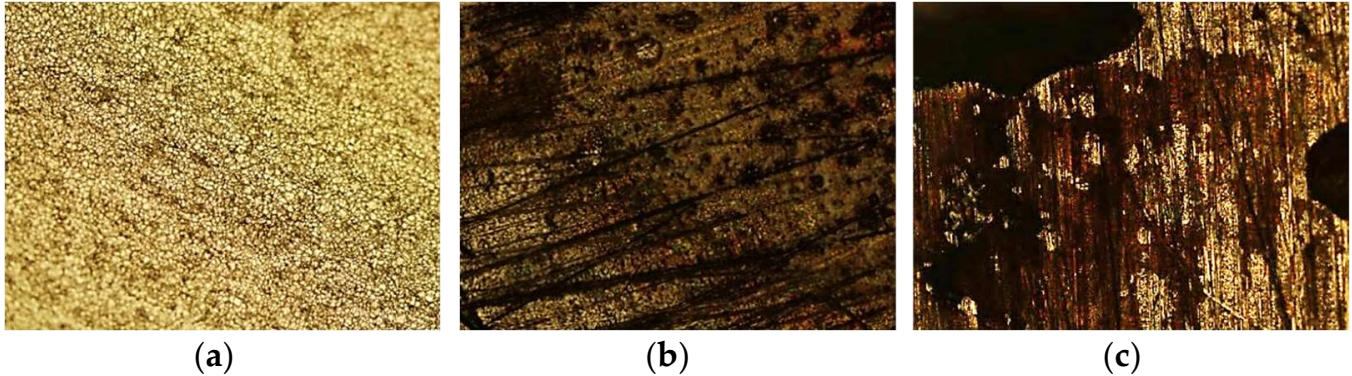
**Figure 3.** Optical microscope images of the AISI 316L samples at a magnification of  $50\times$ : (a) before immersion, (b) after three weeks, (c) after three months.

Figure 3 shows the AISI 316L sample, with a  $50\times$  magnification, without having been in contact with the solution (a), after three weeks (b) and after three months (c).

In Figure 3a, it is possible to observe the grains of the sample, as well as the absence of degradation. In (b), the appearance of dark areas is evident, resulting from the beginning of the corrosion process, which increases drastically in (c), after three months, with a corroded area in the upper-left corner of this image that started as small cracks and evolved until the visible size.

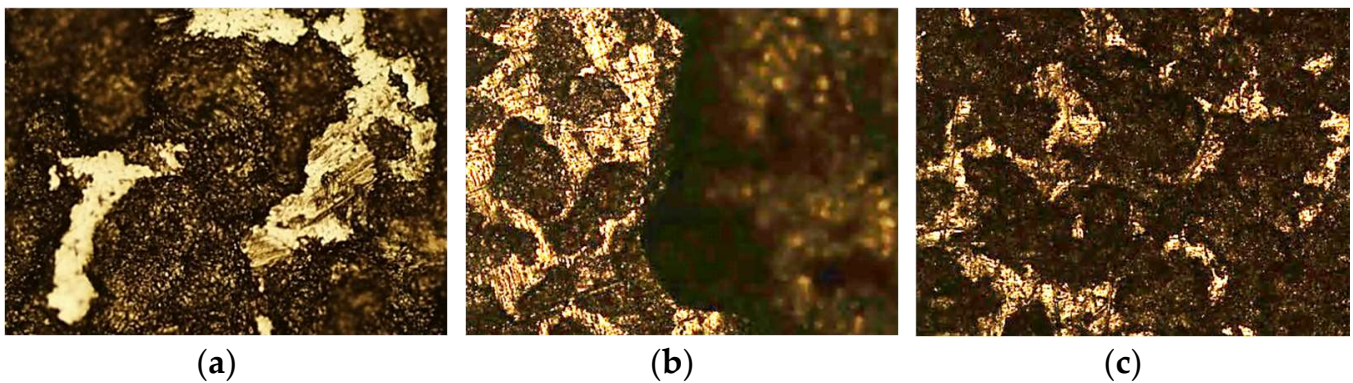
**Figure 4.** Optical microscope image of the AISI 321 sample at a magnification of 50×: (a) before immersion, (b) after three weeks, (c) after three months.

In Figure 4, it is possible to observe the AISI 321 sample, with a  $100\times$  magnification, before immersion (a), after three weeks (b) and after three months (c).

Contrary to the previous stainless steel, the AISI 321 before immersion (a) presents more areas of dark coloration than the white ones, indicating the presence of some oxides in the sample. In image (b), after three weeks, a high corrosion level is visible, with its right side completely degraded. After three months (c), the dark areas increased in size and became more blurred, a distinct sign of the greater level of corrosion, started by pitting.

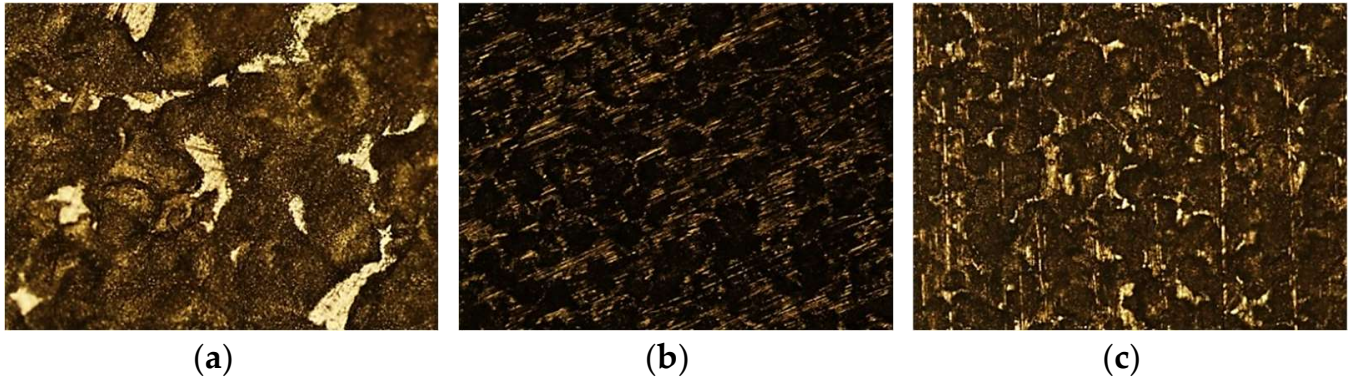
**Figure 5.** Optical microscope image of the Duplex 14452 sample at a magnification of 100×: (a) before immersion, (b) after three weeks, (c) after three months.

The Duplex 14462, also with a 100× magnification, had a better behavior than the first two alloys; however, the chlorine's effect can be observed. Figure 5 shows the sample before contact with the solution (a), after three weeks (b) and after three months (c).

With a microstructure comparable only to the AISI 321 before the immersion, as seen in Figure 5a, after three weeks, the Duplex 14462 shows darker areas, whereas previously, there were clear interstices, which constitute evidence of the beginning of the degradation process; however, these are not intense. Even after three months, the Duplex 14462 presents a much better result than the previous steels, indicating that, among the three, it has the best resistance to the corrosion effect of the NaClO solution.

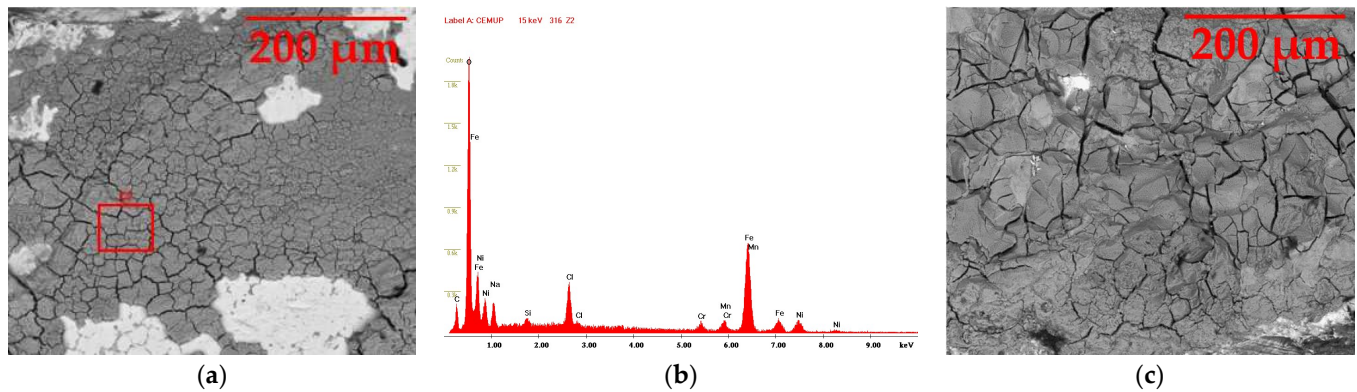
**Figure 6.** SEM image of the AISI 316L sample at a magnification of 500 $\times$ : (a) after three weeks, (b) EDS of the red zone in the first image and (c) after three months.

The AISI 316L stainless steel sample in the SEM is presented in Figure 6 at a 500 $\times$  magnification in two situations: after three weeks of immersion (a) and after three months of immersion (c). Image (b) shows the EDS graphic of the zone in the red square in (a) and can be consulted in Figure A2.

In image (a), the majority of the sample's surface is covered in cracks, which is representative of the start of its degradation. In spite of this, there are also some white-colored areas, which means that not all of the metal was affected by the solution. As for the chemical composition, the white areas, which were less affected, kept small amounts of iron, chromium and nickel, as they reacted with the oxygen and formed a protective layer of chromium oxide, as visible in image (b). Nevertheless, no traces of molybdenum nor magnesium were found, since they were destroyed with the NaClO. In addition, the grey area shows traces of oxygen, due to the corrosion, as well as sodium and chlorine from the solution. On the other hand, in image (c), there are almost no white areas, as the corrosion was more advanced, which is also visible through the increase in the cracks' size, indicative of a higher state of corrosion after three months.

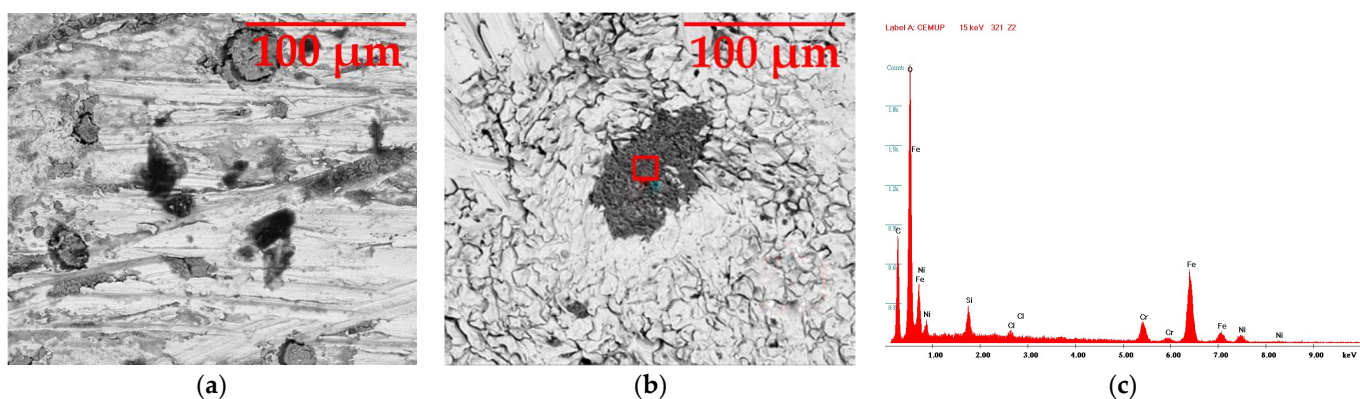
**Figure 7.** SEM image of the AISI 321 sample with 1000 $\times$  magnification: (a) after three weeks and (b) after three months. (c) EDS image of the red zone in the second image.

Figure 7 shows the AISI 321 stainless steel sample in the SEM with 1000 $\times$  magnification in two situations: after three weeks (a) and after three months of immersion (b). In the second image, the corrosion effect was greater, as visible through the increase in the circular pitting size and the darker color in its center. Image (c) shows the EDS graph of the darker area of image (b), highlighted through a red square and present in Figure A3.

In contrast to the AISI 316L, the AISI 321 stainless steel presented more distinct signs of corrosion already after three weeks (image (a)), proving its lower resistance to degradation. The irregular darker circles mean that, in this steel, the corrosion has propagated in the form of pitting, unlike the cracks in the previous one. In image (b), the evolution of the corrosion is highlighted, with the circular zones which started as pitting having increased in their dimensions, visible through the dark area in the center, as well as developed fissures in the surrounding zones, an additional defect. The dark area, as seen in image (c), possesses constituents such as oxygen and chlorine, representative of the corrosion, and the white area, although having been less affected, also has some of these chemical elements but also maintains several of the initial constituents: iron, chromium and nickel.

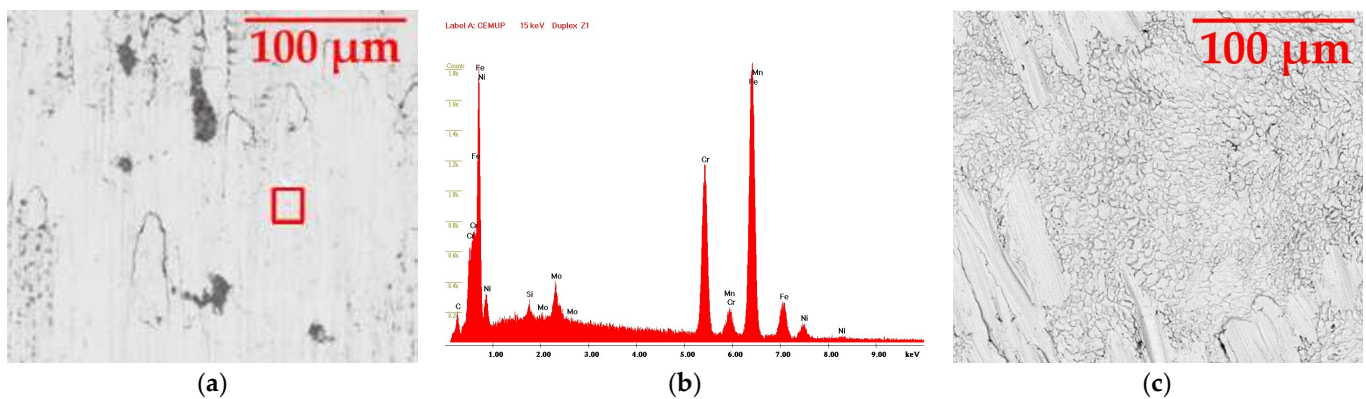
**Figure 8.** SEM image of the Duplex 14462 sample: (a) after three weeks with 500 $\times$  magnification, (b) EDS of the red zone in the first image and (c) after three months with 1000 $\times$  magnification.

The Duplex 14462, on the other hand, presents a completely different result from the previous two samples; it is much more resistant to corrosion caused by the chlorine. Figure 8 represents the sample with a 500 $\times$  magnification after three weeks of immersion (a) and with a 1000 $\times$  magnification after three months of immersion (c). Different magnifications were used to observe the influence of the chlorine in more detail. Image (b) shows the EDS graph of the red-highlighted zone in image (a), which can be consulted in more detail in Figure A4.

The Duplex 14462 samples confirm what had already been demonstrated by optical microscopy: this material had a superior corrosion resistance compared to that of the other two; however, it still had some small grey zones affected by the solution, as seen in image (a), with the predominance of oxygen and chlorine, the origin of the corrosive attacks. Nevertheless, the white areas, making up the majority of the image, kept the concentrations of chromium, nickel and molybdenum present in image (b), showing that there was no deterioration. Image (c) corroborates the practical immunity of the Duplex 14462, with only some scratches on its surface, caused during the cleaning stage.

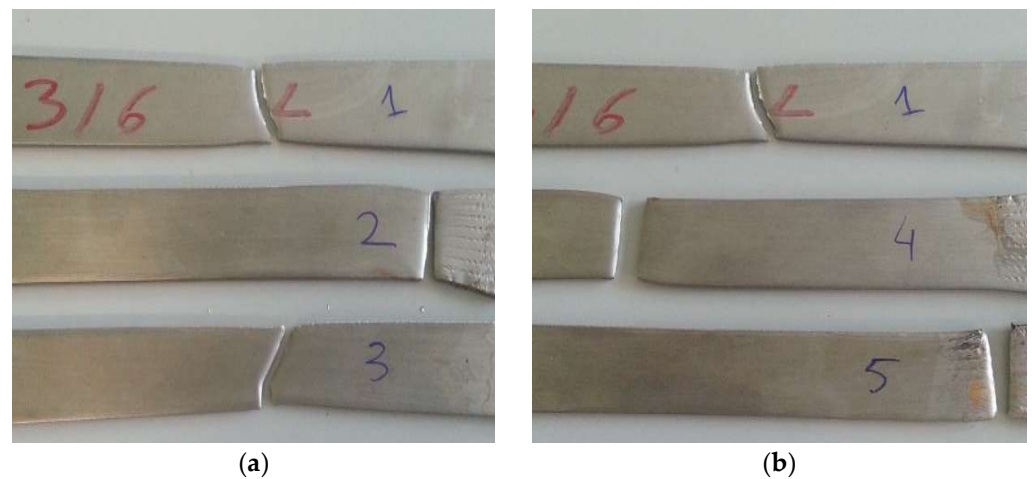
**Figure 9.** AISI 316L samples at three weeks (a) and three months (b) following the tensile test.

In Figure 9, the AISI 316L samples are shown after the tensile test, with the standard at the top, that immersed in 5% NaClO at the center and that immersed in 100% NaClO at the bottom, at three weeks (a) and three months (b) of immersion.

After three weeks (a), the standard specimen and the one immersed in 100% NaClO ruptured approximately in the same zone, in the center, while the specimen immersed in 5% NaClO ruptured near the clamping area of the clamps of the testing machine. On the other hand, after three months, both samples in contact with NaClO ruptured near the clamping of the test machine claws, a fact explained by a significant difference in the cross-sectional area near the rupture zone, due to the corrosion suffered. The standard did not show this behavior, presenting a uniform cross-sectional area throughout its length. In the first case, the third sample presented a rupture similar to the standard one.

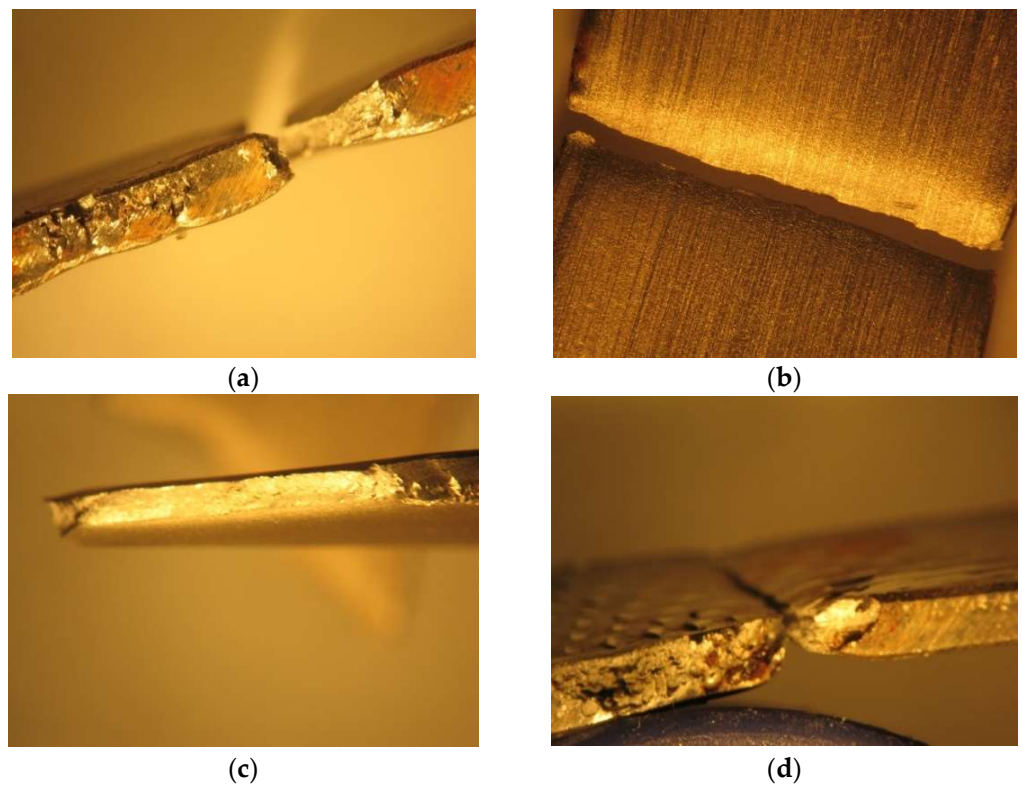
**Figure 10.** Fracture cross-section of the AISI 316L samples immersed in 5% NaClO and 100% NaClO for three weeks (a,c) and three months (b,d).

Figure 10 highlights the fracture zone of the samples immersed in 5% NaClO and 100% NaClO after three weeks ((a) and (c)) and three months ((b) and (d)).

The sample immersed in 5% NaClO for three weeks (a) presents corrosion in its lateral area, a factor that reduced the strength of the material in this region, leading to its failure closer to the clamping zone. In spite of this, after three months (c), the same sample shows no corrosion in the useful area subjected to traction, meaning that this only occurred in its exterior. As for the sample in 100% NaClO, in both cases, the rupture occurred near their edge, since these were more affected by the chlorine. After three weeks (b), no corrosion is found in the useful area subjected to traction; however, after three months (d), a pitting corrosion is clearly observable.

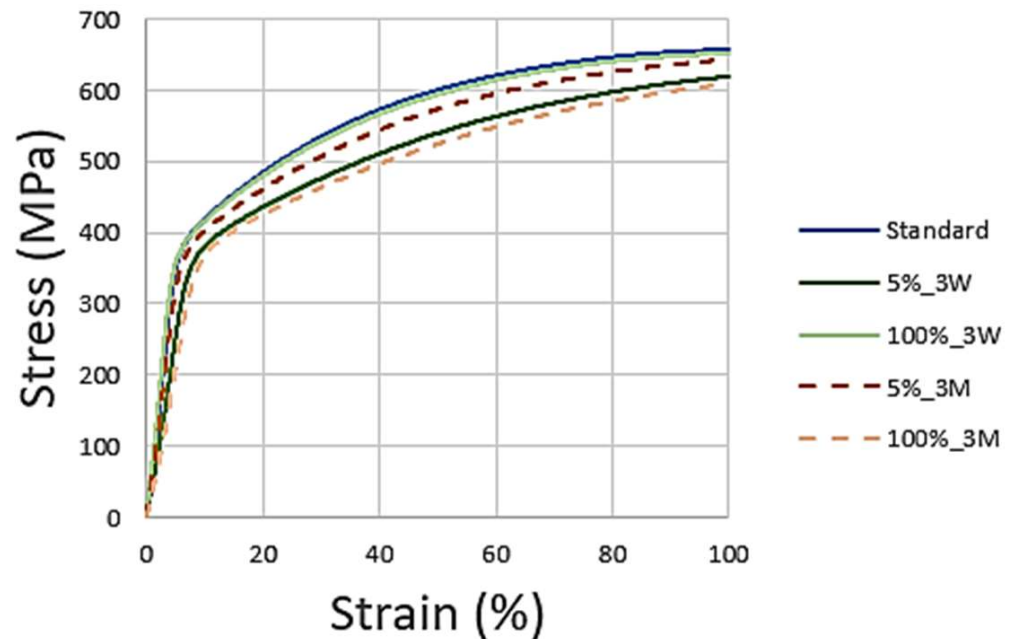
Figure 11. AISI 316L stress–strain curves after three weeks and three months.

Figure 11 presents the stress–strain curves for all the AISI 316L samples.

The AISI 316L presented signals of a decrease in its mechanical resistance to traction due to the NaClO effect. As expected, the standard specimen was the one with the best mechanical resistance, and the one immersed in 100% NaClO for 3 months had the worst result. The specimen at a 100% concentration for 3 weeks showed better mechanical resistance than the one at 5% for 3 months, suggesting that, in this material, the exposure time has more influence than the concentration of the reagent.

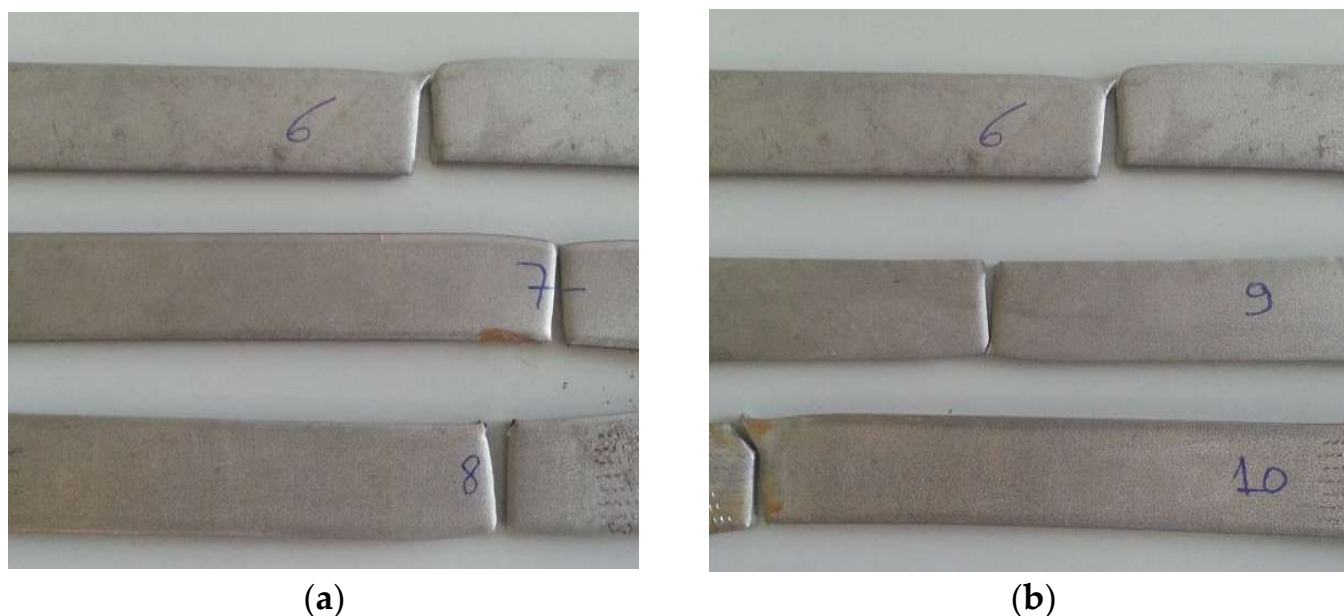
**Figure 12.** AISI 321 samples at three weeks (a) and three months (b) after the tensile test.

As for the AISI 321, Figure 12 shows the three specimens at three weeks (a) and three months (b) after the tensile test: standard sample at the top, 5% NaClO in the middle and 100% NaClO at the bottom.

After three weeks (a), although the failure suffered by the two samples immersed in sodium hypochlorite was not exactly in the same place, it was in the same region, i.e., near the clamping area of the clamps of the testing machine. As for the standard sample, it broke closer to the center, but there is not much difference between the three. In the samples after three months (b), while the standard broke in the central area, the 100% NaClO one broke near the edge, showing signs of corrosion in that region, which reduced its mechanical strength. The 5% NaClO sample fractured in an intermediate zone between the other two, but closer to the center, indicating that it was not so affected by corrosion.

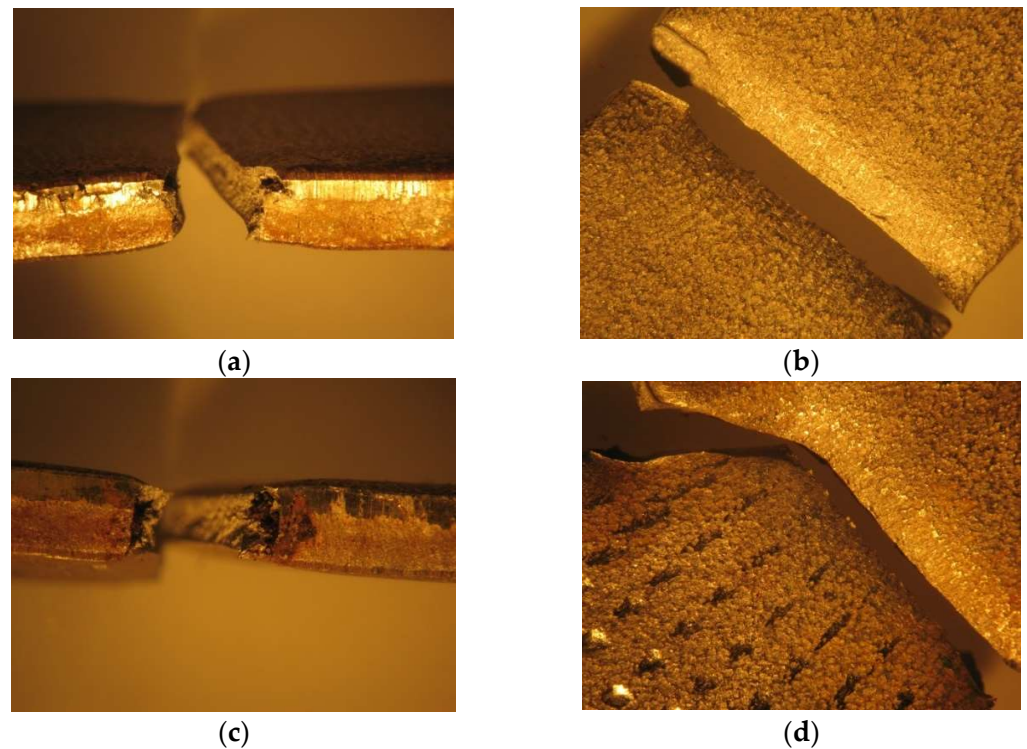
**Figure 13.** Fracture cross-section of the AISI 321 samples immersed in 5% NaClO and 100% NaClO for three weeks (a,c) and three months (b,d).

In Figure 13, the detail of the rupture zone in the two immersed samples is shown: 5% NaClO and 100% NaClO after three weeks ((a) and (c)) and three months ((b) and (d)).

The results for the three-weeks sample are similar to those of the AISI 316L, since the 100% NaClO sample (c) suffered more corrosion due to the higher concentration, but the 5% NaClO sample (a) was not immune either, because the rupture occurred near the end of the specimen. For the three months, the 5% NaClO (b) did not present visible signs of corrosion in the fracture zone, which was linear, but as this occurred somewhat away from the center, there was some degradation, although not significant. The 100% sample (d), on the other hand, presents a non-linear rupture, with visible signs of degradation.

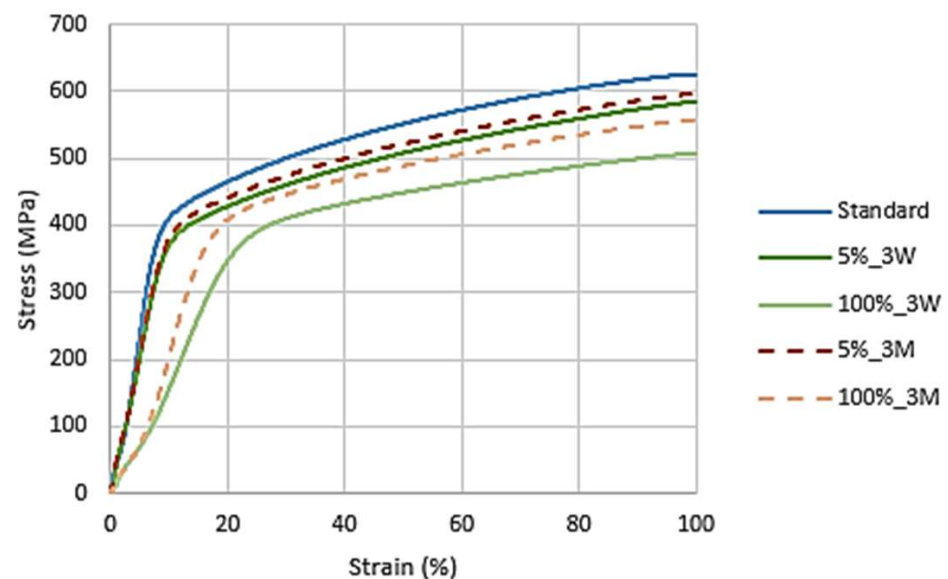
**Figure 14.** AISI 321 stress–strain curves after three weeks and three months of immersion.

Figure 14's graph represents the stress–strain curves for all the AISI 321 samples.

Similar to what happened in the previous material, the AISI 321 also showed signs of a mechanical traction resistance decrease due to the effect of NaClO. As expected, the standard was the specimen that presented the best mechanical resistance, and the ones immersed in 100% NaClO had the least favorable results.

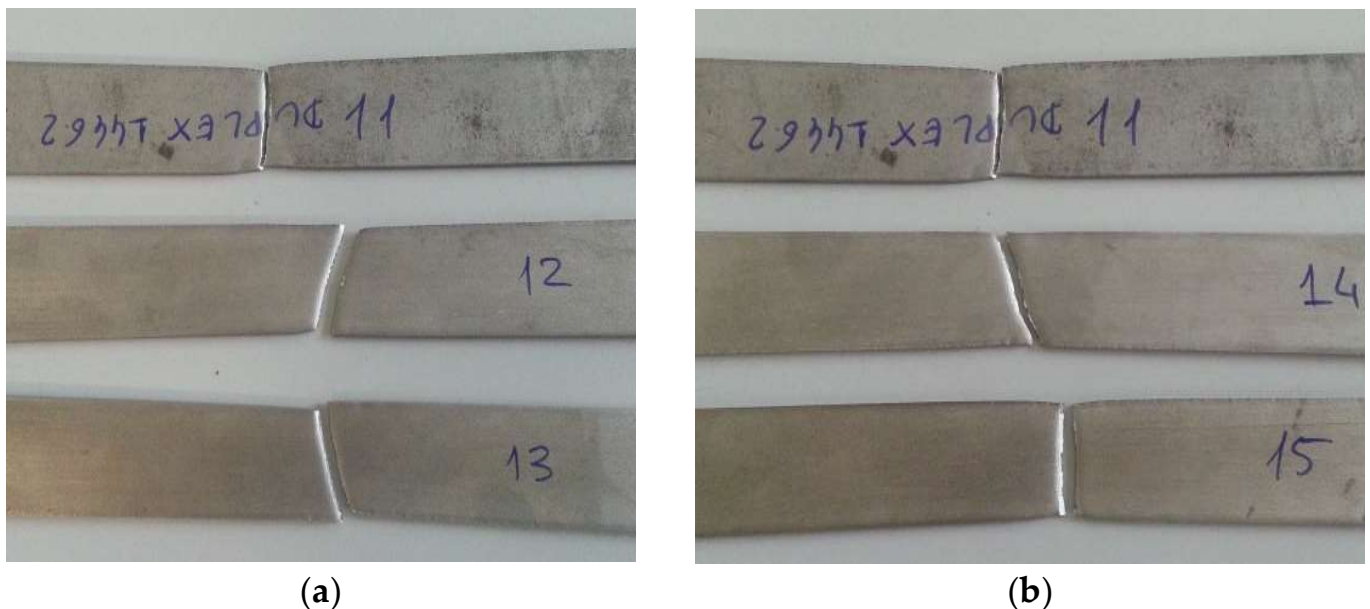
**Figure 15.** Duplex 14462 samples after three weeks (a) and three months (b) of being subjected to the tensile test.

The Duplex 14462 samples after the tensile test are presented in Figure 15. The standard sample is at the top, that immersed in 5% NaClO is at the center and that immersed in 100% NaClO is at the bottom, at three weeks (a) and three months (b) of immersion.

In contrast to the first two alloys, in this case, the samples broke in the same zone, their center, confirming that the solution almost did not influence the Duplex 14462's properties, disregarding the concentrations used or the immersion times.

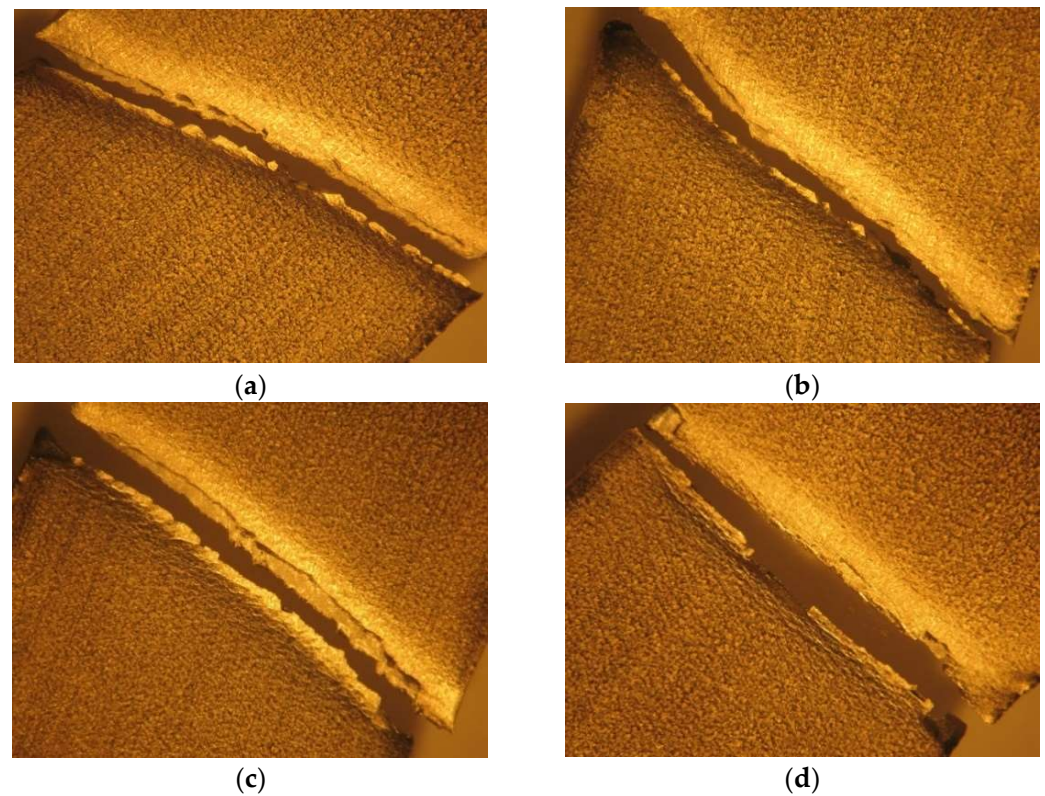
**Figure 16.** Detail of the fracture zone of the Duplex 14462 samples immersed in 5% NaClO and 100% NaClO for three weeks (a,c) and three months (b,d).

In Figure 16, the fracture zone of the samples immersed in 5% NaClO and 100% NaClO after three weeks ((a) and (c)) and three months ((b) and (d)) are presented.

As can be seen, the two samples in both cases show a similar fracture between each other and compared to the standard one, showing no evidence of corrosion in the useful areas of rupture and, therefore, maintaining the strength of the material. This is also observed in Figure 17, showing the stress–strain curves of the tensile tests. Only the sample immersed in 100% NaClO for three months (d), which had the most extreme conditions of the four shown, has a slight wear of the material in the fracture zone.

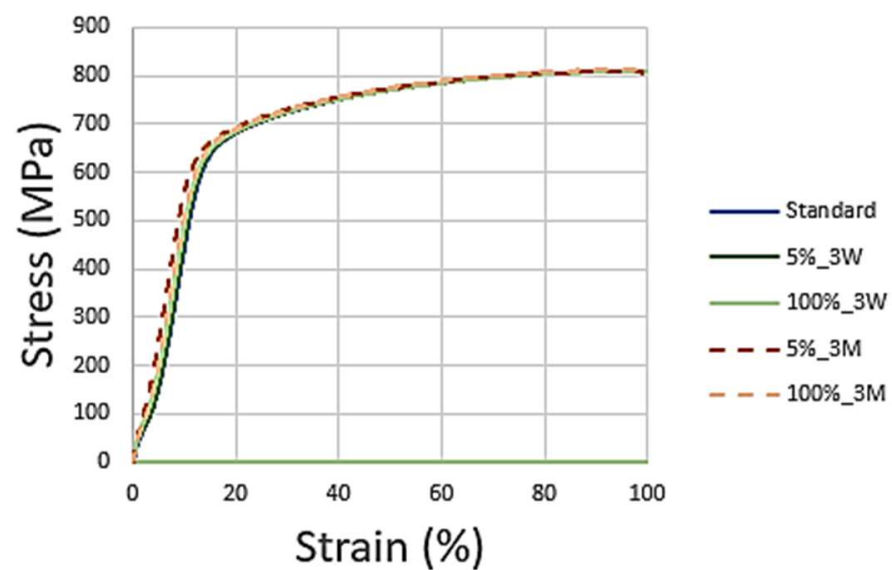
**Figure 17.** Duplex 14462 stress–strain curves after three weeks and three months.

The mechanical resistance to the traction of Duplex 14462 showed no signs of decrease, with the curves of the tests overlapped with the standard, corroborating the previous results obtained, such as the reduced mass variation of this material. This indicates that the referred material showed negligible corrosion degradation in the most aggressive conditions tested: 100% NaClO after three months of immersion.

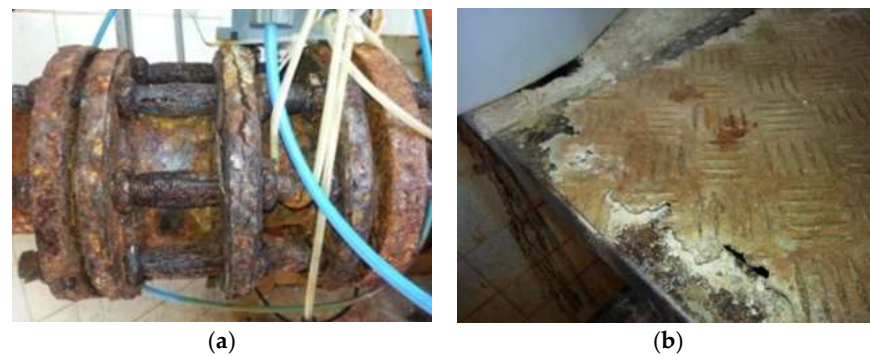
**Figure A1.** Joint screws on the reservoir water inlet pipe (a) and reservoir floor (b) uniform corrosion and in the form of cracks in the municipal facilities.

In municipal facilities, several cases of the deterioration of metallic materials due to chlorine were found, such as pipe joints screws (Figure A1a), pipes, water analyzer support panels, electrical components, valves, pipe supports, equipment and even certain reservoirs accesses (Figure A1b) involving many corrosive processes, which varied according to the NaClO concentrations used. In most cases, if this deterioration had been properly considered at the design stage, and if certain construction details had been taken into account, without necessarily implying an increase in cost, the corrosive attacks could have been avoided or at least minimized. In many cases, the studies consider the compatibility of the material and environment but often disregard possible operational or environmental changes. All these corrosive attacks checked to date show that even materials with higher costs are not immune to corrosion when they are not best suited for the purpose.

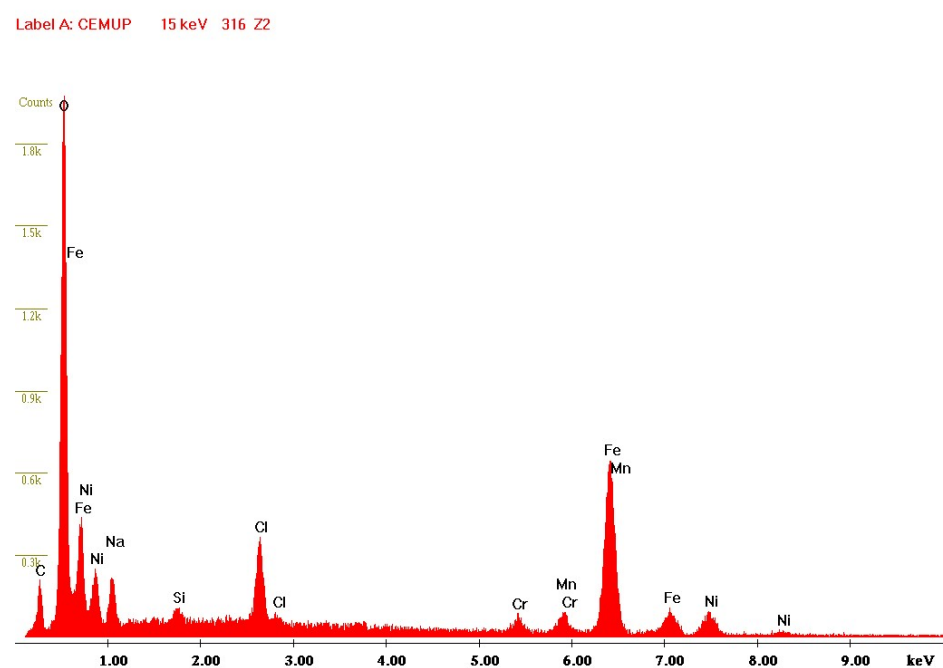
**Figure A2.** EDS of the red zone in the first AISI 316L SEM image.

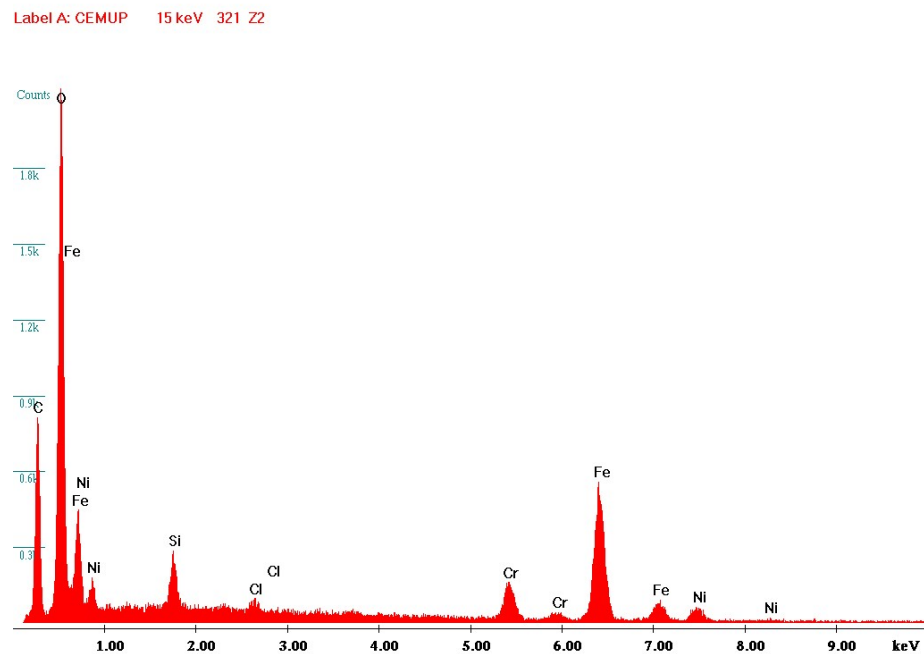
Figure A3. EDS of the red zone in the second AISI 321 SEM image.

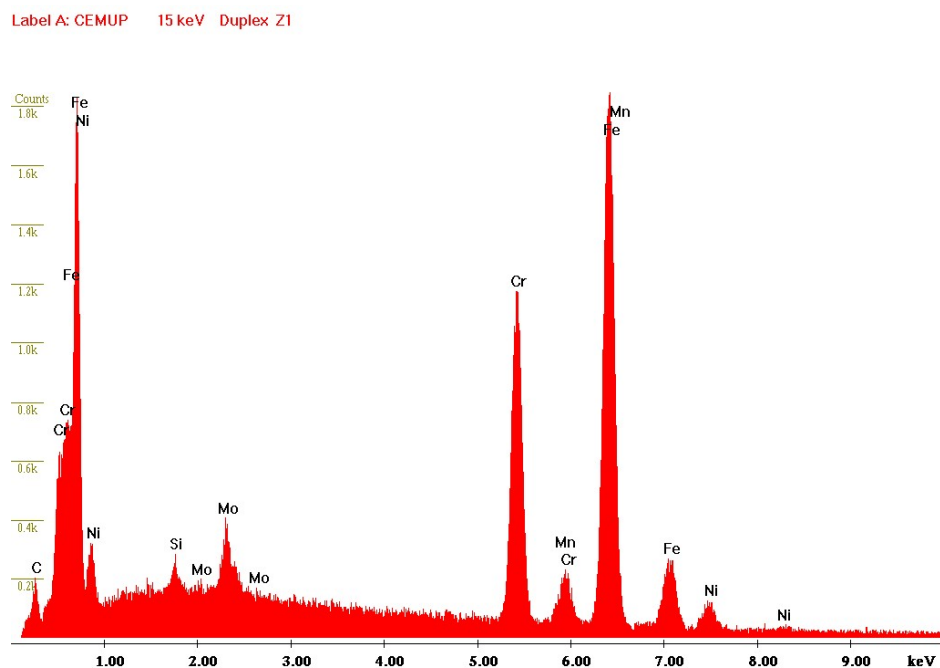
Figure A4. EDS of the red zone in the first Duplex 14462 SEM image.
