# Effect of Salt Solution Erosion on Mechanical Properties and Micropore Structure of Recycled Fine Aggregate ECC

**Keywords:** engineered cementitious composite; recycled fine aggregate; salt solution erosion; mechanical properties; pore microstructure

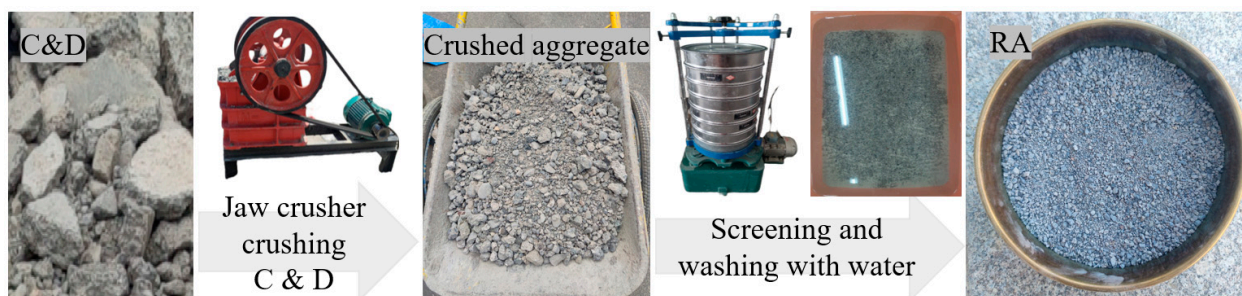
Figure 1. Recycled Fine Aggregate Preparation.

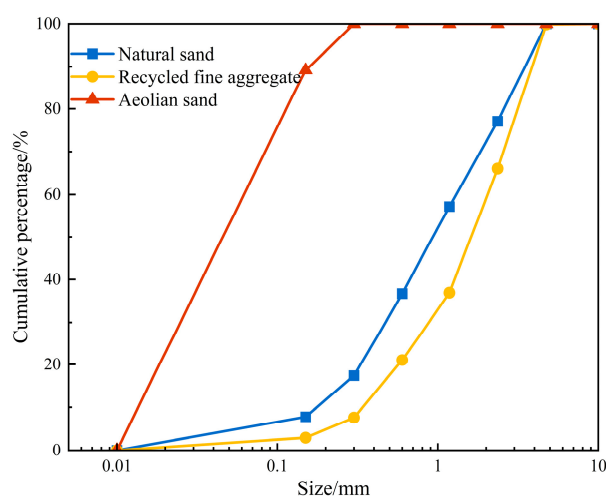
Figure 2. Cumulative curve of grain size grading.

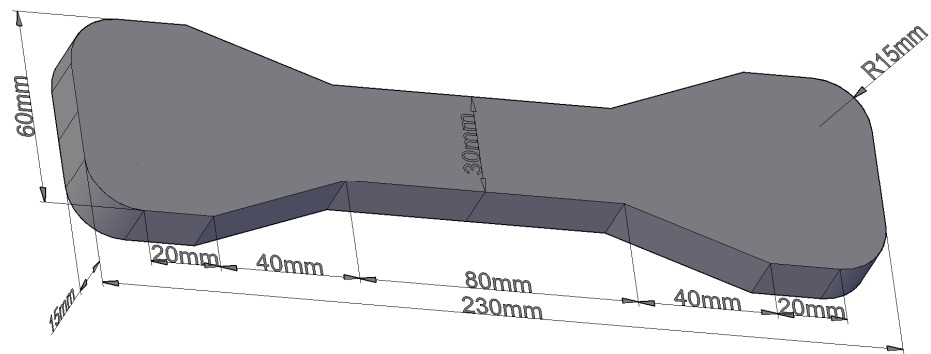
**Figure 3.** Bone-type specimen schematic diagram.

RAECC bone-type specimens (Figure 3) with dimensions of 230 mm × 60 mm × 15 mm were fabricated for uniaxial tensile testing, and RAECC prismatic specimens with dimensions of 400 mm × 100 mm × 100 mm were fabricated for resonance frequency determination.

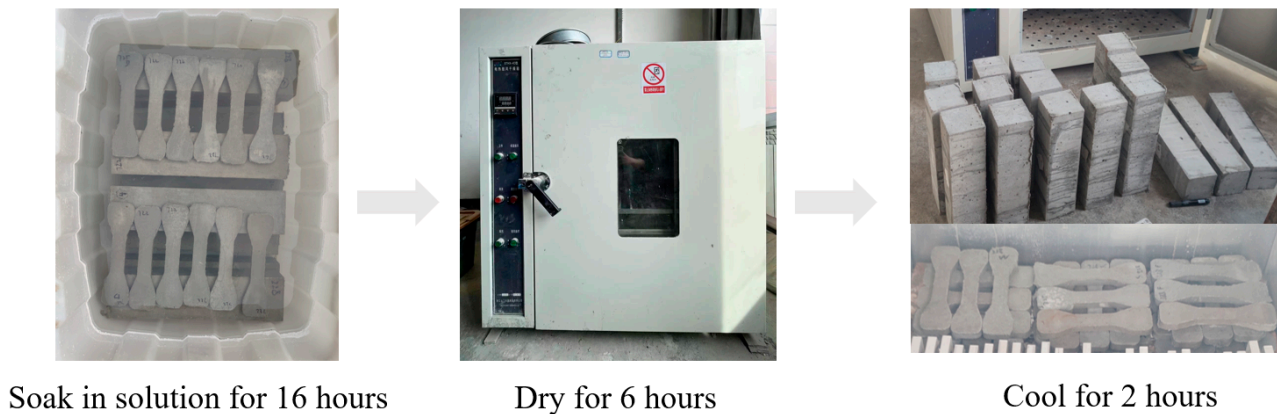
**Figure 4.** Schematic diagram of dry–wet cycle.

Referring to the specification GB/T 50082-2009 [35], the chemical erosion of specimens under dry–wet cycles was conducted on RA ECC. A total of 40 dry–wet cycles were completed, with mechanical properties being tested once every 10 cycles. The dry–wet cycle erosion test procedure is illustrated in Figure 4. Specimens that had been through 28 days of regular upkeep were soaked in a solution for 16 h, then taken out and put in a lab oven adjusted to  $(80 \pm 5 \text{ }^\circ\text{C})$  for dehydration for 6 h, succeeded by 2 h of cooling, resulting in a dry–wet cycle every 24 h. The dry–wet cycle solutions included aqueous solution (W), 5%  $\text{Na}_2\text{SO}_4$  solution (S), and 5%  $\text{Na}_2\text{SO}_4$ –3%  $\text{NaCl}$  solution (F).

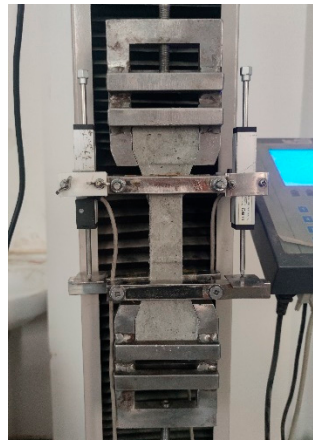
**Figure 5.** Tensile testing equipment.

After the bone-type specimens were cured to the set age, the uniaxial tensile test of RA ECC was carried out by a 5 kN LCD electronic tensile machine of model LDS-5 (Figure 5). The displacement control was adopted, and the loading speed was 0.5 mm/min. The changes in the length of the monitoring zone were recorded by installing two sets of Linear variable displacement transducers (LVDT) on both sides of the specimen, and the final value of the length change was taken as the average value of the two test results, with a measuring scale distance of 80 mm. Before the tensile test, pre-stretching was carried out, the tensile force data on the instrument of the tensile testing machine were observed, and when the data were displayed as 100 N, the recording of the test data was started to ensure that the specimen did not slide in the tensile process.

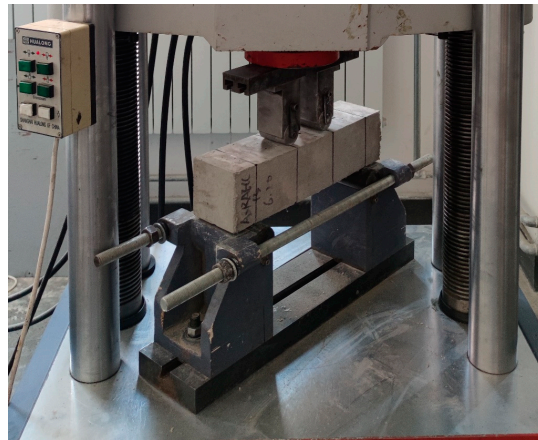
**Figure 6.** Four-point bending test device.

After the prismatic specimens were cured to the set age, the four-point bending test of RAEC (Figure 6) was carried out by the microcomputer-controlled electro-hydraulic servo universal testing machine (WAW-600, range 600 kN) produced by Shanghai Hualong Testing Instrument Co. The prismatic specimens were placed on the lower two rollers at 50 mm from each edge of the specimen on both sides, and the loading method was stress-controlled with a loading speed of 0.06 MPa/s until the specimen was damaged by bending.

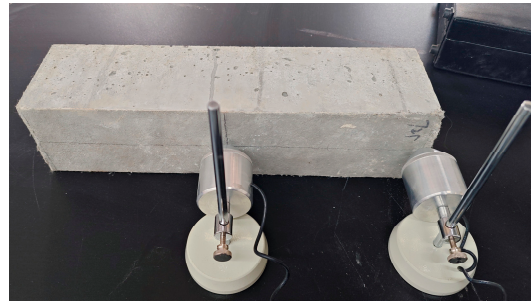
**Figure 7.** Resonance frequency detection.

Referring to the specification GB/T 50082-2009 [35], as shown in Figure 7, the fixed side of the RAEC prismatic specimens was selected for the resonance frequency test, three specimens were tested in each group, and the test was carried out once every 5 dry–wet cycles. Since the initial resonance frequency of each group of specimens was not the same, to facilitate the comparison of the resonance frequency change between different groups of specimens, the change in resonance frequency ratio was used for the comparison, which is calculated as shown in Equation (1):

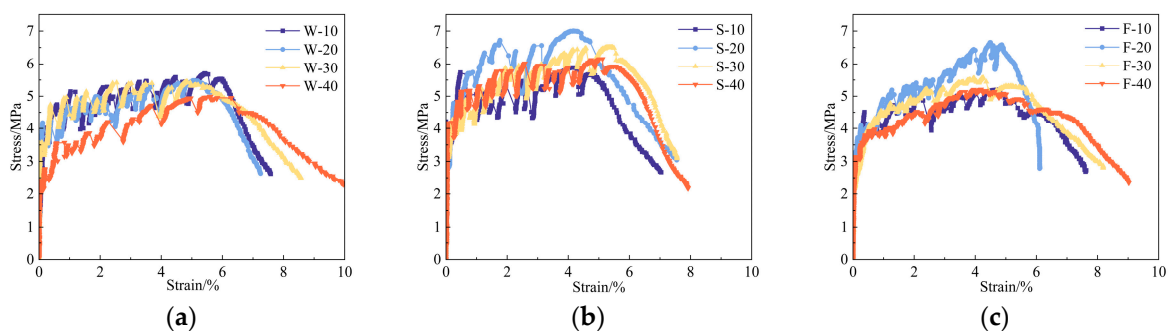
**Figure 8.** RAEC tensile stress–strain curve: (a) aqueous solution (represented by W), (b) 5%  $\text{Na}_2\text{SO}_4$  solution (represented by S), and (c) 5%  $\text{Na}_2\text{SO}_4$ –3% NaCl solution (represented by F).

Figure 8 shows the tensile stress–strain curves of the RAEC bone-type specimens in different salt solutions after 10, 20, 30, and 40 cycles of dry–wet erosion (numbering is denoted by x-y, with x being the solution and y being the number of dry–wet cycles). It can be seen that the tensile curves of the RAEC specimens in different solutions show obvious hardening characteristics with the increase in erosion cycles. However, the specimens in 5%  $\text{Na}_2\text{SO}_4$  solution and 5%  $\text{Na}_2\text{SO}_4$ –3% NaCl solution were brittle due to the erosion-induced matrix, and the erosion made the ductility lower than that of the specimens in aqueous solution.

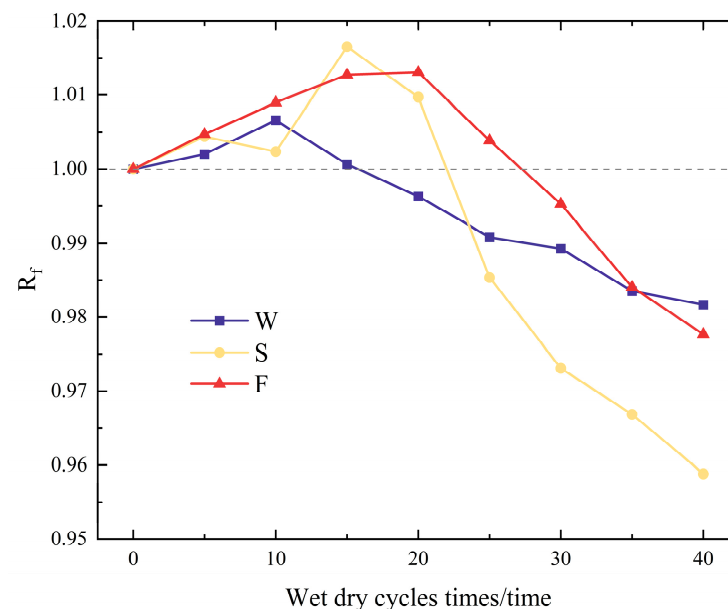
**Figure 10.** Resonance frequency ratio.

The resonance frequency of the RAECC prismatic specimens can indicate the level of internal structure integrity—the higher the integrity, the greater the resonance frequency [38,39]. After every five dry–wet cycles, three sets of resonance frequency data were gathered for the prismatic specimens. These values were then averaged and substituted into Equation (1). The results are shown in Figure 10. It was observed that the  $R_f$  values of the RAECC prismatic specimens in all three solutions increased and then decreased. In the aqueous solution, the  $R_f$  values of the specimens reached a peak after 10 cycles, while those of the specimens in the 5% Na<sub>2</sub>SO<sub>4</sub> solution and the 5% Na<sub>2</sub>SO<sub>4</sub>—3% NaCl solution reached peaks after 15 and 20 cycles, respectively.

The filling effect of the erosion products inside the prismatic specimen caused the interior to become complete, increasing the  $R_f$  value. However, with an increase in the number of cycles, the excessive erosion products started to damage the original internal pore structure, creating new matrix defects, which led to a decrease in completeness and, in turn, a decrease in the  $R_f$  value. Based on the trend of the  $R_f$  value, the order of erosion severity of the RAECC prismatic specimens by dry–wet cycling in different salt solutions was as follows: 5% Na<sub>2</sub>SO<sub>4</sub> solution > 5% Na<sub>2</sub>SO<sub>4</sub>—3% NaCl solution > aqueous solution.

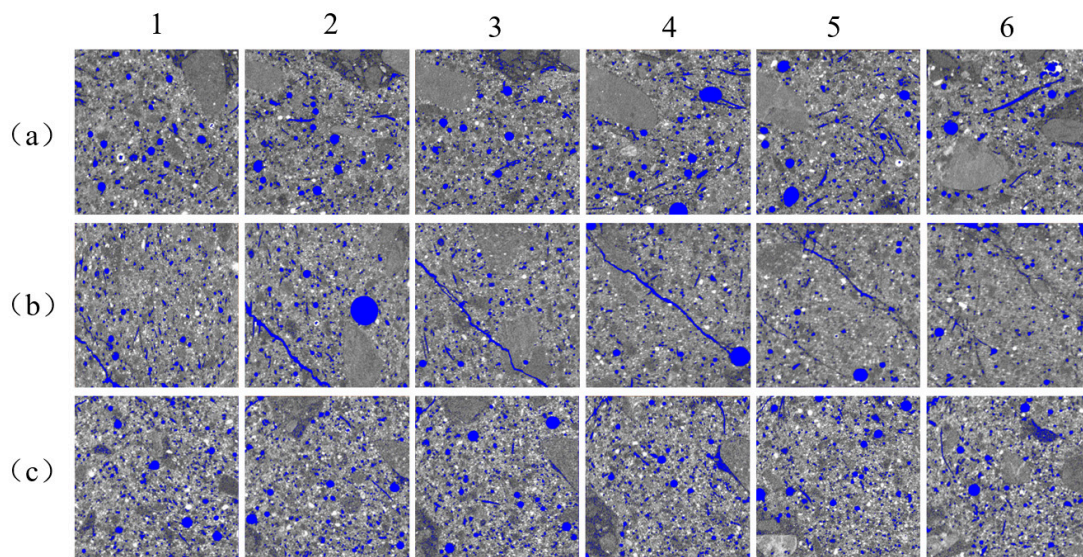
**Figure 11.** X-CT scanning 2D feature slices: (a) C, (b) S-20, and (c) S-40.

From Figure 11, it can be seen that the pore distribution in the 2D slices of the specimens is relatively uniform, and the number of pores and pore diameter of specimen S-20 is smaller than that of specimens in groups C and S-40, which is because after 20 dry–wet cycles, the erosion products filled the pores of the matrix, which reduced the pore diameter and the number of pores. After 40 dry–wet cycles, the overfilling of the erosion products damaged the matrix, which made the number of pores increase.

The light grey area of the cementitious material in Figure 11 is the freshly mixed cement paste containing fly ash, and the dark grey area of the cementitious material is the cement paste attached to the surface of the recycled fine aggregate. It can be seen that the number of cracks at the bond between the recycled fine aggregate and other materials in the specimen is higher than that of other fine aggregates, and the number of pores in and around the dark grey area is high. The high water absorption of the recycled fine aggregate and the internal pores and cracks generated during crushing led to an increase in the porosity of the specimen, and these cracks and pores provided transport channels for aggressive ions, thus affecting the durability of the specimen.

away from the surface of the specimen, which was ignored in the later analysis. From the two-dimensional section in Figure 11, the specimen of group S-20 was sampled in a poor location, and there was a diagonally cut crack on the inside, which had some influence on the analysis.

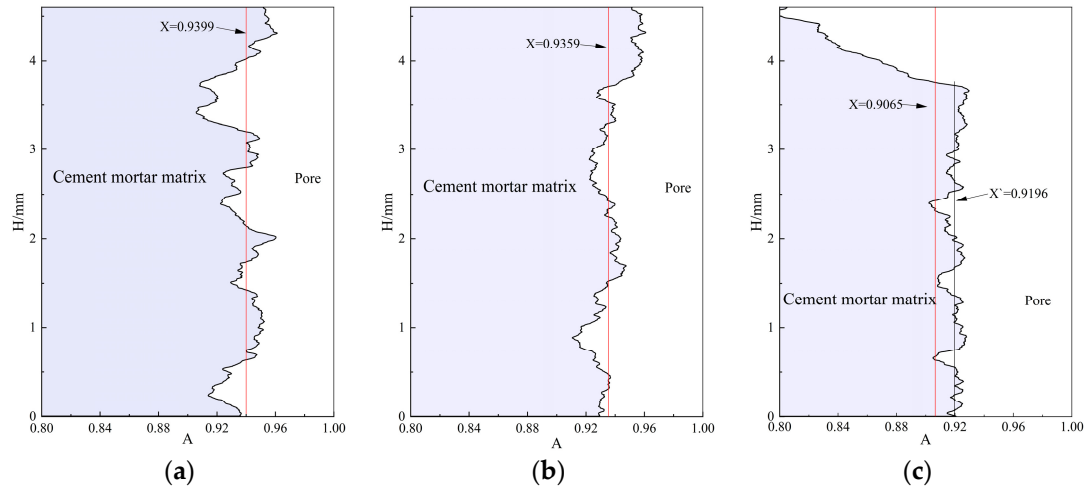
**Figure 12.** Change in cross-sectional area ratio along erosion depth: (a) C, (b) S-20, and (c) S-40.

The A-value distribution curves of the RAEEC specimens under different erosion cycles had different trends, and the downward depression on the curves is the location of large holes. The A-value curve of the uneroded Group C specimens has a larger magnitude of change along the longitudinal axis, while the A-values of the other two groups of specimens have a smaller magnitude of change, which is attributed to the fact that the erosion products filled up some of the pores, making the pore distribution uniform in the 2D slices. From the size of the x-value, with the increase in dry–wet cycle erosion, the x-value decreased by 0.43% and 1.74% in turn; the change is small, but the existence of internal penetrating cracks in the S-20 specimen led to the x-value of the S-20 group being larger than the actual value, so the actual change trend of the x-value with the cycle firstly decreased and then increased, which is in line with the change rule of the resonance frequency.

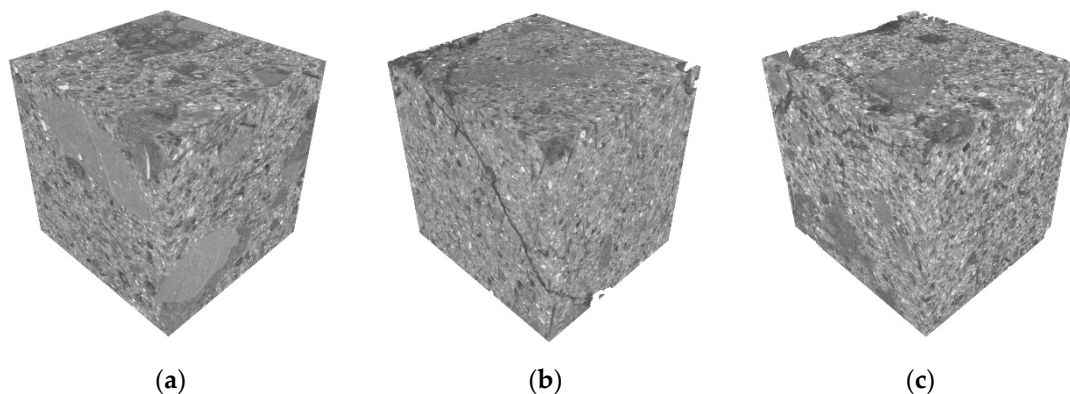
**Figure 13.** CT 3D reconstruction: (a) C, (b) S-20, and (c) S-40.

The X-CT scan 2D slice images were reconstructed in 3D as shown in Figure 13. It can be seen that after 40 sulfate dry–wet cycles, the integrity of the specimen was good and there was no obvious damage. The crack in Figure 13b was caused by sampling and was not an erosion-generated crack, and due to the presence of fibers, the crack occurred throughout the whole specimen, which was broken but did not shatter.

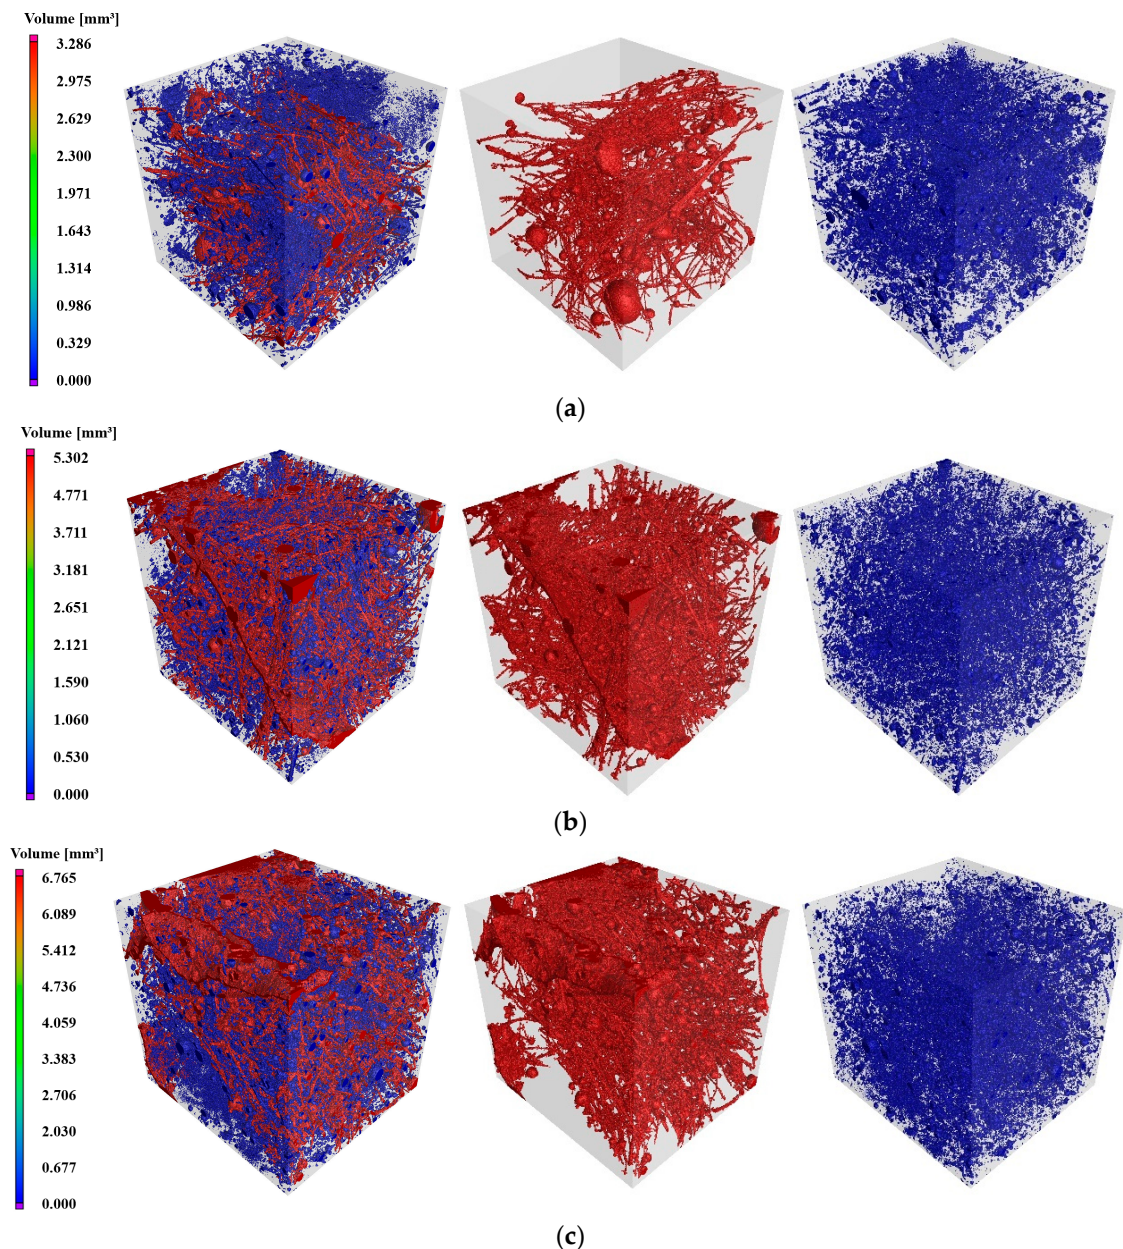
**Figure 14.** 3D reconstruction of pore structure: (a) C, (b) S-20, and (c) S-40.

The pore structure of the 2D slices of the CT scan was analyzed after 3D reconstruction. The results, depicted in Figure 14, show red areas representing large, connected pores and blue areas indicating small pores. The analysis revealed that a significant portion of the total pores in the specimen were red connecting pores. This is attributed to the similarity in the grey scale between fibers and pores in the 2D slice images post-CT scanning, leading to the misidentification of PE fibers as pores during the 3D reconstruction. The PE fibers were well distributed in the specimen, often penetrating through most of the pores, resulting in a larger volume of maximum pores.

Smaller pores, on the other hand, were more uniformly distributed within the specimen, typically existing between aggregates and the grid formed by the largest connected pores. As the salt solution erosion progressed, the number of pores increased gradually. Larger gaps were filled with erosion products, transforming them into smaller pores, ultimately reducing the pore volume. The blue range in the 3D reconstruction map decreased after 20 dry–wet cycles. After 40 cycles, the original pore structure was disrupted by the

transitional filling of erosion products, creating new pores and expanding the range of both red connecting pores and blue independent pores.

The specific pore space data of Figure 14 are presented in Table 3, indicating a continuous increase in the number of pores with erosion time. The increase was measured at 19.03% and 50.79%, respectively. This phenomenon was attributed to erosion products forming within the pores, causing larger pores to split into smaller ones, thereby increasing the overall pore count. Additionally, erosion led to substrate damage, creating new pores. The defect volume ratio in Table 3 characterizes the porosity inside the material, which can reflect the strength of the specimen to a certain extent. The defect volume ratio increased by 6.64% and 45.9%, respectively, with the increase in the number of wet and dry cycles, but due to the existence of internal penetrating cracks in the S-20 specimen and the small growth of the defect volume ratio from C to S-20, the actual defect volume ratio decreased with the increase in wet and dry cycle, followed by an increase, and the trend of the change was opposite to that of the mechanical properties. With the continuation of erosion, the defect volume ratio of the S-40 group reached 9.35%, causing a decrease in the mechanical properties.

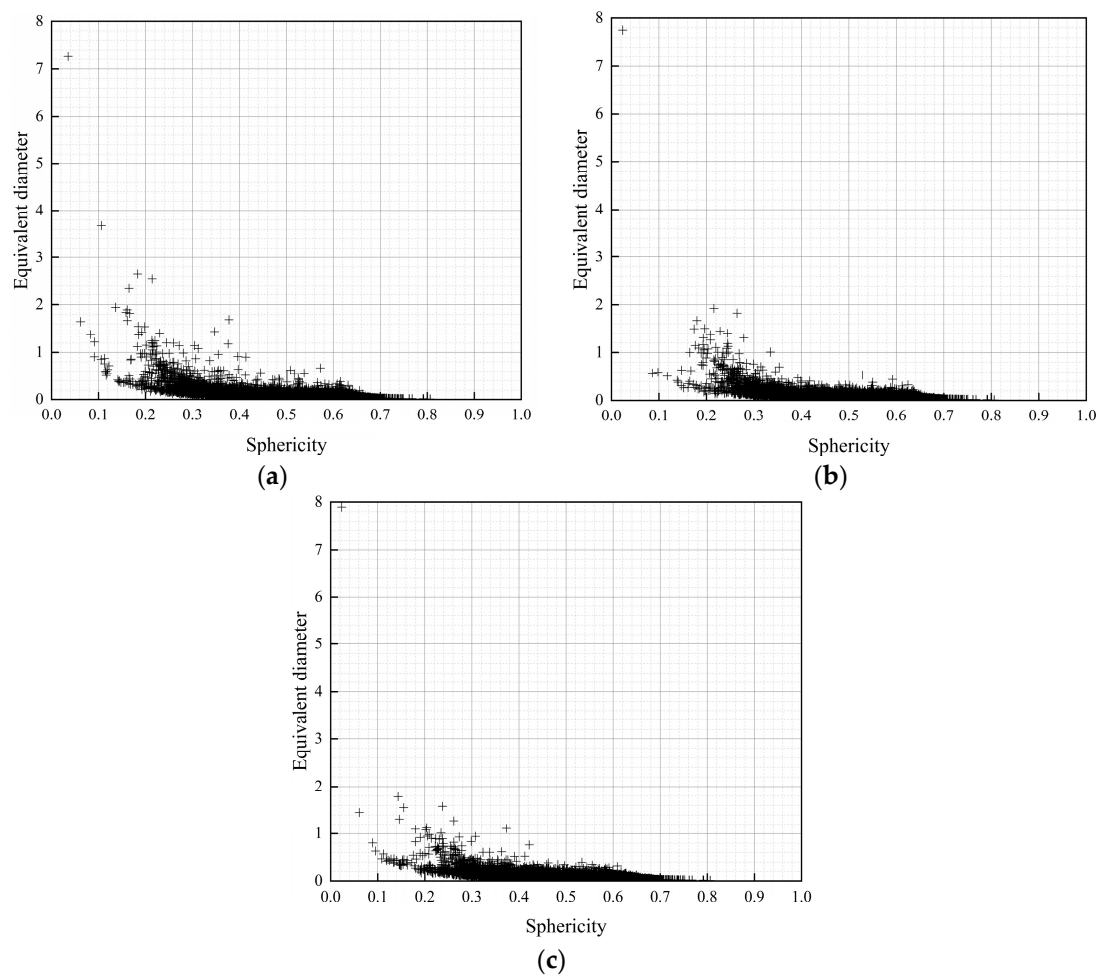
**Figure 15.** Pore sphericity: (a) C, (b) S-20, and (c) S-40.

The sphericity can reflect the geometry of the pores: with a sphericity close to 1, the shape of the pores approximates to a sphere; with a sphericity close to 0, the shape of the pores approximates to a crack. The distribution of the pore sphericity and the equivalent diameter of the pores obtained in the X-CT reconstruction are shown in Figure 15. It can be seen that the diameter of the pores in the uneroded control specimen was larger, the sphericity was smaller, and the shape of the pores in the original state was more similar to

a crack. After 20 dry–wet cycles with erosion by sulphate, due to the filling effect of the erosion products, the number of pores increased, the diameter decreased, the sphericity increased, and the stress concentration at the boundary of the pores with large sphericity rarely occurred [42]. Moreover, the shape and size of the pores were more homogeneous compared to the control, and the homogeneous pores caused an increase in the strength of the matrix. After 40 of dry–wet cycles with erosion by sulphate, due to the transitional filling of the matrix by the erosion products, matrix damage was caused, and the new pores produced at the time of damage were larger in size and number, and had poorer sphericity, which caused a high degree of stress concentration at the pore boundaries [43]. Moreover, the pores were affected by the filling of the erosion products, causing a reduction in strength.
