Article

Material Testing of Historic Bricks and Mortars in Degraded Masonry Structures

Abstract: The subject of this article is material research carried out on the ruins of a medieval castle located in west-central Poland. This facility was built at the beginning of the 15th century by the Order of St. John, and during its long life, it was subjected to many reconstructions. Unfortunately, in 1975, it was destroyed by fire. Since then, it has been left in a state of advanced ruin, exposed to climatic influences without any protection. The subject of the research was to assess the possibility of maintaining such buildings in a severely degraded condition while ensuring their technical efficiency. The article discusses a particular instance of “consolidation” applied to a structure in a state of historical, architectural, and structural ruin. After the diagnosis, it was determined that the structure should be safeguarded using a minimally invasive method. The purpose of these activities was to answer the question of whether the structure could be left to continue operating despite failing to meet the requirements of current standards and regulations while posing an additional dang

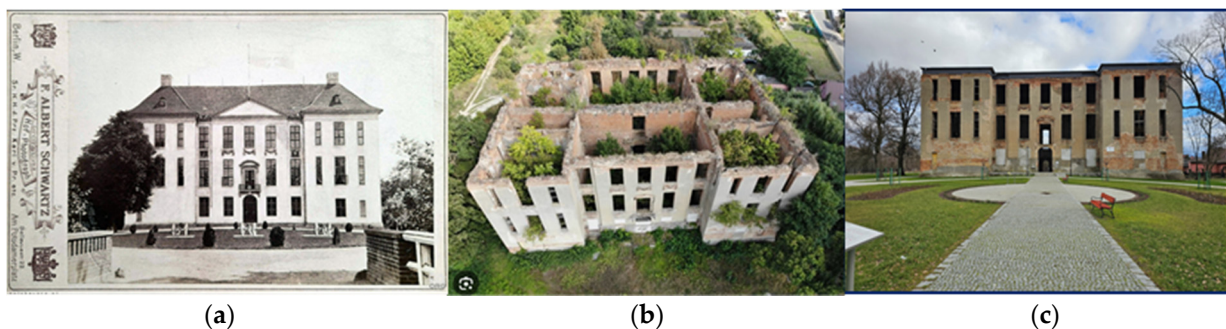
Figure 1. View of the castle: (a) in 1896 [21], (b) in 2018 [22], and (c) in 2023 (photo by authors).

The inspiration to take up the topic presented in the article is very frequent abandonment of fragments of historic fortifications in a state of advanced degradation and, thus, exposing them to further destructive influence of the environment [14]. In such situations, it becomes necessary to “prepare” them for further use in the above-mentioned environment while ensuring the required level of reliability [18–20]. One example of such structures is the remains of a medieval castle (Figures 1–3). In the past, it was the seat of the commander of the Order of St. John. It was built in the years of 1545–1564, replacing the wooden knight’s manor that existed there in the years of 1426–1429. The castle in Słońsk has been expanded and rebuilt many times since its construction. In 1652, it was burned down by the Swedes, and its last expansion took place in 1783 (Figure 1a). Due to a devastating fire that took place in 1975, the facility became a ruin left for over 45 years, threatening a construction disaster. Because it is a monument with high tourist potential, closely related to the rich history of Brandenburg, the Netherlands and Europe, it was decided to preserve it for future generations in its current state (Figure 1b,c).

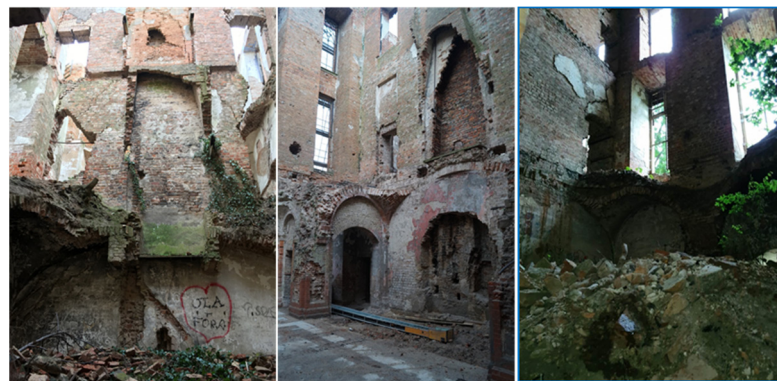
Figure 2. View of walls and vaults—as of 2018 (photos by authors).

The medieval walls of the original structure of the facility have survived to this day, and it was decided to secure them. Already in 2018, the technical condition of the castle’s masonry structure was considered disastrous. The threat here was the exposed slender walls 19 m high without stiffening in the form of vaults, wooden ceilings, and a roof. Chimney walls were particularly at risk of losing stability, while the remains of the vaults

contained a large layer of rubble and vegetation growing on them (Figure 2). In 2021, the building was protected with a temporary wooden roof and covered with roofing felt, which resulted in the quick drying of bricks and mortars with intensive ventilation caused by the lack of windows and doors. The remains of the vaults, like the rest of the building, were on the verge of a construction disaster. The above-mentioned loss of wooden ceilings, vaults, and large fragments of walls significantly weakened the stiffness of the remaining structure of the building, which was due to the walls being left unprotected for the last 45 years. The facility required urgent protection and reinforcement of walls and lintels, as well as reinforcements and additions to the vaults. Carrying out this work turned out to be an extremely difficult and dangerous activity due to the additional threat associated with the not fully recognized and heavily debris-covered surfaces of the structure, which already lost its character as a building. Debris was lying on the ground floor and on the remains of the vaults, which made it very difficult to inventory places that were then inaccessible, hence scanning the facility [23] turned out to be very helpful as it did not have archival documentation (Figure 3).

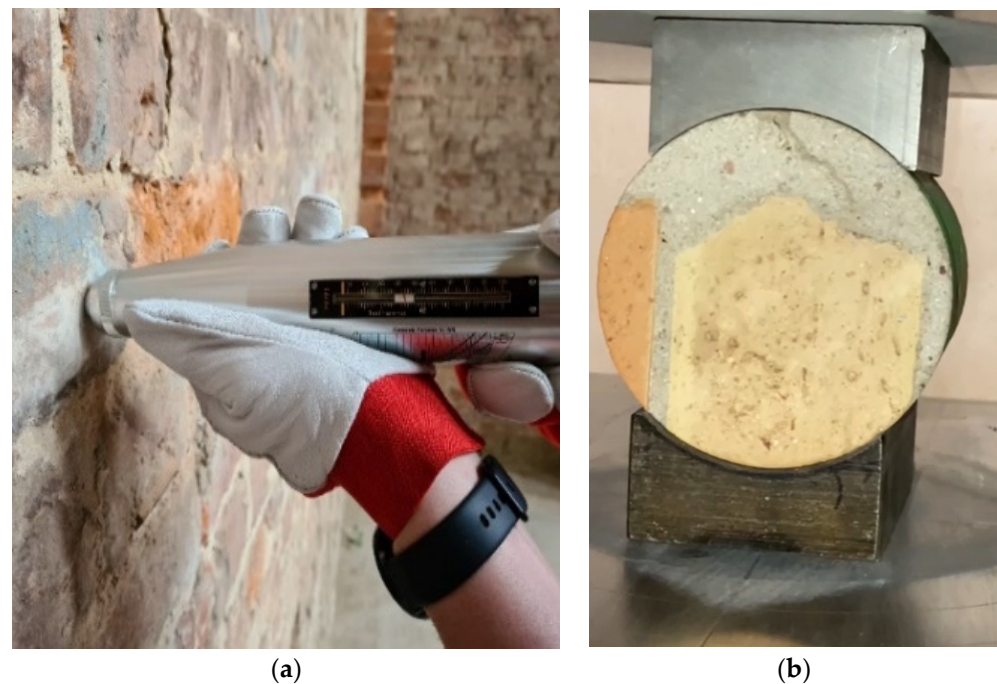
Figure 7. (a) Testing the compressive strength of bricks using an N-type sclerometer; view of a sample (b) (own study).

As written above, part of the material tests were carried out directly on the site. First of all, they concerned the evaluation of the strength of the embedded bricks using a Schmidt sclerometer (Figures 6 and 7). The findings were compared with the results of destructive tests performed on samples taken at several locations overlapping with the locations of the nondestructive tests. Sclerometric tests confirmed the high structural and strength inhomogeneity of the bricks, which was a further impediment to carrying out subsequent structural protection. The strength of the bricks, determined by the nondestructive method, was determined based on the correlation between their strength and the number of sclerometer reflections using the regression curve formula, among others, for the “N” type hammer, developed by Prof. Leonard Runkiewicz and Eng. Wieslaw Rodzik [25]. Therefore, the compressive strength values obtained this way were considered only illustrative due to the considerable scatter of results, the scale of the object size, the heterogeneity of the material, and the inaccuracy of the testing methods. They did not give the expected unambiguous answer about the current state of the remains of the castle walls, so it was decided to leave the structure of the object unchanged and propose another form of protection.

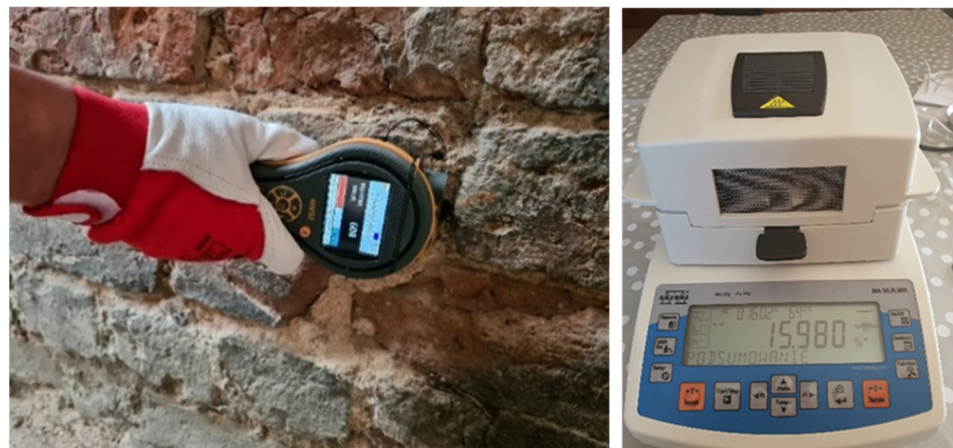
Figure 8. Assessment of the moisture level of walls using the radio and laboratory dry-oven test method (photos by the authors).

Mass moisture measurement was performed using the Protimeter MMS2 meter (Protimeter, Crown Industrial Estate Priorswood Road Taunton TA2 8QY, UK (Figure 7)). These tests were verified using the laboratory dry-oven test method. The results are presented in Table 2 [43].

The graph in Figure 8 shows significant differences in the moisture content in bricks at different measurement points. Until the roofing over the building structure was completed, the walls and vaults showed a very high level of moisture, so they were considered wet.

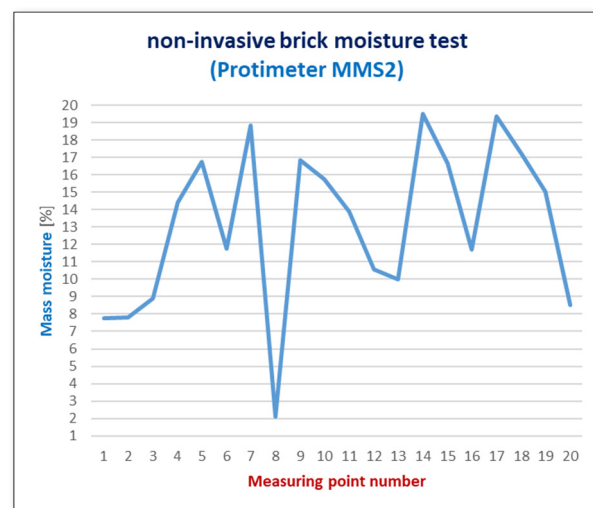
Figure 9. Results of in situ mass moisture measurements using a meter (measurement depth up to 20 mm).

The moisture distribution on the wall surfaces was not uniform. The highest moisture levels were observed in the upper parts of the walls where they directly absorbed atmospheric precipitation. Conversely, the lower parts exhibited the least dampness, with a moisture content of less than 6% (7). The roof made in the spring cut off the rainwater supply, and in the summer, it led to their rapid drying, which was intensified by the strong ventilation of the building without windows and doors. This stabilized and evened out the moisture content in the walls to a level not exceeding $w_m = 6\%$ (7). However, this situation had an impact on the condition of the heavily damp bricks, which partially lost their compact structure, reducing their active load-bearing cross-sections. The process of natural drying of the wall will continue for several years and it is recommended to continue this method of drying the facility.

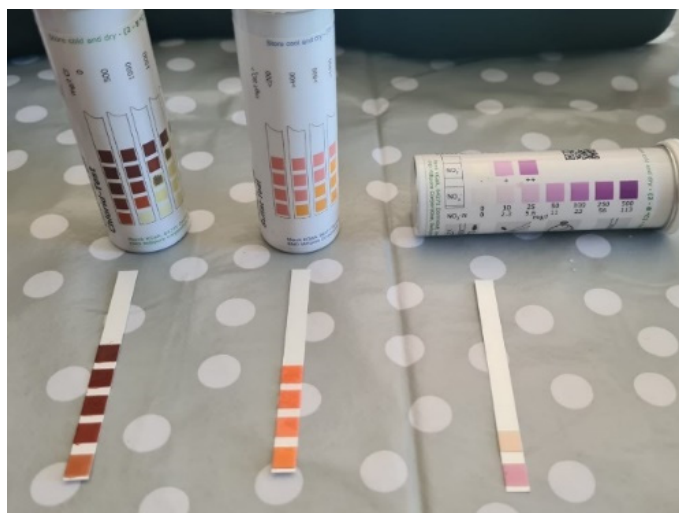
Figure 10. Assessment of salt content carried out on 20 samples taken from various places in the building (photo by authors).

As part of the tests carried out, the level of salt content was determined using the chemical indicator method (Figure 10), the test results are presented in Table 3.

Since the level of nitrates, sulphates, and chlorides was low, these compounds were excluded as the cause of the damage, which confirms the previously stated thesis that the direct cause was the variability of weather conditions and the lack of a roof over the facility.

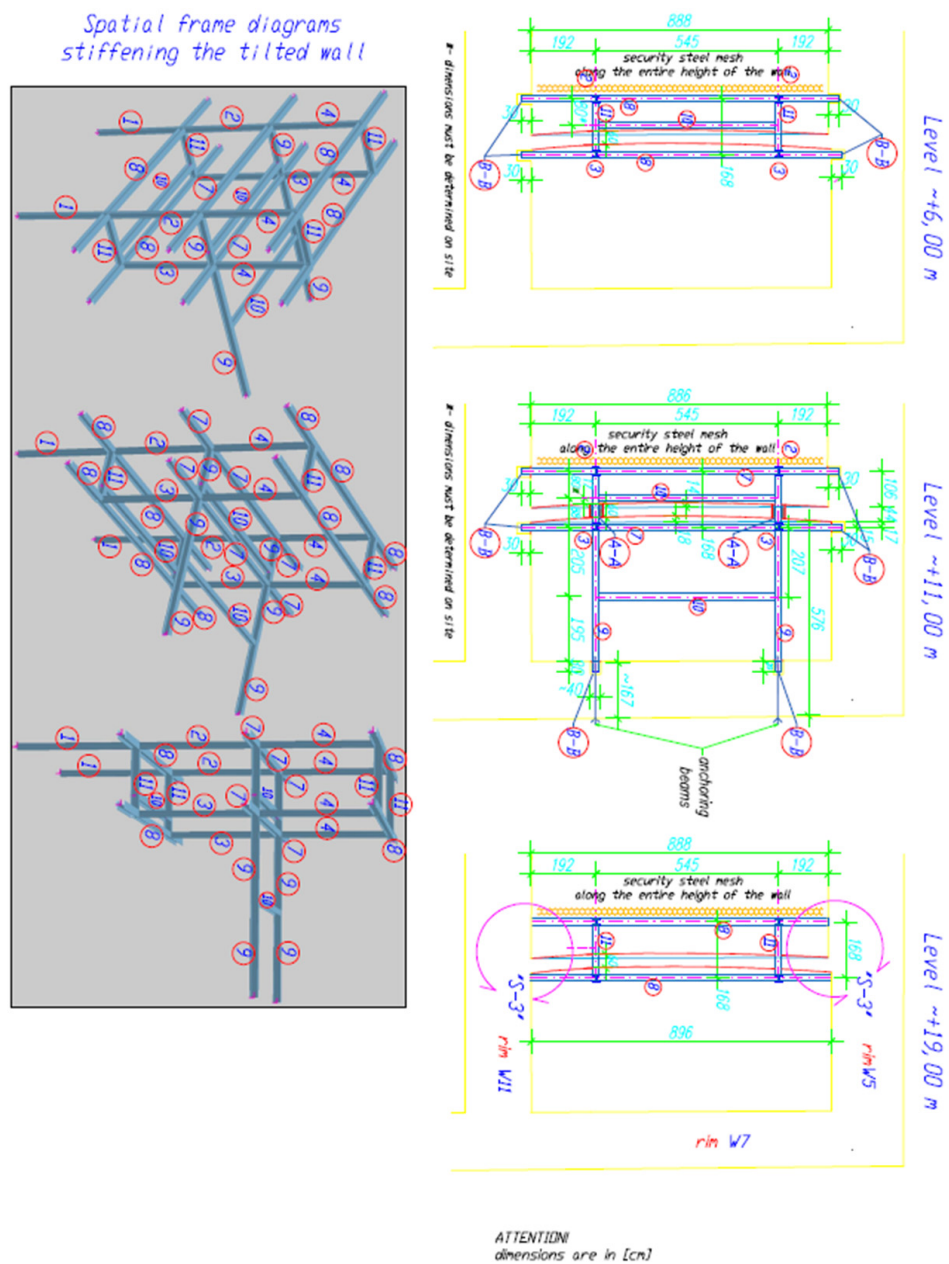
Figure 12. Diagram of an independent structure strengthening the chimney wall (a) frames, (b) cross section (own study).

- Preliminary ad hoc stamping on both sides;
- Cleaning the floor of the rooms and setting up scaffolding;
- Construction and assembly of a steel reinforcing structure and equipping it with light platforms on two levels (Figures 10–12);
- Placing OSB3 boards on platforms to reduce the effects of the impact of a falling wall fragment—they may break, which will allow the rubble to slide more gently to the lower level and the ground floor;
- Filling larger gaps between vault bricks with expansive mortars based on lime, cement, and trass;
- Introduction of reinforcements on damaged wall surfaces using C-FRCM meshes on inorganic mortars; *
- Removal of temporary stamping structures and scaffolding.

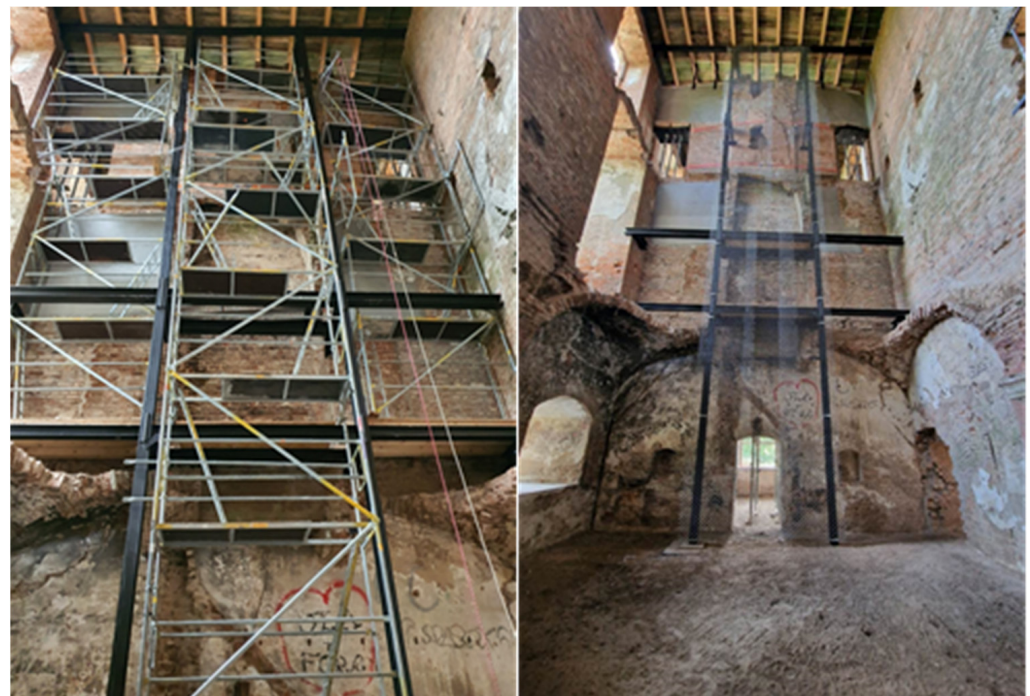
Figure 14. Current view of the strengthened wall and the strengthening structure (photos by authors).

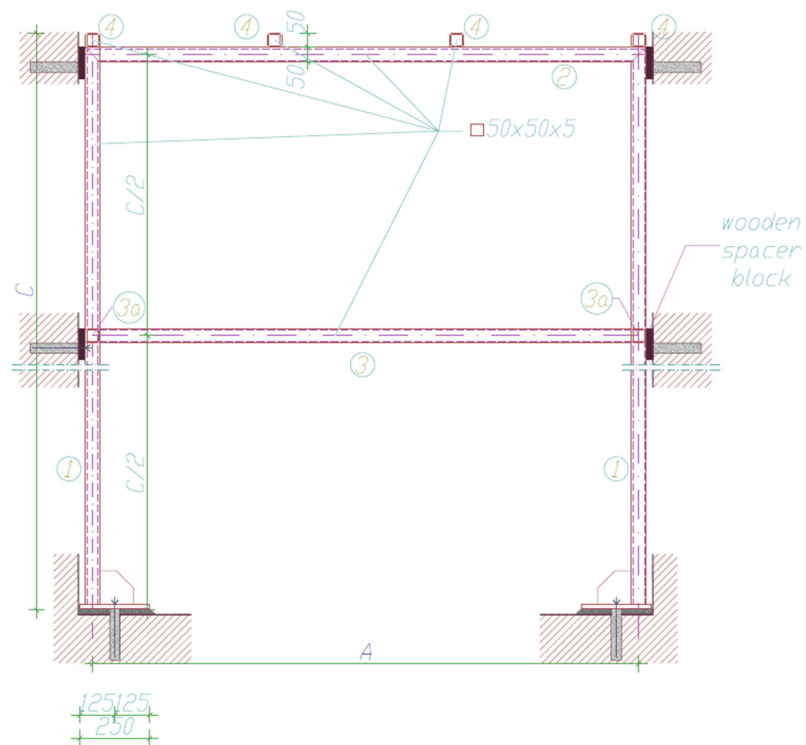
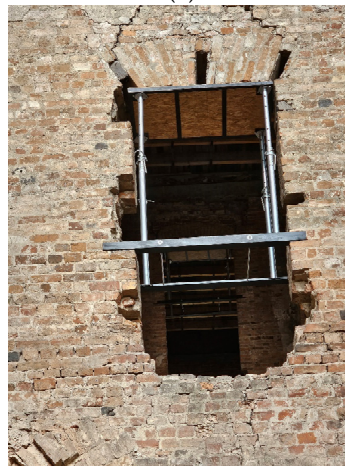
Figure 15. Securing the arches of openings in walls: (a) design; (b) execution (own study).

Some of the vaults required additions (Figures 14–16). This was achieved by reproducing the original, using the recovered bricks.

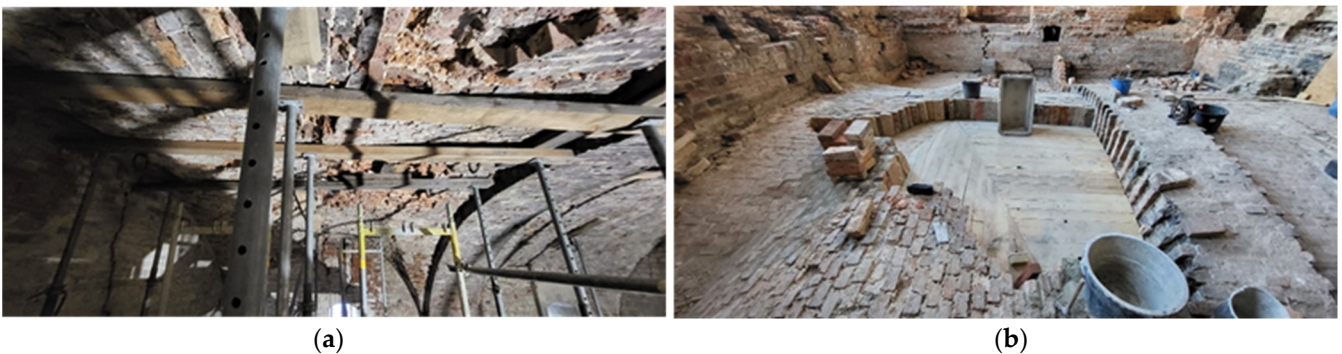
Figure 16. Fragments of the vaults above the ground floor of the castle: (a) view of the damaged bricks from below; (b) filling in (photos by authors).

As a result of covering the ruins with a temporary roof, the facility began to dry out quickly, which had an impact on the building ceramics, especially the vaults, which, after removing unnecessary ballast and cleaning, turned out to be severely deformed structures with local, but deep, defects. Moreover, as a result of drying, the bricks lost their structure and their bottom surfaces became detached to a depth of up to half of their thickness. Therefore, the planned method of strengthening them on both sides with composite meshes on mineral mortars could only be applied locally and only in less damaged structures.

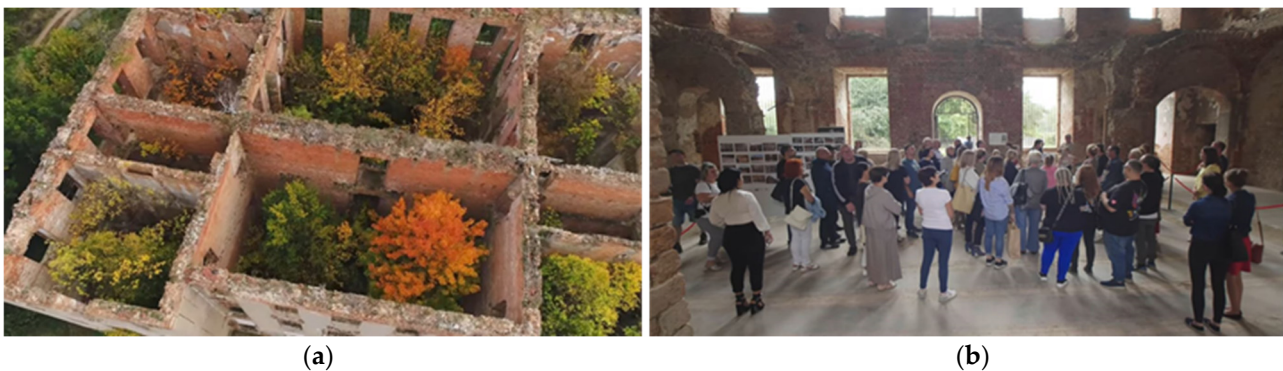
Figure 17. Ruins of the castle in Słońsk: (a) initial condition; (b) current condition (photos by authors).

A wide range of tests carried out on the facility and, as a result, the proposal and implementation of very low-invasive interventions in the structure of the walls made it possible to stop the degradation processes of this structure and its elements while maintaining them in a visually unchanged (authentic) state. Currently, it has been monitored for 3 years, and at the same time, it has been made available to the public for viewing (Figure 17).
