# Post-Tensioned Hollow-Core Concrete Slabs with Unbonded Tendons for Truck Scale Platforms: Design Assumptions and Tests

**Citation:** Szydłowski, R.S.; Łabuzek, B.; Bednarski, Ł. Post-Tensioned Hollow-Core Concrete Slabs with Unbonded Tendons for Truck Scale Platforms: Design Assumptions and Tests. *Materials* **2024**, *17*, 4154. <https://doi.org/10.3390/ma17164154>

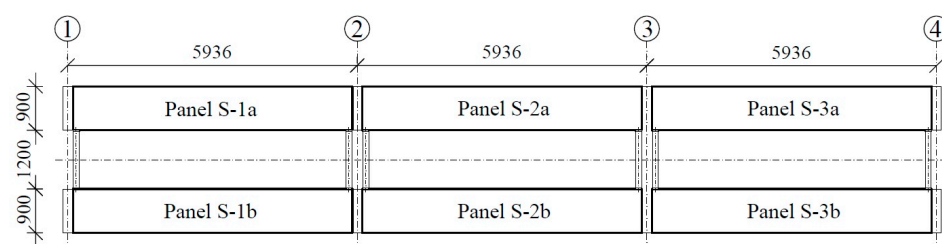
Figure 1. Plan of the platform.

For this study, we designed a platform with dimensions of  $18.0 \times 3.0$  m and constructed a platform composed of three simply supported spans, each with a span of 6.0 m. Another objective was to reduce the total weight of the platform to 24 tons based on the maximum load capacity of a standard 20 ft container. This value is optimal from the perspective of transportation economics. Therefore, we decided to design the platform using two parallel concrete tracks for the wheels with a cross-section of  $0.9 \times 0.28$  m, connected with steel I-beams. The plan for the platform is presented in Figure 1, while the cross-section is given in Figure 2.

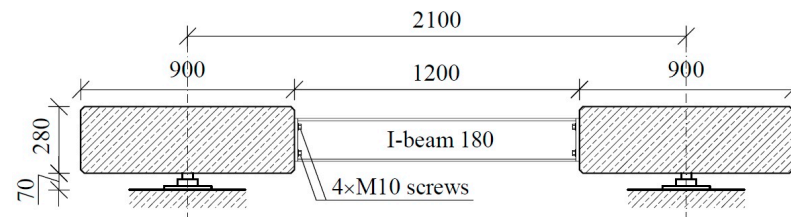
Figure 2. Platform cross-section.

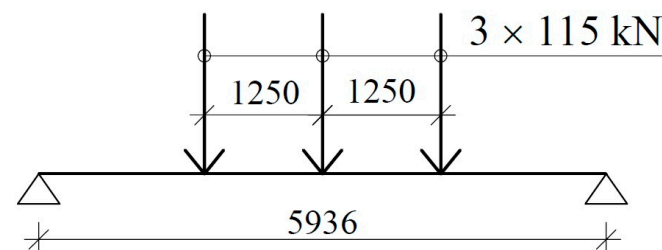
Figure 3. Design load scheme of the selected span.

**Table 1.** Predicted values of the bending moment and stresses in the middle-span cross-section (for the load scheme presented in Figure 3).

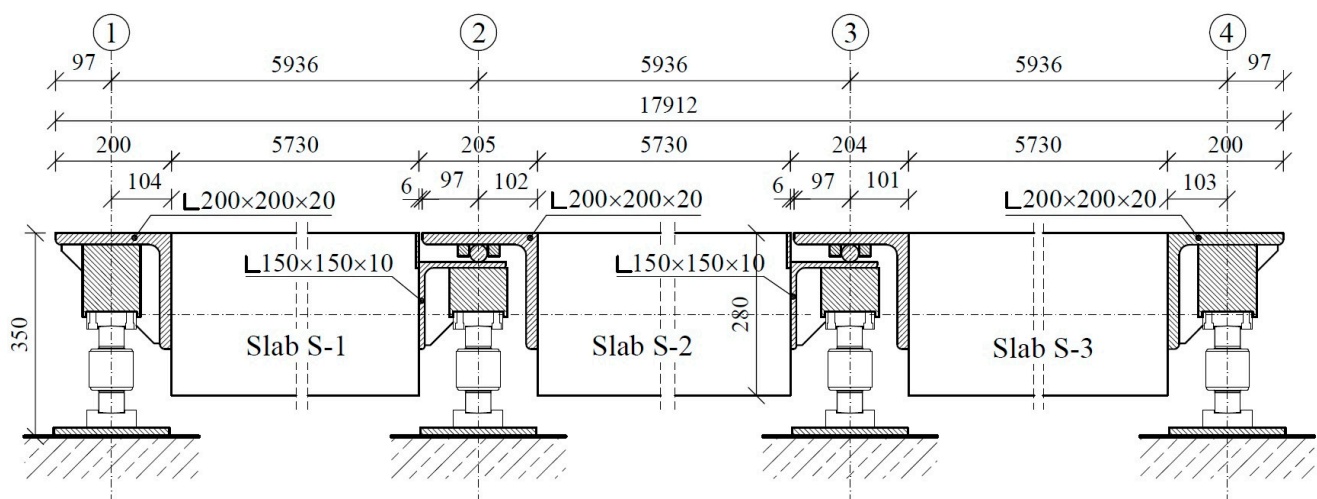
Figure 4. Platform longitudinal cross-section.

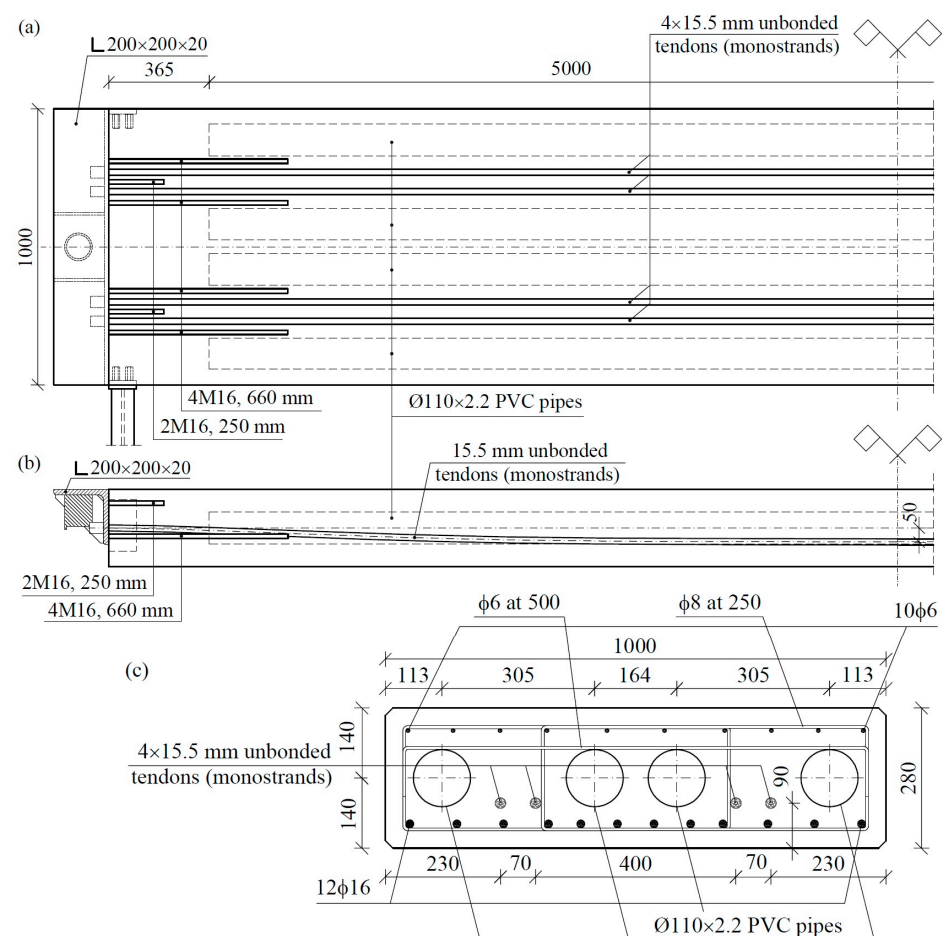
**Figure 5.** Post-tensioned truck scale slab: horizontal plan (a), longitudinal cross-section (b), middle-span cross-section (c).

elements containing 4 unbonded tendons (Figure 5) in each slab with an overhang of 50 mm and a characteristic strength of 1860 MPa. The initial force in each tendon was set to 200 kN. The slab was reinforced near the bottom surface with 12 ribbed bars of 16 mm in diameter. Transverse reinforcement used 6 mm diameter doubled strips with spacing every 250 mm. In addition, 6 longitudinal bars with diameters of 8 mm were used near the top surface. The slabs were made of class C40/50 concrete (according to EC2) based on basalt aggregate and Portland cement. The slabs were prestressed no earlier than 14 days after concreting.

Figure 6a shows a view of the first slab during post-tensioning, while Figure 6b presents a view of the completed platform at its location of use. During the evaluation of the final form, we produced 3 platforms with a dense cross-section of  $0.9 \times 0.28$  mm and 2 with a dense cross-section of  $1.0 \times 0.28$  mm. The following platforms were used in the final version shown in Figure 5.

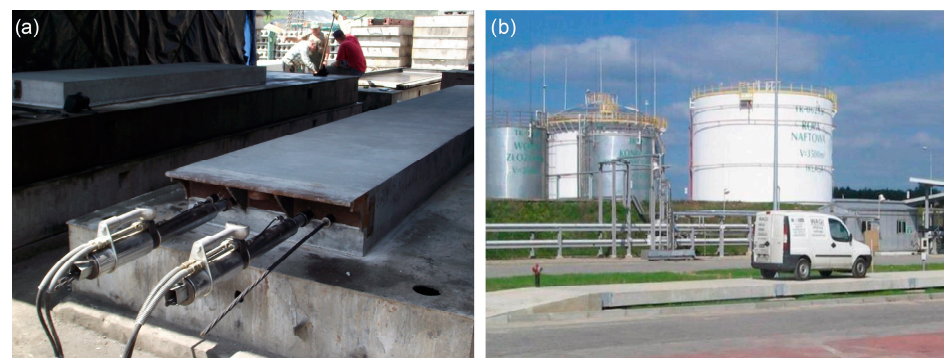
**Figure 6.** View of the first slab during post-tensioning (a); view of the completed platform (b).

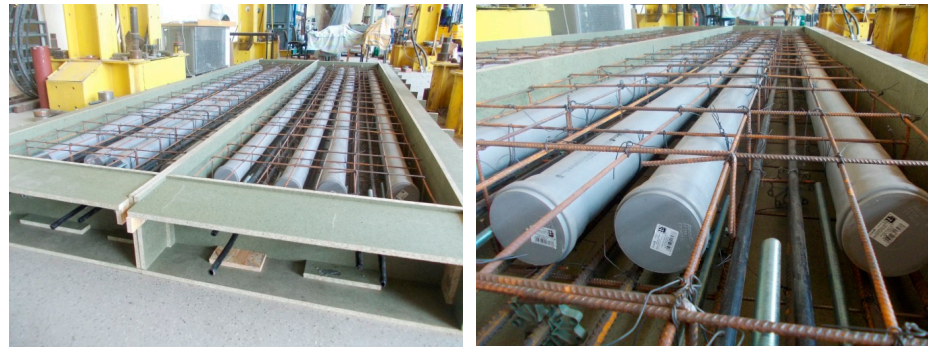
Figure 7. The sample slabs before concreting.

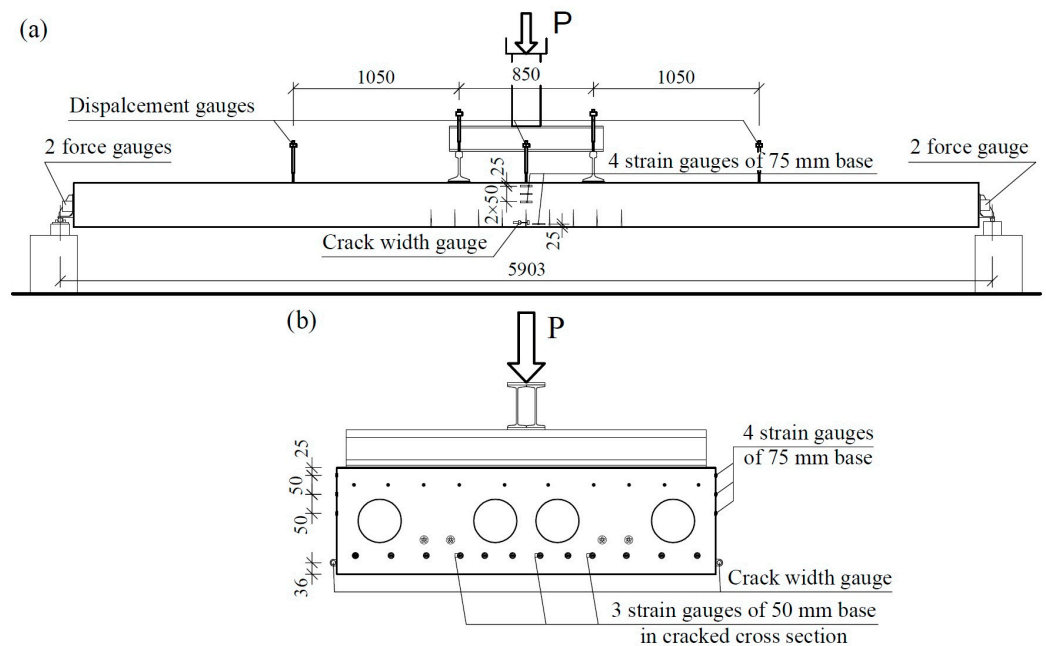
Figure 8. The scheme of the test stand with the locations of the measuring gauges: side view (a) and slab cross-section (b).

Figure 8 shows the scheme of the test stand along with the location of the measuring gauges. Figure 9 shows a view of the stand. The frontal angle bracket support was rotated by  $180^\circ$  relative to the designed slabs. The bracket's geometry and affixing scheme were, however, preserved. In addition, a two-point load was used for the slab. We selected  $0.85$  m

- Three strain gauges with a length of 5 mm installed on three reinforcement bars in a cross-section through a crack;
- Eight strain gauges with a base of 75 mm on the two side surfaces of the slab (four on each side) using the arrangement shown in Figure 8;
- Five displacement transducers to measure the deflection and curvature of the slab;
- Two transducers to measure crack width (on both side surfaces—Figure 8b);
- Four prestress force transducers (on each cable, alternating with two at each end of the slab).

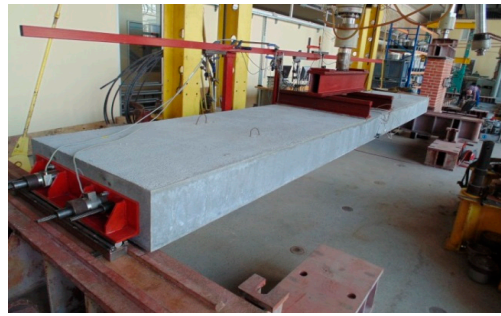
**Figure 9.** View of tested slab and load stand.

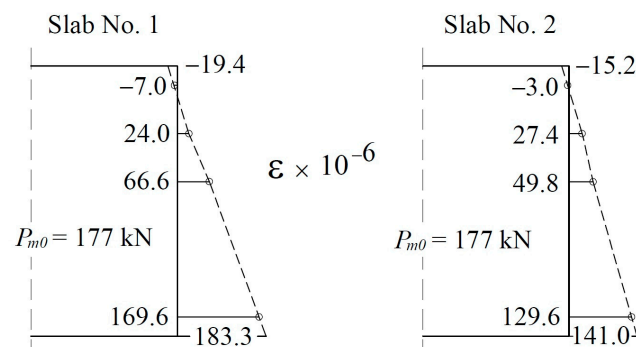
**Figure 10.** Middle span slab cross-section strains due to post-tensioning.

Slabs No. 1 and No. 2 were prestressed 89 and 112 days after concreting. The cables were tensioned under a force of 200 kN with the same equipment and technology used to prestress mass-produced slabs. Figure 10 shows the strain distribution at the cross-section of the center as a result of post-tensioning based on the strain values measured by the strain gauges on the side surfaces. The strain values at the edges of the cross-section were estimated by extending the strain curves. The same figure shows the average values of forces in the tendons after anchoring (177 kN). The values in the two slabs are similar (equal to 6 mm) and differ slightly from the design value (4.4%) calculated for slippage of the wedges in real-life anchorages (169.6 kN). Direct conversion of the strain into stress is always burdened by errors due to differences in the modulus of elasticity for small samples of concrete compared to that for full-scale structures. For this reason, stresses determined using strains should be regarded as only a rough estimation. For slab No. 1, the stresses were calculated as  $-0.81$  MPa for the upper edge and  $8.3$  MPa for the lower edge. The same values for slab No. 2 were calculated as  $-0.64$  MPa and  $5.9$  MPa, respectively. Meanwhile, the predicted values were  $-2.6$  and  $8.0$  MPa (Table 1). Notably, slab No. 2 presented significantly smaller strain values, despite a similar prestressing force. This result was confirmed by camber to be  $1.98$  mm for slab No. 1 and  $1.8$  mm for slab No. 2. This result could be due to differences in the modulus of elasticity or prestressing geometry.

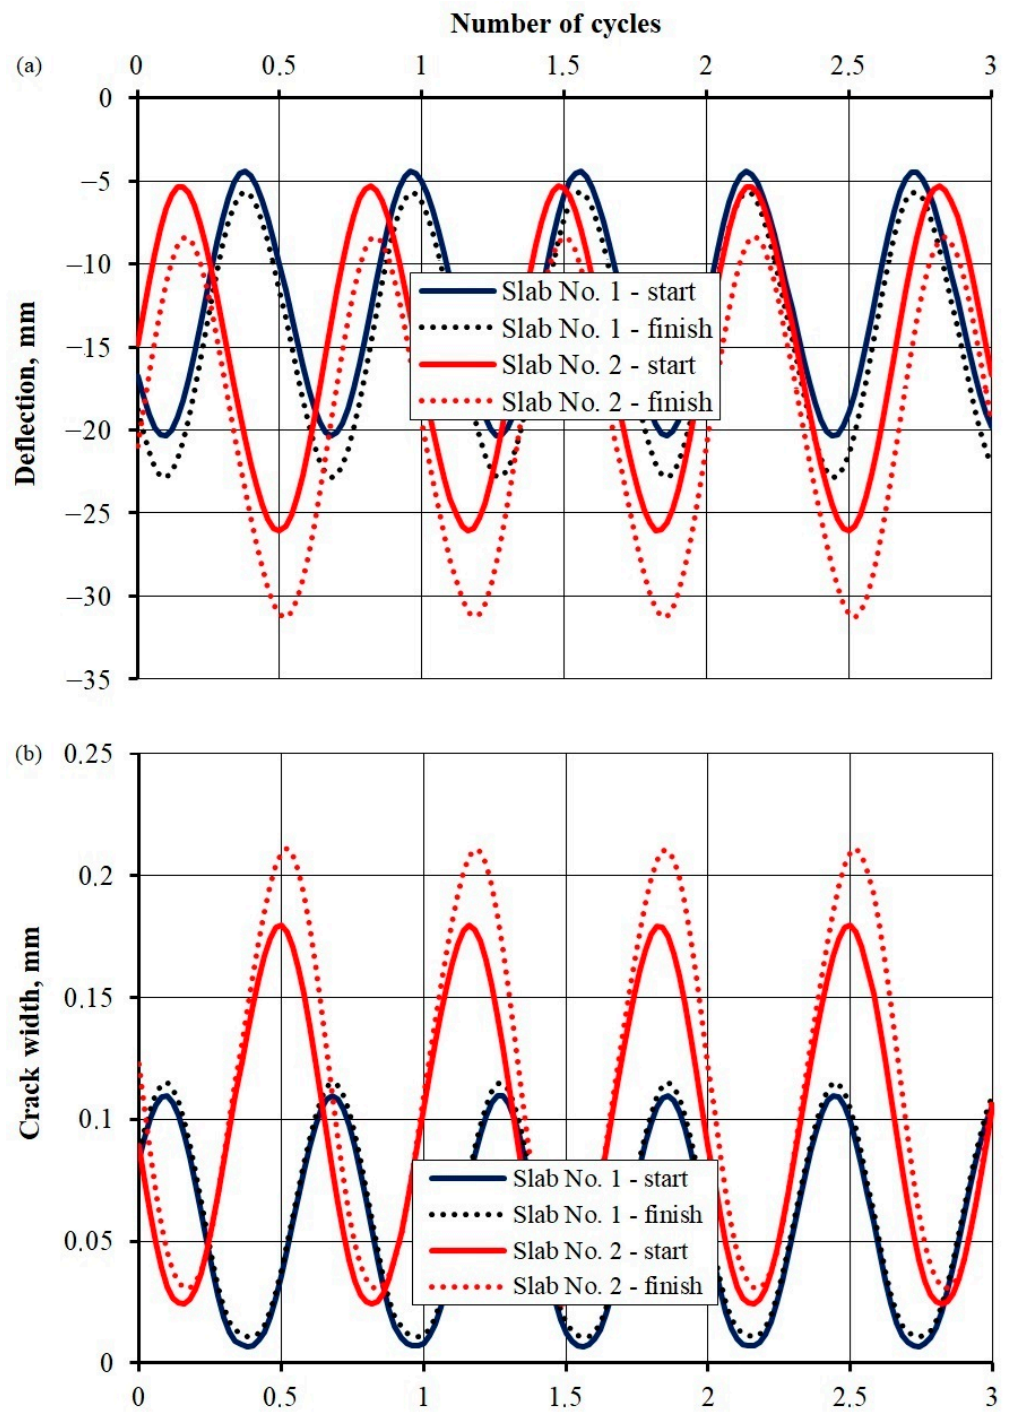
**Figure 11.** Deflection (a) and crack width course (b) during the beginning and end of the repetitive load test.

Figure 11 illustrates the deflection and crack width development at the beginning (after 1000 cycles) and end (after a million cycles for slab No. 1 and 888,000 cycles for slab No. 2) of the repetitive load test. For slab No. 1, when the load changed from 20 to 150 kN, deflection initially changed from 4.4 to 20.4 mm (continuous dark blue line) and from 5.7 to 22.9 mm at the end (dotted dark blue line). The crack width changed from 0.01 to 0.11 mm at the start and from 0.01 to 0.12 mm at the end. For slab No. 2, when subjected to a load change within the limits of 40 and 180 kN, deflection oscillated between 5.3 and 26.2 mm at the start (continuous red line) and between 8.4 and 31.2 mm at the end (dotted red line). The crack width changed from 0.025 to 0.18 mm at the start and from 0.03 to 0.21 mm at the end. The results indicate that the deflection and crack width grew alongside an increase in the load cycles, especially for slab No. 2.

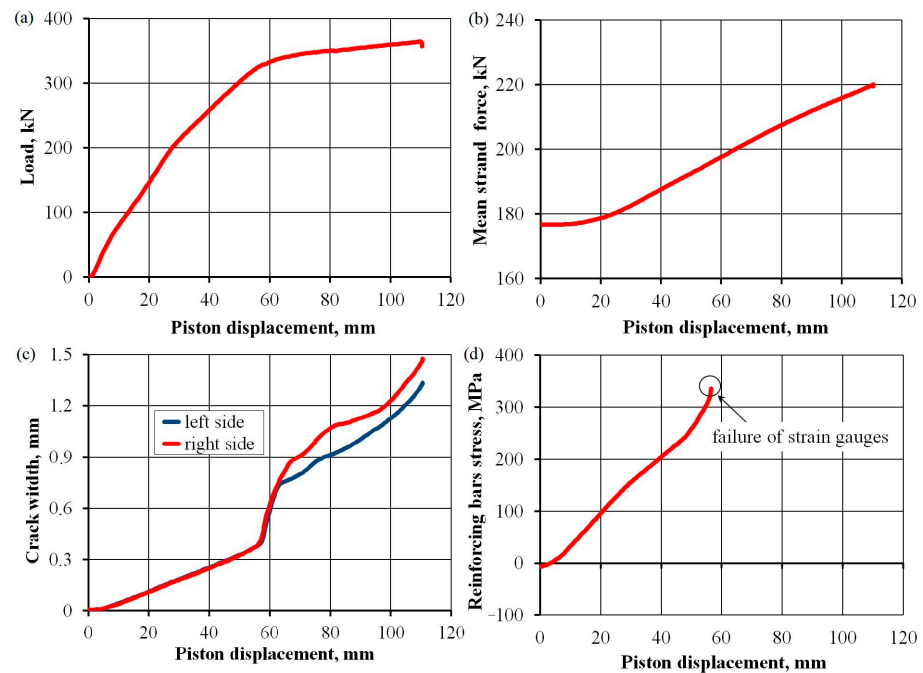
**Figure 12.** Development of selected parameters during the destruction test of slab No. 1: piston load value (a), mean strand force (b), crack width (c), and reinforcing bars stress (d).

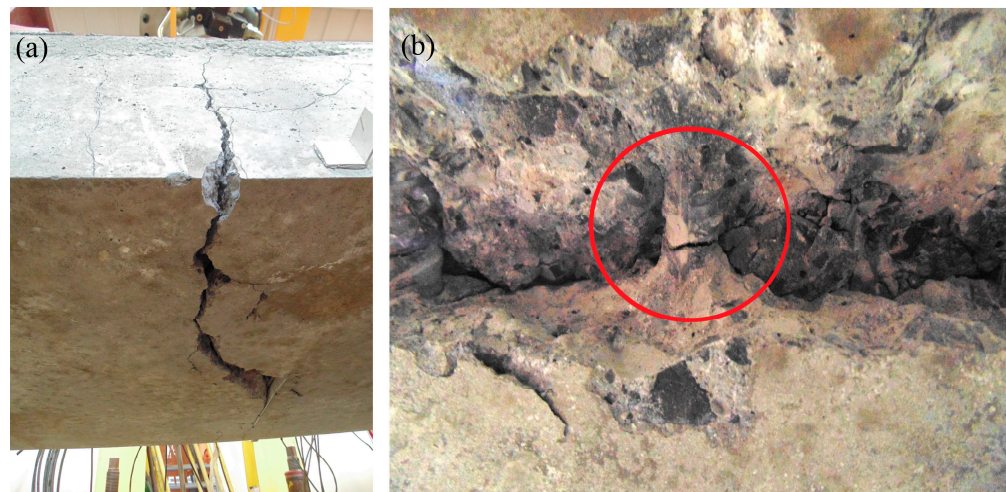
**Figure 13.** Broken slab No. 2: middle cross-section rupture (a); broken reinforcing bar (b) (red circle indicates a broken steel bar).

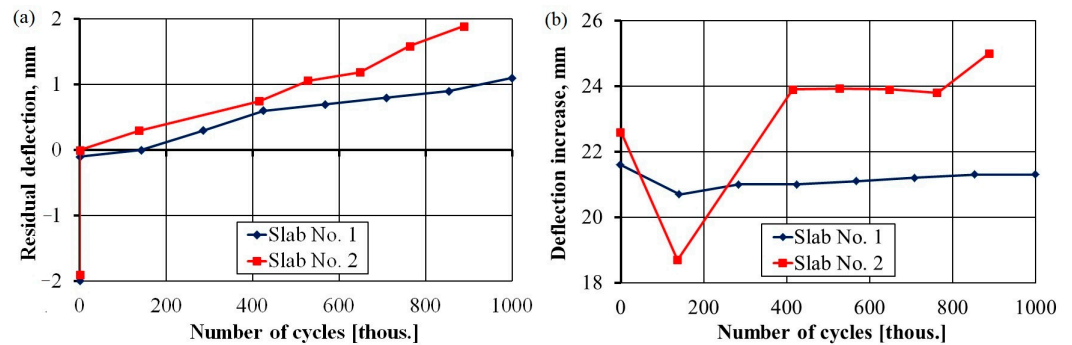
Figure 15. Residual deflection (a); growth of deflection under the control load (b) versus number of load cycles.

The wait time was approximately 30 min after the cyclic loadings were stopped, after which the residual deflection of the slab was registered, as shown in Figure 15a. Due to prestressing, the 2 mm camber of slab No. 1 and 1.8 mm camber of slab No. 2 were permanently eliminated during the initial loading of the slabs. Residual deflections increased with the number of load cycles. For slab No. 1 (under a cyclic load of 150 kN) and slab No. 2 (under a cyclic load of 180 kN), the residual deflection was 1.1 mm after 1 million cycles and 1.9 mm after 888 thousand cycles.

Figure 15b shows the results of increasing deflections when a control load of 180 kN was applied. The results show an increase in value accompanied by an increase in the number of cycles, especially for slab No. 2. Here, the deflection under a control load was much higher shortly after post-tensioning because post-tensioning reduced the effect of the camber.

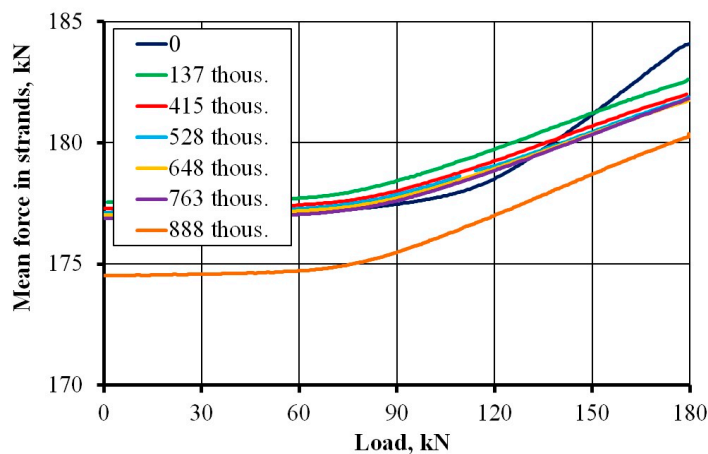
Figure 16. Mean force in strands versus load cycles in slab No. 2.

The significant increase observed in the deflection of slab No. 2, between 763 and 888 thousand cycles, was produced by a significant decrease in the force of one of the strands (Figure 16), which is discussed in the analysis of prestressing forces. Excluding this case from further analysis, the increase in deflections was 21.3 mm for slab No. 1 and 23.9 mm for slab No. 2, constituting 1/278 and 1/248 of the span, respectively. Thus, we can conclude that the limit value was almost achieved for the two slabs based on a limit value of L/250.

Figure 16 shows the course of prestressing force depending on the load applied at different stages of the cyclic load for slab No. 2. For both slabs, a decrease in the initial and final prestressing force with the number of load cycles was observed in the process of loading. This observation highlights the declining role of prestressing and the increasing role of ordinary reinforcement as the number of cycles increases. Indeed, this result was confirmed by the stress increases in ordinary steel (Figure 17b). The drastic decrease in prestressing force after 888 thousand cycles was caused by a decrease in the force of one

strand. The initial value of the force in the cable decreased from 182 kN to 152 kN, i.e., 16%. This decrease was likely caused by a fatigue interruption in one of the seven wires in the strand (a 14% loss in the strand cross-sectional area).

- For the more strongly loaded slab No. 2, we observed a decrease in the role of prestressing as the number of cycles increased (Figure 16). Cross-sectional tensile forces were taken up by the ordinary reinforcement (Figure 17b).

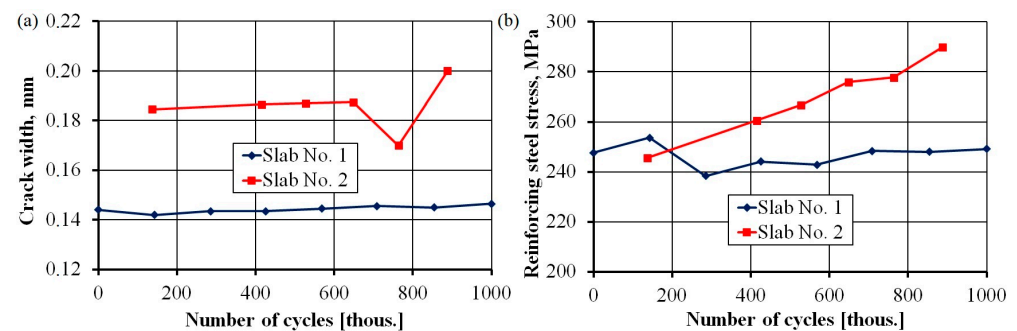
Figure 17. Crack width (a); reinforcing steel stress (b) versus number of load cycles.

Figure 17 shows the changes in the width of cracks and stresses in reinforcing steel with an increase in the number of cycles. In both cases, an upward trend can be observed. The width of the crack remained at a safe level throughout the entire range of loading. In slab No. 1, the width fluctuated between 0.14 and 0.15 mm, while in slab No. 2, the width fluctuated between 0.18 and 0.19 mm. Notably, the width of the crack was smaller than the calculated value of 0.21 mm. The average spacing of cracks was 130 mm—more than two-times lower than the theoretical value of 310 mm. The stresses in ordinary steel oscillated around a calculated value of 245.9 MPa for slab No 1 and clearly increased with the number of cycles for slab No. 2.
