# Petrophysical Analyses of Rock Construction Materials from a Roman Rural Settlement in Podšilo Bay on Rab Island (North-East Adriatic, Croatia)

**Abstract:** This article presents the results of petrophysical analyses of limestones and sandstones used for the construction of the wall structures of a Roman rural settlement located in Podšilo Bay on Rab Island (Croatia). An on-site analysis of the walls indicated the use of different lithotypes, which is an uncommon case in the area. So far, no petrophysical properties of the applied materials have been tested, and their provenance has not been specified. The aim of this research was to determine their usability as construction materials in an attempt to determine the possible reasons behind the usage of multiple lithotypes and their suitability as building materials. The following procedure was used to address these issues: (1) determination of the petrographic characteristics of the rocks, (2) performance of tests to characterise the mechanical properties in a complex stress state of uniaxial tension followed by uniaxial and triaxial compression, and, finally, (3) determination of the internal structure of the rocks using method

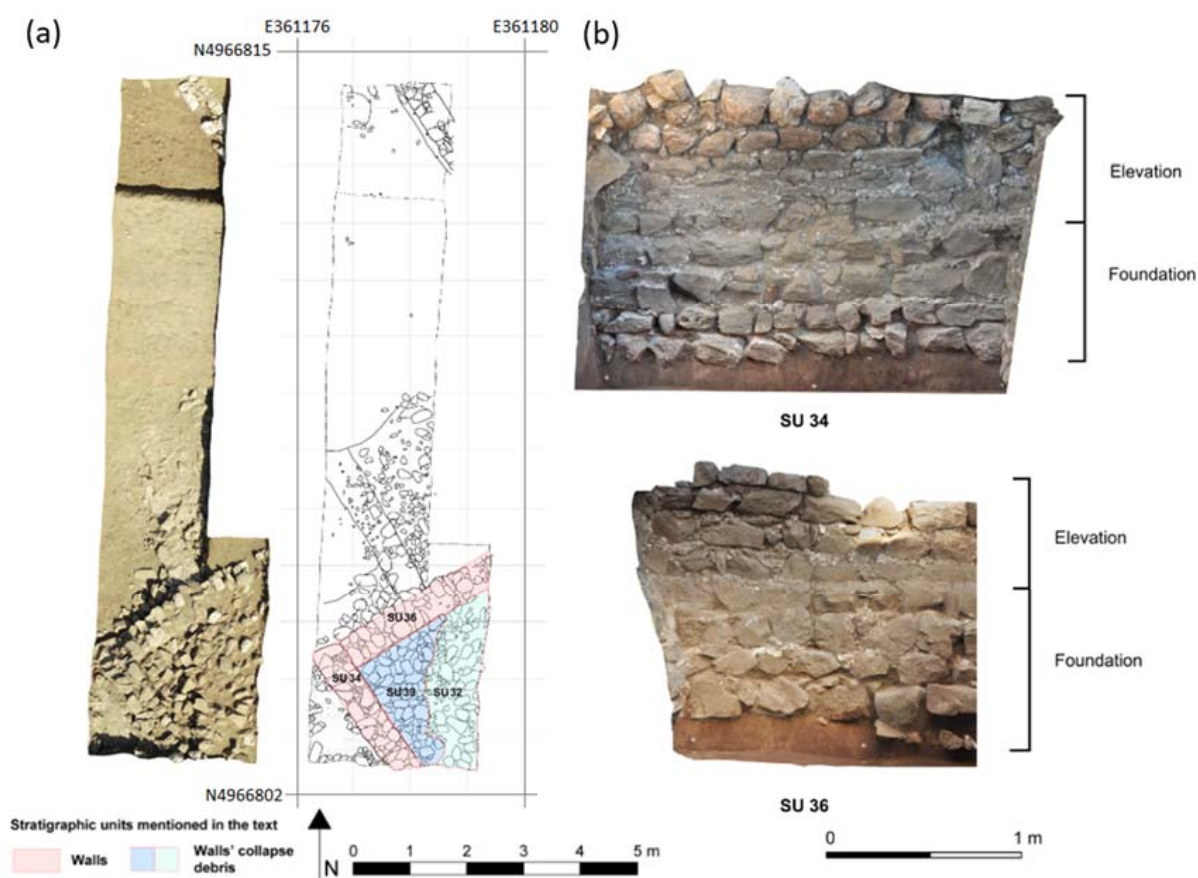
**Figure 4.** Excavation of the Roman structures at Beli grad. (a) Photograph and map of the trench with marked archaeological layers (drawing by K. Rabięga, modified), (b) cleared part of the preserved internal walls SU 34 and SU 36.

The material for petrophysical and endurance research was collected during excavation in Trench 2 in the Beli grad area of Podšilo Bay (Figure 4a,b). The trench was aimed to explore parts of the eastern wing of a building of probable residential use. Part of the stratigraphy in the southern part of Trench 2 comprised a thick layer of rubble collapsed from the adjacent walls—SU 34, 36. The foundation of these walls was mostly constructed with irregular, medium-sized blocks of sandstone and limestone, bound with lime mortar only in their upper part. The wall structure consists of two leaves built of roughly worked sandstone and limestone blocks, joined by lime mortar so that they form regular rows of various heights. The wall core consists of smaller stones bound together with mortar. Walls SU 34 and SU 36 were probably the internal walls of the building (Figure 4b).

Stone samples were collected from SU 32, SU 36, and SU 39 (Figure 4a). SU 32 constitutes the upper part of the destruction debris mixed with soil, SU 36 is the wall extending from NE to SW in the trench from which a loose stone was extracted, while SU 39 is another layer of collapsed stones that lies below SU 32, roughly mixed with soil.

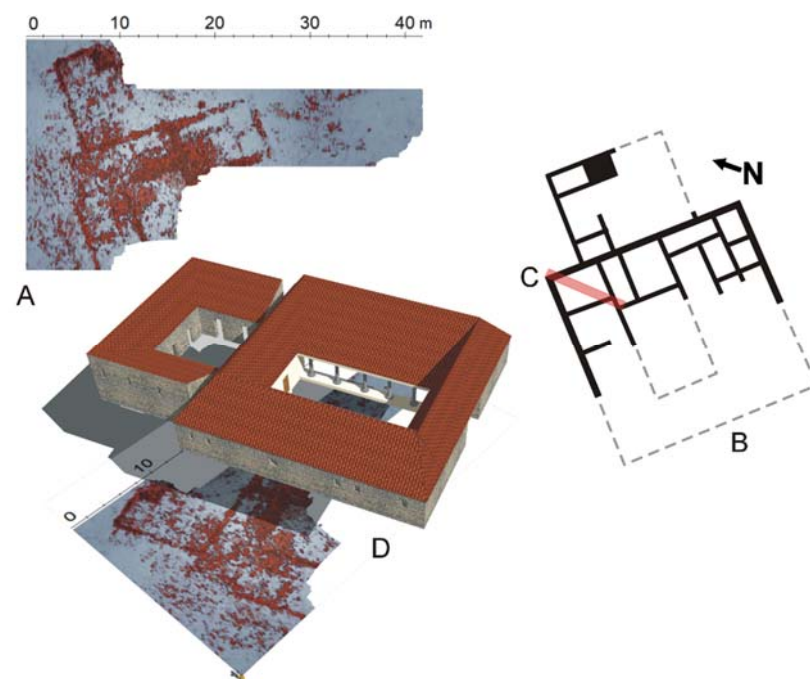
**Figure 5.** (A) Ground-penetrating radar prospecting results showing the remains of a villa at the depth of approximately 0.40 m. Notable is the central courtyard—atrium. (B) A tentative reconstruction of the villa plan on the basis of geophysical surveys and excavations. (C) Location of the archaeological excavation; see text for a detailed discussion. (D) A tentative reconstruction of the villa appearance. (Elaboration of GPR results and drawings: F. Welc).

Following the discovery of a Roman pottery kiln on the shore of the bay, conducted geophysical surveys have identified the location of the settlement's complex structure. Based on the excavations, two structures were identified: a smaller, possibly auxiliary building on the southern slope and a larger complex on the northern slope, interpreted as the settlement's central building (villa). As shown by GPR measurements (GPR), the structure of these buildings is located around an enclosed space [9], perhaps a courtyard, with wings divided into multiple rooms of a yet undetermined function. The surveys have provided the basis for inferring the size of the buildings on the plan (Figure 5), but, unfortunately, when applied to the buildings in their current state, they did not provide answers to either their size or the number of storeys. Most of the Roman archaeological sites in Croatia from the discussed period, including buildings, whether residential or productive structures, are usually preserved only at the foundation level. This is the main reason why it is difficult to reconstruct their original appearance.

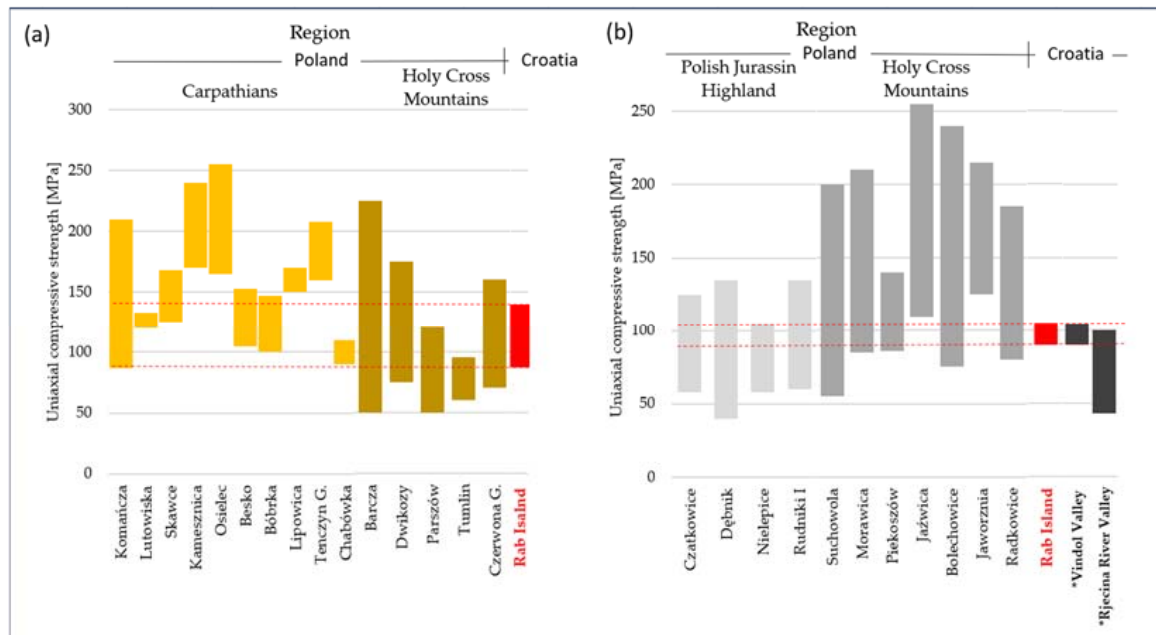
**Figure 10.** Uniaxial compressive strength of rock tests against the strength of rocks from the region of Poland and Croatia: (a) sandstones, (b) limestones. \*—Limestone USC results from Vindol Valley and Rječina River Valley based on [47].

The analysis of the endurance values resulting from uniaxial compression indicates that the investigated rocks are characterised by high or very high endurance. Taking into consideration the endurance of sedimentary rocks, subject to the same processes from the area of Poland, their parameters range from 40 to 250 MPa (Figure 10). Thus, the values obtained in this study are in the middle of this range.

The results of uniaxial compressive tests for limestones were also compared with the results of rocks from Croatia from the literature. The range of USC results for the studied Rab Island limestones are very similar to the results of limestones from the area of the western part of Croatia, specifically the Vindol Valley and Rječina River Valley sites [45], except that the Rječina River Valley limestones are more weathered than the Rab Island limestones. The macroscopic comparison of the Rab Island limestones to limestones from Western Croatia indicates that they are closer to the Rječina River Valley limestones, whose strength is lower. The UCS studies reported by Pollak et al. [48] from 11 sites spread mainly around Southern and Western Croatia present a very large range of results (UCS—25–273 MPa, mean 127 MPa). The authors explain this fact by the structural and lithological changes and limestone weathering effects, and they propose an equation to estimate the UCS based on a visual assessment. Following the classifications presented in [47], the limestones from Rab Island are characterised by significantly lower uniaxial compressive strength than the similar ones presented there, and they are closer in strength to the highly fractured, moderately weathered, and moderately porous limestones.
