# Steel Automotive Wheel Rims—Data Fusion for the Precise Identification of the Technical Condition and Indication of the Approaching End of Service Life

**Abstract:** Steel automotive wheel rims are subject to wear and tear, down to the end of their service life. Manufacturers use standard destructive tests to determine the probable lifetime of the car wheel rim. With this approach, to predict the remaining use time, it is necessary to know the initial parameters of the wheel rim, actual mileage, and its use characteristics, which is difficult information to obtain in the real world. Moreover, this work shows that a vehicle's technical condition can affect the rim's remaining service time. This work describes a new method of precise binary identification of the technical condition of steel car wheel rims using the dispersion of damping factors which result from experimental modal analysis. This work also proposes a new method of indicating the approaching end of wheel rim service life with limited parameters: run-out, average of damping factors, and dispersion of damping factors. The proposed procedure requires two sequential examinations of the rim in standard periods related to

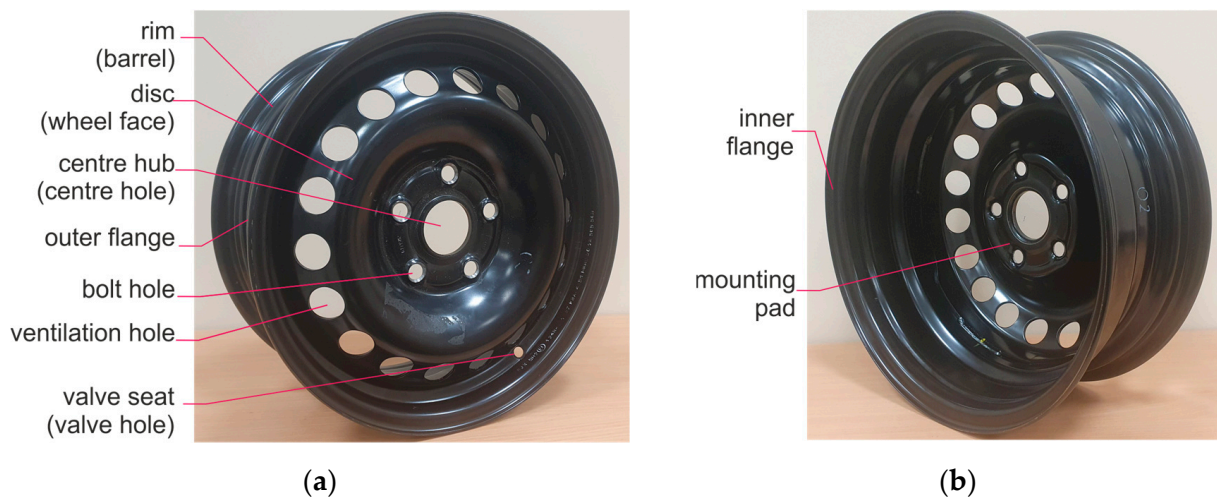
A view of a steel automotive wheel rim with a glossary is presented in Figure 1. The wheel rim is not an ideal axis-symmetric structure. Axial symmetry is disturbed by the ventilation holes, bolt holes, and valve seat. The number of bolt holes and their shape can differ depending on the automotive manufacturer. The bolt hole can be conically or cylindrically shaped.

**Figure 1.** View of a steel automotive wheel rim: (a) Outer view; (b) Inner view.

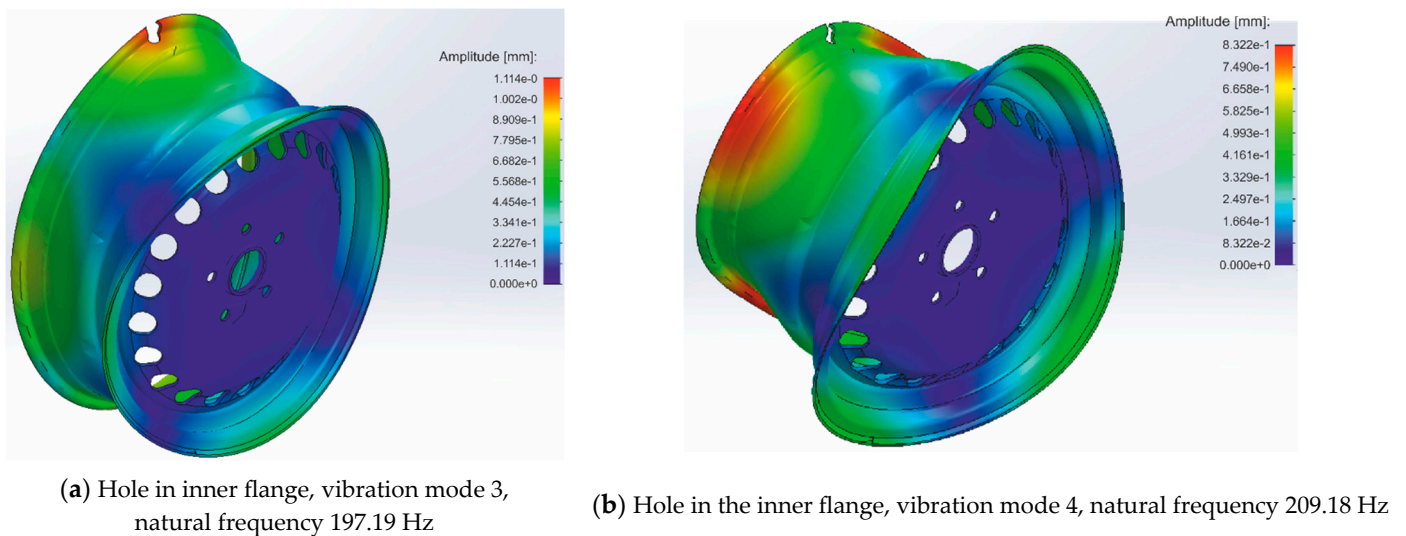
A severely damaged rim can also be described as a rim with a broken-out part of the inner flange. This fact can be simulated with the use of two holes with a diameter equal to 15 mm, as assumed in the previous analysis. Such damage is easily overlooked during inspections. In addition, due to its size, such damage leads to air escaping from the tire. The simulation results of a rim with such damage are shown in Figure 4.

**Figure 4.** Simulation results of a severely damaged wheel rim: (a) Hole in inner flange, vibration mode 3; (b) Hole in the inner flange, vibration mode 4.

The summary of the obtained results is presented in Table 2. As can be seen, the direct analysis of the amplitudes and frequencies of the excited modes for individual cases does not show regular dependency damage to amplitude tendency. On the other hand, studying the variability of the maximum amplitudes and frequencies of the excited modes indicates the possibility of detecting rim damage. As the frequency difference signal is cast in a low band, the presence of a signal in the low band can be used as an indicator of rim damage. Thus, the experimental modal analysis set-up should be characterized by the possibility of measurement in the low band of frequency signals in the range of from 0 to 12 Hz with at least 0.1 Hz resolution of frequency examination. According to the simulation results (see Table 2), measuring modal parameters as the variability of maximum amplitudes is much more complex than the variability of natural frequencies of excited modes.

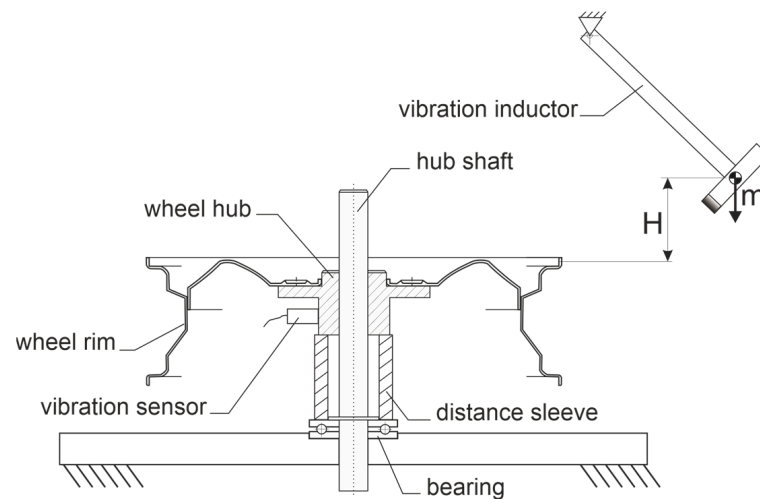
The measurement of experimental modal analysis based on monitored vibration excitation of the rim is presented in Figure 5. The view of the mechanical part of the measurement system for EMA is presented in Figure 6.

**Figure 5.** Scheme of the mechanical components of the measurement system used for experimental modal analysis.

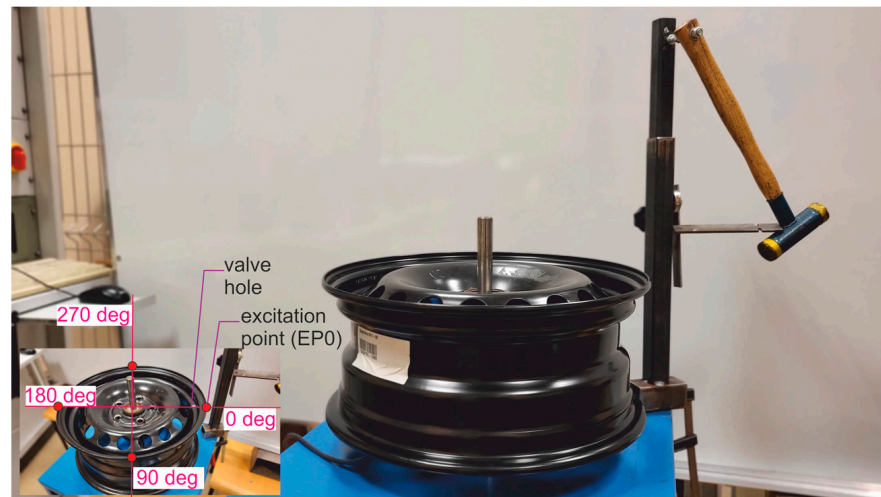
**Figure 6.** View of the mechanical part of the measurement system for EMA with vibration excitation points (EP) marked.

The steel automotive wheel rim is positioned on the hub shaft and fixed by gravity on the hub. The vibration inductor is a roofing hammer of a mass of 425 g that is lifted before the excitation of vibrations to the height of  $H = 26$  cm. In such conditions, the impact energy is 1.08 J.

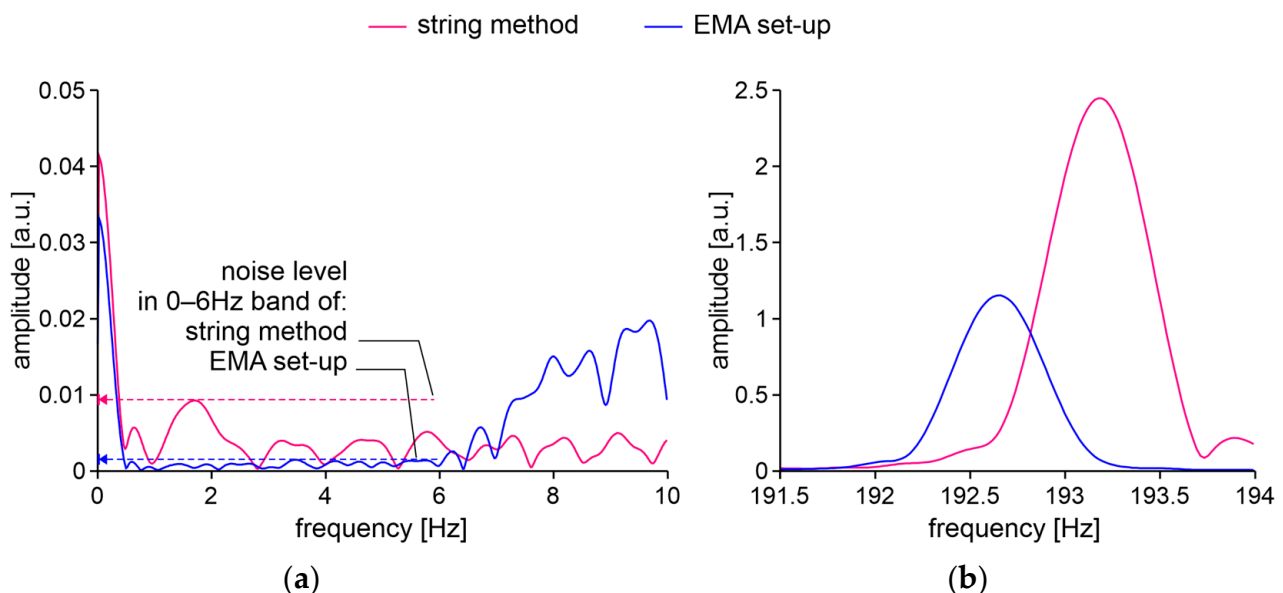
Example results of spectra investigation with the resolution of 0.02 Hz, using the proposed set-up and the string method for an ideal rim, are presented in Figure 7. The string method was called here the measurement of vibrations of a hanging rim, which was positioned on the hub and shaft to which the string was attached. The mentioned string was attached to the ceiling on the other side. The expected mathematical model maximum value does not characterize the constant component (at frequency 0 Hz) due to head coupling with the use of a capacitor to the acquisition card. In the analyzed case, the dominant frequency peak measured in the EMA set-up is 192.60 Hz, and for the string method is 193.3 Hz. The difference is most likely due to the influence of the bearing, which was not present on the shaft in the string method. Additionally, both values are lower than the initial simulations. The differences in natural frequencies of simulation and measurement come from the measurement of the wheel rim coupled with mounting accessories and simulation of only the wheel rim.

**Figure 7.** Ideal OEM rim examination with EMA set-up and using the string method: (a) Low band; (b) Natural frequency band.

In the 0–6 Hz band, the noise level for the string method is 4.5 times greater than for the one obtained from the EMA set-up. Thus, the EMA set-up was used for examinations of typical degraded automotive wheel rims. Moreover, based on measurement characteristics obtained with the acquisition system, for the mentioned vibration excitation points, the damping ratios on natural frequencies are calculated using logarithmic decrement of amplitudes [60].

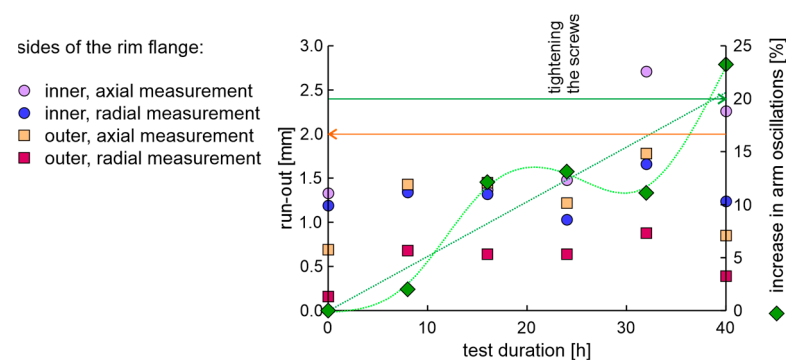
The rim in the OEM new factory condition was examined using the fatigue station and the EMA and run-out measurement system. The duration of a single fatigue cycle was 8 h. The axial and radial run-out values of the rim on the inner and outer sides of the flange are presented in Figure 10. The condition for the end of the test was met in 40 h, as the increase in moment arm oscillations increased above 20%. The obtained results of run-out values show that after 32 h of testing, the rim lost tolerance of dimensions.

Figure 10. The axial and radial run-out values and increase in moment arm oscillations of the new rim from OEM in a fatigue test.

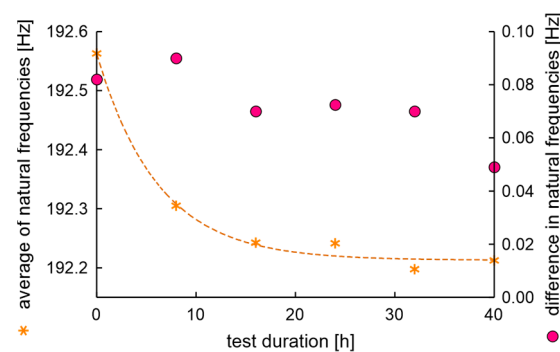
Figure 11. Average values and differences in natural frequencies of the rim of OEM in a standard fatigue test.

In the experiment, the average value of natural frequencies decreased, while the difference in natural frequencies can be characterized by decreased tendency. It can be postulated that the fatigue station performs a peculiar mechanical process related to rim running-in. The average values and dispersion of damping factors are presented in Figure 12.

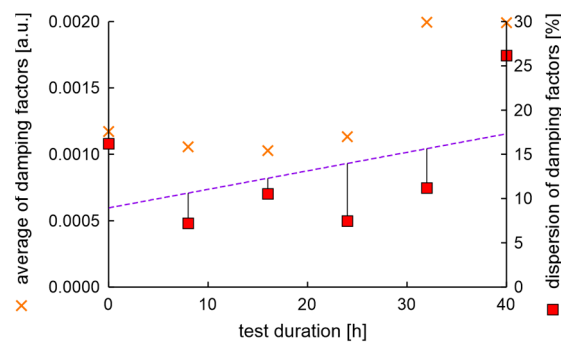
**Figure 12.** Average values and dispersion of damping factors of the rim from OEM in a standard fatigue test.

Results show that the average damping factor increases when the rim loses tolerance of dimensions. In this case, the dispersion of damping factors increases, but with a delay. It can also be seen that the local minimum dispersion of damping factors coincides with the cycle in which the rim mounting bolts were tightened. However, it should be noted that a significant increase in the dispersion of damping factors coincides with an increase in moment arm oscillations above 20%.

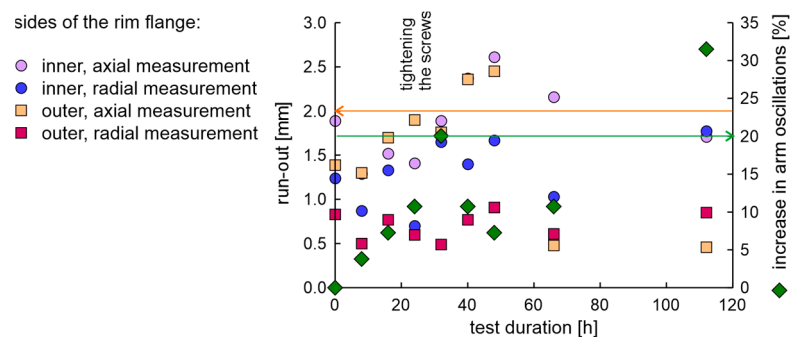
The rim from ARM was examined in a factory-new condition. The axial and radial run-out values of the rim on the inner and outer sides of the rim flange and the increase in moment arm oscillations are presented in Figure 13. The same situation of tightening the screws at the third fatigue cycle occurs for the new rims from OEM and ARM.

**Figure 13.** The axial and radial run-out values and increase in moment arm oscillations of the new rim from ARM.

can be again related to mechanical running-in of the rim in initially new factory conditions. Higher values of differences in natural frequencies than 0.075 Hz are linked with a rim that does not meet run-out standards, see Figure 13.

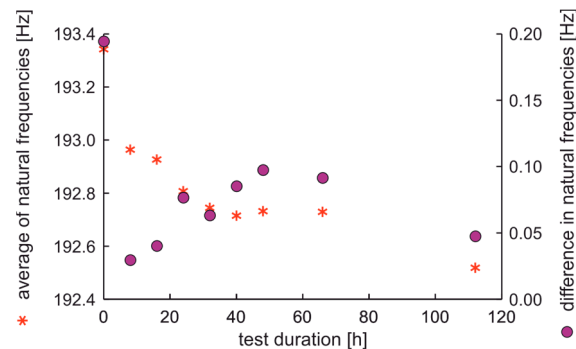
**Figure 14.** Average values and differences in natural frequencies of the new rim from ARM in an extended fatigue test.

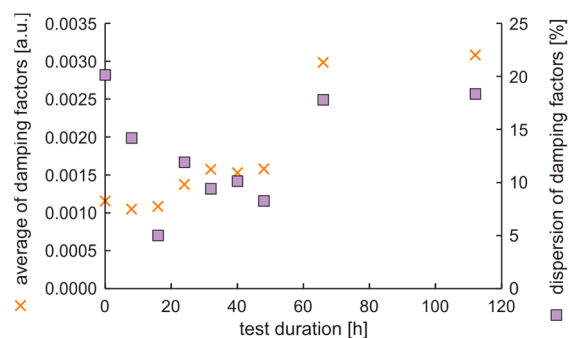
The average values and dispersion of damping factors are presented in Figure 15. The results show that the average damping factor increases with the time of fatigue test duration. The dispersion of damping factor initially decreases when the test duration increases up to 16 h, then stabilizes and increases. The dispersion of damping factors versus test duration is not a monotonic function. The same as in the previous study, the maximum value of the dispersion of damping factors is related to the maximum increase of oscillations of the moment arm.

**Figure 15.** Average values and dispersion of damping factors of the new rim from ARM in an extended fatigue test.

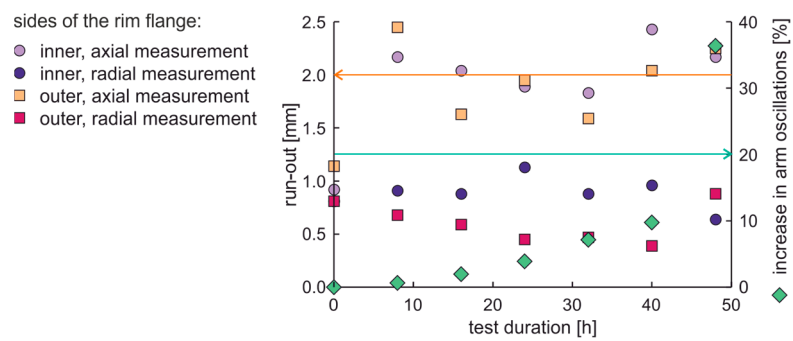
The fatigue station for the dynamic wheel cornering fatigue test can also be used to simulate different rim–hub contacts. The current trial used a slightly rusty hub to mount the rim. The rim of the same ARM is examined as in Section 6.2. The axial and radial run-out values of the rim on the inner and outer sides of the rim flange are presented in Figure 16. Values indicate that the run-out norm was exceeded much earlier than in Sections 6.1 and 6.2.

**Figure 16.** The axial and radial run-out and increase in moment arm oscillation values of the new rim from ARM in the fatigue test with a rusty hub.

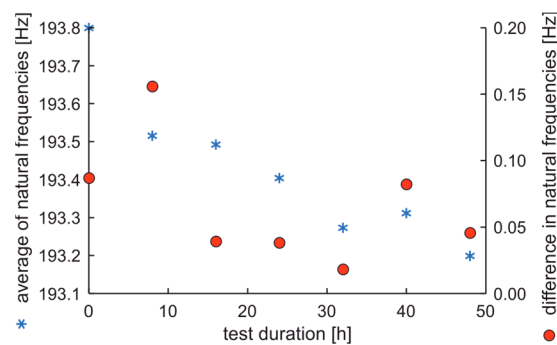
**Figure 17.** Average values and differences in natural frequencies of the new rim from ARM in the fatigue test with a rusty hub.

The course of the average natural frequency shows, as before (see Figure 10), a characteristic decrease during the fatigue test. However, the course of difference in natural frequencies is now characterized by greater values than presented in Figure 13, but it cannot be related to mechanical running-in of the rim in the initially new factory condition. The difference in natural frequencies is greater than 0.16 Hz at 8 h. This fact corresponds with the substantial run-out in the outer flange of the rim, whose axial deviation is 2.5 mm.

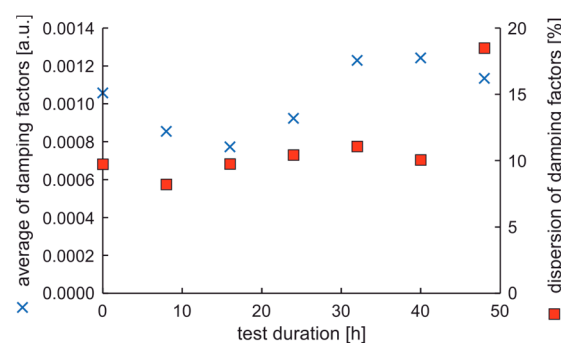
**Figure 18.** Average values and dispersion of damping factors of the new rim from ARM in the fatigue test with a rusty hub.

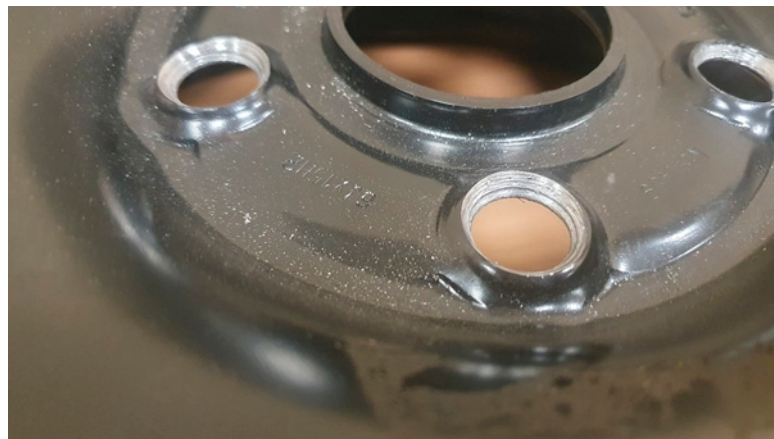
From the 40 h of test time, signs of degradation of the rim bolt holes and acoustic clicking were observed. The degradation of the rim bolt holes after 40 h of test duration is presented in Figure 19.

**Figure 19.** Degradation of bolt holes after 40 h of the fatigue test with rusty hub use for the new rim from ARM.

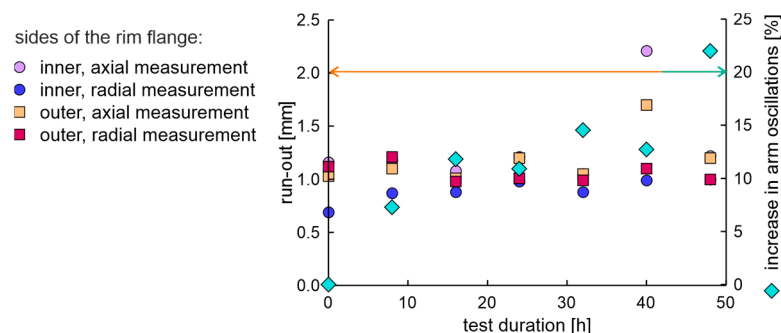
New rims of LCM sometimes seem to be a good selection from an economic point of view. Thus, two new rims were used in examinations. The axial and radial run-out values of the rim on the inner and outer sides of the flange are presented in Figure 20. During the 40 h of the fatigue test, the PN standard is completely met, while the ETRTO standard is exceeded only for measurements after 8 and 24 h. These results are better than for the new rim of ARM.

**Figure 20.** The axial and radial run-out values of the first new rim of LCM in a fatigue test.

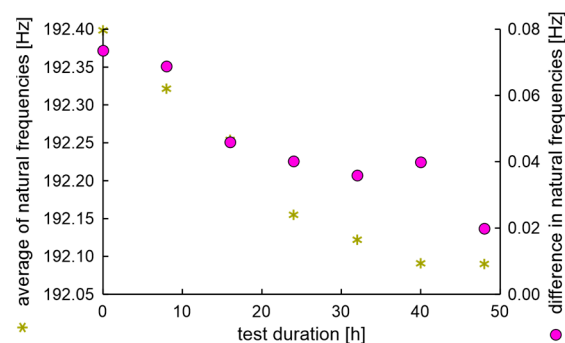
The average values and differences in natural frequencies of the first rim of LCM are presented in Figure 21. The average of natural frequencies and the difference in natural frequencies' tendency to decrease with test duration is evident.

**Figure 21.** Average values and differences in natural frequencies of the first new rim of LCM.

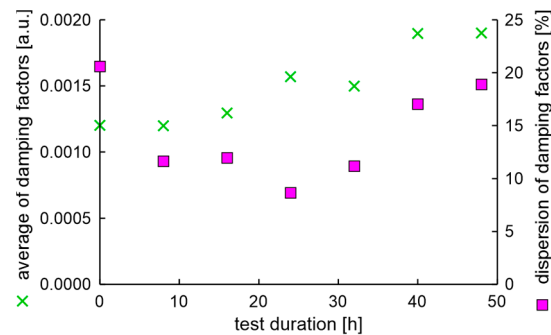
the test and corresponds with the time of maximum increase of moment arm oscillations. The only issue that can be found in the first new rim of LCM is the high initial value of the dispersion of damping factors. However, this value unexpectedly decreases during the fatigue test.

**Figure 22.** Average values and dispersion of damping factors of the first new rim of LCM in a fatigue test.

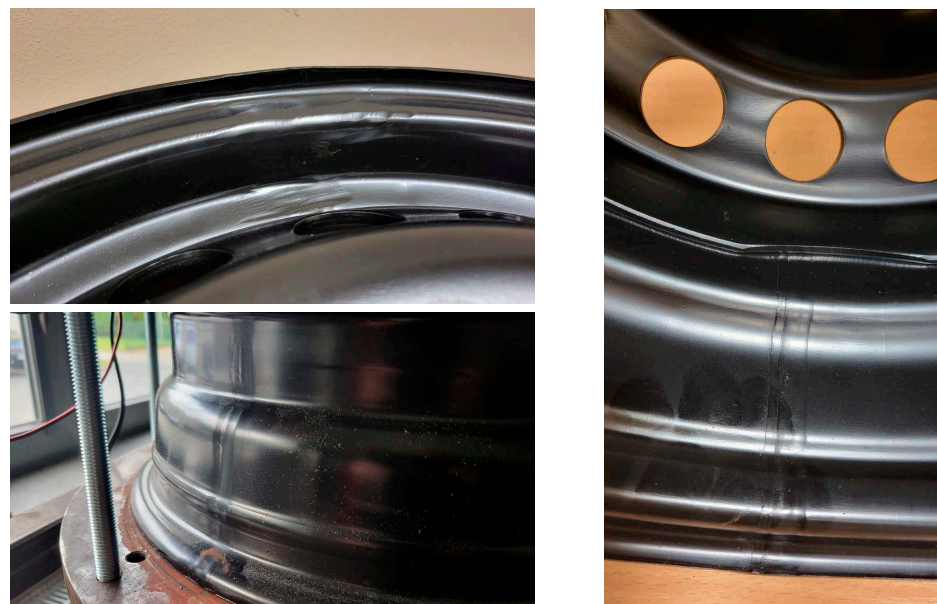
The second rim of LCM was not so fine. Its run-out values do not fit with the ETRTO and PN standards; its construction imperfections are visible in Figure 23. For reasons of safety of the testing personnel, this wheel was not subjected to fatigue tests.

**Figure 23.** Views of imperfections of the second rim from LCM.

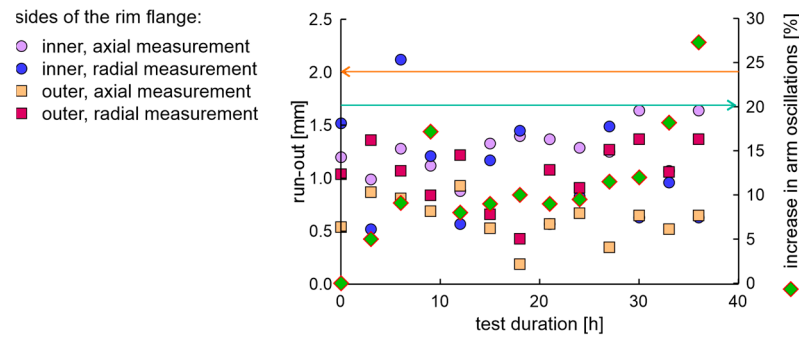
**Figure 24.** The increase of moment arm oscillations and run-out values of the used rim of OEM in a fatigue test.

The obtained results of the run-out indicate that after 6 h of the fatigue test, the rim lost its dimensional tolerance, but its shape somehow regenerated. It can be noticed that the used rim lost its dimensional tolerance much earlier than a new rim from the same OEM (Figure 10 Section 6.1). The average values and differences in natural frequencies are presented in Figure 25.

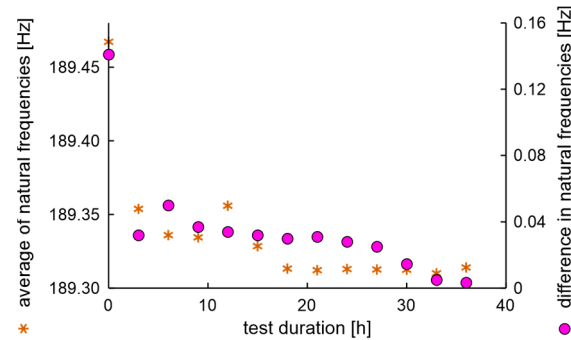
**Figure 25.** Average values and differences in natural frequencies of the used rim of OEM in a standard fatigue test with reduced time between EMA tests.

The EMA initial test results show that the difference in natural frequencies is more significant than that obtained for the new rim of the same producer, which can be expected, as the rim was used. Interestingly, the local maximum difference in natural frequencies at 6 h correlates with the maximum run-out. The average values and dispersion of damping factors are presented in Figure 26.

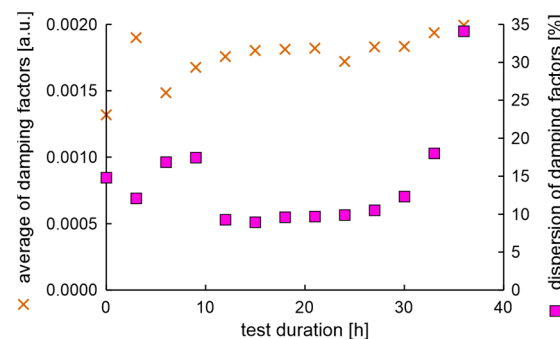
**Figure 26.** Average values and dispersion of damping factors of the used rim of OEM in the fatigue test.

after the dimension degradation point. Also, the maximum dispersion of damping factors is correlated with the maximum increase of moment arm oscillations.

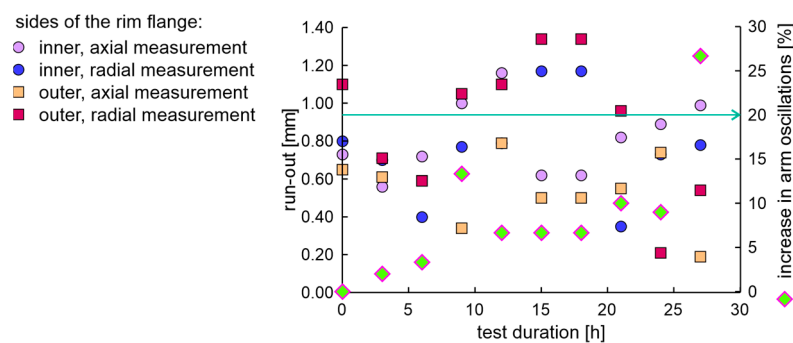
**Figure 28.** The increase in moment arm oscillations and run-out values of the new cut rim from OEM in a fatigue test.

The end condition of the test occurred in 27 h, which is faster than for any other new, undamaged rim. However, the run-out values, measured during the fatigue test of the rim with artificially generated cracks, are much smaller than for unmodified rims. The characteristics of natural frequencies during the fatigue test presented in Figure 29 appear normal.

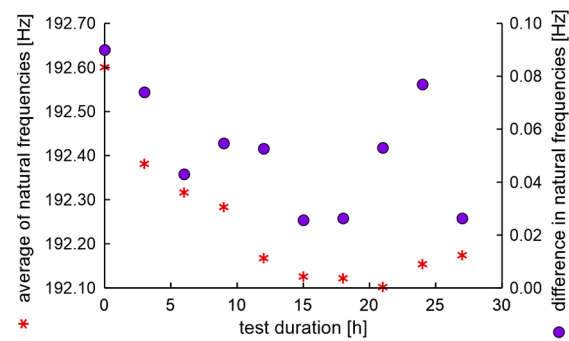
**Figure 29.** Average values and differences in natural frequencies of the cut rim of OEM in a standard fatigue test.

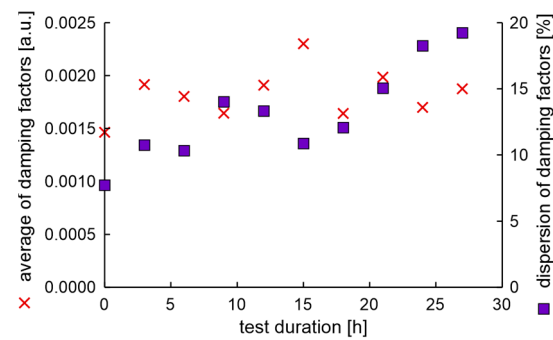
Measured damping factors during fatigue experiments presented in Figure 30 are also similar to the results obtained in previous sections.

**Figure 30.** Average values and dispersion of damping factors of the cut rim of OEM in a fatigue test.

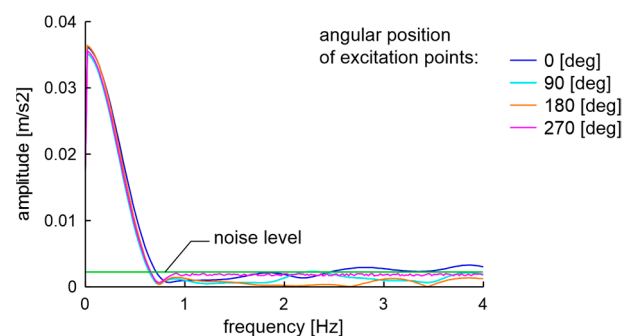
**Figure 31.** Low band spectra of EMA of 51/2Jx14H2 rim in an acceptable technical condition with a visual and run-out examination at the beginning of the experiment.

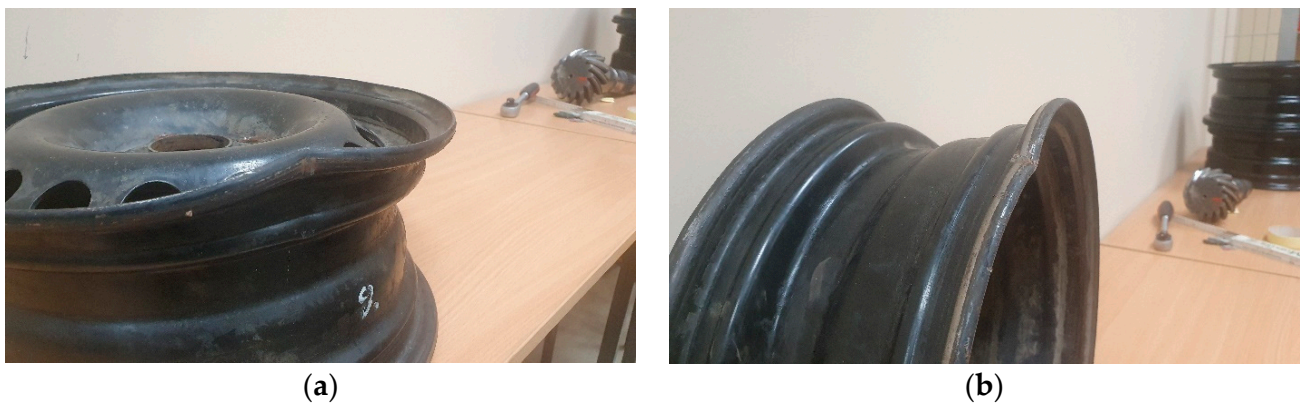
The run-out values of the used rim during the experiment are presented in Table 5. It is visible that the rim does not meet the run-out standards after hitting the curb. However, interestingly, the wheel passed the soapy water test for rim–tire integrity. Therefore, further operation was on non-public roads.

**Figure 32.** View of rim: (a) After it hit a curb; (b) Further six months of operation on partially paved forest roads.

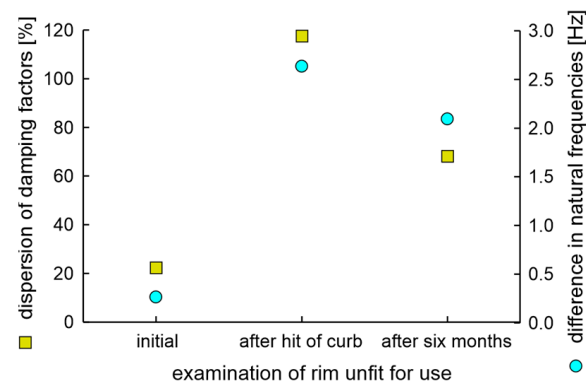
The obtained results show that during operation in the conditions of forest roads, the heavy degradation of the radial component of the geometrical dimension somehow decreases. Differences in natural frequencies and the dispersion of damping factors of the used rim are presented in Figure 33, which confirms this thesis. Still, all measured values here are much higher than in previously submitted laboratory cases of rim degradation with fatigue station use, as shown in Section 6.1, Section 6.2, Section 6.3, Sections 6.4 and 6.5.

**Figure 33.** Differences in natural frequencies and dispersion of damping factors of unfit for use rim type 51/2Jx14H2 of OEM.
