Article

Thermal Fatigue Behavior of Air-Plasma Sprayed Thermal Barrier Coating with Bond Coat Species in Cyclic Thermal Exposure

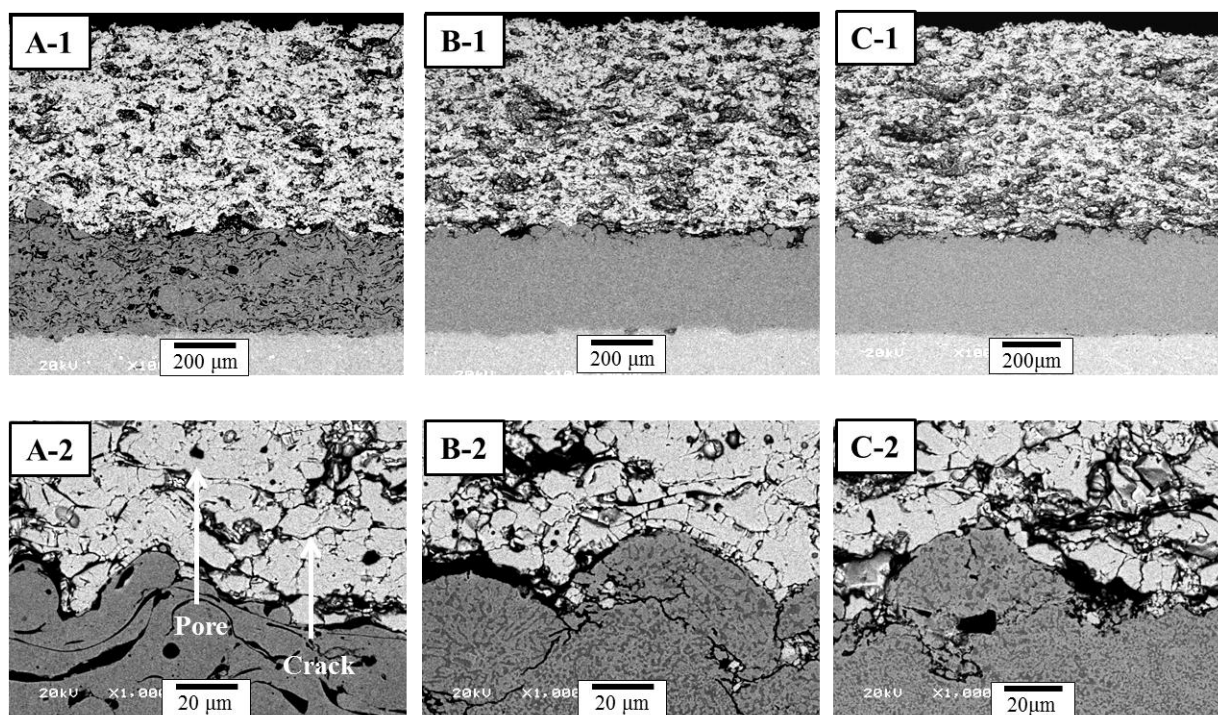
Figure 2. Cross-sectional microstructures of as-prepared thermal barrier coating (TBCs): (A) TBC with air-plasma spray (APS) bond coat; (B) Thermal barrier coating (TBC) with HVOF bond coat; and (C) TBC with low-pressure plasma spray (LPPS) bond coat. Each number indicates the overall and interface microstructures, respectively.

The cross-sectional microstructures of as-prepared TBC specimens are shown in Figure 2, indicating that Figure 2(A-1)–(C-1) are the microstructures of the TBCs with different bond coats prepared by the APS, HVOF and LPPS processes, respectively. The top coats prepared by the APS process showed intrinsic defects, such as pores, unmelted particles, and splat boundaries. In the APS process, many small particles are accelerated by the high-power plasma to impinge on the bond coat to form the top coat. The interface microstructures between the top and bond coats of TBCs formed in this study are shown in Figure 2. The interface of the TBCs (Figure 2(A-2)–(C-2)) showed irregular shapes at the interface between the top and bond coats, without the formation of a TGO layer and cracking between the top and bond coats. The bond coats prepared by the HVOF and LPPS exhibited similar microstructure with a dense microstructure and no oxide formation, whereas the APS bond coat featured high levels of visible oxides.

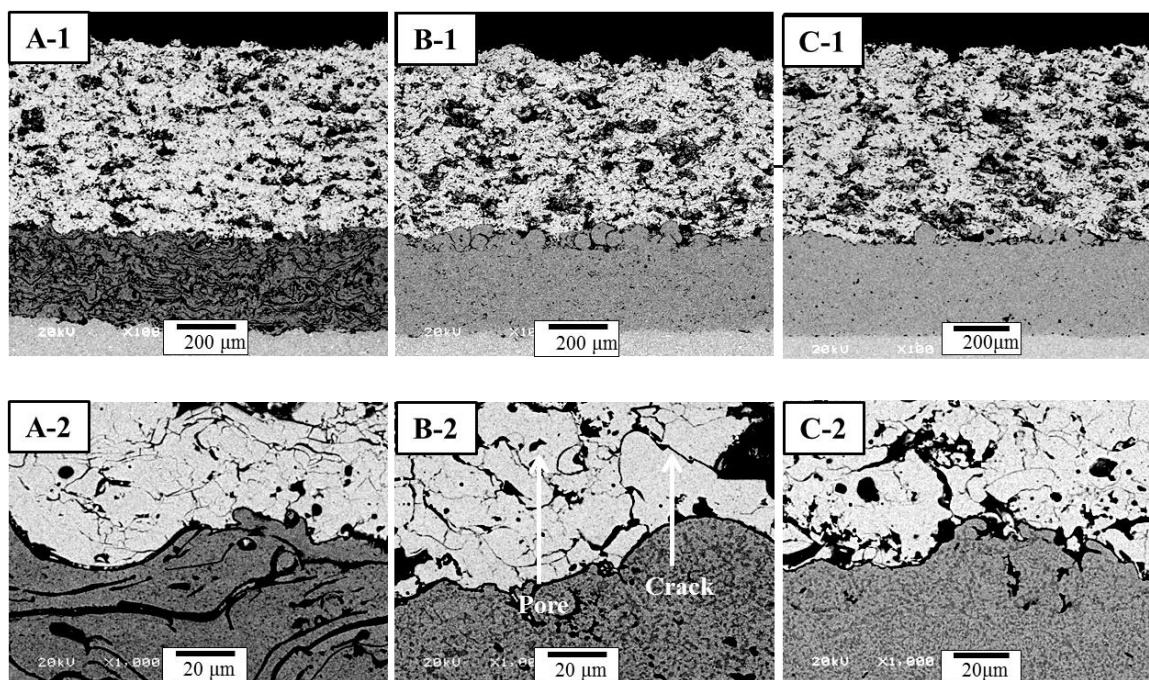
Figure 3. Cross-sectional microstructures of TBCs after FTF tests for 1429 cycles: (A) TBC with APS bond coat; (B) TBC with HVOF bond coat; and (C) TBC with LPPS bond coat. Each number indicates the overall and interface microstructures, respectively.

Cross-sectional microstructures of different bond coats deposited by the APS, HVOF, and LPPS are shown in Figure 3 after the FTF tests for 1429 cycles. After the thermal fatigue tests for 1429 cycles using the FTF apparatus, the interface microstructure of each TBC showed a sound condition without cracking or delamination. The TGO layer was not fully developed after 1429 cycles, because of the relatively short thermal exposure time (5 min) and the lower temperature on the bond coat (the temperature of bottom surface: 350–500 °C), showing a thickness for the TGO layer in the range of 2–3 μm. The interface microstructures were densified owing to resintering during the thermal exposure to 1429 cycles, even though the thermal exposure time was just 119 h. The interface microstructures of each TBC system after the FTF were much similar with each other, compared with the as-prepared TBC.

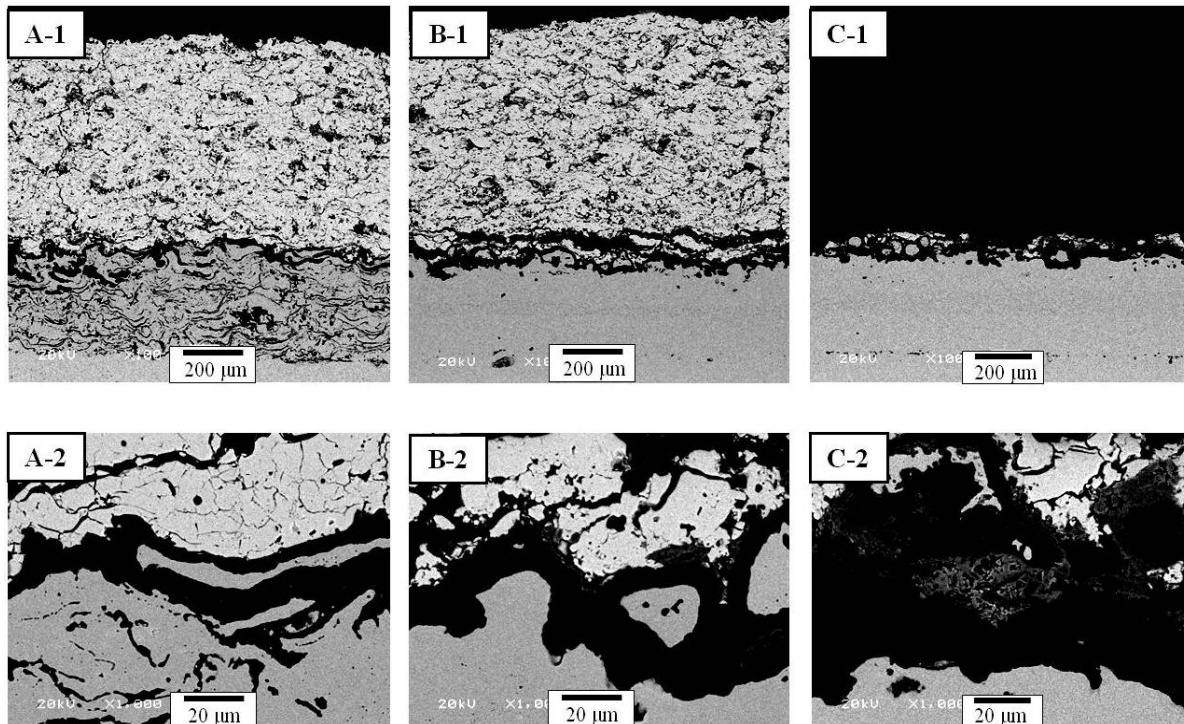
Figure 4. Cross-sectional microstructures of TBCs after CFTF tests: (A) TBC with APS bond coat; (B) TBC with HVOF bond coat; and (C) TBC with LPPS bond coat. Each number indicates the overall and interface microstructures, respectively.

The cross-sectional microstructures of different bond coats deposited by the APS, HVOF, and LPPS processes are shown in Figure 4 after the CTFT tests. The TBC with the APS bond coat (Figure 4(A-1)) showed defects, such as the horizontal and vertical cracks, in the top coat, TGO layer at the interface, and oxidation in the bond coat after the CTFF for 1429 cycles. In the case of TBC with the HVOF bond coat (Figure 4(B-1)), a thick and long crack near the interface between the top coat and TGO layer was newly developed. The TBC with the LPPS bond coat (Figure 4(C-1)) was delaminated after 780 cycles, but no delamination was observed in other TBCs. The nominal thickness of the TGO layer in the TBC with the APS bond coat (Figure 4(B-1)) was 10.5 mm, whereas the nominal thickness of the TGO layer was 16.5 mm for the TBC with the HVOF bond coat (Figure 4(B-2)). The nominal thickness for the TGO layer for the TBC with the LPPS bond coat was 13.3 mm (Figure 4(C-2)), after delaminating at 780 cycles. The oxidation of the bond coat leads to a change in sign of stresses due to the smaller coefficient of thermal expansion (CTE) of the TGO layer. It is assumed that small cracks formed in the regions of initial tensile stress at the peak tips before and grow into the valleys after stress conversion [28]. The lifetime of different bond coats deposited by the APS, HVOF, and LPPS processes is shown in Figure 5 after the CTFT tests. The result indicates that the structural effectiveness is one of important factors for thermal durability of TBC system.

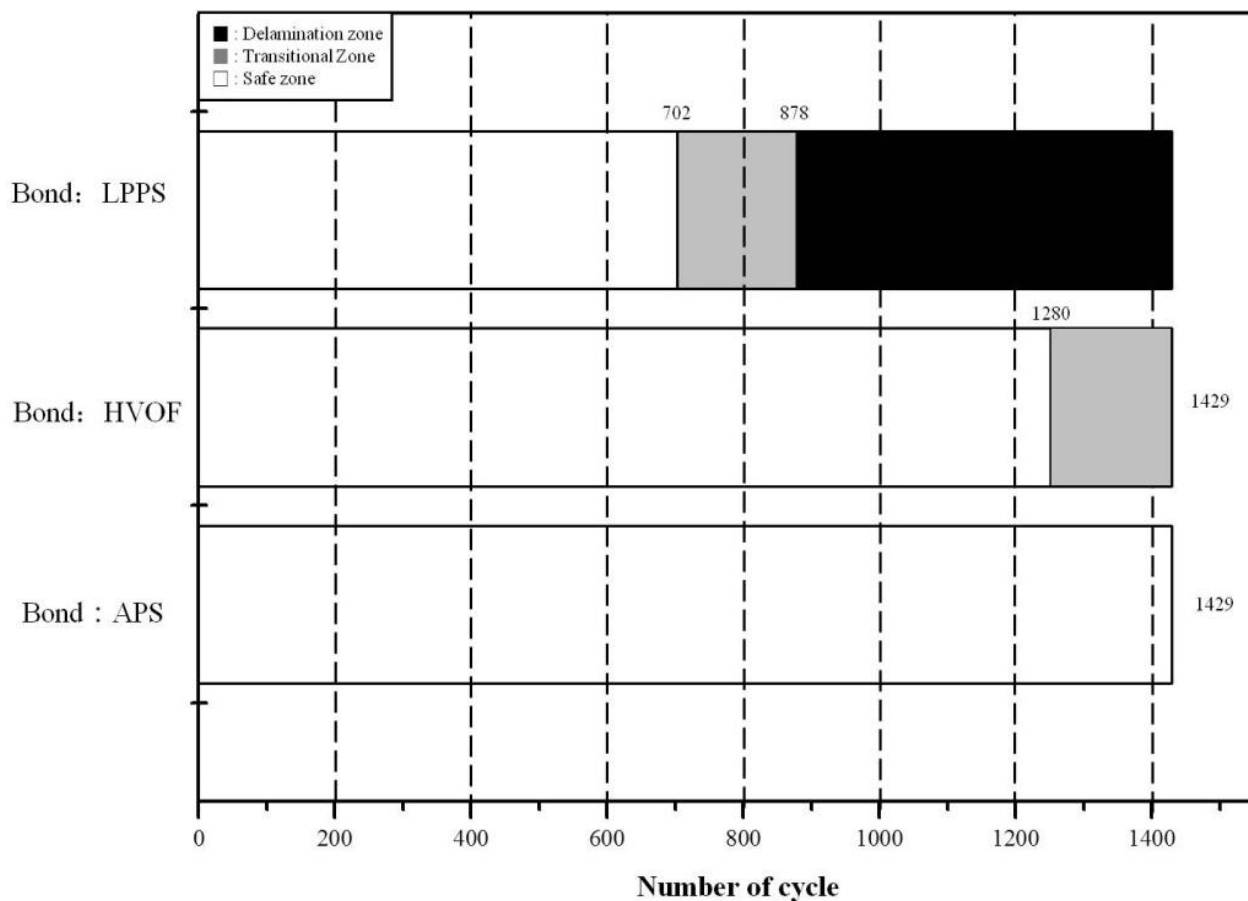
Figure 5. The lifetime of TBCs with different bond coats after CFTF tests as a function of cycle number.

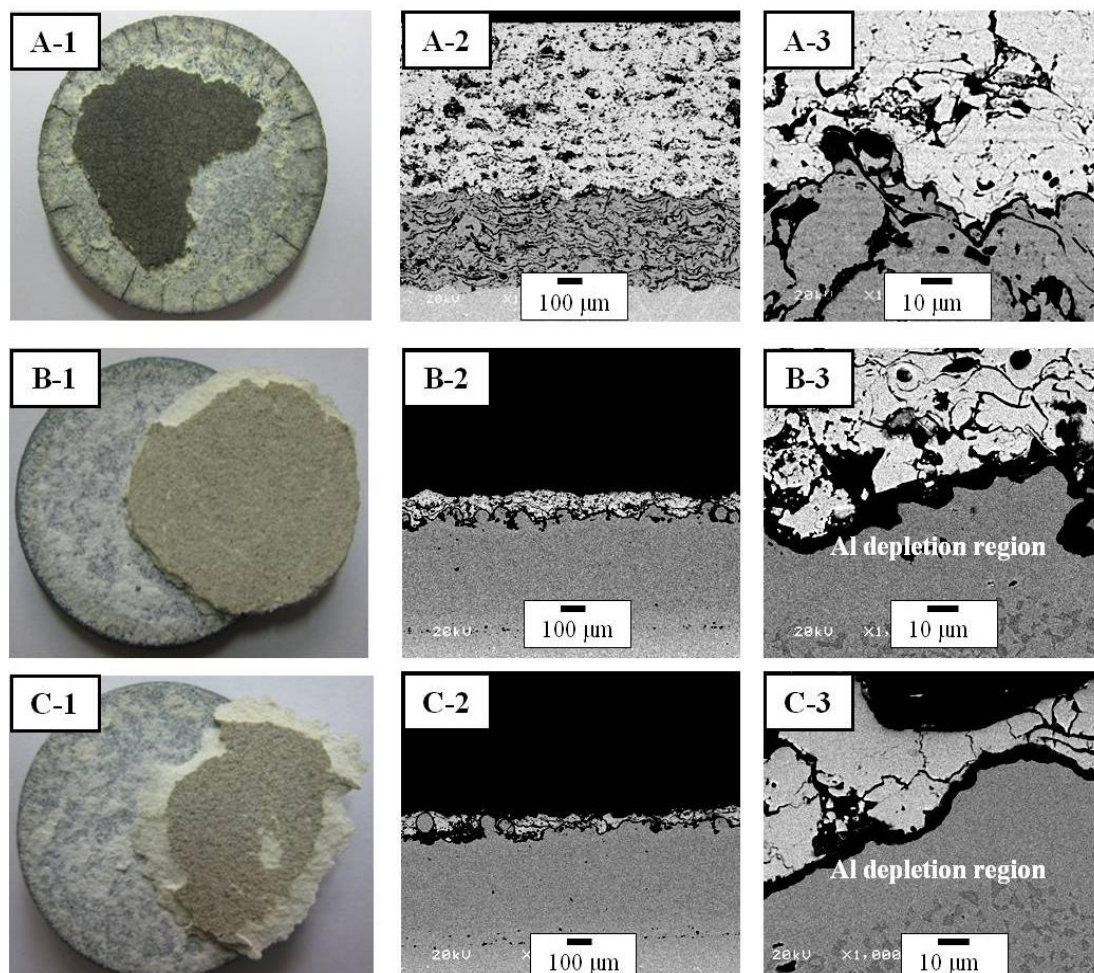
Figure 6. Surface micrographs and cross-sectional microstructures of TBCs after TS tests: (A) TBC with APS bond coat; (B) TBC with HVOF bond coat; and (C) TBC with LPPS bond coat. Each number indicates surface micrographs, cross-sectional interface microstructures between the top and bond coats, and high magnification interface microstructures, respectively.

The surface micrographs and cross-sectional microstructures of TBCs after the TS tests are shown in Figure 6. The surface micrographs showed a delamination of spalling mode at the interface between the bond and top coats. This may be due to the large temperature difference between the substrate and the top coat surface during the quenching and annealing processes. The temperature difference causes thermal stresses at the interface of the bond and top coats. The mismatch in the CTEs between the top and bond coats or oxidation of the bond coat leads to delamination and failure. The TBCs with the APS bond coat were delaminated in the range of 145–159 cycles, whereas the TBCs with the HVOF bond coat were delaminated after 30–36 cycles. In addition, the TBCs with the LPPS bond coat were delaminated after 42–46 cycles. In the TBCs with the APS bond coat, the radial cracks were created from the edge of specimens due to the relatively higher number of cycles. The TBCs with the bond coats by the HVOF and LPPS showed the Al depletion region between the bond and top coats. Usually the depletion of Al in the bond coat after oxidation was about 6 wt % for the VPS bond coat and about 4 wt % for the APS bond coat at TBC failure, indicating that the lifetime of TBCs with the APS bond coat was superior to that of TBCs with the VPS bond coat [26]. The result of previous study is in agreement with our results of the CFTF and TF.

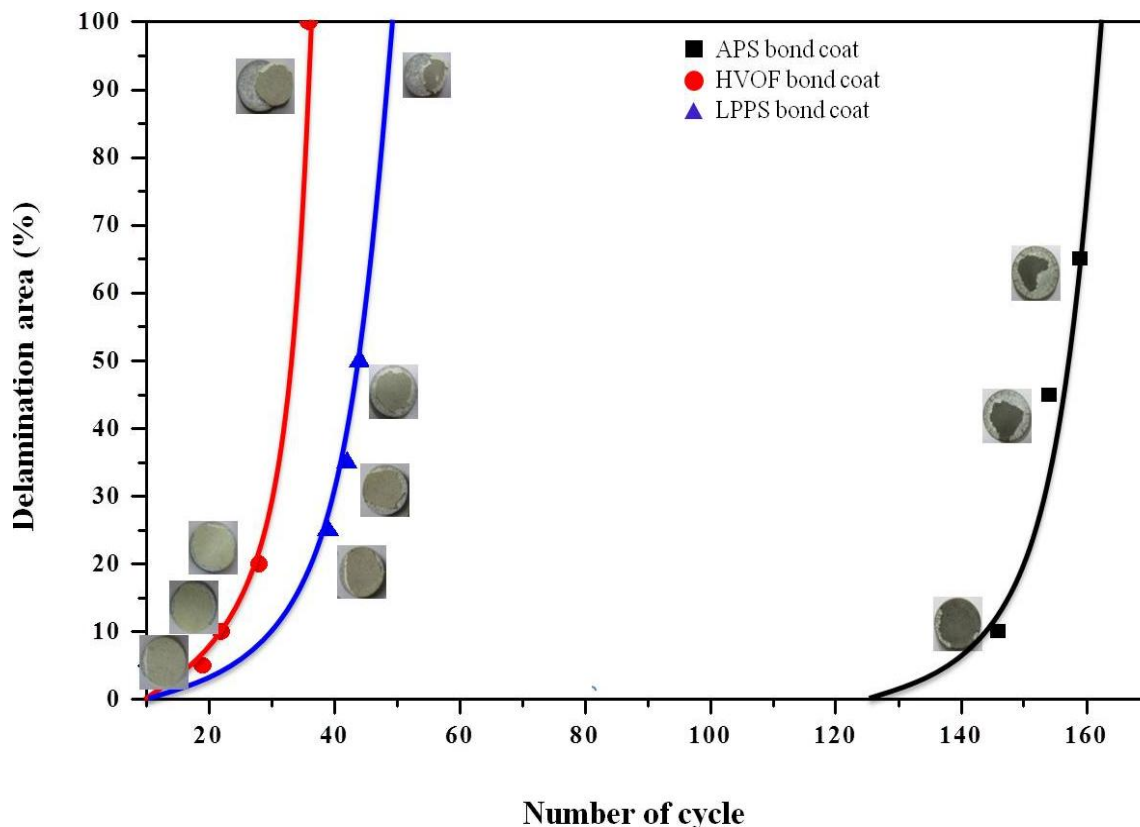
Figure 7. Variation of delamination area with thermal fatigue cycle in thermal-shock tests. The solid curves are empirical data fits.

Evolution of the delamination area during the TS tests is shown in Figure 7 as a function of cycle number. The TBC with the APS bond coat started to be delaminated after 130 cycles, where the delamination area was only 5%. After 155 cycles, the TBC was delaminated more than 60%. However, the TBC with the APS bond coat was not completely delaminated. The TBC with the HVOF bond coat started to be delaminated after 18 cycles, where the area of delamination was 10%. After 36 cycles, the top coat was completely delaminated. In the case of the TBC with the LPPS bond coat, the delamination started to occur after 40 thermal cycles, which was completed after 52 cycles. In all cases, the top coats were delaminated more than 50% in the range of 10–25 cycles after starting to delaminate, meaning that control of the initial delamination is more important in enhancing the lifetime performance of TBCs. The lifetime of TBCs with different bond coats after the thermal fatigue and thermal-shock tests are shown in Table 1.

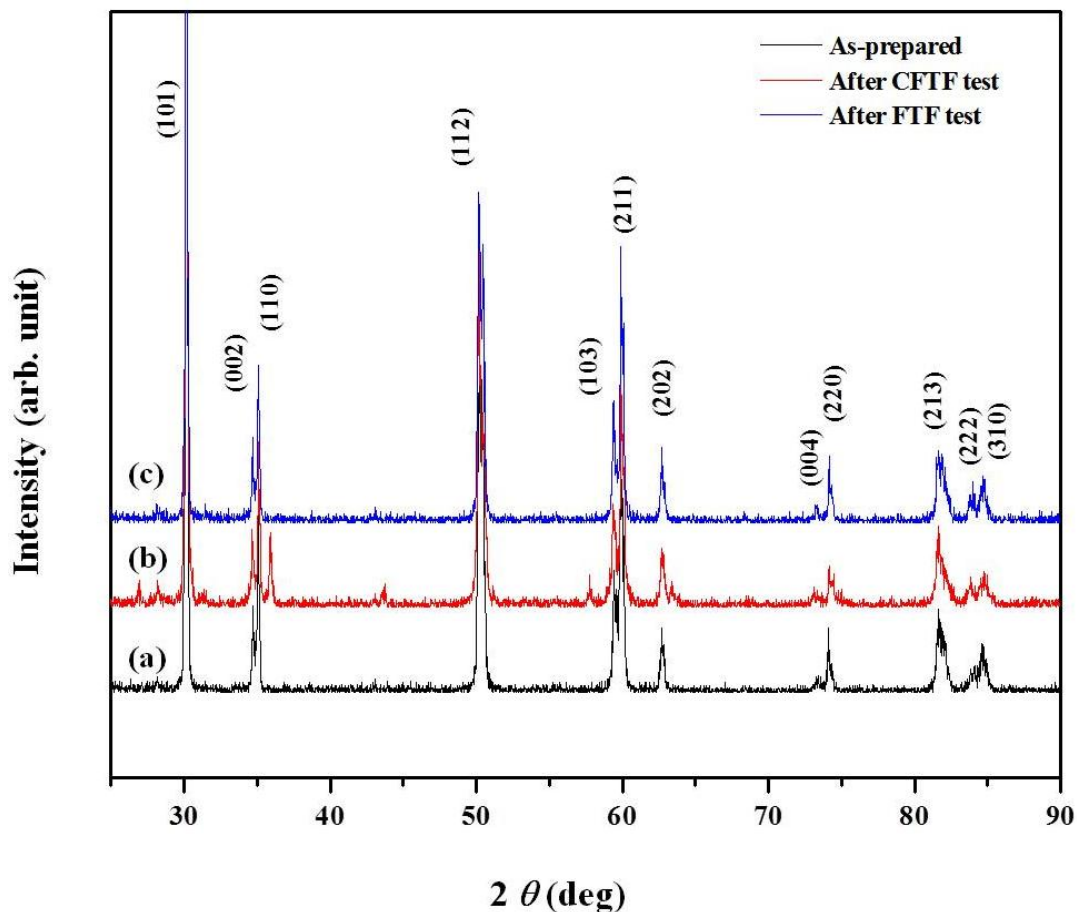
Figure 8. X-ray diffraction (XRD) pattern of TBCs of as-prepared and after cyclic thermal exposure.

X-ray diffraction (XRD) patterns were investigated to confirm the phase identification of the TBCs before and after the tests as shown in Figure 8. All of the peaks were tetragonal and cubic phases without any monoclinic phase before and after thermal exposure. Any phase transformation causing cracks and defects in the TBC was not observed after all tests performed in this study. It is important to suppress the monoclinic phase to enhance the thermal stability. It was verified that the TBCs prepared in this work was not affected by any phase transformation.

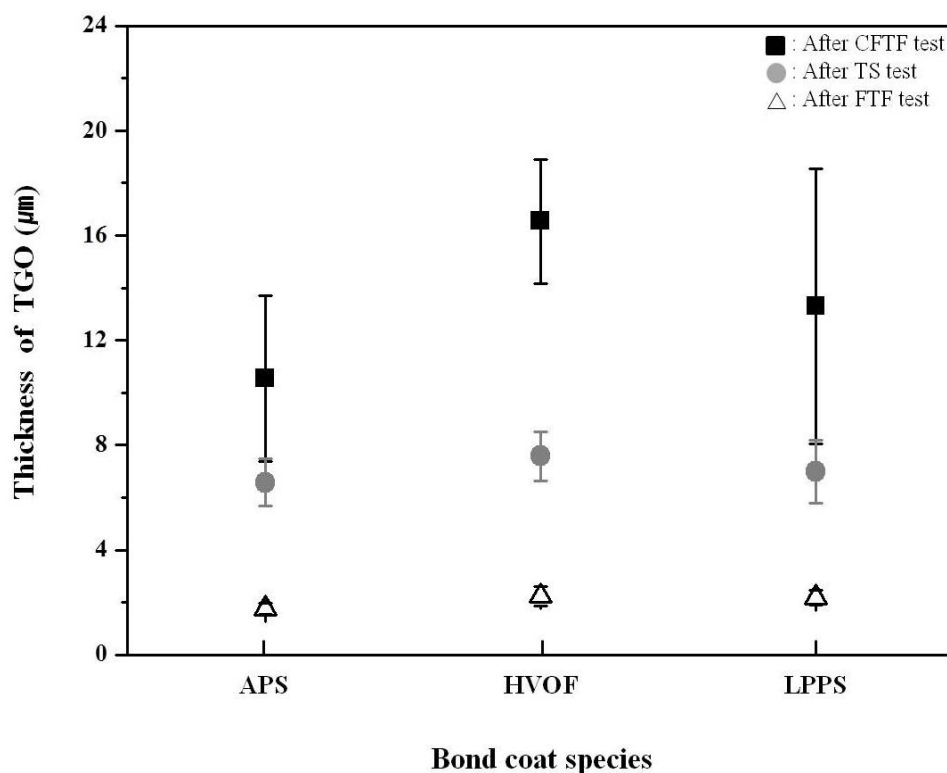
Figure 9. Thickness of thermally grown oxide (TGO) layer with bond coat species after different thermal exposure tests. Black, gray, and white marks indicate the TGO thickness values after the CFTF, TS, and FTF tests, respectively.

The thickness of the TGO layer for the three TBC systems after each test are shown in Figure 9. After the FTF tests, the TGO layer was not fully developed after 1429 cycles, owing to the relatively short thermal exposure time (119 h), showing nominal thicknesses of the APS, HVOF, and LPPS specimens as 1.8, 2.2, and 2.3 μm , respectively. The TBCs with the bond coats prepared by the APS and HVOF processes showed nominal thicknesses of the TGO layer as 10.5 and 16.5 μm , respectively, after the CFTF tests for 1429 cycles. In the case of the TBC with the LPPS bond coat, the nominal thickness of the TGO layer was 13.3 μm after the CTFT tests at TBC delamination (780 cycles). The difference in the thickness of the TGO layer between the FTF and CFTF tests was due to different thermal exposure times and the temperature of bottom surface. If the exposure time is increased at higher temperature, the thickness of the TGO layer would be increased in a certain cycles. Also, the temperature of bottom surface affects the growth of the TGO layer, resulting in a thicker thickness of TGO layer at higher temperature. After the TS tests, the thickness of the TGO layer did not show a difference with bond coat species in the FTF tests, showing nominal thicknesses of 6.6, 7.6, and 7.0 μm , for the APS, HVOF, and LPPS, respectively.

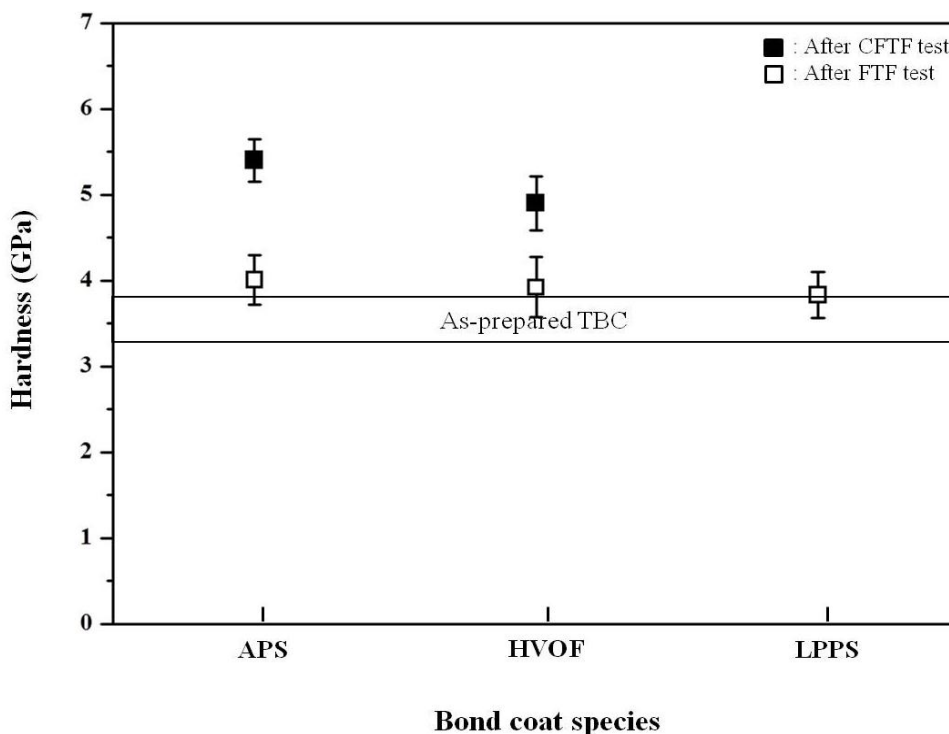
Figure 10. Hardness values of top coats before and after cyclic thermal exposure. Indentation for hardness was conducted on the sectional plane with a load of 3 N. The nominal value of as-prepared TBC was indicated inside figure. Filled and open marks indicate the hardness values after the CFTF and ETF tests, respectively.

The hardness values of the top coats before and after thermal exposure were measured using a Vickers indentation method (Figure 10). The indentation tests were conducted on the sectional plane with a load of 3 N at room temperature. The hardness values of the top coats in the as-prepared TBCs were determined to be 3.45 ± 0.23 GPa (mean \pm standard deviation). After the FTF tests for 1429 cycles, the hardness values of the top coats were increased to 4.01 ± 0.29 , 3.92 ± 0.35 , and 3.83 ± 0.27 GPa for the bond coats prepared by the APS, HVOF, and LPPS processes, respectively. The increase in the hardness values after thermal exposure was due to the reduction of pores and defects [29,30], which is in good agreement with the microstructural evolution in Figures 2–4. The microstructural evolution of the top coat prepared by the APS was more advanced, resulting in the disappearance of the pores and splat boundaries. The TBCs with the bond coats prepared by the APS and HVOF processes showed hardness values of 5.40 ± 0.25 and 4.90 ± 0.32 GPa, respectively, after the CTFT tests for 1429 cycles. The TBC with the LPPS bond coat was delaminated after the ETF tests for 780 cycles and hence there was no hardness value. After the TS tests, all of the TBCs were delaminated at the interface between the top and bond coat, therefore there was no hardness value in the top coat. The hardness values of the bond coats before and after the thermal exposure tests are shown in Figure 11. In the bond coats, the hardness values were modestly decreased, independent of bond coat species, compared with those of as-prepared bond coats. This result agrees with that of previous investigation [29,30]

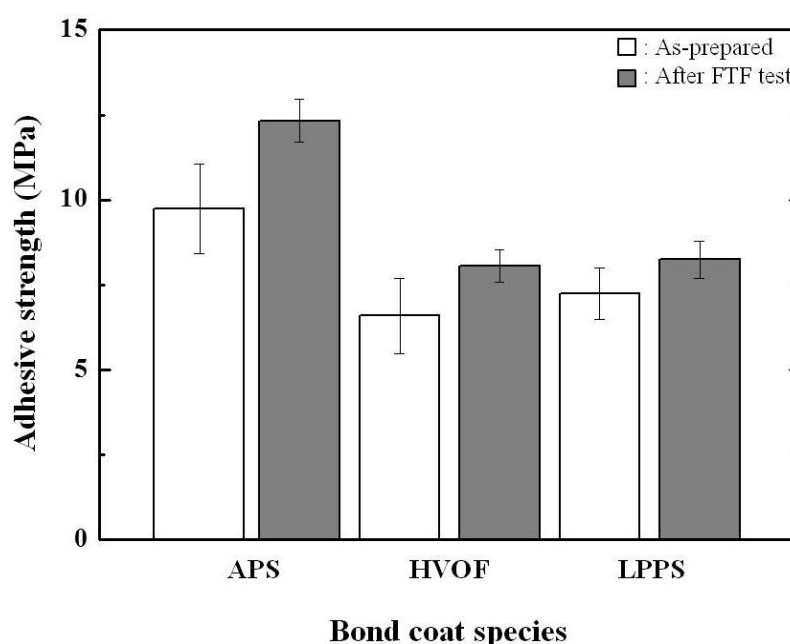
Figure 12. Adhesive strength values of TBCs before and after the FTF.

The origin of delamination at the interface between the bond and top coats is strongly related to the adhesive strength. Therefore, the adhesive strength values were measured for the TBCs before and after the FTF tests, which are shown in Figure 12. The adhesive strength values of the as-prepared TBCs with the bond coats prepared by the APS, HVOF, and LPPS processes were determined to be 9.73 ± 1.33 (mean \pm standard deviation), 6.58 ± 1.11 , and 7.23 ± 0.76 MPa, respectively. All of the TBCs were completely delaminated near the interface between the top and bond coats. The adhesive strength values of the top coats are increased to 12.32 ± 0.63 , 8.58 ± 1.12 , and 8.24 ± 0.54 MPa for the TBCs with the bond coats prepared by the APS, HVOF, and LPPS processes, respectively, after the FTF tests for 1429 cycles. The results indicate the interface stability of the TBCs with the APS bond coat is better than the TBCs with the HVOF or LPPS bond coat. Therefore, the TBCs with the APS bond coat provided superior TBC lifetime in cyclic thermal exposure.
