Article

Fiberglass Grids as Sustainable Reinforcement of Historic Masonry

Keywords: Textile Reinforced Mortars (TRM); GFRP grids; ageing tests; mechanical tests; masonry walls; masonry tile vaults; ring beam reinforcement

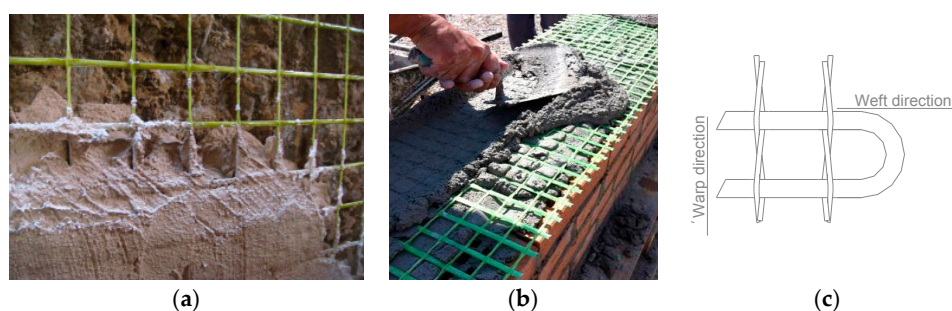
Figure 1. (a) $66 \times 66 \text{ mm}^2$ GFRP grid; (b) $33 \times 33 \text{ mm}^2$ GFRP grid; (c) schematic layout.

The TRM material used in the investigation is made up of an inorganic lime- or low cement-based mortar and GFRP grid. While the mortars are different both in composition and mechanical properties, the same GFRP grid has been used to reinforce all masonry structural elements described in Section 3. The GFRP grid is a commercially available product (Figure 1). It is characterized by a mesh size of $33 \times 33 \text{ mm}^2$ or $66 \times 66 \text{ mm}^2$ and continuous fiber filaments embedded in thermosetting epoxy vinyl ester resin matrix. The meshes are manufactured using fiberglass, with AR-glass (Alkali Resistant) reinforcement and have a zirconium content equal to or greater than 16%. The weight density of the $66 \times 66 \text{ mm}^2$ and $33 \times 33 \text{ mm}^2$ grids is 0.5 and 1 kg/m^2 , respectively.

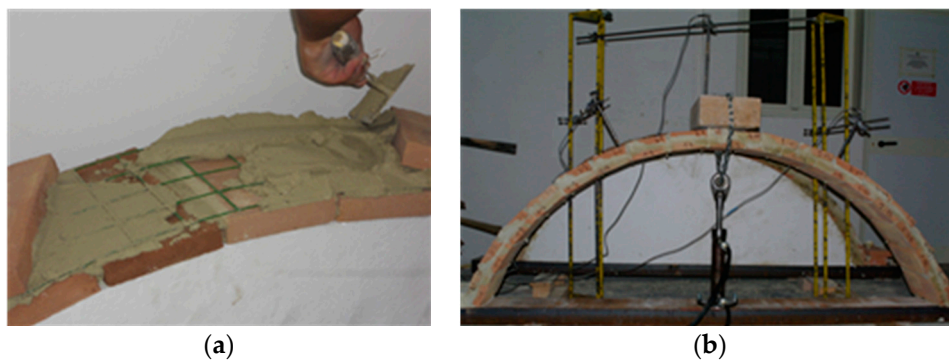
Figure 3. (a) Reinforcement application; (b) test arrangement.

Specimens were tested by applying a vertical compression load at vault crown (Figure 3b). Test results are reported in Table 2. All test specimens are identified by a three index code, in which the first character indicates the number of arch rings (DR, double-layer arch; TR, triple-layer arch); the second character designates the type of strengthening completed (UT, unreinforced; IT, reinforced vault with GFRP grid placed into the mortar bed joints; OT, reinforced with GFRP grid placed both into the mortar bed joints and on the outer surface of the arch); and the third index indicates the identification number of the specimen.

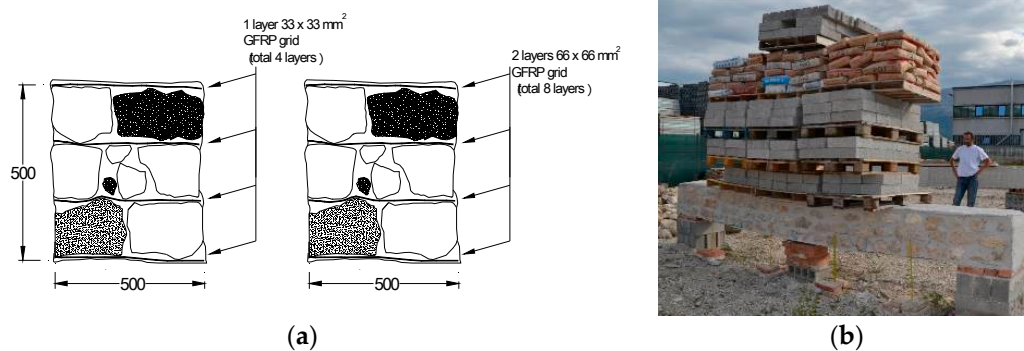
Figure 4. Ring beams under loading: (a) grid arrangement for stonemasonry beams; (b) P5-G33-V.

The reinforced masonry ring beams were tested by applying a bending load perpendicularly and parallel to the mortar bed joints and GFRP grid. The ends of each beam were simply supported on two $0.5 \times 0.5 \times 0.25 \text{ m}^3$ masonry blocks. The bending load was applied to the beams using concrete cubes and/or cement bags. The deflections and possibility of the beam twisting has been taken into account by applying linear variable displacement transducers on both sides of the beams (Figure 4b).

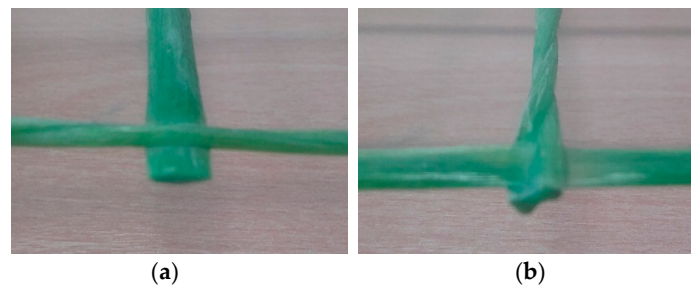
Figure 5. 66×66 mm² GFRP grid: (a) weft direction (SR type); (b) warp direction (SC type).

To determinate the effect of accelerated alkaline corrosion (ageing) on the strength characteristics of the material, GFRP specimens have been subjected to different ageing treatments to evaluate any change in their mechanical characteristics. Specimens were cut from the warp and weft directions of the $66 \times 66 \text{ mm}^2$ GFRP mesh, using a diamond saw. The glass fibers in the two directions present different cross section shapes: Rectangular-shaped in the weft direction, and made of two twisted circular-cross section cords in the warp direction (Figure 5).

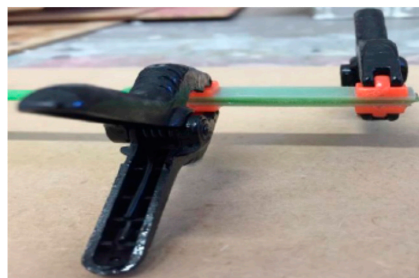
Figure 7. Detail of the epoxy tabs glued at both ends of the specimens.

resin at both ends of the specimen (Figure 7). All tensile tests were conducted with crosshead speed of 0.2–0.3 mm/min at room temperature of 21 ± 2 °C and humidity equal to 50%.

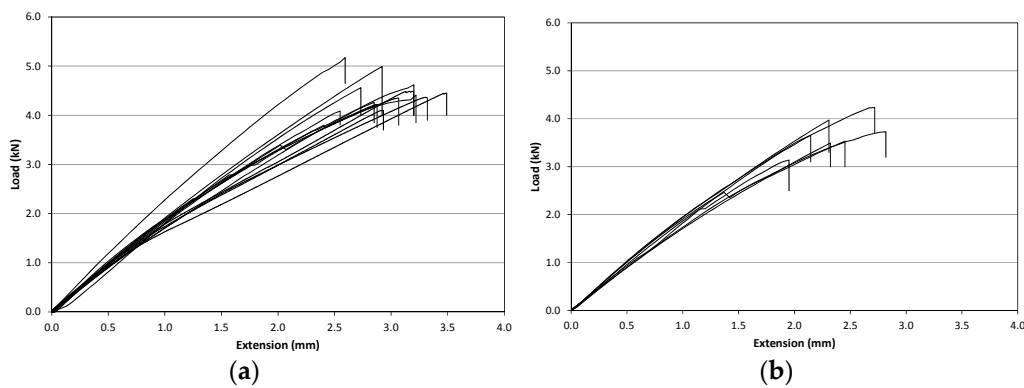
Figure 8. Load-extension curves for untreated specimens: (a) SR-series; (b) SC-series.

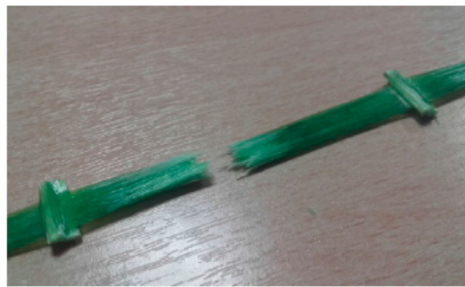
Figure 9. Catastrophic collapse of the GFRP sample.

SC specimens exhibited an average tensile strength of 986.2 MPa (SD = 85.9 MPa) and a Young's modulus of 74,224 MPa (SD = 2904 MPa). SR-type presents a tensile strength before treatment of 1179.1 MPa (SD = 78.22 MPa) and a Young's modulus of 70,189 MPa (SD = 1422 MPa). Two different failure modes for untreated GFRP specimens were observed: The first was a catastrophic collapse (tensile failure of the specimen approx. in the central part) (Figure 9) and the second was a partial fiber-failure at the GFRP grid joint (Figure 10).

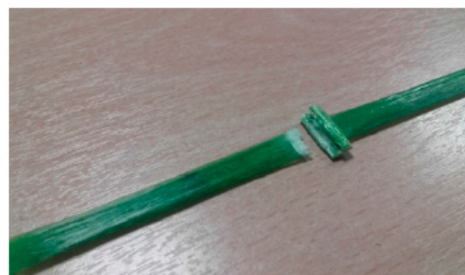
Figure 10. Partial fiber-failure at the GFRP grids joint.

The joint between the fibers in the two directions represents a defect as the fibers have to deviate from a straight line and rupture may easily occur in this point. Additionally, the twisted configuration in the warp direction (SC specimens) may cause a misalignment between the direction of the tensile load and the fiber orientation, reducing the tensile capacity of the specimens. Test results demonstrated that tensile strength in the warp direction (SC specimens) is approx. 16.4% smaller compared to the one in the weft direction (SR specimens). Test scattering (i.e., standard deviation, SD) is also larger for SC specimens.

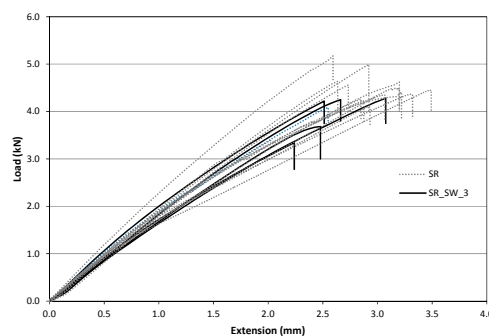
Figure 11. Comparison between SR and SR_SW_3.

After the treatment's time, samples were tested in tension to evaluate the possible effects on the tensile capacity and on Young's modulus. Tests have been carried out using the same test set up introduced for the untreated specimens (Section 4.1). Similar to the previous tests, the GFRP specimens subjected to ageing treatment exhibited an approximately linear trend up to the failure similar to the untreated samples (Figures 11 and 12).

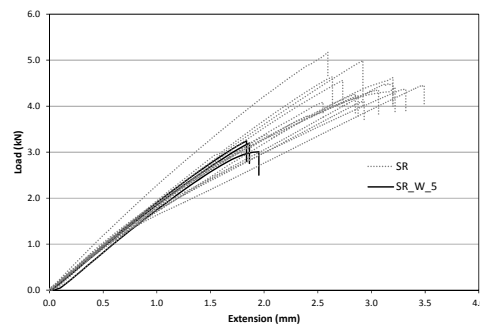
Figure 12. Comparison between SR and SR_W_5.

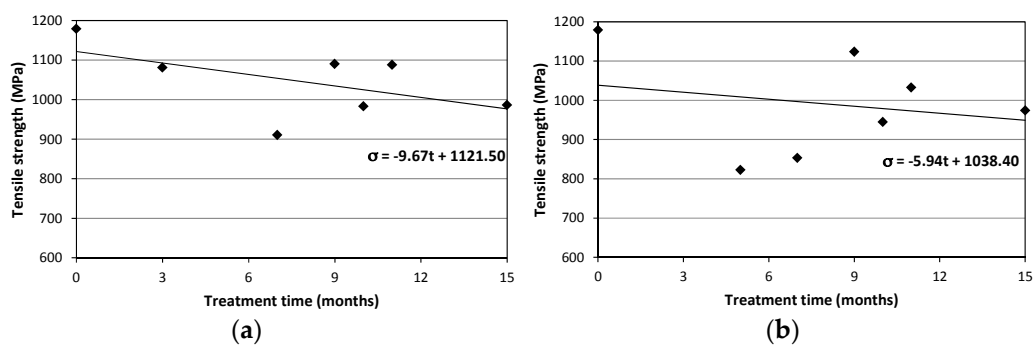
Figure 13. Tensile strength vs. treatment time for SR-series (a) NaCl solution; (b) deionized water.

Specimens characterized by the circular cross-section (SC) exhibited the maximum decrease in average tensile strength after 3 and 5 months respectively for NaCl and deionized water treatments. Strength reduction was 21.2% for specimens immersed in NaCl solution and 19.4% for those in deionized water. For those characterized by rectangular cross-section (SR) the maximum decrease for the average tensile strength were 22.8% (after 7 months) and 30.2% (after 5 months) for NaCl and deionized water treatments, respectively. Figure 11 shows the average values of the tensile strength for the specimens of the SR-series subjected to NaCl and deionized water treatments. Figure 12 shows the results for SC-samples.

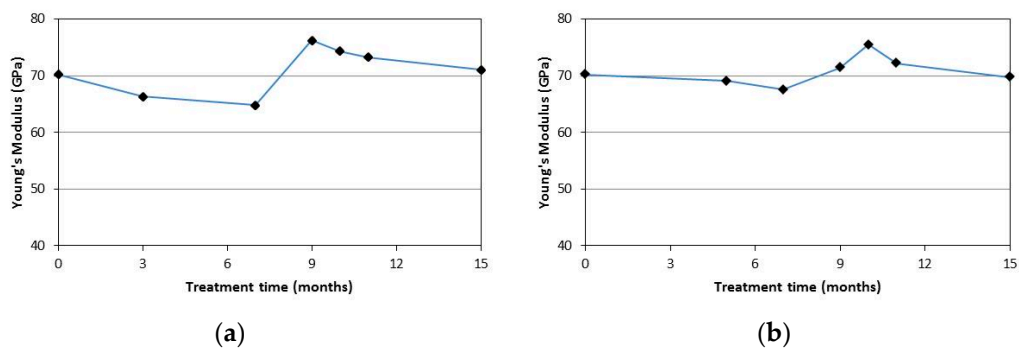
Figure 15. Young's modulus vs. treatment time for SR-series: (a) NaCl solution; (b) deionized water.

Figure 15 shows the average values of the Young's modulus for the specimens of the SR-series for both the ageing treatments after different months. Figure 16 shows the results for SC-series samples. It can be noted that a clear trend cannot be identified for the Young's modulus. The Young's modulus seems not to be affected by both the treatments (NaCl solution and deionized water solution) and its values remain constant with increasing treatment periods.

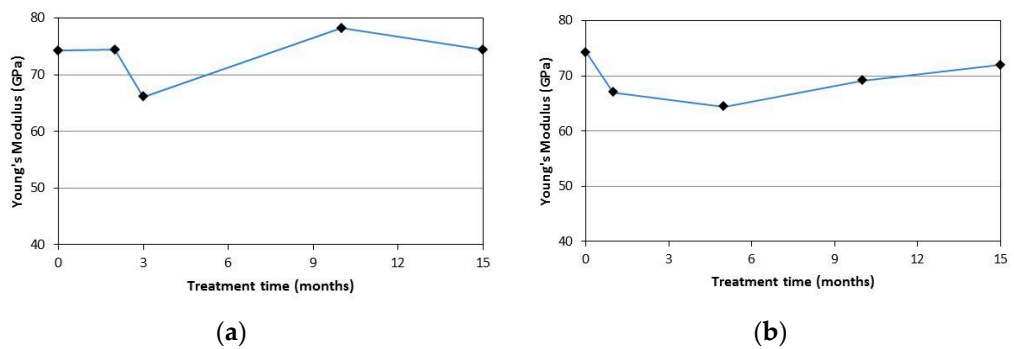
Figure 16. Young's modulus vs. treatment time for SC-series: (a) NaCl solution; (b) deionized water.

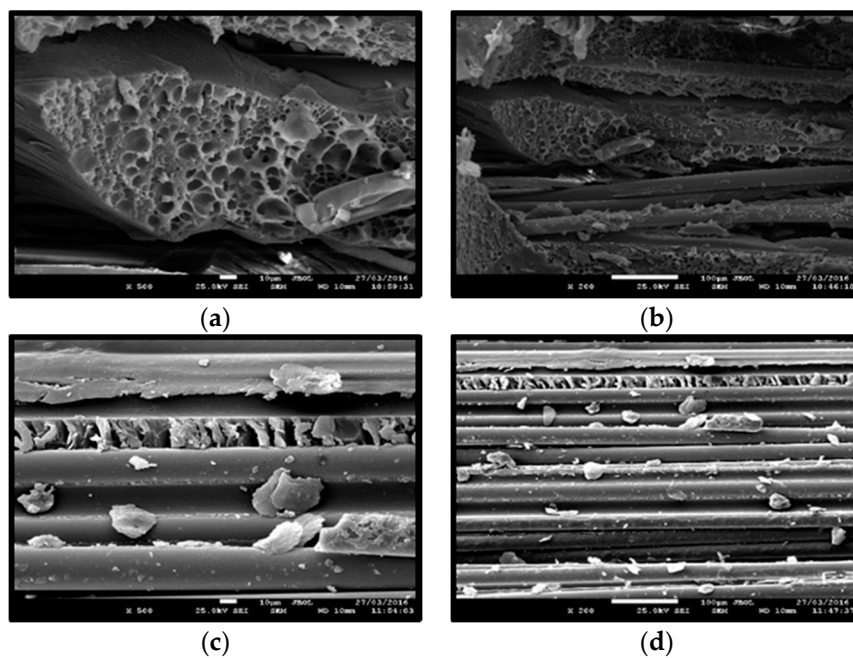
Figure 17. SEM micrograph of GFRP specimen aged in deionized water for 11 months: (a,b) section perpendicular to the fiber; (c,d) section parallel to the fiberglass filament.

A FEI Quanta 200 Scanning Electron Microscopy (SEM, FEI, Hillsboro, OR, USA) was used to evaluate the morphology of the fractured surfaces of the GFRP samples. Before the scanning a thin layer (15 nm thickness) of gold-palladium as conducting material has been applied on the GFRP specimen's surface, because the untreated sample is not a conducting material and specimens could not be analyzed without the applied layer. Figure 17a,b shows SEM micrographs in a SR_W_11 specimen after failure. It can be noted the cross section of a single glass filament. Scanning electron micrographs also display micro-cracking on the fibers due to ageing in deionized water, degradation of the epoxy matrix and evidence of fibers pull out. Figure 17c,d show the glass filament before the

test: It can be noted that the resin does not protect the lateral surface of the glass filaments and this is the main cause of the degradation of the mechanical characteristics of the fibers.
