Article

Timber Structures of Florence Cathedral: Wood Species Identification, Technological Implications and Their Forest Origin

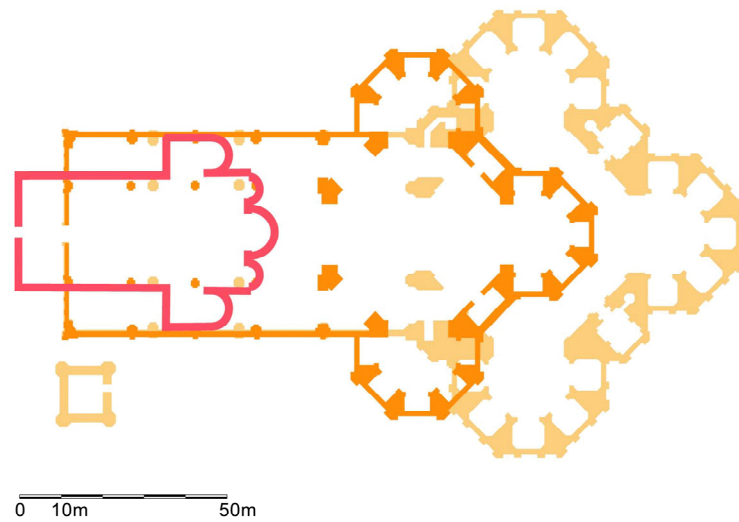
Figure 1. In red the profile of the ancient cathedral (Santa Reparata); in orange the project of Arnolfo di Cambio for the new cathedral (1296); in yellow the project by Francesco Talenti, corresponding to the adopted solution (1357).

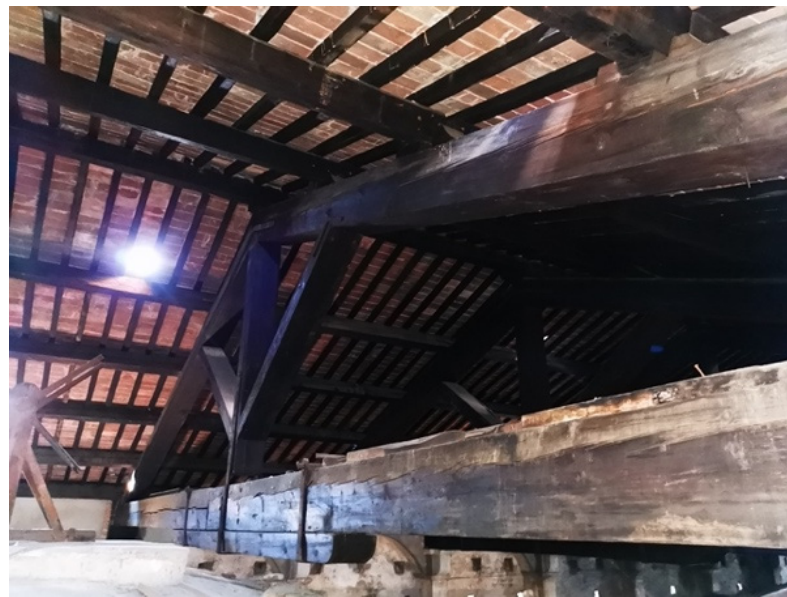
Figure 2. One of the trusses of the central nave.

characterised by a wooden forest that hardly finds analogous examples in architectures of the same dimensions and characteristics (Figure 2).

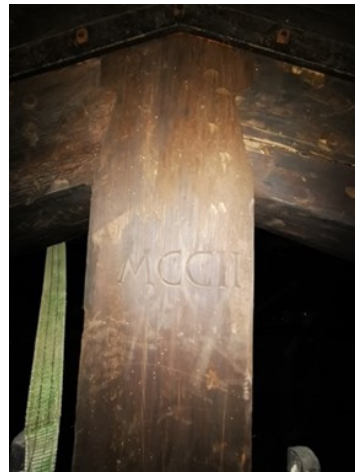
Figure 8. One of the elm wood king posts of the central nave shows a graved possible dating (MCCII). In this case, the graved year would be more than two centuries before the assembling of the roof, marking a possible reuse from a previous structure.
